# Arboricultural Assessment Impact & Tree Protection Report

The Rectory & Quayside  
Mountshannon  
Co. Clare

Project No.	Project name	Date	Revision
TINI003	The Rectory & Quayside	05/12/24	C

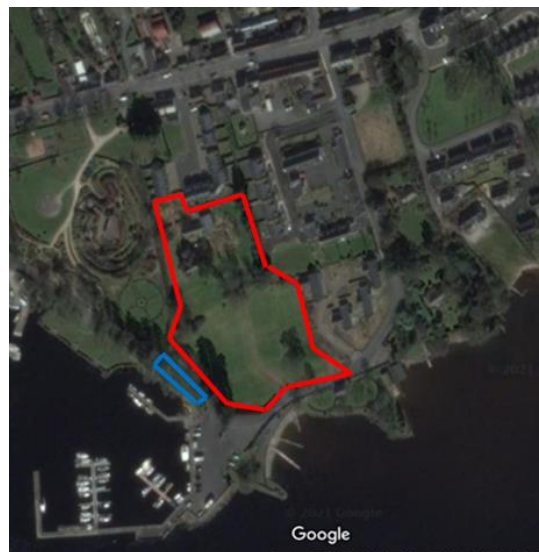
**Image 1.** Site boundaries  
Red (Rectory), Blue (Quayside). indicative only

The Rectory site encompasses the lands surrounding the rectory and with the exception of a cluster of ornamental cherries and a large mature oak the trees are located on the boundaries of the site. (image 1 red line). The age range of the trees is mixed but mainly mature (chart 1) with a small number of trees within that category which might pre-date the rectory building.
