1.0 INTRODUCTION

Layde Consulting was appointed by Carlin Planning Ltd to undertake a series of bat activity surveys and potential roost assessments for a proposed Regeneration Scheme within Monaghan town, extending to lands at the rear of Dublin Street North. This report summarises the key findings in relation to identified bat species within the study area and provides further recommendations as necessary.

1.1 Site Overview & Development Proposals

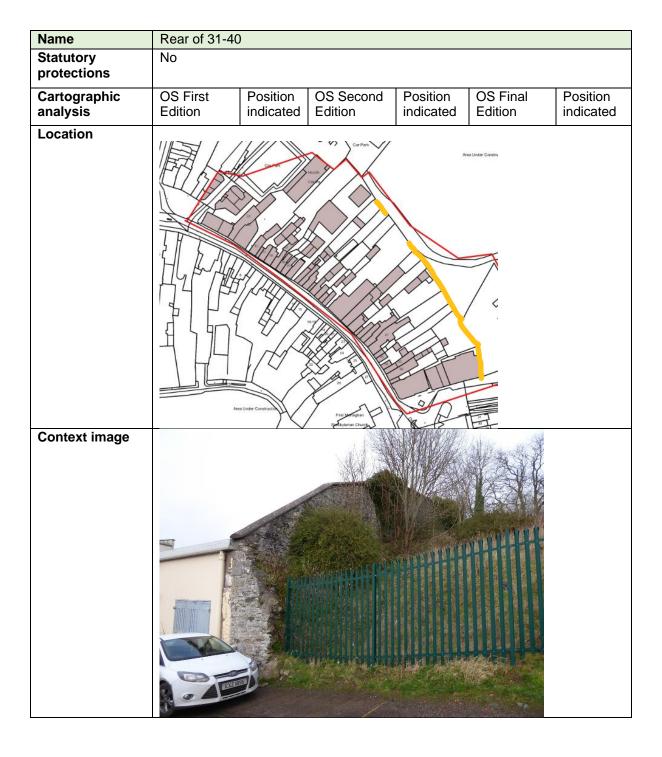
8.3.1 Stone Wall SW01

Image 1	
Image 2	
Description	Tall coursed rubble boundary wall with coping to top. Colonised by vegetation to a greater or lesser extent along its length. Follows the line of the historic boundary between the Dublin Street plots and the hill behind. Does not follow the boundary line of 1791 but follows the line present on the OS First Edition in 1836. Was associated with the now demolished Asylum infirmary and its gate lodge; the wall turns the corner at Old Cross Square and a break line where the return was demolished is evident.
Planning History	None
Other relevant information	
Consideration	A strong urban boundary denoting the historic edge of Monaghan town and the last intact feature of the former Asylum infirmary site. Where possible this should be incorporated into future development plans.
