CLONASLEE FLOOD RELIEF SCHEME

Appendix 16.8: Conservation Report

CONSERVATION REPORT

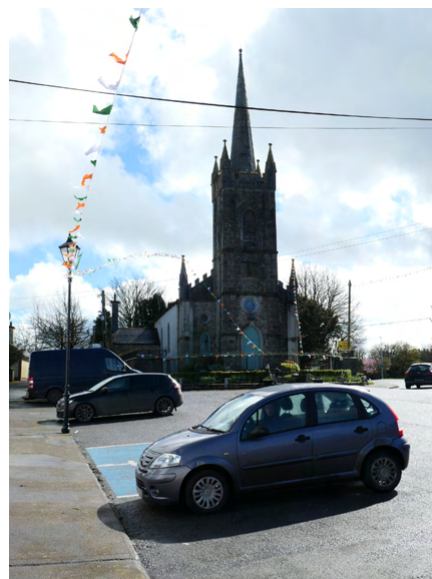
Fig.01 Church of Ireland parish church

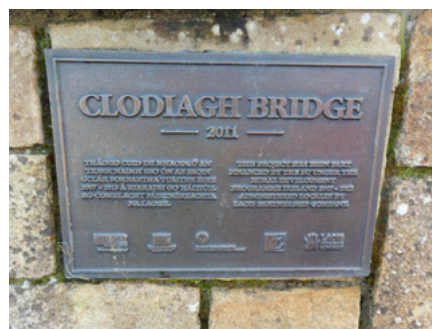
Fig.02 Clodiagh Bridge plaque

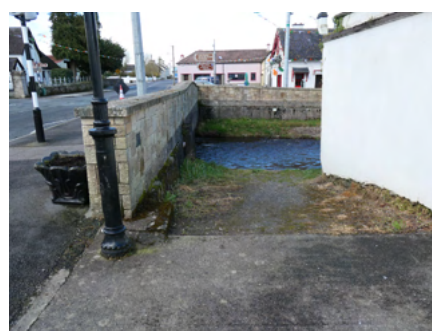
Fig.03 Clodiagh Bridge

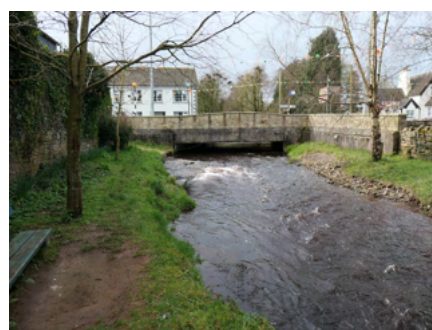
Fig.04 Clodiagh Bridge from north

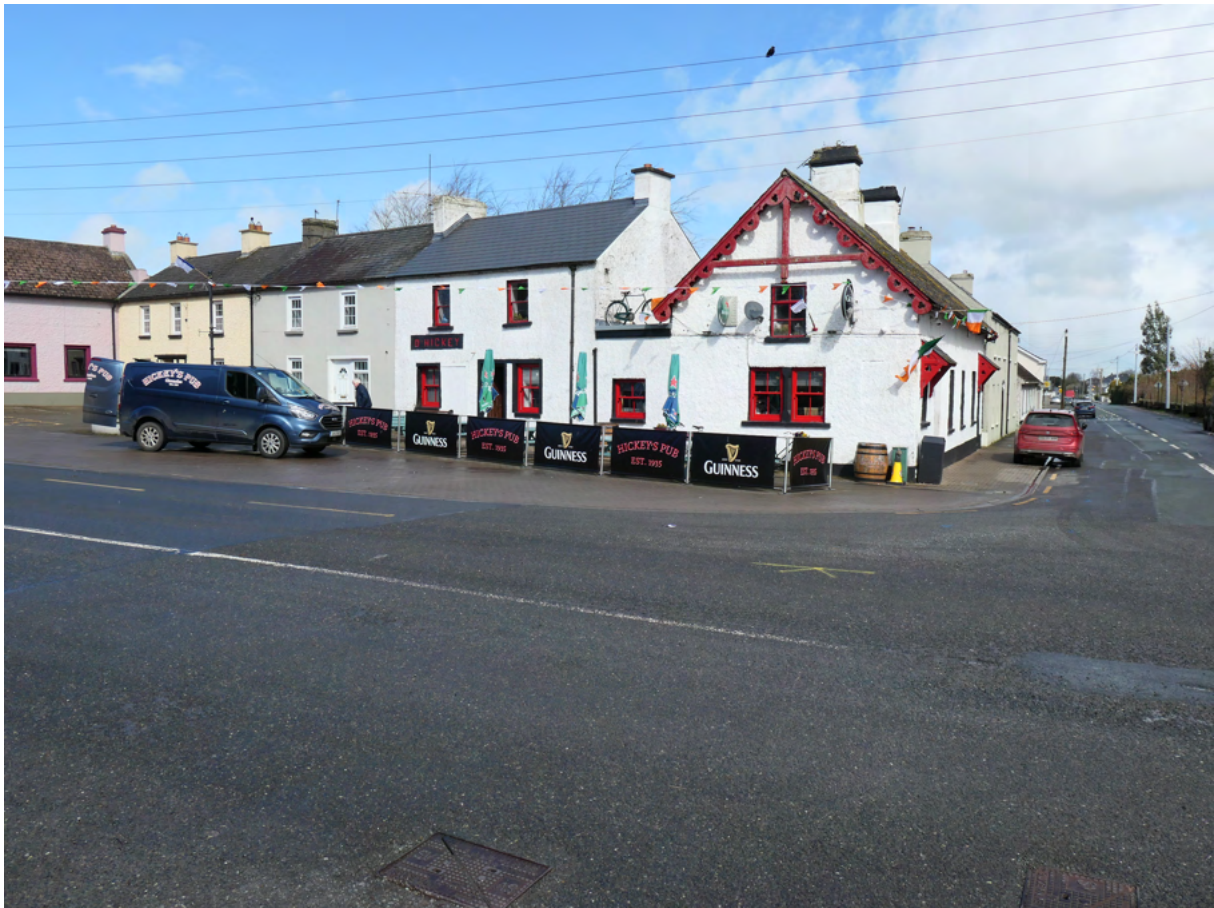
None of the Protected Structures listed above will be affected by the proposed Flood Relief Scheme.

Fig.06 M D Hickey pub facade, The Square (RPS 343)

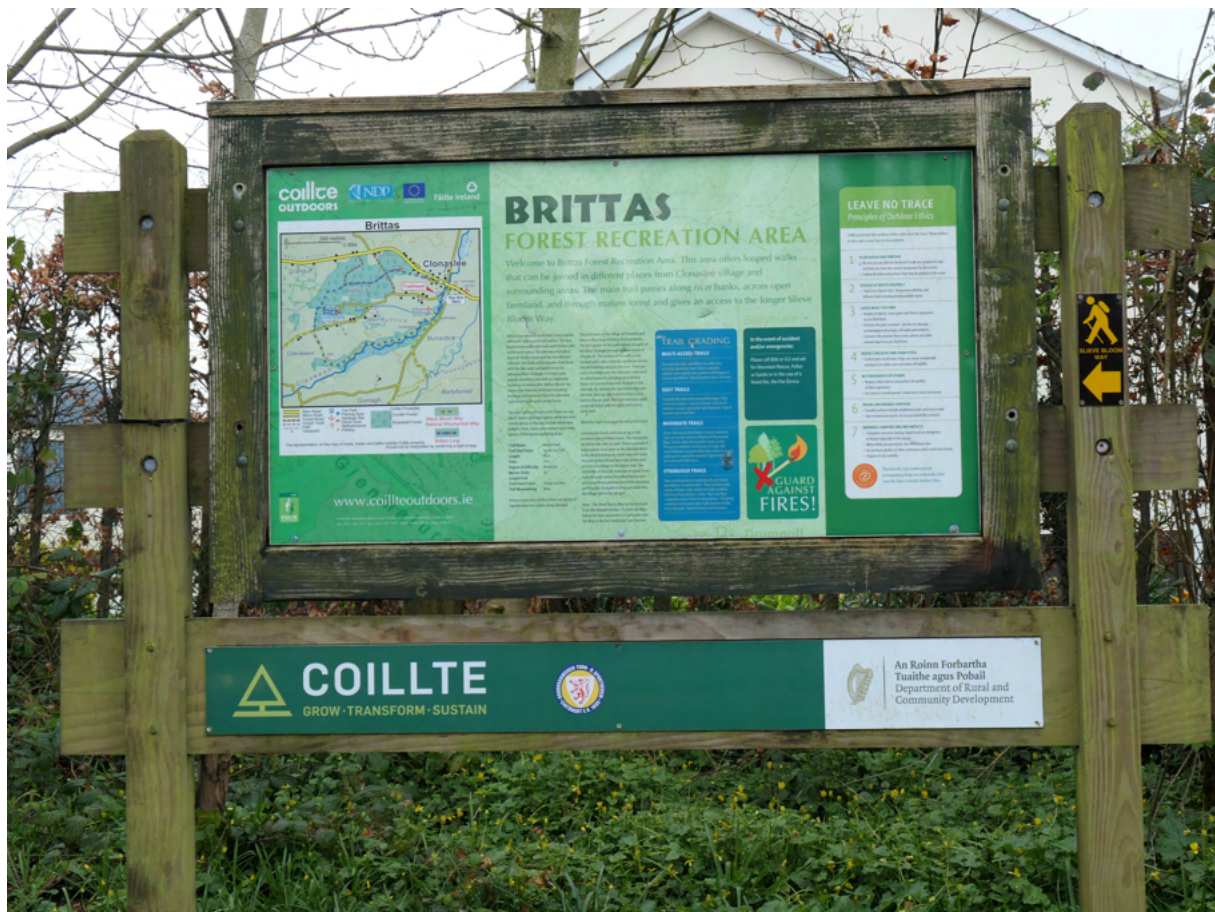
The area impacted by the Flood Relief Scheme was reviewed and contains no structures of built heritage significance.

Fig.07 Brittas Wood information board

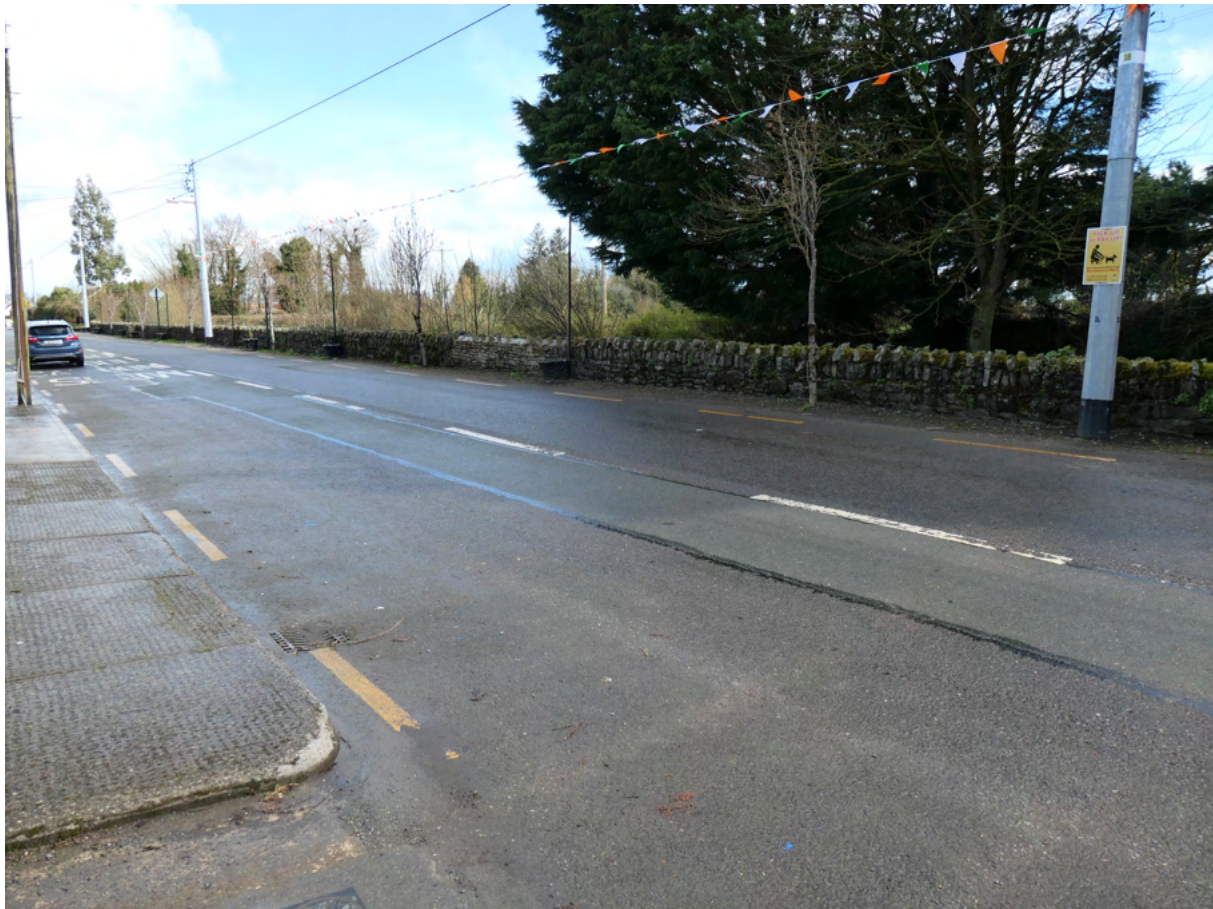
The wall between Chapel Street and the river is approximately 800mm high, reducing in height towards the south end at Clodiagh Bridge. It is approximately 600mm wide and is constructed from uncoursed, as-found, rubble stone laid in lime mortar bedding. The height of the original wall was increased at some time in the past through the addition of a course of vertically-set stones spaced apart and set in a roughly domed mortar bed. The wall can be considered in ten sections demarcated by square planters set alongside the wall and numbered 01 to 10 from north to south.

Fig.08 Chapel Street from south

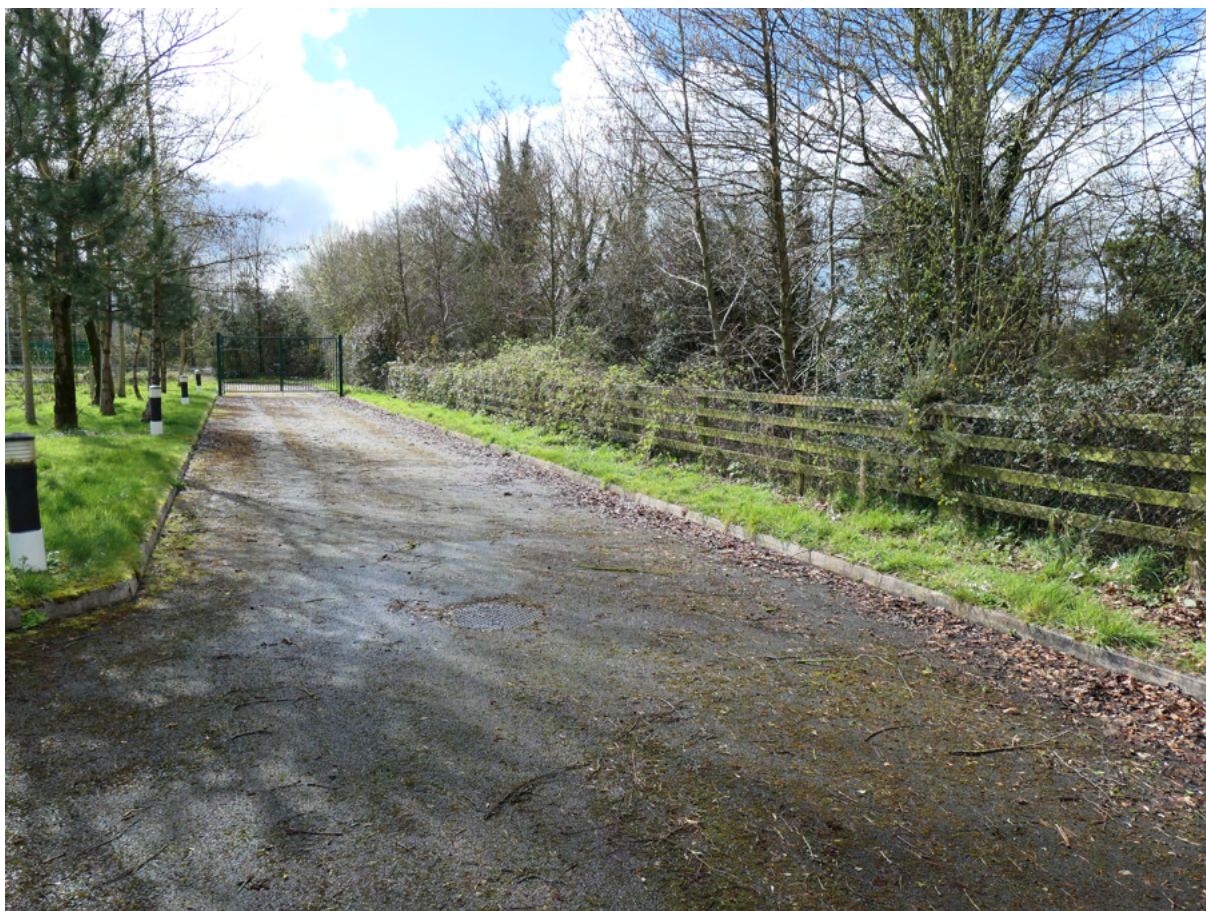
The area impacted by the Flood Relief Scheme was reviewed in the company of William Clooney (ICW Coordinator) and was found to contain no structures of built heritage significance.

Fig.33 Tullamore Road
