### Tree Survey Report

Project <b>Tree Survey for the Douglas and Togher Flood Relief Scheme.</b>				
Client <b>ARUP</b>				
Project no	No pages	Client reference	©DixonBrosnan 2016	
1653	-	-	v010111	
<p>DixonBrosnan 7 The Cedars Bridewood Ovens Co Cork          Tel 086 8511437   carl@dixonbrosnan.com   www.dixonbrosnan.com</p>				
Report no	Date	Edit	Prepared by	
1666	18/04/17	0 – Issue to client	Mark Donnelly	
			Carl Dixon	
<p style="font-size: small;">This report and its contents are copyright of DixonBrosnan. It may not be reproduced without permission. The report is to be used only for its intended purpose. The report is confidential to the client, and is personal and non-assignable. No liability is admitted to third parties.</p> <p style="text-align: right; font-weight: bold; font-size: small;">Do you <i>really</i> need a printed copy of this report?</p>

## DOUGLAS- Flood Relief Scheme

04/04/2017

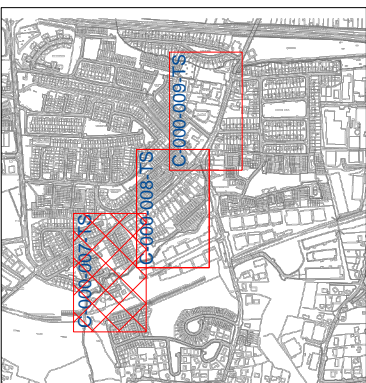
Drawing No.: C-000-007-TS (04/04/2017)-Tree Survey (Not to Scale)

No.	Species	Age Class	Girth (mm)	Height (m)	Spread (m)				Condition	Risk Code	Comments	Rec	RPA (m)
					N	E	S	W					
853	Sycamore	M	400	12		10			Fair	B	4 stems	3	-
854	Western Red Cedar	SM	200	4					Good	C	Hedge (and <i>Cypressus macrocarpa</i> )	2	2.4
855	Alder	SM	250	12		5			Good	C	GROUP of 20 trees	2	3.0
856	Elm	M	500	15		10			Poor	A	Dead 2 trees	3	-
857	Willow	M	250	9		8			Good	C	GROUP of 5 trees	2	3.0
858	Elm	M	350	10	5				Poor	A		3	-
859	Elm	M	380	20		10			Poor	A	GROUP of 4 trees	3	-
860	Sycamore	SM	300	18		10			Fair	B	5 stems	2	3.6
861	Elm	M	500	20		9			Poor	C	2 dead Elm	3	-
862	Sycamore	SM	300	15		9			Good	C	2 trees (1 ash)	1	3.6
863	Sycamore	M	900	20		20			Good	C	2 stems	1	10.8
864	Ash	M	350						Poor	B	Poor tree. 2 stems	3	-
865	Sycamore	M	380	18		10			Good	C		1	4.2
866	Alder	M	280	14		8			Good	C	1 tree	2	3.3
867	Alder	M	200	15		8			Fair	C	3 trees	2	2.4
868	Alder	M	300	18		8			Fair	B		3	-
869	Beech	SM	350	18		8			Poor	A	Rot at base	3	-

870	Alder	M	300	18		8			Poor	A	Rot at base	3	-
871	Elm	M	350	15		6			Poor	A	Dead	3	-
872	Elm	SM	300	12		6			Poor	A	Dead	3	-
873	Ash	M	1000	18		15			Poor	B	Veteran tree. Dead top. Rot at base. POLLARD	1	12.0
874	Evergreen Oak	M	450	13		10			Good	C	Specimen tree - RETAIN	1	5.4
875	Elm	M	450	13		10			Poor	A	2 trees dead	3	-

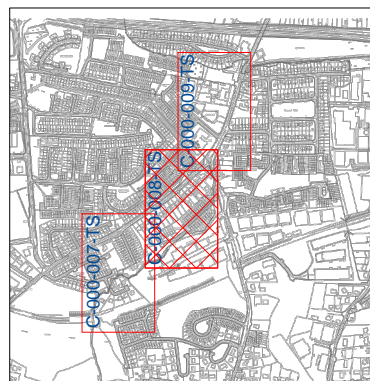
Drawing No.: C-000-008-TS (04/04/2017)-Tree Survey (Not to Scale)

No.	Species	Age Class	Girth (mm)	Height (m)	Spread (m)				Condition	Risk Code	Comments	Rec	RPA (m)
					N	E	S	W					
842	Horse Chestnut	M	450	23		18			Fair	B	Poor form. 3 stems. 30 % crown reduction if compromised by excavations	2	5.4
843	Ash	M	450	18	10				Fair	B		3	-
844	Elm	M	450	8		5			Fair	B		3	-
845	Lime	M	300	13		10			Fair	B	4 stems - Will need leaning stem removed	2	3.6
846	Ash & Elm	M	450	18		9			Good	B	GROUP of 10 trees	2	5.4
847	Ash	SM	400	9		8			Good	C		2	4.8
848	Ash	SM	500	9		8			Good	C	Over culvert	2	6.0
849	Ash	SM	500	9		8			Poor	A	Poor form	2	6.0
850	Ash	SM	300	9		8			Poor	A	Cankered	2	6.0
851	Ash	SM	400	9		8			Fair	B	Forked	2	4.8
852	Ash	SM	580	12		10			Fair	B	Poor health	3	-
338	Norway Maple	IM	200	8		4			Good	C	Retain if possible	2	2.4
337	Norway Maple	IM	200	8		4			Good	C	Retain if possible	2	2.4
336	Birch	IM	150	5		4			Good	C	Retain if possible	2	1.8
335	Birch	IM	150	5		4			Good	C	Retain if possible	2	1.8

334	Birch	IM	150	5		4			Good	C	Retain if possible	2	1.8
333	Norway Maple	IM	250	9		4			Poor	A	Damaged	3	-
332	Norway Maple	IM	230	9		5			Poor	A	Damaged	3	-
331	Norway Maple	SM	300	10		6			Good	C	Retain if possible	2	3.6
352	Lime	IM	200	8		5			Good	C	Retain if possible	2	2.4
353	Lime	IM	200	8		5			Good	C	Retain if possible	2	2.4
354	Lime	IM	250	8		5			Good	C	Retain if possible	2	3.0
355	Lime	IM	300	8		5			Good	C	Retain if possible	2	3.6
356	Callery Pear	IM	200	8		4			Good	C	Retain if possible	2	2.4

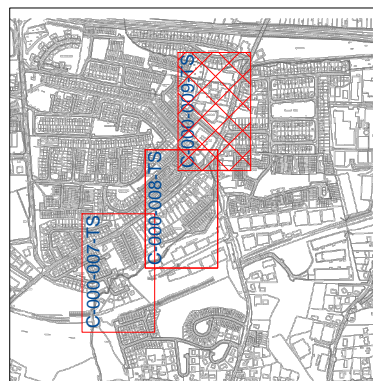
Drawing No.: C-000-009-TS (04/04/2017)-Tree Survey (Not to Scale)

No.	Species	Age Class	Girth (mm)	Height (m)	Spread (m)				Condition	Risk Code	Comments	Rec	RPA (m)
					N	E	S	W					
839	Lime	SM	300	8		5			Good	C		1	3.6
840	Lime	SM	200	8		5			Fair	C	Suppressed and damaged at base	1	2.4
841	Beech	SM	360	10		10			Good	C		1	4.2
350	Silver Birch	IM	150	5		3			Good	C	Commemorative Tree (Priority Tree)	2	1.8
349	Cherry	SM	350	8		6			Good	C		2	4.2
348	Ash	IM	200	5		4			Poor	B	Poor Health - Cankered	3	-
347	Cherry	SM	300	6		4			Good	C		2	3.6
346	Rowan	M	350	9		4			Good	C		2	4.2
351	Silver Birch	SM	250	9		5			Good	C		2	3.0
345	Cherry	SM	300	8		5			Good	C		2	3.6
344	Ash	SM	350	9		8			Good	B		2	4.2
343	Oak	SM	250	9		6			Fair	C	Poor Form	2	3.0
342	Birch	SM	200	8		4			Good	C	Good form - Retain if at all possible	2	2.4
341	Birch	SM	200	8		4			Good	C	Retain if possible	2	2.4
340	Birch	SM	200	8		4			Good	C	Retain if possible	2	2.4
339	Norway Maple	IM	150	5		2			Good	C	Retain if possible	2	1.8

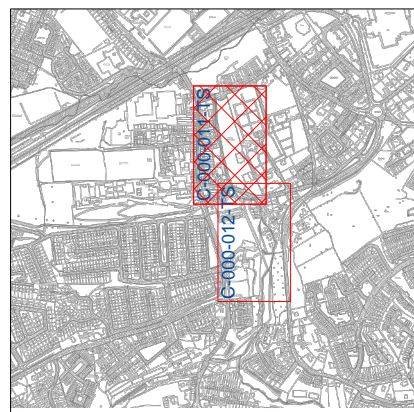
Drawing No.: C-000-011 TS (04/04/2017)-Tree Survey (Not to Scale)

No.	Species	Age Class	Girth (mm)	Height (m)	Spread (m)				Condition	Risk Code	Comments	Rec	RPA (m)
					N	E	S	W					
681	Sycamore	SM	300	8		7			Good	C		1	3.6
682	Ash	SM	400	9		8			Good	C		1	4.8
683	Norway Maple	SM	350	8		8			Good	C		1	4.2
684	Norway Maple	SM	260	7		7			Good	C		2	4.2
685	Ash	SM	300	7		7			Good	C		2	3.6
686	Norway Maple	SM	300	7		6			Good	C		2	3.6
687	Birch	IM	150	6		3			Good	C		2	1.8
688	Birch	IM	200	6		4			Good	C		2	2.4
689	Birch	IM	190	6		4			Good	C		2	2.4
690	Norway Maple	SM	400	8		9			Poor	B	Poor form	3	-
691	Norway Maple	SM	300	9		8			Good	C		2	3.6
692	Norway Maple	SM	320	8		7			Good	C		2	3.9
693	Norway Maple	SM	300	8		7			Good	C	Could remove or thin	3	3.6
694	Norway Maple	SM	290	9		9			Good	C		2	3.6
695	Norway Maple	SM	400	8		7			Poor	B	Poor form	2	4.8
696	Norway Maple	SM	280	8		7			Poor	B	Poor form/fork	3	-
697	Norway Maple	SM	290	7		6			Good	C		1	3.3
698	Norway Maple	IM	280	7		6			Good	C		2	3.3

No.	Species	Age Class	Girth (mm)	Height (m)	Spread (m)				Condition	Risk Code	Comments	Rec	RPA (m)
					N	E	S	W					
712	Lime	SM	450	9		7			Poor	A	Rot at base	3	-
713	Lime	SM	150	5		3			Poor	B	Suppressed	2	1.8
714	Aspen	M	400	11		8			Good	C	Good tree	1	4.8
715	Ash	SM	250	6		4				B	Suppressed	2	3.0
716	Lime	SM	280	9		5			Good	C		2	3.3
717	Lime	SM	350	10		6			Good	C		2	4.2
718	Lime	SM	250	7		5			Fair	B	Suppressed	3	-
719	Aspen	IM	440	11		8			Good	C		2	5.4
720	Aspen	M	400	12		8			Good	C		2	4.8
721	Norway Maple	SM	400	10		8			Good	C		2	4.8
722	Lime	M	450	11		9			Good	C		2	5.4
723	Lime	SM	400	10		8			Fair	B	Forked	2	4.8
724	Rowan	M	250	7		6			Good	C		1	3.0
725	Rowan	M	250	7		6			Good	C		1	3.0
726	Maple	SM	350	9		7			Poor	B	Damaged base	3	-
727	Maple	SM	360	9		7			Poor	B	Damaged base	3	-
728	Lime	M	680	12		10			Good	C		1	8.1
729	Norway Maple	SM	360	9		8			Good	C		1	4.2
730	Rowan	M	240	7		6			Good	C		1	2.7
731	Norway Maple	SM	380	11		8			Good	C		1	4.5

732	Norway Maple	SM	400	10		8			Fair	B		3	-
733	Ash	SM	400	11		9			Good	C		1	4.8
734	Norway Maple	SM	380	11		9			Fair	B	Forked. Poor form	3	-
735	Field Maple	SM	420	11		9			Fair	B	Damaged stem	3	-
736	Oak	SM	320	9		5			Fair	B	Poor form	2	3.9
737	Horse Chestnut	SM	280	9		4			Good	B	Thin out	3	-
738	Horse Chestnut	SM	330	9		6			Fair	B	Thin out/Damaged stems	3	-
739	Norway Maple	SM	250	9		6			Good	C		2	3.0
740	Norway Maple	SM	340	10		8			Good	C		2	4.2
741	Field Maple	SM	300	9		5			Good	C		2	3.6
742	Norway Maple	SM	280	8		5			Good	C		2	3.3

No.	Species	Age Class	Girth (mm)	Height (m)	Spread (m)				Condition	Risk Code	Comments	Rec	RPA (m)
					N	E	S	W					
743	Norway Maple	SM	200	9		6			Good	C		2	2.4
744	Norway Maple	M	500	11		10			Poor	B	Poor form	3	-
745	Norway Maple	SM	240	10		5			Good	C		2	3.0
746	Norway Maple	SM	230	10		5			Good	C		2	2.7
747	Horse Chestnut	SM	350	11		8			Poor	B	Poor form	3	-
748	Field Maple	M	320	11		8			Good	C		2	3.9
749	Norway Maple	SM	380	10		8			Poor	B	Poor form	3	-
750	Lime	SM	280	10		9			Good	C		2	3.3
751	Norway Maple	SM	480	12		10			Poor	B	Poor form	3	-
752	Field Maple	M	320	10		7			Good	C		2	3.9
753	Field Maple	M	480	11		8			Good	C		1	5.4
754	Horse Chestnut	SM	360	9		9			Good	C		2	4.2
755	Field Maple	M	440	10		8				C		1	5.4
756	Field Maple	M	400	10		9			Good	C		1	4.8
757	Norway Maple	SM	400	12		10			Good	C		2	4.8
758	Norway Maple	SM	400	12		10			Poor	B		3	-
759	Norway Maple	SM	400	12		10				C		1	4.8
760	Norway Maple	SM	430	11		8			Fair	B	Poor form	3	-

761	Norway Maple	SM	380	10		6			Fair	C	Close to facilities	3	-
762	Norway Maple	SM	380	10		8			Good	C		1	4.5
763	Norway Maple	SM	350	10		6			Good	C		1	4.2
764	Lime	SM	400	9		8			Good	C		1	4.8
765	Norway Maple	SM	360	10		8			Fair	B	Poor form	2	4.2
766	Norway Maple	SM	300	10		6			Fair	B	Close to river	2	3.6
767	Norway Maple	SM	250	10		8			Fair	B	Damaged. NO TAG	2	3.0
768	Alder	M	400	10		10			Good	C	3 stems (1 sycamore). NO TAG	2	4.8
769	Sycamore	SM	280	10		3			Poor	B	Poor form	3	-
770	Ash	M	450	5		3			Fair	C	Pollarded	2	5.4
771	Ash	IM	300	10		4			Good	B	Can't reach potential	3	-
772	Ash	IM	200	9		4			Good	B	Can't reach potential	3	-
773	Ash	IM	350	10		8			Fair	B	Won't reach potential	3	-

No.	Species	Age Class	Girth (mm)	Height (m)	Spread (m)				Condition	Risk Code	Comments	Rec	RPA (m)
					N	E	S	W					
774	Sycamore	IM	350	11		9			Fair	B	Won't reach potential	3	-
775	Sycamore	IM	150	7		3			Fair	B	Won't reach potential	3	-
776	Ash	IM	200	7		5			Fair	B	Won't reach potential	3	-
777	Ash	IM	200	8		5			Fair	B	Won't reach potential	3	-
778	Sycamore	M	400	15		10			Fair	B	4 stems	3	-
779	Alder	M	400	15		10			Fair	C	4 stems	1	4.8
780	Alder	M	800	15		15			Good	C	2 stems	1	9.6
781	Alder	M	500	15		10			Good	C		1	6.0
782	Alder Sycamore Elder	M SM M	300 300 150	15		10			Fair		Could be retained but not if RPA is compromised	2	3.6
783	Sycamore	SM	230	12		10			Fair		4 stems	2	2.7
784	Alder	M	320	10		8			Fair		2 stems	2	3.9
785	Red Oak	SM	320	10		10			Good	C		2	3.9
786	Rowan	M	250	8		6			Fair	B	End of lifespan	2	3.0
787	Lime	SM	350	10		10			Good	C	Poor form	2	4.2
788	Beech	SM	360	10		10			Good	C	Poor form	2	4.5

No.	Species	Age Class	Girth (mm)	Height (m)	Spread (m)				Condition	Risk Code	Comments	Rec	RPA (m)
					N	E	S	W					
803	Beech	M	850	20		15			Good	C	Damage to stem (Reduce crown 30 % - SURGERY)	1	10.2
804	Rowan	M	350	8		5			Good	C		2	4.2
805	Norway Maple	SM	300	10		9			Good	C		1	3.6
806	Horse Chestnut	SM	400	10		9			Good	C		2	4.8
811	Beech	M	700	22		10			Fair	B	Not tagged. On corner. Crown reduction 30 %	1	8.4
