APPENDICES 5.10

Report of Geophysical Survey
Dun Laoghaire Cruise Project
At Dun Laoghaire Harbour, Co. Dublin
Licence Number: 13R73

Report of Geophysical Survey
Dun Laoghaire Cruise Project
At Dun Laoghaire Harbour, Co. Dublin
Licence Number: 14R0049

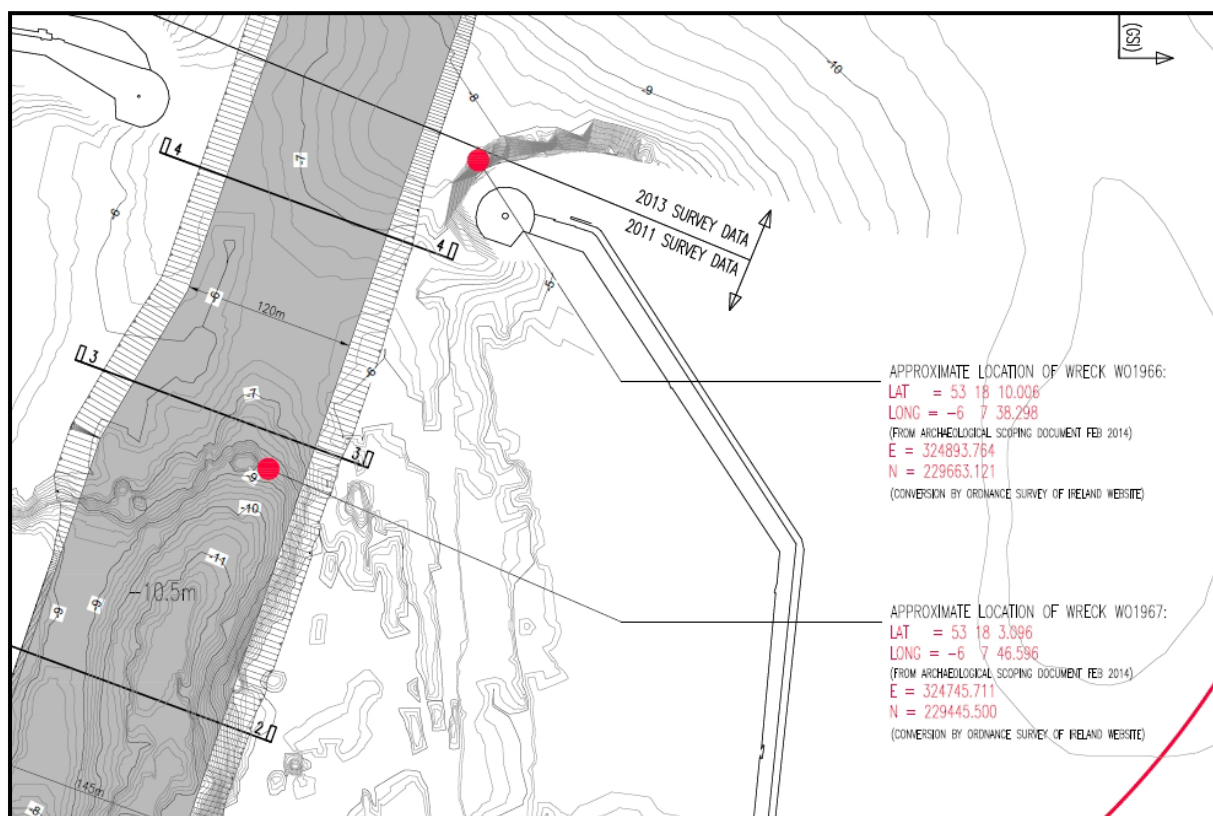
Figure 3. Known Wreck Locations

and turning circle. These consist of Wreck W01966 –discovered by Marlin Sub Aqua Club in harbour entrance at 53 18 10.006 N/ 006 07 38.298 W and Wreck W01967 identified during national sea bed survey inside of harbour entrance at 53 18 03.096 N/ 06 07 46.596 W. Both potential wreck sites should be considered as key archaeological constraints.

The WO1967 AND WO1966 wreck site locations (as seen in figure 3) are recorded in the SMR. It should be noted that there is a degree of uncertainty as to the accuracy of these locations. There is some correlation between the reported wreck locations and the sonar contact locations which were noted during the geophysical survey. The contacts may represent exposed or washed out debris associated with these wrecks.

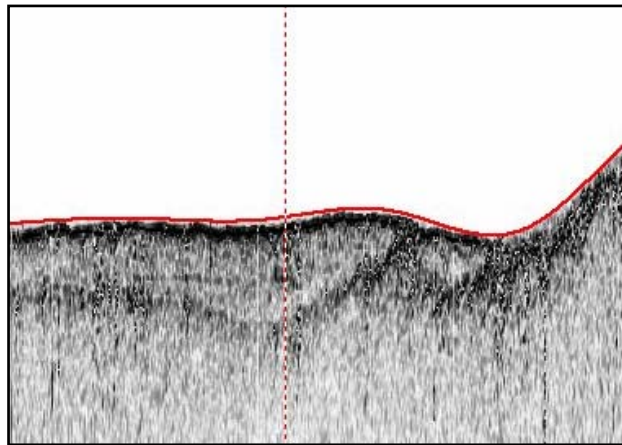
Plate 7. Sub Bottom Profiler section showing undulating seafloor substrate

In the main harbour area, the sub bottom profiler indicated the presence of a strong surface reflector with a possible sub horizon noted 2.5-3.2m below. This sub horizon was generally noted as a uniform horizon throughout much of the inner harbour survey area, however it did ascend and descend in places. The horizon appeared to mask the current bed level in many places but it was noted to undulate in certain areas, thus indicating that it was not a multiple reflector. No evidence of the recorded shipwreck WO1967 was noted in the sub bottom profiler record. The absence of evidence for the wreck remains can be attributed to a number of reasons:

- Density similarities between wreck remains and surrounding substrate
- Reflective co-efficient similarities
- Failure to pass directly over large buried sections

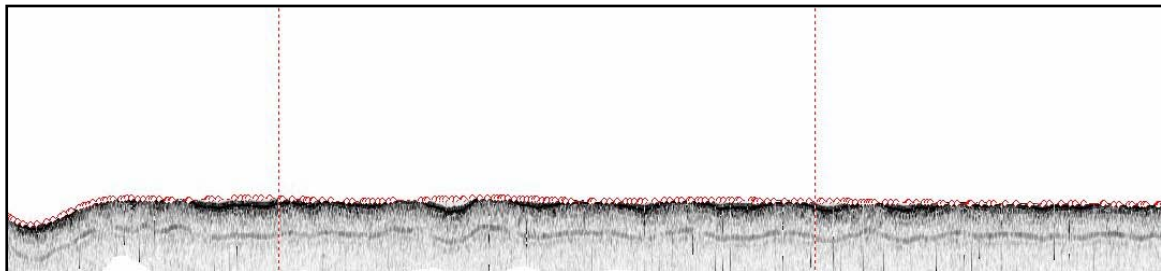
Plate 8. Central Sub Bottom Profiler line

In the outside harbour area, the substrate appeared to be more compact, thus making penetration more difficult. The survey did not manage to record bedrock depths as it was not designed as a low frequency, low resolution survey. It did however manage to record some data from this area. It recorded that a possible substrate horizon was noted 2.2 – 3.6m below the current bed level, throughout the outer survey area. The sub bottom profiler survey of the outer harbour area, did not appear to record the presence of any potential archaeological material.

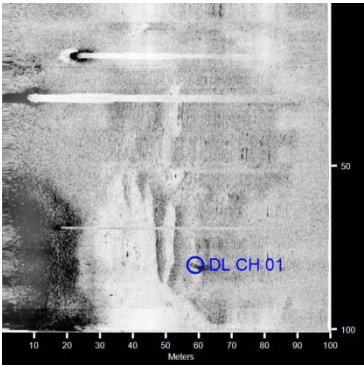
<p>DL CH 01</p> <ul style="list-style-type: none"> • Sonar Time at Target: 5/22/2014 12:49:23 PM • Click Position 53.2971607666 -6.1309018096 (WGS84) 0.0000000000 0.0000000000 (NAD27LL) 53.2971607666 -6.1309018096 (LocalLL) (X) 724594.07 (Y) 729058.92 (Projected Coordinates) • Map Projection: IRENET95.IrishTM • Acoustic Source File: E:\Dunleary Sidescan and MagData\DunlearySidescan\20140522124914.jsf • Ping Number: 35819 • Range to target: 58.59 Meters • Fish Height: 12.99 Meters • Heading: 46.890 Degrees • Event Number: 0 • Line Name: 20140522124914 • Water Depth: 0.78 Meters 	<p>Dimensions and attributes</p> <ul style="list-style-type: none"> • Target Width: 0.00 Meters • Target Height: 0.00 Meters • Target Length: 5.34 Meters • Target Shadow: 0.00 Meters • Mag Anomaly: • Avoidance Area: • Classification1: Piling • Classification2: • Area: • Block: • Description: Piling

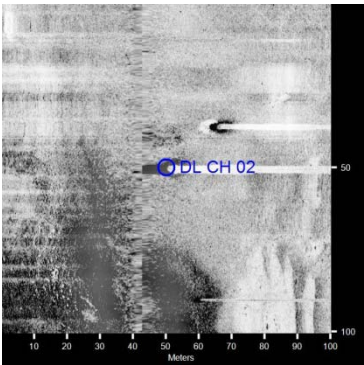
<p>DL CH 02</p> <ul style="list-style-type: none"> • Sonar Time at Target: 5/22/2014 12:49:45 PM • Click Position 53.2978074885 -6.1311158715 (WGS84) 0.0000000000 0.0000000000 (NAD27LL) 53.2978074885 -6.1311158715 (LocalLL) (X) 724577.92 (Y) 729130.50 (Projected Coordinates) • Map Projection: IRENET95.IrishTM • Acoustic Source File: E:\Dunleary Sidescan and MagData\DunlearySidescan\20140522124914.jsf • Ping Number: 35977 • Range to target: 7.42 Meters • Fish Height: 13.28 Meters • Heading: 59.890 Degrees • Event Number: 0 • Line Name: 20140522124914 • Water Depth: 0.78 Meters 	<p>Dimensions and attributes</p> <ul style="list-style-type: none"> • Target Width: 0.00 Meters • Target Height: 0.00 Meters • Target Length: 0.00 Meters • Target Shadow: 0.00 Meters • Mag Anomaly: • Avoidance Area: • Classification1: Piling • Classification2: • Area: • Block: • Description: Piling

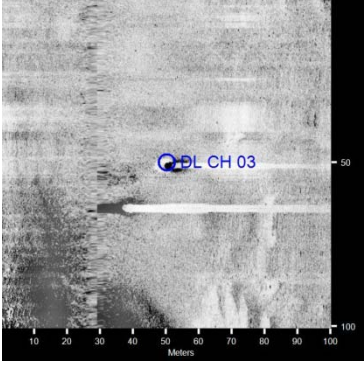
<p>DL CH 03</p> <ul style="list-style-type: none"> • Sonar Time at Target: 5/22/2014 12:49:51 PM • Click Position 53.2978487951 -6.1308344414 (WGS84) 0.0000000000 0.0000000000 (NAD27LL) 53.2978487951 -6.1308344414 (LocalLL) (X) 724596.56 (Y) 729135.58 (Projected Coordinates) • Map Projection: IREN95.IrishTM • Acoustic Source File: E:\Dunleary Sidescan and MagData\DunlearySidescan\20140522124914.jsf • Ping Number: 36018 • Range to target: 21.09 Meters • Fish Height: 14.65 Meters • Heading: 51.890 Degrees • Event Number: 0 • Line Name: 20140522124914 • Water Depth: 0.78 Meters 	<p>Dimensions and attributes</p> <ul style="list-style-type: none"> • Target Width: 0.00 Meters • Target Height: 0.00 Meters • Target Length: 0.00 Meters • Target Shadow: 0.00 Meters • Mag Anomaly: • Avoidance Area: • Classification1: Piling • Classification2: • Area: • Block: • Description: Piling

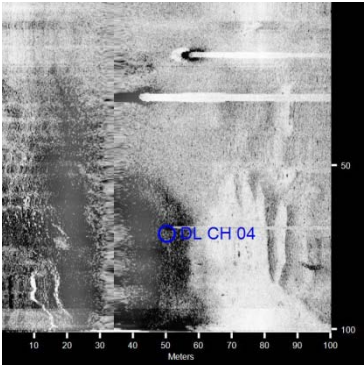
<p>DL CH 04</p> <ul style="list-style-type: none"> • Sonar Time at Target: 5/22/2014 12:49:27 PM • Click Position 53.2974451108 -6.1313525058 (WGS84) 0.0000000000 0.0000000000 (NAD27LL) 53.2974451108 -6.1313525058 (LocalLL) (X) 724563.20 (Y) 729089.77 (Projected Coordinates) • Map Projection: IREN95.IrishTM • Acoustic Source File: E:\Dunleary Sidescan and MagData\DunlearySidescan\20140522124914.jsf • Ping Number: 35848 • Range to target: 16.01 Meters • Fish Height: 12.69 Meters • Heading: 52.390 Degrees • Event Number: 0 • Line Name: 20140522124914 • Water Depth: 0.78 Meters 	<p>Dimensions and attributes</p> <ul style="list-style-type: none"> • Target Width: 0.00 Meters • Target Height: 0.00 Meters • Target Length: 0.00 Meters • Target Shadow: 0.00 Meters • Mag Anomaly: • Avoidance Area: • Classification1: Piling • Classification2: • Area: • Block: • Description: Piling

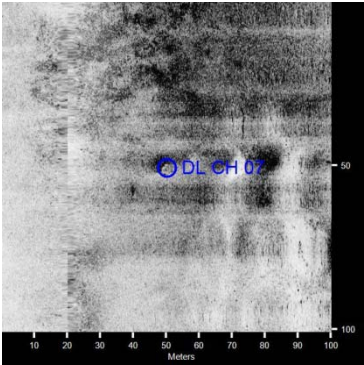
<p>DL CH 07</p> <ul style="list-style-type: none"> • Sonar Time at Target: 5/22/2014 12:46:20 PM • Click Position 53.3006666875 -6.1307857419 (WGS84) 0.0000000000 0.0000000000 (NAD27LL) 53.3006666875 -6.1307857419 (LocalLL) (X) 724591.60 (Y) 729449.17 (Projected Coordinates) • Map Projection: IRENET95.IrishTM • Acoustic Source File: E:\Dunleary Sidescan and MagData\DunlearySidescan\20140522124252.jsf • Ping Number: 34527 • Range to target: 30.08 Meters • Fish Height: 11.91 Meters • Heading: 177.200 Degrees • Event Number: 0 • Line Name: 20140522124252 • Water Depth: 0.78 Meters 	<p>Dimensions and attributes</p> <ul style="list-style-type: none"> • Target Width: 0.00 Meters • Target Height: 0.00 Meters • Target Length: 0.00 Meters • Target Shadow: 0.00 Meters • Mag Anomaly: • Avoidance Area: • Classification1: Possible wreck • Classification2: • Area: • Block: • Description: Possible area of scattered remains of Shipwreck WO1967

It is subsequently recommended that the magnetic anomalies and the side scan sonar contacts are investigated to determine their nature, age and extent. This should be undertaken by a team of archaeological divers, subject to the approval of the Department of Arts, Heritage and Gaeltacht.

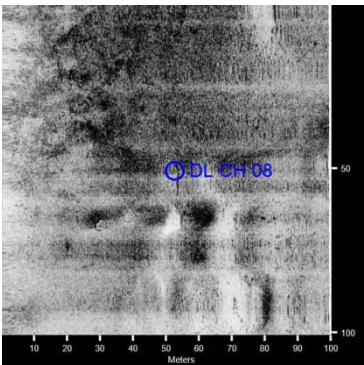
<p>DL CH 08</p> <ul style="list-style-type: none"> • Sonar Time at Target: 5/22/2014 12:46:27 PM • Click Position 53.3006136323 -6.1311863342 (WGS84) 0.0000000000 0.0000000000 (NAD27LL) 53.3006136323 -6.1311863342 (LocalLL) (X) 724565.05 (Y) 729442.57 (Projected Coordinates) • Map Projection: IRENET95.IrishTM • Acoustic Source File: E:\Dunleary Sidescan and MagData\DunlearySidescan\20140522124252.jsf • Ping Number: 34572 • Range to target: 52.34 Meters • Fish Height: 12.79 Meters • Heading: 181.290 Degrees • Event Number: 0 • Line Name: 20140522124252 • Water Depth: 0.78 Meters 	<p>Dimensions and attributes</p> <ul style="list-style-type: none"> • Target Width: 0.00 Meters • Target Height: 0.00 Meters • Target Length: 8.00 Meters • Target Shadow: 0.00 Meters • Mag Anomaly: • Avoidance Area: • Classification1: Linear Feature • Classification2: • Area: • Block: • Description: Small linear feature possibly associated with Shipwreck WO1967

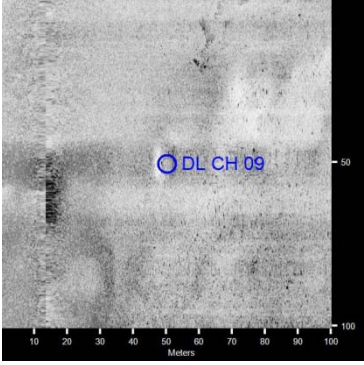
<p>DL CH 09</p> <ul style="list-style-type: none"> • Sonar Time at Target: 5/22/2014 1:00:15 PM • Click Position 53.3008309355 -6.1317900100 (WGS84) 0.0000000000 0.0000000000 (NAD27LL) 53.3008309355 -6.1317900100 (LocalLL) (X) 724524.19 (Y) 729465.69 (Projected Coordinates) • Map Projection: IRENET95.IrishTM • Acoustic Source File: E:\Dunleary Sidescan and MagData\DunlearySidescan\20140522125659.jsf • Ping Number: 40442 • Range to target: 36.72 Meters • Fish Height: 7.91 Meters • Heading: 178.500 Degrees • Event Number: 0 • Line Name: 20140522125659 • Water Depth: 0.78 Meters 	<p>Dimensions and attributes</p> <ul style="list-style-type: none"> • Target Width: 0.00 Meters • Target Height: 0.00 Meters • Target Length: 0.00 Meters • Target Shadow: 0.00 Meters • Mag Anomaly: • Avoidance Area: • Classification1: Possible wreck • Classification2: • Area: • Block: • Description: Possible remains associated with Wreck WO1967

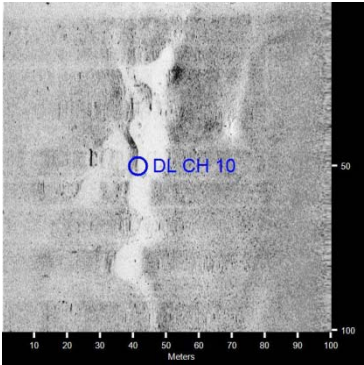
<p>DL CH 10</p> <ul style="list-style-type: none"> • Sonar Time at Target: 5/22/2014 12:59:51 PM • Click Position 53.3010333641 -6.1301022225 (WGS84) 0.0000000000 0.0000000000 (NAD27LL) 53.3010333641 -6.1301022225 (LocalLL) (X) 724636.09 (Y) 729491.16 (Projected Coordinates) • Map Projection: IRENET95.IrishTM • Acoustic Source File: E:\Dunleary Sidescan and MagData\DunlearySidescan\20140522125659.jsf • Ping Number: 40267 • Range to target: 58.79 Meters • Fish Height: 7.13 Meters • Heading: 181.390 Degrees • Event Number: 0 • Line Name: 20140522125659 • Water Depth: 0.78 Meters 	<p>Dimensions and attributes</p> <ul style="list-style-type: none"> • Target Width: 0.00 Meters • Target Height: 0.00 Meters • Target Length: 46.67 Meters • Target Shadow: 0.00 Meters • Mag Anomaly: • Avoidance Area: • Classification1: Possible wreck • Classification2: • Area: • Block: • Description: Possible wreck remains associated with WO1967

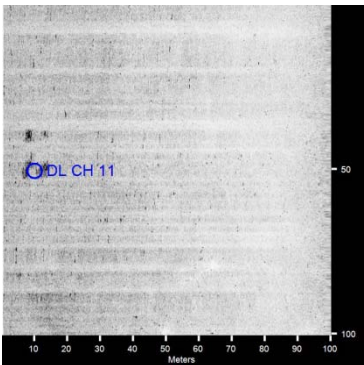
<p>DL CH 11</p> <ul style="list-style-type: none"> • Sonar Time at Target: 5/22/2014 12:53:04 PM • Click Position 53.3017122297 -6.1297387873 (WGS84) 0.0000000000 0.0000000000 (NAD27LL) 53.3017122297 -6.1297387873 (LocalLL) (X) 724658.33 (Y) 729567.32 (Projected Coordinates) • Map Projection: IRENET95.IrishTM • Acoustic Source File: E:\Dunleary Sidescan and MagData\DunlearySidescan\20140522124914.jsf • Ping Number: 37385 • Range to target: 90.03 Meters • Fish Height: 7.81 Meters • Heading: 49.390 Degrees • Event Number: 0 • Line Name: 20140522124914 • Water Depth: 0.78 Meters 	<p>Dimensions and attributes</p> <ul style="list-style-type: none"> • Target Width: 0.00 Meters • Target Height: 0.00 Meters • Target Length: 5.79 Meters • Target Shadow: 0.00 Meters • Mag Anomaly: • Avoidance Area: • Classification1: Unknown • Classification2: • Area: • Block: • Description: Unknown seafloor anomaly

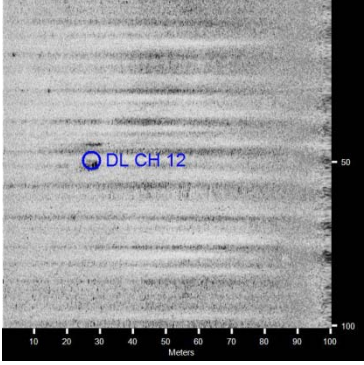
<p>DL CH 12</p> <ul style="list-style-type: none"> • Sonar Time at Target: 5/22/2014 12:58:21 PM • Click Position 53.3029671753 -6.1287160279 (WGS84) 0.0000000000 0.0000000000 (NAD27LL) 53.3029671753 -6.1287160279 (LocalLL) (X) 724722.84 (Y) 729708.72 (Projected Coordinates) • Map Projection: IREN95.IrishTM • Acoustic Source File: E:\Dunleary Sidescan and MagData\DunlearySidescan\20140522125659.jsf • Ping Number: 39632 • Range to target: 72.75 Meters • Fish Height: 6.74 Meters • Heading: 161.000 Degrees • Event Number: 0 • Line Name: 20140522125659 • Water Depth: 0.78 Meters 	<p>Dimensions and attributes</p> <ul style="list-style-type: none"> • Target Width: 0.00 Meters • Target Height: 0.00 Meters • Target Length: 3.47 Meters • Target Shadow: 0.00 Meters • Mag Anomaly: • Avoidance Area: • Classification1: Unknown Anomaly • Classification2: • Area: • Block: • Description: Unknown Anomaly

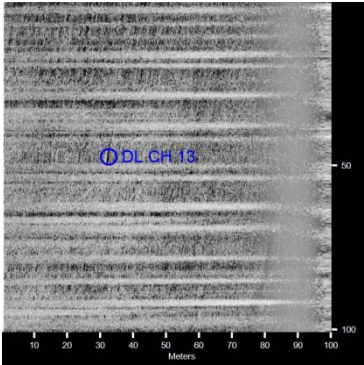
<p>DL CH 13</p> <ul style="list-style-type: none"> • Sonar Time at Target: 5/22/2014 12:40:21 PM • Click Position 53.3048352500 -6.1263773015 (WGS84) 0.0000000000 0.0000000000 (NAD27LL) 53.3048352500 -6.1263773015 (LocalLL) (X) 724873.25 (Y) 729920.64 (Projected Coordinates) • Map Projection: IREN95.IrishTM • Acoustic Source File: E:\Dunleary Sidescan and MagData\DunlearySidescan\20140522123816.jsf • Ping Number: 31983 • Range to target: 67.57 Meters • Fish Height: 9.86 Meters • Heading: 100.200 Degrees • Event Number: 0 • Line Name: 20140522123816 • Water Depth: 0.77 Meters 	<p>Dimensions and attributes</p> <ul style="list-style-type: none"> • Target Width: 0.00 Meters • Target Height: 0.00 Meters • Target Length: 0.00 Meters • Target Shadow: 0.00 Meters • Mag Anomaly: • Avoidance Area: • Classification1: Unknown • Classification2: • Area: • Block: • Description: Unknown anomaly

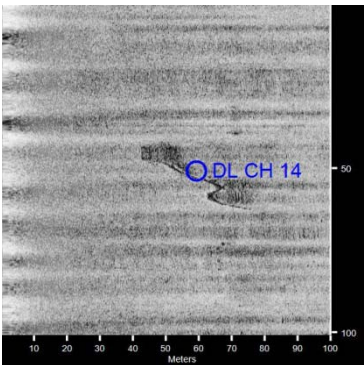
<p>DL CH 14</p> <ul style="list-style-type: none"> • Sonar Time at Target: 5/22/2014 12:01:48 PM • Click Position 53.3063906032 -6.1121202333 (WGS84) 0.0000000000 0.0000000000 (NAD27LL) 53.3063906032 -6.1121202333 (LocalLL) (X) 725818.78 (Y) 730118.70 (Projected Coordinates) • Map Projection: IREN95.IrishTM • Acoustic Source File: E:\Dunleary Sidescan and MagData\DunlearySidescan\20140522115910.jsf • Ping Number: 15596 • Range to target: 58.98 Meters • Fish Height: 10.45 Meters • Heading: 260.590 Degrees • Event Number: 0 • Line Name: 20140522115910 • Water Depth: 0.77 Meters 	<p>Dimensions and attributes</p> <ul style="list-style-type: none"> • Target Width: 0.00 Meters • Target Height: 0.00 Meters • Target Length: 0.00 Meters • Target Shadow: 0.00 Meters • Mag Anomaly: • Avoidance Area: • Classification1: Anchor and chain • Classification2: • Area: • Block: • Description: Anchor and chain

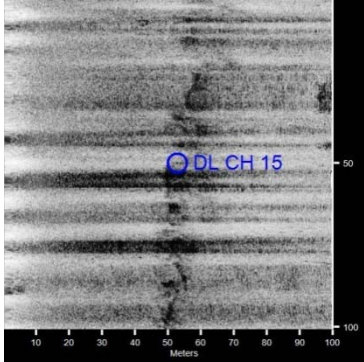
<p>DL CH 15</p> <ul style="list-style-type: none"> • Sonar Time at Target: 5/22/2014 11:59:47 AM • Click Position 53.3061049463 -6.1071315286 (WGS84) 0.0000000000 0.0000000000 (NAD27LL) 53.3061049463 -6.1071315286 (LocalLL) (X) 726152.06 (Y) 730095.72 (Projected Coordinates) • Map Projection: IRENET95.IrishTM • Acoustic Source File: E:\Dunleary Sidescan and MagData\DunlearySidescan\20140522115910.jsf • Ping Number: 14740 • Range to target: 52.54 Meters • Fish Height: 10.64 Meters • Heading: 229.900 Degrees • Event Number: 0 • Line Name: 20140522115910 • Water Depth: 0.77 Meters 	<p>Dimensions and attributes</p> <ul style="list-style-type: none"> • Target Width: 0.00 Meters • Target Height: 0.00 Meters • Target Length: 93.46 Meters • Target Shadow: 0.00 Meters • Mag Anomaly: • Avoidance Area: • Classification1: Unknown • Classification2: • Area: • Block: • Description: Unknown linear seafloor feature, possible prop wash

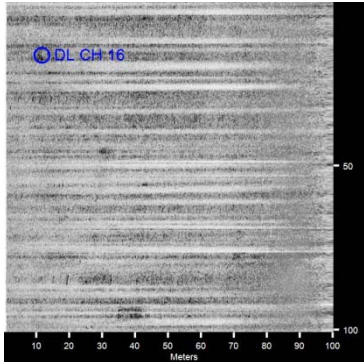
<p>DL CH 16</p> <ul style="list-style-type: none"> • Sonar Time at Target: 5/22/2014 11:58:09 AM • Click Position 53.3067361799 -6.1063798733 (WGS84) 0.0000000000 0.0000000000 (NAD27LL) 53.3067361799 -6.1063798733 (LocalLL) (X) 726200.29 (Y) 730167.27 (Projected Coordinates) • Map Projection: IRENET95.IrishTM • Acoustic Source File: E:\Dunleary Sidescan and MagData\DunlearySidescan\20140522115006.jsf • Ping Number: 14046 • Range to target: 88.47 Meters • Fish Height: 11.33 Meters • Heading: 99.500 Degrees • Event Number: 0 • Line Name: 20140522115006 • Water Depth: 0.77 Meters 	<p>Dimensions and attributes</p> <ul style="list-style-type: none"> • Target Width: 0.00 Meters • Target Height: 0.00 Meters • Target Length: 0.00 Meters • Target Shadow: 0.00 Meters • Mag Anomaly: • Avoidance Area: • Classification1: Navigation marker • Classification2: • Area: • Block: • Description: Navigation marker

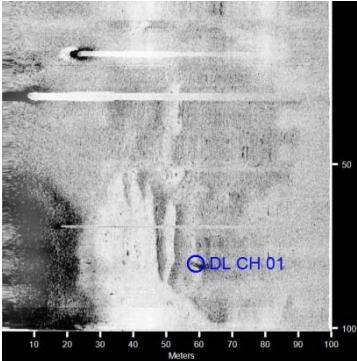
<p>DL CH 01</p> <ul style="list-style-type: none"> • Sonar Time at Target: 5/22/2014 12:49:23 PM • Click Position 53.2971607666 -6.1309018096 (WGS84) 0.0000000000 0.0000000000 (NAD27LL) 53.2971607666 -6.1309018096 (LocalLL) (X) 724594.07 (Y) 729058.92 (Projected Coordinates) • Map Projection: IREN95.IrishTM • Acoustic Source File: E:\Dunleary Sidescan and MagData\DunlearySidescan\20140522124914.jsf • Ping Number: 35819 • Range to target: 58.59 Meters • Fish Height: 12.99 Meters • Heading: 46.890 Degrees • Event Number: 0 • Line Name: 20140522124914 • Water Depth: 0.78 Meters 	<p>Dimensions and attributes</p> <ul style="list-style-type: none"> • Target Width: 0.00 Meters • Target Height: 0.00 Meters • Target Length: 5.34 Meters • Target Shadow: 0.00 Meters • Mag Anomaly: • Avoidance Area: • Classification1: Piling • Classification2: • Area: • Block: • Description: Piling

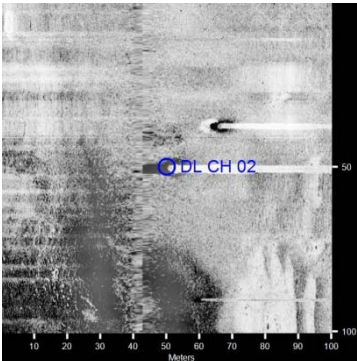
<p>DL CH 02</p> <ul style="list-style-type: none"> • Sonar Time at Target: 5/22/2014 12:49:45 PM • Click Position 53.2978074885 -6.1311158715 (WGS84) 0.0000000000 0.0000000000 (NAD27LL) 53.2978074885 -6.1311158715 (LocalLL) (X) 724577.92 (Y) 729130.50 (Projected Coordinates) • Map Projection: IREN95.IrishTM • Acoustic Source File: E:\Dunleary Sidescan and MagData\DunlearySidescan\20140522124914.jsf • Ping Number: 35977 • Range to target: 7.42 Meters • Fish Height: 13.28 Meters • Heading: 59.890 Degrees • Event Number: 0 • Line Name: 20140522124914 • Water Depth: 0.78 Meters 	<p>Dimensions and attributes</p> <ul style="list-style-type: none"> • Target Width: 0.00 Meters • Target Height: 0.00 Meters • Target Length: 0.00 Meters • Target Shadow: 0.00 Meters • Mag Anomaly: • Avoidance Area: • Classification1: Piling • Classification2: • Area: • Block: • Description: Piling

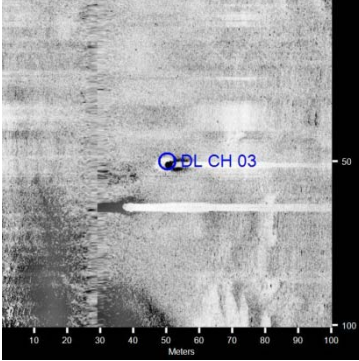
<p>DL CH 03</p> <ul style="list-style-type: none"> • Sonar Time at Target: 5/22/2014 12:49:51 PM • Click Position 53.2978487951 -6.1308344414 (WGS84) 0.0000000000 0.0000000000 (NAD27LL) 53.2978487951 -6.1308344414 (LocalLL) (X) 724596.56 (Y) 729135.58 (Projected Coordinates) • Map Projection: IREN95.IrishTM • Acoustic Source File: E:\Dunleary Sidescan and MagData\DunlearySidescan\20140522124914.jsf • Ping Number: 36018 • Range to target: 21.09 Meters • Fish Height: 14.65 Meters • Heading: 51.890 Degrees • Event Number: 0 • Line Name: 20140522124914 • Water Depth: 0.78 Meters 	<p>Dimensions and attributes</p> <ul style="list-style-type: none"> • Target Width: 0.00 Meters • Target Height: 0.00 Meters • Target Length: 0.00 Meters • Target Shadow: 0.00 Meters • Mag Anomaly: • Avoidance Area: • Classification1: Piling • Classification2: • Area: • Block: • Description: Piling

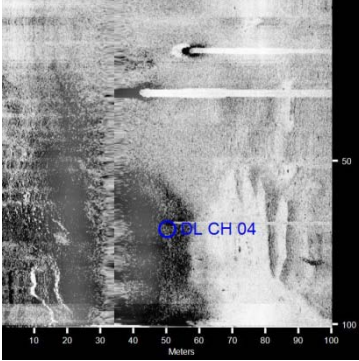
<p>DL CH 04</p> <ul style="list-style-type: none"> • Sonar Time at Target: 5/22/2014 12:49:27 PM • Click Position 53.2974451108 -6.1313525058 (WGS84) 0.0000000000 0.0000000000 (NAD27LL) 53.2974451108 -6.1313525058 (LocalLL) (X) 724563.20 (Y) 729089.77 (Projected Coordinates) • Map Projection: IREN95.IrishTM • Acoustic Source File: E:\Dunleary Sidescan and MagData\DunlearySidescan\20140522124914.jsf • Ping Number: 35848 • Range to target: 16.01 Meters • Fish Height: 12.69 Meters • Heading: 52.390 Degrees • Event Number: 0 • Line Name: 20140522124914 • Water Depth: 0.78 Meters 	<p>Dimensions and attributes</p> <ul style="list-style-type: none"> • Target Width: 0.00 Meters • Target Height: 0.00 Meters • Target Length: 0.00 Meters • Target Shadow: 0.00 Meters • Mag Anomaly: • Avoidance Area: • Classification1: Piling • Classification2: • Area: • Block: • Description: Piling

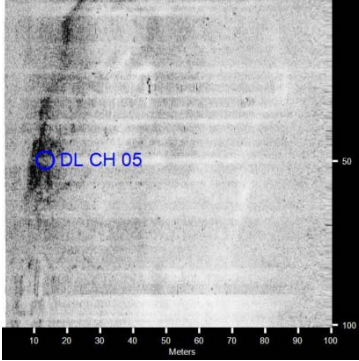
This anomaly was located to the south of the previous mooring chain, on the eastern end of the proposed outer harbour approach channel. The side scan sonar image indicated that this was a 95.3m long undulating seafloor anomaly. A 50m circular search survey was carried out on this area. The survey recorded seafloor variations but there was no visible trace of any cultural heritage features. Further review of the feature based on the results of the dive survey indicates that this may have propeller wash caused by a passing vessel. Consequently, it is most likely that this was an acoustic artefact and not a physical anomaly.

<p>DL CH 05</p> <ul style="list-style-type: none"> • Sonar Time at Target: 5/22/2014 12:47:29 PM • Click Position 53.2988385418 -6.1301625805 (WGS84) 0.0000000000 0.0000000000 (NAD27LL) 53.2988385418 -6.1301625805 (LocalLL) (X) 724638.45 (Y) 729246.87 (Projected Coordinates) • Map Projection: IREN95.IrishTM • Acoustic Source File: E:\Dunleary Sidescan and MagData\DunlearySidescan\20140522124252.jsf • Ping Number: 35016 • Range to target: 86.91 Meters • Fish Height: 13.09 Meters • Heading: 181.790 Degrees • Event Number: 0 • Line Name: 20140522124252 • Water Depth: 0.78 Meters 	<p>Dimensions and attributes</p> <ul style="list-style-type: none"> • Target Width: 0.00 Meters • Target Height: 0.00 Meters • Target Length: 60.93 Meters • Target Shadow: 0.00 Meters • Mag Anomaly: • Avoidance Area: • Classification1: Unknown • Classification2: • Area: • Block: • Description: Unknown undualtion on seafloor. Image appears to indicate slight seafloor depression

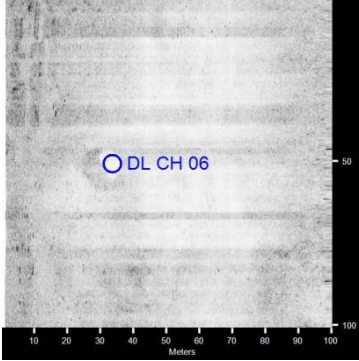
<p>DL CH 06</p> <ul style="list-style-type: none"> • Sonar Time at Target: 5/22/2014 12:46:58 PM • Click Position 53.2995445018 -6.1300202997 (WGS84) 0.0000000000 0.0000000000 (NAD27LL) 53.2995445018 -6.1300202997 (LocalLL) (X) 724645.88 (Y) 729325.66 (Projected Coordinates) • Map Projection: IREN95.IrishTM • Acoustic Source File: E:\Dunleary Sidescan and MagData\DunlearySidescan\20140522124252.jsf • Ping Number: 34792 • Range to target: 66.60 Meters • Fish Height: 14.35 Meters • Heading: 179.290 Degrees • Event Number: 0 • Line Name: 20140522124252 • Water Depth: 0.78 Meters 	<p>Dimensions and attributes</p> <ul style="list-style-type: none"> • Target Width: 0.00 Meters • Target Height: 0.00 Meters • Target Length: 6.70 Meters • Target Shadow: 0.00 Meters • Mag Anomaly: • Avoidance Area: • Classification1: Unknown • Classification2: • Area: • Block: • Description: Unknown seafloor conical shaped depression

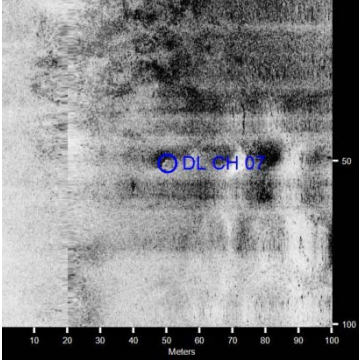
<p>DL CH 07</p> <ul style="list-style-type: none"> • Sonar Time at Target: 5/22/2014 12:46:20 PM • Click Position 53.3006666875 -6.1307857419 (WGS84) 0.0000000000 0.0000000000 (NAD27LL) 53.3006666875 -6.1307857419 (LocalLL) (X) 724591.60 (Y) 729449.17 (Projected Coordinates) • Map Projection: IREN95.IrishTM • Acoustic Source File: E:\Dunleary Sidescan and MagData\DunlearySidescan\20140522124252.jsf • Ping Number: 34527 • Range to target: 30.08 Meters • Fish Height: 11.91 Meters • Heading: 177.200 Degrees • Event Number: 0 • Line Name: 20140522124252 • Water Depth: 0.78 Meters 	<p>Dimensions and attributes</p> <ul style="list-style-type: none"> • Target Width: 0.00 Meters • Target Height: 0.00 Meters • Target Length: 0.00 Meters • Target Shadow: 0.00 Meters • Mag Anomaly: • Avoidance Area: • Classification1: Possible wreck • Classification2: • Area: • Block: • Description: Possible area of scattered remains of Shipwreck WO1967

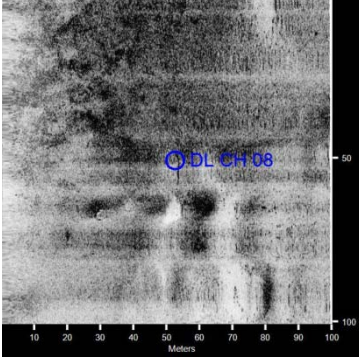
<p>DL CH 08</p> <ul style="list-style-type: none"> • Sonar Time at Target: 5/22/2014 12:46:27 PM • Click Position 53.3006136323 -6.1311863342 (WGS84) 0.0000000000 0.0000000000 (NAD27LL) 53.3006136323 -6.1311863342 (LocalLL) (X) 724565.05 (Y) 729442.57 (Projected Coordinates) • Map Projection: IREN95.IrishTM • Acoustic Source File: E:\Dunleary Sidescan and MagData\DunlearySidescan\20140522124252.jsf • Ping Number: 34572 • Range to target: 52.34 Meters • Fish Height: 12.79 Meters • Heading: 181.290 Degrees • Event Number: 0 • Line Name: 20140522124252 • Water Depth: 0.78 Meters 	<p>Dimensions and attributes</p> <ul style="list-style-type: none"> • Target Width: 0.00 Meters • Target Height: 0.00 Meters • Target Length: 8.00 Meters • Target Shadow: 0.00 Meters • Mag Anomaly: • Avoidance Area: • Classification1: Linear Feature • Classification2: • Area: • Block: • Description: Small linear feature possibly associated with Shipwreck WO1967

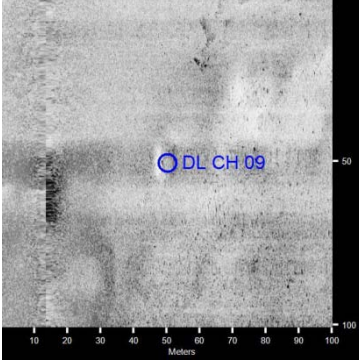
<p>DL CH 09</p> <ul style="list-style-type: none"> • Sonar Time at Target: 5/22/2014 1:00:15 PM • Click Position 53.3008309355 -6.1317900100 (WGS84) 0.0000000000 0.0000000000 (NAD27LL) 53.3008309355 -6.1317900100 (LocalLL) (X) 724524.19 (Y) 729465.69 (Projected Coordinates) • Map Projection: IRENET95.IrishTM • Acoustic Source File: E:\Dunleary Sidescan and MagData\DunlearySidescan\20140522125659.jsf • Ping Number: 40442 • Range to target: 36.72 Meters • Fish Height: 7.91 Meters • Heading: 178.500 Degrees • Event Number: 0 • Line Name: 20140522125659 • Water Depth: 0.78 Meters 	<p>Dimensions and attributes</p> <ul style="list-style-type: none"> • Target Width: 0.00 Meters • Target Height: 0.00 Meters • Target Length: 0.00 Meters • Target Shadow: 0.00 Meters • Mag Anomaly: • Avoidance Area: • Classification1: Possible wreck • Classification2: • Area: • Block: • Description: Possible remains associated with Wreck WO1967

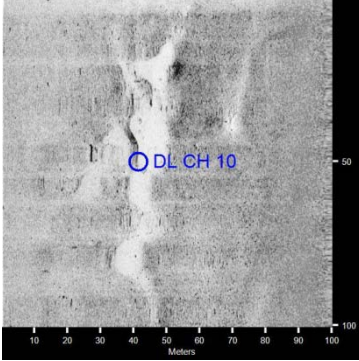
<p>DL CH 10</p> <ul style="list-style-type: none"> • Sonar Time at Target: 5/22/2014 12:59:51 PM • Click Position 53.3010333641 -6.1301022225 (WGS84) 0.0000000000 0.0000000000 (NAD27LL) 53.3010333641 -6.1301022225 (LocalLL) (X) 724636.09 (Y) 729491.16 (Projected Coordinates) • Map Projection: IRENET95.IrishTM • Acoustic Source File: E:\Dunleary Sidescan and MagData\DunlearySidescan\20140522125659.jsf • Ping Number: 40267 • Range to target: 58.79 Meters • Fish Height: 7.13 Meters • Heading: 181.390 Degrees • Event Number: 0 • Line Name: 20140522125659 • Water Depth: 0.78 Meters 	<p>Dimensions and attributes</p> <ul style="list-style-type: none"> • Target Width: 0.00 Meters • Target Height: 0.00 Meters • Target Length: 46.67 Meters • Target Shadow: 0.00 Meters • Mag Anomaly: • Avoidance Area: • Classification1: Possible wreck • Classification2: • Area: • Block: • Description: Possible wreck remains associated with WO1967

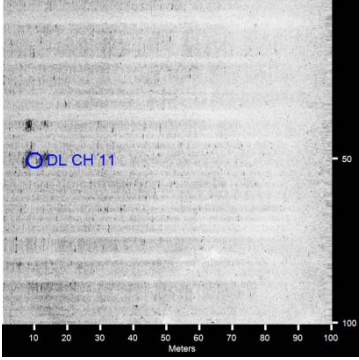
<p>DL CH 11</p> <ul style="list-style-type: none"> • Sonar Time at Target: 5/22/2014 12:53:04 PM • Click Position 53.3017122297 -6.1297387873 (WGS84) 0.0000000000 0.0000000000 (NAD27LL) 53.3017122297 -6.1297387873 (LocalLL) (X) 724658.33 (Y) 729567.32 (Projected Coordinates) • Map Projection: IRENET95.IrishTM • Acoustic Source File: E:\Dunleary Sidescan and MagData\DunlearySidescan\20140522124914.jsf • Ping Number: 37385 • Range to target: 90.03 Meters • Fish Height: 7.81 Meters • Heading: 49.390 Degrees • Event Number: 0 • Line Name: 20140522124914 • Water Depth: 0.78 Meters 	<p>Dimensions and attributes</p> <ul style="list-style-type: none"> • Target Width: 0.00 Meters • Target Height: 0.00 Meters • Target Length: 5.79 Meters • Target Shadow: 0.00 Meters • Mag Anomaly: • Avoidance Area: • Classification1: Unknown • Classification2: • Area: • Block: • Description: Unknown seafloor anomaly

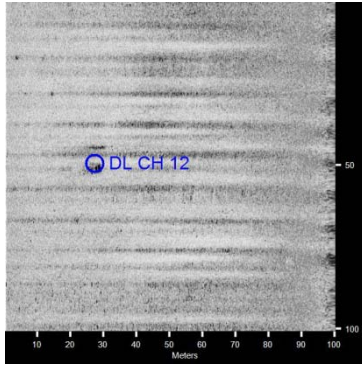
<p>DL CH 12</p> <ul style="list-style-type: none"> • Sonar Time at Target: 5/22/2014 12:58:21 PM • Click Position 53.3029671753 -6.1287160279 (WGS84) 0.0000000000 0.0000000000 (NAD27LL) 53.3029671753 -6.1287160279 (LocalLL) (X) 724722.84 (Y) 729708.72 (Projected Coordinates) • Map Projection: IRENET95.IrishTM • Acoustic Source File: E:\Dunleary Sidescan and MagData\DunlearySidescan\20140522125659.jsf • Ping Number: 39632 • Range to target: 72.75 Meters • Fish Height: 6.74 Meters • Heading: 161.000 Degrees • Event Number: 0 • Line Name: 20140522125659 • Water Depth: 0.78 Meters 	<p>Dimensions and attributes</p> <ul style="list-style-type: none"> • Target Width: 0.00 Meters • Target Height: 0.00 Meters • Target Length: 3.47 Meters • Target Shadow: 0.00 Meters • Mag Anomaly: • Avoidance Area: • Classification1: Unknown Anomaly • Classification2: • Area: • Block: • Description: Unknown Anomaly

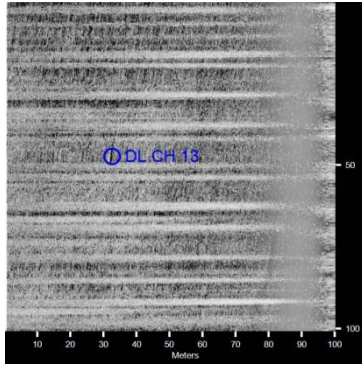
<p>DL CH 13</p> <ul style="list-style-type: none"> • Sonar Time at Target: 5/22/2014 12:40:21 PM • Click Position 53.3048352500 -6.1263773015 (WGS84) 0.0000000000 0.0000000000 (NAD27LL) 53.3048352500 -6.1263773015 (LocalLL) (X) 724873.25 (Y) 729920.64 (Projected Coordinates) • Map Projection: IRENET95.IrishTM • Acoustic Source File: E:\Dunleary Sidescan and MagData\DunlearySidescan\20140522123816.jsf • Ping Number: 31983 • Range to target: 67.57 Meters • Fish Height: 9.86 Meters • Heading: 100.200 Degrees • Event Number: 0 • Line Name: 20140522123816 • Water Depth: 0.77 Meters 	<p>Dimensions and attributes</p> <ul style="list-style-type: none"> • Target Width: 0.00 Meters • Target Height: 0.00 Meters • Target Length: 0.00 Meters • Target Shadow: 0.00 Meters • Mag Anomaly: • Avoidance Area: • Classification1: Unknown • Classification2: • Area: • Block: • Description: Unknown anomaly

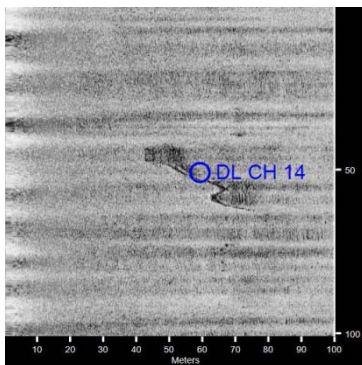
<p>DL CH 14</p> <ul style="list-style-type: none"> • Sonar Time at Target: 5/22/2014 12:01:48 PM • Click Position 53.3063906032 -6.1121202333 (WGS84) 0.0000000000 0.0000000000 (NAD27LL) 53.3063906032 -6.1121202333 (LocalLL) (X) 725818.78 (Y) 730118.70 (Projected Coordinates) • Map Projection: IRENET95.IrishTM • Acoustic Source File: E:\Dunleary Sidescan and MagData\DunlearySidescan\20140522115910.jsf • Ping Number: 15596 • Range to target: 58.98 Meters • Fish Height: 10.45 Meters • Heading: 260.590 Degrees • Event Number: 0 • Line Name: 20140522115910 • Water Depth: 0.77 Meters 	<p>Dimensions and attributes</p> <ul style="list-style-type: none"> • Target Width: 0.00 Meters • Target Height: 0.00 Meters • Target Length: 0.00 Meters • Target Shadow: 0.00 Meters • Mag Anomaly: • Avoidance Area: • Classification1: Anchor and chain • Classification2: • Area: • Block: • Description: Anchor and chain

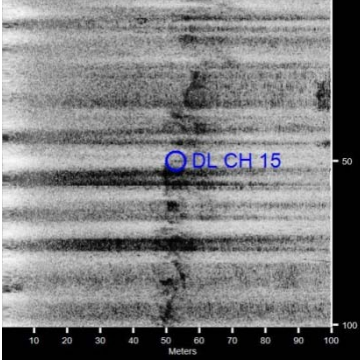
<p>DL CH 15</p>	<p>DL CH 15</p> <ul style="list-style-type: none"> • Sonar Time at Target: 5/22/2014 11:59:47 AM • Click Position 53.3061049463 -6.1071315286 (WGS84) 0.0000000000 0.0000000000 (NAD27LL) 53.3061049463 -6.1071315286 (LocalLL) (X) 726152.06 (Y) 730095.72 (Projected Coordinates) • Map Projection: IRENET95.IrishTM • Acoustic Source File: E:\Dunleary Sidescan and MagData\DunlearySidescan\20140522115910.jsf • Ping Number: 14740 • Range to target: 52.54 Meters • Fish Height: 10.64 Meters • Heading: 229.900 Degrees • Event Number: 0 • Line Name: 20140522115910 • Water Depth: 0.77 Meters 	<p>Dimensions and attributes</p> <ul style="list-style-type: none"> • Target Width: 0.00 Meters • Target Height: 0.00 Meters • Target Length: 93.46 Meters • Target Shadow: 0.00 Meters • Mag Anomaly: • Avoidance Area: • Classification1: Unknown • Classification2: • Area: • Block: • Description: Unknown linear seafloor feature, possible prop wash

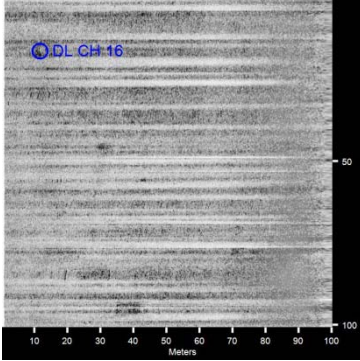
<p>DL CH 16</p>	<p>DL CH 16</p> <ul style="list-style-type: none"> • Sonar Time at Target: 5/22/2014 11:58:09 AM • Click Position 53.3067361799 -6.1063798733 (WGS84) 0.0000000000 0.0000000000 (NAD27LL) 53.3067361799 -6.1063798733 (LocalLL) (X) 726200.29 (Y) 730167.27 (Projected Coordinates) • Map Projection: IRENET95.IrishTM • Acoustic Source File: E:\Dunleary Sidescan and MagData\DunlearySidescan\20140522115006.jsf • Ping Number: 14046 • Range to target: 88.47 Meters • Fish Height: 11.33 Meters • Heading: 99.500 Degrees • Event Number: 0 • Line Name: 20140522115006 • Water Depth: 0.77 Meters 	<p>Dimensions and attributes</p> <ul style="list-style-type: none"> • Target Width: 0.00 Meters • Target Height: 0.00 Meters • Target Length: 0.00 Meters • Target Shadow: 0.00 Meters • Mag Anomaly: • Avoidance Area: • Classification1: Navigation marker • Classification2: • Area: • Block: • Description: Navigation marker

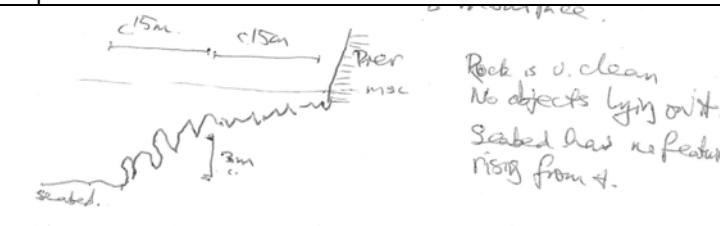
Images	<p>Sketch section of rock armour at base of East Pier, recorded on dive log</p>

<p>Rock is v. clean No objects lying on it. Seabed has no features rising from it.</p>

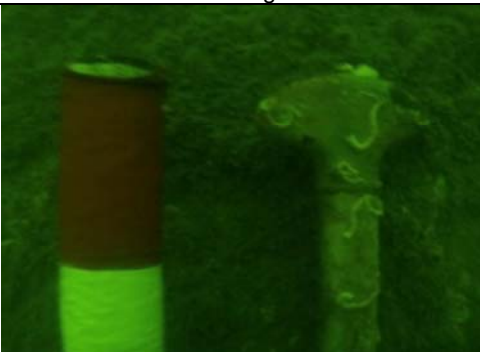
Dive No.	5
Date	26/11/2014
Location	W01966
Shotline coordinates	691412E 5909801N UTM 29N; 324893E 229663N ING
Dive Supervisor	BMcA
Diver	NB
Time in	13:25
Time out	16:20
Sea state	Calm
Dive depth	10m
Observations	<p>The purpose of the dive was to locate W01966 at the charted location.</p> <p>Underwater visibility remained very good at 1-1.5m.</p> <p>Underwater search proceeded into the centre of the harbour entrance and also northwest, extending 80m in this direction from the shotline to cover the extended area. The <i>Keary</i> was repositioned to facilitate this work to the west of the shotline.</p> <p>The multi-beam data of 2004 shows an anomaly in the centre of the harbour entrance, and this became a focus of attention for the dive work. It is located at 691315E 5909810N UTM 29N / 324795E 229672N ING. The feature is only a localized hollow, and does not have any features exposed within it or apparent through probing.</p> <p>The zone northwest of the shotline has no features exposed on the seabed.</p> <p>The search area included elements of the rock armour, and two modern objects were identified lying among its boulders: an aluminum paddle and a steel box.</p> <p>No material of archaeological interest was identified.</p>

Image	<p>Photograph of handle of modern aluminum paddle, with tip of scale bar showing</p>

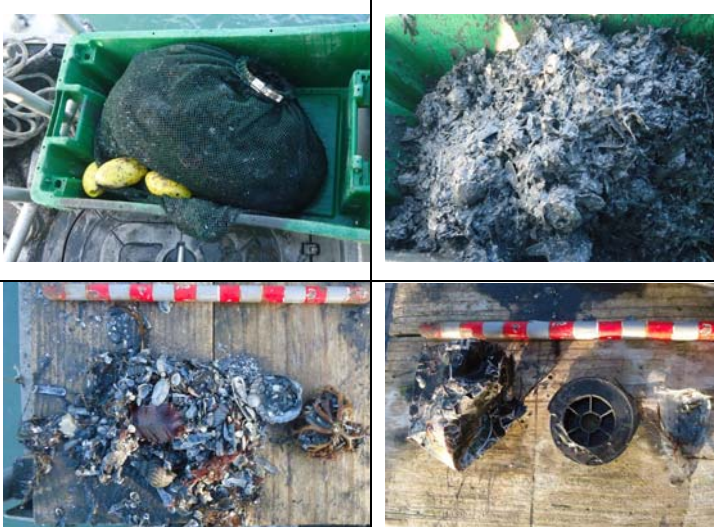
Dive coordinates	691260E 5909593N UTM 29N / 324737E 229456N ING	
Dive Supervisor	BMcA	
Diver	KMcC	
Time in	11:28	
Time out	13:30	
Sea state	Calm	
Dive depth	10m	
Observations	<p>Dredging work excavated a c. 2m x 2m sized hole centered on the anomaly. The dredge spoil was directed into a mesh bag, which was inspected and emptied when full.</p> <p>The anomaly turned out to be an isolated rock, measuring 1m long by 30cm wide. It was not associated with other pieces. Further dredging in this location was terminated.</p> <p>Dive work returned to a search-and-probe survey, working to the north and east of the shotline.</p> <p>The encrusted feature observed on Dive 2 was relocated, and a trench opened around it, to facilitate dredging.</p>	
Images	<p>Picture sequence showing the recovery of the dredged spoil within its sealed mesh sack (top left); the contents removed for sorting (top right); contents with silt and sand removed after water hosing (bottom left); final selection of objects recovered from the spoil, which in this instance are all modern pieces and were not retained (bottom right). Scale bar 15cm long.</p>

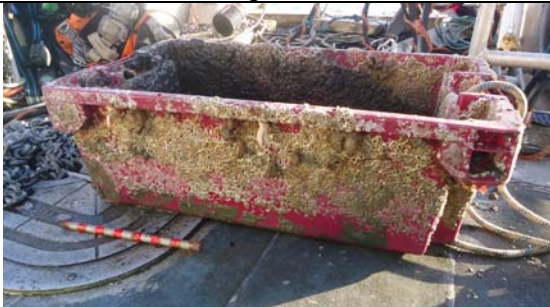
Dive depth	10m
Observations	Inspection dive at end of dredging observed that the object was no longer fixed to the seabed. On inspection and recovery to the surface, it was seen to be an abandoned fishbox. The depth of its burial in the silt and underlying gravel and sand indicates the disturbed nature of this substrate, which has continued to provide no indication of wreckage.
Image Encrusted fishbox recovered to the surface that was buried and only partially exposed at the charted location of W01967.

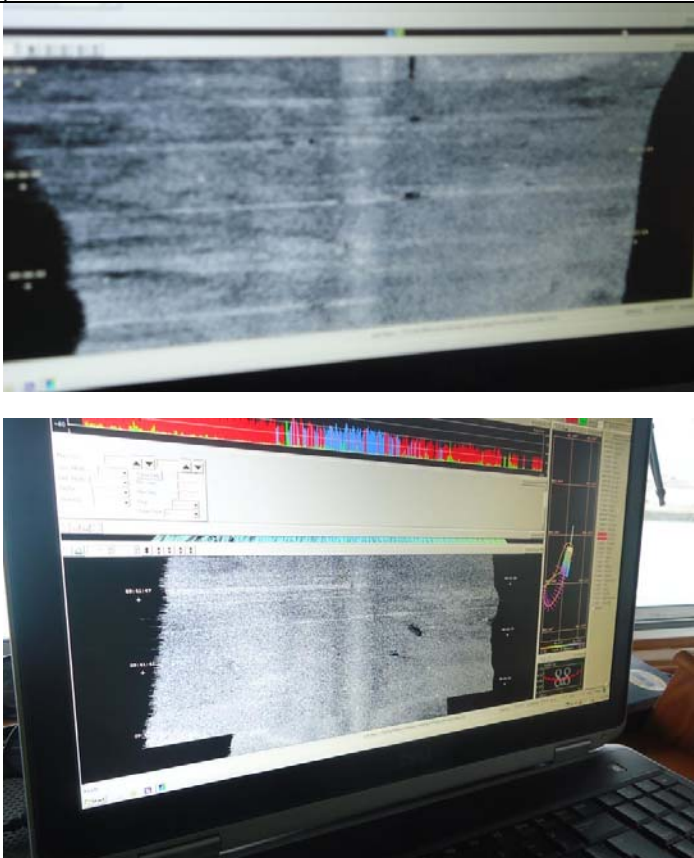
Date	26/11/2014
Activity	Geophysical Survey
Observations	<p>The <i>RV Keary</i> is equipped with a variety of onboard marine geophysical survey devices. Given the difficulty in locating wreckage at the charted locations, it was agreed to run the vessel's multi-beam sonar over the harbour area in an effort to locate W01967. The intention was to verify the nature of the seabed and observe any defined hard points, which could then be plotted and returned to for diving.</p> <p>The data produced was 'live feed' and not subject to post-processing. A selection of screen-grab images is presented below. A series of localized soft deposits or hollows were observed, as were already known, but no features of obvious archaeological potential were observed.</p>
Images	<p>Screen-grab images of multi-beam monitor. The upper image shows to localized hard points as black dots, and these refer to piling posts within the marina.</p> <p>The lower images shows the seabed at the charted location of W01967. The dark patches refer to hollows rather than hard points, and were inspected as part of the dive work.</p>

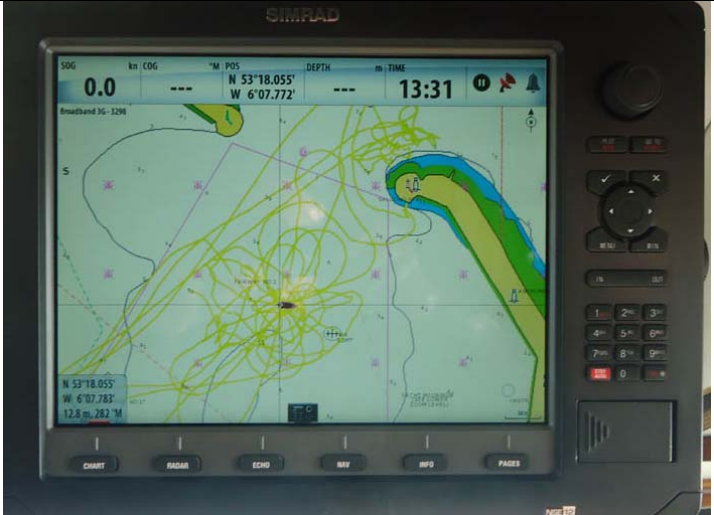
<p>column and will snag any substantial obstruction or object on the seabed. Tension is maintained on the line by hand, where slight variations can be detected easily.</p> <p>As the image below shows, a series of runs were completed across the harbour area, focusing on the charted location of W01967, but also extending large distances away from it. Not features of snags were observed.</p>
<p>Image</p> <p>Screen-grab showing navigation monitor recording vessel tracklines following during grapple survey. The locus point is the charted location of W01967.</p>

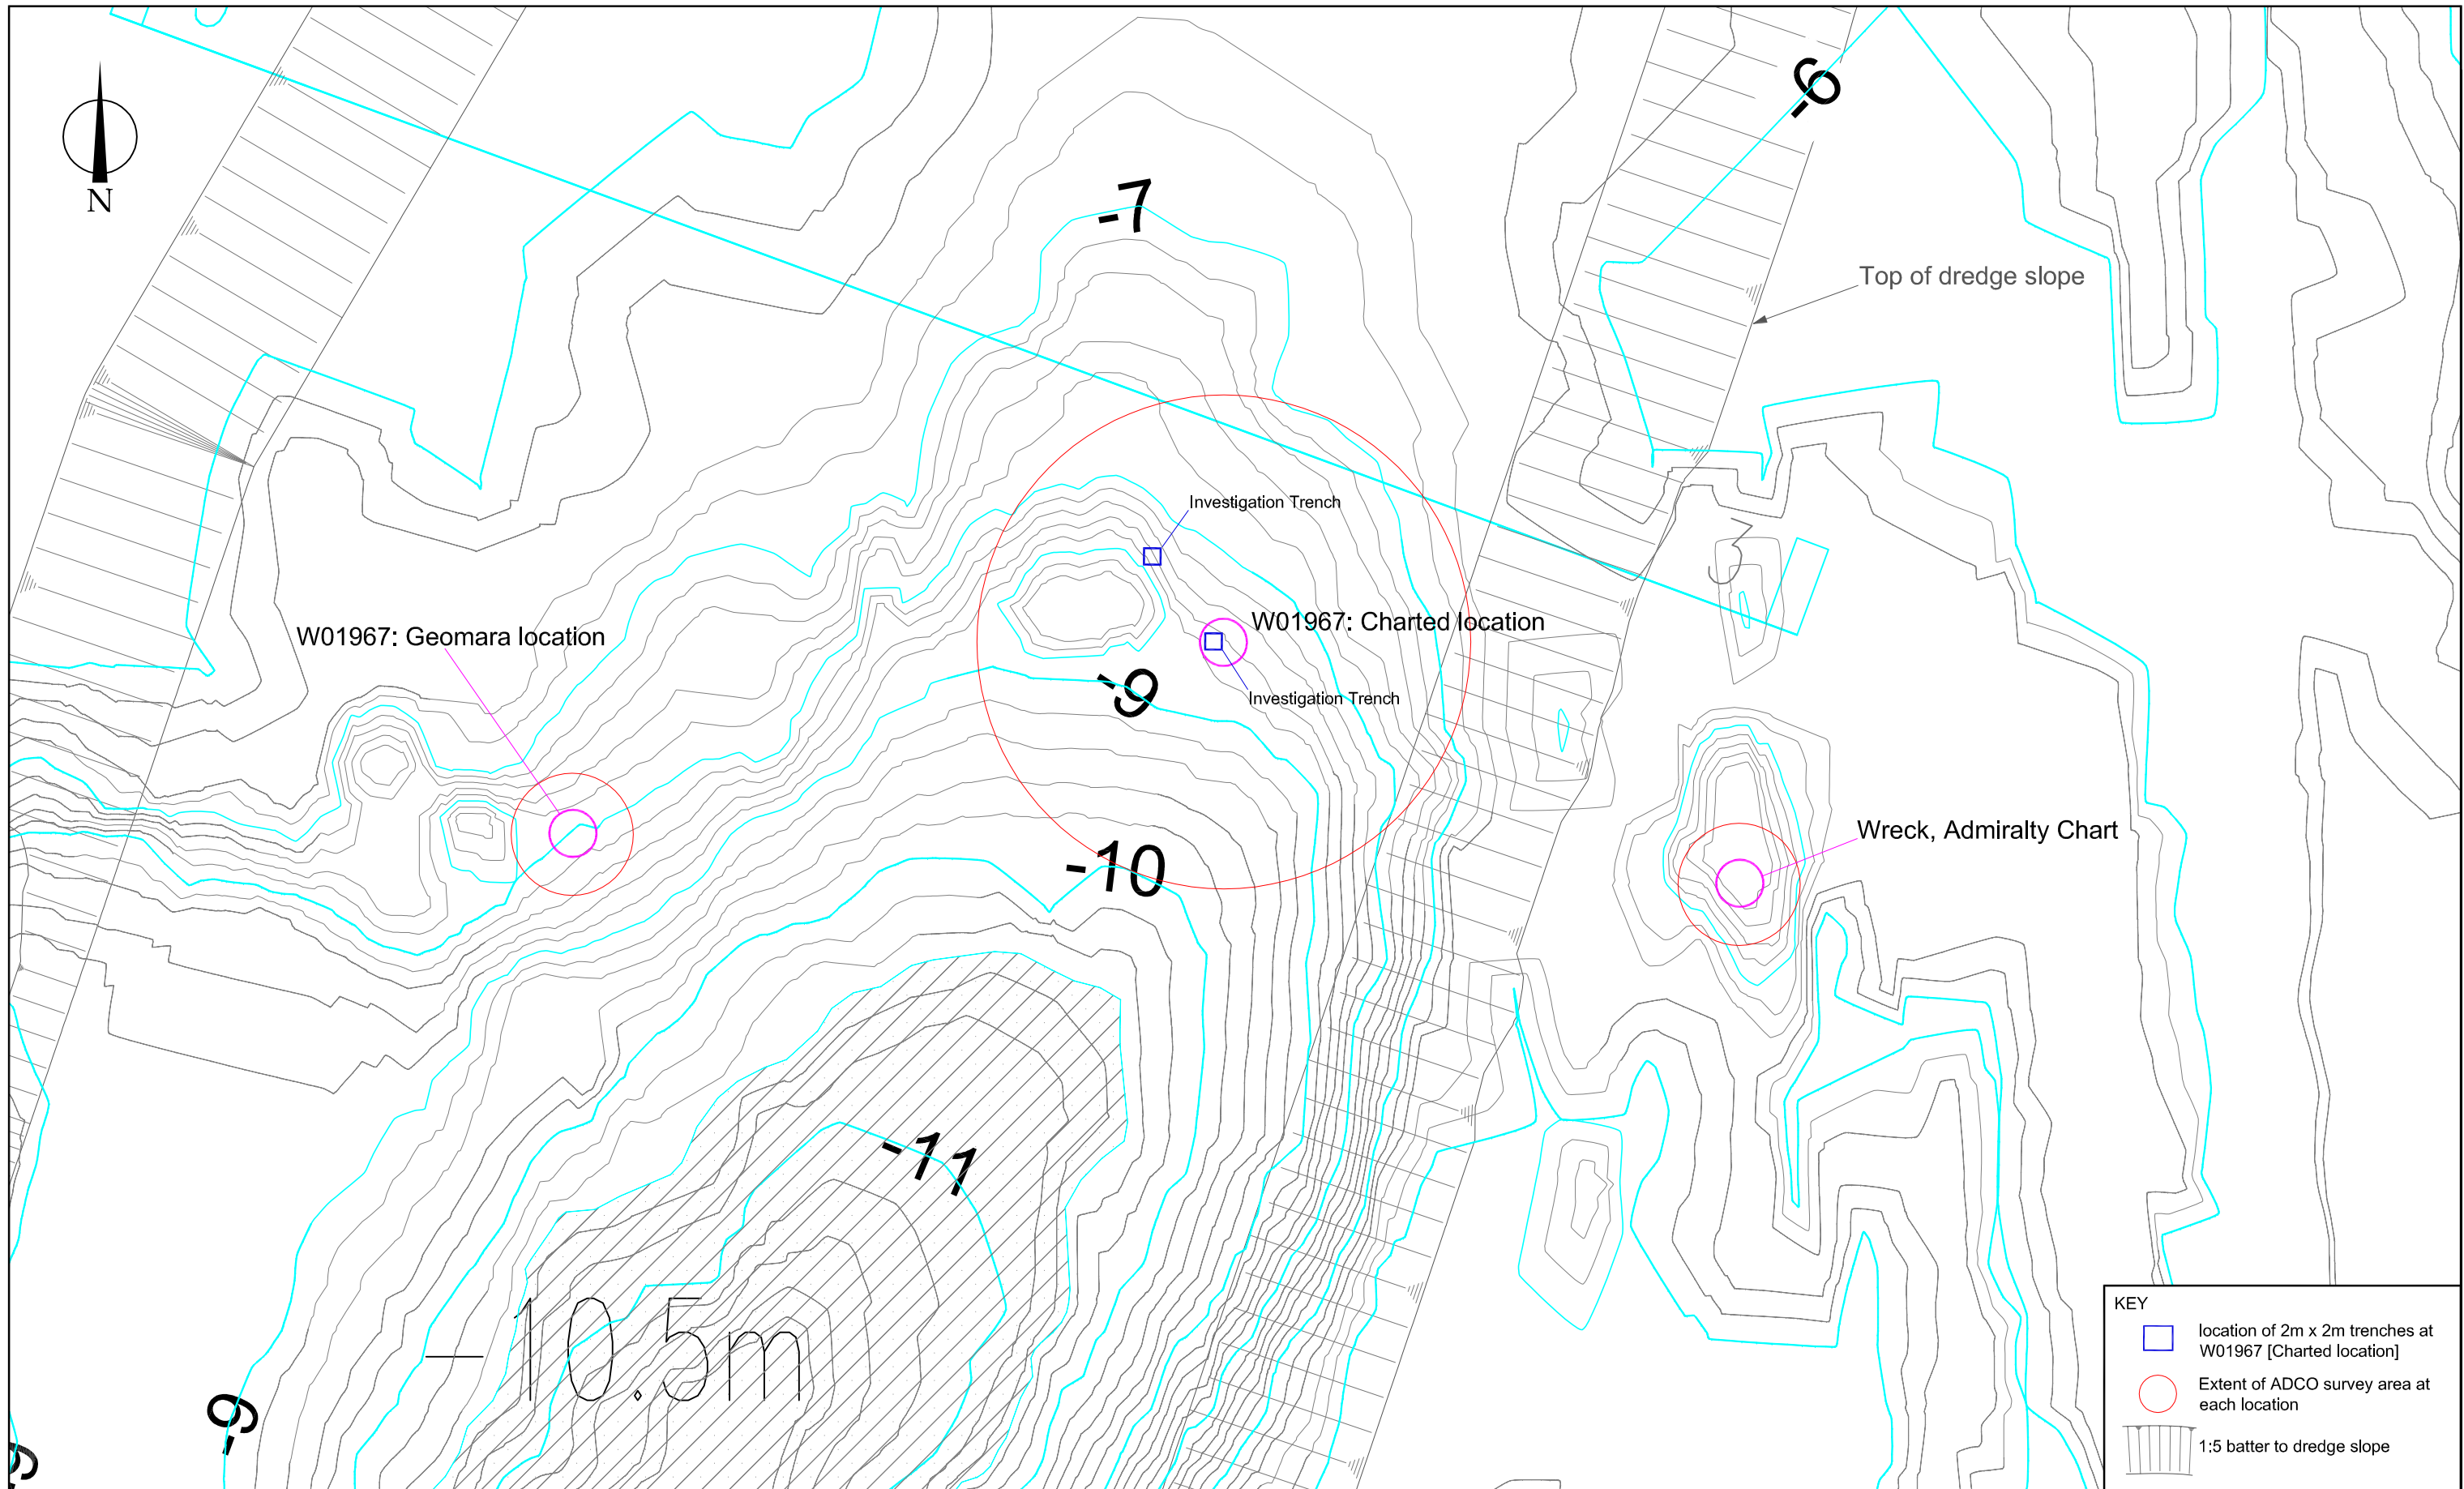
Geomara's marine geophysical survey report. A circular search on the seabed was undertaken, extending out 15m from the target location (Dive 1) (Figure 7, W01967: Geomara location). No wreckage was identified. The seabed was observed to be generally flat with a low undulation and with a surface level of silt that blankets a harder gravel some 20cm below.

The search area for W01967 was repositioned to the charted location as recorded by the INSS in 2004 (Dives 2, 3, 8-11, 21) (Figure 7, W01967: Charted location). The seabed was more undulating and a slight hollow was encountered to the west of the target location. One encrusted feature was observed, while probing located a hard buried object. This work was followed by two investigation trenches being cut, but neither feature was archaeological in nature; the former being an abandoned fish box, the latter an isolated boulder. A metal-detector survey also failed to return any anomalies (Dive 21). Additional inspections of the seabed were made, extending the search area in all directions, and including the location of a wrecksite that is recorded on the Admiralty Chart 60m east-southeast of W01967 (Dive 13). No evidence for wreckage was observed during these additional searches.

A3	Job/Exc No. 14E00441	Compiled by R.Bangerter	CAD reference Dun_Laoghair2014	Client IAC Ltd./ Dun Laoghair Harbour Company Ltd.	Title Figure 7- Detail of Project Drawing showing W01967 (Charted), W01967 (Geomara), & Wreck (Admiralty Chart) and extent of ADCO Underwater Survey at same.
	Date 18.12.2014	Scale 1:750	Drawing No. Figure 7	Project Dun Laoghair Harbour Development Project- Archaeological Investigations
