APPENDICES 5.10

Report of Geophysical Survey
Dun Laoghaire Cruise Project
At Dun Laoghaire Harbour, Co. Dublin
Licence Number: 13R73

Report of Geophysical Survey
Dun Laoghaire Cruise Project
At Dun Laoghaire Harbour, Co. Dublin
Licence Number: 14R0049

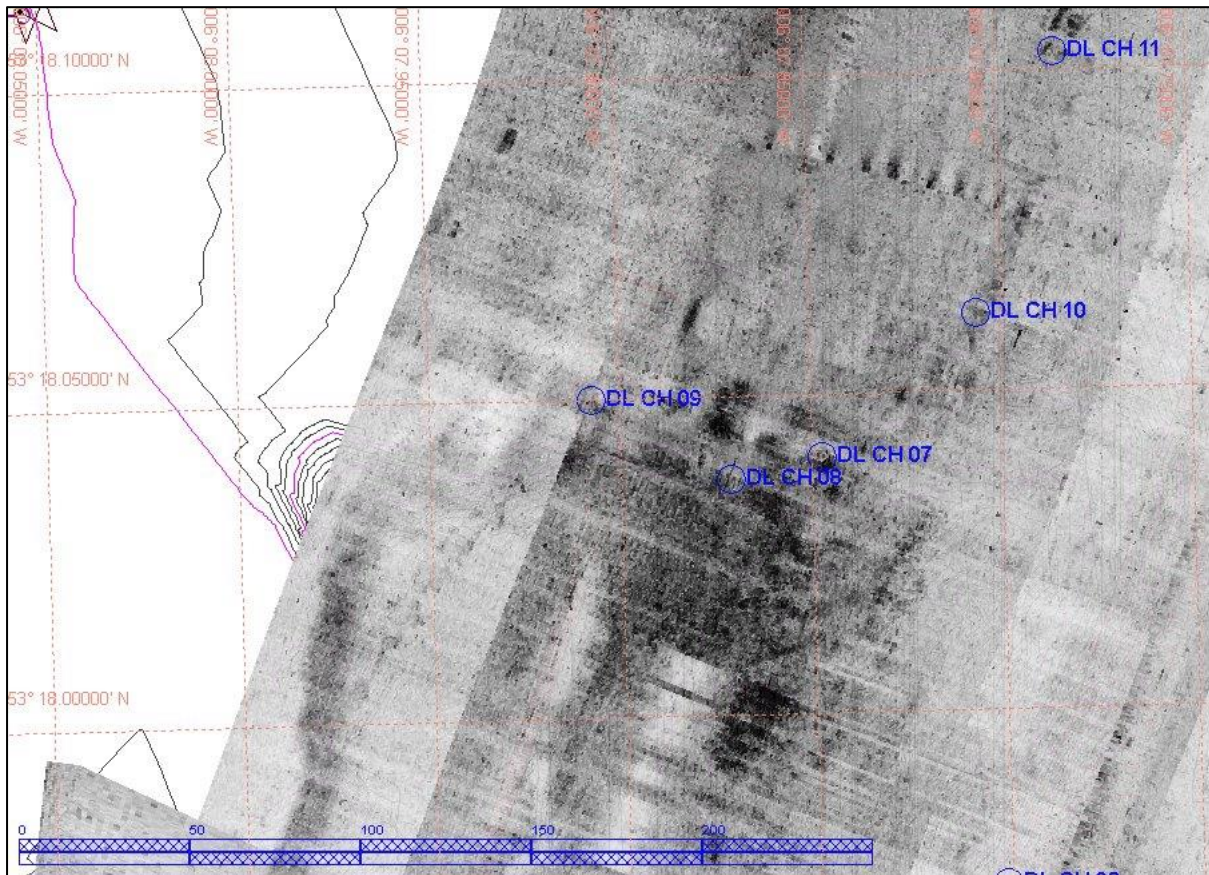
The survey data indicated that the survey area surrounding the site of potential wreck WO1967 (anomalies DL CH 07-10) had changed considerably since the first geophysical survey which took place during May 2014. The most significant aspect of this change was the flat nature of the seafloor, where it had previously been scoured (see plates 8 & 9). A number of the seafloor anomalies noted in this area were still present (see figure 10). These were recorded during diver investigations as modern debris and small seafloor undulations and not of archaeological significance.

Figure 8. Anomalies DL CH 07-10 after 1st survey

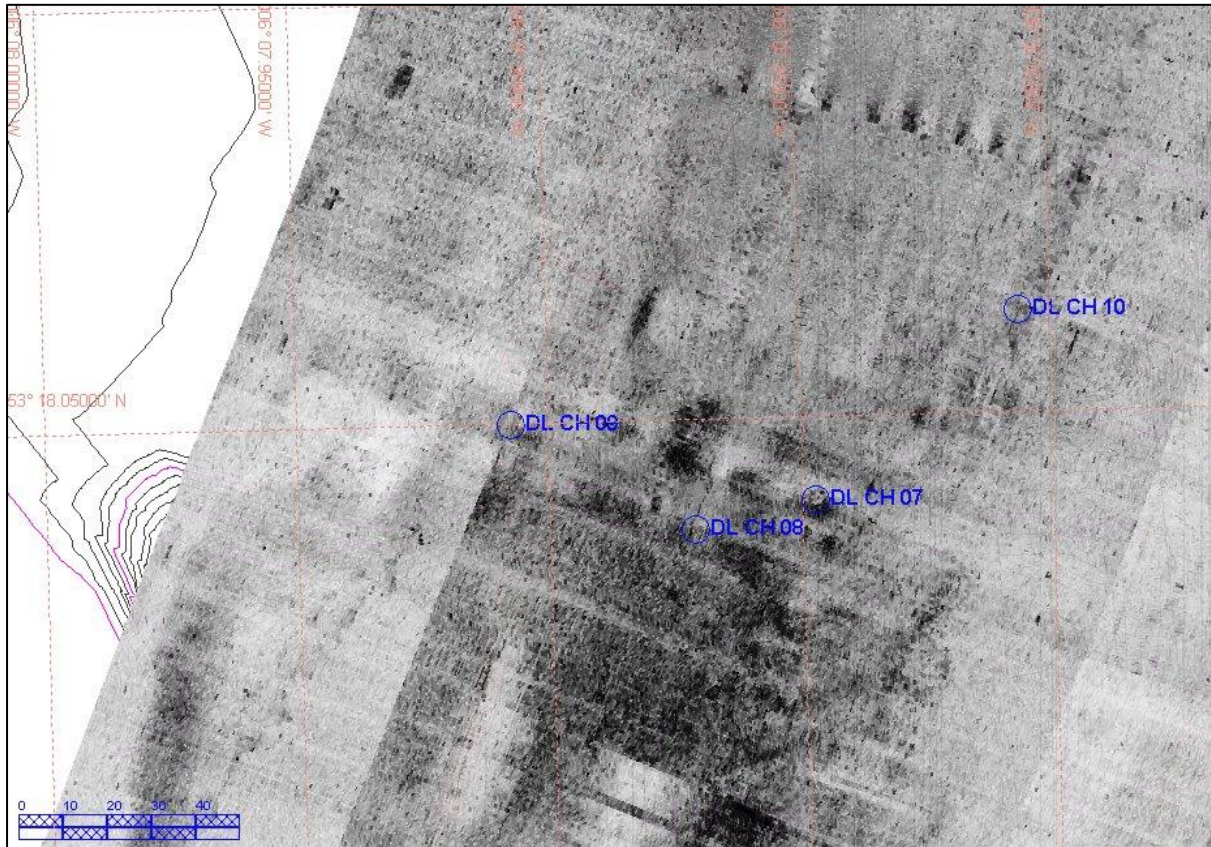
The most significant aspect of this change was the flat nature of the seafloor, where it had previously been scoured. A number of the seafloor anomalies noted in this area were still present (see figures 9 & 10). These were recorded during diver investigations as modern debris and small seafloor undulations and not of archaeological significance.

The previously recorded undulating seafloor typified by scour ridges was no longer present. These undulations appear to have been caused by ferry traffic. As ferry transits had ceased from the time of the geophysical survey to the time of the investigations, the seafloor has subsequently naturally silted in the areas of scour.

Figure 9. Anomalies DLCH 07-10 after 2nd survey

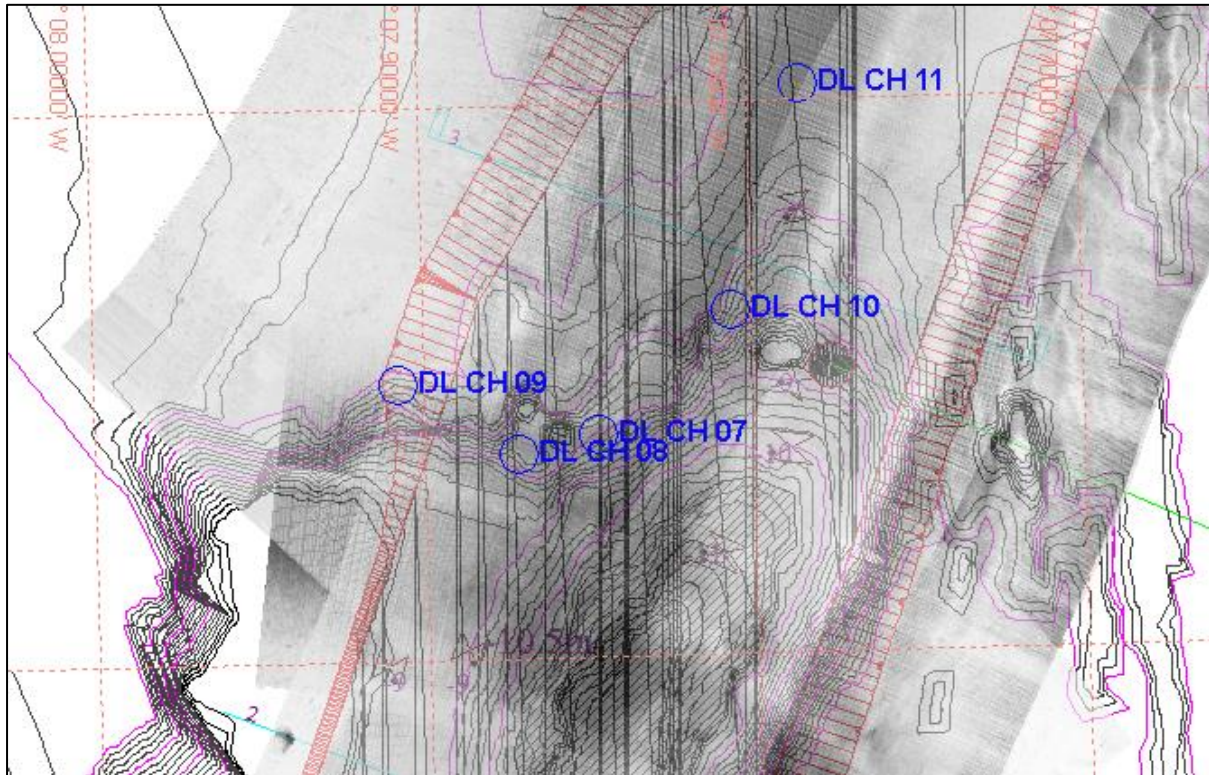
Figure 11. Contacts within proposed development area.

The side scan sonar survey indicates that there are no new seafloor anomalies in this area which would suggest the presence of archaeological features or material. The contacts located within the proposed development area are not considered to be of any archaeological importance.
