## N6 Galway City Ring Road

**Karst Survey Report**

Reference: GCOB-4-03-0-6.2.8\_010

Issue 4 | 28 March 2025

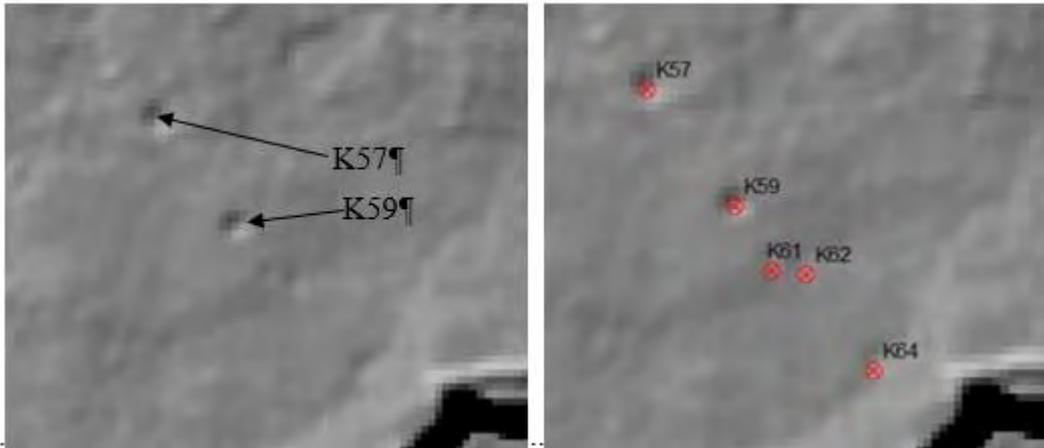
Potential features were identified during the desk study and then investigated in the field. As an example, Figure 1.a presents the lidar image showing two clear circular shapes interpreted as likely karst landforms but also shows multiple surrounding features that are less clear. The potential features (K57 and K59) were visited and confirmed as enclosed depressions during the field survey. Survey of the surrounding features also confirmed three further enclosed depressions (K61, K62 and K64) as shown in Figure 1.b.

Figure 1a (left) lidar image showing two potential enclosed depressions identified from the desk study, 1b (right) karst features confirmed during field survey

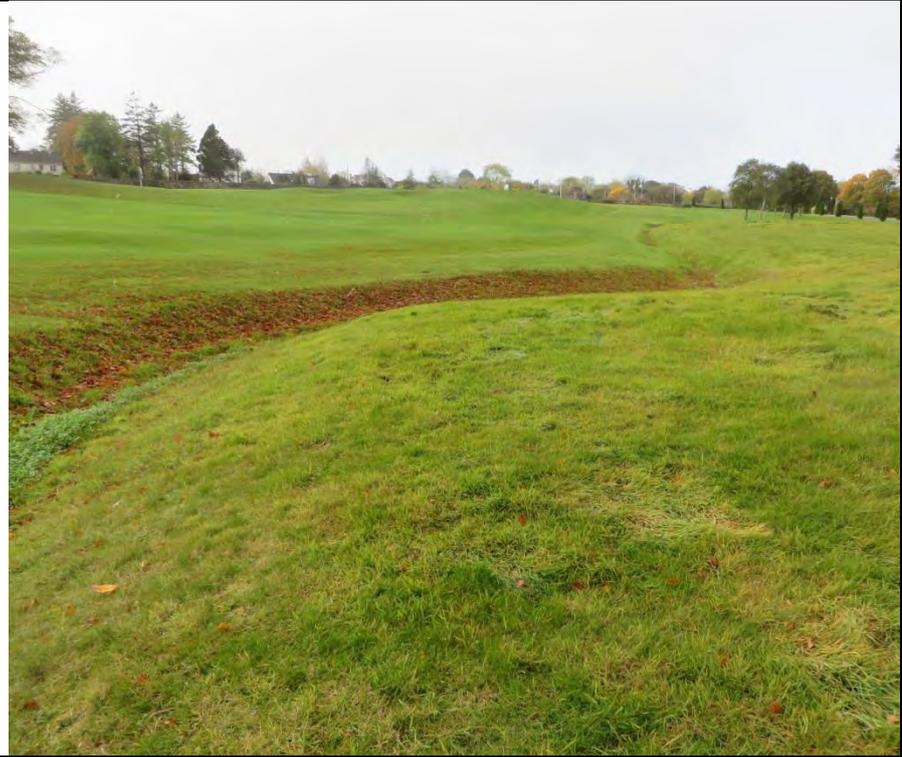
Other sources: aerial photography
<b>Field survey date</b>	21/10/2014
<b>Field survey status</b>	Confirmed
<b>Water present</b>	Yes
<b>Additional Information</b>	Spring discharging into large pond. Drain also discharges into the pond. The drain may be modified and contains little water on day of visit.

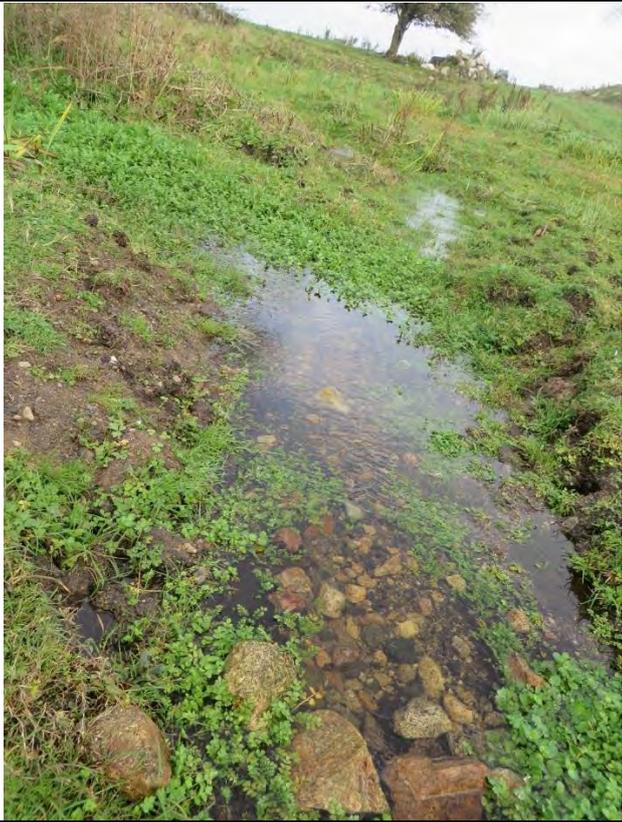
<b>Feature ID</b>	<b>K7</b>
<b>Feature type</b>	Spring
<b>Coordinates</b>	527195, 728079
<b>Source</b>	Field Survey
<b>Field survey date</b>	20/10/2014
<b>Field survey status</b>	Confirmed
<b>Water present</b>	Yes
<b>Additional Information</b>	
<b>Site photo</b>

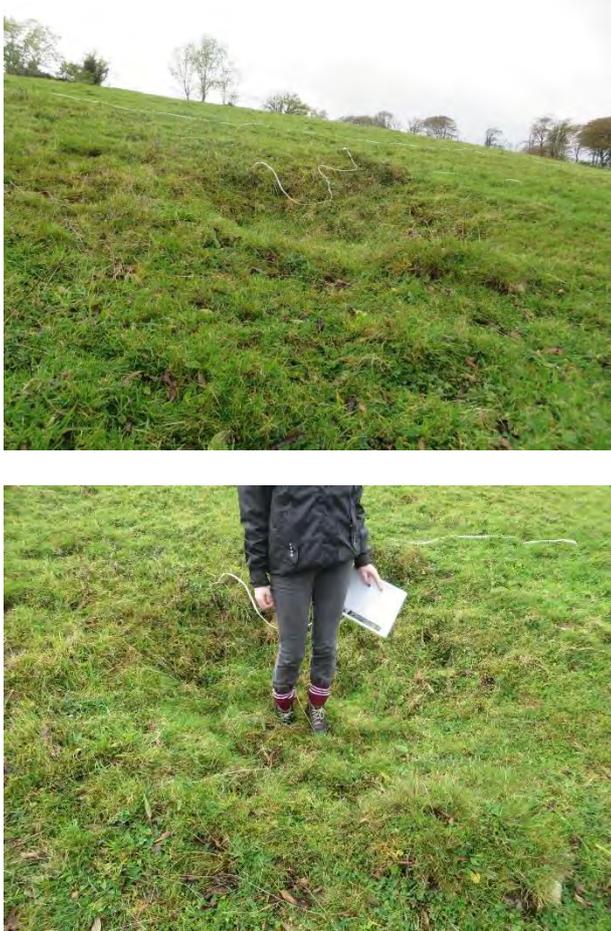
<b>Feature ID</b>	<b>K10</b>
<b>Feature type</b>	Enclosed depression
<b>Coordinates</b>	527301, 728143
<b>Source</b>	Field Survey
<b>Field survey date</b>	20/10/2014
<b>Field survey status</b>	Confirmed
<b>Water present</b>	No
<b>Additional Information</b>	1 m diameter small enclosed depression, base contains loose rocks
<b>Site photos</b>

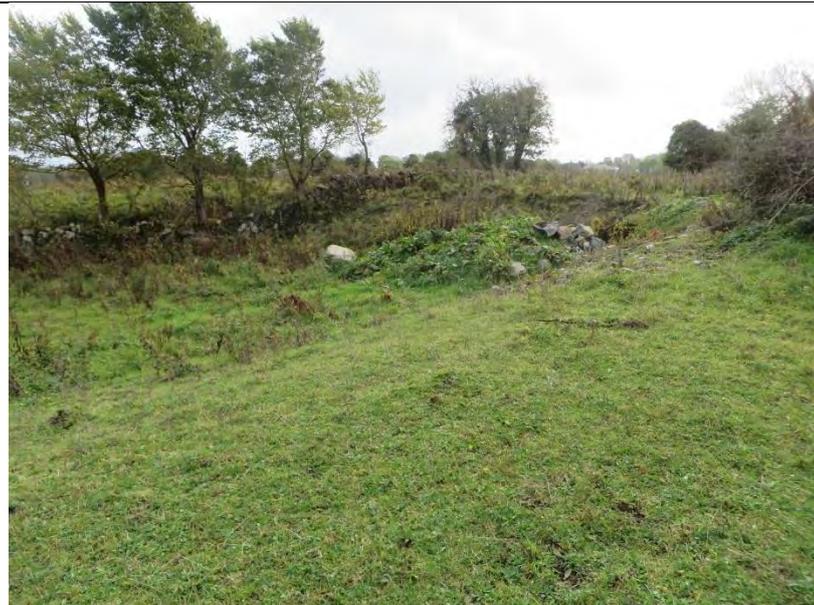
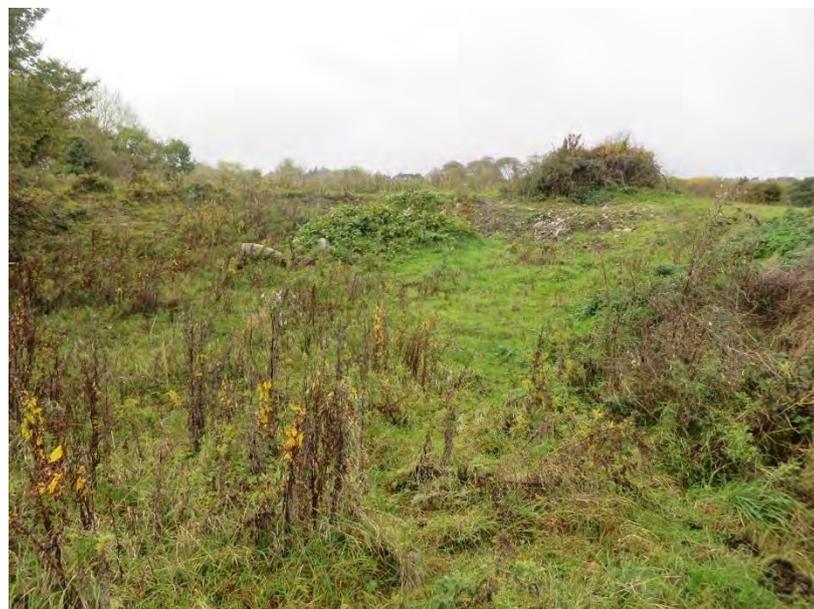
<p>Other sources: aerial photography</p>
<b>Field survey date</b>	20/10/2014
<b>Field survey status</b>	Confirmed
<b>Water present</b>	No
<b>Additional Information</b>	15m diameter enclosed depression.

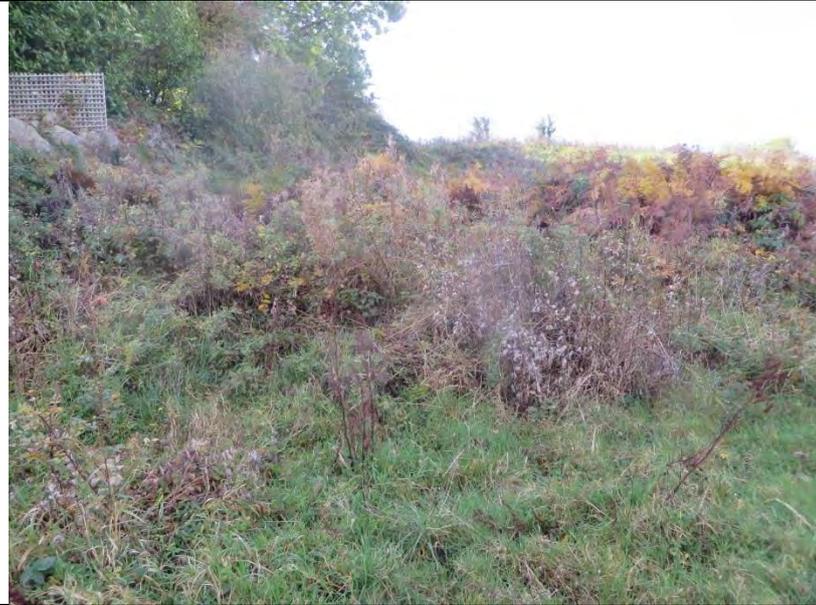
Other sources: aerial photography
<b>Field survey date</b>	21/10/2014
<b>Field survey status</b>	Confirmed
<b>Water present</b>	No
<b>Additional Information</b>	20m diameter enclosed depression with gently sloped sides.

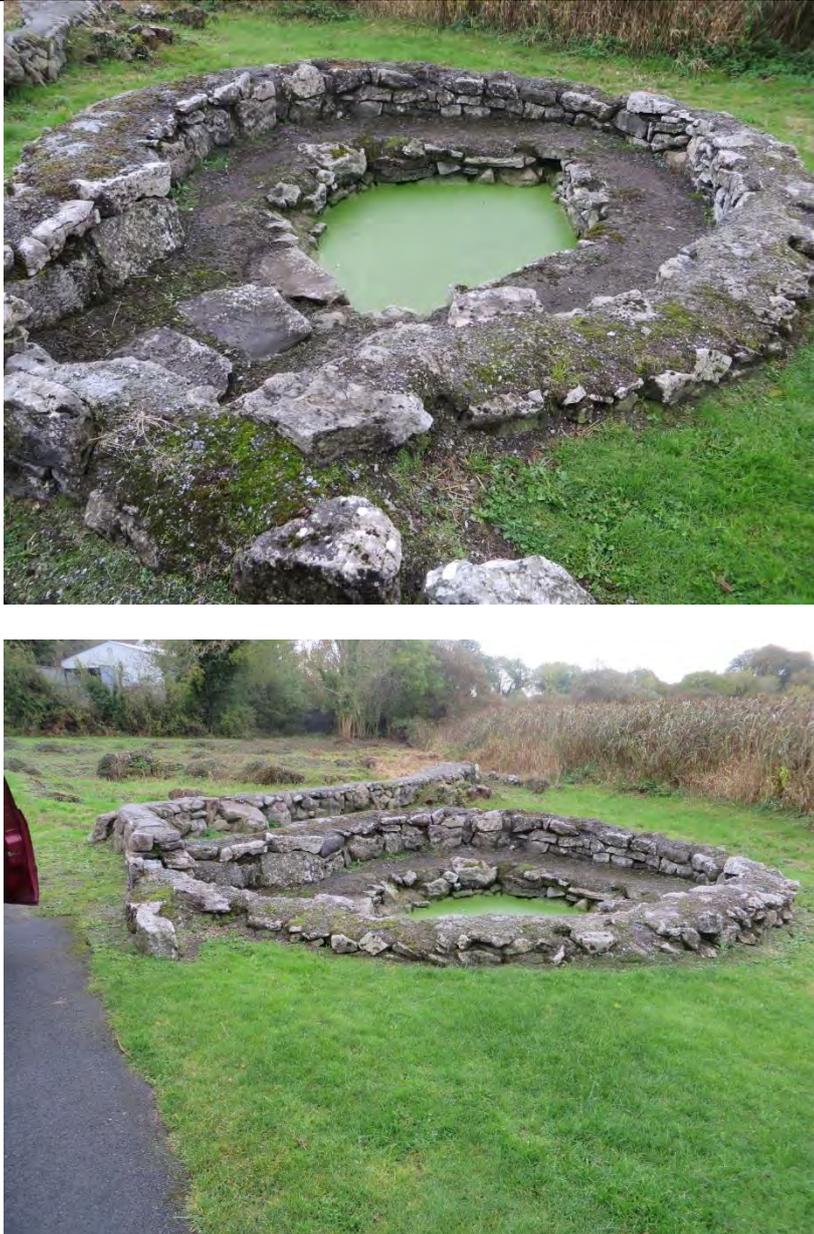
<b>Feature ID</b>	<b>K17</b>	
<b>Feature type</b>	Spring	
<b>Coordinates</b>	528345, 728630	
<b>Source</b>	Field Survey	
<b>Field survey date</b>	17/10/2014	11/11/2014
<b>Field survey status</b>	Confirmed	Confirmed
<b>Water present</b>	Yes Electrical conductivity: 520 uS/cm Temperature: 13.8 °C pH: 7.83	Yes Electrical conductivity: 622 uS/cm Temperature: 12 °C pH: 6.87
<b>Water elevation</b>	n/a	6.12 mAOD
<b>Additional Information</b>	Constructed pond (2 m diameter) covered in algae surrounded by constructed stone wall beside path.	
<b>Site photos</b>

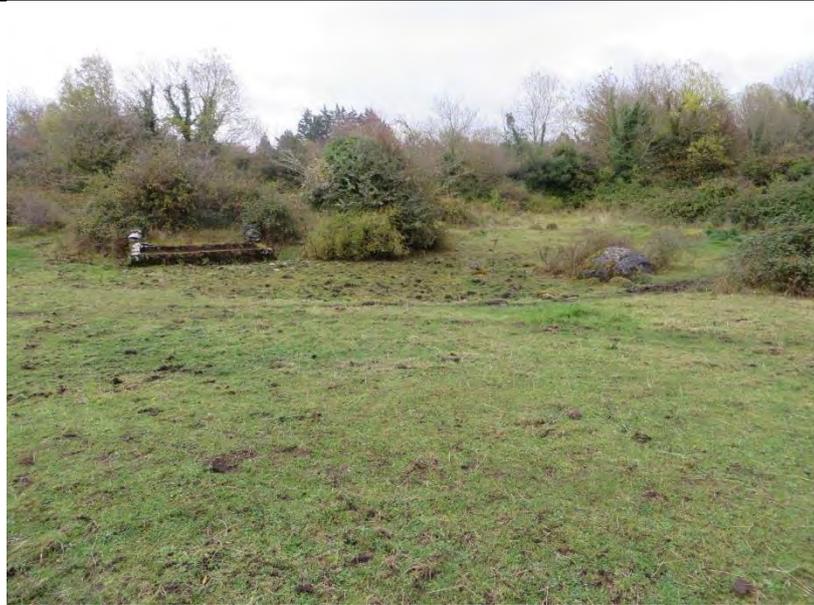
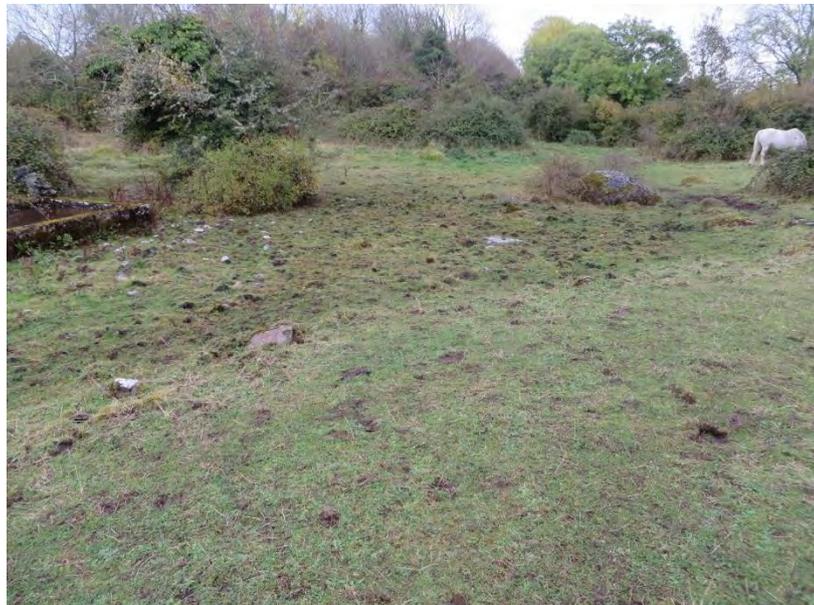
<p>Other sources: aerial photography</p>
<b>Field survey date</b>	17/10/2014
<b>Field survey status</b>	Confirmed
<b>Water present</b>	<p>Yes</p> <p>Electrical conductivity: 350 uS/cm</p> <p>Temperature: 14.2 °C</p> <p>pH: 8.72</p>
<b>Additional Information</b>	Water logged depression in field.

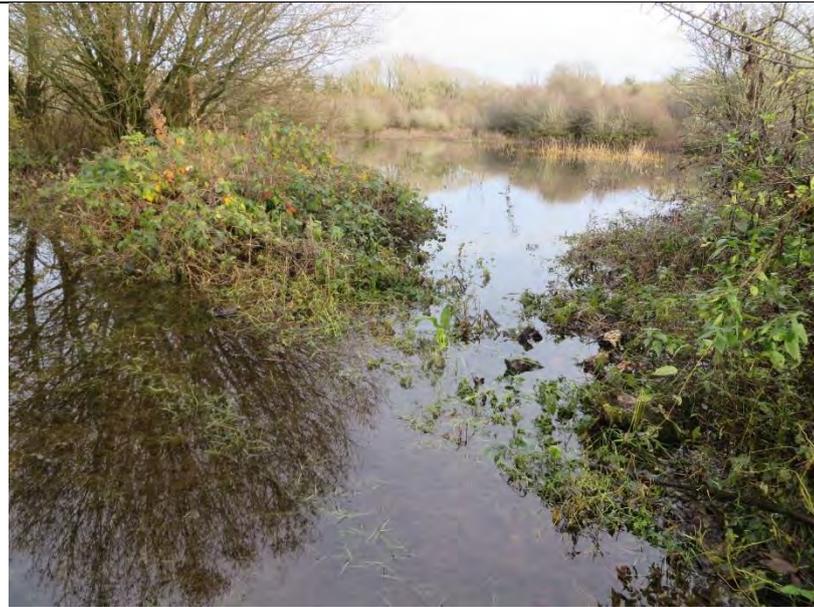
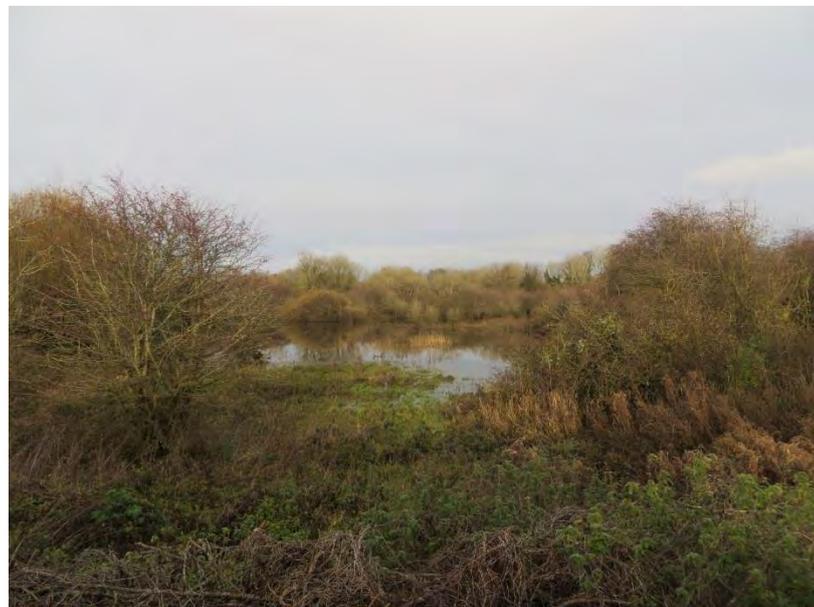
**Site Photos**  
11/11/2014

Other sources: aerial photography	
<b>Field survey date</b>	17/10/2014	11/11/2014
<b>Field survey status</b>	Confirmed	Confirmed
<b>Water present</b>	No	Yes Electrical conductivity: 481 uS/cm Temperature: 9.8 °C pH: 7.64

<b>Water elevation</b>	10.42 mAOD
<b>Additional Information</b>	A plug hole was not found
<b>Site photos</b> 17/10/2014

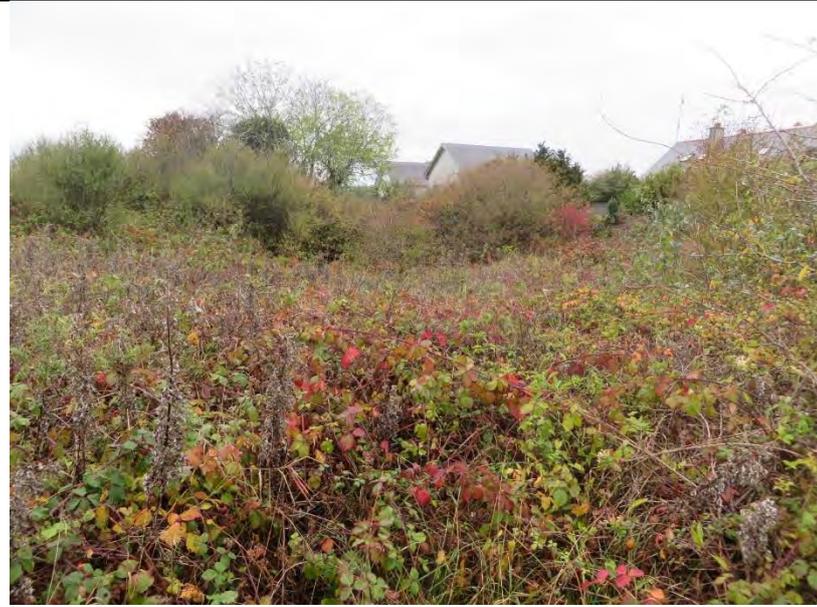
Other sources: aerial photography
<b>Field survey date</b>	17/10/2014
<b>Field survey status</b>	Confirmation/identification problem
<b>Water present</b>	No
<b>Additional Information</b>	Area covered in briars and vegetation preventing access.

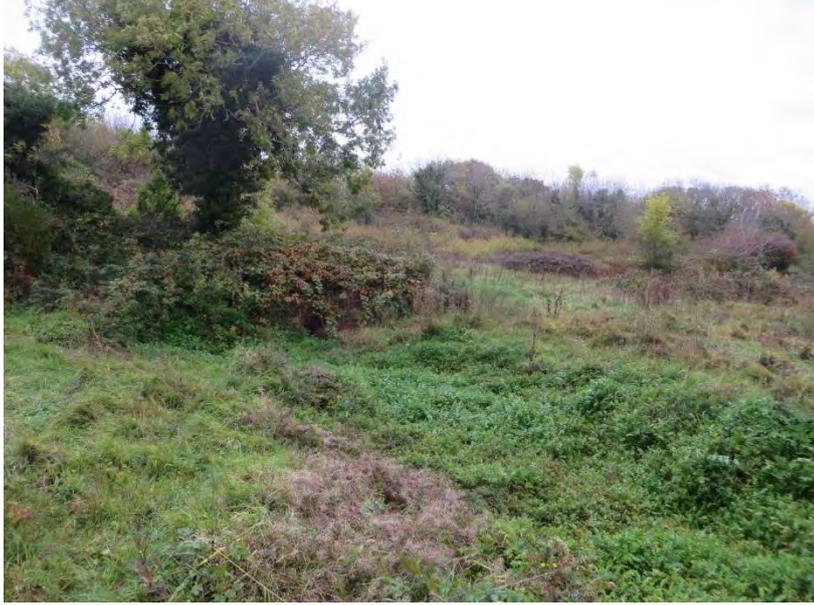
<b>Field survey date</b>	17/10/2014	12/11/2014
<b>Field survey status</b>	Confirmed	Confirmed
<b>Water present</b>	Yes Electrical conductivity: 490 uS/cm Temperature: 10.4 °C pH: 7.74	Yes Electrical conductivity: 480 uS/cm Temperature: 10.7 °C pH: 7.31
<b>Water elevation</b>		Water level elevation: 6.06 mAOD Elevation was recorded where the water is discharging beneath briars.

<b>Additional Information</b>	Stream channel from spring location contains considerable vegetation. Flow not measurable due to thick vegetation within channel Flow from spring discharge point was audible on the 12/11/2014.
<b>Site photo</b>	Spring discharge location

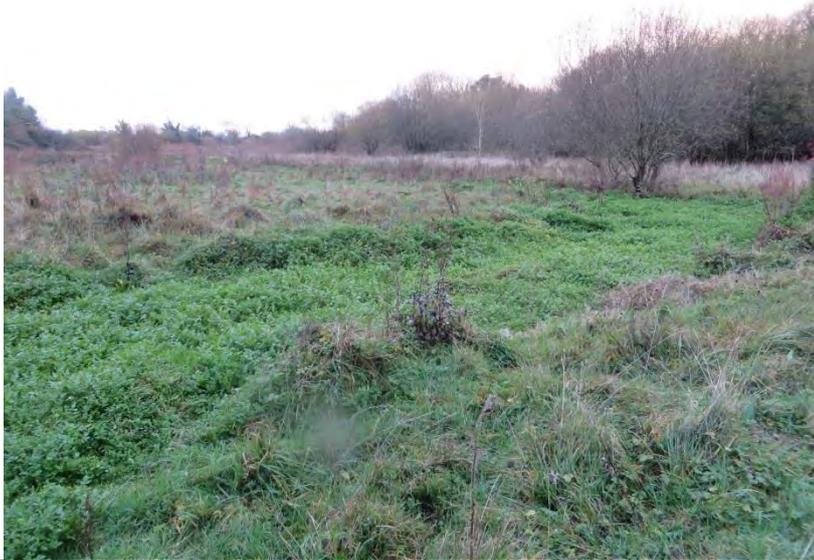
Spring discharge channel containing thick vegetation

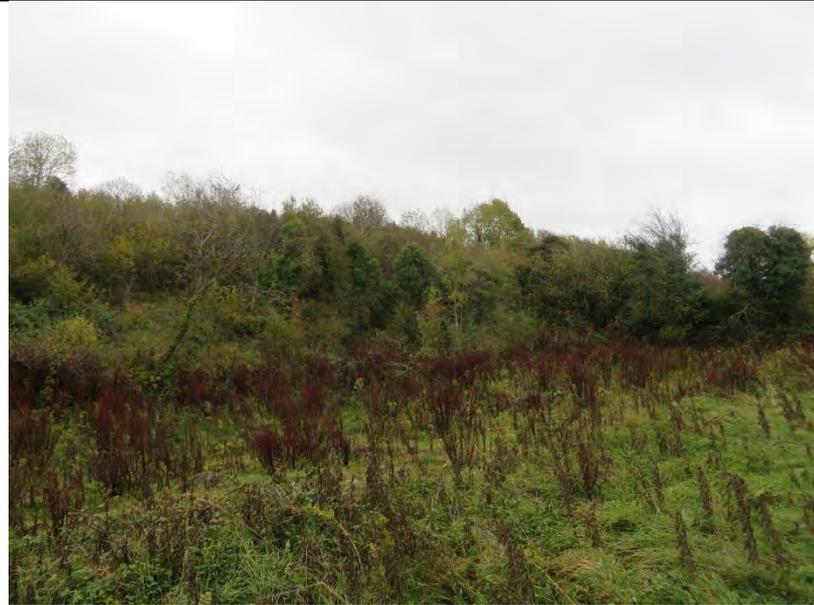
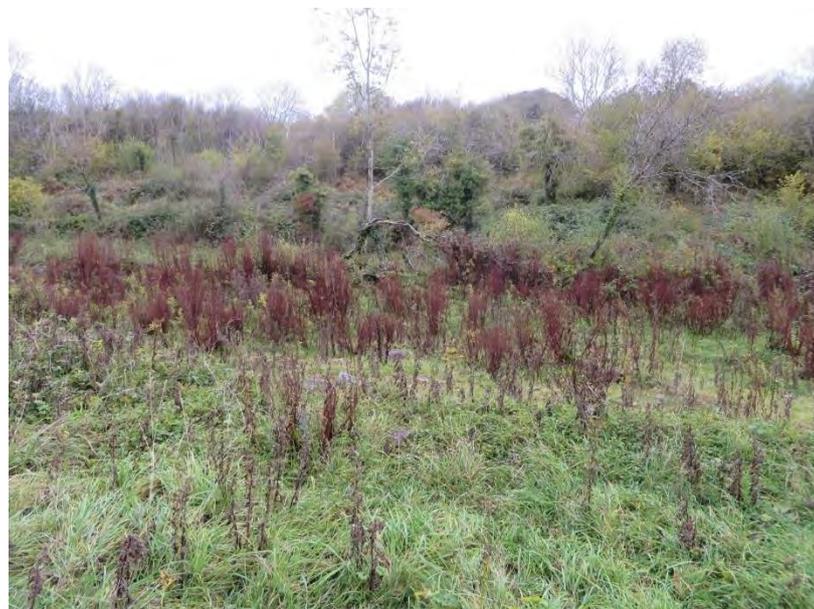
**Site photo**

<b>Field survey date</b>	17/10/2014
<b>Field survey status</b>	Confirmed
<b>Water present</b>	No
<b>Additional Information</b>	Turlough is divided in two parallel sections with relatively well defined edges. The elevation of the eastern section is lower than the western section. A potential plug hole evident in the upper western section

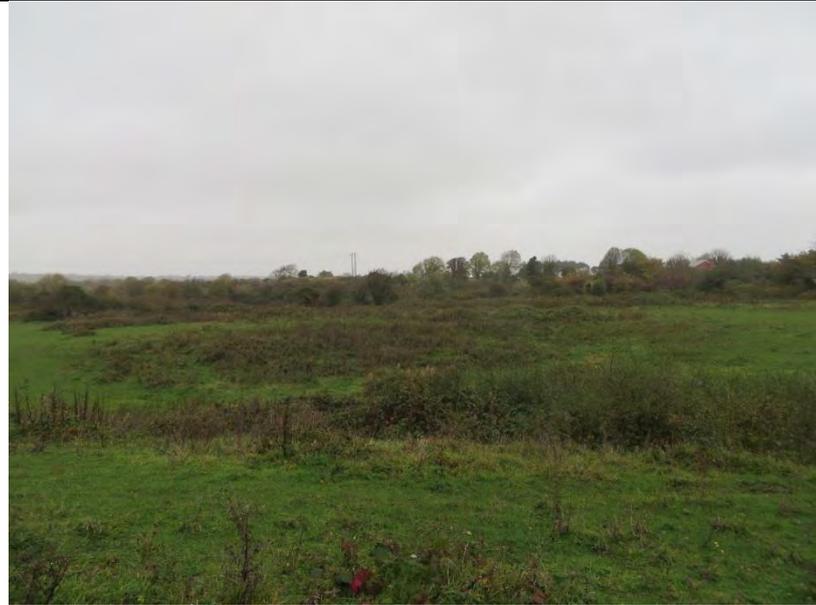
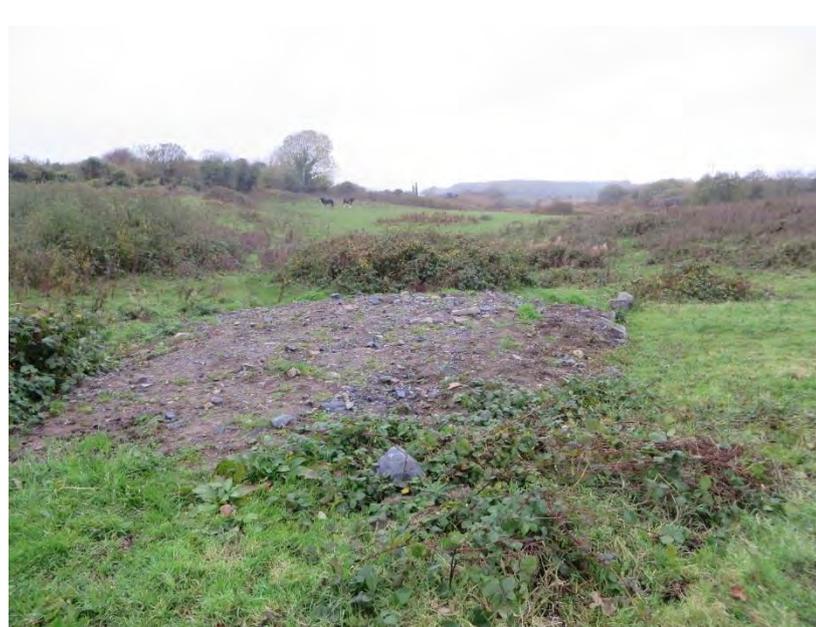
**Site photos**

<b>Field survey date</b>	20/10/2014
<b>Field survey status</b>	Confirmed
<b>Water present</b>	No
<b>Additional Information</b>	30 m diameter enclosed depression. However this feature is questionable as there may be disposal of material to the east of the depression.

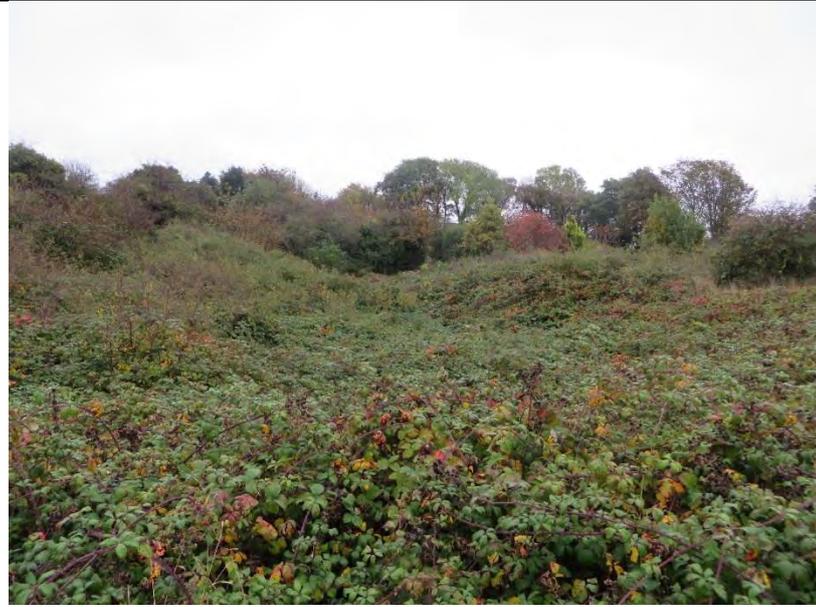
**Site photos**

<b>Field survey date</b>	20/10/2014
<b>Field survey status</b>	Confirmation/identification problem
<b>Water present</b>	Unknown
<b>Additional Information</b>	May be enclosed depression but access inhibited by dense vegetation

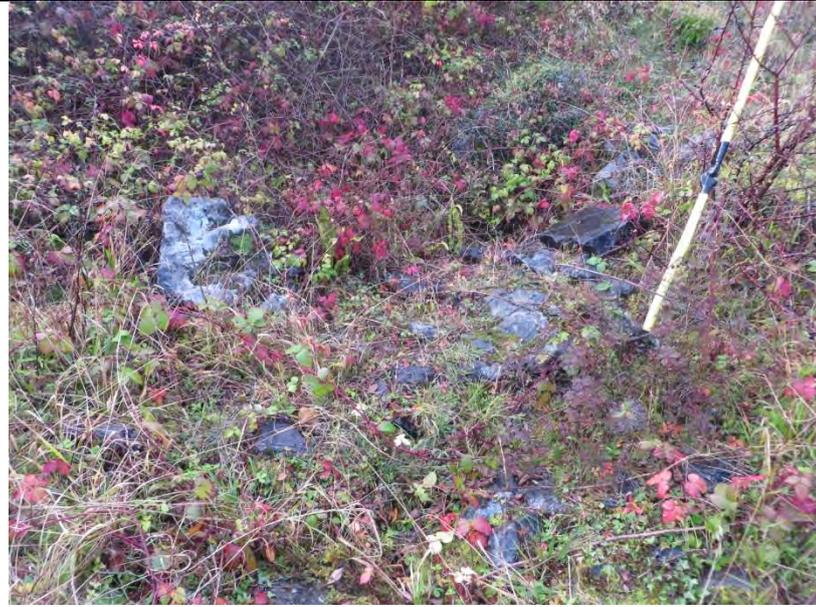
**Site photo**

<b>Field survey date</b>	16/10/2014
<b>Field survey status</b>	Confirmed
<b>Water present</b>	No
<b>Additional Information</b>	Small depression with rock exposed Approx. 2 m diameter and 1 m depth

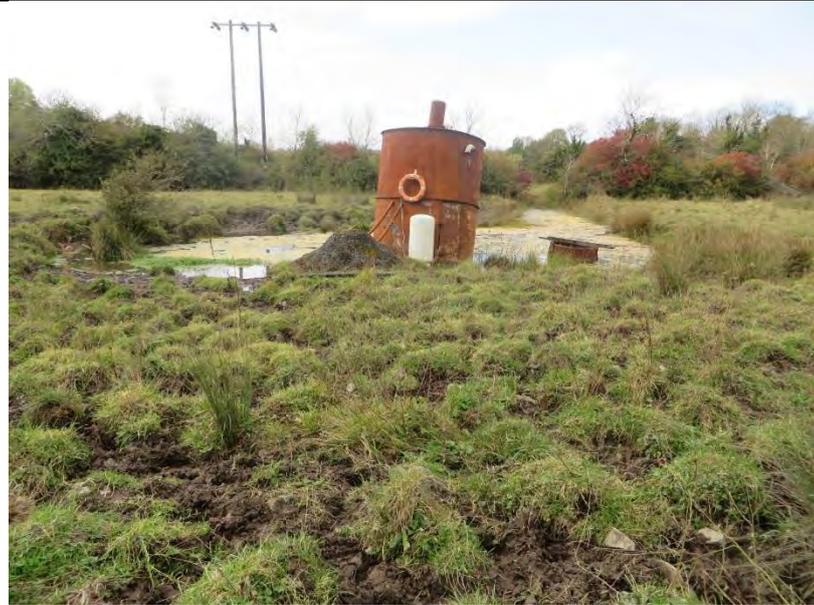
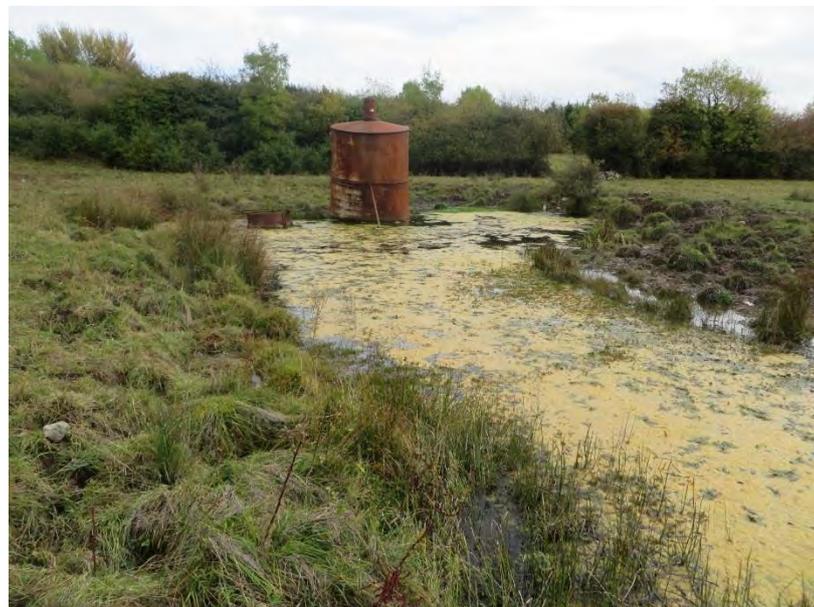
**Site photo**

<b>Field survey date</b>	16/10/2014
<b>Field survey status</b>	Confirmed
<b>Water present</b>	Yes Electrical conductivity: 680 uS/cm Temperature: 15.1 °C pH: 7.28
<b>Additional Information</b>

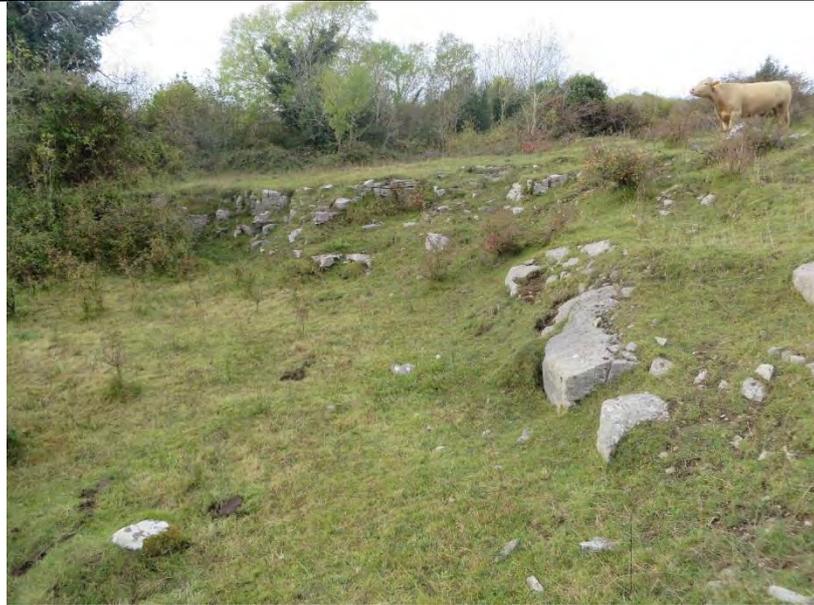
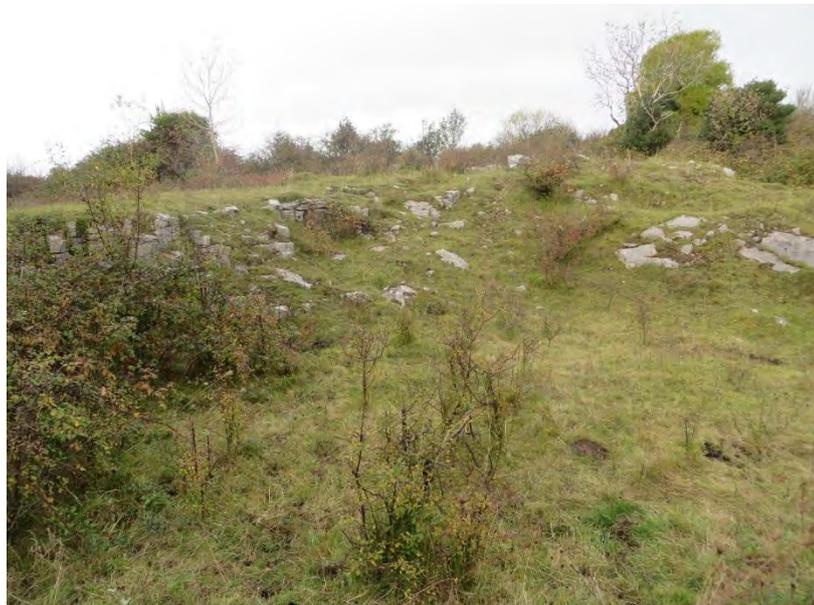
**Site photos**

<b>Field survey date</b>	16/10/2014
<b>Field survey status</b>	Confirmed
<b>Water present</b>	No
<b>Additional Information</b>	Exposed rock at northern side and gentle slope on Southern side Approx. 20 m diameter 2 m depth

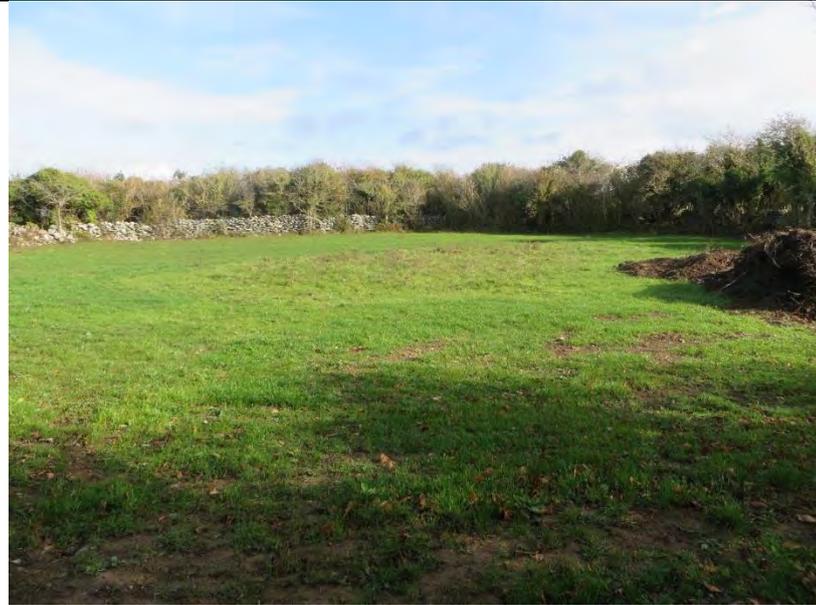
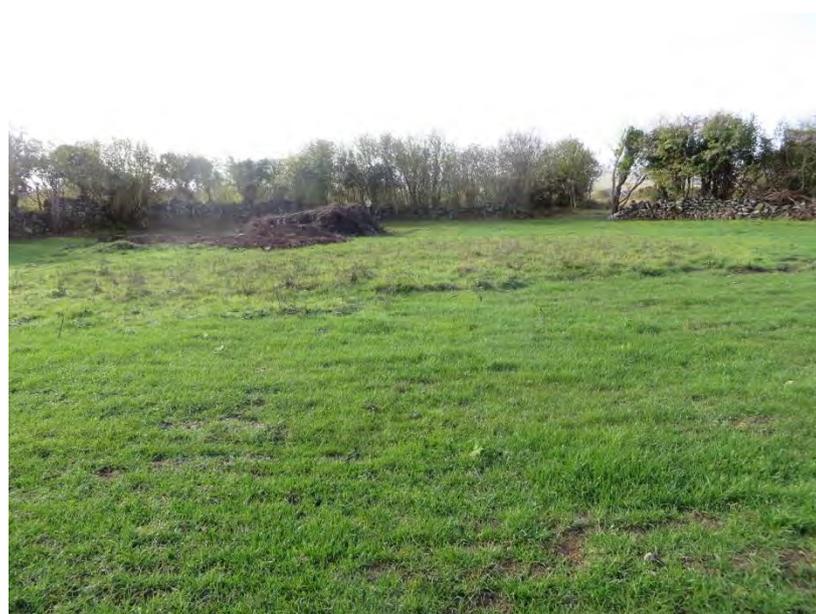
**Site photos**

<b>Field survey date</b>	16/10/2014
<b>Field survey status</b>	Confirmed
<b>Water present</b>	No
<b>Additional Information</b>	Slight enclosed depression which may be filled in

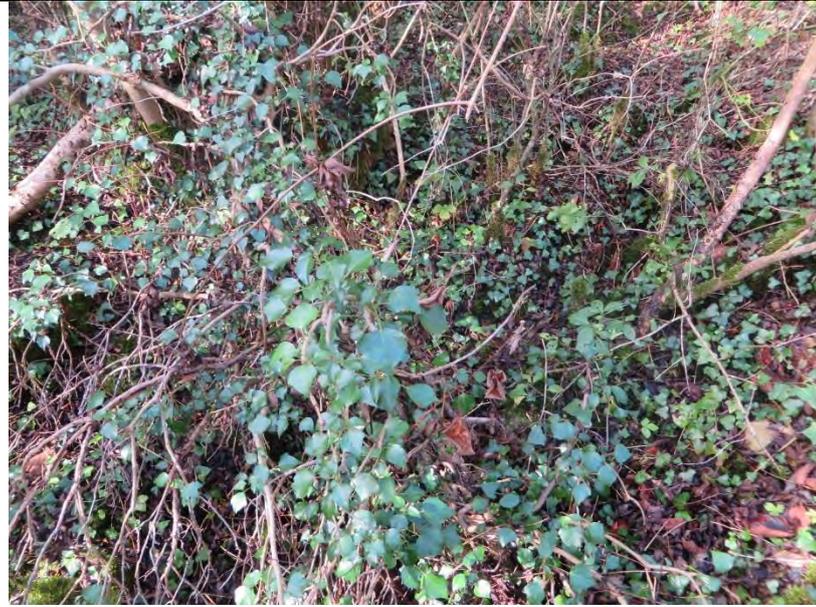
**Site photos**

<b>Field survey date</b>	16/10/2014
<b>Field survey status</b>	Confirmed
<b>Water present</b>	No
<b>Additional Information</b>	Very small enclosed depression plug hole not obvious but probably due to covering of moss

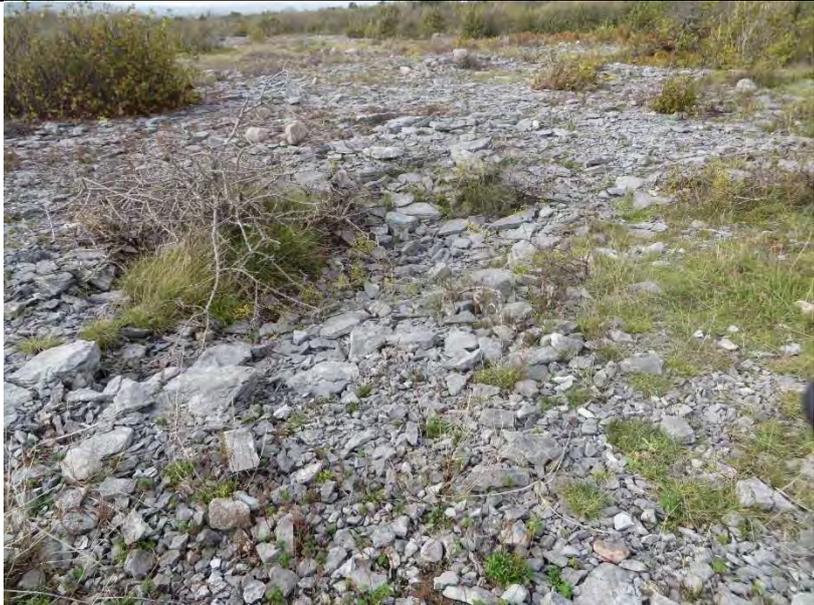
<b>Feature ID</b>	<b>K61</b>
<b>Feature type</b>	Enclosed Depression
<b>Coordinates</b>	530360, 728644
<b>Source</b>	Field Survey
<b>Field survey date</b>	16/10/2014
<b>Field survey status</b>	Confirmed
<b>Water present</b>	No
<b>Additional Information</b>	Approx. 1m diameter Enclosed depression is in line of depressions running EW
<b>Site photo</b>

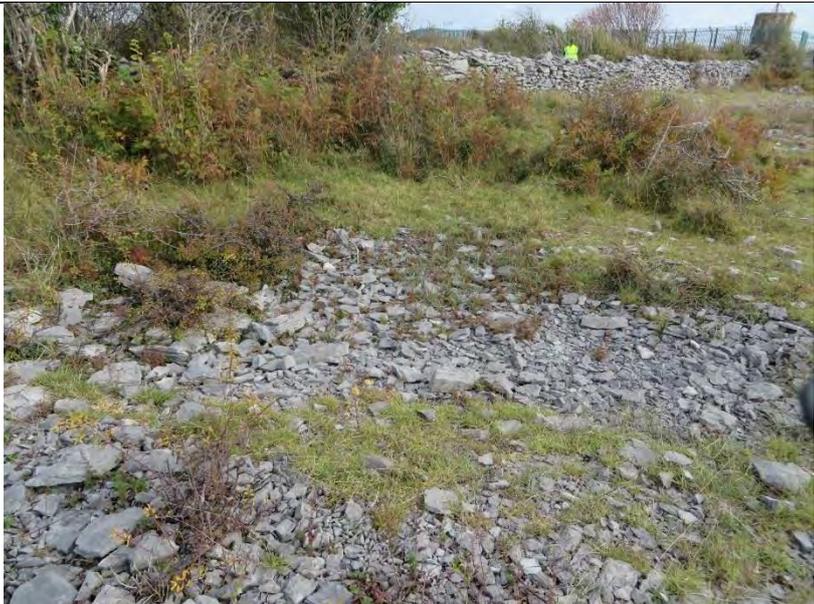
<b>Feature ID</b>	<b>K62</b>
<b>Feature type</b>	Enclosed Depression
<b>Coordinates</b>	530369, 728642
<b>Source</b>	Field Survey
<b>Field survey date</b>	16/10/2014
<b>Field survey status</b>	Confirmed
<b>Water present</b>	No
<b>Additional Information</b>	Approx. 2m diameter and less than 0.5 m in depth. Enclosed depression is in line of depressions running EW
<b>Site photo</b>

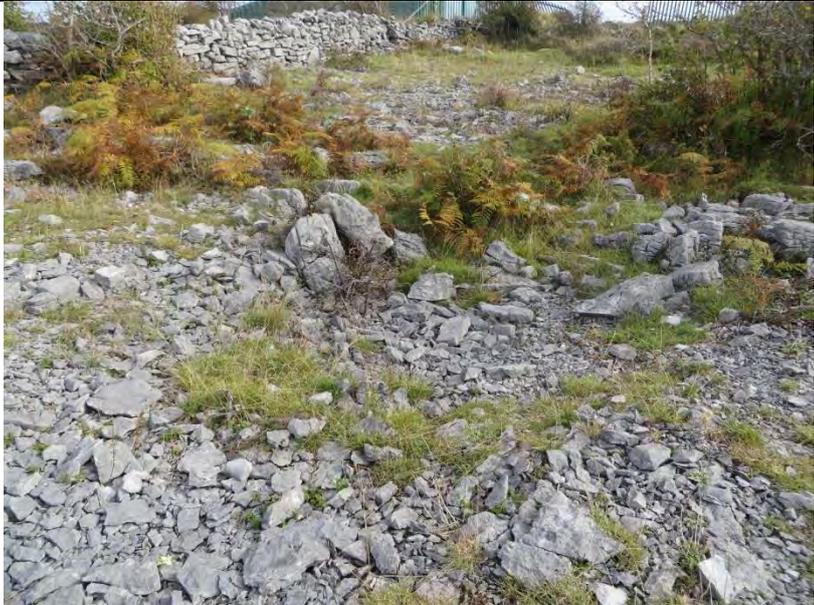
<b>Feature ID</b>	<b>K64</b>
<b>Feature type</b>	Enclosed Depression
<b>Coordinates</b>	530386, 728617
<b>Source</b>	Field Survey
<b>Field survey date</b>	16/10/2014
<b>Field survey status</b>	Confirmed
<b>Water present</b>	No
<b>Additional Information</b>	Approx. 2m diameter and less than 0.5 m in depth. Enclosed depression is in line of depressions running EW
<b>Site photo</b>

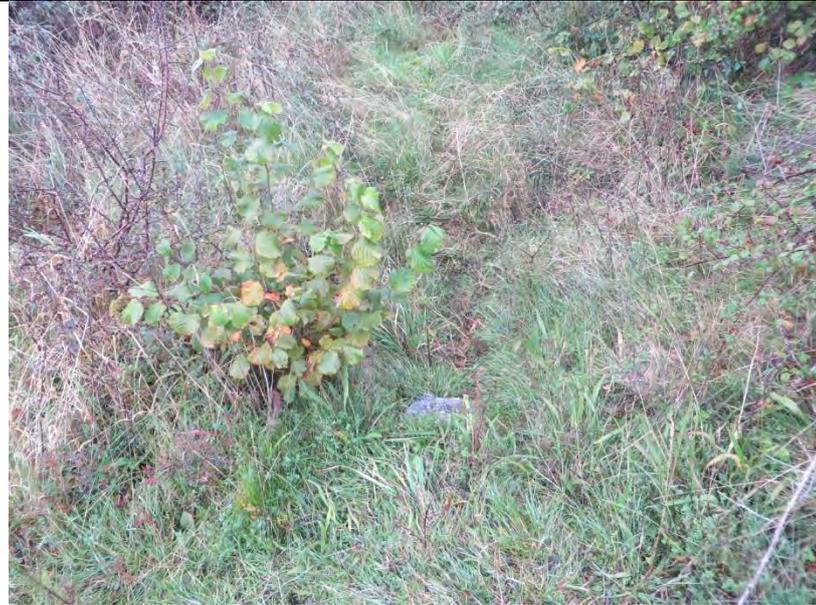
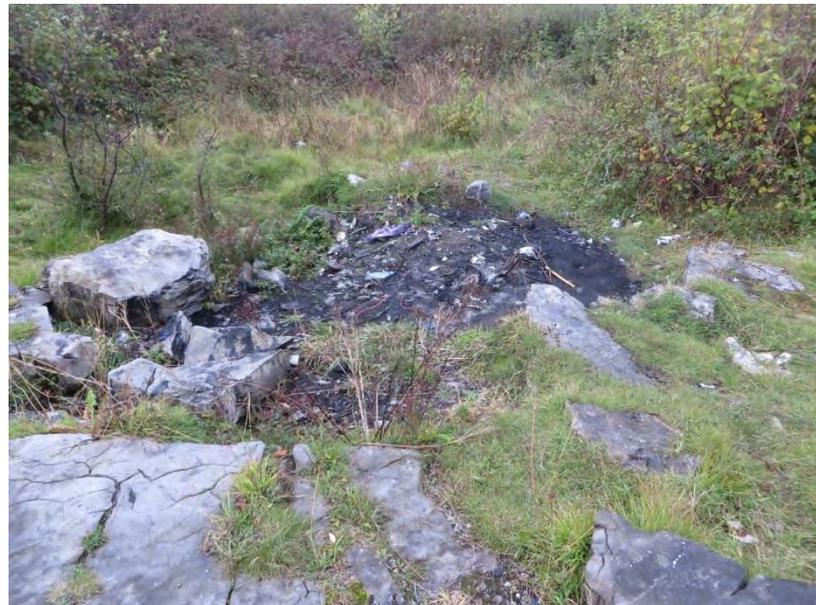
**Site photo**

<b>Field survey date</b>	16/10/2014
<b>Field survey status</b>	Confirmed
<b>Water present</b>	No
<b>Additional Information</b>	2 depressions 3 m diameter and 1 m diameter less than 0.5 m depth. Larger depression is filled with a fire pit

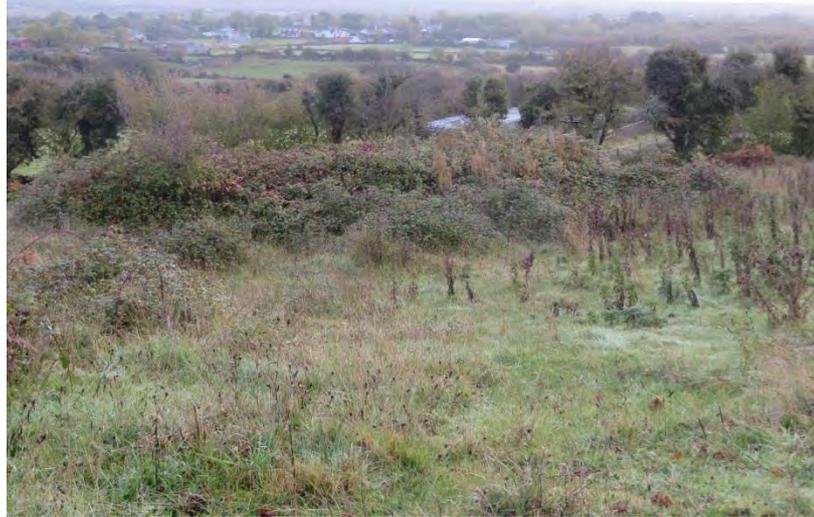
**Site photo**

<b>Field survey date</b>	17/10/2014
<b>Field survey status</b>	Confirmation/identification problem
<b>Water present</b>	Unknown
<b>Additional Information</b>	Circle of brambles. Looks like a dip in the middle but covered in brambles preventing access.

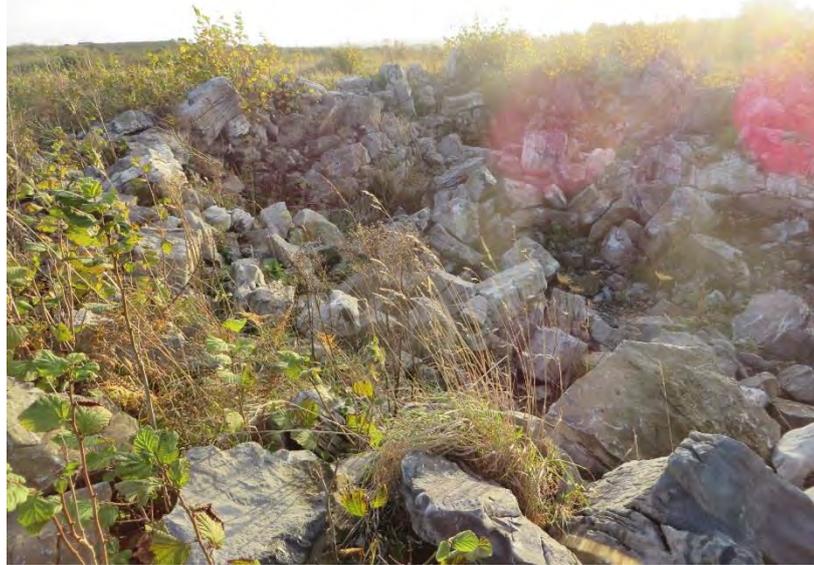
**Site photo**

<b>Field survey date</b>	21/10/2014
<b>Field survey status</b>	Confirmed
<b>Water present</b>	No
<b>Additional Information</b>	Numerous boulders in depression Approx. 20 x 10m diameter and depth of 2m

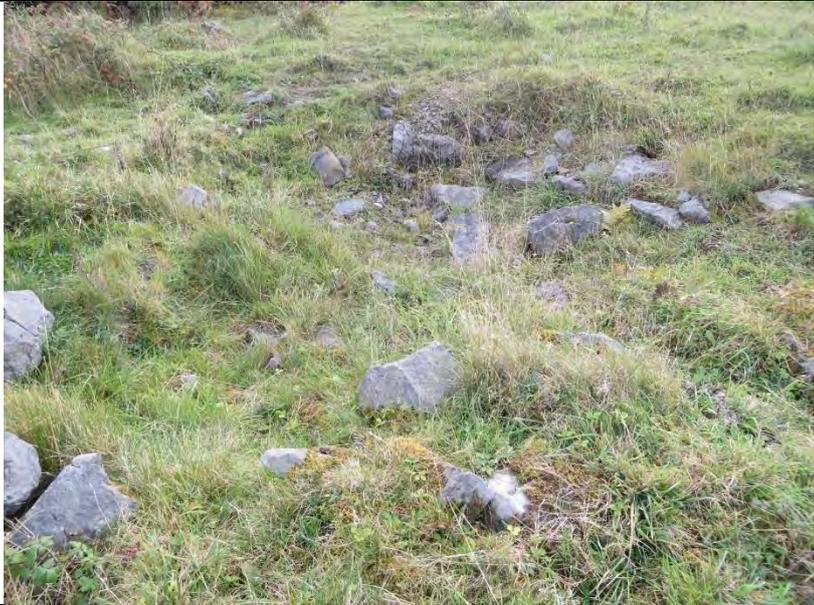
<b>Feature ID</b>	<b>K71</b>
<b>Feature type</b>	Enclosed depression
<b>Coordinates</b>	530694, 728662
<b>Source</b>	Field Survey
<b>Field survey date</b>	16/10/2014
<b>Field survey status</b>	Confirmed
<b>Water present</b>	No
<b>Additional Information</b>	2m by 4m along slope line Small depression near top of slope contains exposed rock
<b>Site photo</b>

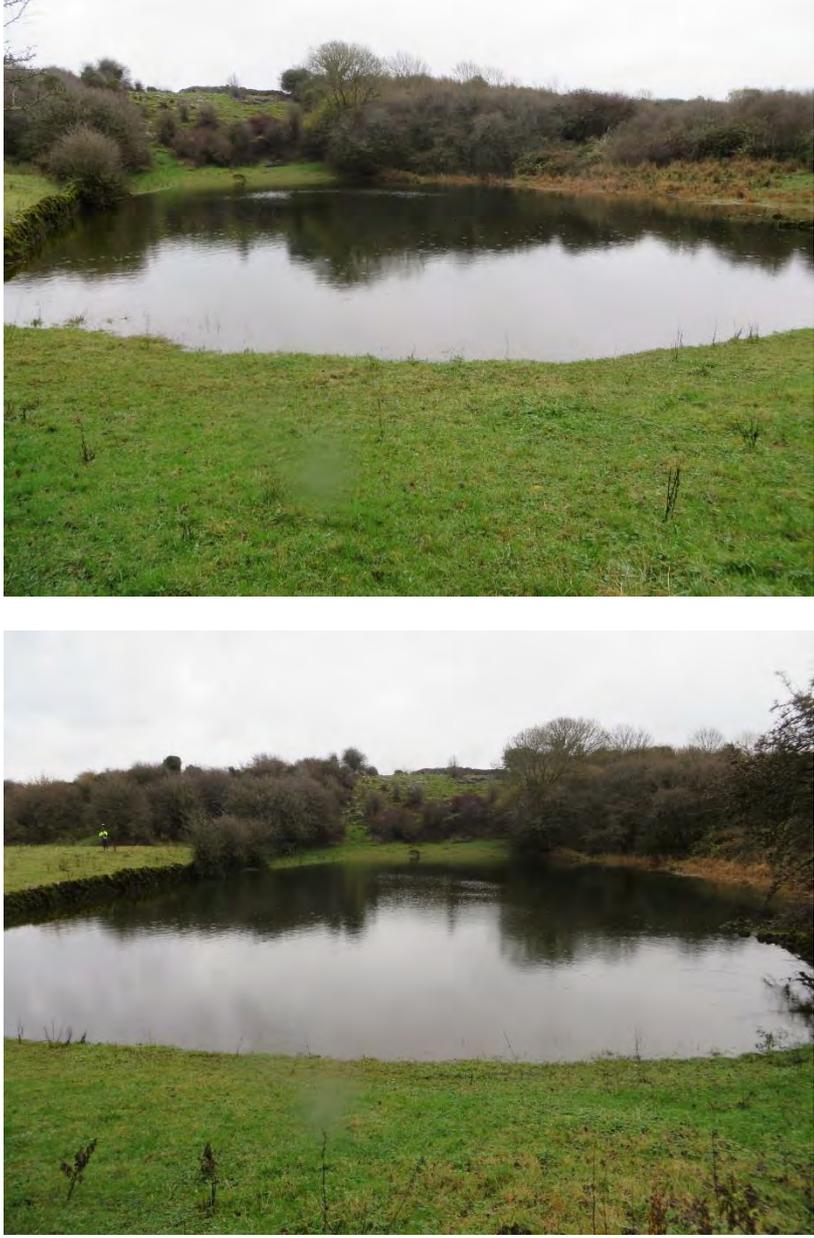
<b>Field survey date</b>	12/11/2014
<b>Field survey status</b>	Confirmed
<b>Water present</b>	Yes Electrical conductivity: 513 uS/cm Temperature: 9.2 °C pH: 7.37
<b>Water elevation</b>	14.13 mAOD

<b>Additional Information</b>	Turlough visited while in flood Estimated highest extend of water is 15.37 mAOD measured in adjacent field
<b>Site photo</b>
