## N6 Galway City Ring Road

**Karst Survey Report**

Reference: GCOB-4-03-0-6.2.8\_010

Issue 4 | 28 March 2025

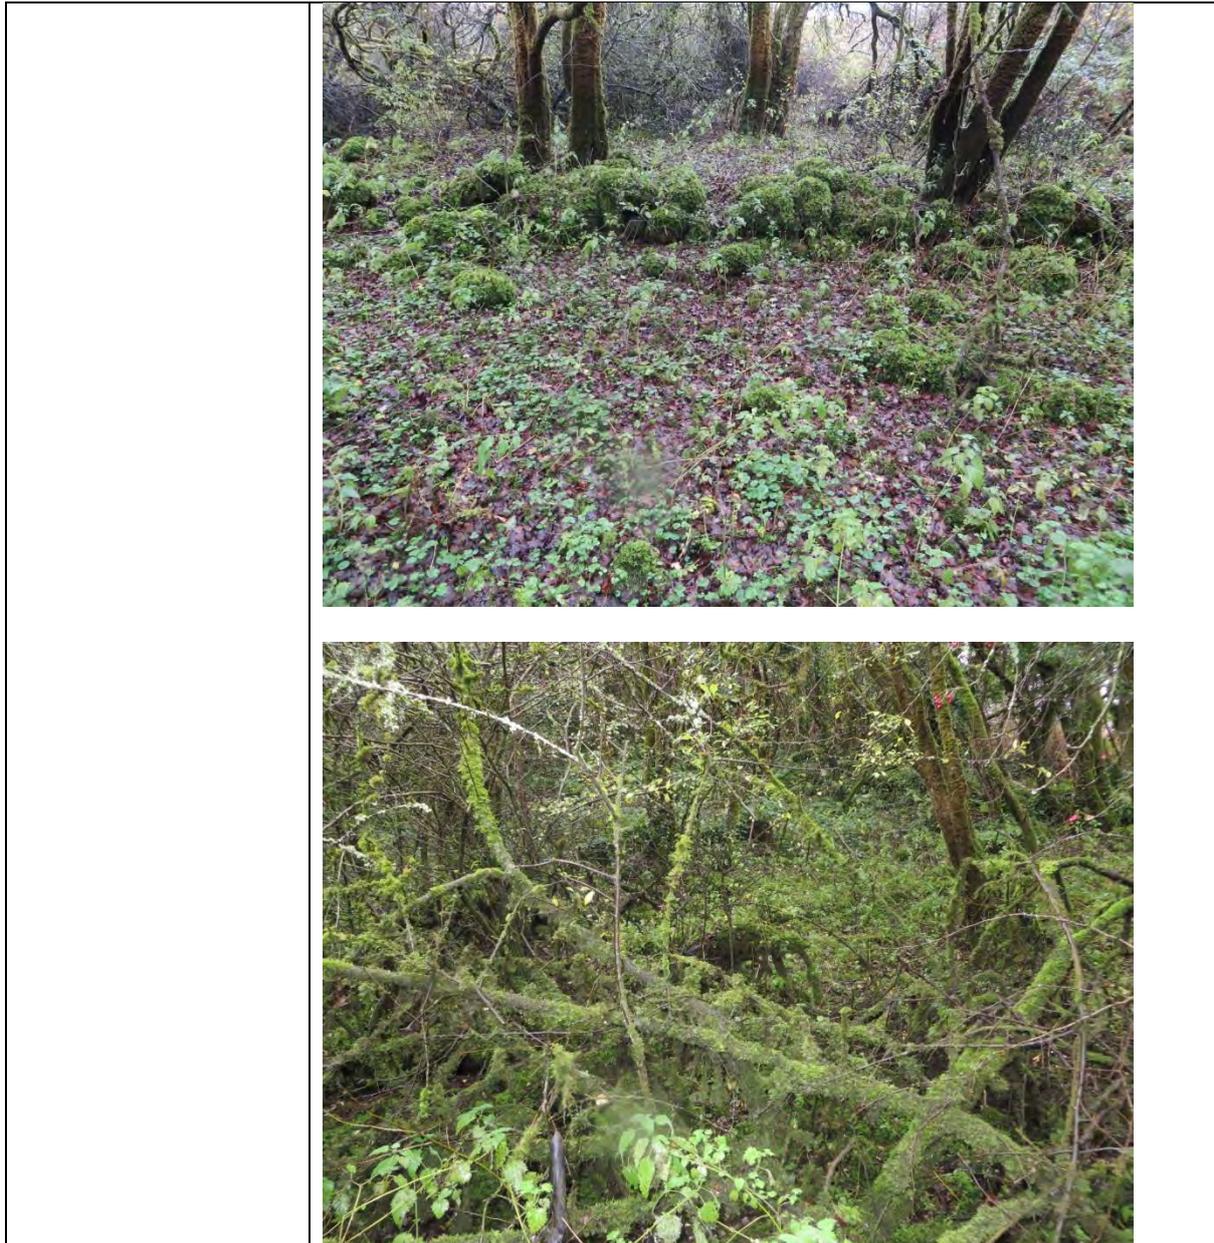
<b>Field survey date</b>	12/11/2014
<b>Field survey status</b>	Confirmed
<b>Water present</b>	No
<b>Ground level elevation</b>	15.46 mAOD, Estimated elevation. Elevation not recorded within feature due to tree coverage. Elevation reading taken 20 m south and approx.. 1m higher elevation (actual recorded elevation was 16.456)
<b>Additional Information</b>	Area mossy and covered with trees
<b>Site photo</b>

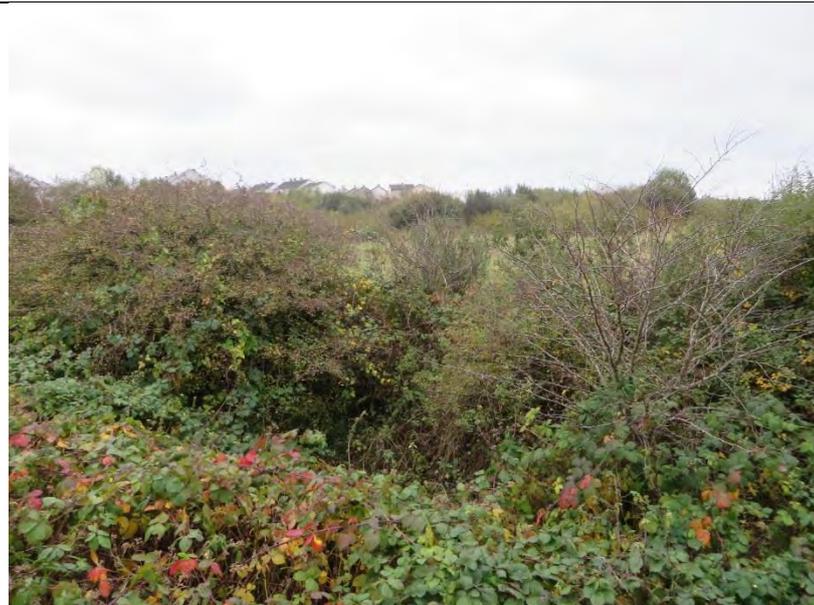
**Site photo**

<b>Field survey date</b>	22/10/2014
<b>Field survey status</b>	Confirmation/identification problem
<b>Water present</b>	Unknown
<b>Additional Information</b>	Cannot access depression. Access hindered due to dense vegetation.

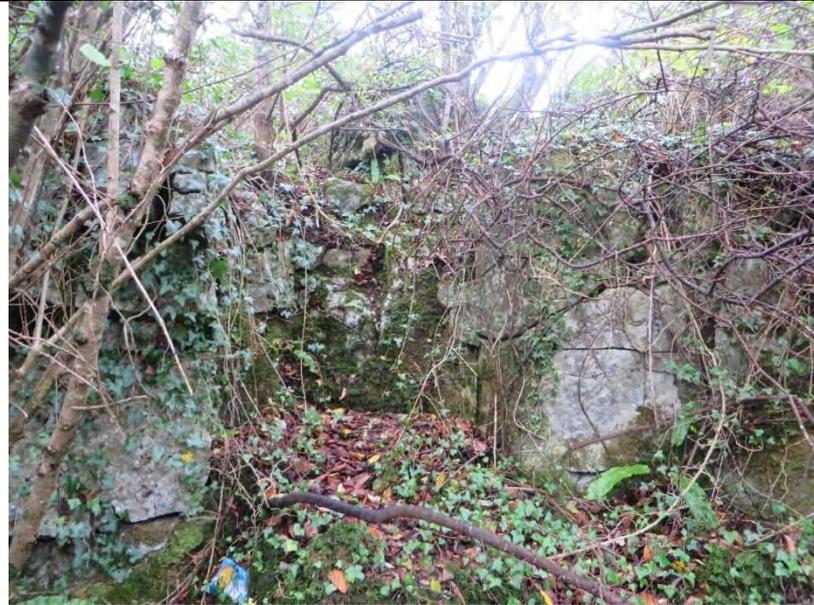
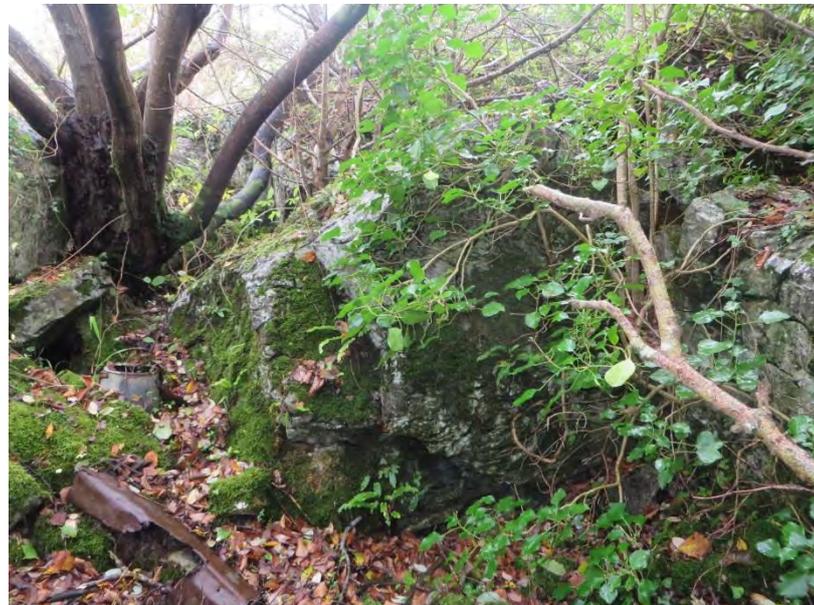
**Site photo**

<b>Field survey date</b>	20/10/2014
<b>Field survey status</b>	Confirmed
<b>Water present</b>	No
<b>Additional Information</b>	10m diameter 4m depth. Steep sides with exposed rock May also be as result of rock excavation

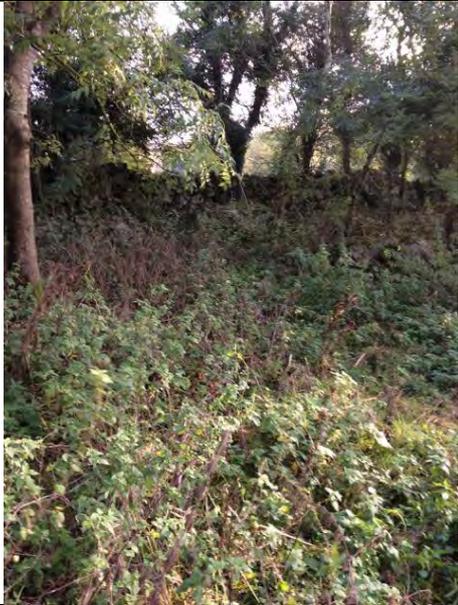
<b>Feature ID</b>	<b>K82</b>
<b>Feature type</b>	Enclosed depression
<b>Coordinates</b>	531437, 729244
<b>Source</b>	Field Survey
<b>Field survey date</b>	16/10/2014
<b>Field survey status</b>	Confirmed
<b>Water present</b>	No
<b>Additional Information</b>	10 m diameter. Possible enclosed depression slightly questionable
<b>Site photo</b>

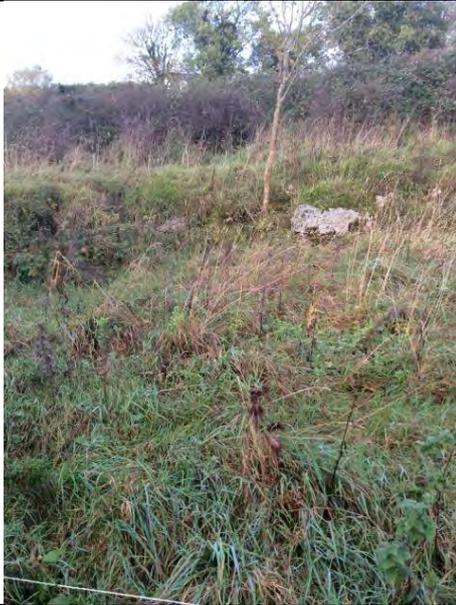
<b>Feature ID</b>	<b>K85</b>
<b>Feature type</b>	Enclosed depression
<b>Coordinates</b>	531456, 729194
<b>Source</b>	Field Survey
<b>Field survey date</b>	16/10/2014
<b>Field survey status</b>	Confirmed
<b>Water present</b>	No
<b>Additional Information</b>	10 m diameter semicircle intercepted by wall/road (N84). Possible enclosed depression slightly questionable as it could be as a result of excavation for N84 road construction
<b>Site photo</b>

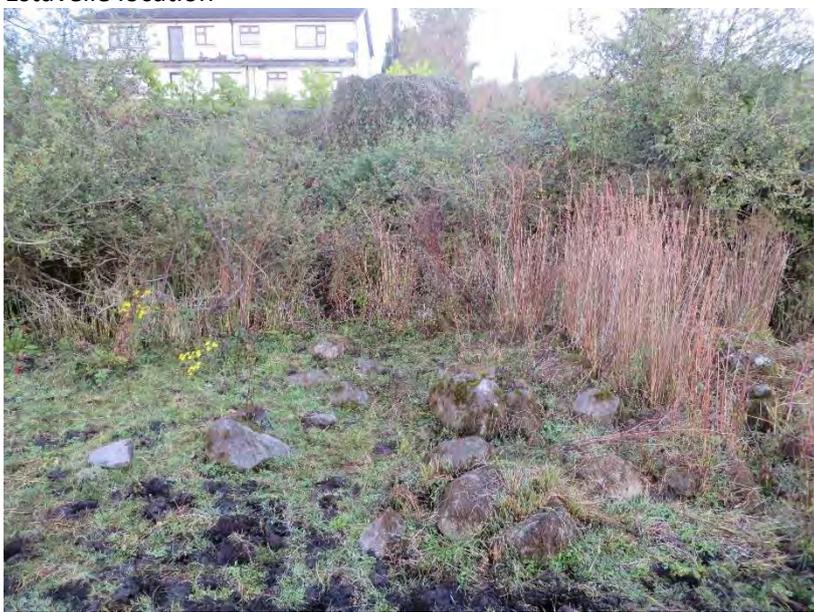
<b>Feature ID</b>	<b>K86</b>	
<b>Feature type</b>	Estavelle	
<b>Coordinates</b>	531476, 729108	
<b>Source</b>	EIS N6 Galway City Outer Bypass Vol 2 2006	
<b>Field survey date</b>	16/10/2014	11/11/2014
<b>Field survey status</b>	Confirmed	Confirmed
<b>Water present</b>	No	Yes Electrical conductivity: 590 uS/cm Temperature: 9 °C pH: 7.52 No flow to permit flow measurement
<b>Water elevation</b>	n/a	8.927
<b>Additional Information</b>	Drain runs from estavelle location near break in slope towards Ballindooley lough	
<b>Site photo</b>	<p>Estavelle location</p>

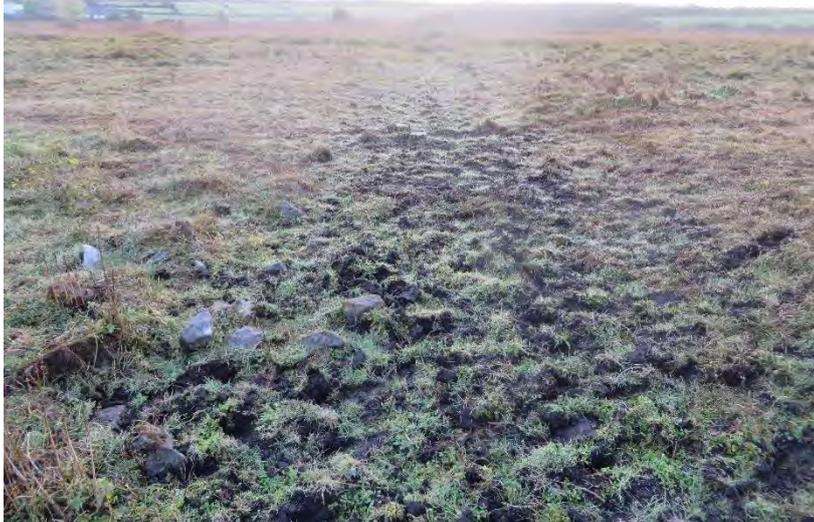
<p>Shallow ditch running between the estavelle and Ballindooley Lough:</p>

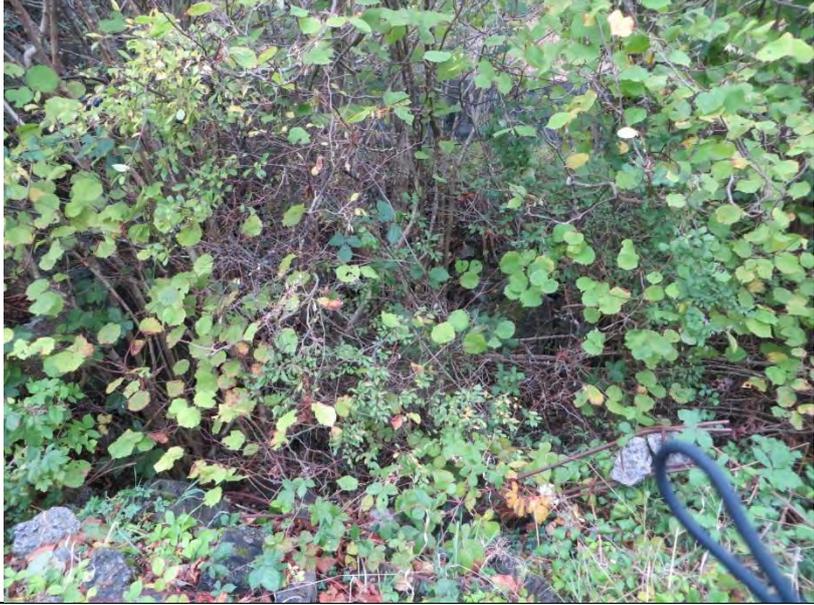
Figure 2a shows the lidar image of three potential enclosed depression identified from the desk study. During the site visit K88 was confirmed to be an enclosed depression, however, onsite inspection K80 and K84 were found to be mounds and therefore classified as not karst (Figure 2b).

<b>Feature ID</b>	<b>K88</b>
<b>Feature type</b>	Enclosed depression
<b>Coordinates</b>	531671, 727351
<b>Source</b>	Field Survey
<b>Field survey date</b>	22/10/2014
<b>Field survey status</b>	Confirmed
<b>Water present</b>	No
<b>Additional Information</b>	Approximate dimensions: 30m x 5m Elongated depression in an ESE WNW direction. The ESE wall is approx. 4m high. The depression contains numerous trees.
<b>Site photo</b>

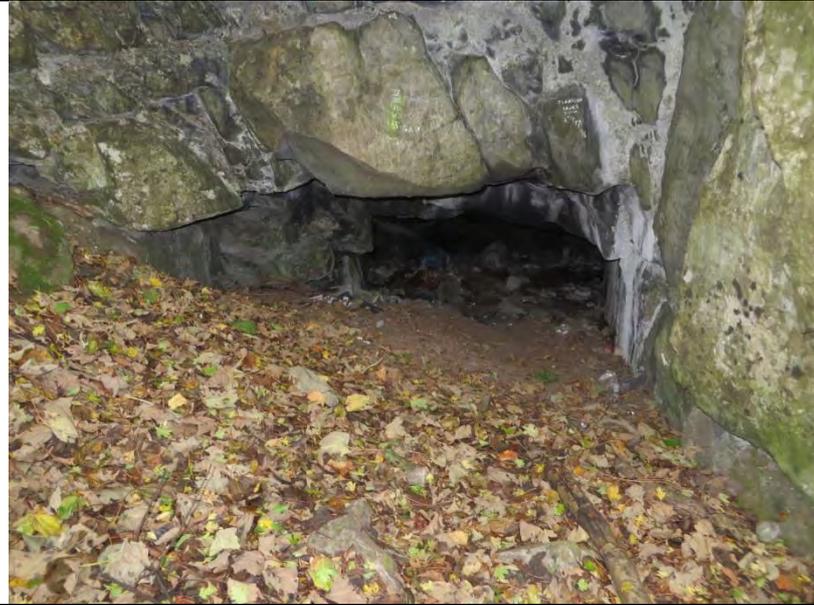
<b>Field survey date</b>	22/10/2014
<b>Field survey status</b>	Confirmed
<b>Water present</b>	No
<b>Additional Information</b>	Approx. 3m wide x 1 m high opening to cave
<b>Site photo</b>

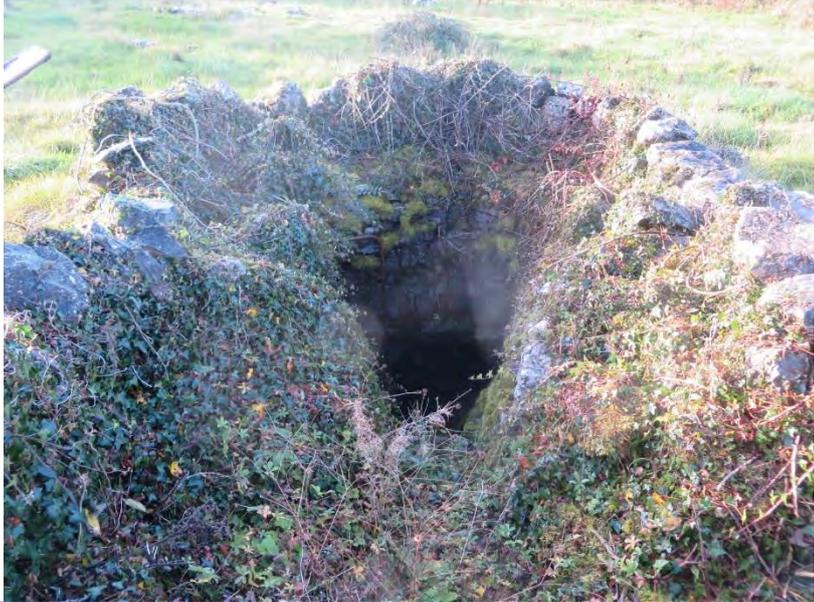
<b>Feature ID</b>	<b>K92</b>
<b>Feature type</b>	Well/ spring
<b>Coordinates</b>	531781, 729453
<b>Source</b>	Field Survey
<b>Field survey date</b>	21/10/2014
<b>Field survey status</b>	Confirmed
<b>Water present</b>	Yes Electrical conductivity: 370 uS/cm Temperature: 11.1 °C pH: 7.61
<b>Additional Information</b>	Approximate dimension: 2m diameter Old well surrounded by stone wall
<b>Site photo</b>

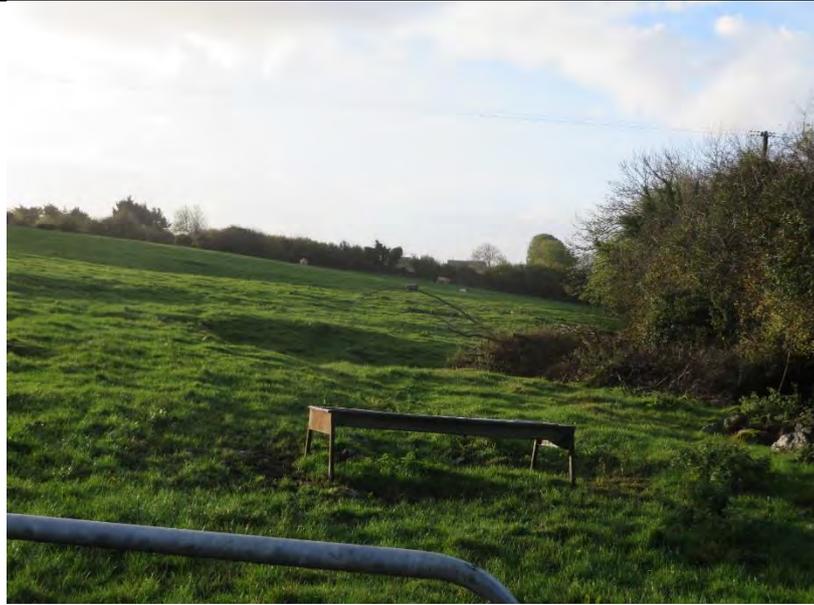
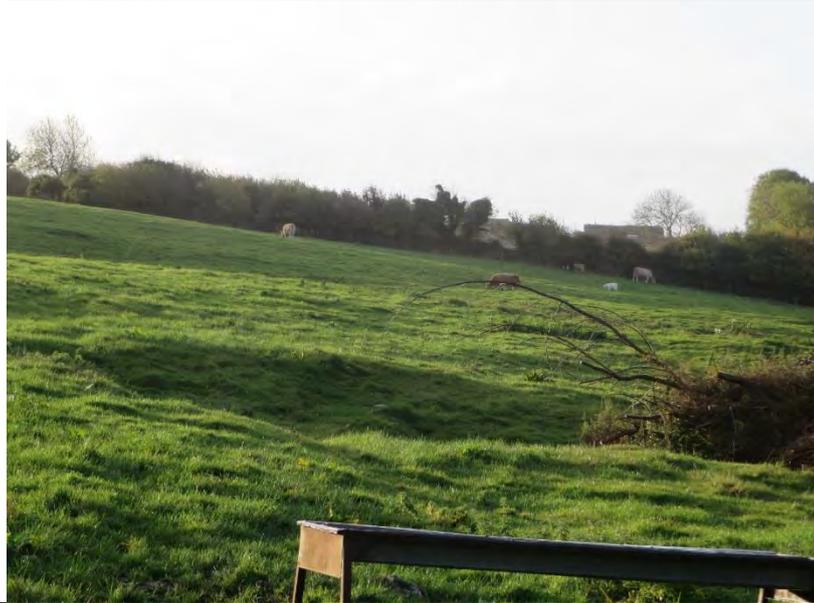
<b>Field survey date</b>	21/10/2014
<b>Field survey status</b>	Confirmed
<b>Water present</b>	No
<b>Additional Information</b>	Approx. 15m diameter Access inhibited due to cattle in field

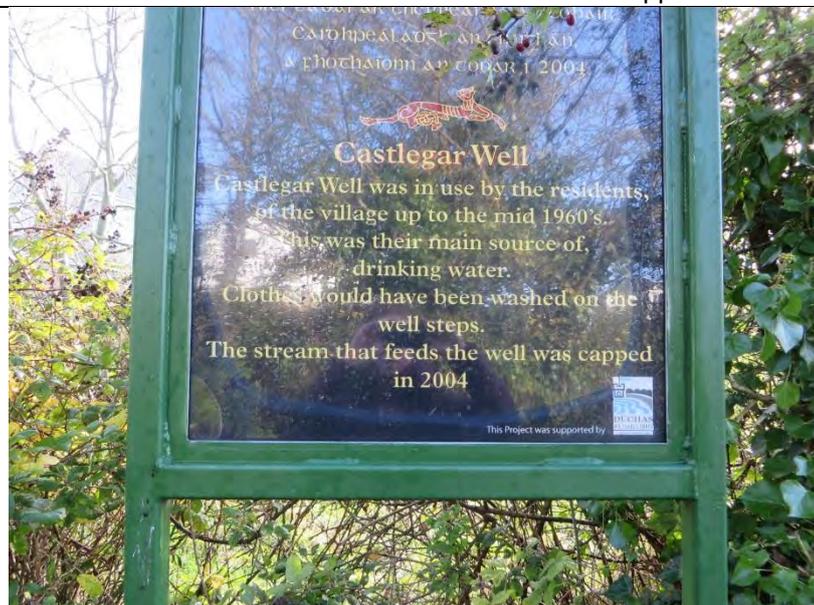
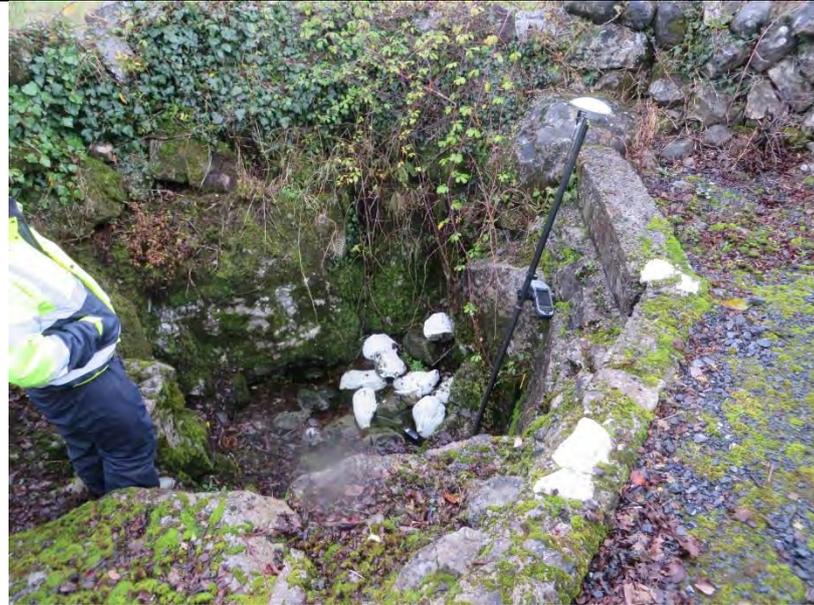
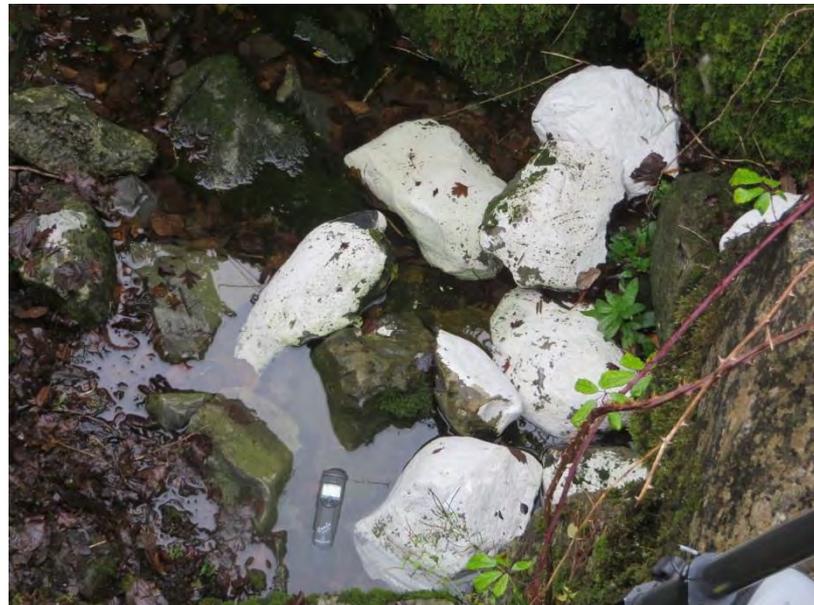
<b>Field survey status</b>	Confirmed	Confirmed
<b>Water present</b>	No	Yes Electrical conductivity: 728 uS/cm Temperature: 10.9 °C pH: 7.06
<b>Water level elevation</b>	n/a	3.73 mAOD
<b>Additional Information</b>	Approx. 2 m diameter Notice beside spring states that the feature is known as Castlegar well. It also notes that the stream that feeds the well was capped in 2004.	
<b>Site photo</b>

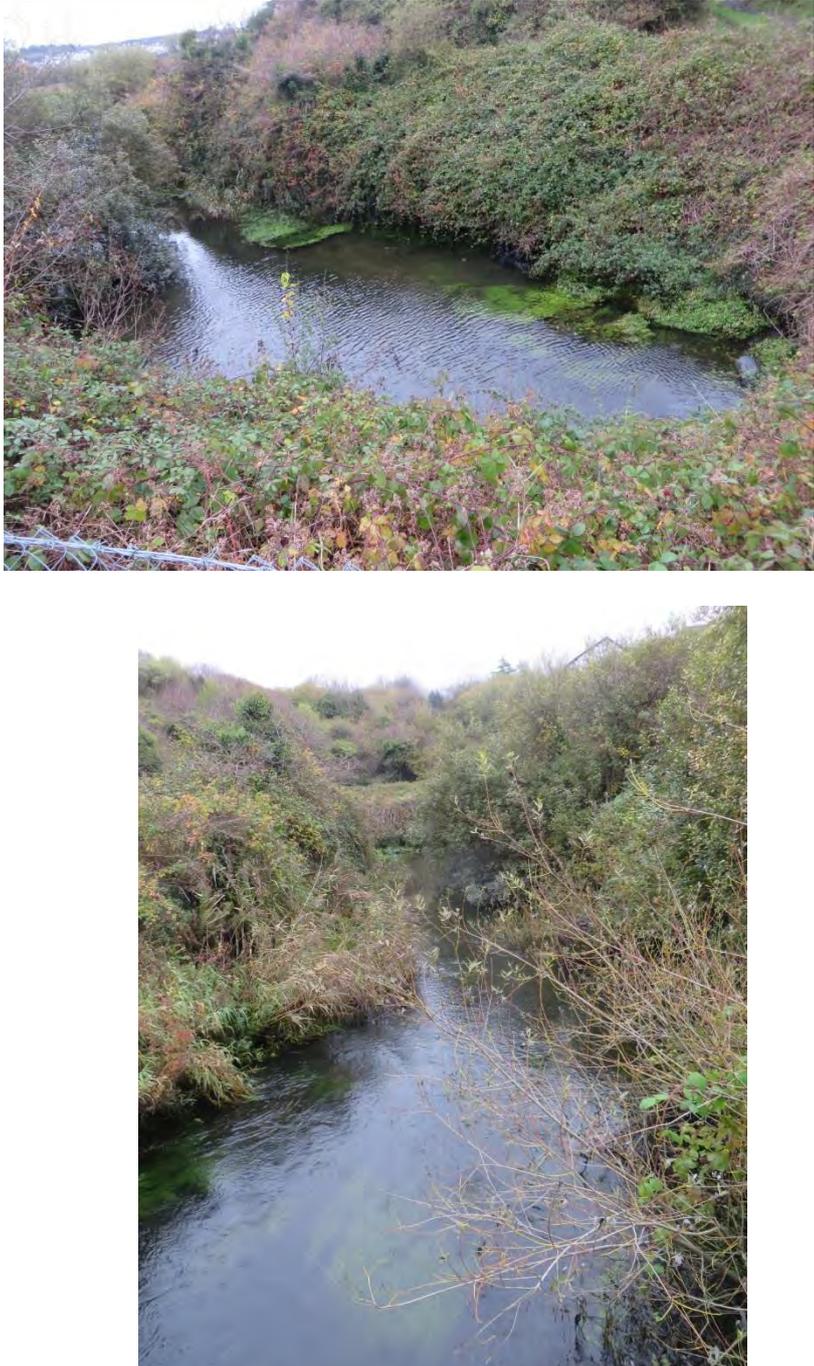
<b>Field survey date</b>	22/10/2014	12/11/2014
<b>Field survey status</b>	Confirmed	Confirmed
<b>Water present</b>	Yes Electrical conductivity: 370 uS/cm Temperature: 11.3 °C pH: 7.76  Flow direction into swallow hole No flow measurement taken	Yes Electrical conductivity: 576 uS/cm Temperature: 10.6 °C pH: 7.52  Flow direction into swallow hole Flow: 765 l/s
<b>Water level elevation</b>	n/a	1.77 mAOD
<b>Additional Information</b>	Terryland River discharges into or can be fed by this spring / swallow hole.	
<b>Site photo</b>

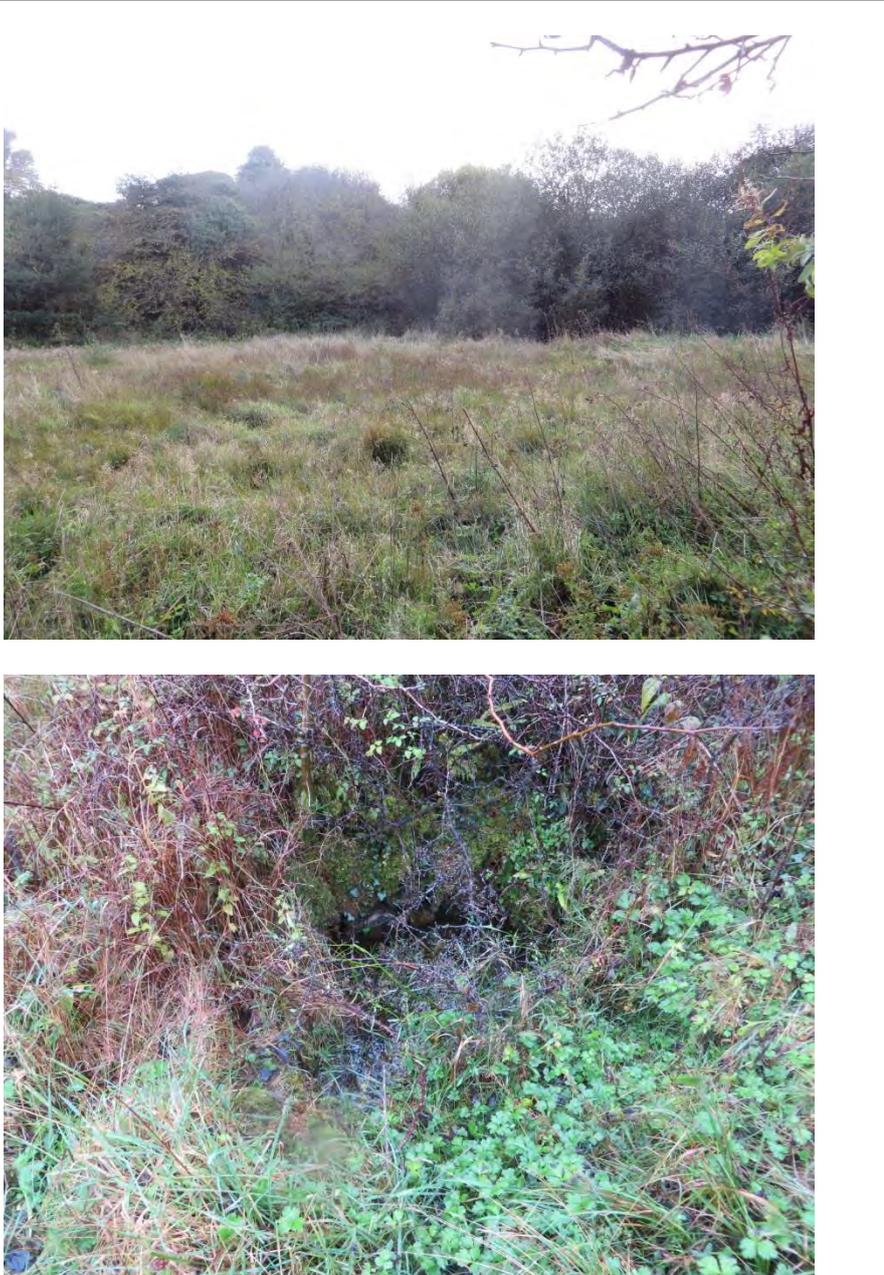
<b>Field survey date</b>	21/10/2014	12/11/2014
<b>Field survey status</b>	Confirmed	Confirmed
<b>Water present</b>	No	Yes Electrical conductivity: 219 uS/cm Temperature: 8.1 °C pH: 6.4
<b>Elevation measurements</b>	n/a	Ground level in centre: 12.11 mAOD Standing water: 12.17 mAOD (531947, 728372) & 12.22 mAOD (531934, 728379)
<b>Additional Information</b>	Approx 40 m diameter flat bottom depression. Soft muddy base. Sides and base composed of subsoil. No seepages.

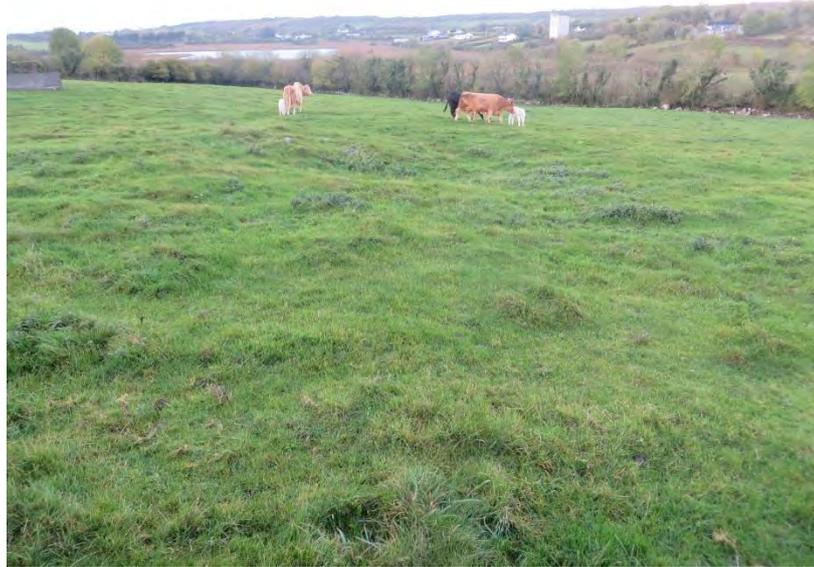
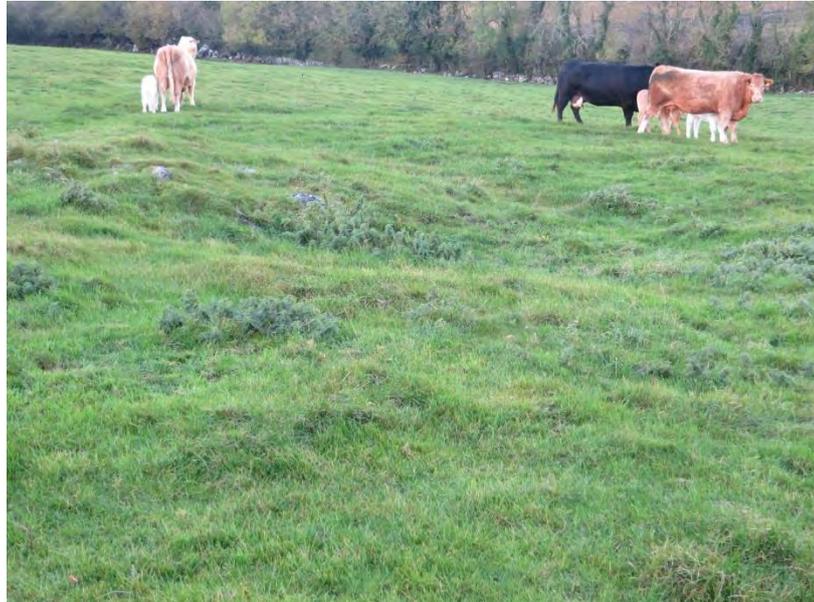
<b>Field survey date</b>	21/10/2014
<b>Field survey status</b>	Confirmed
<b>Water present</b>	No
<b>Additional Information</b>	Approx. 3m diameter depression

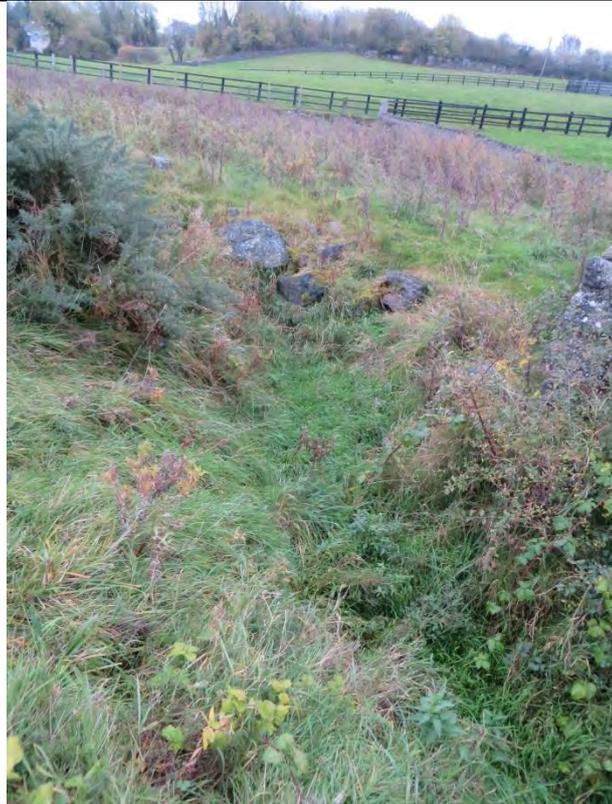
<b>Field survey date</b>	21/10/2014	12/11/2014
<b>Field survey status</b>	Confirmed	Confirmed
<b>Water present</b>	No	Yes Electrical conductivity: 995 uS/cm Temperature: 12 °C pH: 7.06  Flow not great enough for flow measurement
<b>Additional Information</b>	Drain leading from spring towards Terryland River

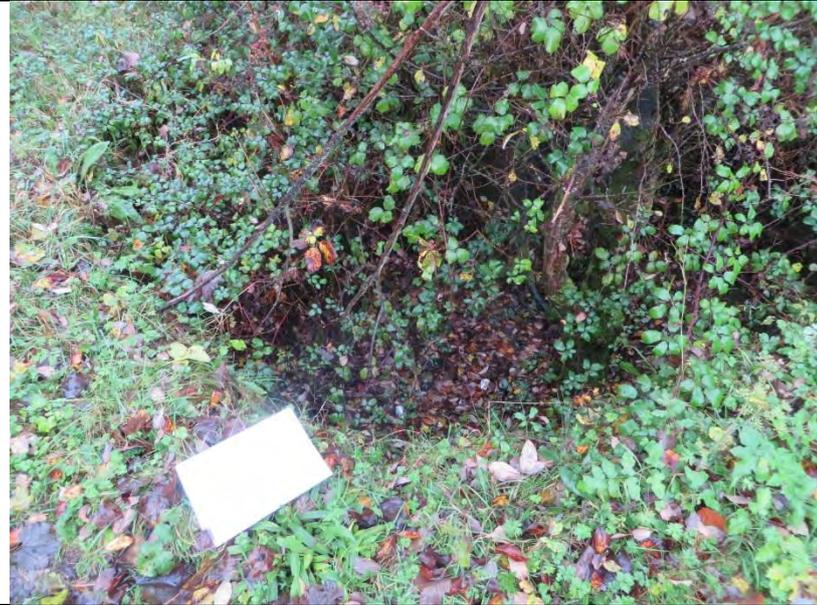
<b>Field survey date</b>	12/11/2014
<b>Field survey status</b>	Confirmed
<b>Water present</b>	No
<b>Ground level elevation</b>	24.01 mAOD at base of depression
<b>Additional Information</b>	Approx. dimensions: 3m diameter, 2m depth. Very steep sides. Likely to be an old dug well.

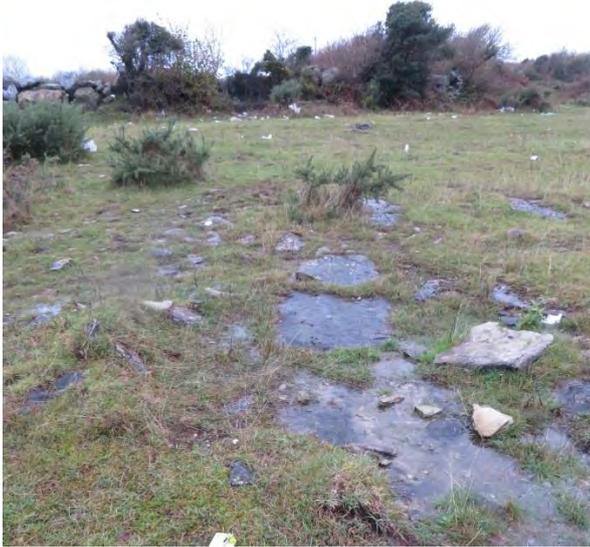
<b>Feature ID</b>	<b>K126</b>
<b>Feature type</b>	Seepage
<b>Coordinates</b>	533644, 726504
<b>Source</b>	Field Survey
<b>Field survey date</b>	13/11/2014
<b>Field survey status</b>	Confirmed
<b>Water present</b>	Yes Electrical conductivity: 474 uS/cm Temperature: 10.4 °C pH: 7.38
<b>Water level elevation</b>	48.56 mAOD
<b>Additional Information</b>	Seepage in middle of field
<b>Site photos</b>	<p>Seepage from down gradient:</p>

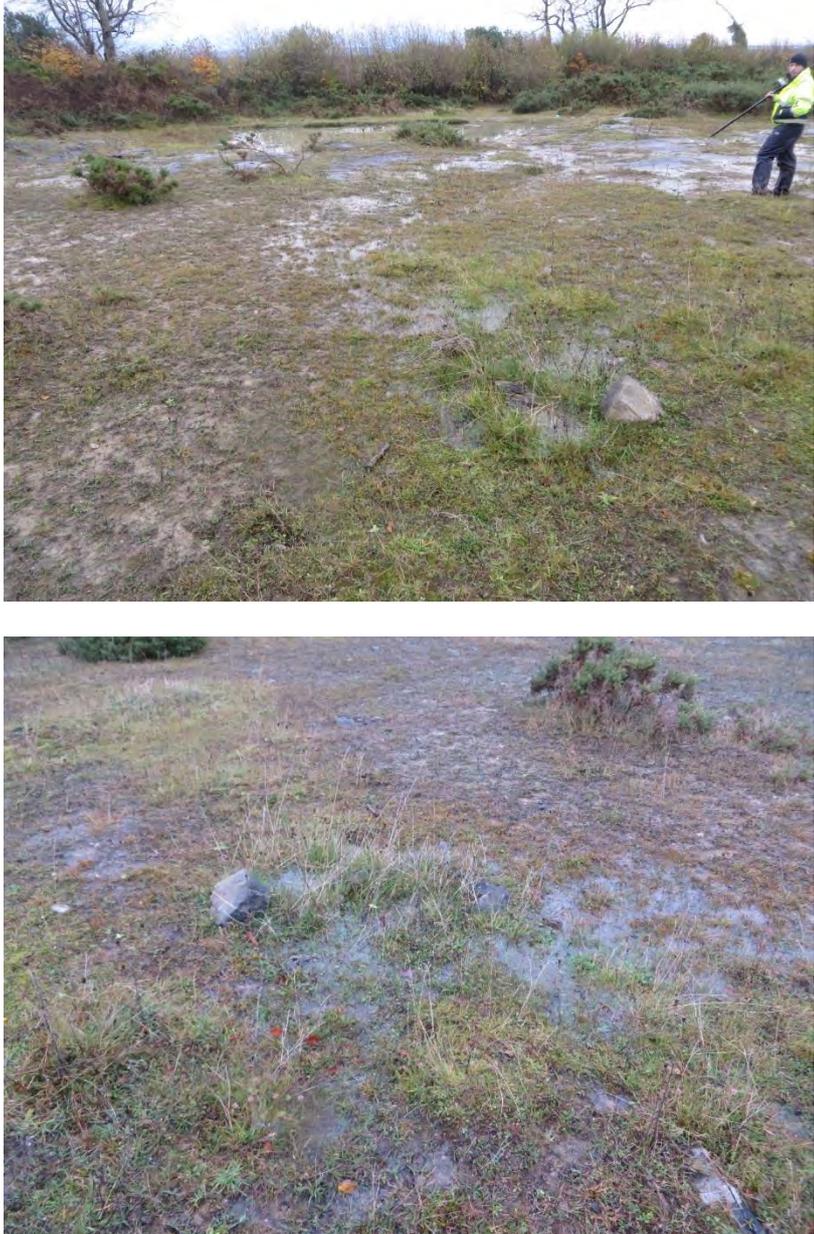
<b>Feature ID</b>	<b>K129</b>
<b>Feature type</b>	Seepage
<b>Coordinates</b>	533701, 726678
<b>Source</b>	Field Survey
<b>Field survey date</b>	13/11/2014
<b>Field survey status</b>	Confirmed
<b>Water present</b>	Yes Electrical conductivity: 470 uS/cm Temperature: 11.2 °C pH: 7.68
<b>Water level elevation</b>	55.95 mAOD
<b>Additional Information</b>	Small stream from seepage feeding K130 enclosed depression. Very low flow cannot get flow measurement
<b>Site photos</b>

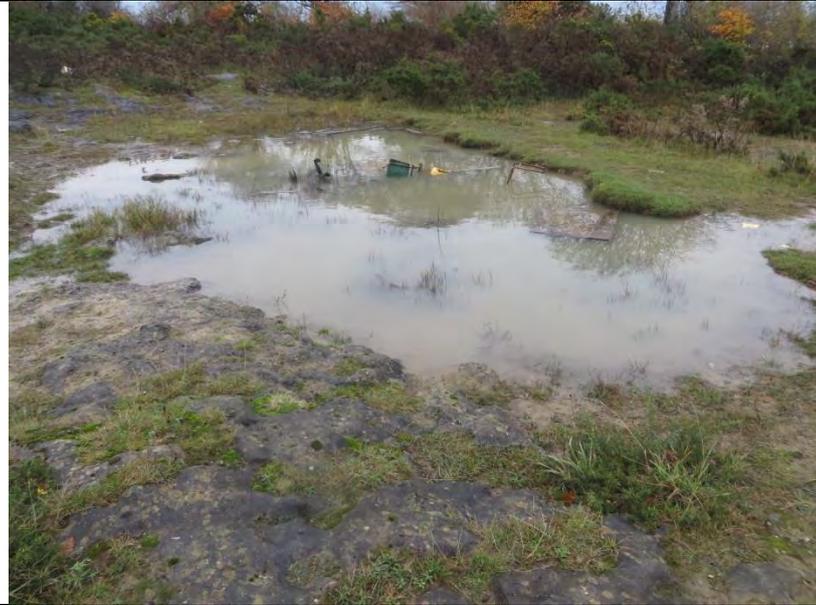
<b>Field survey date</b>	13/11/2014
<b>Field survey status</b>	Confirmed
<b>Water present</b>	<p>Yes</p> <p>Electrical conductivity: 199 uS/cm</p> <p>Temperature: 7.1 °C</p> <p>pH: 8.13</p>
<b>Elevation levels</b>	<p>Base of enclosed depression: 54.74 mAOD</p> <p>Water level elevation: 55.01 mAOD</p>
<b>Additional Information</b>	Enclosed depression filled with water from stream k314.

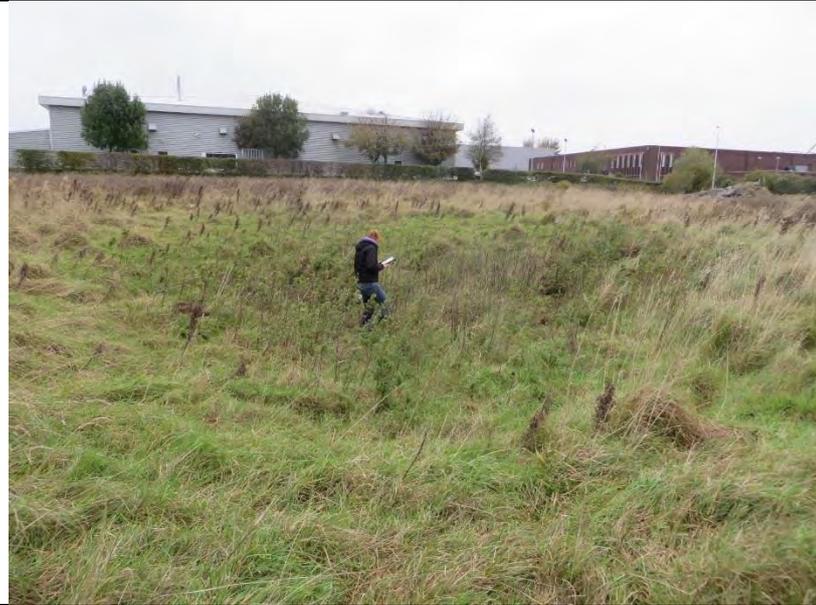
<b>Feature ID</b>	<b>K131</b>
<b>Feature type</b>	Enclosed depression
<b>Coordinates</b>	533815, 728265
<b>Source</b>	Lidar:

<b>Field survey date</b>	22/10/2014
<b>Field survey status</b>	Confirmed
<b>Water present</b>	No
<b>Additional Information</b>	Approx. dimensions: 10m diameter and 1.5m depth

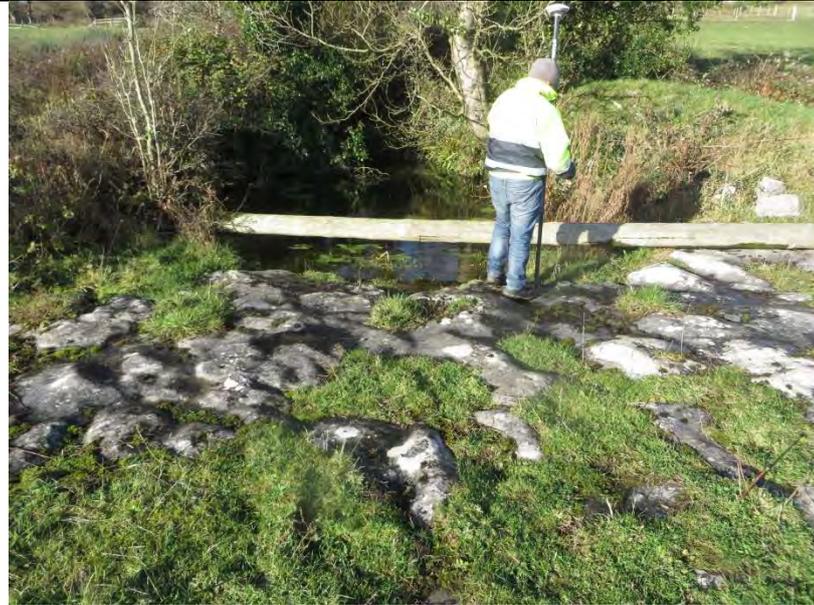
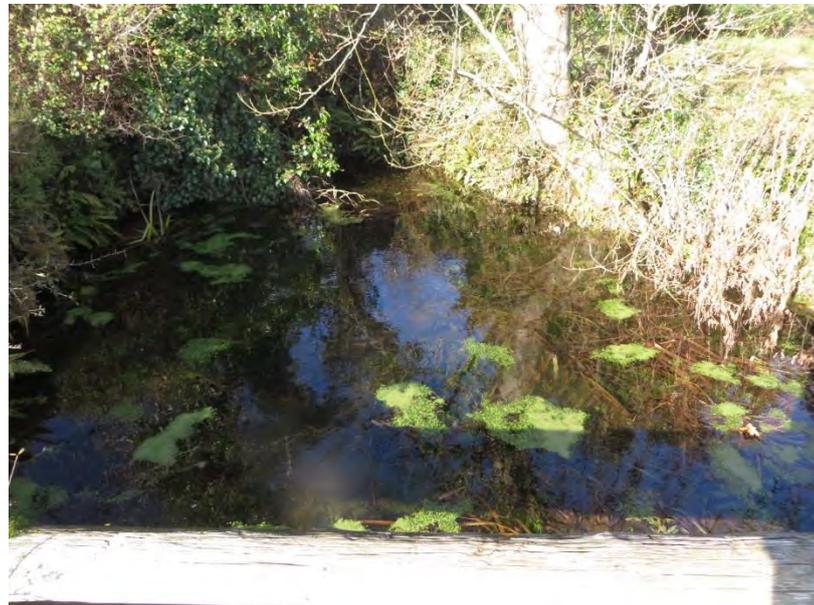
<b>Feature ID</b>	<b>K132</b>
<b>Feature type</b>	Enclosed depression
<b>Coordinates</b>	533886, 726657
<b>Source</b>	Lidar:

<b>Field survey date</b>	14/11/2014
<b>Field survey status</b>	Confirmed
<b>Water present</b>	Yes Electrical conductivity: 553 uS/cm Temperature: 11.5 °C pH: 7.27
<b>Water elevation</b>	46.03 mAOD
<b>Additional Information</b>	Initially identified in the desk study as a potential enclosed depression. Approx. 3m diameter pond.

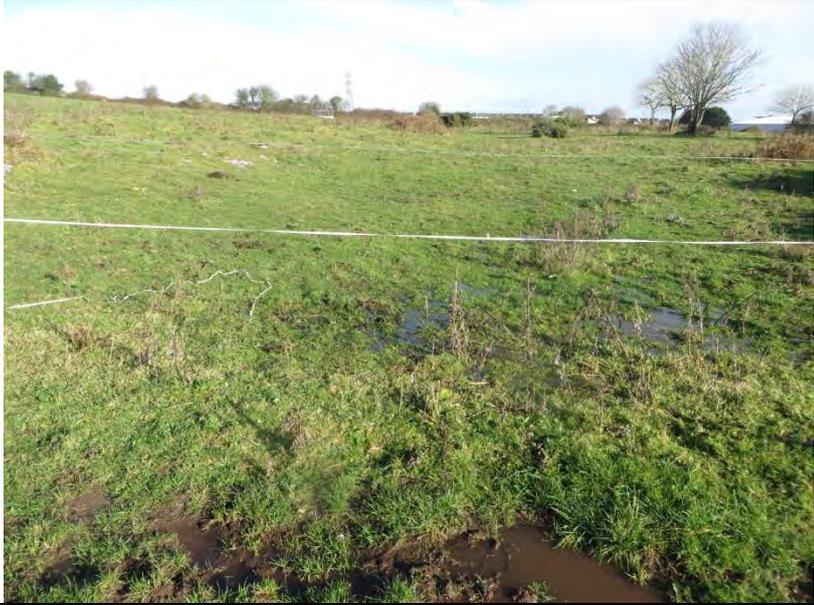
<b>Feature ID</b>	<b>K135</b>
<b>Feature type</b>	Enclosed Depression
<b>Coordinates</b>	533959, 726688
<b>Source</b>	Field Survey
<b>Field survey date</b>	14/11/2014
<b>Field survey status</b>	Confirmed
<b>Water present</b>	Yes
<b>Additional Information</b>	Very shallow and wide depression.
<b>Site photos</b>

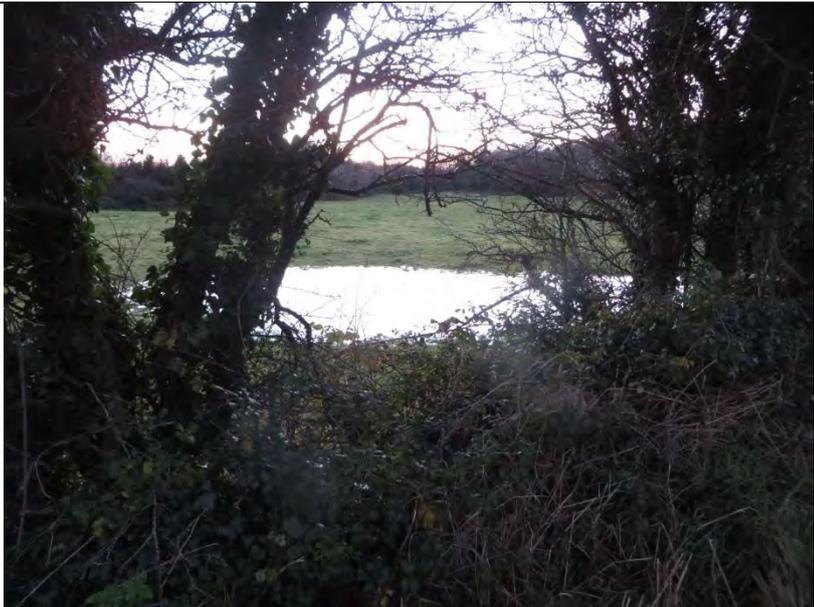
<b>Feature ID</b>	<b>K140</b>
<b>Feature type</b>	Flooded land (possible spring)
<b>Coordinates</b>	534085, 725198
<b>Source</b>	Field Survey
<b>Field survey date</b>	13/11/2014
<b>Field survey status</b>	Confirmed
<b>Water present</b>	Yes
<b>Additional Information</b>	Field with areas of flooding. A local informed that there were springs in the field.
<b>Site photos</b>

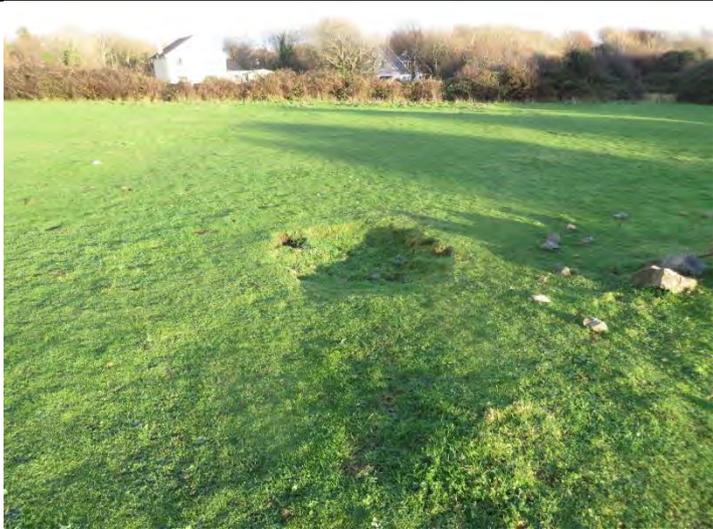
<b>Feature ID</b>	<b>K142</b>
<b>Feature type</b>	Enclosed Depression
<b>Coordinates</b>	534166, 724582
<b>Source</b>	Field Survey
<b>Field survey date</b>	13/11/2014
<b>Field survey status</b>	Confirmed
<b>Water present</b>	No
<b>Additional Information</b>	
<b>Site photos</b>

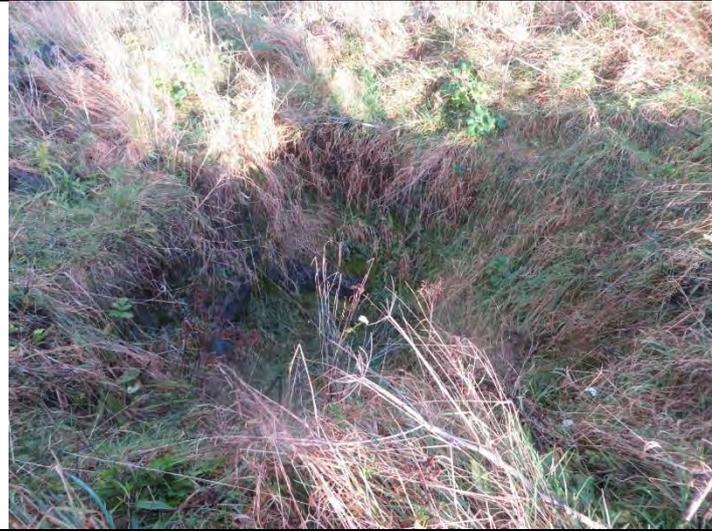
<b>Feature ID</b>	<b>K145</b>
<b>Feature type</b>	Enclosed Depression
<b>Coordinates</b>	534209, 724682
<b>Source</b>	Lidar

<b>Field survey date</b>	13/11/2014
<b>Field survey status</b>	Confirmed
<b>Water present</b>	No
<b>Additional Information</b>	Approx. 2 m in diameter and 1m deep

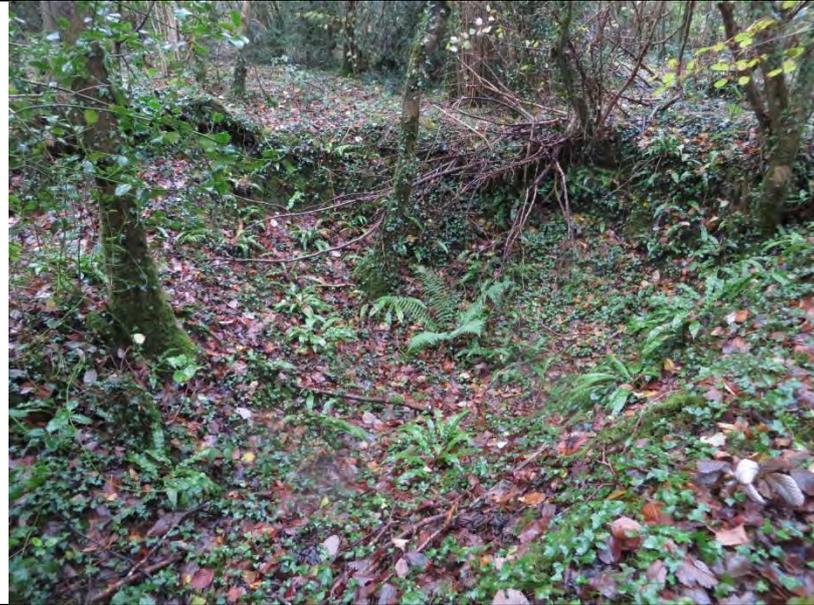
<b>Feature ID</b>	<b>K151</b>
<b>Feature type</b>	Enclosed Depression
<b>Coordinates</b>	534393, 725257
<b>Source</b>	Lidar:

<b>Field survey date</b>	13/11/2014
<b>Field survey status</b>	Confirmed
<b>Water present</b>	No
<b>Additional Information</b>	Approx. 5m diameter, but not circular. Adjacent to K152.

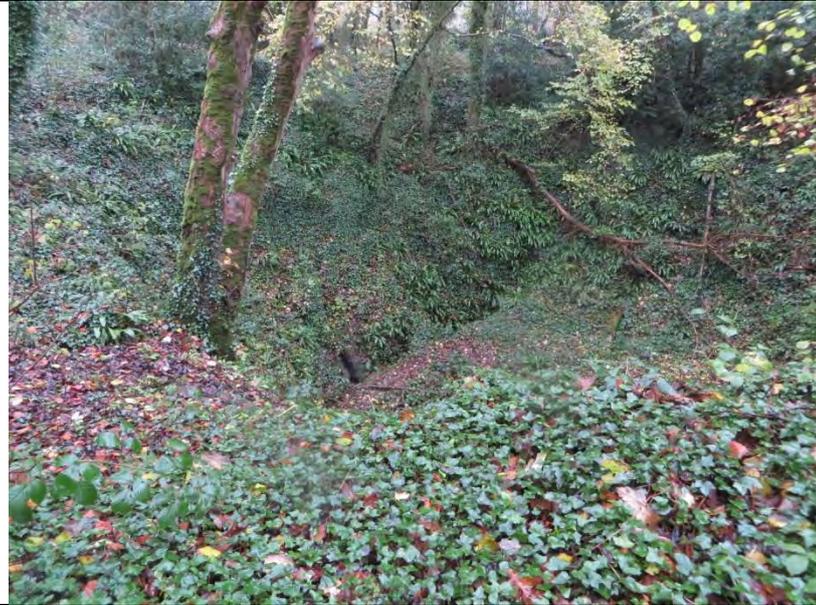
<b>Feature ID</b>	<b>K152</b>
<b>Feature type</b>	Enclosed Depression
<b>Coordinates</b>	534397, 725257
<b>Source</b>	Lidar:

<b>Field survey date</b>	13/11/2014
<b>Field survey status</b>	Confirmed
<b>Water present</b>	No
<b>Additional Information</b>	Approx. 7m diameter. Adjacent to K151

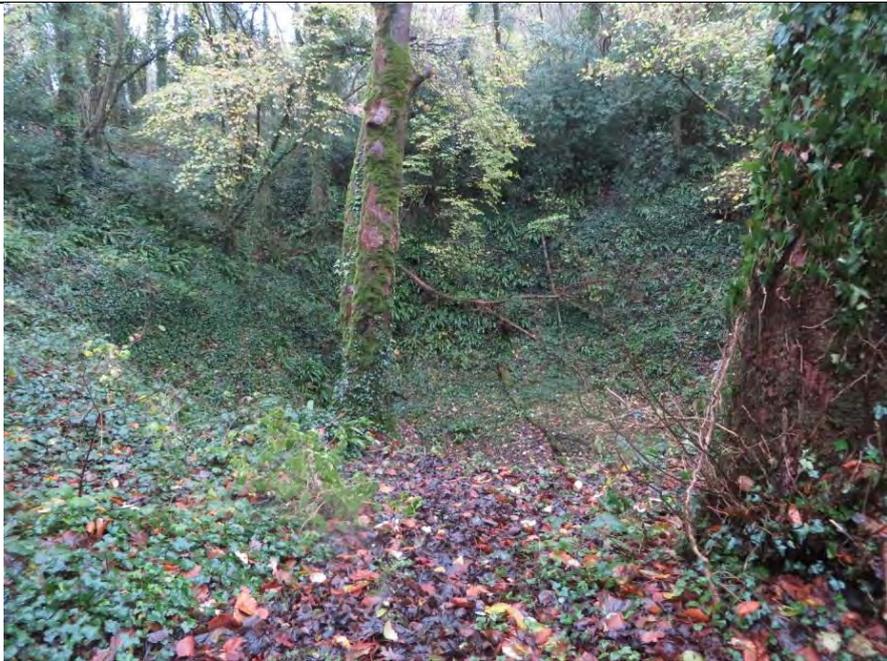
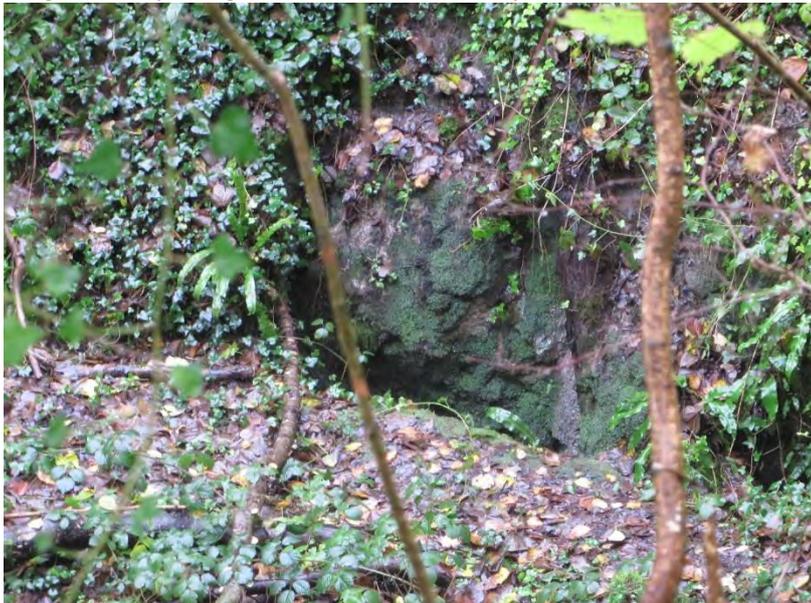
<b>Feature ID</b>	<b>K154</b>
<b>Feature type</b>	Enclosed Depression
<b>Coordinates</b>	534460, 725261
<b>Source</b>	GSI database

<b>Field survey date</b>	13/11/2014
<b>Field survey status</b>	Confirmed
<b>Water present</b>	No
<b>Additional Information</b>	Approx. dimensions: 40 m diameter 20 m deep. Potential plug hole evident The large enclosed depression is fenced off preventing access. A plug hole opening is evident at the base of the enclosed depression. This may contain water, however access is not possible due to protective fencing.
<b>Site photos</b>

<p>Plug hole / opening at base of enclosed depression</p>
