## N6 Galway City Ring Road

**Karst Survey Report**

Reference: GCOB-4-03-0-6.2.8\_010

Issue 4 | 28 March 2025

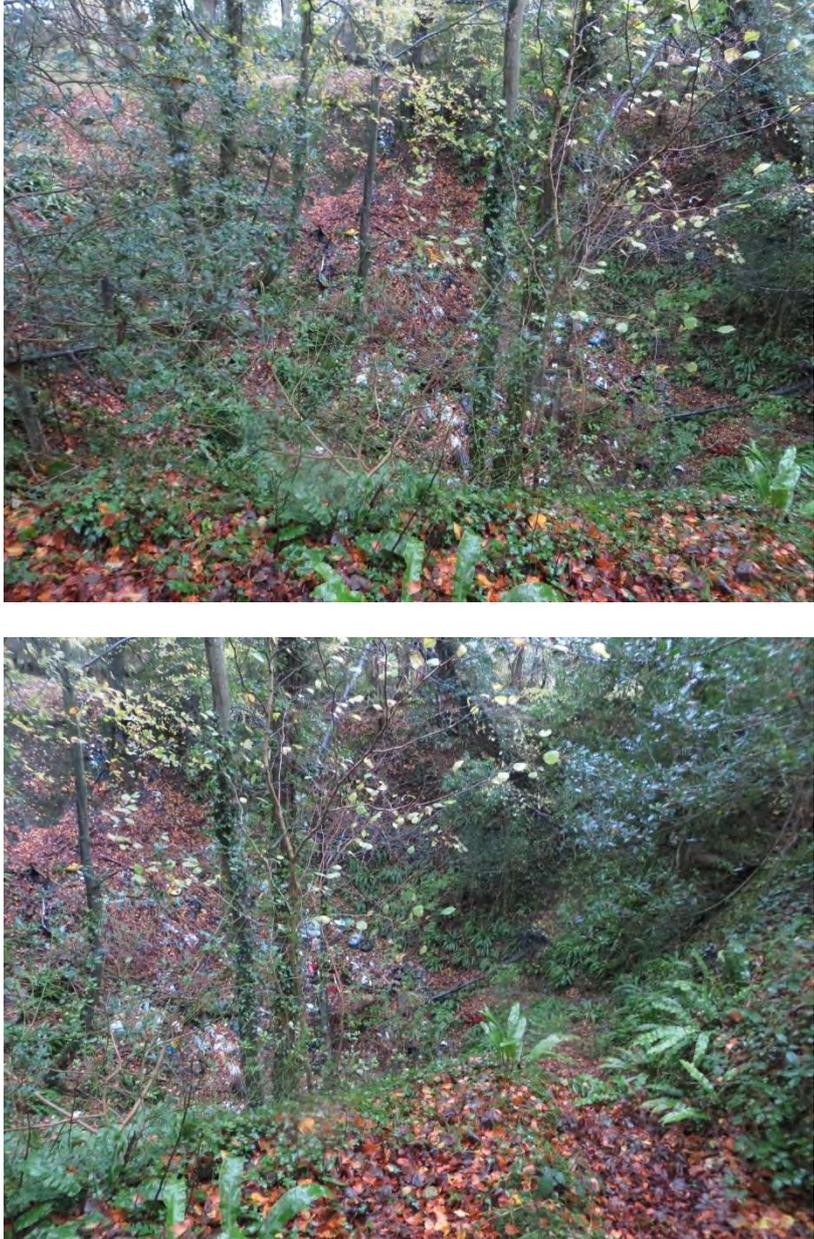
<b>Feature ID</b>	<b>K159</b>
<b>Feature type</b>	Enclosed Depression
<b>Coordinates</b>	534562, 725325
<b>Source</b>	GSI database

<b>Field survey date</b>	13/11/2014
<b>Field survey status</b>	Confirmed
<b>Water present</b>	No
<b>Additional Information</b>	Approx. dimensions: 30 m diameter 20 m deep. Contains waste Possible plug hole identified
<b>Site photos</b>

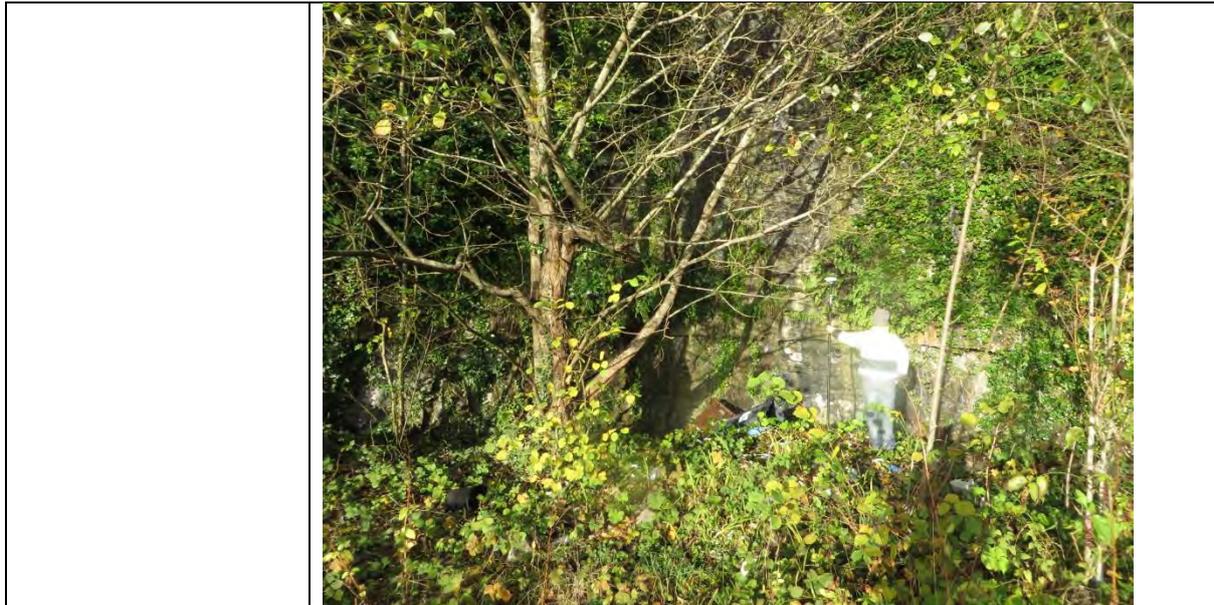
<b>Feature ID</b>	<b>K160</b>
<b>Feature type</b>	Spring (Quarry inflow)
<b>Coordinates</b>	534588, 725786
<b>Source</b>	GSI database; Well survey carried out by Bride Naughton GSI 1972.

<b>Field survey date</b>	14/11/2014
<b>Field survey status</b>	Confirmed
<b>Water present</b>	Yes Electrical conductivity: 490 uS/cm Temperature: 12 °C pH: 8.23
<b>Additional Information</b>	Feature is located in old quarry. Water is discharging from fractures approx. 5m above ground level.
<b>Site photos</b>

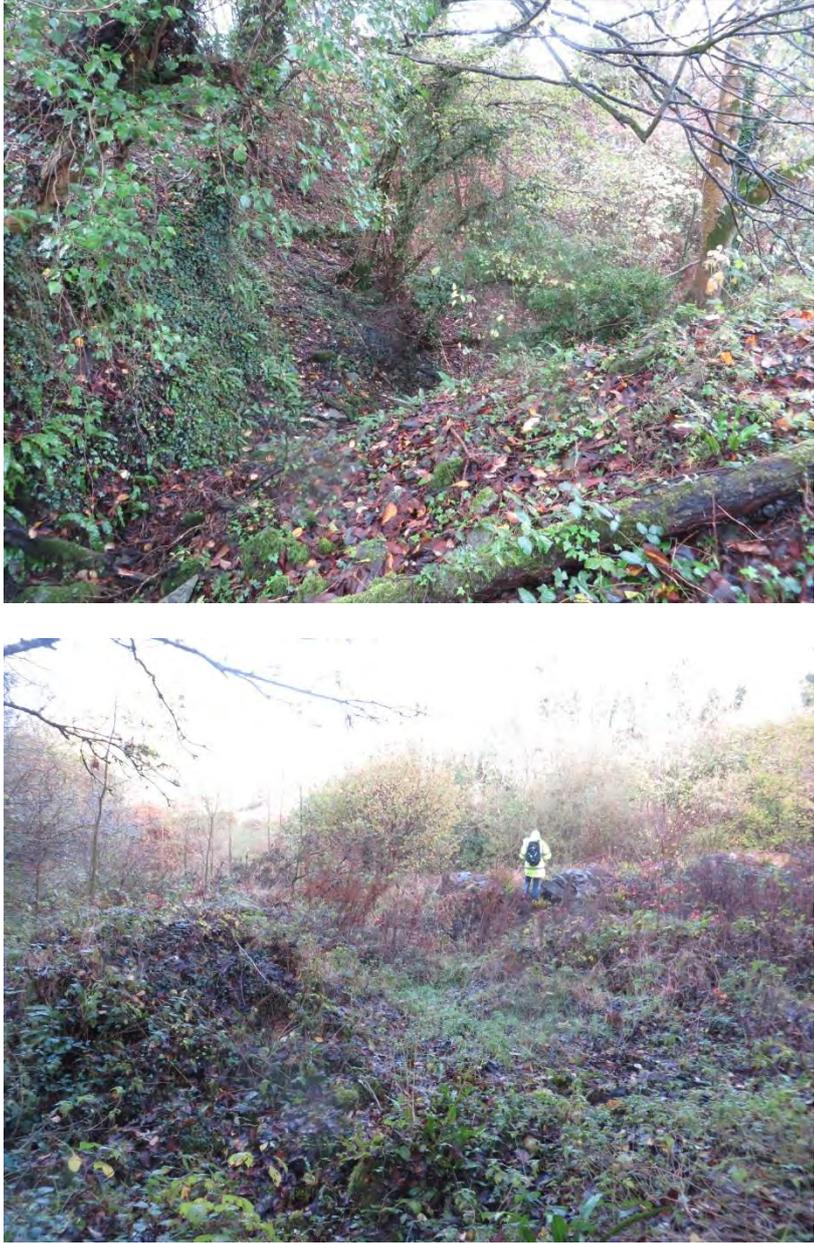
<b>Field survey date</b>	14/11/2014
<b>Field survey status</b>	Confirmed
<b>Water present</b>	No
<b>Ground level elevation</b>	Elevation within depression 13.39 mAOD. This is not the base of the depression
<b>Additional Information</b>	Very large depression. Large part of enclosed depression is filled in with waste and material.
<b>Site photos</b>

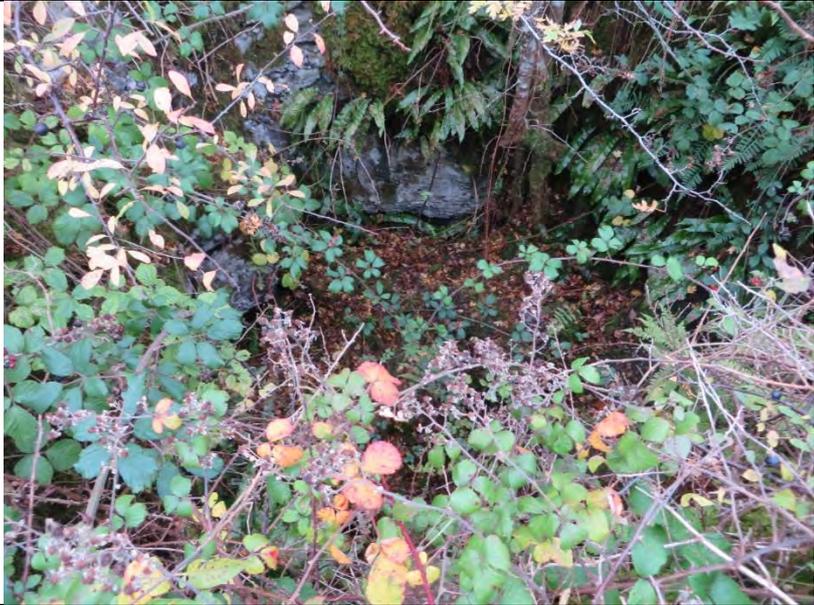
<b>Feature ID</b>	<b>K170</b>
<b>Feature type</b>	Well/enclosed depression
<b>Coordinates</b>	534787.19, 728293.49
<b>Source</b>	Field survey
<b>Field survey date</b>	22/10/2014
<b>Field survey status</b>	Confirmed
<b>Water present</b>	No
<b>Additional Information</b>	Dug well Approx. 3m diameter and 2m to base Base of well is covered in moss covered rocks
<b>Site photos</b>

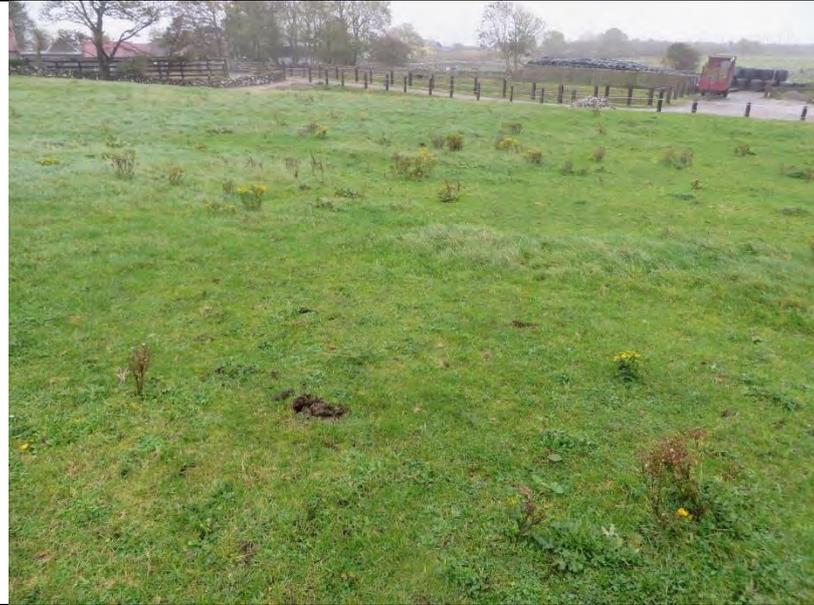
<b>Field survey date</b>	23/10/2014
<b>Field survey status</b>	Confirmed
<b>Water present</b>	No
<b>Additional Information</b>	Very shallow depression

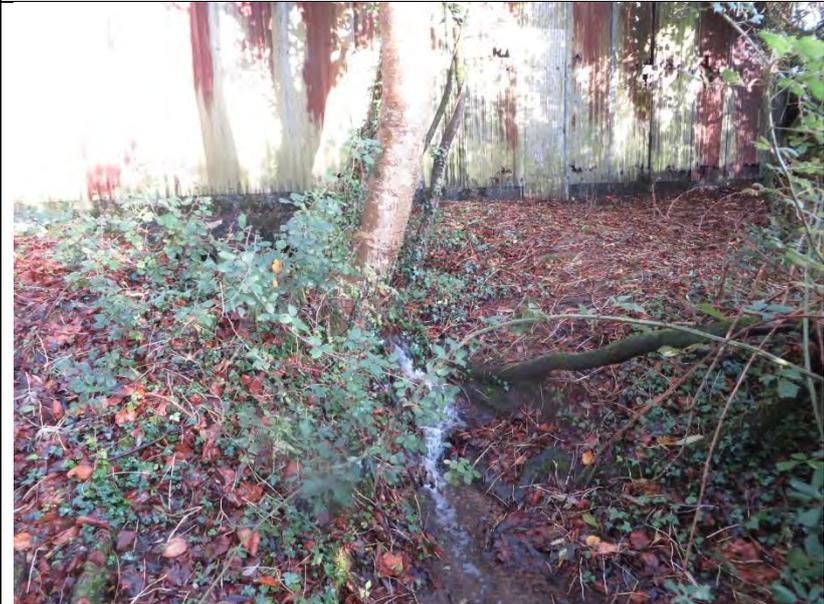
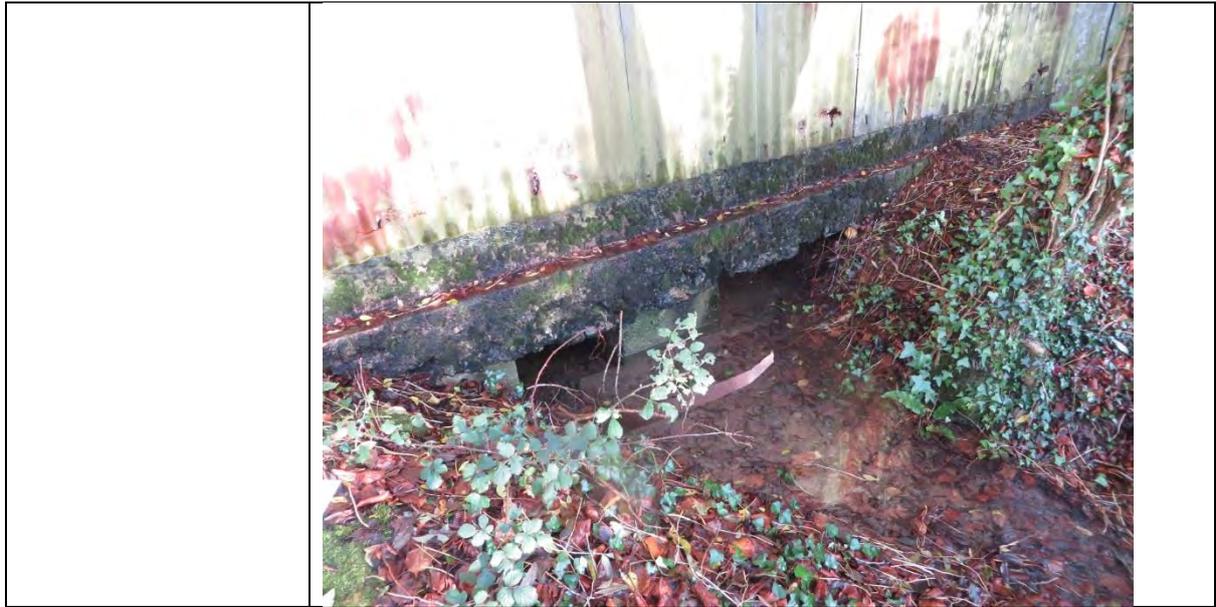
<b>Field survey date</b>	14/11/2014
<b>Field survey status</b>	Confirmed
<b>Water present</b>	Yes Electrical conductivity: 510 uS/cm Temperature: 9.7 °C pH: 7.88 Flow: 6.3 l/s
<b>Water level elevation</b>	25.22 mAOD
<b>Additional Information</b>	Spring discharges from under an old building.
<b>Site photos</b>

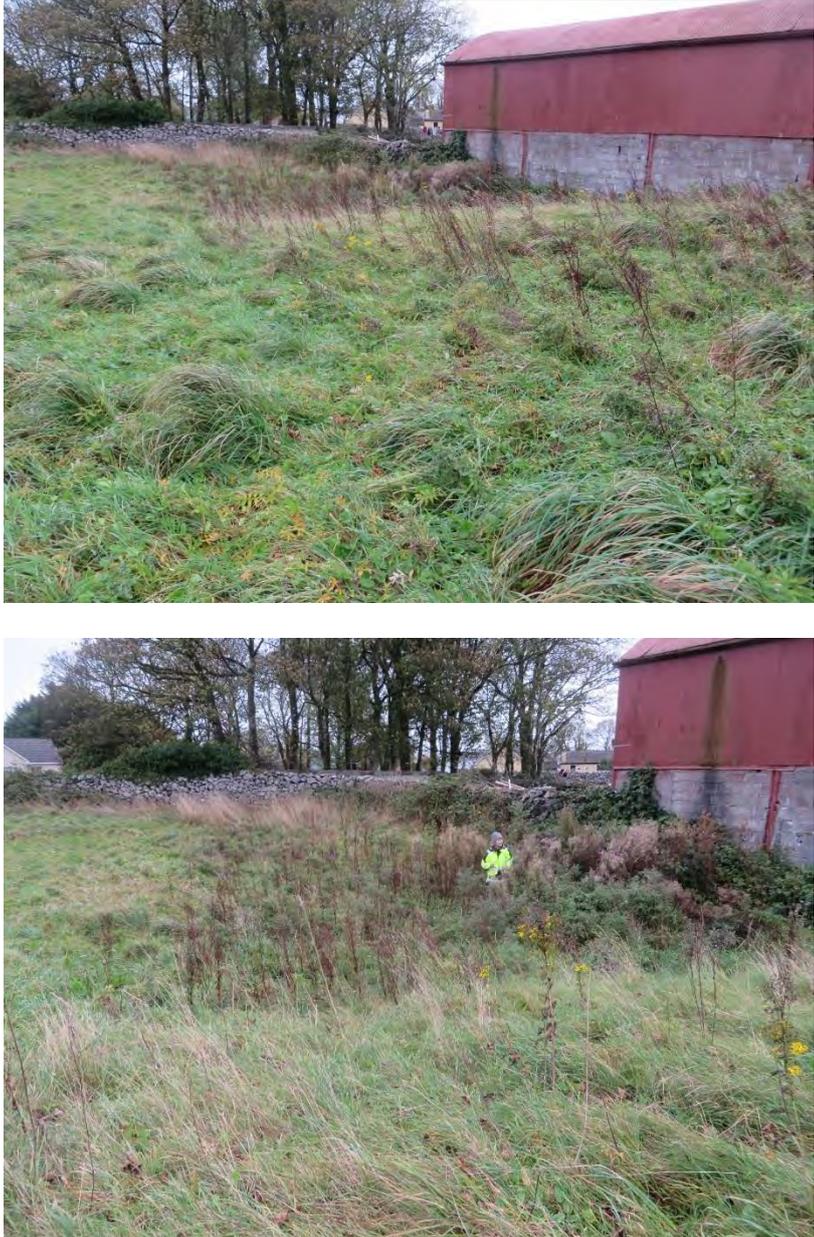
<b>Feature ID</b>	<b>K175</b>
<b>Feature type</b>	Enclosed depression
<b>Coordinates</b>	534857, 727168
<b>Source</b>	Field survey
<b>Field survey date</b>	23/10/2014
<b>Field survey status</b>	Confirmed
<b>Water present</b>	No
<b>Additional Information</b>	Approx. dimensions: 20m diameter, 2m depth
<b>Site photos</b>

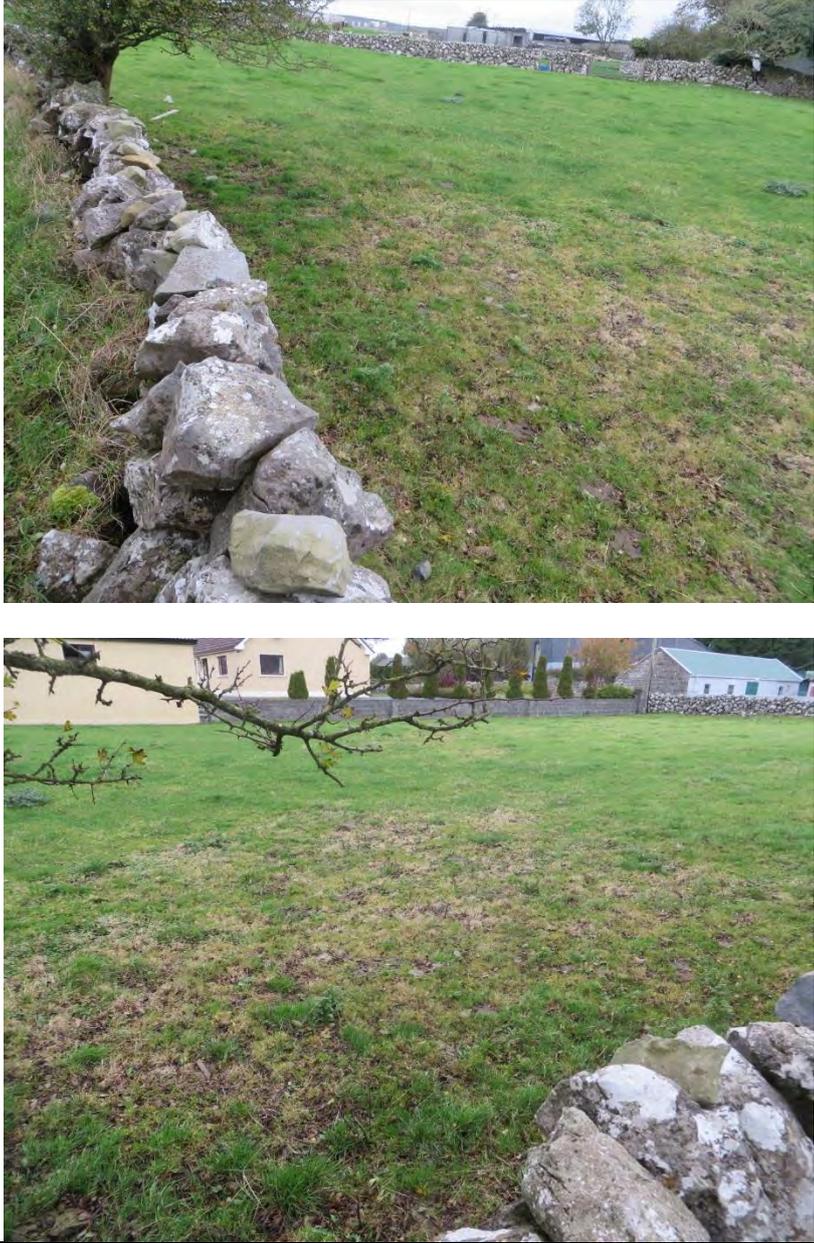
<b>Feature ID</b>	<b>K179</b>
<b>Feature type</b>	Enclosed depression
<b>Coordinates</b>	534990, 727121
<b>Source</b>	Field survey
<b>Field survey date</b>	23/10/2014
<b>Field survey status</b>	Confirmed
<b>Water present</b>	No
<b>Additional Information</b>	Approx. dimensions: 20m diameter semicircle. Shallow
<b>Site photos</b>

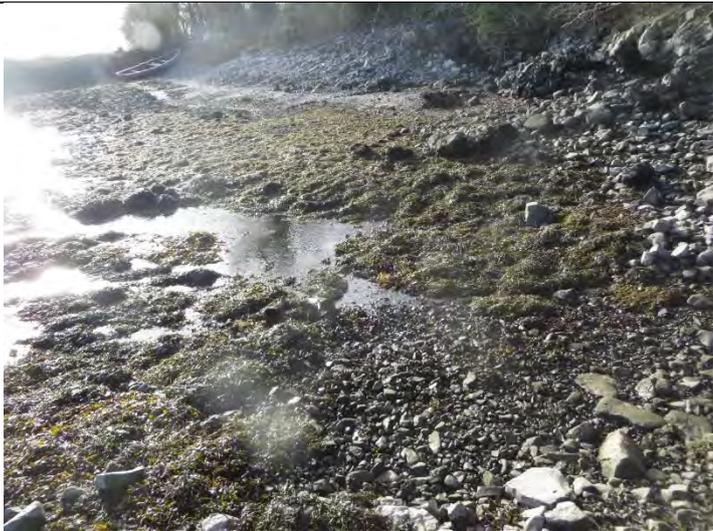
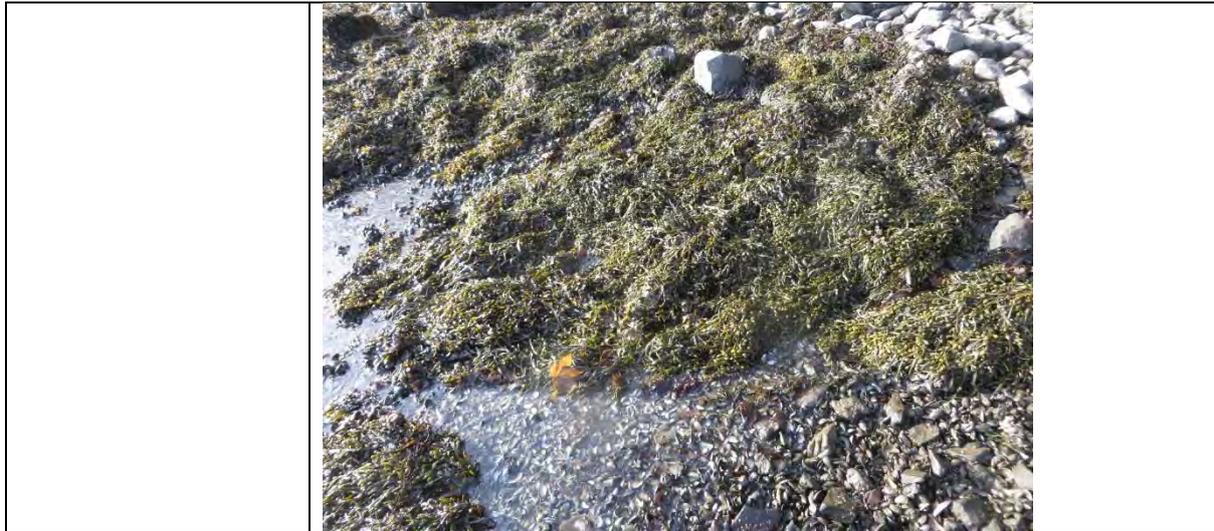
<b>Field survey date</b>	14/11/2014
<b>Field survey status</b>	Confirmed
<b>Water present</b>	Yes Electrical conductivity: Outside instrument range Temperature: 11.5 °C pH: 7.34
<b>Additional Information</b>	Flow from spring too wide to measure. Flow discharges directly to sea
<b>Site photos</b>

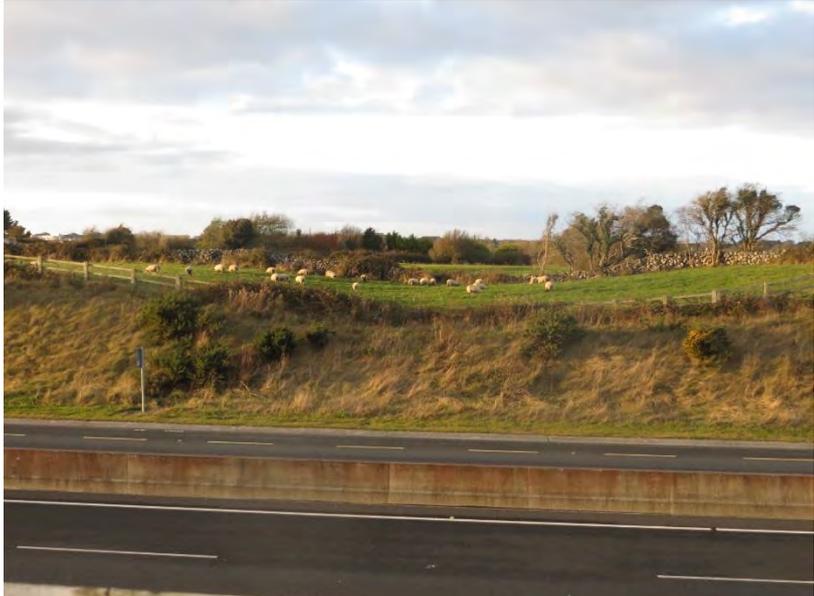
<b>Feature ID</b>	<b>K193</b>
<b>Feature type</b>	Enclosed depression
<b>Coordinates</b>	535482, 727051
<b>Source</b>	Field survey
<b>Field survey date</b>	17/11/2014
<b>Field survey status</b>	Confirmed
<b>Water present</b>	No
<b>Additional Information</b>	Approx. 30m diameter depression cut in half by M6 motorway
<b>Site photos</b>

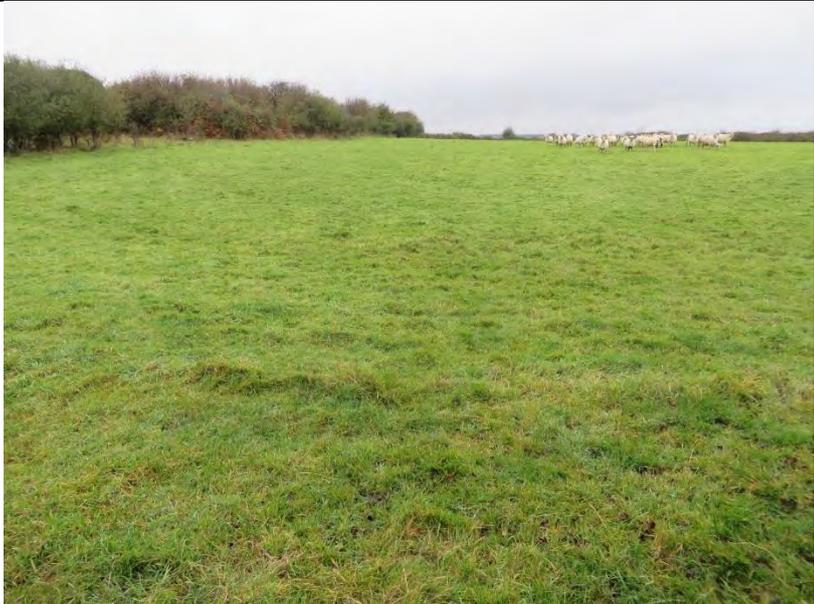
<b>Feature ID</b>	<b>K202</b>
<b>Feature type</b>	Enclosed depression
<b>Coordinates</b>	536033, 726313
<b>Source</b>	Field survey
<b>Field survey date</b>	23/11/2014
<b>Field survey status</b>	Confirmed
<b>Water present</b>	No
<b>Additional Information</b>	Very shallow enclosed depression Approx. 20m diameter
<b>Site photos</b>

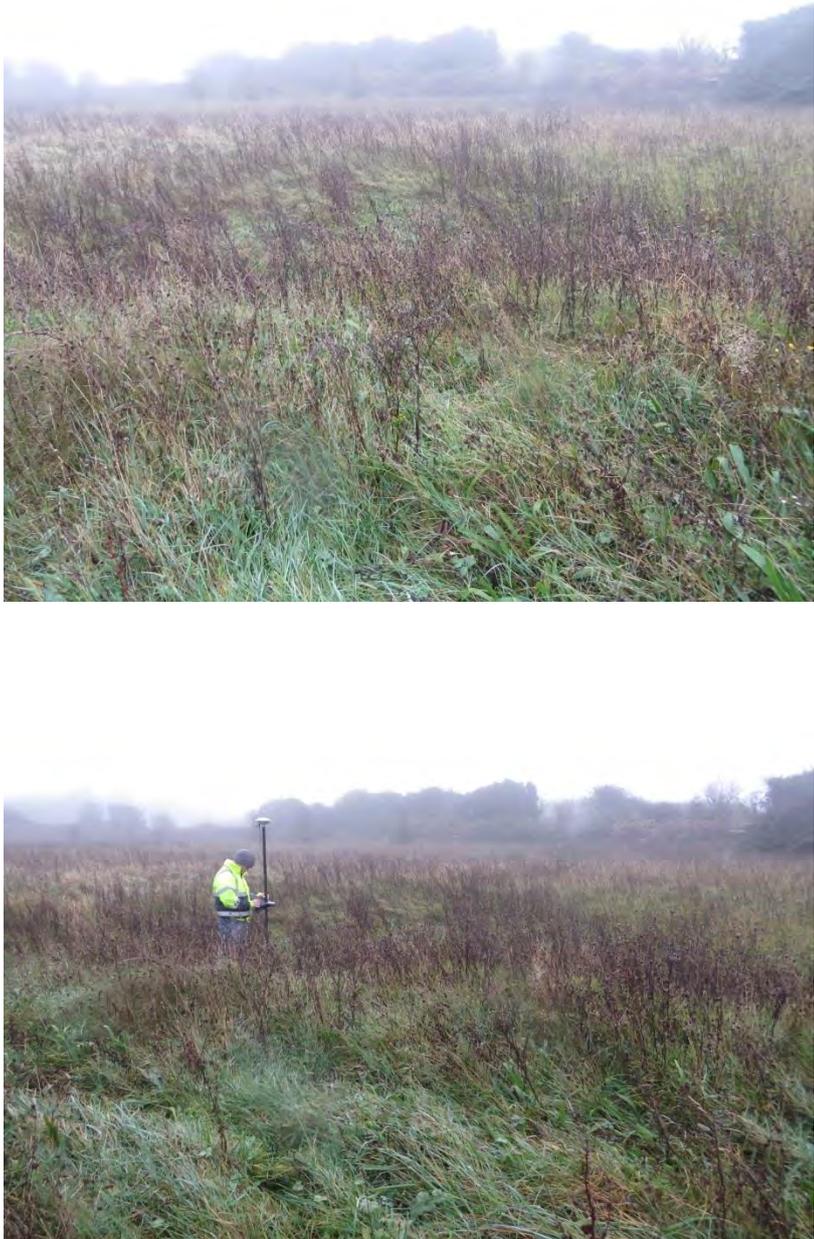
<b>Feature ID</b>	<b>K203</b>
<b>Feature type</b>	Enclosed depression
<b>Coordinates</b>	536033, 725740
<b>Source</b>	Field survey
<b>Field survey date</b>	18/11/2014
<b>Field survey status</b>	Confirmed
<b>Water present</b>	No
<b>Ground level elevation</b>	29.44 mAOD
<b>Additional Information</b>	Small enclosed depression Approximate dimensions: 5m x 2 m less than 1 m deep
<b>Site photos</b>

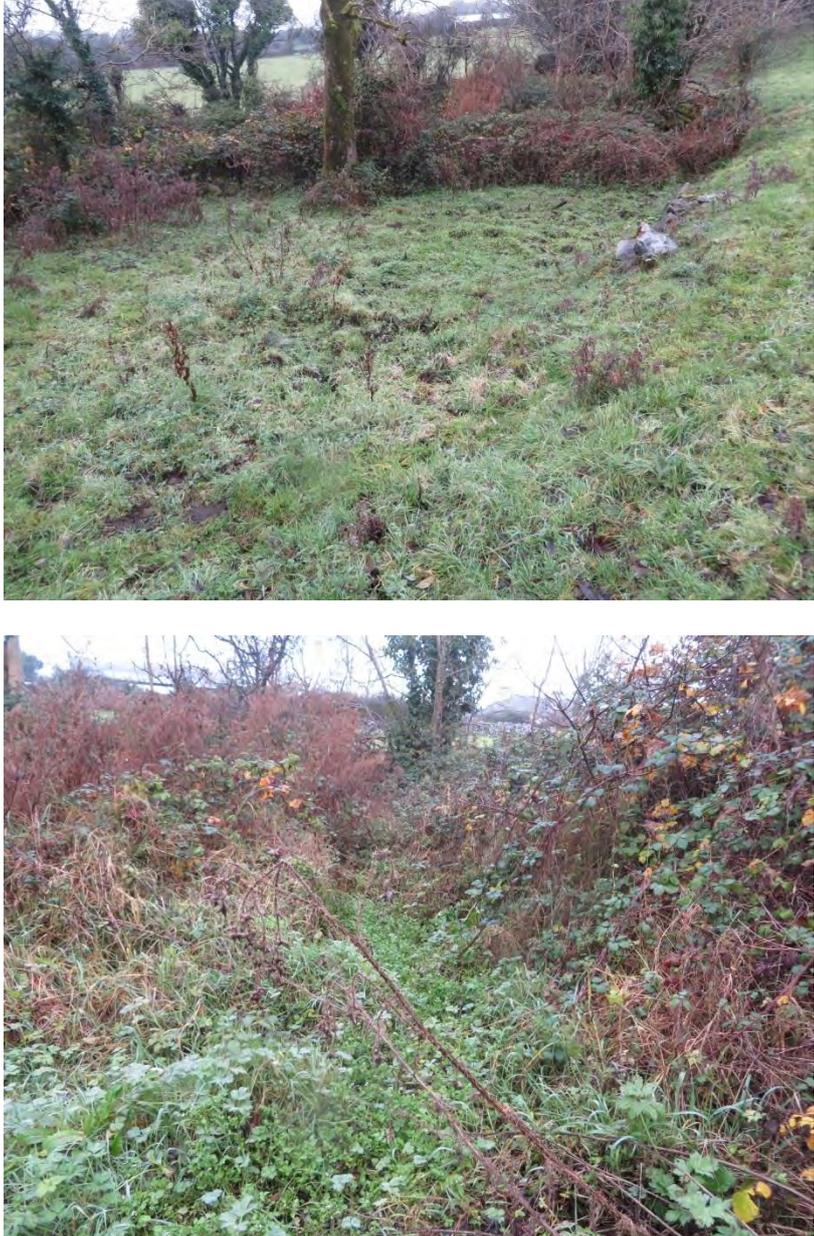
<b>Field survey date</b>	18/11/2014
<b>Field survey status</b>	Confirmed
<b>Water present</b>	Yes Electrical conductivity: 704 uS/cm Temperature: 9.8 °C pH: 7.88
<b>Water level elevation</b>	26.37 mAOD
<b>Additional Information</b>	The spring is at the base of a depression. The ground is very soft and covered in vegetation. Water is present, however due to the low water

<p>levels and vegetation flow not measurable. The spring discharge area is approx. 20 m diameter.</p> <p>The landowner lives in the house across the road and informed us that the spring has been used in the past as the drinking water supply but is currently not in use.</p>
<p><b>Site photos</b></p>

<p>The first photograph shows a wide view of a grassy field with scattered trees and dense brush in the background. The second photograph shows a closer view of dense brush and trees, with a path or stream bed visible in the foreground.</p>

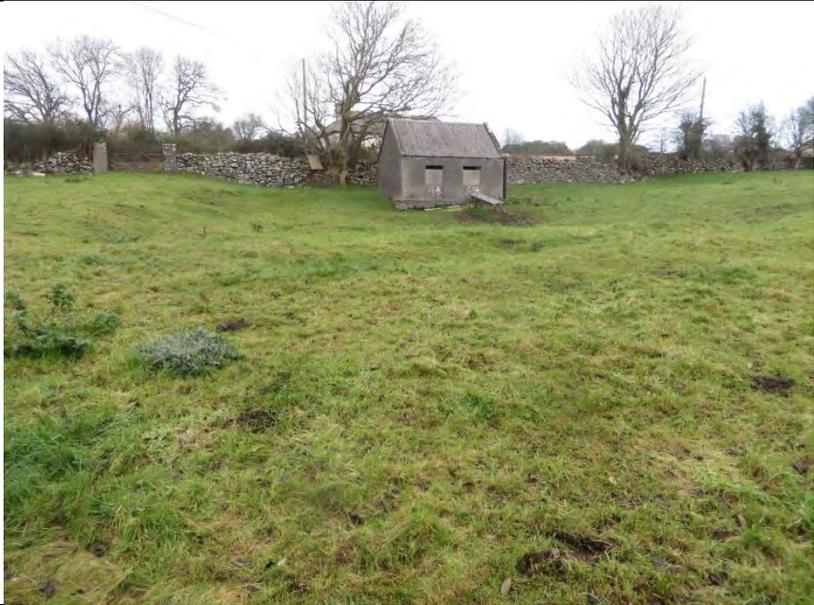
<b>Feature ID</b>	<b>K213</b>
<b>Feature type</b>	Enclosed Depression
<b>Coordinates</b>	536132, 726003
<b>Source</b>	Field survey
<b>Field survey date</b>	18/11/2014
<b>Field survey status</b>	Confirmed
<b>Water present</b>	No
<b>Additional Information</b>	Approx. dimensions: 20 m diameter. The depression may contain some fill or modification
<b>Site photos</b>

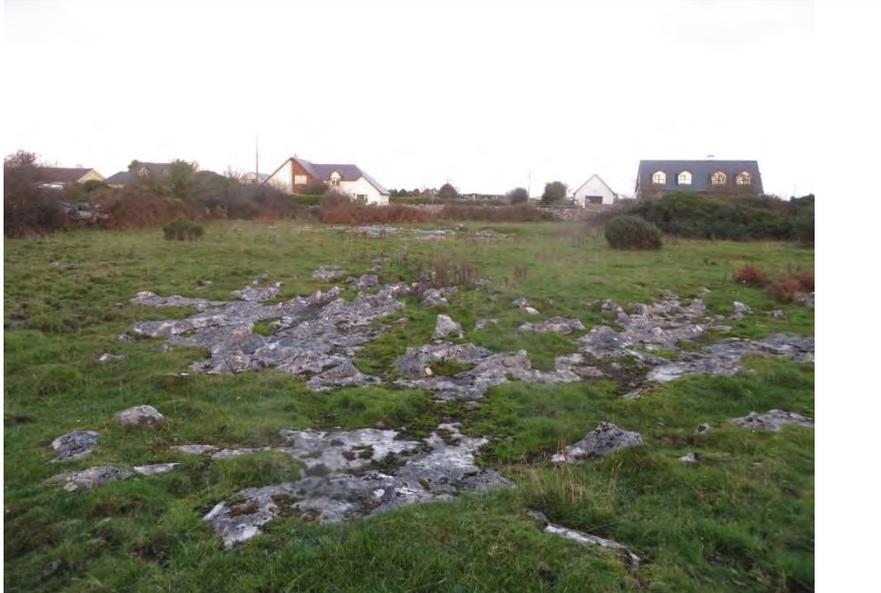
<b>Field survey date</b>	17/11/2014
<b>Field survey status</b>	Confirmed
<b>Water present</b>	No
<b>Additional Information</b>	Superficial solution features. Small shallow dips and small patches of outcrop.
<b>Site photos</b>

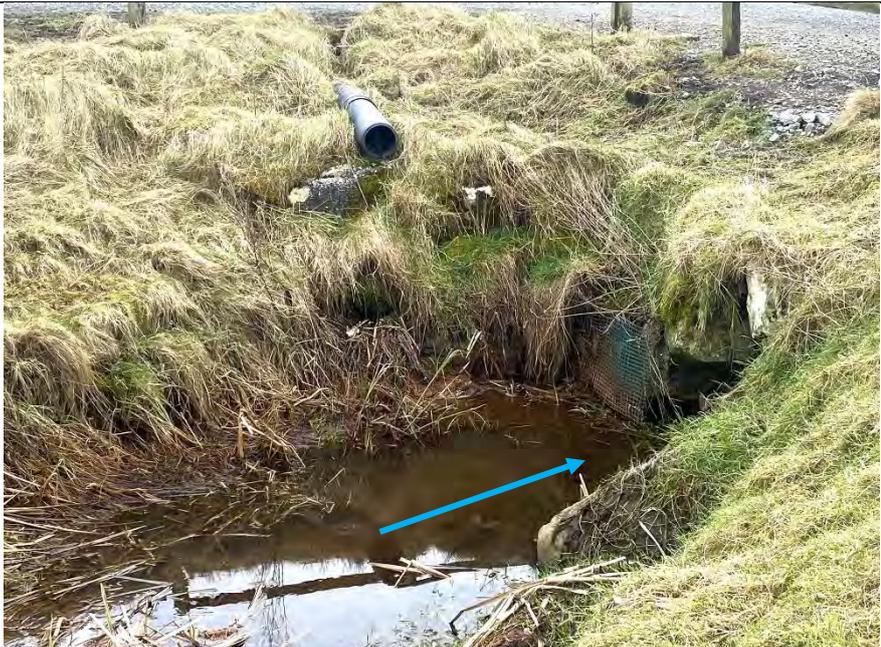
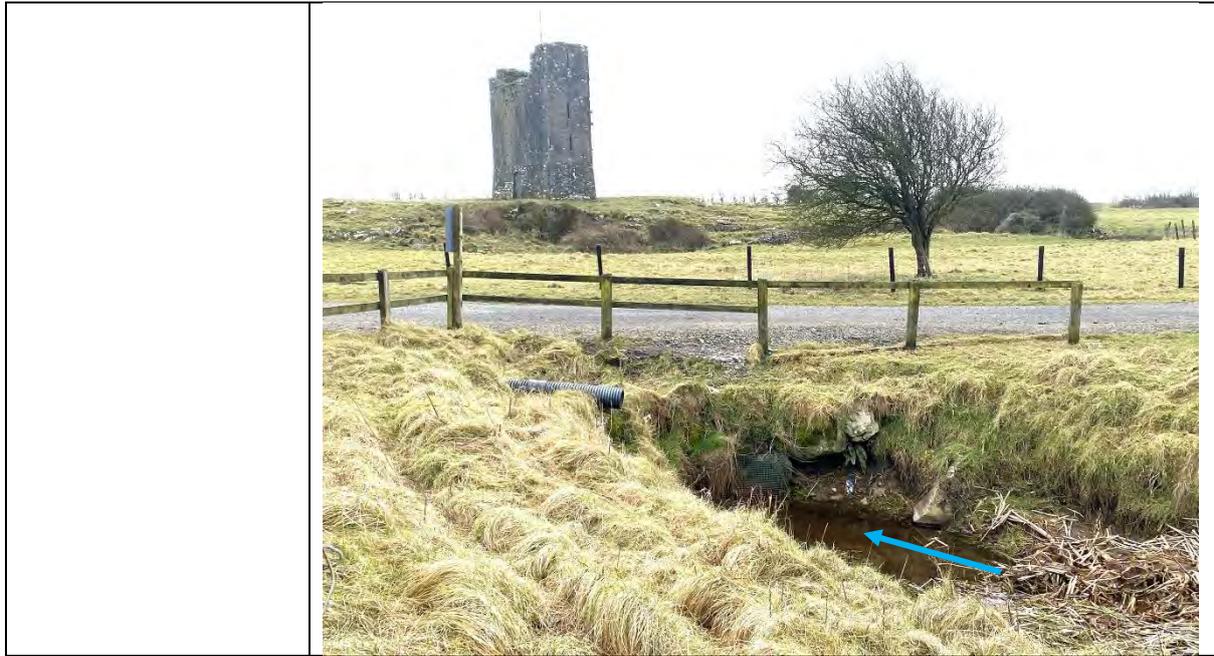
<b>Field survey date</b>	19/03/2024
<b>Field survey status</b>	Identified by Galway Racecourse
<b>Water present</b>	No
<b>Additional Information</b>	The swallow hole is located at the end of a channel extending from an area of wet vegetation to the north. The channel is also heavily vegetated. Drainage from the racecourse is directed towards this wetland and ultimately discharges into the swallow hole. The land to the south of the swallow hole rises towards Ballybrit castle where outcrop can be seen.
<b>Site photos</b>
