**Report on Investigations into Planning,  
Environmental Compliance and General Nuisances  
Associated with a Quarry Operated**

**P. McCaffrey & Sons Ltd.  
Ballymagroarty,  
Ballintra,  
Co. Donegal**

**REPORT**

December, 2000

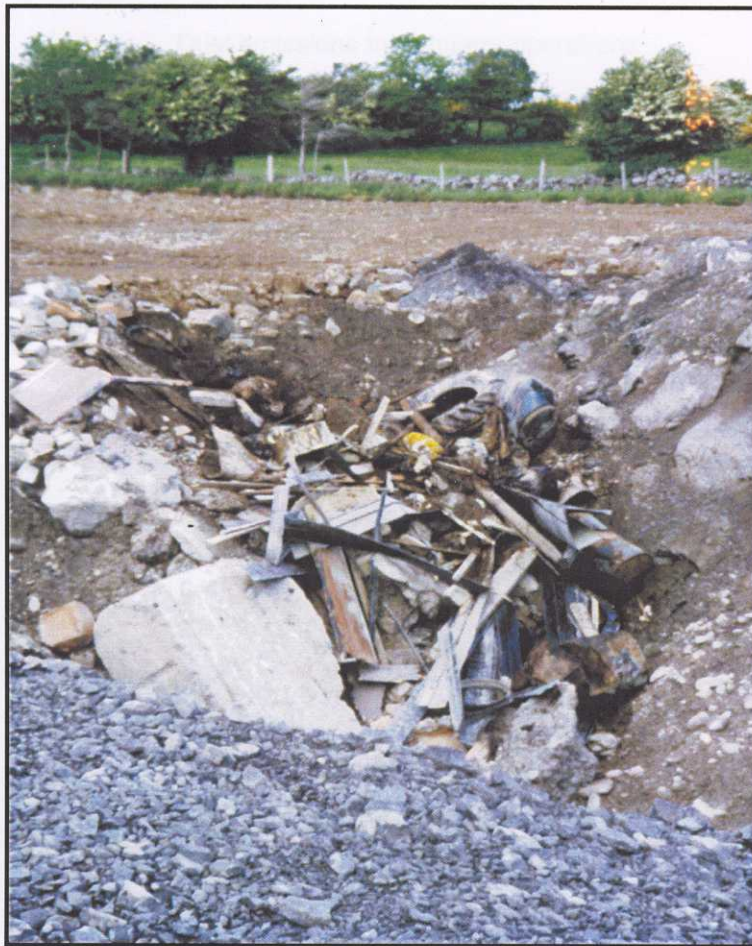
Quarry No. 3. (Partly backfilled with scrap metal/drums).

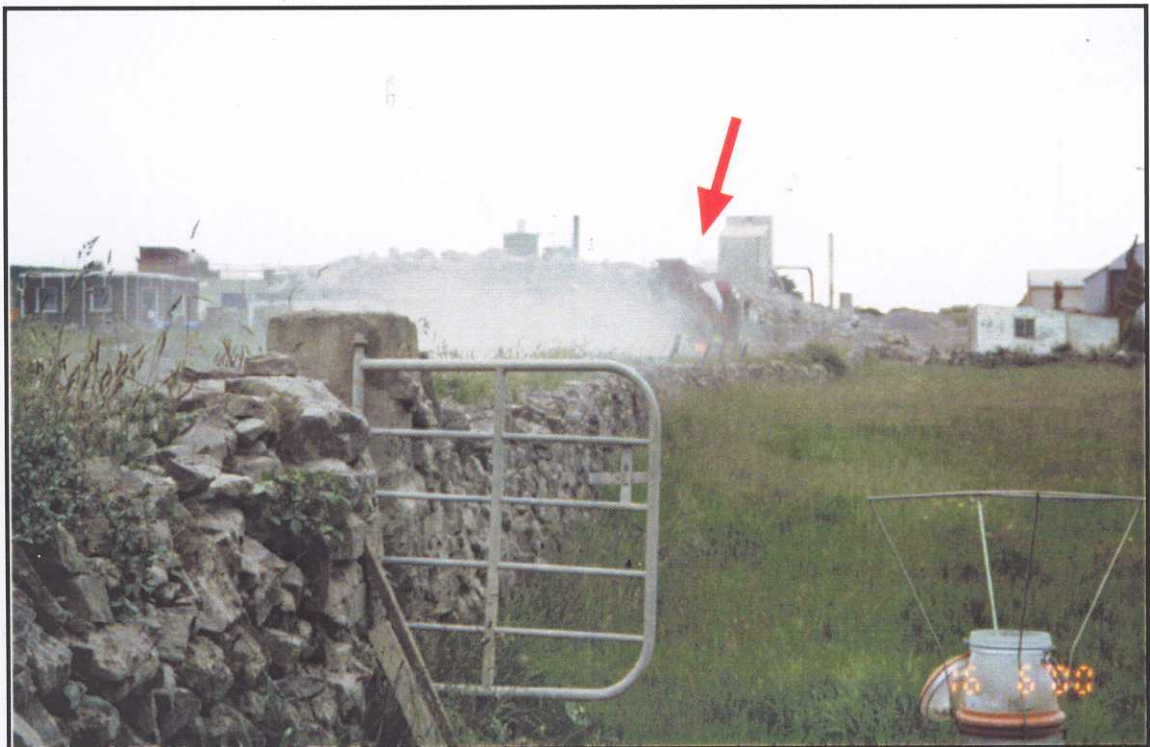
An examination of the Gorman land and photographs presented by the Gorman's clearly indicate in our opinion problems with dust pollution from McCaffrey's quarry. Photographs 5 to 9 attached confirm this observation. A visual inspection of the quarry from the perimeter of the site identified the following dust sources:

Dust emissions from quarry access road.

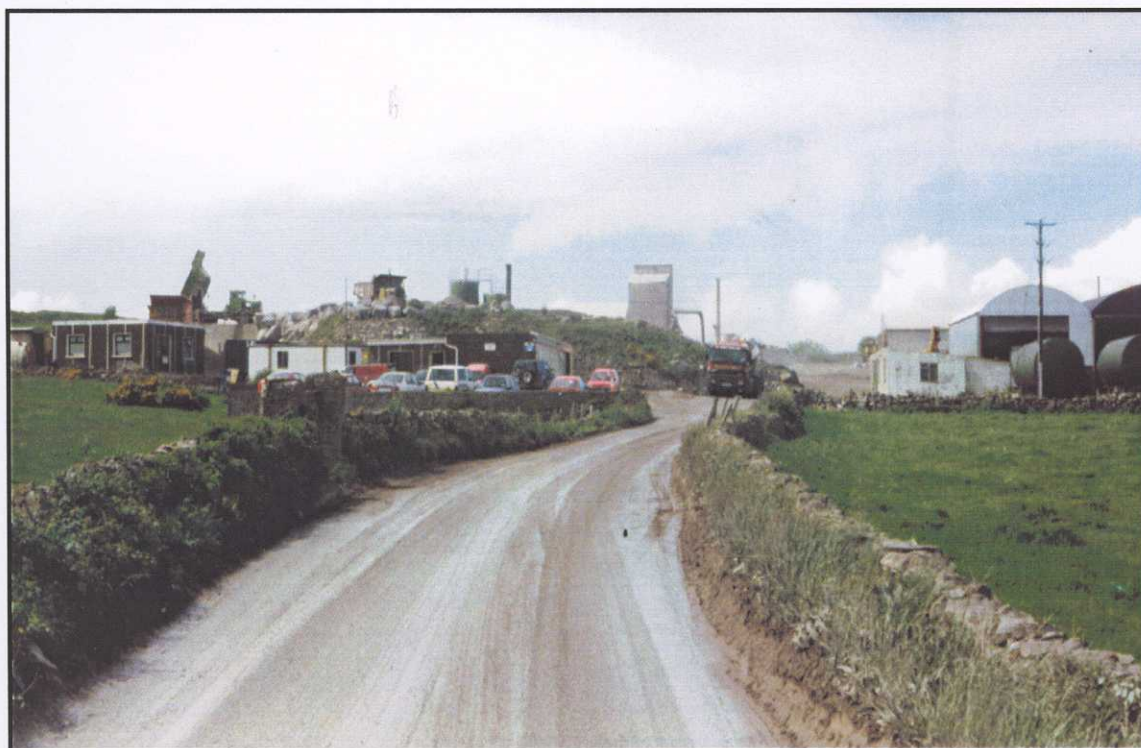
No mitigation measures for visual impact / dust emissions.

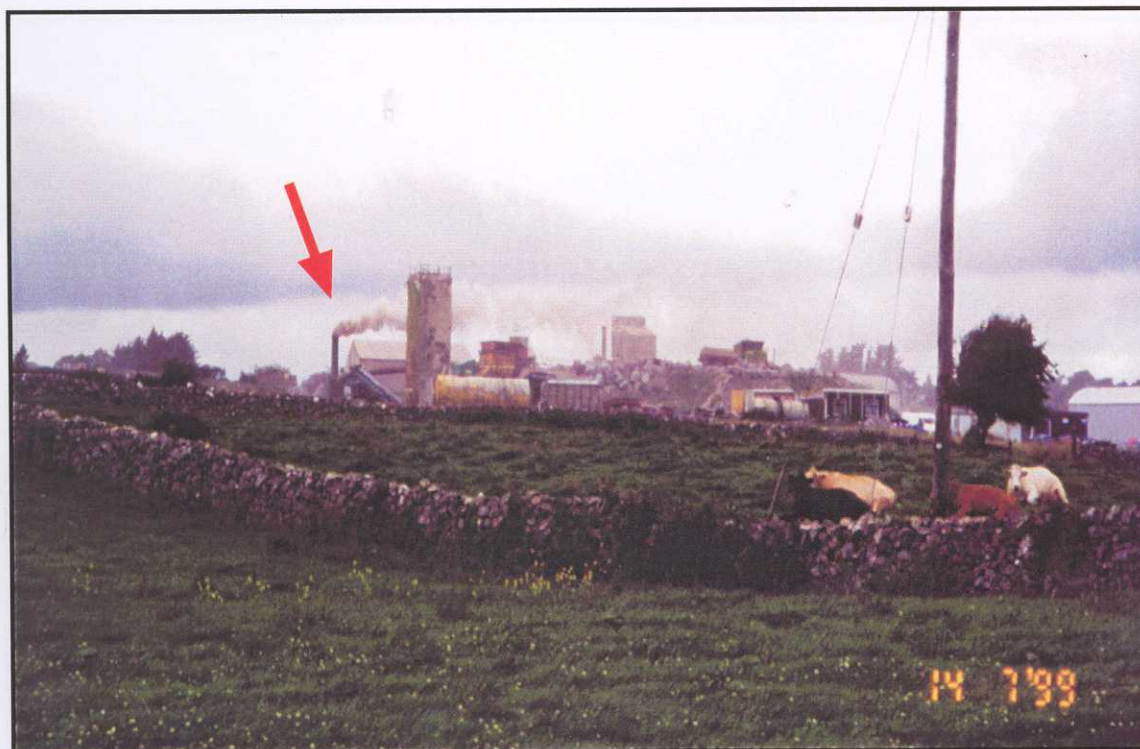
Air discharges from asphalt plants.

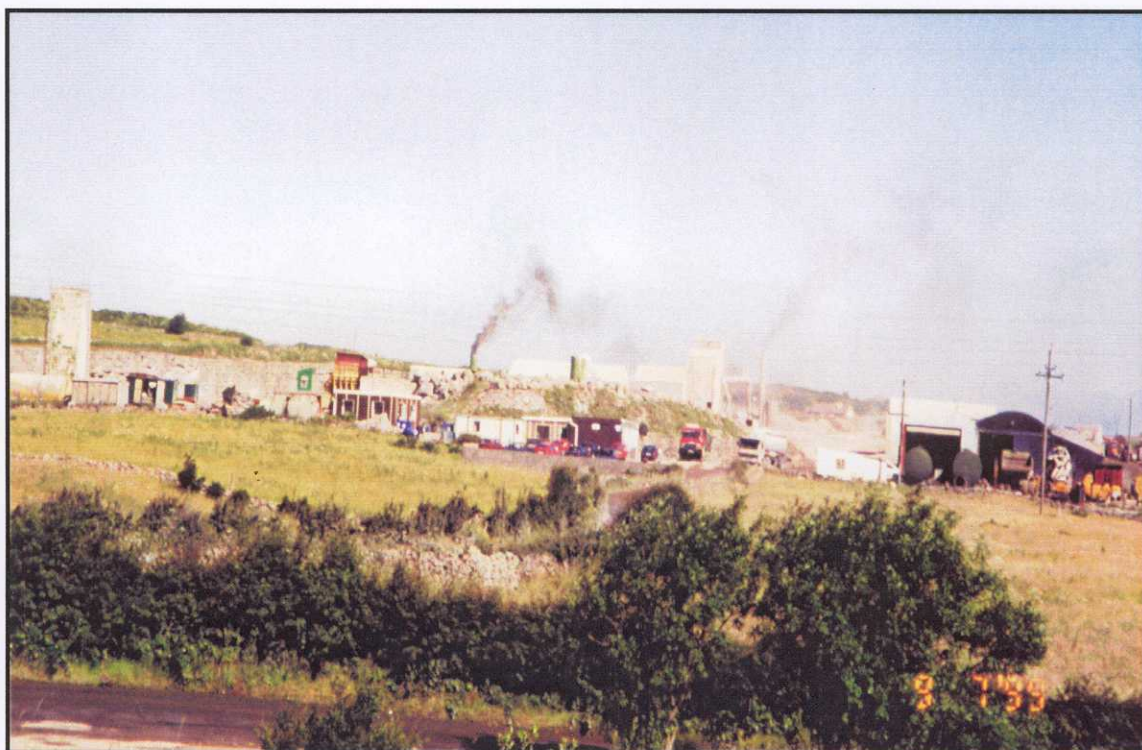
Air discharges from asphalt plants.

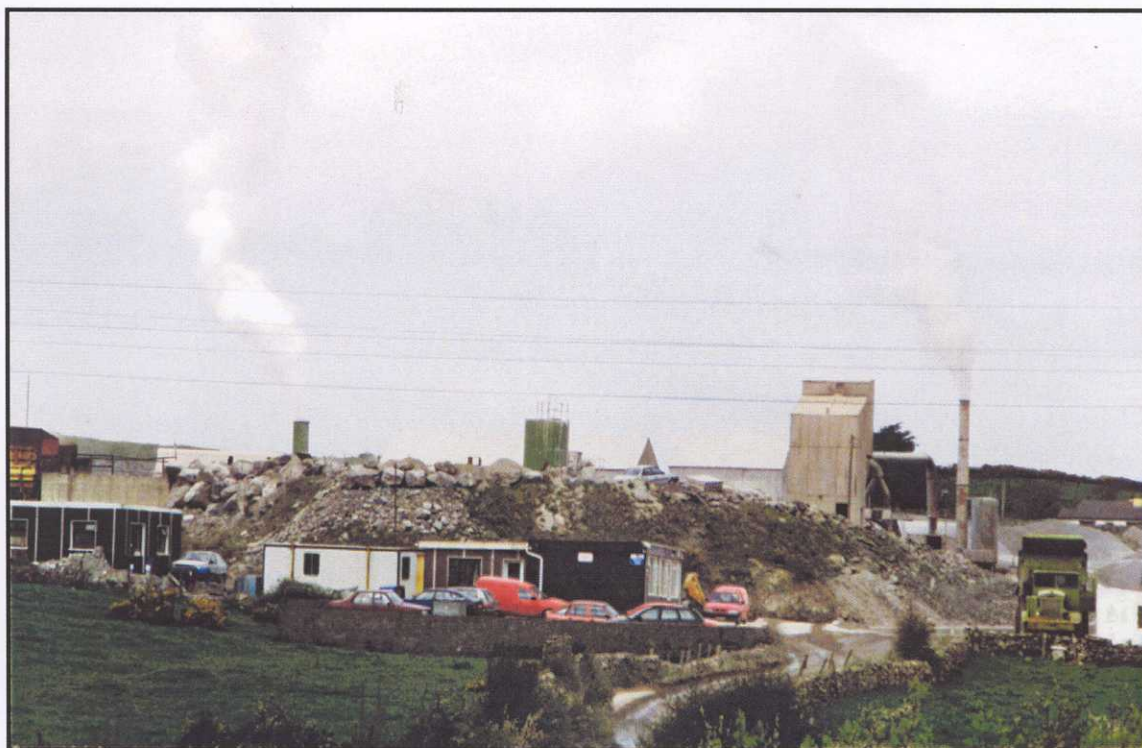
Air discharges from asphalt plants.

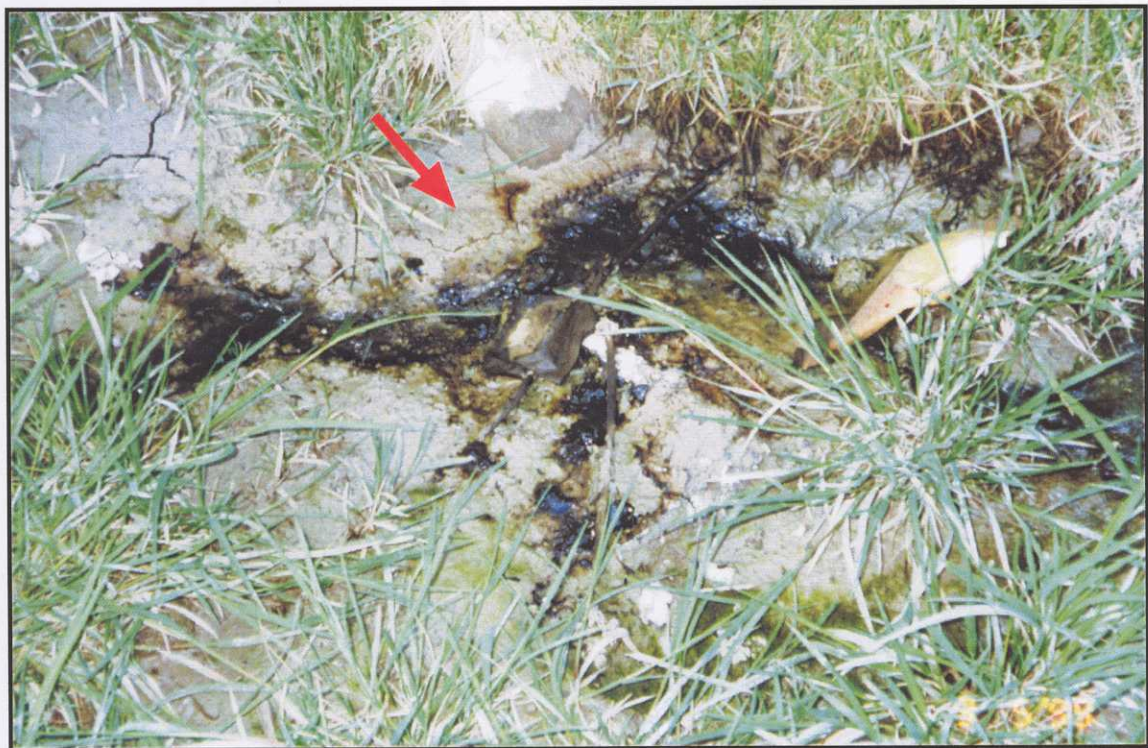
Bitumen residues that have flowed into the Gorman land.

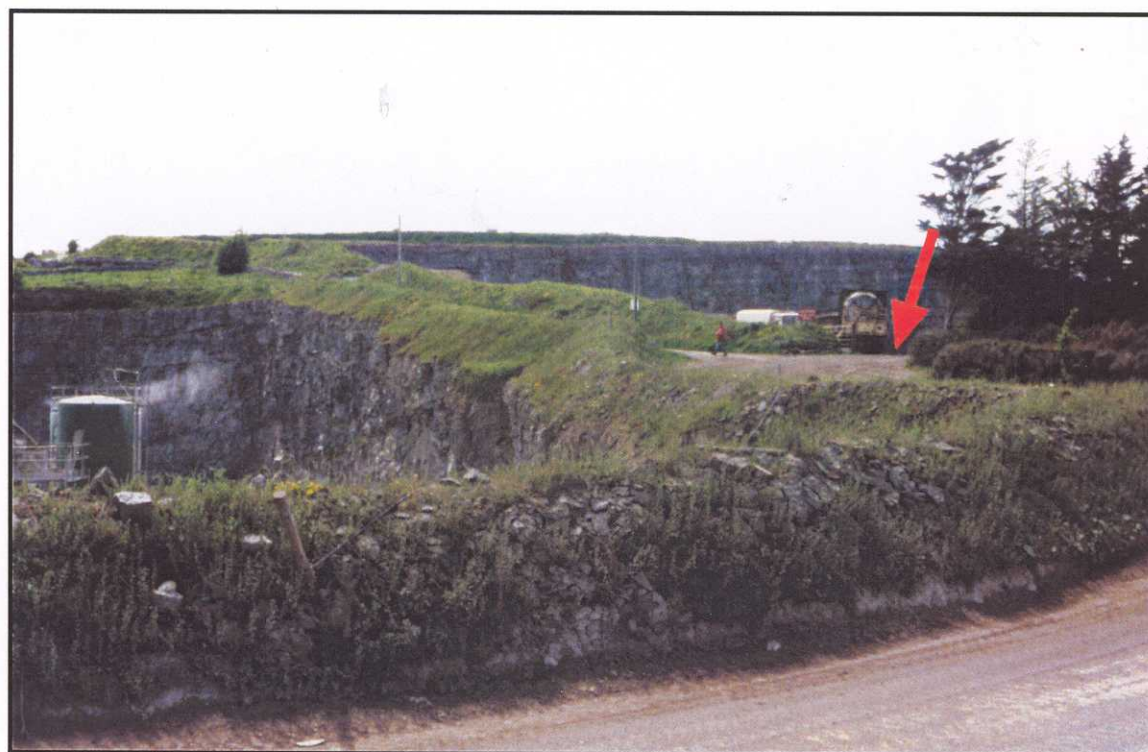
A number of unprotected cliff faces have been identified with no protection to prevent unauthorised access. No signs have been erected to warn of the dangerous condition of the cliff faces or no effort has been made to prevent people from straying into these areas. Attached Photographs 23 to 25 show the unprotected cliff faces.

Public road running between unprotected cliff faces to quarries No. 1 and No. 2.

We recommend that this issue be brought to the immediate attention of the Garda Siochana, Donegal County Council and the Health and Safety Authority.

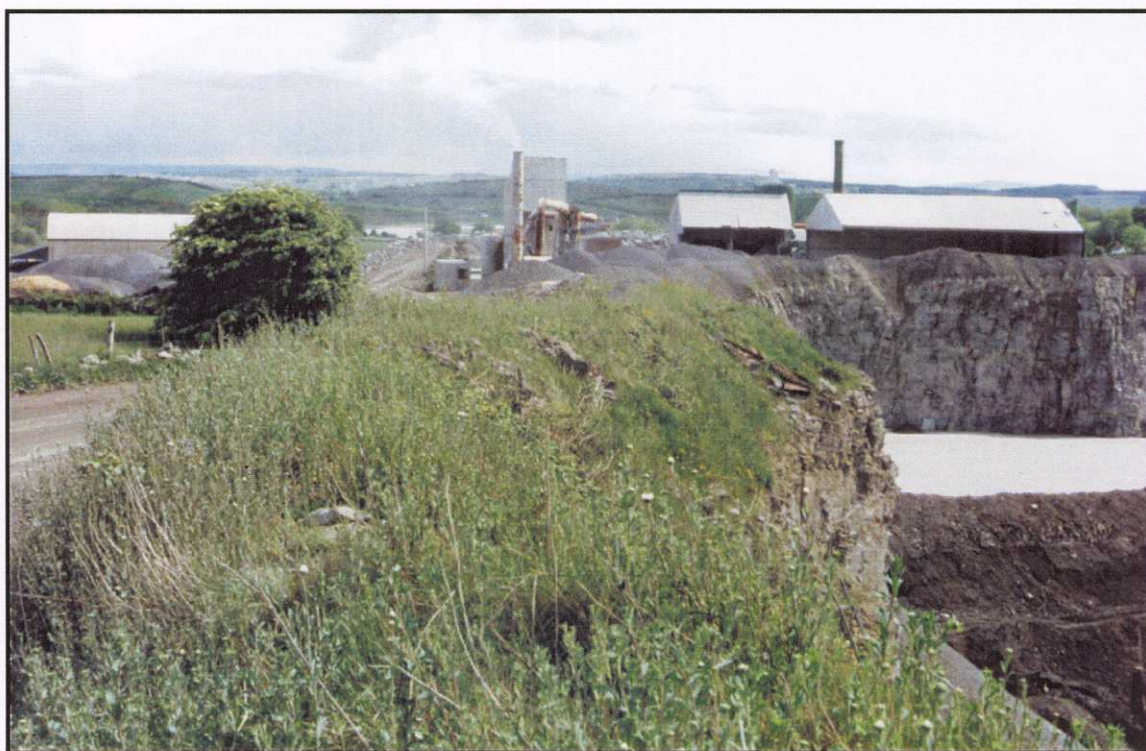
Unprotected cliff face to quarry No. 1 including tailings pond.

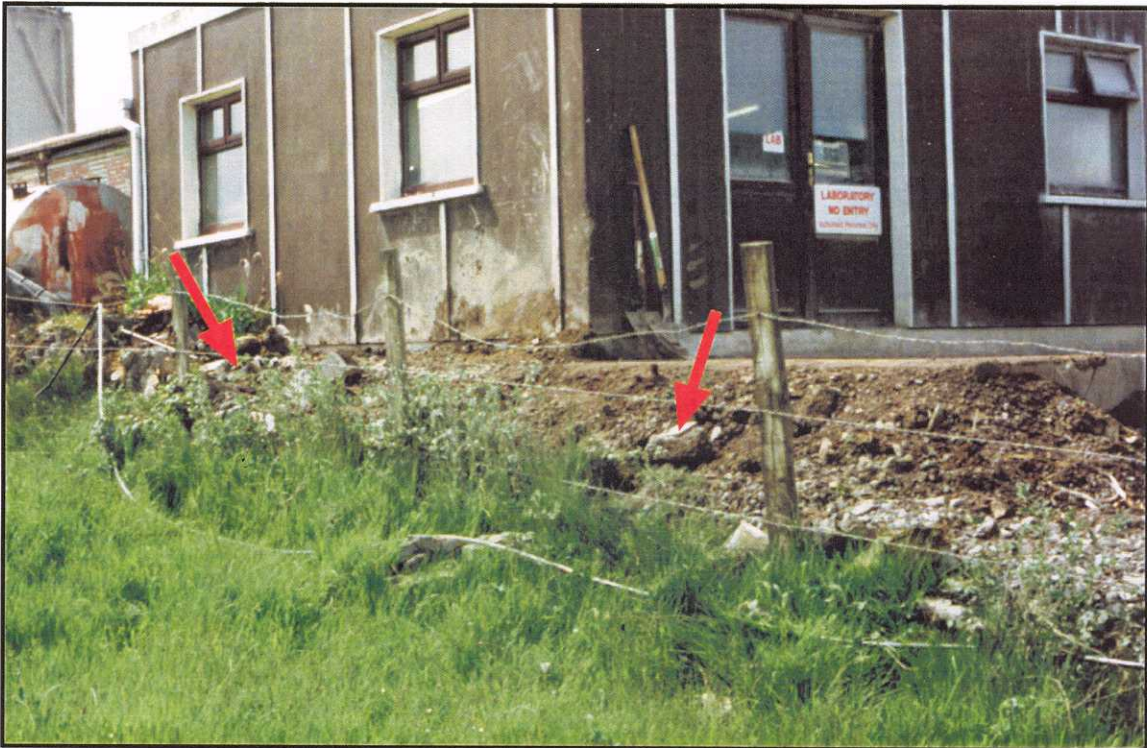
Boundary wall with quarry, removed without permission.

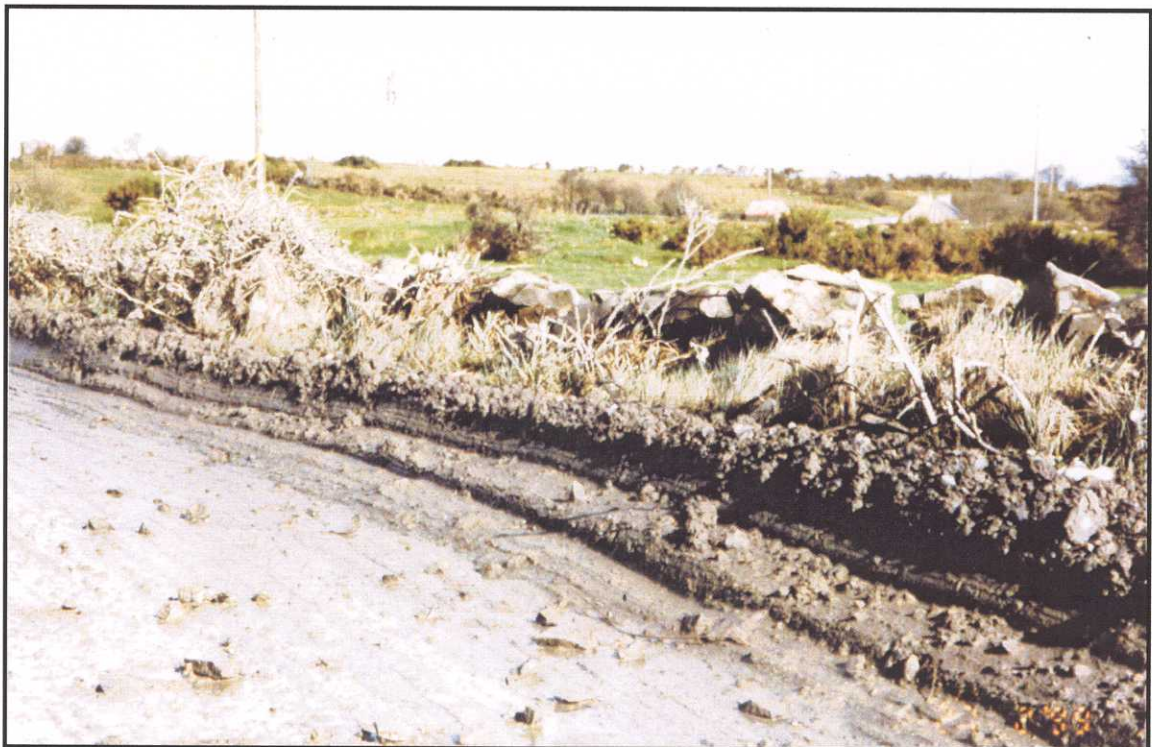
As a result of the volume and amount of heavy traffic that uses this roadway the approach road has naturally widened with the dry stone walls pushed back causing them to become unstable. Furthermore as the road has widened McCaffreys have raised the level of the approach road by overlaying with surface materials. This has in effect reduced the ditch height, and this now makes these ditches unsatisfactory for retaining stock. As a result of the natural widening and vibration from the heavy traffic the stone walls regularly collapse as shown on the attached Photographs 27 and 28. Obviously when the ditches collapse, stock can immediately leave the fields and can end up on the heavily trafficked N15.

Level of access road almost equal with height of Gorman stone wall.

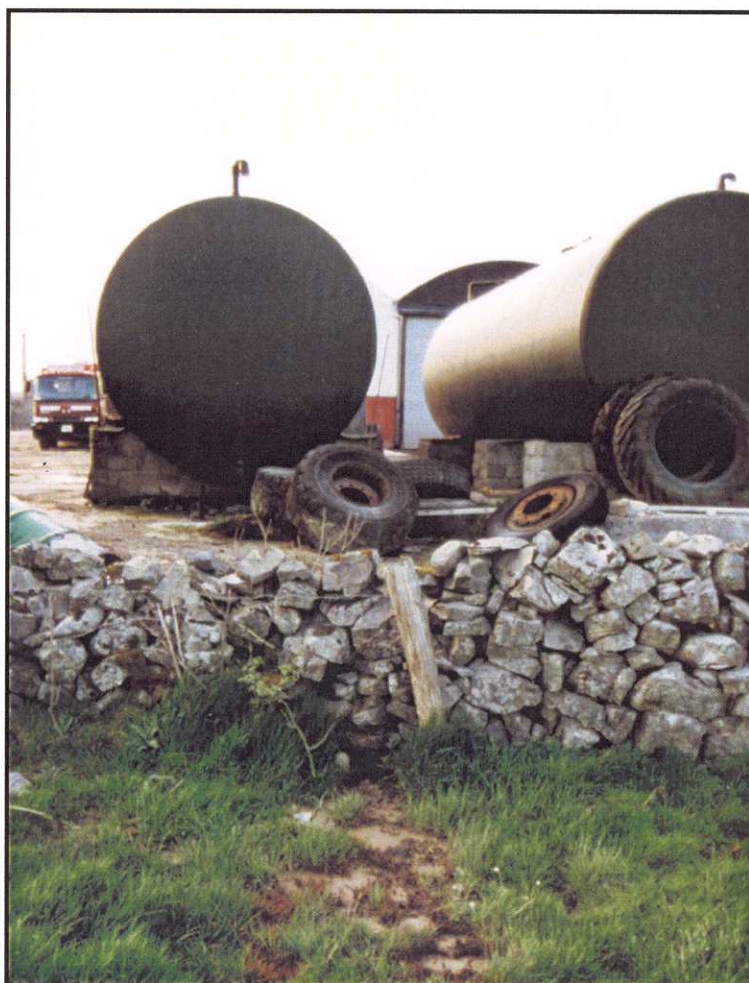
**Damien Tansey**  
Photo 29

The Gormans have also raised the issue of unbunded tanks adjoining their property. A leak or even runoff from this area has the potential to cause significant damage to their property. Photograph 29

Unbunded storage tanks.
