# Appendix 2

## Submission on rElAR

Ref: -QD05E.323037

This report examines and critically assesses the rEIAR submitted by Patrick McCaffrey & Sons Ltd (hereafter McCaffreys) and the impact of the quarry on local residents, landowners, the environment, quality of life, human health, property, health and safety. Deficiencies and shortcomings in the rEIAR are identified.

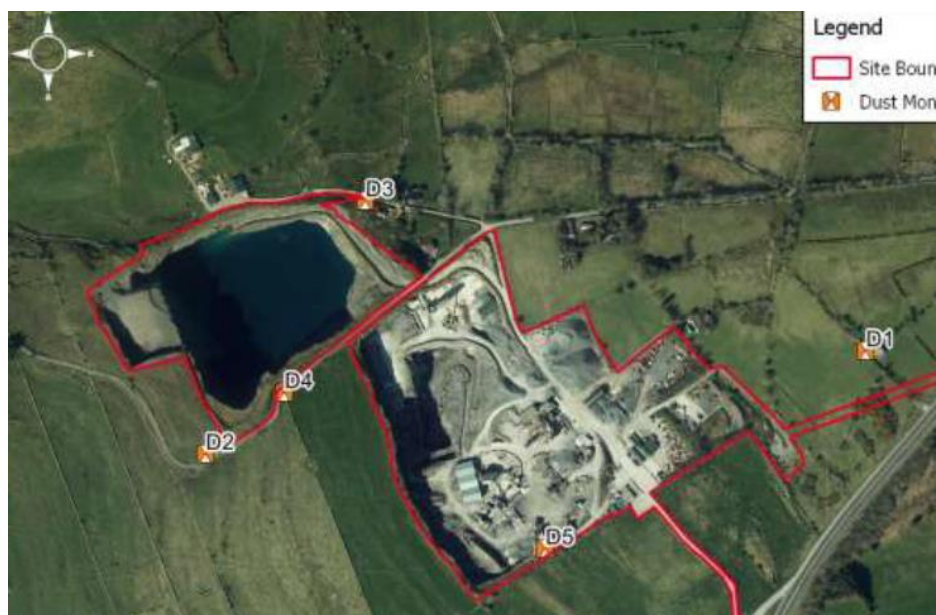
Figure 16: Berghoff Monitoring Locations taken from Figure 9-5 in rEIAR

Since the publication of the Inspector's report in 2016, McCaffreys have had ample opportunity to put in place dust deposition measuring sensors at a more appropriate and sensible locations but have failed to do so. The data presented in this rEIAR on dust deposition relies on that same poorly designed measuring system and consequently can only give a very incomplete and partial picture of the dust nuisance generated by McCaffrey's quarry, see Figure 16 for location of measuring points (I have had to assume that D1 in Figure 9-5 of the rEIAR corresponds with DS1 in Appendix 9-4, etc.). Not only is it poorly designed but the data presented in Appendix 9-4 is incomplete with significant gaps. For example, no data is reported for the whole of 2009. Readings stopped completely in November 2022, so there is no data at all for the past three years. From January 2006 to December 2024, there should be 1140 monthly readings, yet only 845 dust readings are available in Appendix 9-4. This suggests a clear breach of the conditions of

McCaffrey's Air Pollution Licence. Section 8.1 of the Licence required McCaffreys to submit the dust deposition results to Donegal County Council on a monthly basis.

A condition of McCaffrey's Air Pollution Licence is a dust deposition limit of  $180\text{mg/m}^2/\text{day}$  (condition 8.2 of the Licence). Any analysis of McCaffrey's compliance with environmental standards should be performed in the context of this licence condition. However, the analysis presented in the rEIAR uses a higher value of  $350\text{mg/m}^2/\text{day}$ , a strange approach. An analysis of the raw data presented in Appendix 9-4 of the rEIAR reveals that the quarry exceeded the daily dust deposition limit set out in its licence in approximately 13.75% of the monthly averaged readings. The percentage exceeding the limit set in the Air Pollution Licence for each Berghoff measuring location is given in Table 1.

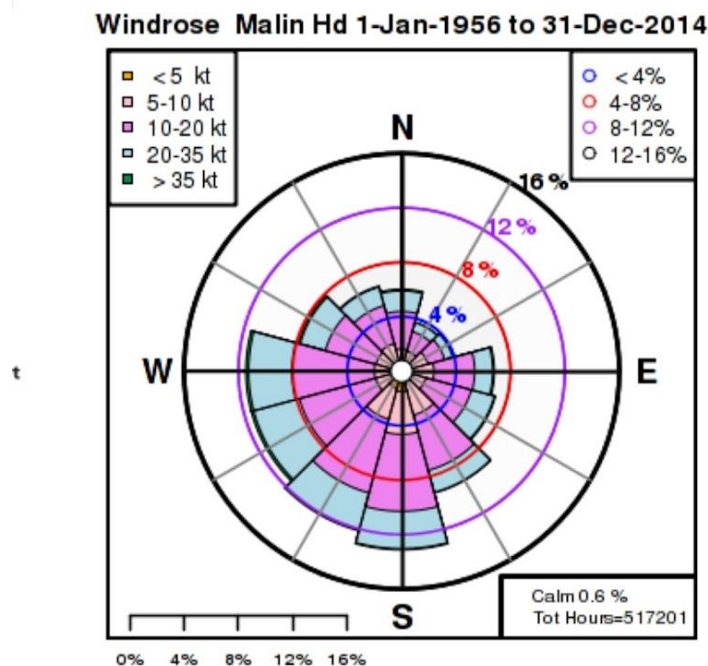
Figure 17: Windrose for Malin Head (Co. Donegal) – Met Eireann

The analysis presented in the rEIAR on this suspect dataset suffers the further handicap of being conducted using Windrose data that is not representative of actual wind patterns in Donegal. The Windrose presented for Finner in Co. Donegal (Figure 9-4 in the rEIAR) not representative as it shows that the prevailing winds are from the SE.

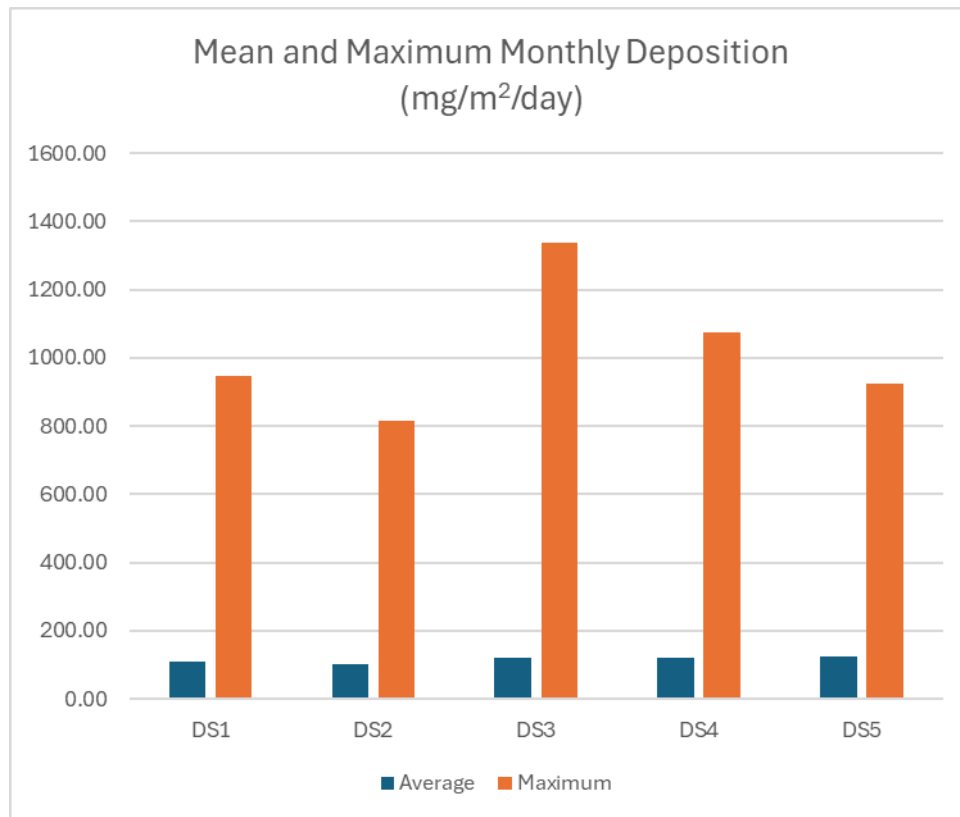
Figure 18: Average and maximum dust deposition rates at sensors (averaged monthly)

However, the analysis in Table 1 raises fundamental questions concerning the validity and veracity of the data presented in Appendix 9-4 of the rEIAR. An examination of this summary data, taking into account the topography of the site, the prevailing wind direction, location of quarry operations, results in the KT Cullen report and the Inspector's comments, would expect to reveal much higher levels of dust deposition at for example DS5 than at DS4 (D5 and D4 in the applicant's rEIAR as reproduced in Figure 16). DS5 is located close to the rock breaker and screening machinery and to lots of internal quarry traffic, all of which generate copious amounts of dust. On the other hand, DS4 is located relatively far from the main dust generating quarry activities and is sited on an elevated plateau well above the south quarry, north west from the main quarry activities. The prevailing wind direction here is from the quadrant between South and West as shown in the Met Eireann's windrose for Malin Head (Figure 17), so dust would rarely blow in the direction of DS4. I would expect the dust deposition readings for DS5 to a multiple of, perhaps an order of magnitude greater than, the readings for DS4. Yet, McCaffrey's data shows them to be almost identical. The only conclusion that can be drawn is that McCaffrey's dust deposition data cannot be relied upon. The dust data submitted in the rEIAR lacks validity and credibility.

Figure 18 plots the average and maximum deposition rates presented in Table 1. It should be noted that the maximum daily deposition values do not stand up to any objective analysis either. It is just not credible that DS4 would record a higher maximum value than DS5. The data submitted by the applicant in Appendix 9-4 is simply not credible.

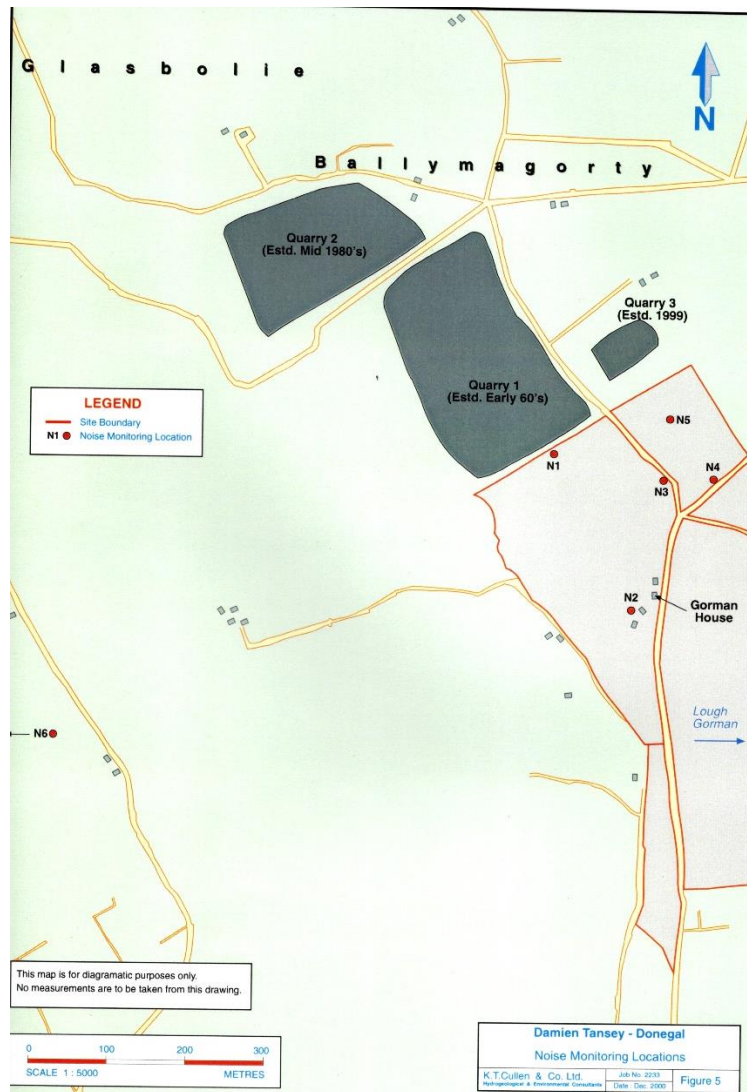
Figure 19: KT Cullen Noise measurement locations

Table 11-10 in the rEIAR provides an incomplete statement of noise sources as it has omitted sources such as the main fixed impact breaker which is on an elevated site, and the heavy traffic into and out of the site to/from the N15. KT Cullen & Co Ltd, in their report on planning, environmental compliance and general nuisance associated with the quarry, found that in the year 2000, the noise levels at the site boundary (N1) were 75.1 dB(A), see Figure 19 (and Appendix 2.3). They recommended that, to comply with EPA guidance, noise levels at the site boundary should be reduced to 55dB(a) by daytime (0800 to 2200) and 45dB(a) at night (2200 to 0800). McCaffrey's Air Pollution Licence has a condition (9.2) limiting noise at the site boundary to 55 dB(A) daytime and 45 dB(A) at night-time, the same as recommended by KT Cullen.

On 21<sup>st</sup> August 2025, using a smartphone app, I made a series of noise measurements near the site boundary at N1 (see Figure 19 above for location). Weather conditions were dry, overcast and calm. The readings revealed average noise readings ranging from 63dB(A) to 71 dB(A) during the measurement period, with peak reading of 86 dB(A), as shown in Figure 20.

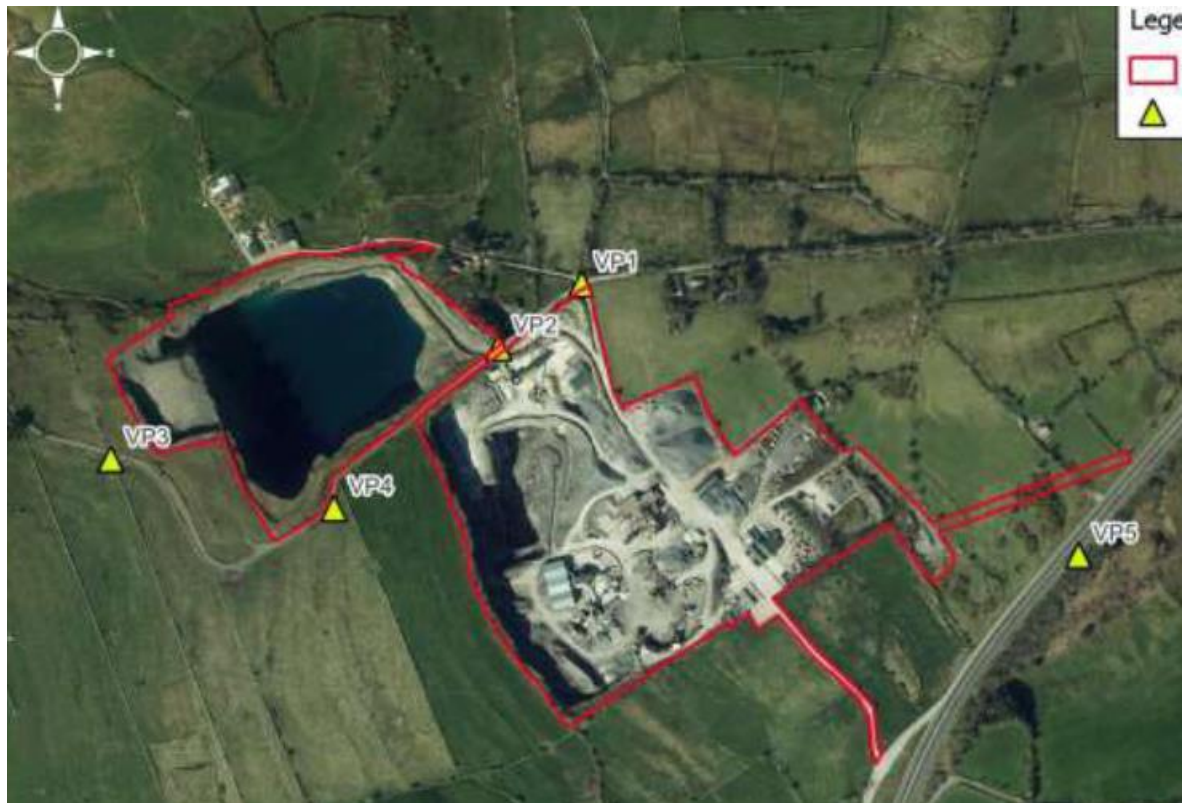
Figure 22: Viewpoints given in Figure 12-10 of the rEIAR

The pictures in the applicant's rEIAR present a very partial and false impression of what are in reality beautiful panoramic views and landscapes in this locality. The picture below in Figure 21 was taken from a point on the L7265 between VP3 and VP4. The locations identified the VP points are taken from in Figure 12-10 of the rEIAR and reproduces below in Figure 22.

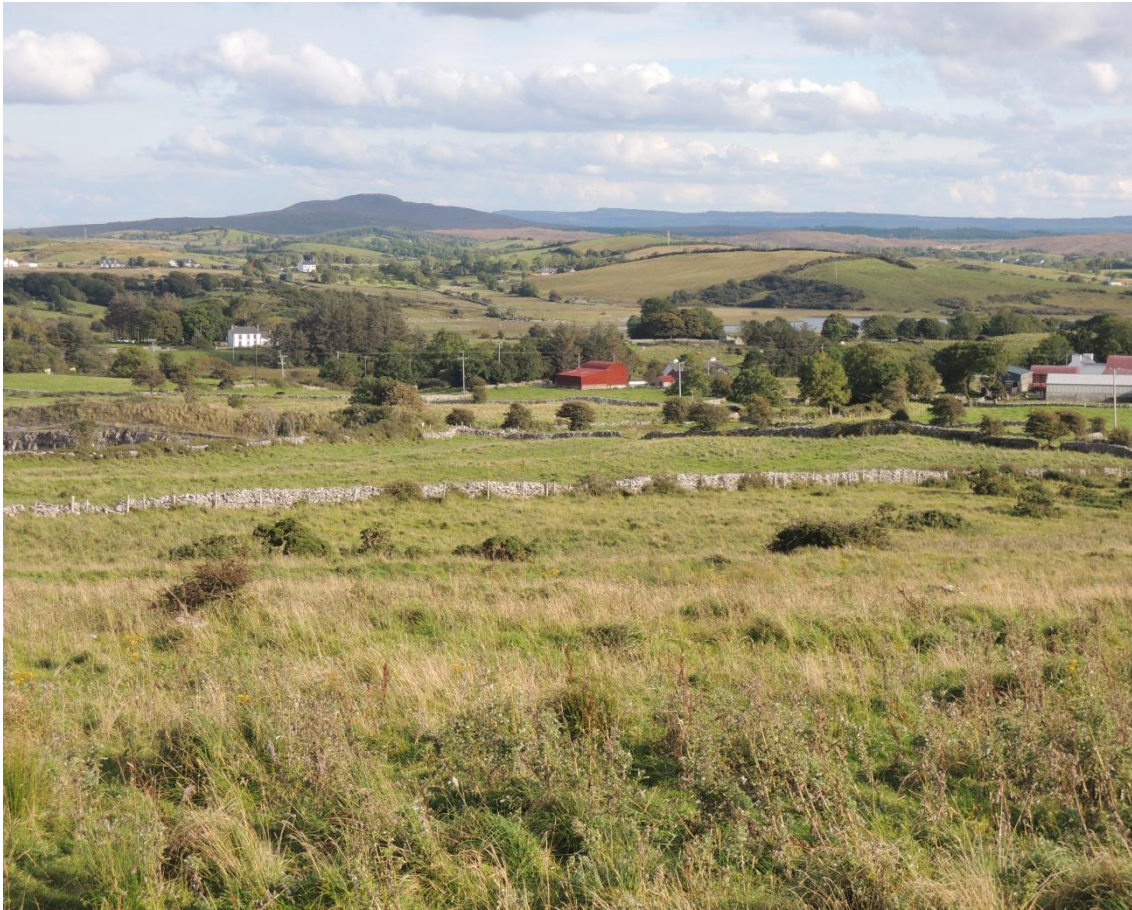
Figure 23: Looking east from VP4

The views from VP4 looking east offer panoramic views Breesy Hill with the Fermanagh plateau on the horizon. Sadly, if the viewer turns a few degrees to the left they are confronted by the unsightly south quarry, as can be understood in the Figures 23 and 24.

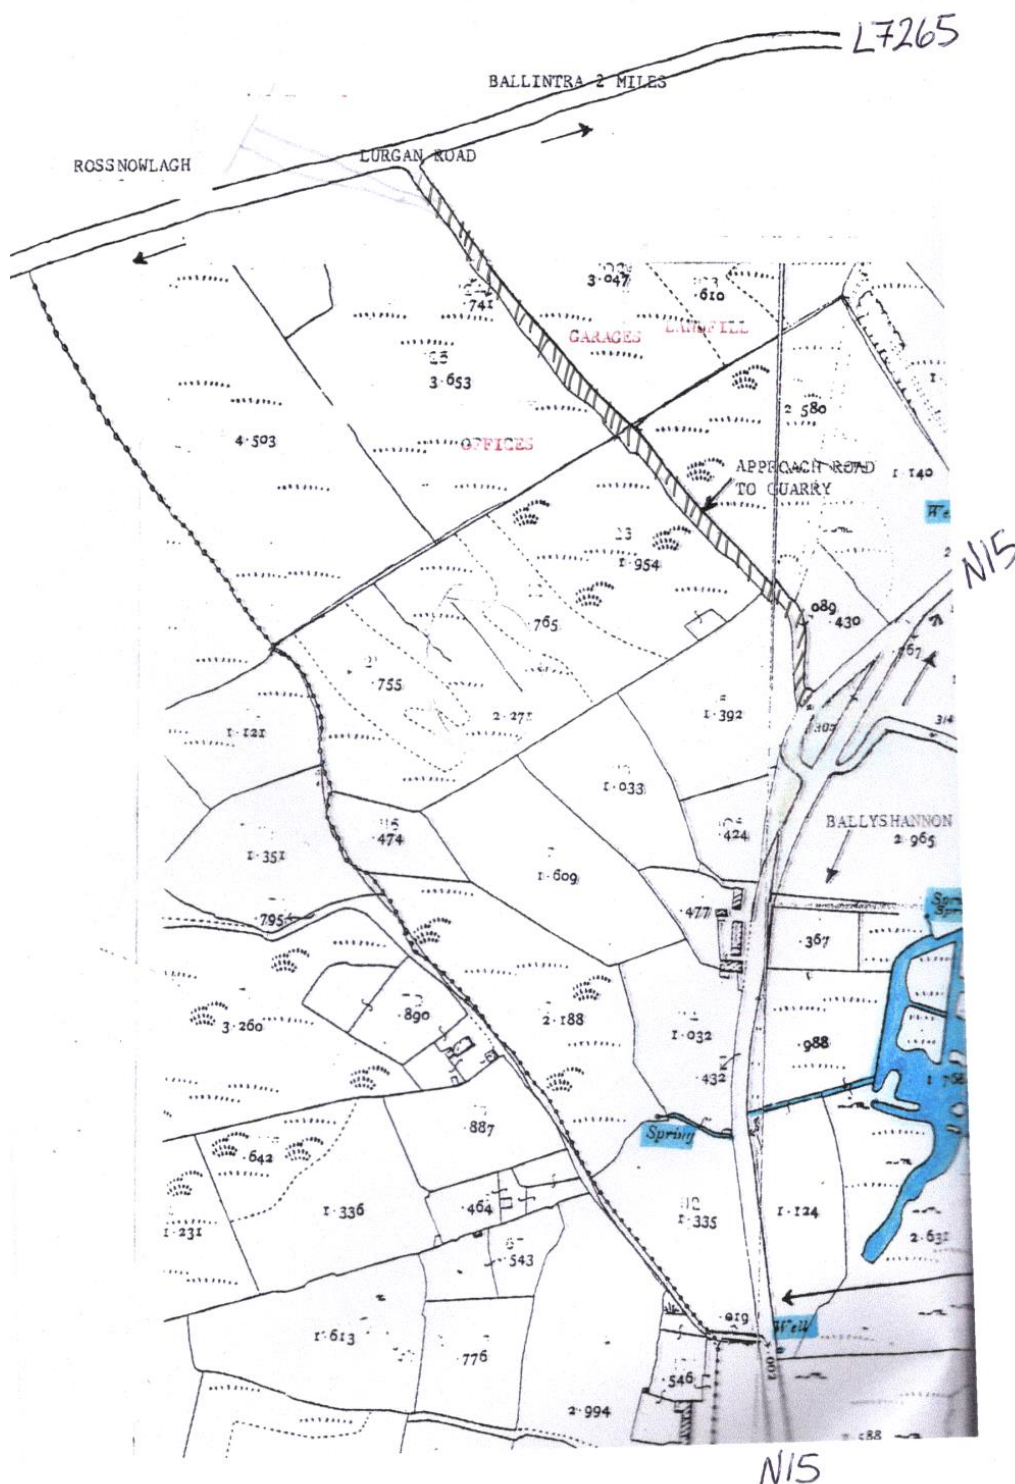
The rEIAR does not address the issue of the public access road through the south quarry. This road has essentially been commandeered by P McCaffrey & Sons Ltd as an internal quarry road between the quarry and the storage and machinery yards on the opposite side of the road. The road is used by pedestrians, cyclists and local traffic that have to negotiate loading shovels, dumpers and trucks driving and reversing on and across the road. The road is not properly demarcated, is covered in muck and dirt from the quarry and is a traffic hazard.

In Section 3.2.7 of the rEIAR, this road is described as a 'private road'. This is repeated in Figure 3-4 of the rEIAR and elsewhere in the application. This description completely misrepresents the actual situation. This is not a private quarry road but a publicly accessible road that runs from the N15 to the L7265. It is shown hatched in the map in Figure 31. The applicant has failed repeatedly in their application to show in their maps and diagrams that this road runs right through the south quarry.

Figure 31: Publicly accessible road through quarry from N15 to L7265 shown hatched

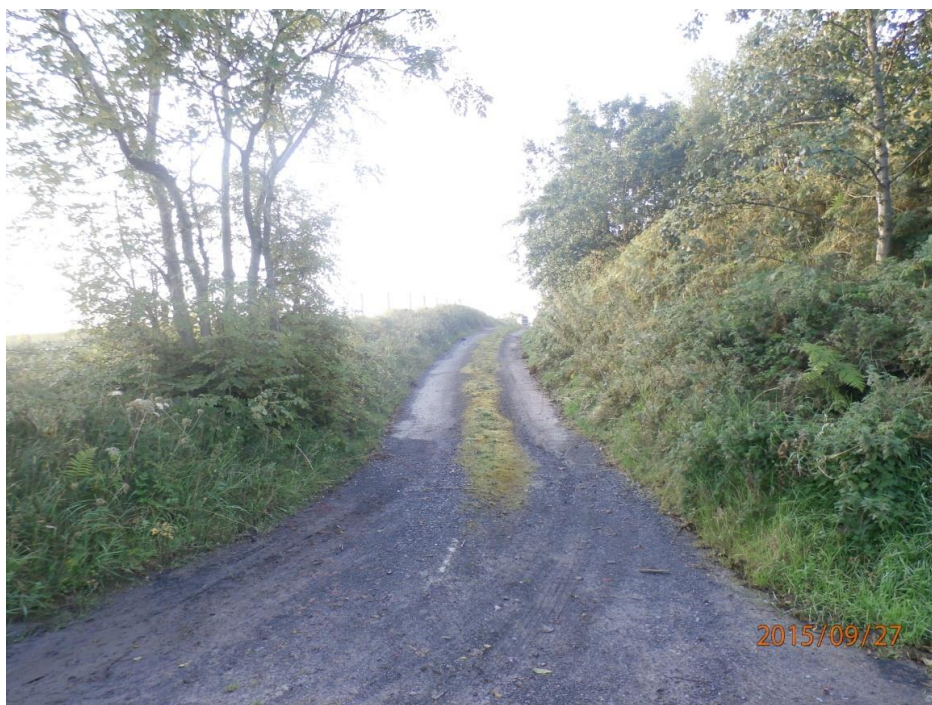
Traffic to and from the quarry has pushed back my drystone walls along the length of the road. This traffic is composed mainly of quarry vehicles. The quarry operator has raised the height of the access road by approximately 600mm. This has widened the road and put additional weight against the drystone walls, which are subject to collapse (Figures 32, 33 and 34). This is particularly hazardous as the lands are adjoining the heavily trafficked N15 and any farm animals that escape pose a serious traffic hazard. The road is substandard in width and design for such heavy traffic. Lorries going to and from the quarry have been increasing in size and loading tonnage over the years. The road was originally a narrow rural road similar to the other end of the road where it joins the L7265, as shown in Figure 35.

Figure 35: Northern section of access road through quarry at junction with L7265.  
This section of road is not subject to quarry traffic and shows  
the character and width of the original road

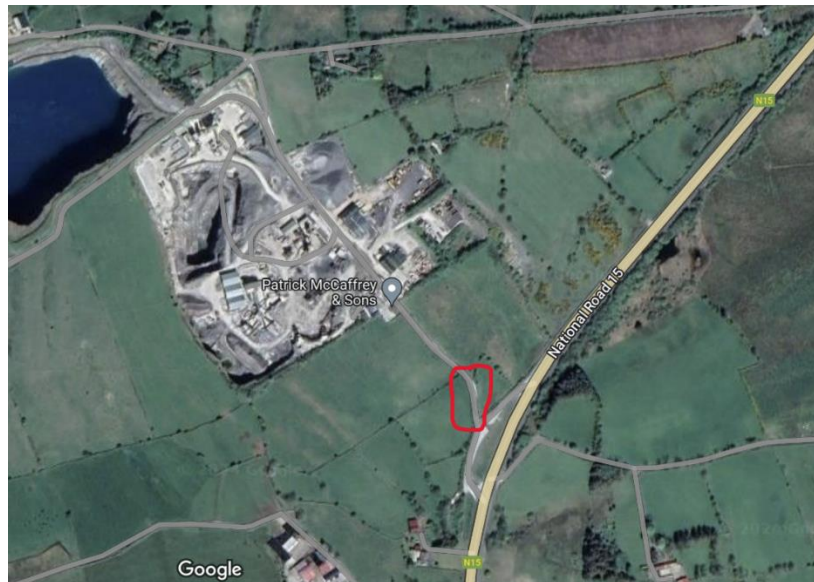
This road-widening was inflicted on my property and resulted in serious and significant damage (please refer to Google map for exact location in Figure 36). It was carried out without my permission or knowledge. It demonstrates the utter contempt with which McCaffrey's Quarry treats local residents and how they make life very difficult and stressful here.

This work was carried out over a distance of almost 80m on the road, resulting in a 140m of damage to my roadside boundaries on both sides. I own the lands on both sides of the road. The demolition of my roadside boundary hedges, drystone wall and barbed wire fences was according the quarry contracts manager aimed at widening the road and creating a road wide enough for two vehicles to pass at the bend. My drystone walls were demolished by pushing them back with a digger and collapsing then into my fields. They filled any gap created along the length of the destruction with road-filling materials to act as a foundation for the road-widening. In

Figure 36: Aerial view showing the stretch of the road (identified in red) where McCaffreys undertook work to widen the road in 2024 and caused serious damage to my property
