*Structural Report and Construction/Augmentation Management Plan
at
Emlaghmore, Ballyconneely, Co. Galway.*

Client	Mr. Patrick Ridge
Project Number	1475.100
Project Title	Structural Report and Construction/Augmentation Management Plan
Location	Emlaghmore, Ballyconneely, Co. Galway.
Date of Inspection	13th of March 2020.
Weather Conditions	Cold and Dry

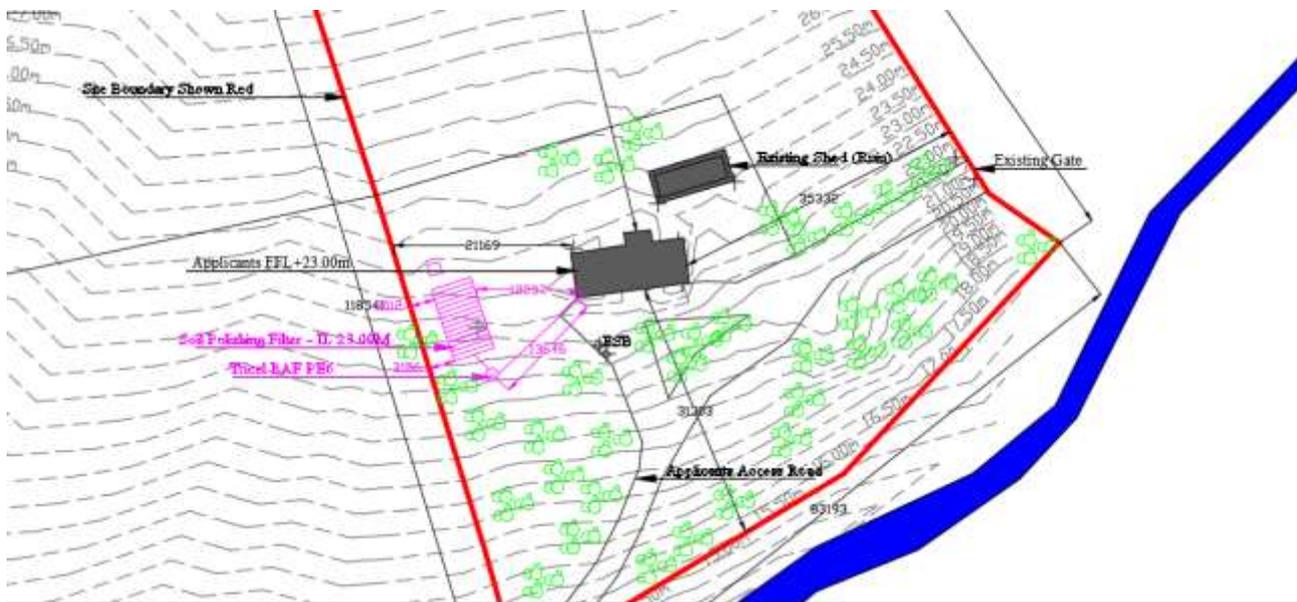
Fig 1.8. – Site Layout Detail

The surface water generated will be collected in the galleys and diverted into the proposed soakaway area as noted on the site layout plan.
