## Chapter 9

### The geotechnical reports

#### 9.1 Digest of Galway County Council report

## WINDFARMS AND BLANKET PEAT

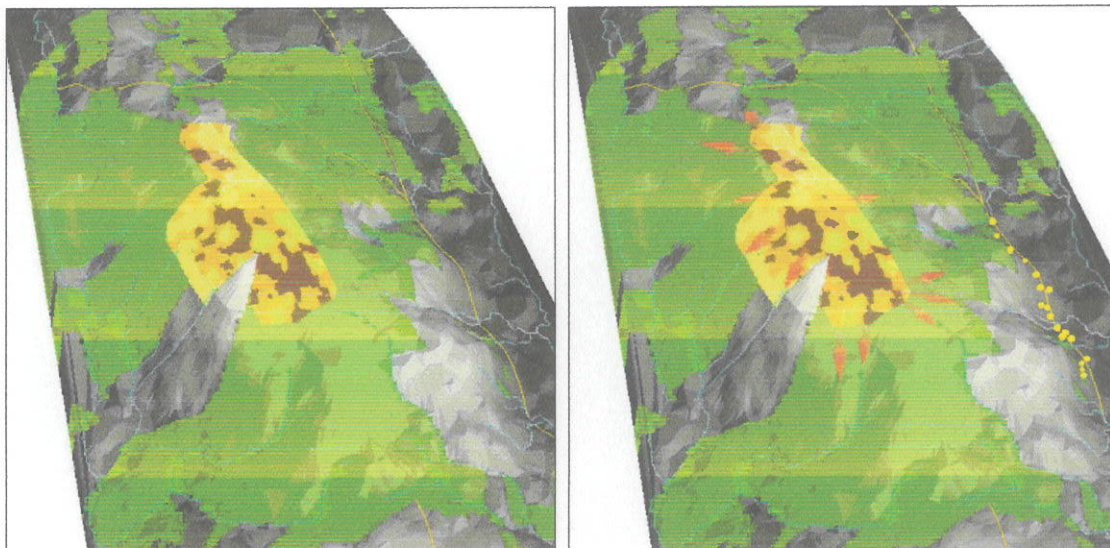
**Figure 10.2a, above left:** Three-dimensional view of the Cashlaundrumlahan summit from the WNW. It shows showing the extent of forestry (green shading), stream-courses (blue), roads (brown) and the depth of peat in the wind farm

**Figure 10.2b, above right:** As 10.2a but with arrows indicating potential 'avalanche corridors' and dots representing the main buildings in the landscape.

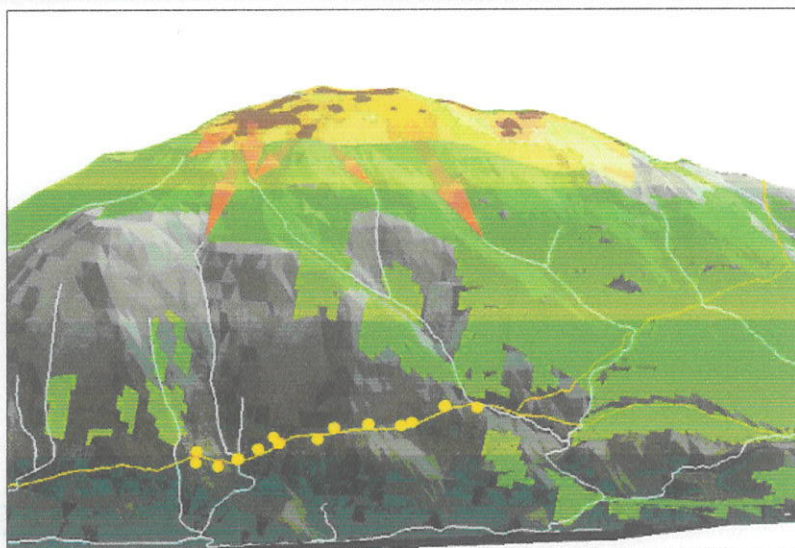
**Figure 10.2:c** As b but viewed from the SSW,

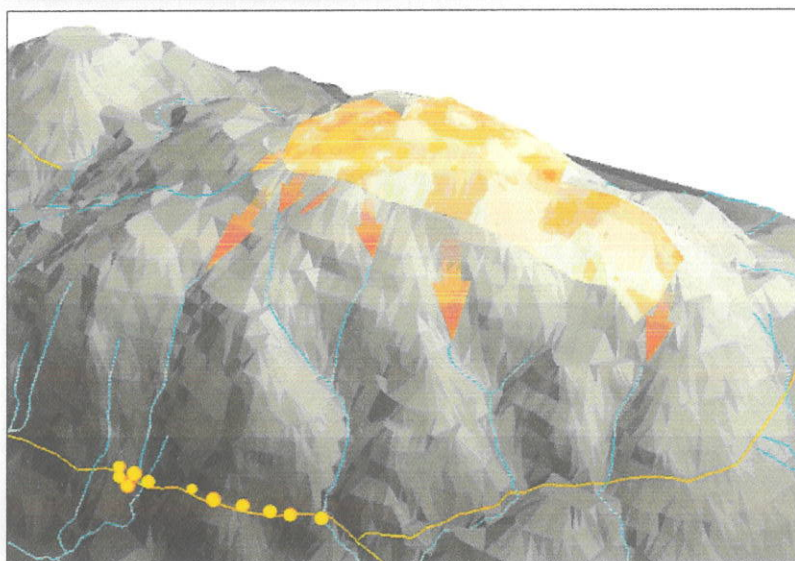
**Figure 10.2d:** As b but viewed from the SSE and without the forestry cover.

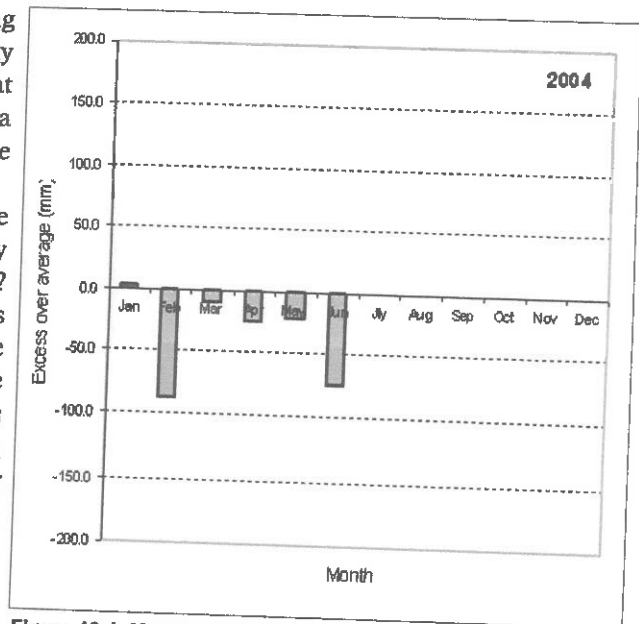
The record since the slide also exhibits an unexpected and perhaps significant pattern. Fig 10.4 shows, for 2004, the difference from the 14-year mean monthly rainfall while fig 10.5 shows the 12-

Figure 10.4: Monthly rainfall data for Derrybrien, 2004. Each bar indicates the deviation of the month's rainfall total from the appropriate 14-year monthly mean.

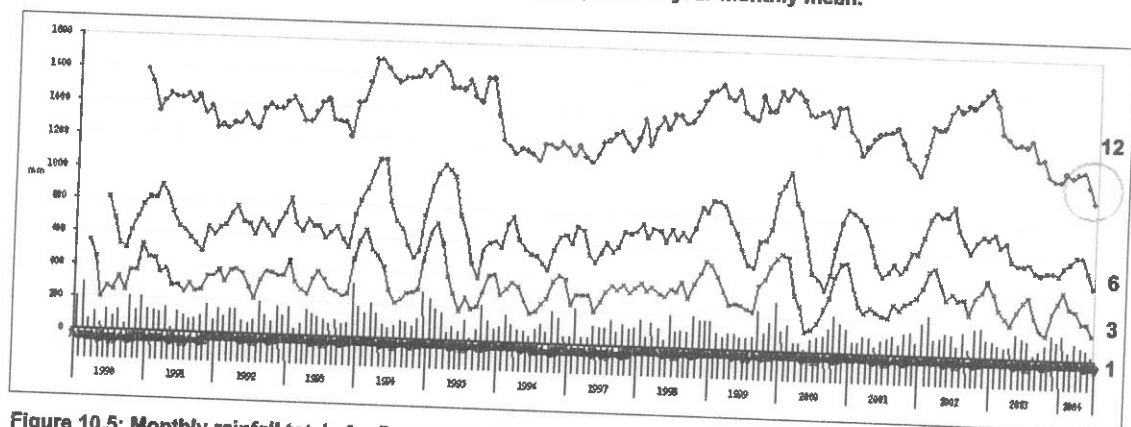
month, 6-month and 3-month moving averages of cumulative total monthly rainfall. They show that the rainfall at Derrybrien has reached new lows for a more extended period than at any time previously.

Figure 10.5: Monthly rainfall totals for Derrybrien, January 1990 to June 2004. The vertical bars at the bottom of the diagram (labelled 1) indicate monthly rainfall totals and the continuous lines indicate the accumulated rainfall for the three, six and twelve months preceding the last day of each month. The moving 12-month rainfall total for 2004 (circled in red) is the lowest in data series at 952mm.

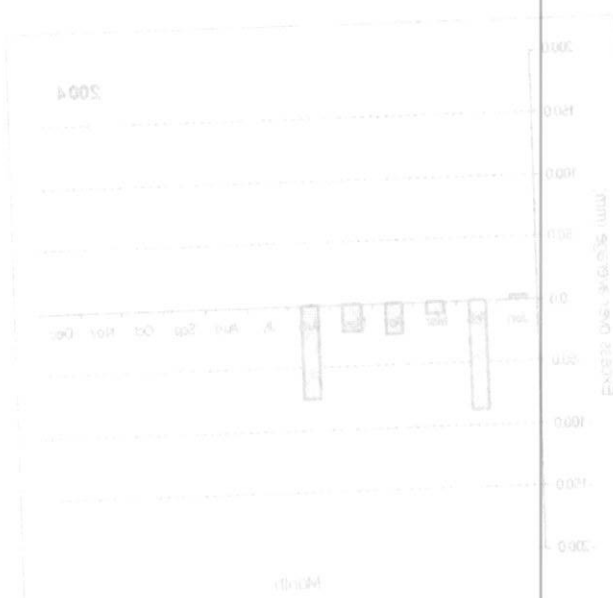
Figure 10.4: Monthly rainfall data for Derryphen, 2004. Each bar indicates the deviation of the month's rainfall total from the appropriate 14-year monthly mean.

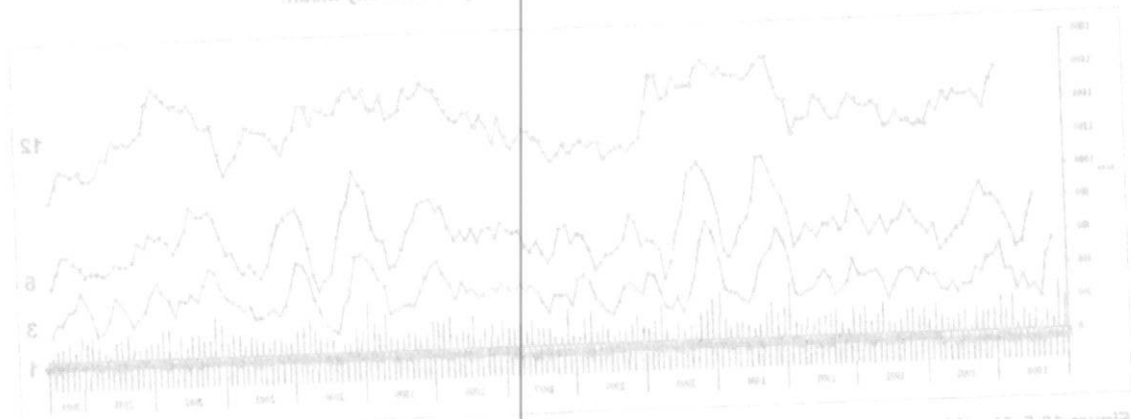
Figure 10.5: Monthly rainfall totals for Derryphen, January 1990 to June 2004. The vertical bars at the bottom of the diagram (labelled 1) indicate monthly rainfall totals and the continuous lines indicate the accumulated rainfall for the three, six and twelve months preceding the last day of each month. The moving 12-month rainfall total for 2004 (circled in red) is the lowest in data series at 925mm.

month, 6-month and 12-month moving averages of cumulative total monthly rainfall. They show that the rainfall at Derryphen has reached new lows for a more extended period than at any time previously.

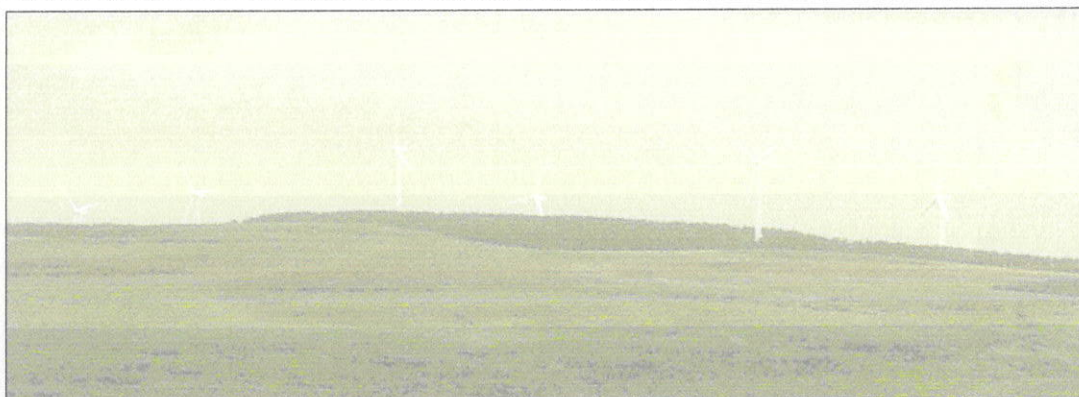
Plate 10.3a, above: The recently-erected 9-turbine wind farm at Sonnagh Old, four km to the north of the Derrybrien scheme from which this photograph was taken.
