Summary Presentation on the Proposed MetroLink Route and its Potential Effect on AerCap House

Hines Real Estate Submission

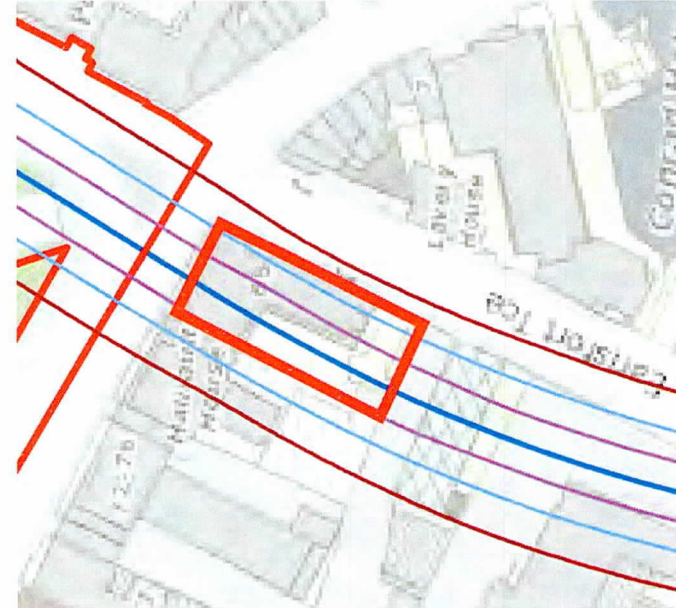
Based on the overlay, it is clear that the substructure to the basement is located at the top of the exclusion zone as presented DOC ML1-JAI-GEO-ROUT XX-RP-Y-00034.

Section 2.4 Damage to AerCap Substructure in the Exclusion Zone

We understand that AerCap House could not have been developed in its current form had the Metrolink Tunnel been previously constructed, as there are substructure elements required to extend into the exclusion zone, which could cause damage to the Metrolink Tunnel.
