**Re: Project Metrolink - Phase IIa Building Damage Assessment for Cadenza Building on Earlsfort Terrace**

**Ref: 24-115-TN001 (Rev.1)**

This technical note presents the results of the Phase 2a assessment of building damage that could occur due to tunnelling-induced ground movements during the construction of the Metrolink Tunnel under the Irish Life Cadenza Building on Earlsfort Terrace in Dublin City Centre.

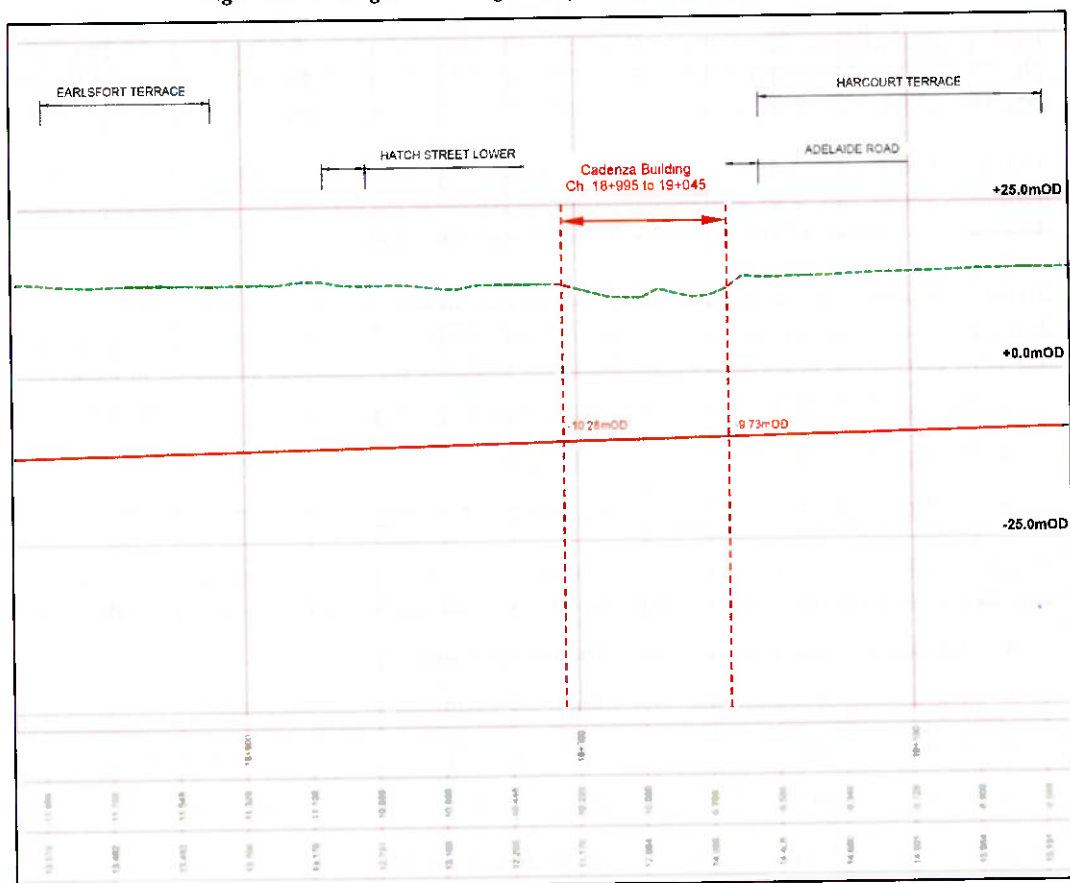
Figure 3-2 Design tunnel profile (top of rail level) from RO Long-Section Drawings

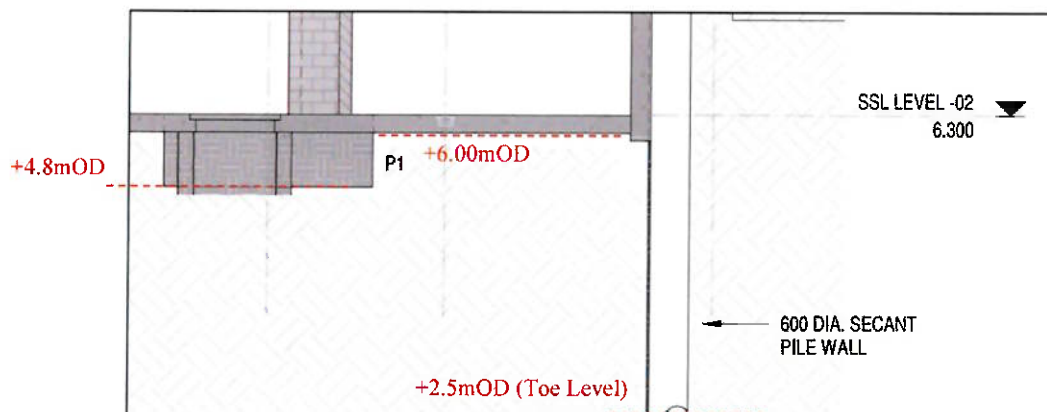
- The foundation is a 3.5m x 3.5m x 1.2m deep Grade C40/50 reinforced concrete pad that has been constructed as a thickened integral section of the 300mm thick basement floor slab;
- Formation level for the floor slab is at +6.00mOD.
- Formation level for the pad foundation is 1.2m lower at +4.80mOD.
- The pad foundations are supporting the internal concrete frame for the building, which has spans up to 15.0m with post-tensioned concrete floor slabs.
- The foundations have been designed to be supported on rock at an allowable bearing pressure up to 1,000 kPa.

Figure 3-6 Profile of basement floor slab, 1.2m deep P1 pad foundations and 640mm diameter perimeter secant pile wall

Figure 3-3 identifies a typical pad foundation for the interior columns over the tunnel alignment. A profile of the foundation and basement floor slab is shown in Figure 3-6.

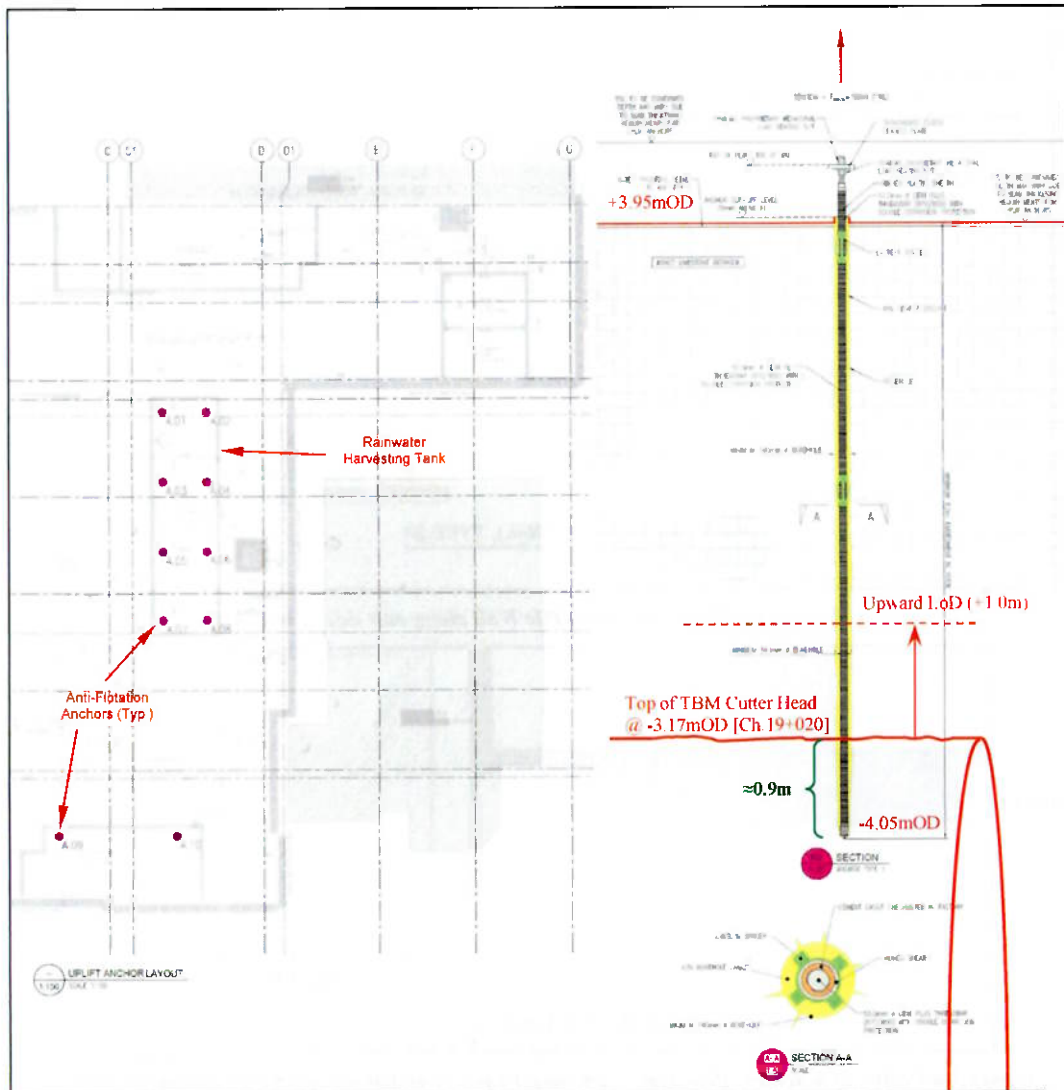
- The anchors are comprised of 8.0m long 50mm diameter GEWI Plus Dywidag Steel Threadbars with double-corrosion protection grouted into a 140mm diameter drillhole.
- Formation level for the rainwater harvesting tank is at +3.95mOD. The anchors extend 8.0m below this level to a toe level of -4.05mOD.
- This is 0.9m below the crown of the TBM tunnel bore at this location (Ch. 19+020), as illustrated on Figure 3-7, which means that the TBM will hit the end of the anchors at the design profile and by up to 1.9m at the upward Limit of Deviation.
- The anchors have been designed for a characteristic (unfactored) uplift force of 750kN.

Figure 3-7 Profile of anti-flotation anchors for rainwater harvesting tank

Details of the anti-flotation anchors are shown on Figure 3-7.

Significantly, as discussed in Section 3.0 and illustrated in Figure 3-7, at the design tunnel alignment the TBM cutter head will hit the bottom 0.9m of the anti-flotation anchors for the rainwater retention tank in the basement and this will increase to 1.9m if the tunnel is raised by 1.0m to the upper limit of the LoD.

The anti-flotation anchors under the rainwater harvesting tank could be avoided by moving the horizontal alignment of the tunnel 15.0m to the west. However, are additional anti-flotation anchors for another tank in the basement at the south end of the building that could be impacted, as shown on Figure 3-7. This would also adversely impact the façade and entrance lobby on the west side of the building, as discussed.

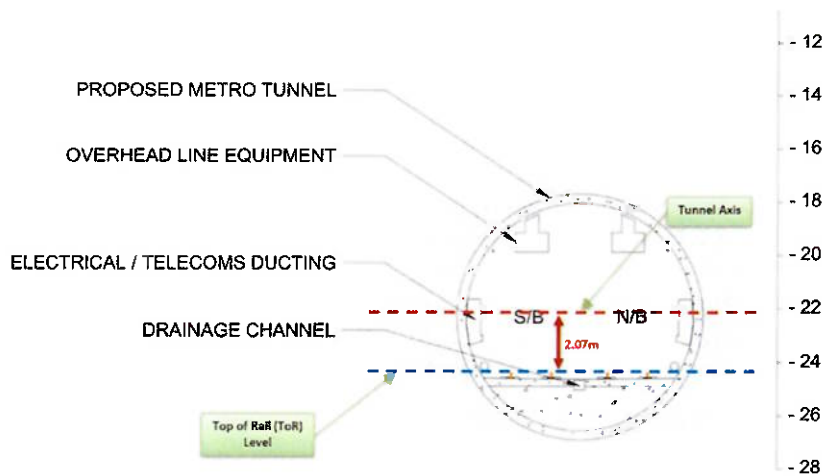
- Tunnel Diameter – Internal = 8.50m
- Tunnel Diameter – External = 9.20m (350mm thick concrete lining segments)
- Diameter of TBM Cutter Head = 9.53m (165mm annular clearance outside segments)
- Height of tunnel axis above Top of Rail (ToR) level = **2.07m**

The calculation of tunnelling settlements for the Building Damage Assessment is based on the **9.53m** outer diameter of the TBM cutter head.

*Figure 3-8 – Typical profile of the tunnel*

Figure 3-8 shows a typical profile of the tunnel. The following is a summary of relevant information on the tunnel geometry from Section 2.1 of the BDR (copy in Appendix A):

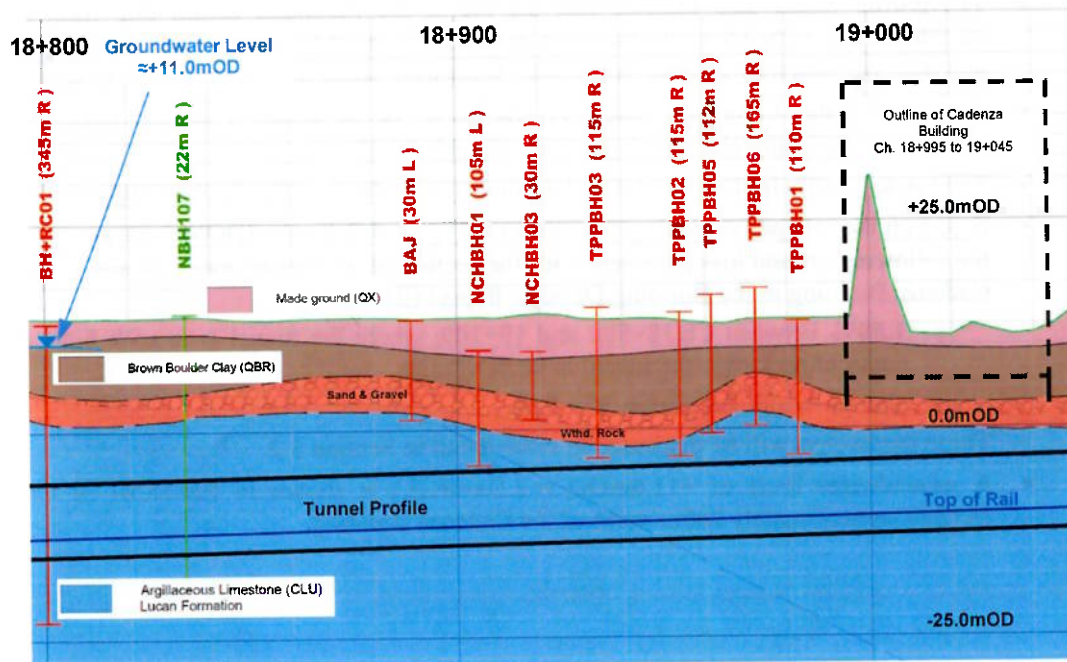
- The interpreted geological section in Figure 4-2 would indicate that the subgrade for the basement floor slab at +6.00mOD is in the glacial till deposits of Boulder Clay.

Figure 4-2 Geological Cross-Section [Sheet 26 of 28 from Appendix A20.9 to Chapter 20 of the EIAR]

The corresponding interpreted geological cross-section at this location from Appendix A20.9 of the EIAR is shown in Figure 4-2. The outline of the Cadenza Building, basement and perimeter secant pile wall has been added to the profile over the tunnel.

- None of these boreholes are identified on the geological cross section in Figure 4-2.
- None of the logs for the investigation points shown on the location plans or geological sections were included in the EIAR so it is not possible to verify the ground conditions interpreted by Jacobs/IDOM.

The site investigation carried out on the site of the Cadenza Building in 2018 indicates that the top of rock is at a higher level than shown on the geological cross section produced by Jacobs/IDOM for the EIAR (Figure 4-2) i.e.:

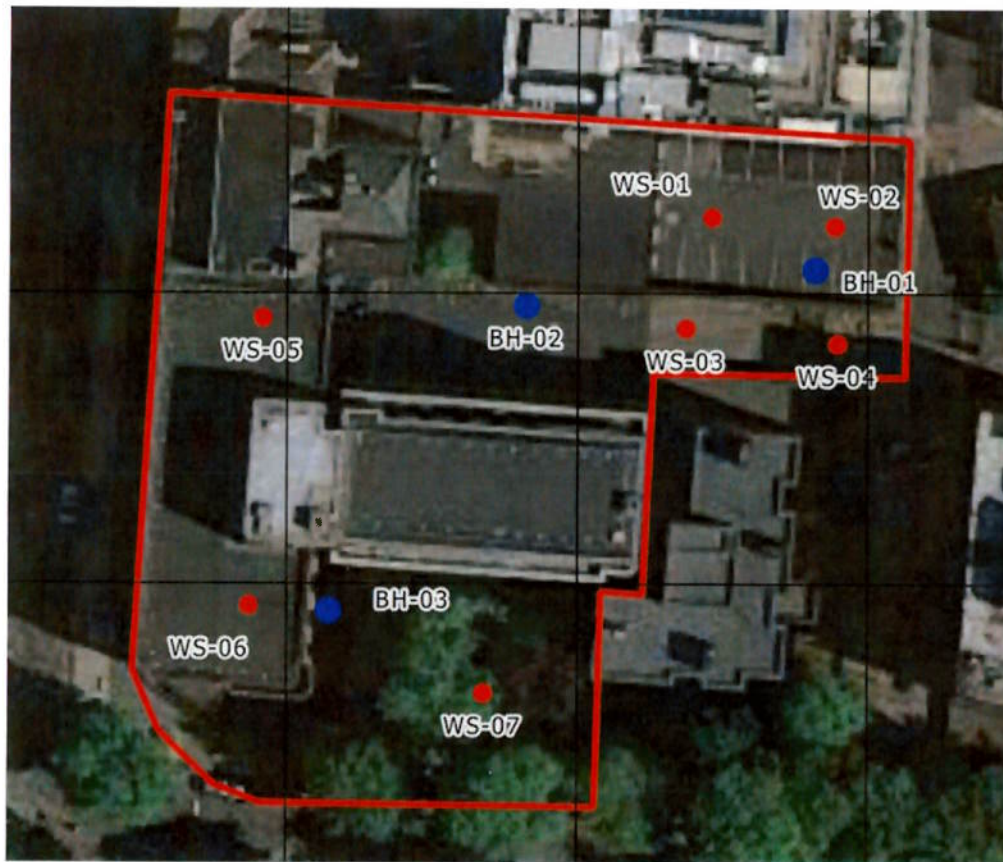
The coreholes were terminated in competent rock at levels between +1.5mOD and +2.7mOD, which is below the basement floor slab (+4.8mOD) and generally below the toe level for the perimeter secant pile wall (+2.50mOD). However, they did not reach the design level of the tunnel, which is below -3.0 to -3.5mOD.

The highest groundwater level recorded in the piezometers ranged from +7.75mOD to +8.40mOD, which is 1.75-2.4m above subgrade level for the basement floor slab.

*Figure 4-3 SI Location plan for 2018 Ground Investigation for Urban Solutions*

Figure 4-3 shows the location plan for the site investigation that was carried out at the site of the Cadenza Building in 2018 for Urban Solutions. The investigation was comprised of 3 No. rotary coreholes (BH-1 to BH-3) at the locations shown on Figure 4-3. Copies of the logs are included in Appendix B.

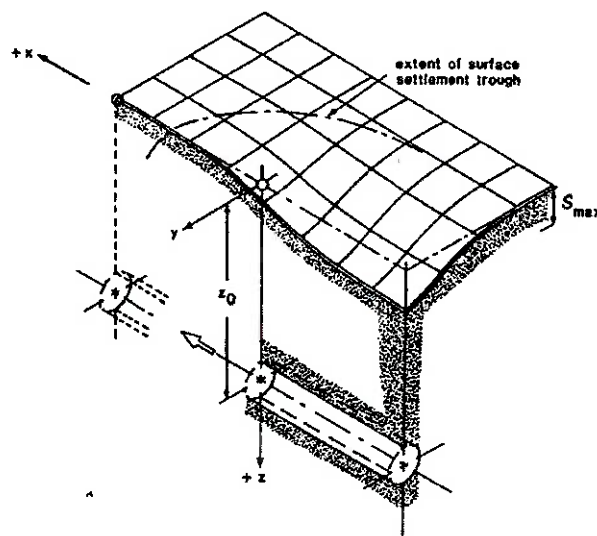
Figure 5-1 Profile of settlements over an advancing tunnel (Mair et al, 1996)

As described in Section 4.2.2 of the BDR, the shape of the settlement trough above the tunnel has been assumed to follow a Gaussian distribution curve centred over the centreline of the tunnel, as illustrated in Figure 5-1 and Figure 5-2.

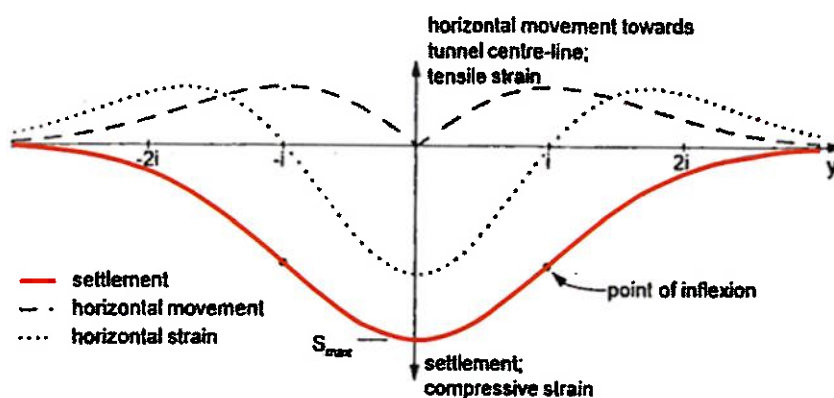
Figure 5-2 Profile of vertical and horizontal movements over the tunnel centreline and the corresponding horizontal strains (Figure 4-3 of the BDR in Appendix 5.17 of the EIAR)

Figure 5-2 shows a typical profile of horizontal movement across the settlement trough. The resultant vectors of ground movement are directed towards the tunnel axis. The calculations for each analysis case are presented in Appendix C.

Figure 5-2 shows a typical profile of horizontal ground strains across the settlement trough. The calculations for each analysis case are presented in Appendix C.

The tunnel passes under the eastern façade at an acute angle of about 15 degrees. This will have the effect of “stretching out” the transverse settlement trough shown in Figure 5-2 so that, although the maximum settlement over the centreline of the tunnel will be the same, the slope of the trough will be flatter along the line of the secant pile wall. For this assessment we have conservatively assumed that the transverse profile will apply.

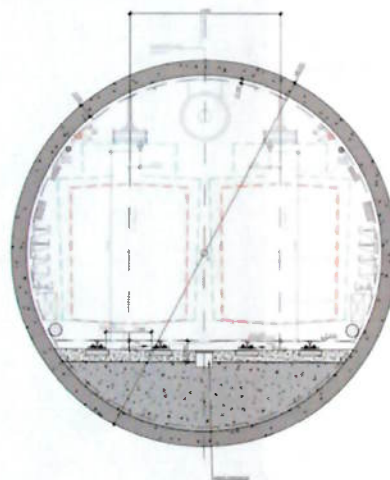
- Typology: Universal ring.
- Thickness: 35 cm.
- Concrete class: C40/50
- Reinforcement: Steel bars class C + steel fibres (Model Code FRC 4e)
- Fire protection: Polypropylene fibres

Figure 2-1: TBM Tunnel Geometry

The MetroLink tunnel alignment will consist of a single bore bi-directional tunnel constructed by means of a tunnel boring machine (TBM) that will be specified and designed to enable tunnelling generated ground movements to be minimised. The tunnels have been designed with an internal diameter of 8.5m, determined by the rolling stock kinematic clearance, and railway services requirement (See Figure 2-1).

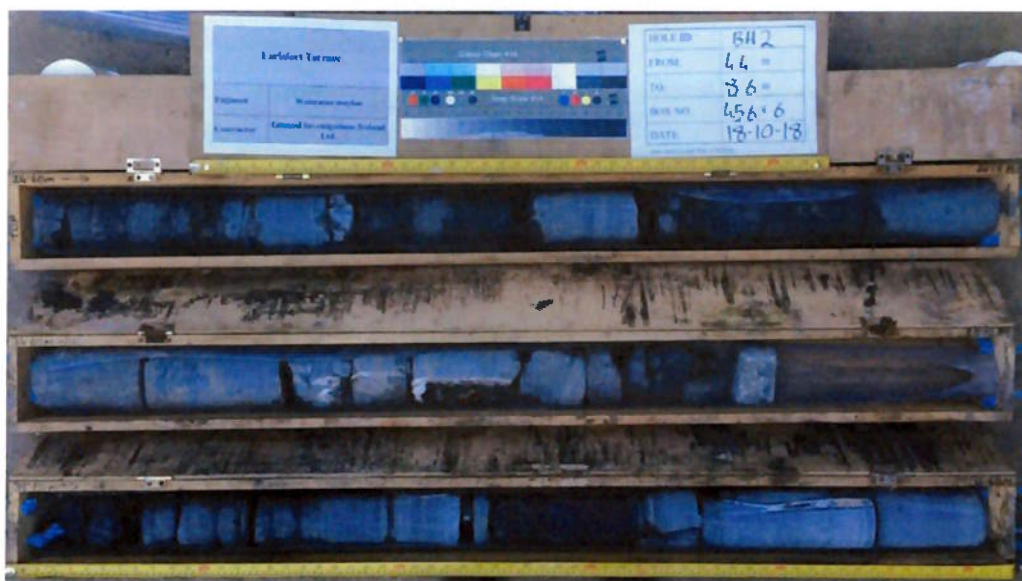
BH02 4.40m – 8.60m (Box 4,5,6)

The photograph displays four long, narrow metal plates arranged vertically. The top plate features a blue label with the following information:  
**Exhibit Form**  
Engineer: W. J. [illegible]  
Contractor: General Investigation Fund Ltd.  
Roll No: BH3  
From: 00  
To: 45  
Batch No: 123-6  
Date: 10-10-18  
A color calibration chart and a yellow measuring tape are positioned above the plates.
