MetroLink - Module 1

Witness Statement by [Brian Kavanagh of GARLAND] on Behalf of Charlemont & Dartmouth Community Group in relation to [Building Settlement]

This statement relates to building settlement and principally concerns impacts upon Dartmouth Road properties 26-28 and 32-35 and Dartmouth Square West nos. 1, 3, 5, 7, 9, 10, 11, 12, 13, 14, 15, 16.

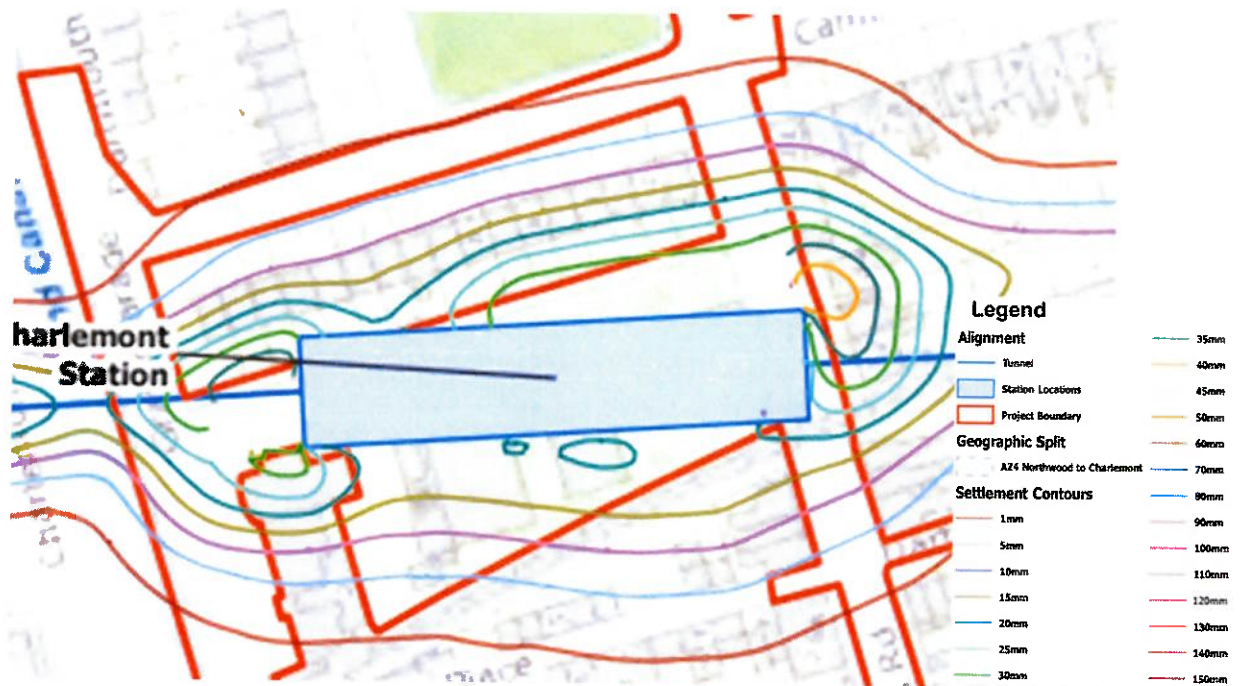
(Extract from Drawing ML1-JAI-EIA-ROUT_XX-DR-Y-21147)

We refer to the revised predicted settlements reproduced below.

35mm Rear of Dartmouth Road

A review of the EIAR and associated appendices, it is evident that a very limited assessment of settlement and subsidence has been carried out. It can be seen from the above diagram that the houses directly over the tunnels on Dartmouth Road fall within the 35mm to 45mm settlement zone. This is defined as “slight” risk category. We would query this classification as “slight”. However, given that all but one of the buildings covered by this submission are protected structures, they should be classed as damage category risk 3 (moderate) or 4 (severe). We will discuss this later.

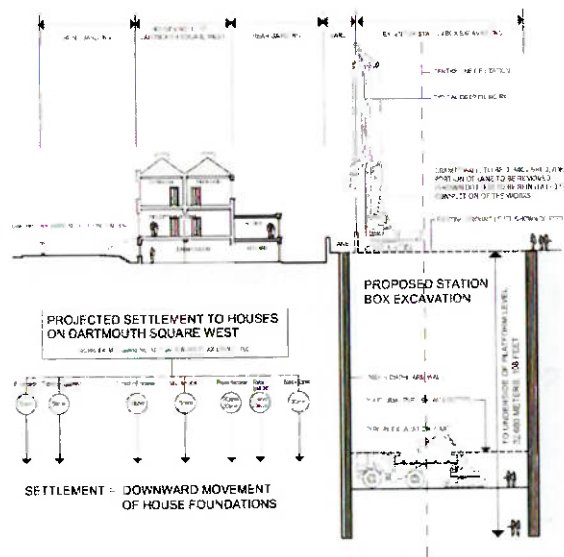
DEEP EXCAVATION, PROJECTED SETTLEMENT TO HOUSES AT DARTMOUTH SQUARE WEST

SETTLEMENT OF 30mm PROJECTED FOR HOUSES AT DARTMOUTH SQUARE WEST

- A. EXTREME DEPTH OF EXCAVATIONS - SETTLEMENT CONCERN
B. PROXIMITY OF CONSTRUCTION PILING RIGS AND PILES - VIBRATION AND SETTLEMENT CONCERNS
C. PROXIMITY OF METRO TUNNEL AND STATION BOX - VIBRATION AND SETTLEMENT CONCERN
D. SEE ALSO ACCOMPANYING COLOURED CONTOUR PLAN PROJECTED SETTLEMENTS

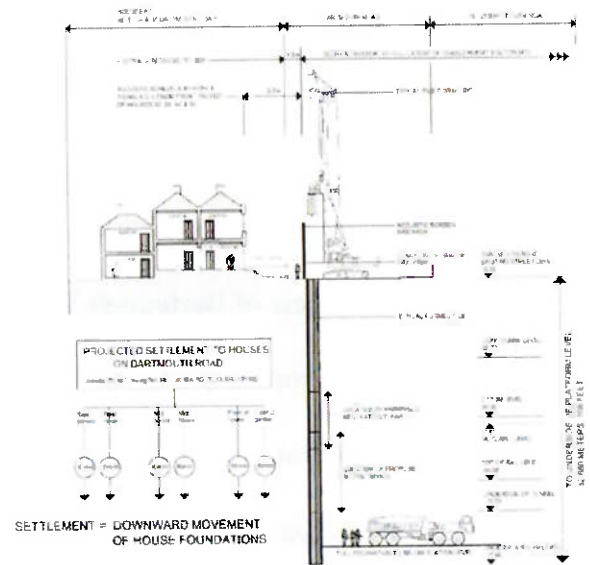
SETTLEMENT OF 45 MT PROJECTED FOR HOUSES 32 TO 35 DARTMOUTH ROAD.

- A. EXTREME DEPTH OF EXCAVATIONS - SETTLEMENT CONCERNS
- B. PROXIMITY OF CONSTRUCTED DRILLING RIG AND PILES - VIBRATION AND SETTLEMENT CONCERNS
- C. PROXIMITY OF RETRO TUNNEL AND VENTILATION TUNNEL - VIBRATION AND SETTLEMENT CONCERNS
- D. REINFORCED FOOTPATH - REDUCED TO 3 IN. FOR 8 YEARS - DARK UNSAFE
- E. FACTORS - HEIGHT OF REARLIFT AND STRENGTHENING OF HIGH FOR 8 YEARS - CURE REPAIRS

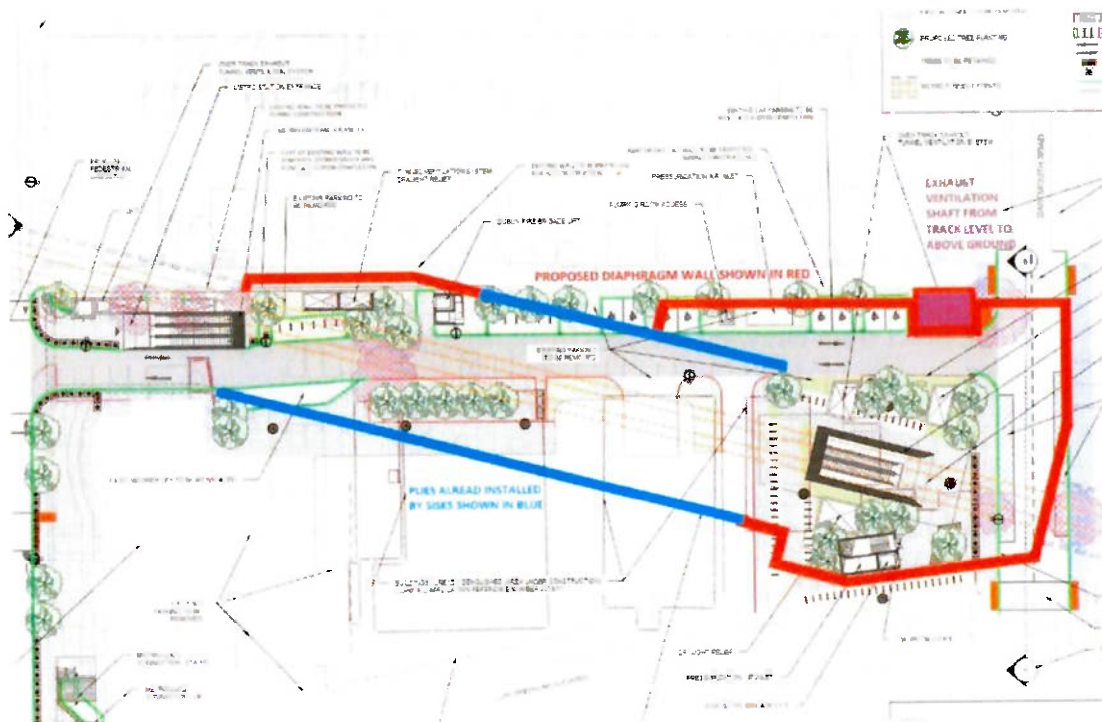
However, these settlements are based on a “rectangular” station box. In fact, the actual extent of the station is considerably more, see extract from drawing below.
