**Our Case Number:** ABP-314724-22

**Re:** Railway (Metrolink - Estuary to Charlemont via Dublin Airport) Order [2022]  
Metrolink. Estuary through Swords, Dublin Airport, Ballymun, Glasnevin and City Centre to Charlemont, Co. Dublin

#### **Site and Impacts of Metrolink**

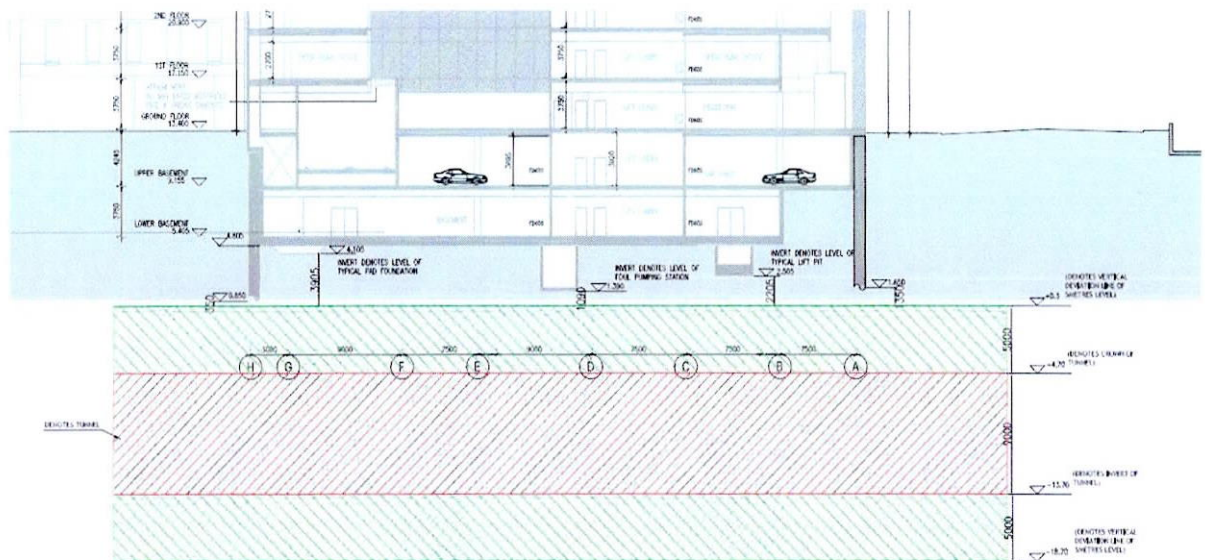
The extract below shows the proposed tunnel route with vertical deviations highlighted in relation to the existing basement structure, which clearly highlights both our clients and professional design team's concerns with its close proximity.

Figure 1: Proposed Metrolink Tunnel Route against Existing Double Basement Structure

It is noted that all drawings in the Railway Order show the old building layout which was demolished circa 2014. This is a concern as the Arthur Cox Building at 13 and 14 Earlsfort Terrace has complex and sensitive basement, pile and façade structures in relation to the proposed tunnel. We expect the Arthur Cox Building to be replaced on all relevant drawings and the correct building parameters used in the assessment of the building going forward.

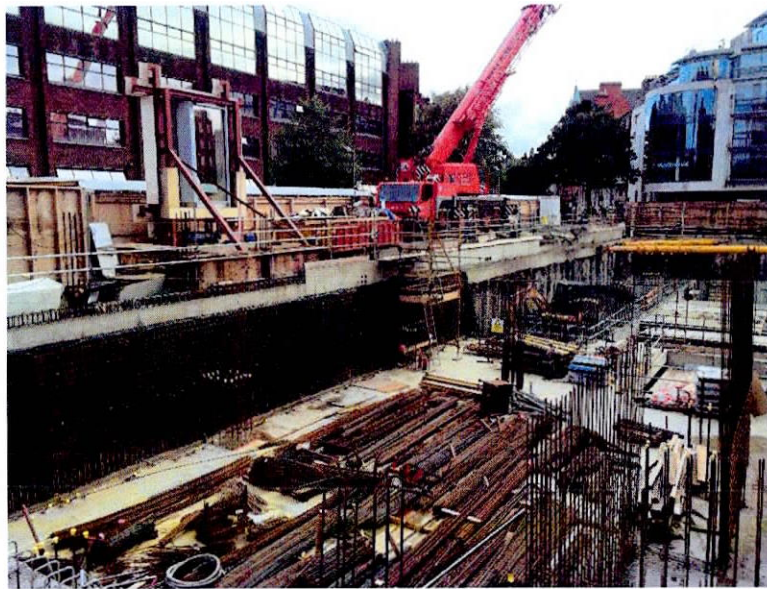
Photograph 1: Secant Piled Wall Supporting Perimeter Columns

- *Secondly, there is a perimeter secant pile wall around the basement, as shown in Figure 3, which is load bearing and supports parts of the façade and external columns. There is a high percentage of glass on the façade, which would make it sensitive to differential settlements. Also, there is a concentration of load on the toe of the piles, which will be closer to the crown of the tunnel. This means that the settlement of the piles could significantly exceed the estimated greenfield settlements that could occur at the ground surface. Furthermore, if the tunnel alignment is raised to the upper Limit of Deviation (LOD), which is 5m above the alignment shown on the planning drawings, then the toe of the piles will be only approx. 1.35m above the crown of the tunnel. This is a significant concern as it could lead to excessive settlement and damage of the façade. It could also impact the stability of the tunnel bore during and after construction with concentrated loading on the tunnelling lining."*

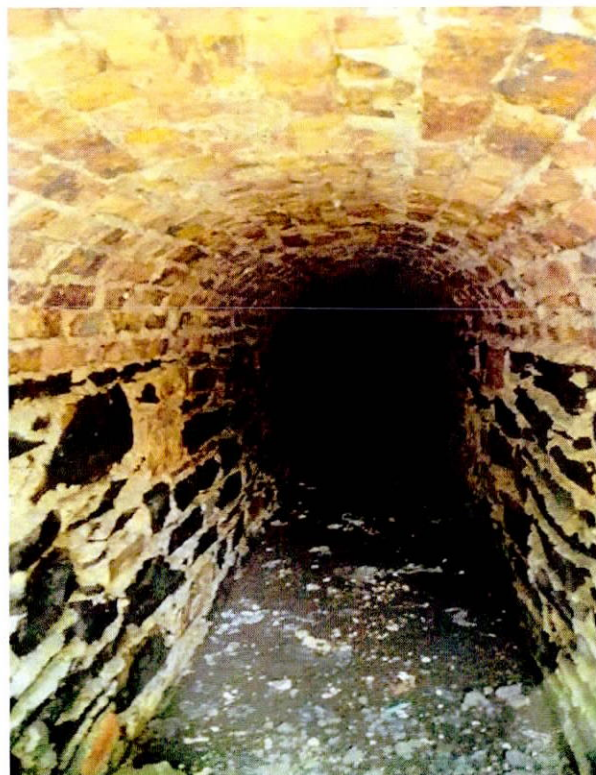
- v) The culvert of the Old River Stein originally ran through the site prior to construction of the Arthur Cox Building construction (refer to Photograph 2)

Photograph 2: Old River Stein Culvert Running Through the Site Prior to Construction of the Arthur Cox Building

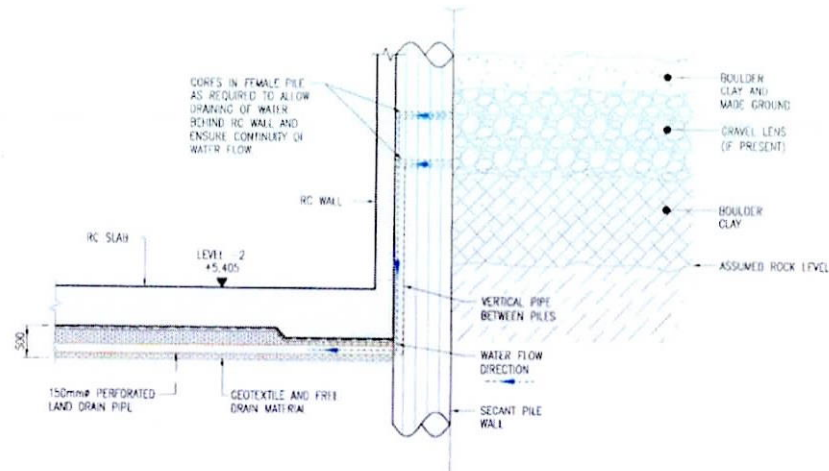
- vi) The construction of the secant piled wall required the culvert to be diverted under the new basement (refer to Figure 1).

Figure 2: Diverted River Stein Culvert

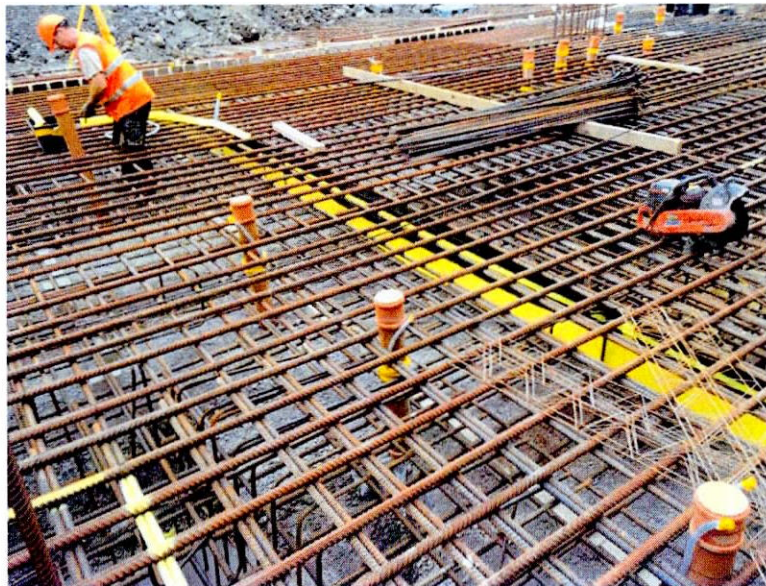
- 1) *The basement of the Arthur Cox building is designed for 0.2mm crack width as required for waterproof concrete structures utilizing the structurally designed reinforcement in the elements and strategically positioned crack-inducing injecting units. If cracking of 1-5mm occurs due to the new conditions arising from the tunnel construction, it would permanently damage the waterproofing system and the basement structure.*

Photograph 3: Rascor White Tank Injection System in Basement Slab

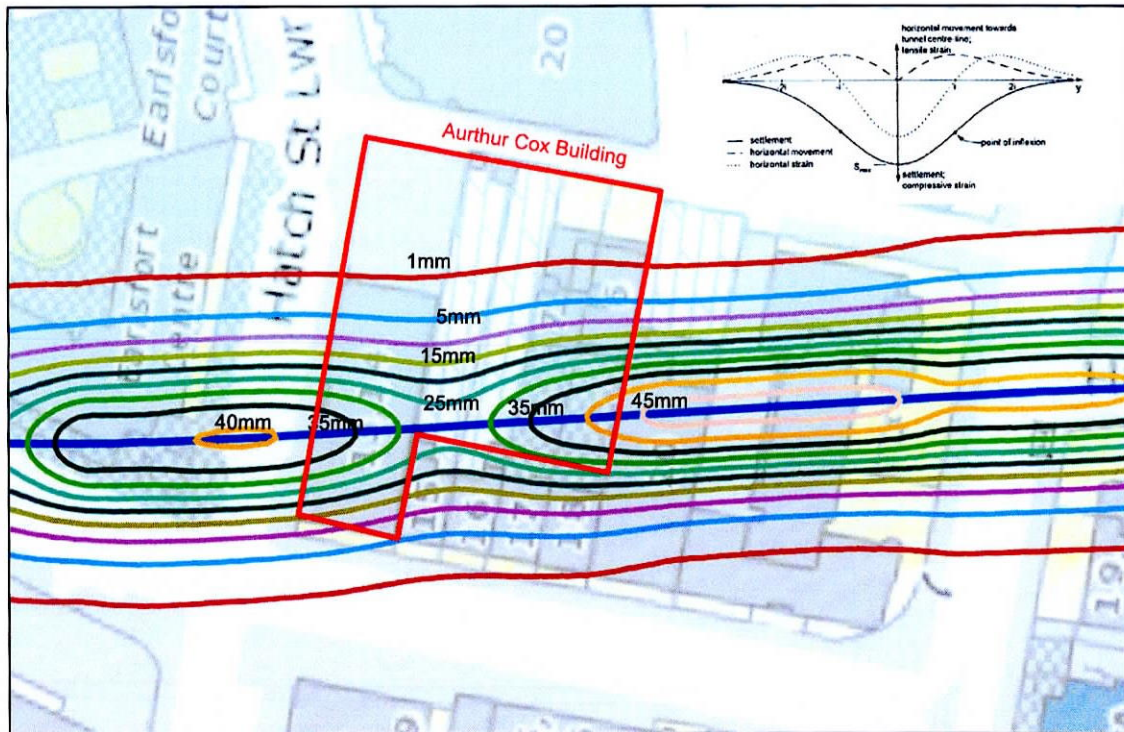
- Figure 1 of this letter shows the estimated greenfield settlements at the Arthur Cox Building. They are presented as 5mm contours for a trough of settlements centred about the tunnel with the maximum value at the tunnel centreline, as illustrated by the inset figure.

- The maximum settlements under the building are estimated as 25-45mm along the tunnel centreline, reducing to <5mm over a distance of about 25m to either side of the tunnel.

**Figure 1 – 5mm settlement contours at Aurthur Cox Building (≈Ch. 18950-19000) [Phase 1 Greenfield Settlements]**

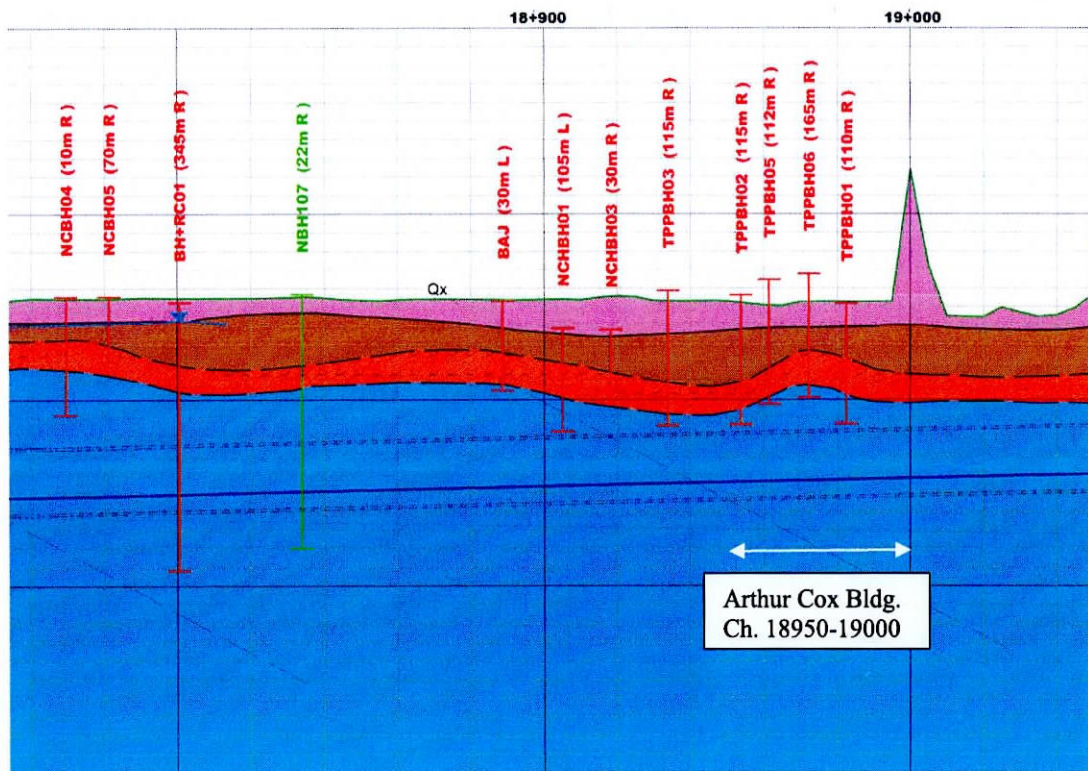
**Figure 2 – Interpreted geological profile (Appendix A20.9 of EIAR) at location of Aurthur Cox Building**

- The calculated maximum settlements are a function of the ground conditions at and above the tunnel horizon, and the estimated volume of ground loss which is expressed as a percentage of the face area of the 9.5m diameter tunnel as follows:
  - 1.5% where the tunnel is in rock but the depth of rock cover above the tunnel is <4.5m (i.e. 50% of the tunnel diameter); and
  - 0.75% where the tunnel is in rock with >4.5m cover.
- The range of maximum settlements calculated for the section of the tunnel under the Arthur Cox Building (approx. Chainage 18+900m to 19+000m) is directly proportional to the assumed % ground loss. Therefore, the settlement contours on Figure 1 reflect the following assumptions that were made in the calculations for the BDR, as summarised in Table 5.1 of the report:
  - Ch. 18900 to 18960: **1.50%**
  - Ch. 18960 to 18980: **0.75%**
  - Ch. 18980 to 19100: **1.50%**

Figure 2 of this letter shows the interpreted ground profile along the centreline of the tunnel from Appendix A20.9 of the EIAR.

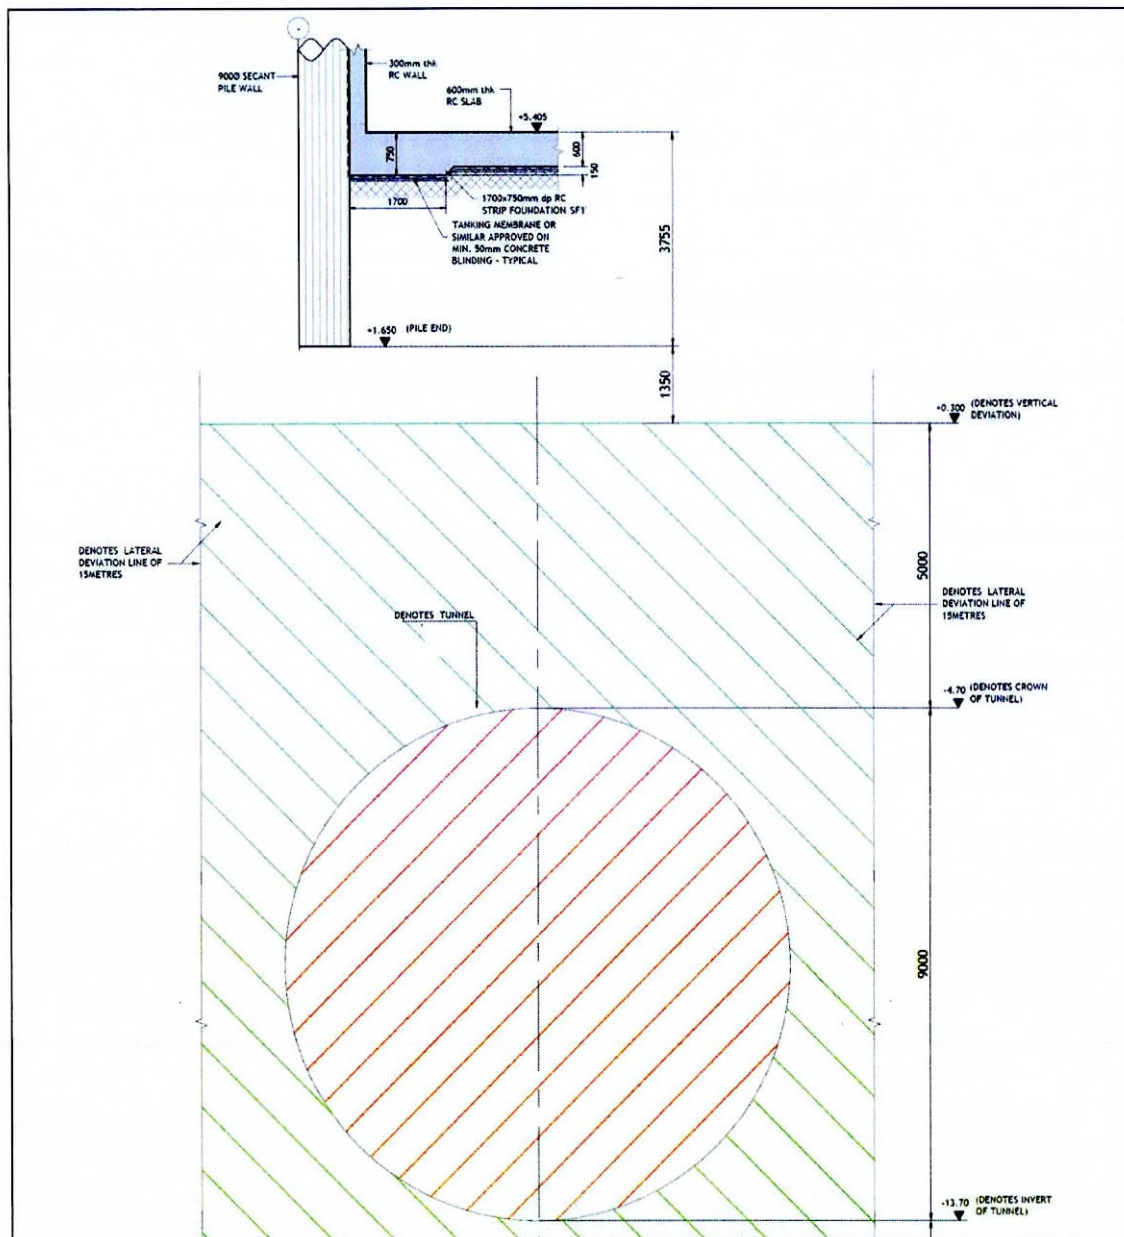
- Secondly, there is a perimeter secant pile wall around the basement, as shown in Figure 3, which is load bearing and supports parts of the façade and external columns. There is a high percentage of glass on the façade,

which would make it sensitive to differential settlements. Also, there is a concentration of load on the toe of the piles, which will be closer to the crown of the tunnel. This means that the settlement of the piles could significantly exceed the estimated greenfield settlements that could occur at the ground surface. Furthermore, if the tunnel alignment is raised to the upper Limit of Deviation (LOD), which is 5m above the alignment shown on the planning drawings, then the toe of the piles will be only approx. 1.35m above the crown of the tunnel. This is a significant concern as it could lead to excessive settlement and damage of the façade. It could also impact the stability of the tunnel bore during and after construction with concentrated loading on the tunnelling lining.

**Figure 3 – Profile of tunnel, basement and secant pile wall at the Aurthur Cox Building**

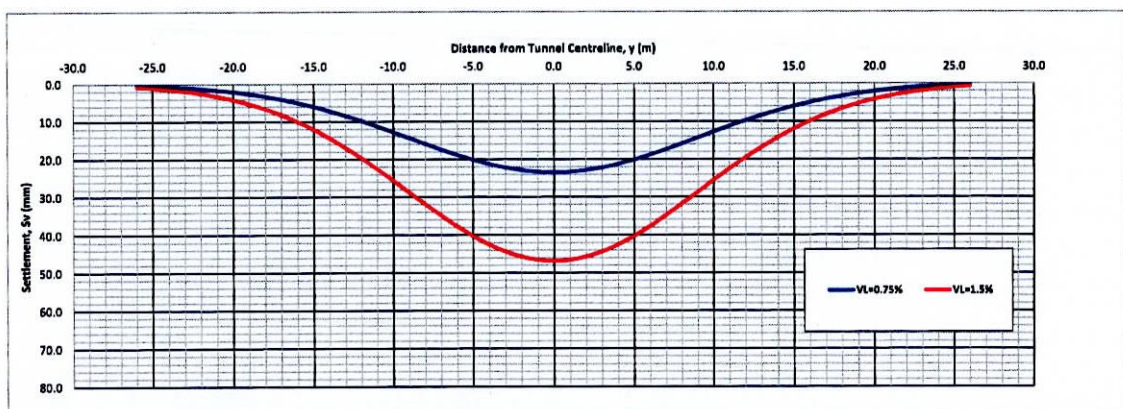
- Figure 4.1a and 4.1b show the calculated distribution of settlements at street level (18.0m cover to tunnel) and at the underside of the basement floor slab, where the depth of cover to the tunnel reduces to 9.5m. The settlements have been calculated for the same criteria in the Phase 2a preliminary assessment in the BDR assuming 0.75% and 1.5% ground loss for the range of interpreted ground conditions.

**Figure 4a – Distribution of greenfield settlements at ground level (18.0m cover) for 0.75% and 1.5% Volume Loss (VL)**

- The greenfield settlements at street level range from about 25–45mm and are spread out over a distance of 25m to either side of the tunnel centreline, as shown in the BDR. However, at the underside of the basement floor slab the maximum settlements for the same range in ground loss are  $\approx 50\%$  greater (37.5mm–75.0mm) and they are concentrated over a narrower corridor that extends only 15m to either side of the tunnel centreline.

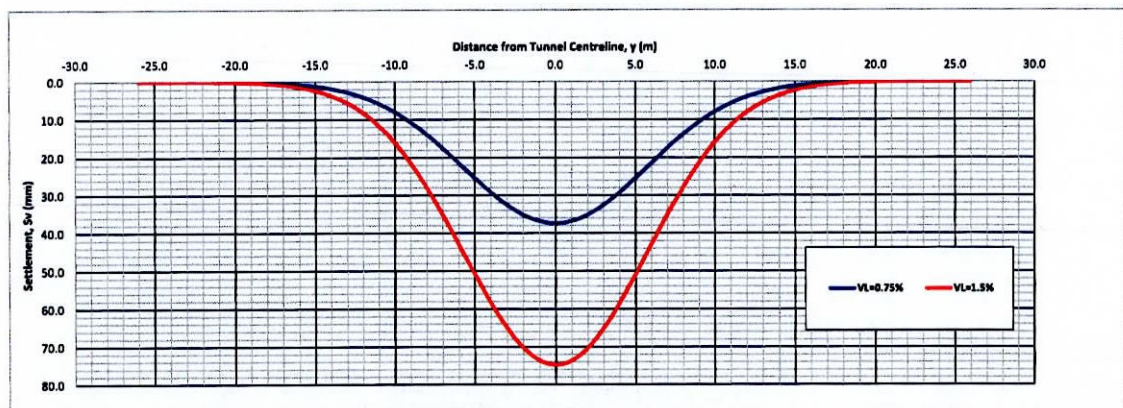
**Figure 4b – Distribution of greenfield settlements at basement level (9.5m cover) for 0.75% and 1.5% Volume Loss (VL)**
