25/60220 - PERMISSION for continued use of the existing quarry to the permitted depth of minus 5 mOD, including drill-ing, blasting, crushing, processing, stockpiling of materials, associated roads and ancillary services (granted under Planning Ref. File No.: 09/1958 and ABP Ref.: PL07.235821); Continued use of open storage areas; Continued use of existing permitted concrete manufacturing facility (granted under Planning Ref. File No. 09230 and 19/517: ABP-304769-19); Continued use of the existing office (granted under Planning Ref. File No.: 09/1958 and ABP Ref.: PL07.235821); Continued use of the existing maintenance shed (granted under Planning Ref. File No. 09610); Continued use of the existing water management system (including settlement lagoons), weighbridge and wheelwash; Lateral extension of the existing permitted quarry area over a previously permitted extraction area (granted under Planning Ref. File No. 06/4125) of c.4.6 ha. area to a final floor level of minus 5 mOD. The total quarry extraction area will be c. 13 Ha.; Restoration of the application area to natural habitat after uses following completion of ex-traction. The proposed development is within an overall appl

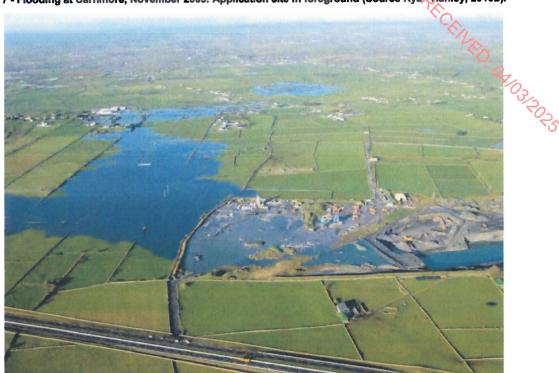
Plate 7 - Flooding at Carnmore, November 2009. Application site in foreground (Source Ryan Hanley, 2010b).

Recurring flood events are mapped by the OPW in the area Cammore which is located 1.3km to the northwest of the site. Flooding appears to be caused by heavy rain and surface water ponding in localized hollows. The proposed development site has not been affected by this flooding.

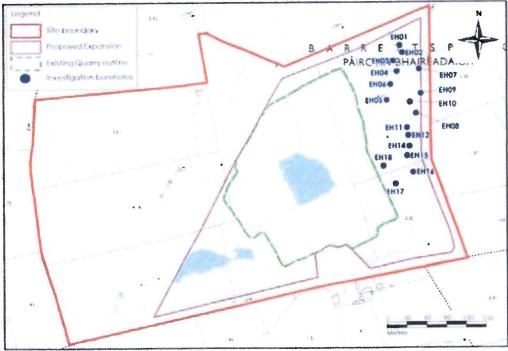
Figure 7.7 Investigation Drilling in the Proposed Expansion Area

The locations of the investigation holes are shown on Figure 7.7 below and dulling logs are shown in Appendix 6.2 of the Land. Soils and Geology Chapter (Chapter 6).

To determine whether the upper competent limestone layer extends east into the proposed expansion area, a total of 18 no. 100mm investigation holes were drilled in the rock proposed for extraction (i.e. holes were drilled down to -5m OD). Apart from some shallow weathering (non-karstic) in the upper 2-3m of rock, the rock in all holes was dry, hard and competent with all holes returning fine rock chips and dust during drilling. The groundwater levels measured in the boreholes were typically <3m below ground level (groundwater level of approximately 22m OD) which is consistent with the level of the current inflows to the quarry.
