# NATURA IMPACT STATEMENT ADDENDUM

Response to Request for Further Information

Park Road Bridge, Limerick.

ABP Ref: ABP-322037-25 Our Ref: 177AE Park Road Bridge Limerick

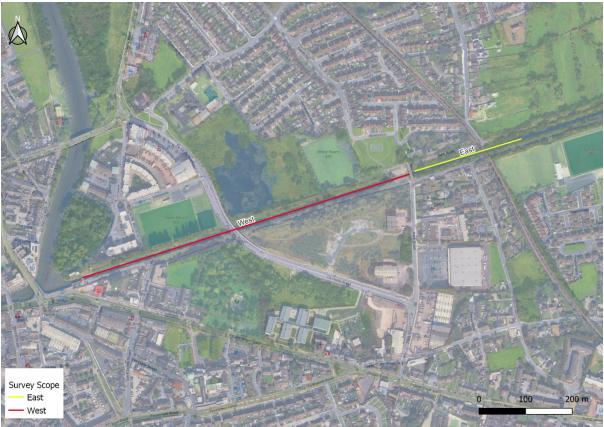
Figure 1. Extent of the area surveyed for otter.

There were no signs of otter within the immediate vicinity of the bridge, nor further upstream or downstream. The next bridge west, had far better potential to preserve otter spraint remains as the bridge itself sheltered anything underneath from the elements and the presence of boulders and the bridge itself would be territorial landmark points which an otter typically would utilise to assert ownership of the area. No evidence of otter usage were found here.

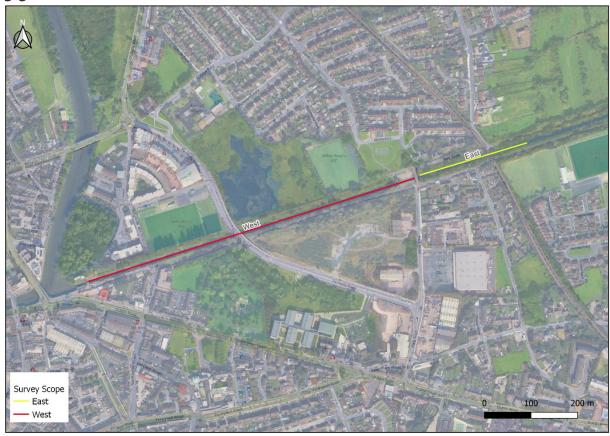
Figure 2. Map of survey effort.

As a result of this and conditions with substrate (extremely silty making walking with waders impossible) in the canal, it was decided the best approach would be to survey the canal from a kayak.

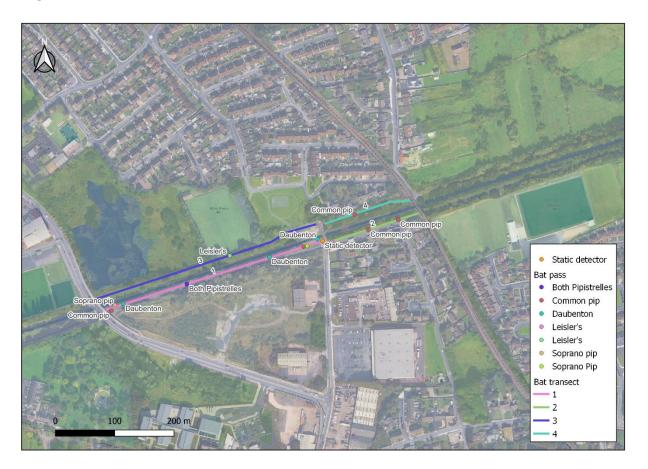
Figure 5 Bat survey results.

No bats were observed emerging from any structures within the bridge.
