ARCHITECTURAL DESIGN REPORT

Cleeves Riverside Quarter | October 2025

CRQMP-FCBS-XX-XX-RP-AA-0010 P01 - 16/10/2025

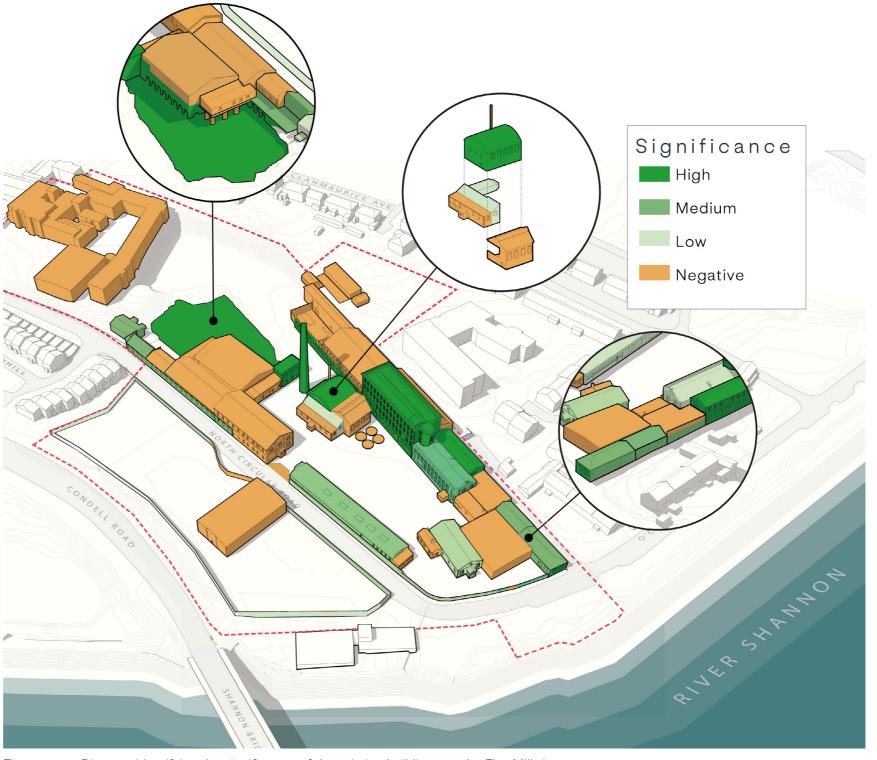
Figure 1.3.3 - Diagram identifying the significance of the existing buildings on the Flax Mill site

Note: The buildings on the Salesians site do not appear on the Record of Protected Structures nor are they part of curtilage of the Flaxmill complex meaning they are not in the attendant grounds. A summary appraisal of Fernbank House is included in the Statement of Significance.

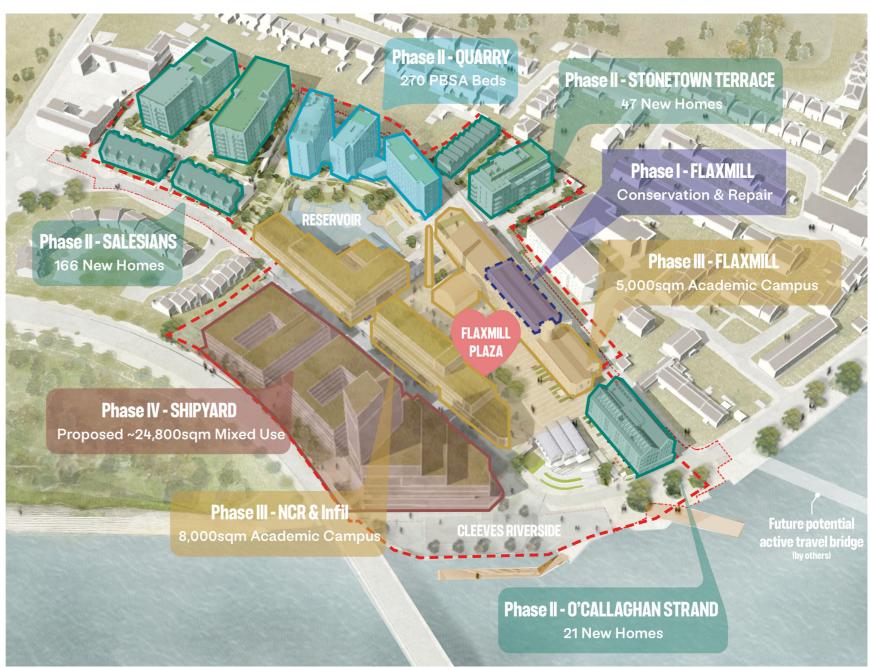
Figure 2.2.1 - Masterplan Extent and Overall Phases

Phase I - Conservation & Repair of the Mill

Works on the conservation and repair of the Mill building were identified as a priority, specifically to stabilise the top floor. A contractor has been selected to undertake these works, which are due to be complete in Q3 2026.

Phase IV

The final phase will see the realisation of employment-led uses on the Shipyard site.

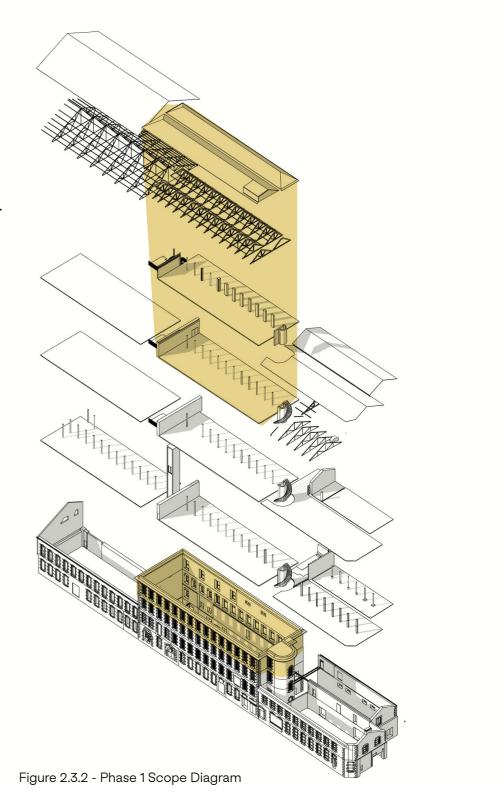
- Roof coverings replaced with thermal enhancements to form insulated warm roof;
- Repair / renewal of timber roof trusses, purlins and rafters on a basis of repair need;
- Removal of lift overrun to enable reforming of hipped roof profile;
- New roof access via central valley to serve building in its Phase 01-completed 'shell state';
- · Repair / renewal of cast iron gutters;
- Upgrade of rainwater drainage system new and additional downpipes and chutes;
- New secondary 'fail safe' gutter system;
- Water tank retained, overhauled, repaired
- New roof to the water tank.

- Demounting and storage of historic windows to allow for masonry repair works to progress;
- Rebuild north-west aspect Partial take down and rebuild of masonry at the north-west aspect to address displacement;
- Rebuild parapet Take down and reconstruction of parapet to address displacement
- New, additional brick courses to top of parapet to provide edge protection
- New, lead clad coverings to improve weathering,
- · New rainwater outlets to improve drainage;
- Cornice reformed with weathering, repaired / rebuilt as required;
- Removal of horizontal wrought iron banding at Level 03
 NE and SW walls, NW gable;
- Removal of wall linings back to masonry at Level 03,

- Repair of cut / failed beam supporting Level 03 floor deck;
- Removal of ceiling and modern partitions at Level 03;
- Modern Level 03 floor linings removed back to original floor finish and consolidation where eroded / missing;
- Consolidation of jack arches forming the structural deck of level 03 - entailing removal of soffit plaster where it survives at Level 02, deep packing / repointing of open joints;

- Blasting SA2½ of exposed iron beams and tie rods to remove corrosion and application of protective coatings;
- Manual prep ST3 of iron column coatings followed by application of new protective coatings;

The diagram to the right indicates the scope of works.

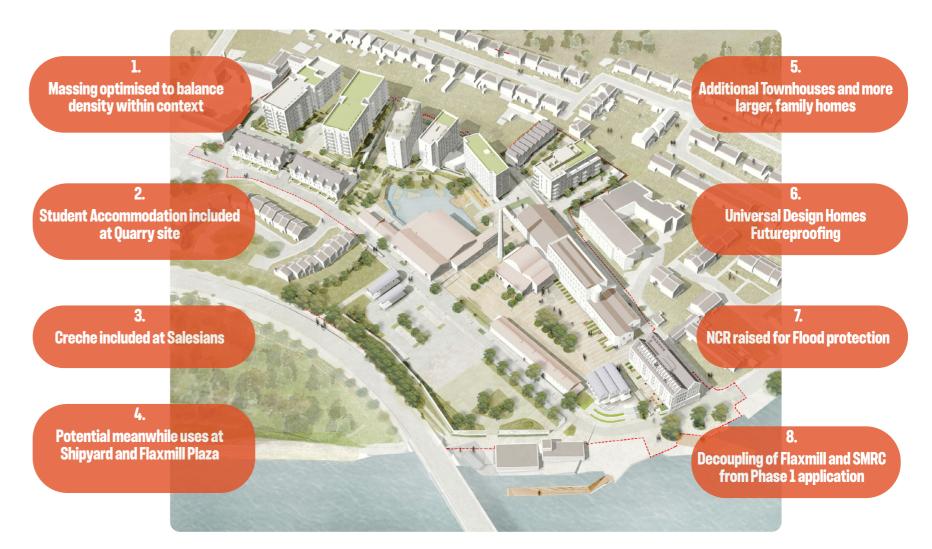
Figure 2.4.1 - Phase II Design Development from 2023 Masterplan Diagram

The diagram to the right indicates the main areas of development since the 2023 Masterplan on the Phase II plots.

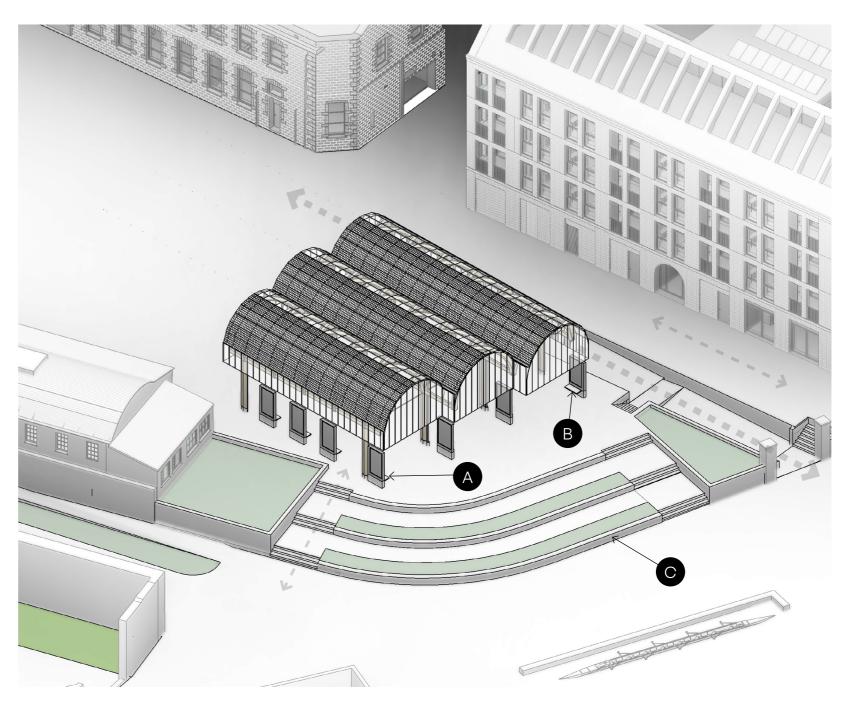
- A Interpretive signage sharing site history incorporated into wind baffle panels
- B Seating incorporated into panels under the shelter of the canopy
- Integrated seating edge at base of heritage wall overlooking riverside

Figure 2.5.1.1 - Diagrammatic Axonometric view at Riverside Canopy

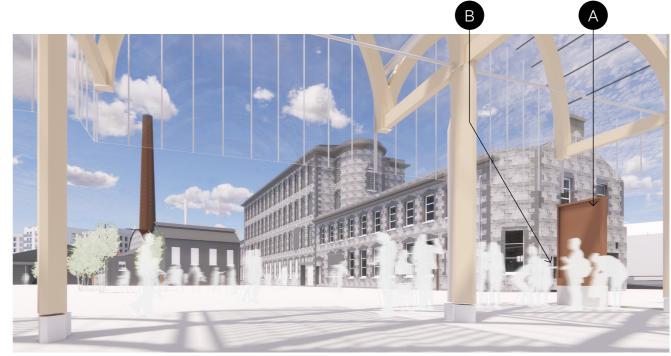
- A Interpretive signage sharing site history incorporated into wind baffle panels
- B Seating incorporated into panels under the shelter of the canopy
- Integrated seating edge at base of heritage wall overlooking riverside

Figure 2.5.1.3 - Sketch view under Riverside Canopy

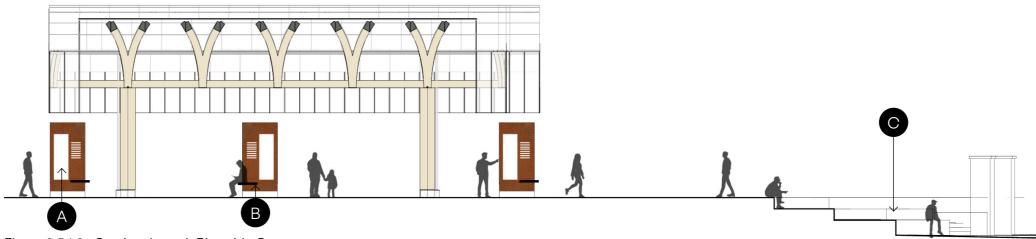
Figure 2.5.1.2 - Section through Riverside Canopy

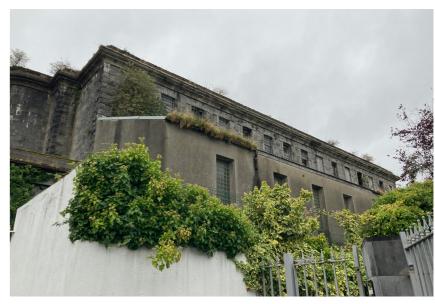
Figure 2.5.1 - Photo of C20th rear lean-to obscuring the Main mill facade

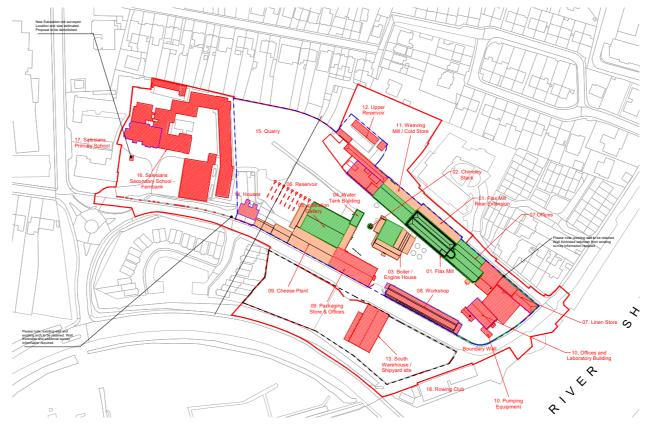
The diagram below is an extract from the Masterplan Conservation Strategy drawing - CRQMP-FCBS-ZZ-XX-DR-AA-1901- see appendix for full version.

Figure 2.5.2 - Masterplan Conservation Strategy Diagram

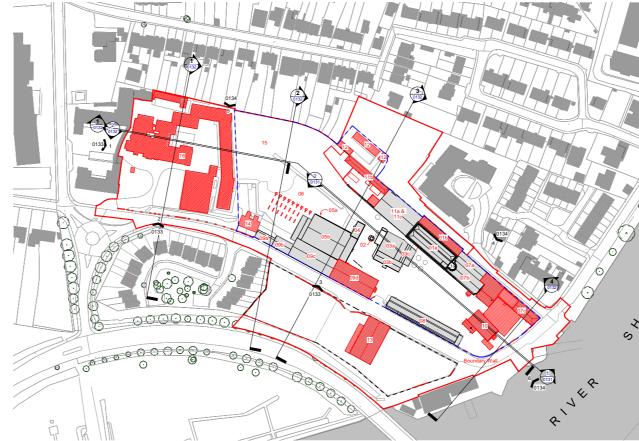
The diagram to the right is an extract from submission drawing CRQMP-FCBS-ZZ-XX-DR-AA-1900, showing the proposed Phase II removal extent.

Figure 2.5.3 - Phase II Removal Strategy Diagram

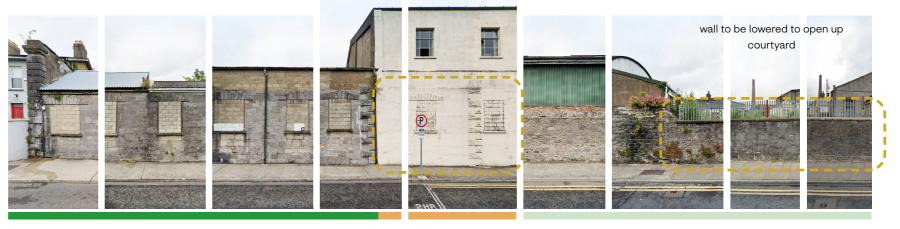
Figure 2.5.4 - North Circular - Flaxmill Site Boundary

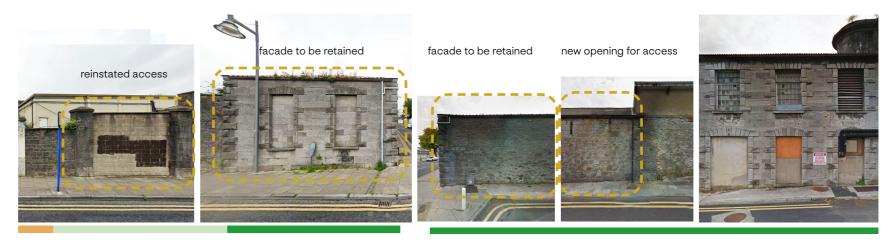
Figure 2.5.5 - O'Callaghan Strand - Flaxmill Site Boundary

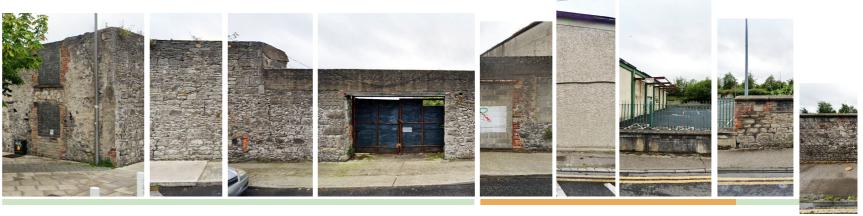
Figure 2.5.7 - North Circular - Shipyard Site Boundary

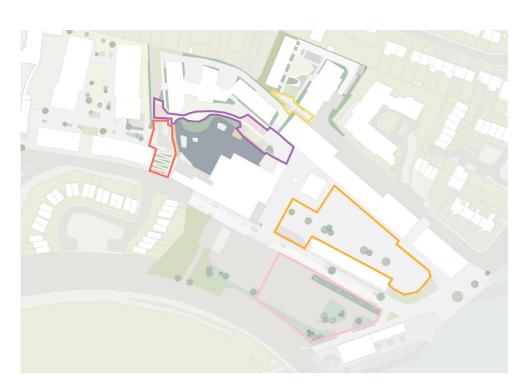
Figure 2.5.3.1 Public Space Plan Diagram

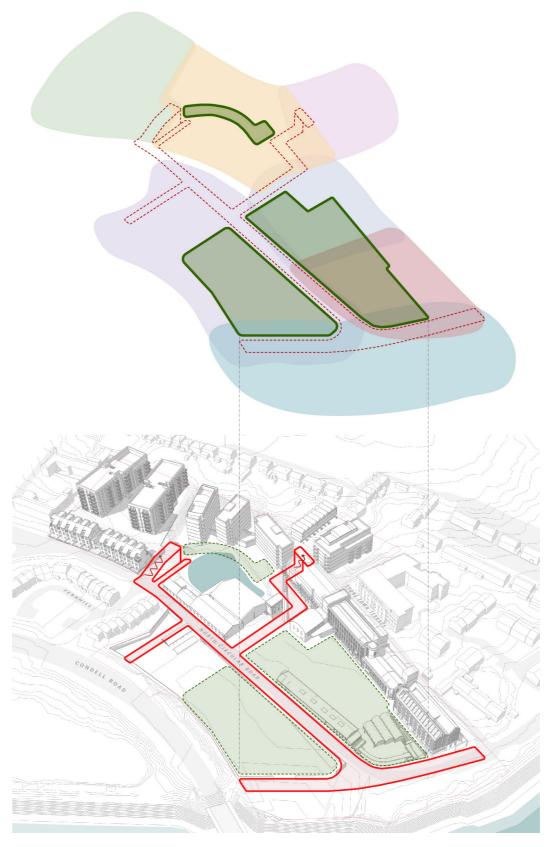
Figure 2.5.3.2 Public Open Space Network Diagrams, with site character areas

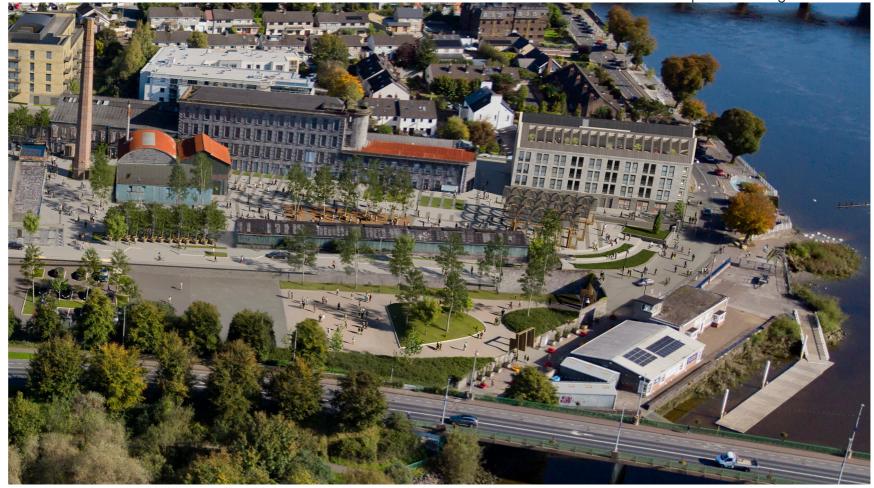
Figure 2.5.3.5 - Flaxmill & Shipyard Open Space Area

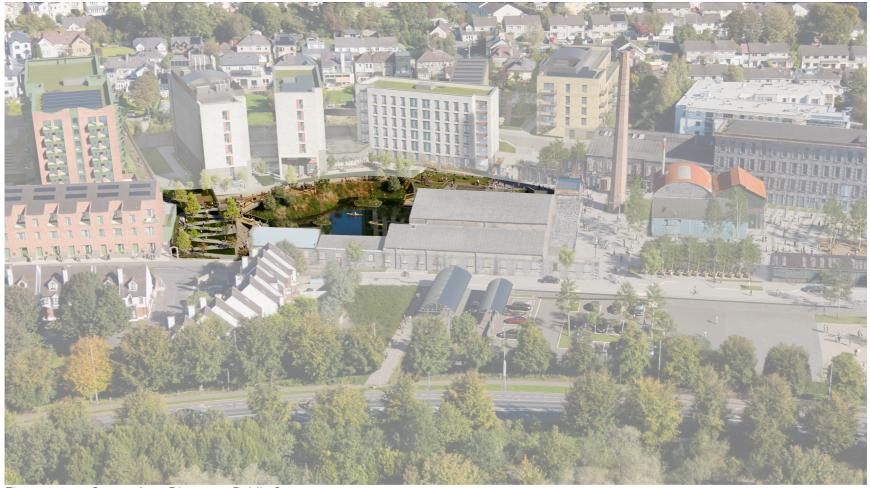
Figure 2.5.3.7 Quarry Area Diagram - Public Spaces

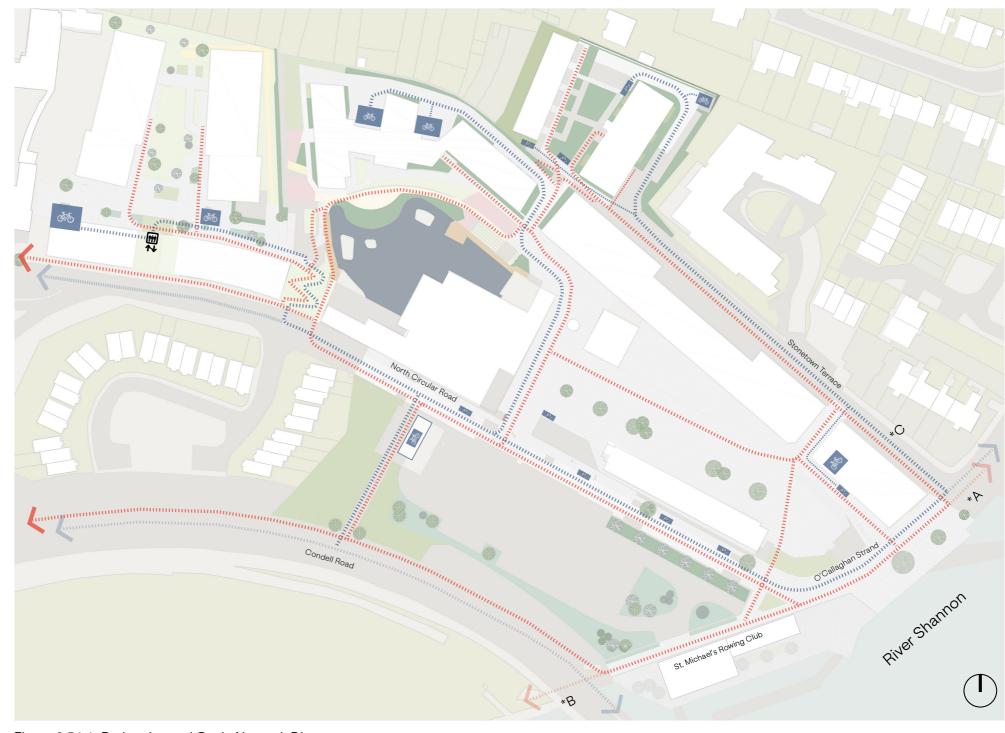
A Mobility Hub for public use, on the Shipyard site, offers covered bike parking and a location for a bike repair point and e-charging.

Figure 2.5.4.1- Pedestrian and Cycle Network Diagram

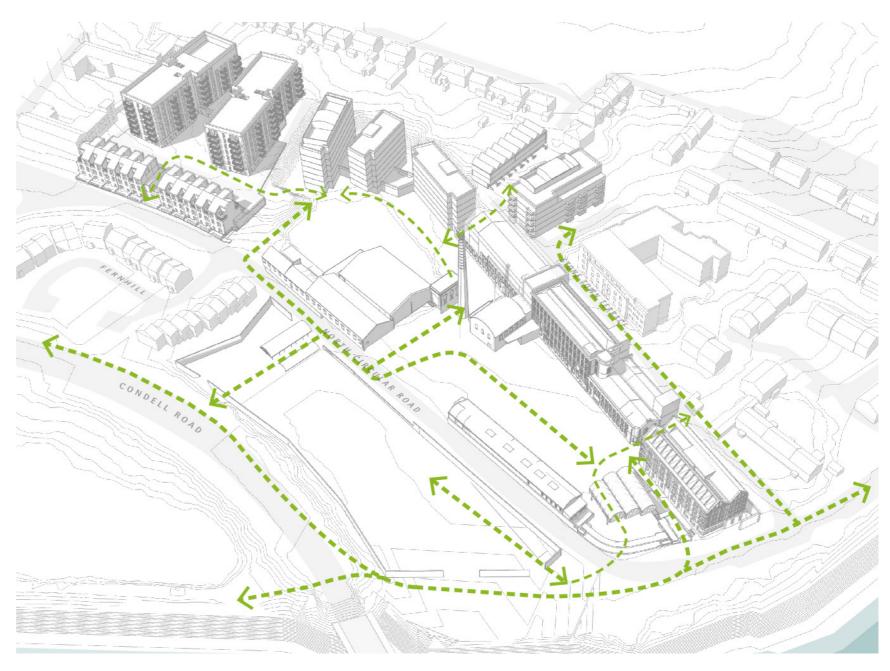
Figure 2.5.5.1 - Permeability and Connectivty Diagram

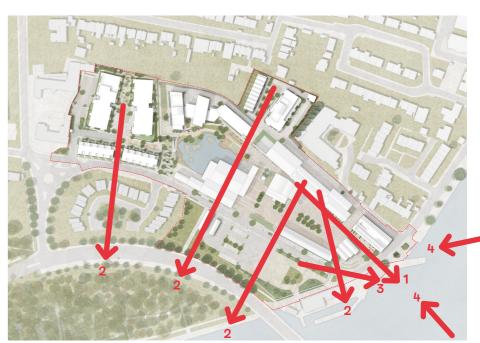
- The view from the Flaxmill offer sweeping views of Limerick City Centre. These views will be offered as part of the new public space from the Engine House to the Shannon quay wall.
- 2. Views from the Flaxmill to the Special Area of Conservation (SAC) and the estuary to the south, these views are also available from the Stonetown Terrace site and the Salesians Site.
- 3. Views from the Shipyard site to the Docklands will strengthen the relationship to the Docklands
- 4. Views to the Cleeves Site from the City, focusing on the views of the Flaxmill, the mill yard and the Chimney

Figure 2.5.14 - Key Views Plan

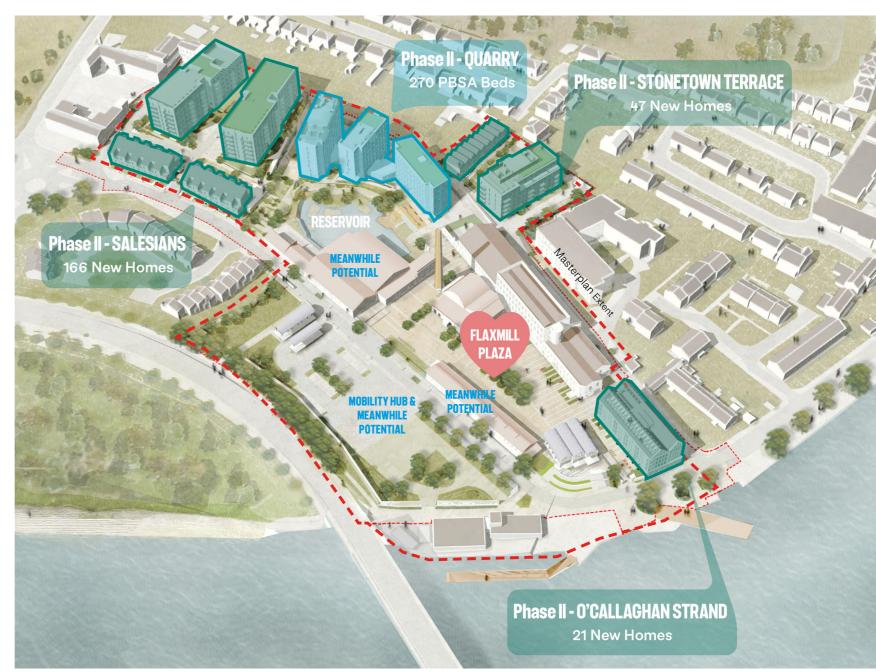
Buildings are generally proposed to step up in scale as they radiate out from the Chimney and Flaxmill, with the tallest buildings in Phase II being the Quarry PBSA and Salesians apartment buildings at 6 and 7 storeys. The dramatic changes in level across the site, such as the two storey step down at the reservoir, have also been used to lessen the overall impact of scale and massing while maximising development opportunities.

Massing of buildings within Phase II has been informed by the characterful gables and silhouettes of buildings already on site, with a contemporary interpretation of modern pitched roofs, barrel vaulted plant enclosures and expressed gables on the city skyline proposed.

Figure 2.5.15 - Phase II scale and massing diagram

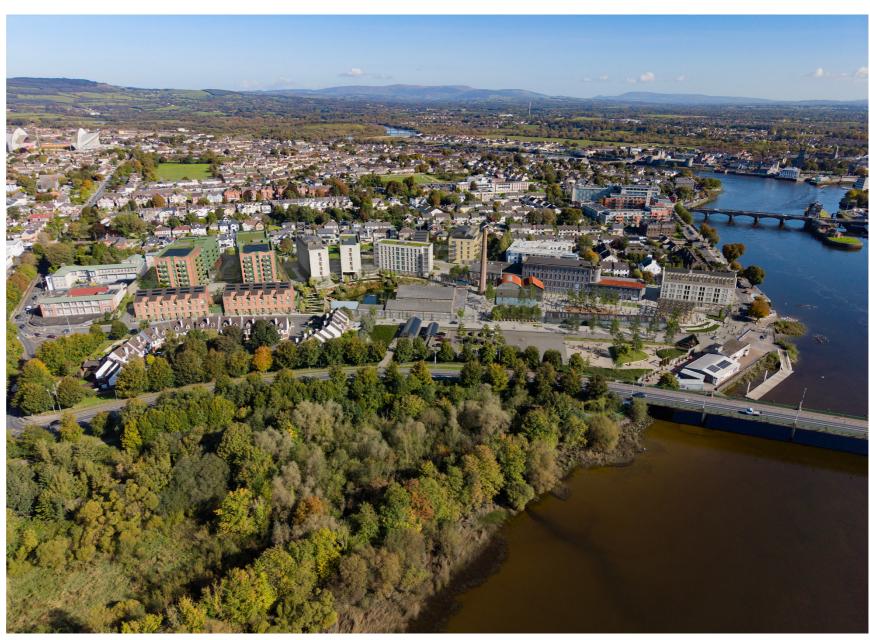
Figure 2.5.16 - Phase II Aerial CCI from the south looking north

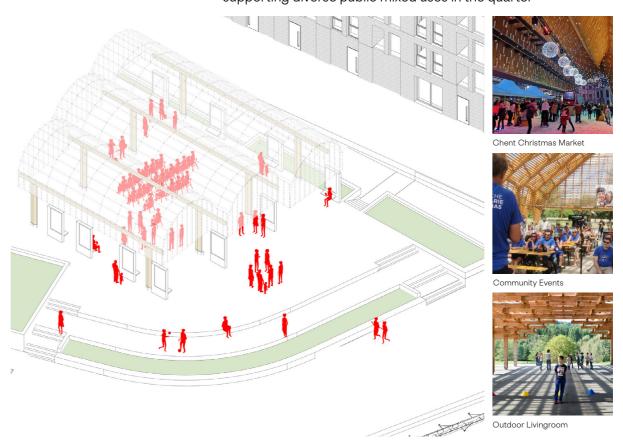
Figure 2.5.7.2 Potential Riverside Canopy Uses

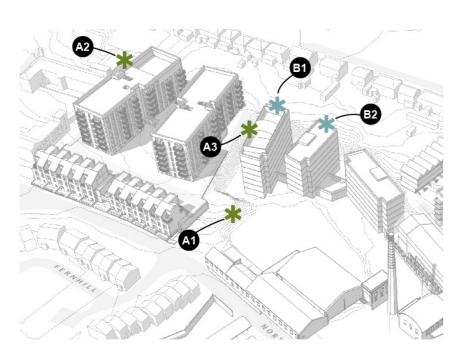
Minimise impact on the existing natural ecosystems: Measures have been reviewed with the project ecologist to include the provision of bat houses and swift boxes, along with light fitting heights and locations. Refer to diagram for strategy notes. Refer to landscape architect's design report as well as relevant EIAR chapters prepared by the project ecologist for further details on the related proposals.

Figure 2.5.8.2 - Ecology Strategy diagram: Indicative Locations of (A) Bat Houses and (B) Bird Boxes.
Refer to plan and elevation drawings for further details

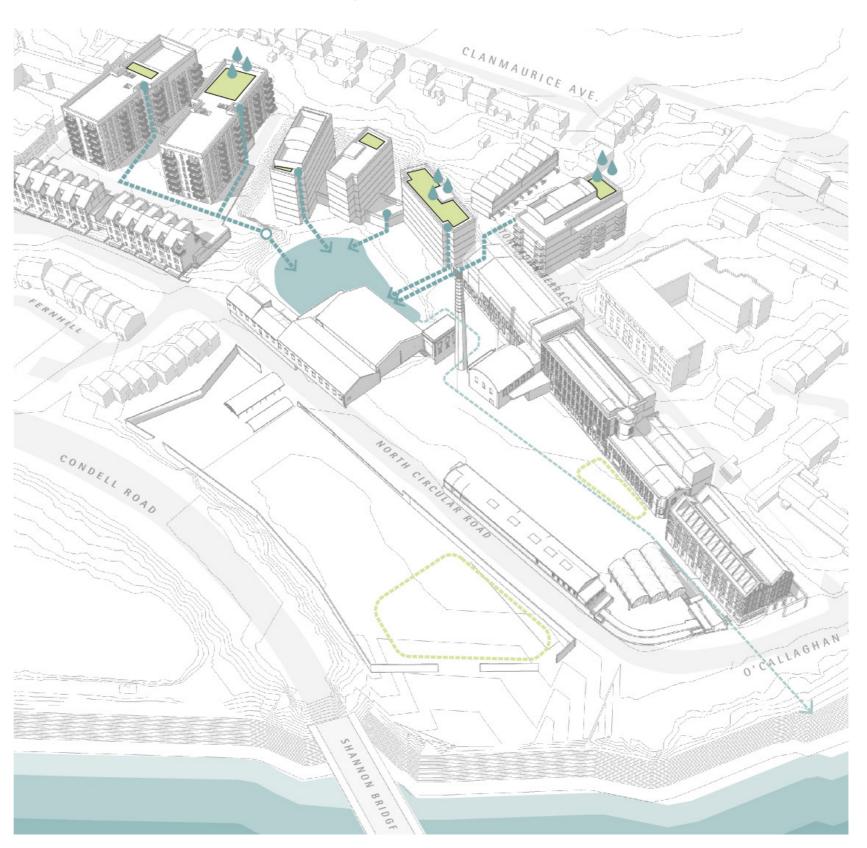
SuDS, Rain Gardens, Green Roofs, leveraging site topography, and industrial fabric to incorporate water into public realm as a sustainable amenity. Refer to landscape architect's design report as well as relevant drainage report and EIAR chapters prepared by the project engineers for further details on the proposals.

Figure 2.5.8.1 - Blue-Green infrastructure strategy diagram. Refer to plan drawings and engineering reports for further details

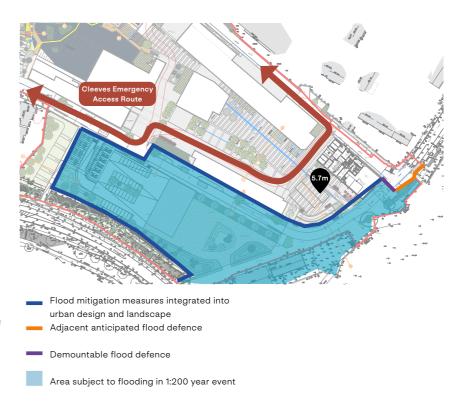
The Phase II scheme proposes adopting the approach to raise the North Circular Road level and development ground floors to 5.7m AOD. The proposed routes within the Quarry site are also raised to 5.7m AOD to allow for emergency access. All residential units are proposed to be raised above 5.7m AOD.

Raising the levels of North Circular Road allows the majority of the site to be accessed by the emergency services during the 1 in 200 year flood event, as well as protect the Quarry and Flaxmill Plaza sites from tidal flooding as the North Circular Road will act as a barrier between the rising water from the River Shannon and the site. This strategy also provides for additional vehicular access to Stone Town Terrace above the flood level with an emergency route through the Flaxmill Plaza, as the existing access road from O'Callaghan Strand is below the proposed 5.7m AOD 1:200 year flood level (current level is 4.20m AOD).

Figure 2.5.22 - 5.7m AOD Flood Level and Emergency Access Route

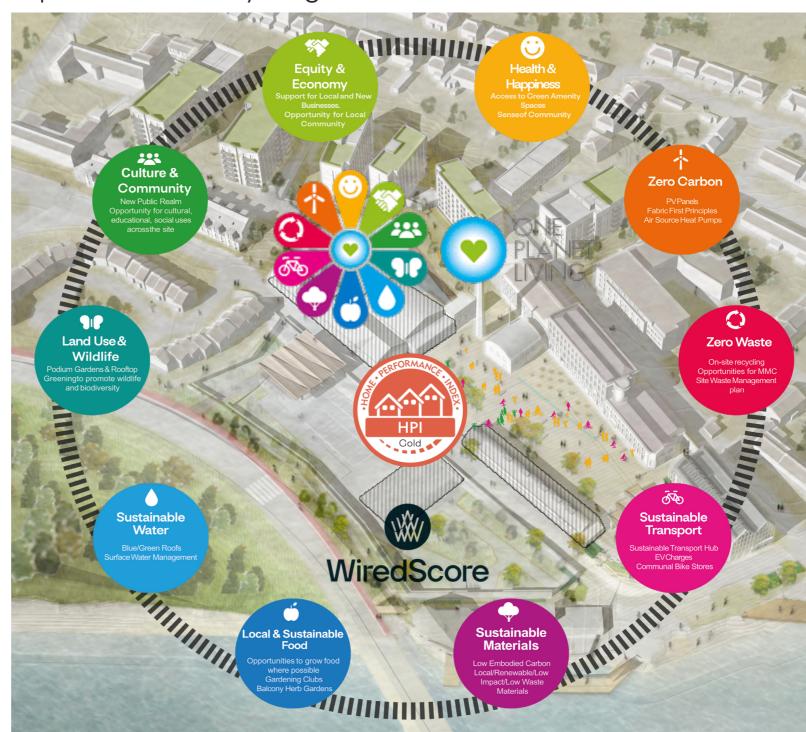
Figure 2.5.24 - Sustainability targets and influences diagram

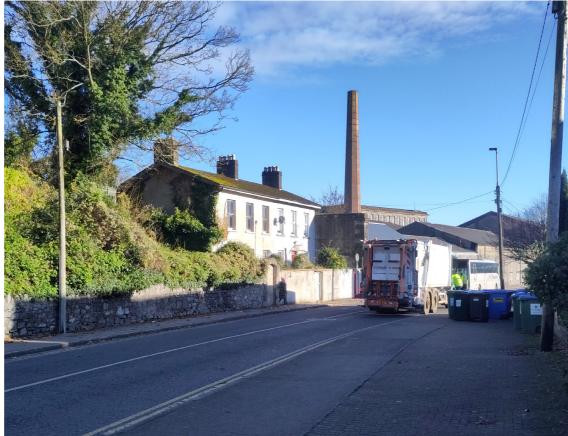
The houses are currently vacant and unliveable, in a poor state of repair.

Figure 3.1.1 - External View of Houses

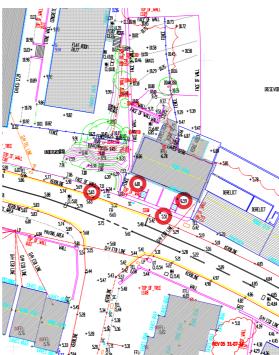
Their ground floor level, raised 1-1.3m above the pavement, makes accessing them difficult, and their rear gardens excavated down c.2.5m from the surrounding quarry wall makes for extremely difficult and suitable resident amenity.

The diagram and images to the right indicate the level changes from road to front door, and the difficult amenity offered in relation to the sites topography, while the accompanying photos show the poor state of repair of the existing fabric.

Figure 3.1.3 - Topo levels outside Houses

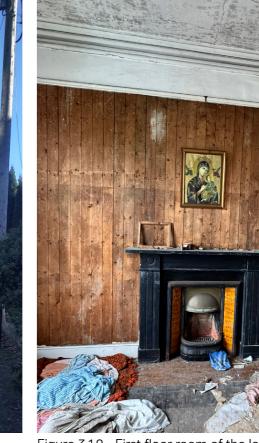
Figure 3.1.2 - First floor room of the left house

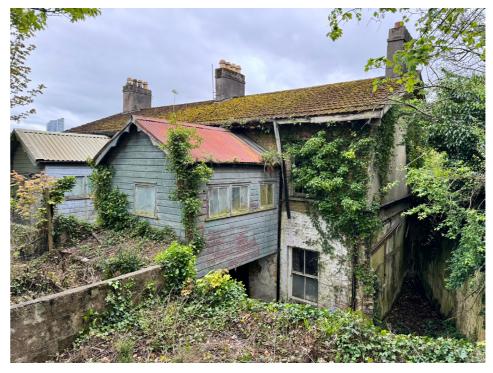
Figure 3.1.4 - House Rear Elevation

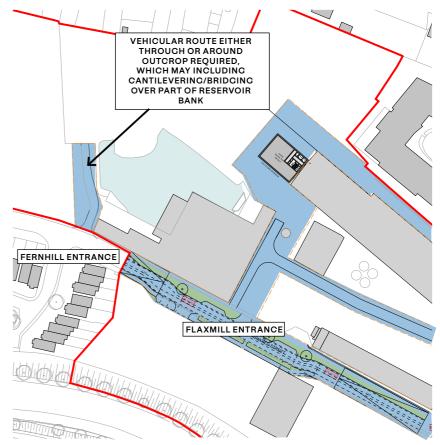
Figure 3.1.5 - Construction Access

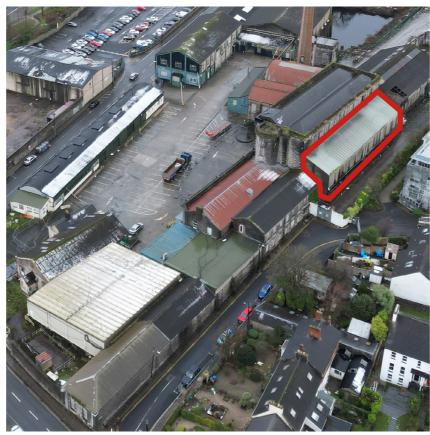
As part of Phase I works to repair and stabilise the top floor of the main mill, this building is proposed to have its roof removed and be taken down a level to enable the erection of scaffolding to perform the works. Once these works have taken place, the building will be left in a state of partial removal.

Figure 3.2.1 - Flaxmill Lean-To

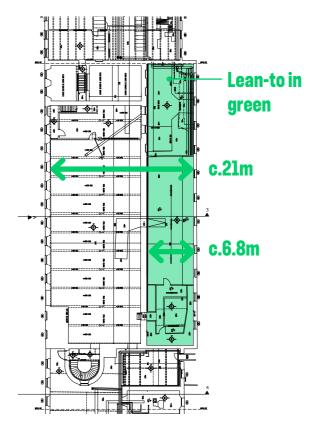
Its removal will reveal the currently closed off north elevation of the main mill, which will be a heritage benefit.

Figure 3.2.2 - Existing Plan with overall widths shown and interface between leant-to and original north elevation

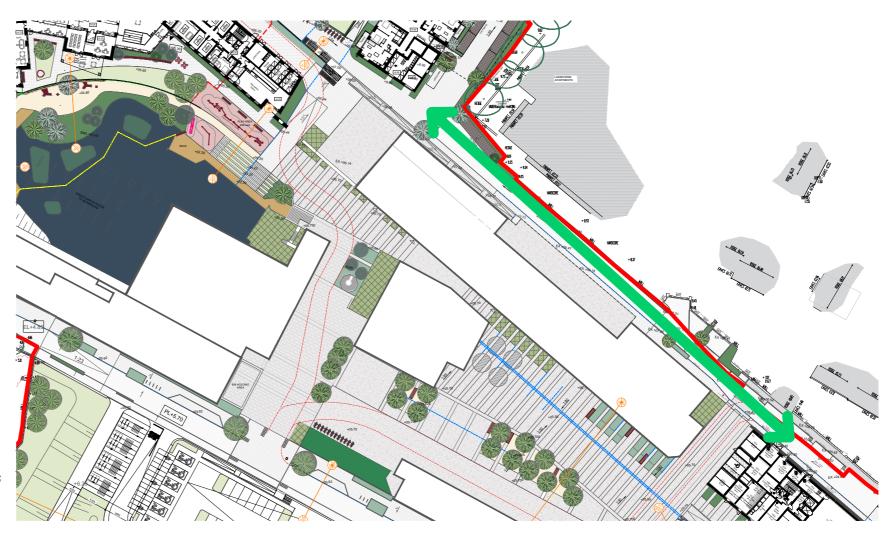
Figure 3.2.5 - Proposed Future Access to Stonetown Terrace

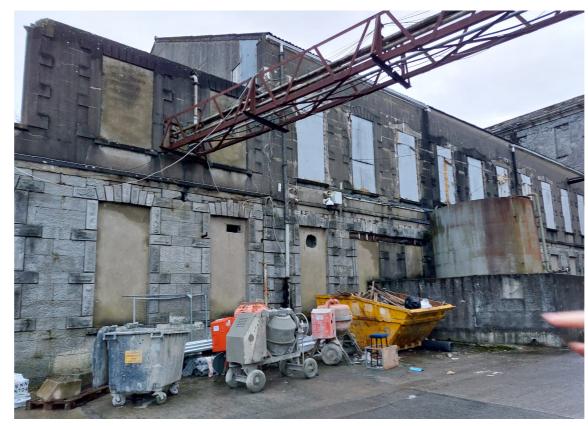
Figure 3.2.1 - Junction between Weaving Mill phases with 1950s first floor over

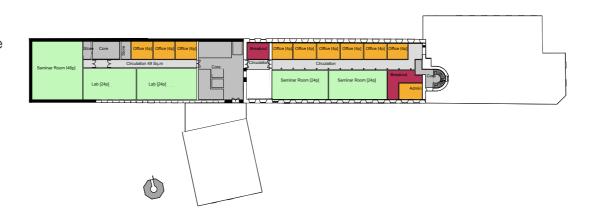
Future academic uses have been tested within the first Weaving Mill Building and partially behind the existing façade of the second building, as part of later phases of development on the Cleeves Riverside Quarter site. The successful adaptation potential of this space for future academic accommodation can be seen on the sketch diagram to the right.

Figure 3.2.2 - Sketch plan of academic uses in Weaving and Main Mill volumes within and behind retained fabric

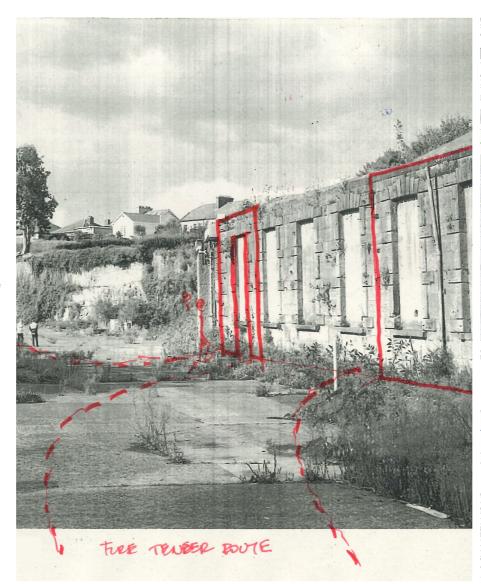
Figure 3.3.2 - Identification of openings to be made

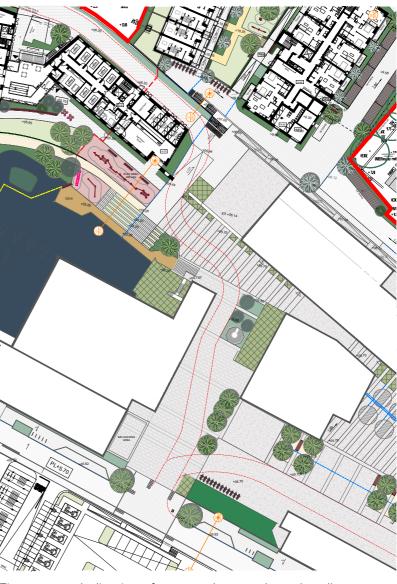
Figure 3.3.3 - Indication of proposed routes through wall

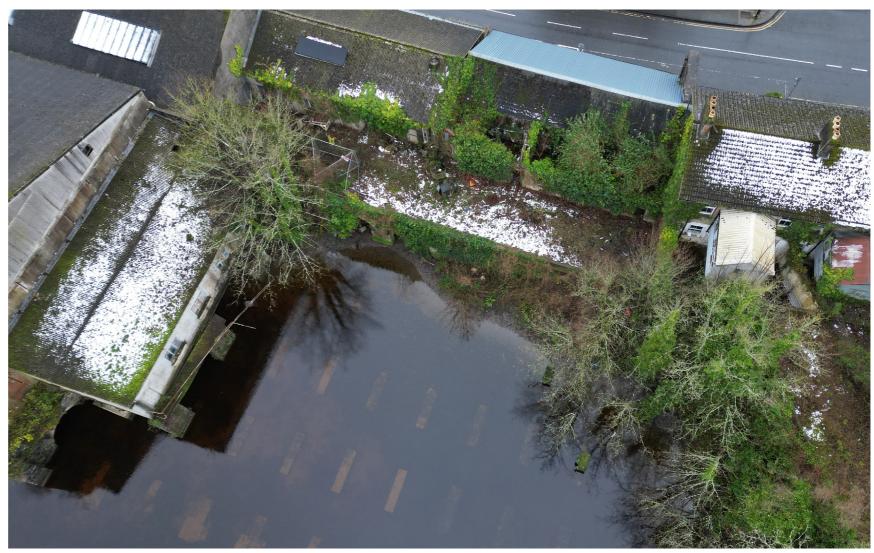
Figure 3.4.1 - Drone image of Reservoir Piers

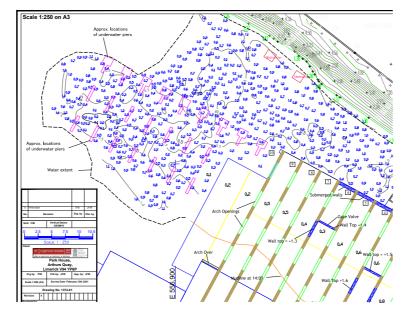
Figure 3.4.2 - Measured Survey of Reservoir Piers

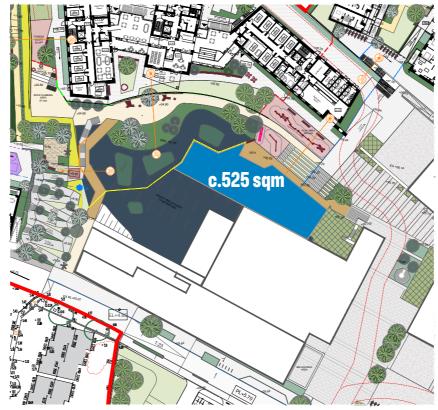
Figure 3.4.3 - Diagram showing amenity extent with Pier area restricted

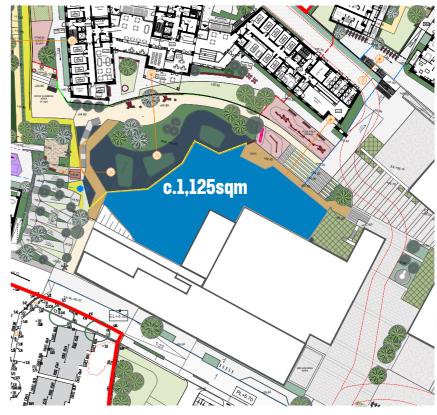
Figure 3.4.4 - Diagram showing amenity extent with Piers removed

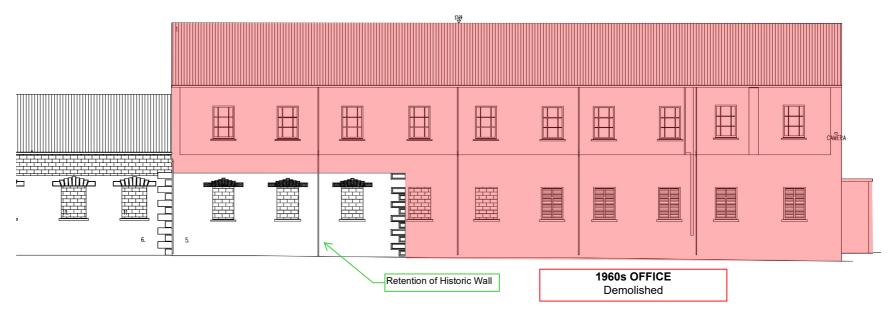
Figure 3.5.2 - Element of Cheese Plant Office Wall being retained - North Circular Road Elevation

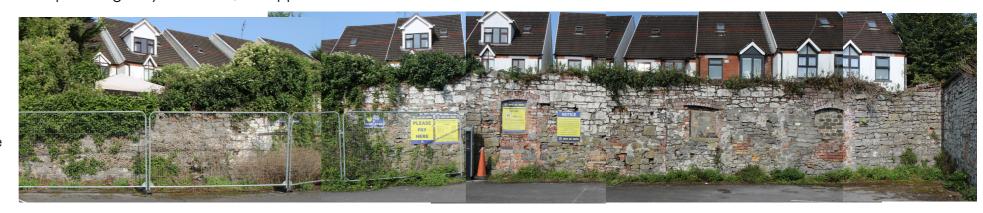
The wall of the shipyard site is largely the residual facades of former buildings that occupied the site from the 1800s up until the 1990s. Where they survive most retain scars of former openings some of which were later insertions to the original wall. Most former openings have been infilled with concrete blocks. Long sections of the historic wall have been raised with concrete. The wall is in poor repair but

stable. To the north the historic wall bordering Fernhill has collapsed and is in need or repair and reconstruction.

Figure 3.6.1 - Shipyard north walls - currenty condition poor requiring repair and rebuilding in parts

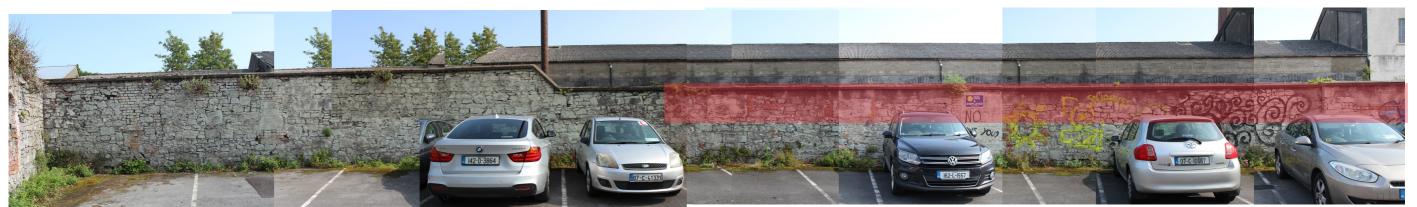
The proposed raising of North Circular Road for flood mitigation poses construction challenges to retain the façade of the Shipyard Warehouse for a temporary use, with the site ultimately proposed to deliver commercial uses in Phase IV of the masterplan.

Figure 3.6.2 - Shipyard walls onto North Circular Road - section in red to be lowered in line with raised level of the road.

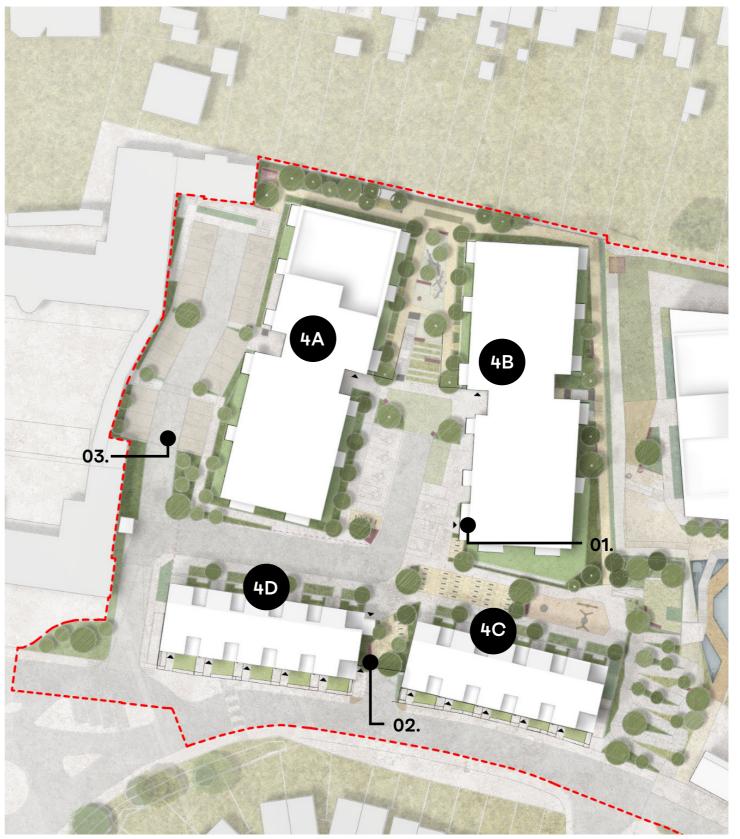
The two rows of three-storey triplexes are a 'back-to-back' typology, with the rear half elevated by one-storey above the lower ground residential car park. So on the upperground level new front doors are created onto the new public realm, which looks east towards the Flaxmill and Reservoir.

Two larger apartment buildings (4A & 4B) are orientated north-south, set back from North Circular Road to mitigate the sense of mass from the street. Outside of the historic curtilage of the Mill, these buildings offer the opportunity to provide increased density and more homes for Limerick. The long gardens of the homes in Clanmaurice Avenue ensure a significant distance between the new and existing buildings.

Figure 5.1.2 - Salesians plot site layout diagram

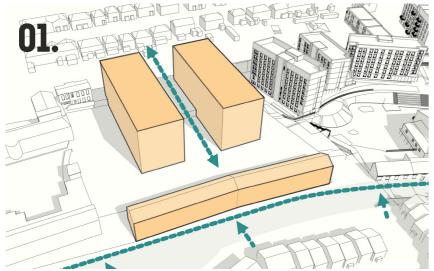
01. Aligned Massing

The is an opportunity to reinforce the residnetial streetscape along North Circular Road, whilst providing two taller apartment blocks to the rear, aligned north/south to optimise daylight and views through.

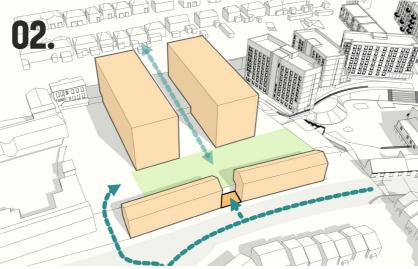
02. Improve Public Realm

Residential car parking spaces are proposed in a lwoer gorund car park off of North Circular Road. This reduces vehicular traffic into the heart of the scheme and improves the potential for a positive public realm.

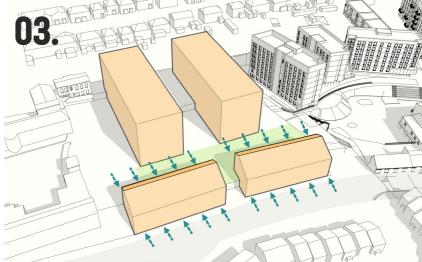
03. Increase density and active frontages

Introduce back-to-back triplexes delivering more homes but also providing front doors and passive surveillance onto both North Circular Road but also the new Public Realm created at the centre of the plot.

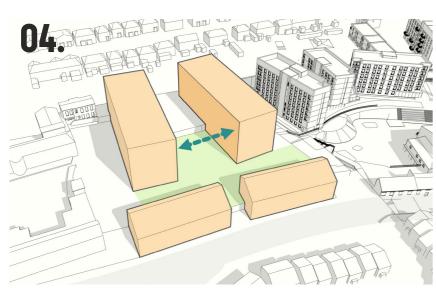
04. Enhance the Communal Open Space

Splay open the blocks to improve sunlight and daylight penetration from the south as well as maximising the amount of amenity space available.

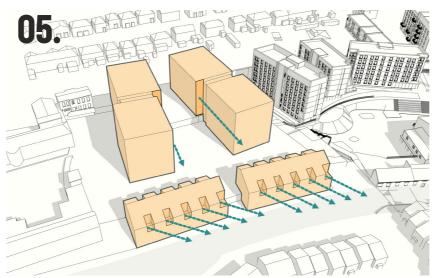
05. Improve dual aspect

Break down the perceived length of the buildings by offsetting around the core. This also breaks down the perceived length of the building into two. The core is recessed and the two buildings have different materials to break mass down further.

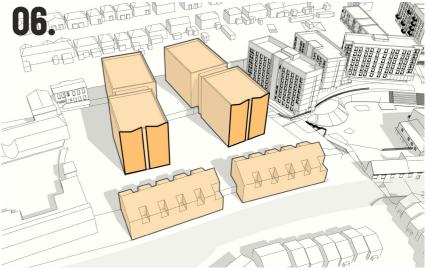
06. Celebrate the gables

Narrow gables break down mass and celebrate the ends of buildings. Expressed form speaks to the history of the site with its industrial roofscape.

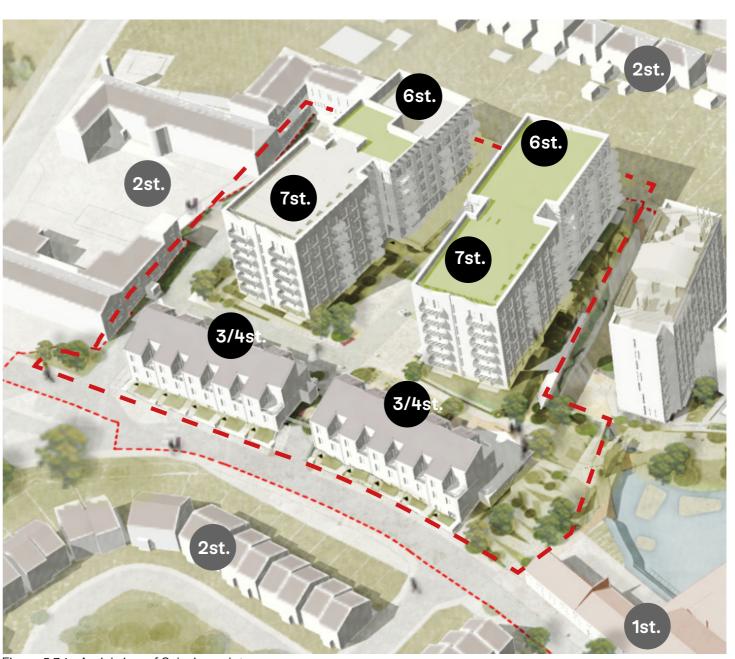
Figure 5.3.1 - Aerial view of Salesians plot

The massing integrates this transition in scale by first creating a familiar terrace house-inspired apartment typology to North Circular Road. Orientated east west to reestablish the continuity of the street frontage, these buildings create a 3/4 storey edge to the site. The steeply pitched roofs that deal with the level change establish a connection to the homes opposite.

The taller apartment buildings bring a more mill-like typology to the site, drawing on the legacy of the Cleeves Mill. These are located within the site, set away from the street front to mitigate the impact of height from the road. The switch in orientation to north-south prevents an impenetrable wall of housing being created, only presenting the thinner gable ends to the street. The ground level then changes again across the length of these buildings, which allows them to appear smaller to the rear of the site, at only 6 storeys rather than 7 storeys. Locating some roof plant to the north, rather than additional apartments, further mitigates scale and the sense of overlooking from the northern boundary.

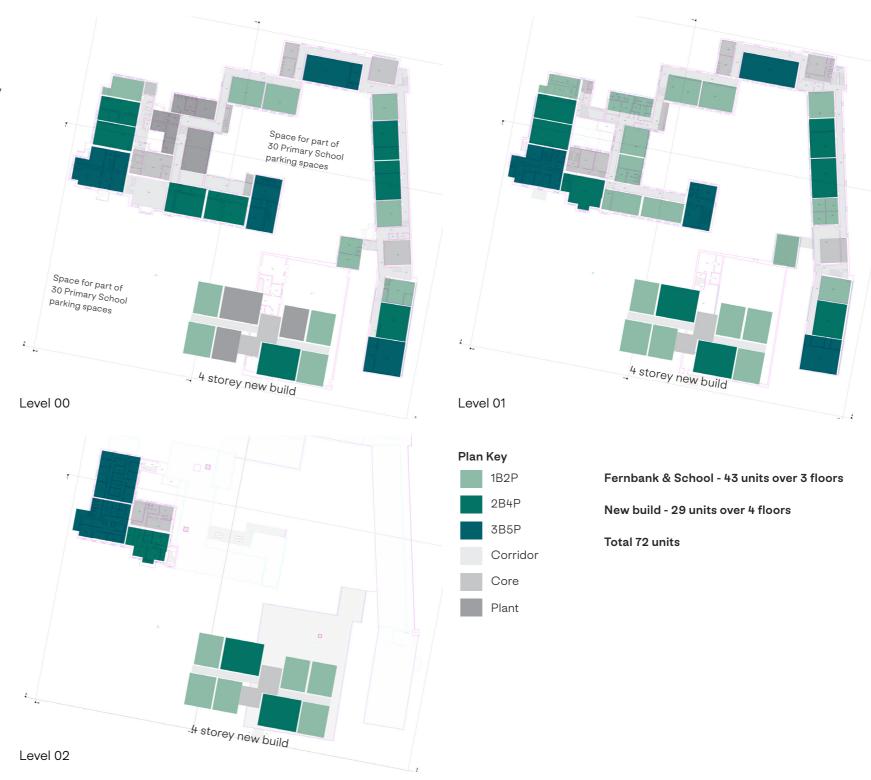
Figure 5.4.4 - Fernbank & School Retention Residential Capacity Sketch

Re-use studies have indicated that approximately 72 homes could be accommodated within the existing fabric once alterations have been made. The existing building occupies a large proportion of the Salesians site as a long, low-rise building. Its reuse would allow approximately ½ of the site to come forward with new accommodation while still providing the existing 30 Primary School parking spaces on the site. This would result in a c.4 storey newbuild residential building of c.8 units to a core also on the site.

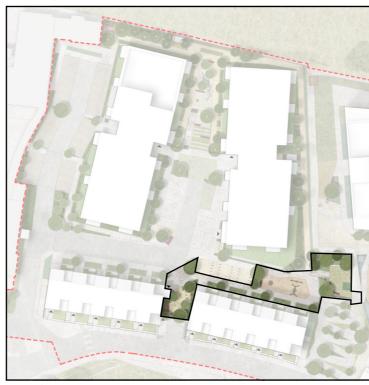
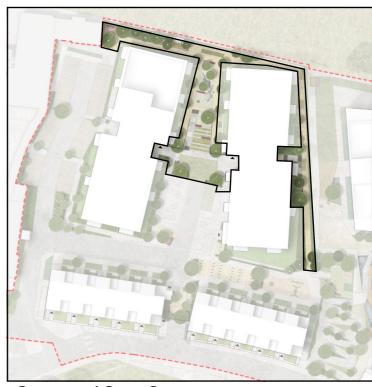
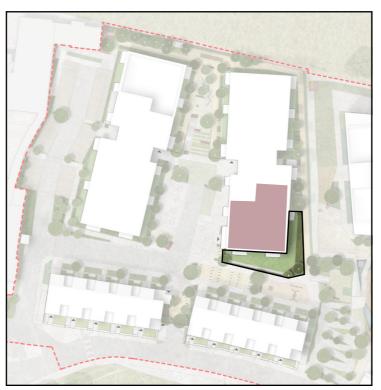
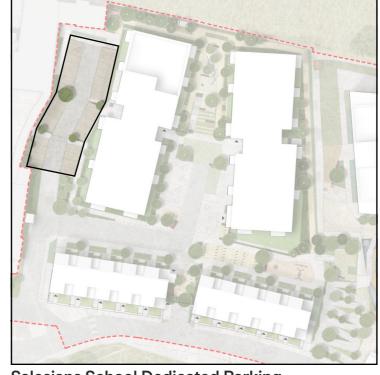
Figure 5.7.1 - Salesians Amenity Summary Diagrams

Further into the site, the more sheltered and protected areas are given over to secure communal open space. The level change creates an elevated terrace, away from any of the vehicle spaces, resulting in a quiet and secluded amenity space. Raised up and open to the south, this space receives good sunlight and has an excellent visual connection out over the site to the long views of the river, wetlands, and city in the distance.

In terms of other uses, the creche has its own dedicated, secure external space adjacent to the public open space, which itself contains a play space that children can make use of. The Salesians Primary School also has use of their own dedicated parking spaces, securely accessed from the western end of the site.
