ARCHITECTURAL DESIGN REPORT

Cleeves Riverside Quarter | October 2025

CRQMP-FCBS-XX-XX-RP-AA-0010 P01 - 16/10/2025

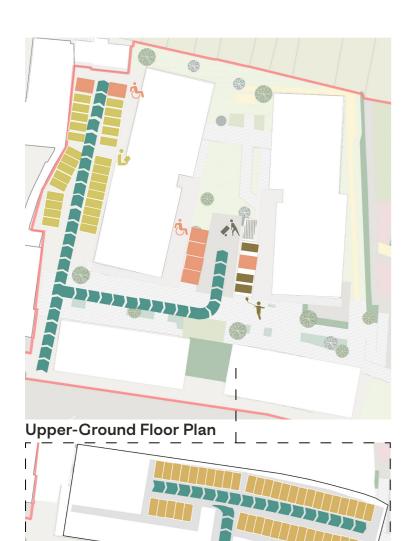
Figure 5.8.1 - Salesians Mobility and Servicing Diagrams

- · Vehicle access to the main site is from the southwest corner. This provides access to the dedicated parking for the Primary School, the creche parking, the accessible parking for the apartments, and the delivery drop off.
- Additional parking for the apartments is provided in a semi-basement car park accessed from North Circular Road, between the two sets of back-to-back Triplexes.

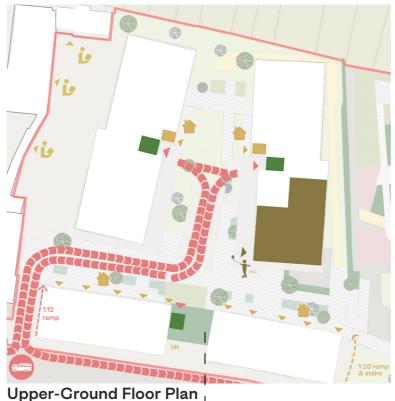
Lower-Ground Plan

- A lift provides access up from the shared basement car park, and there is stepped and ramped access up from the south-east corner of the site. This is publicly accessible for UD access or parents with prams accessing the creche.
- Apartment access is via two communal lobbies, each leading to a stair and two lifts. Triplexes and the Creche are accessed direct from outside. The school on the adjacent site can be accessed from its parking spaces.
- Emergency fire tender access to the stair cores is achieved by providing space for a turning head outside of apartments buildings

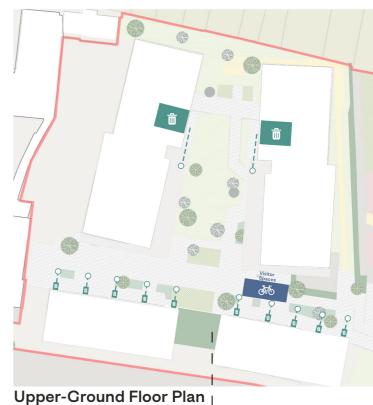
Lower-Ground Plan

- · A single communal bike store for the site is located in the semi-basement, accessed from either end of the site or through the middle, next to the car park entrance. Visitor cycle parking is provided in the landscape.
- Communal bin stores for the apartment blocks are accessed externally, adjacent to the communal lobby entrances. Triplexes have bins integrated into their front garden walls.

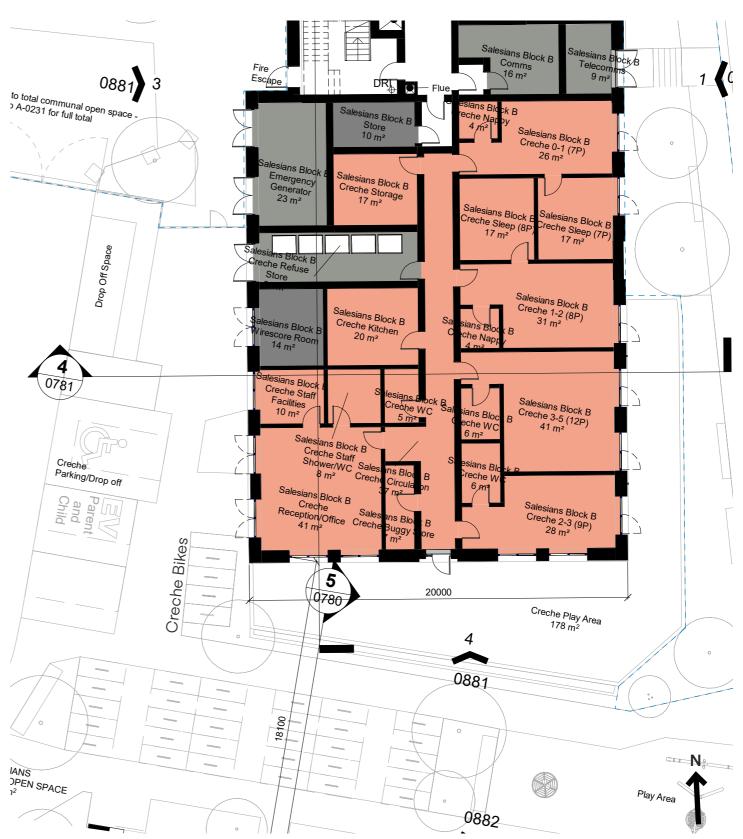
Figure 5.8.2 - Upper-Ground Plan, showing creche layout

The design accommodates 36 creche spaces, over the minimum 35 required by the number of units with 2bedrooms or more across the whole masterplan scheme in line with Planning Guidelines for Childcare Facilities (2001). Universal Design Guidelines for Early Learning and Care Settings Sample Creche has been used to identify the appropriate split of ages for these children, which is 7no. 0-1yrs, 8no. 1-2yrs. 9no. 2-3yrs and 12no. 3-5yrs. The number of children per room and their age range can be seen on the diagram to the right. Staff levels have been assumed to align with Schedule 6 of the Child Care Act 1991 Regulations Amended 2016, resulting in c.7 staff. Sanitary and ancillary provisions have been provided following Universal Design Guidelines for Early Learning and Care Settings. All food catering equipment that generate fat, oil and grease (FOG) will discharge through grease traps located external to the building.

The creche has 168 sqm of external space, 4 parking spaces and 4 cycle spaces, providing more spaces than those recommended in Table DM 9(a) of the Limerick Development Plan.

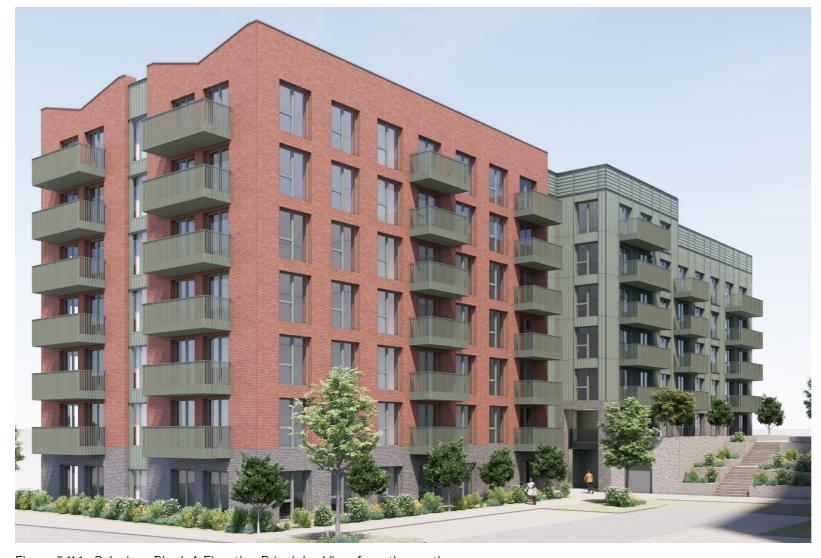
Figure 5.11.1 - Salesians Block A Elevation Principles View, from the south

The front gables are particularly prominent: from within the site, from the street front, and from the river. The visual weight of these gables is reduced by dividing them into two elegant vertical bays that echo the slender gables of other prominent industrial buildings in Limerick.

Given the less sensitive location outside the curtilage of the historic Mill site, there is the opportunity to have a more playful roofscape and these gables offer a modern interpretation of the pitched-roof industrial forms that characterise many similarly-scaled mill and warehouse buildings in the city.

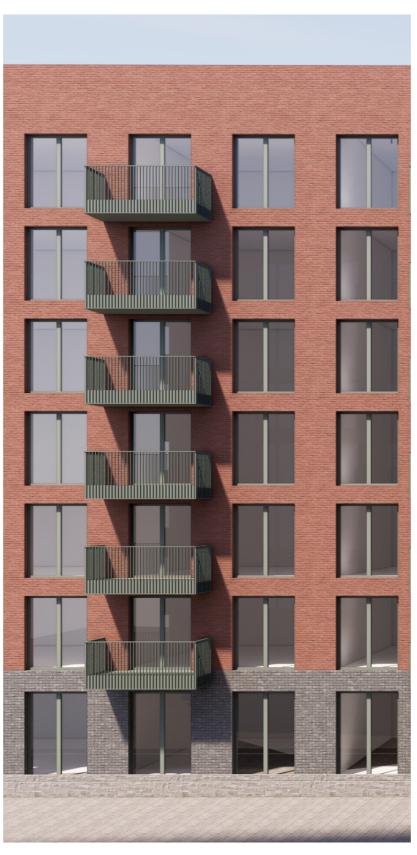
Figure 5.11.4 - Typical Brick Bay

The play of material and texture introduces variety to these buildings, whose massing and articulation is otherwise rigorous and repetitive. An elegant proportion of solid and void creates a calm and rhythmic facade, making a clear reference to the architectural language of the Cleeves mill and the industrial typology more generally.

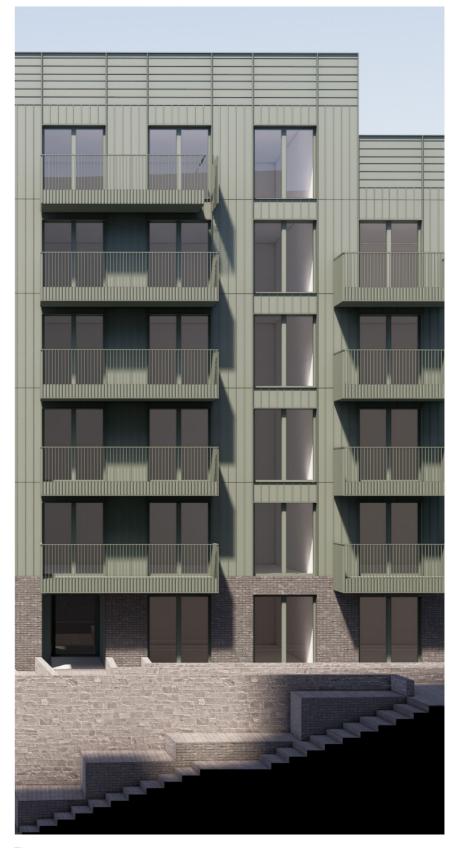
Figure 5.11.5 - ypical Metal Bay

A light green, ribbed metal cladding has been introduced to add variety to the longer buildings and continue the rich history of lighter industrial sheds on the historic Mill site. All metal window frames and railings will be the same green tone, tying both the brick and metal elements together.

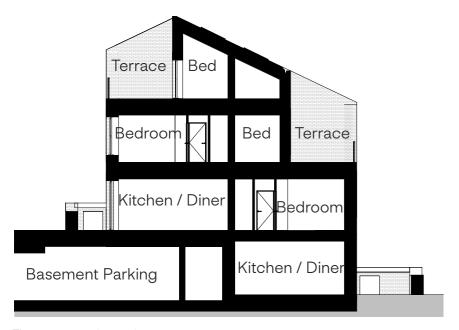
Figure 5.12.1 - Cross Section, showing the split level plan

This typology echoes the principles of rhythm, proportion, verticality, and playful roofscape evident on the apartment blocks. Inset terraces break up the massing of the pitched roof, introducing additional easterly aspect and opening up oblique views to the historic mill or riverfront, depending on orientation. These terraces, besides offering fantastic amenity, articulate each home within the block and reinforce a sense of verticality mirrored by the window proportions.

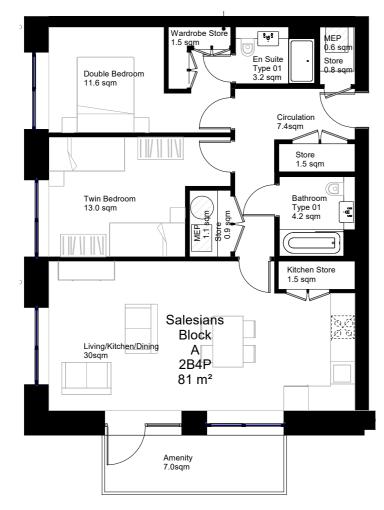
Layout Type 4_2B49_F01 2 Bed 4 persons 81sqm

7sqm of Private Amenity

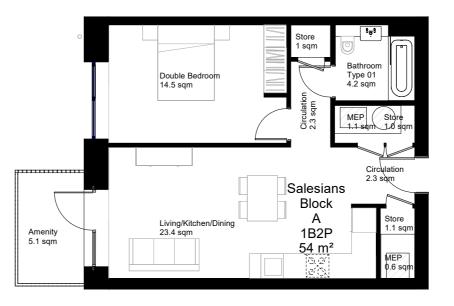
Layout Type 4_1B2P_F01 1Bed 2 persons 54sqm

5sqm of Private Amenity

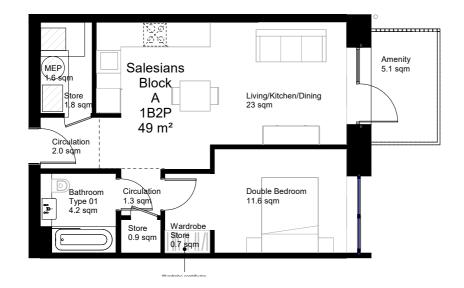
Layout Type 4_1B2P_F02 1Bed 2 persons 49sqm

5sqm of Private Amenity

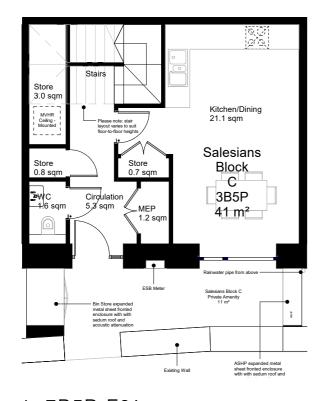
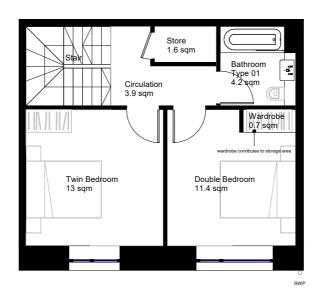
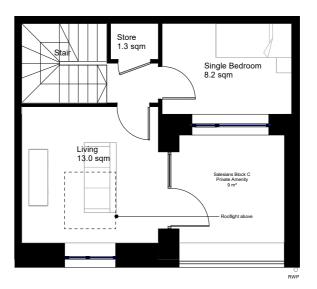
Layout Type 4_3B5P_F01 3 Bed 5 persons 110.4sqm

9sqm of Private Amenity + Front garden of varying size

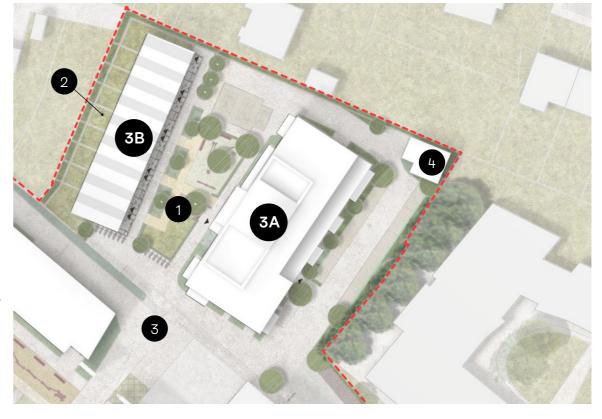
Figure 6.1.1 - Stonetown Terrace Site Layout Diagram

- External Communal Amenity space for residents
- Private terraces / gardens for townhouses
- Pedestrian connectivity from Stonetown Terrace to Quarry, Flaxmill and lower sites via new ramp and steps integrated into the quarry edge
- 4 Secure Bike Shelter for Residents

3A 5 Storey Apartment Block

3B 3 Storey Townhouses

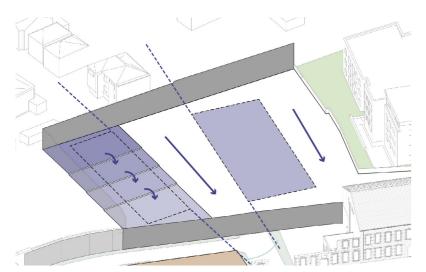
01. Stepped Site Levels

In response to the existing gradients (higher to the NW, lower at the SE at the entrance from Stonetown Terrace, all sloping down towards the reservoir), new site levels are set closer to the lower existing levels to the east, removing previous fill material in the centre of site, and stepping up to the NW along the western boundary. Thus orienting the new development to the south overlooking the reservoir, whilst reducing impacts on neighbours.

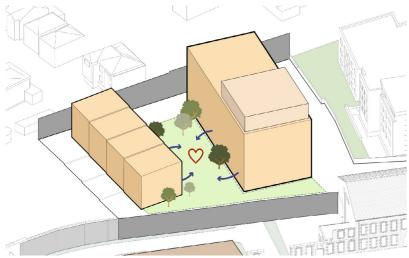
04. Communal External Amenity

The blocks are arranged around a communal amenity garden for all ages, with play spaces for young children, promoting a sense of community. Oriented to the south this shared garden allows all to benefit from sunlit amenity space with views over the reservoir and industrial heritage elements unique to the site. Townhouses benefit from front yards with easy access to the communal garden.

Figure 6.1.2 - Stonetown Terrace Design Evolution Strategy Diagrams

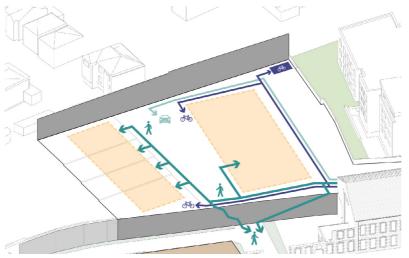
02. Pedestrian Oriented Approach

Prioritizing a pedestrian friendly approach to the new residences, a pedestrian entrance sequence through a communal garden is facilitated from the quarry/reservoir side, with vehicular and cycle approach via a shared surface from Stonetown Terrace arriving at parking to the north of the site. Steps and a universally accessible ramp to/from the reservoir. Service vehicles (refuse & deliveries) are limited to the entrance area of the site to avoid a vehicular dominated landscape elsewhere.

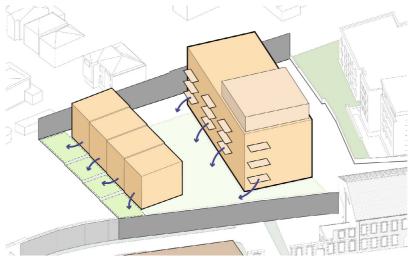
05. Private Amenity Space

Apartments are provided with private terraces facing west overlooking the communal garden, east, or south. Dual aspect dwellings at the south benefit from terrace views overlooking the reservoir or looking down Stonetown Terrace towards the riverside. Townhouses benefit from private rear gardens and front yards with easy access to the communal garden.

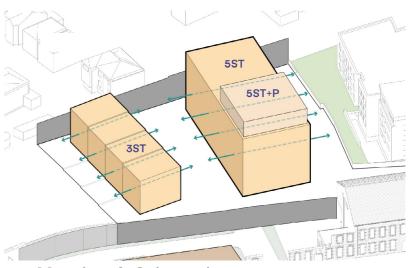
03. Massing & Orientation

The proposed massing of the mixed residential typologies (townhouses and apartments) responds to the neighbouring massing, with the apartment block located to the east adjacent to the Landsdowne Hall apartments and a terrace of townhouses to the west adjacent to the neighbouring Clanmaurice Ave houses. Both are arranged along the N-S axis to optimize daylight access to dwellings, with rooftop plant massing located to the south away from neighbours.

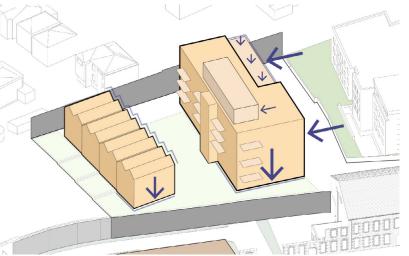
06. Enhancing Daylight & Sunlight

In order to minimize daylight impacts on neighbouring properties and to optimize sunlight to external amenity space, the blocks are dropped by 1.5m. The apartment block massing at the north east steps down to reduce impacts on Landsdowne Hall, whilst the higher massing of rooftop plant is located to the south west. Townhouses roof configuration is pitched, optimizing sunlight access in external amenity space.

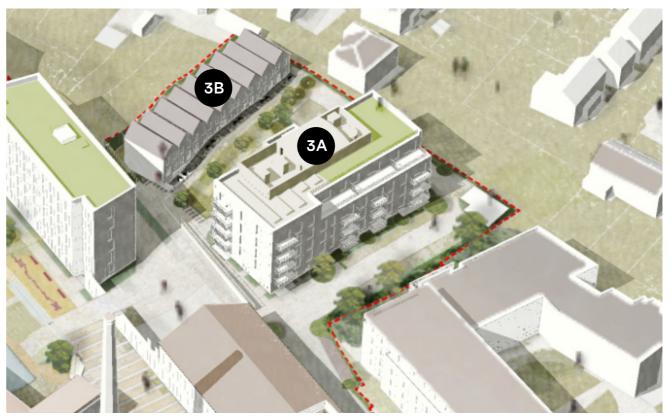
Figure 6.1.3 - Aerial Sketch View of Stonetown Terrace

- - 5 Storey Apartment Block
- 3 Storey Townhouses

An open roof top plant area housing air source heat pumps (ASHPs) enclosed with acoustic screening is located towards the west and south following the stepped massing. A barrel vault roof form covers an internal plant room. The townhouse roofs are pitched in response to the character of surrounding residential streets to the north, and with gables facing the garden bring a sense of identity to individual homes.

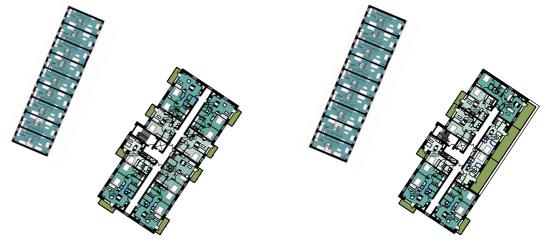
Figure 6.2.2 - Typical Floor

(1st/2nd/3rd floor of apt block)

Figure 6.2.3 - Top Floor Plans

(4th Floor plan of Apartment Block / 2nd floor of townhouses)

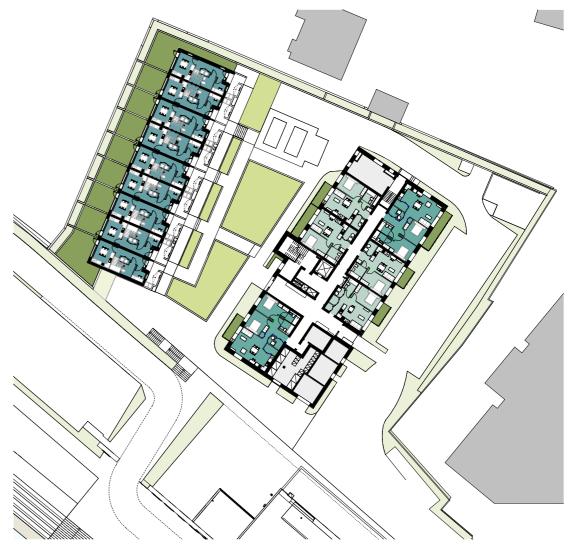
Figure 6.2.1 - Ground Floor Plan in context

A Diversity of dwelling types is offered within the plot incorporating a mix of 38no. apartments and 9no. townhouse typologies

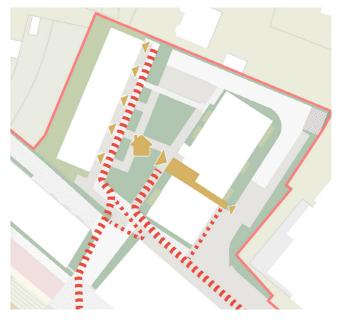
Figure 6.3.1 - Entrance Strategy & Pedestrian Access Diagram

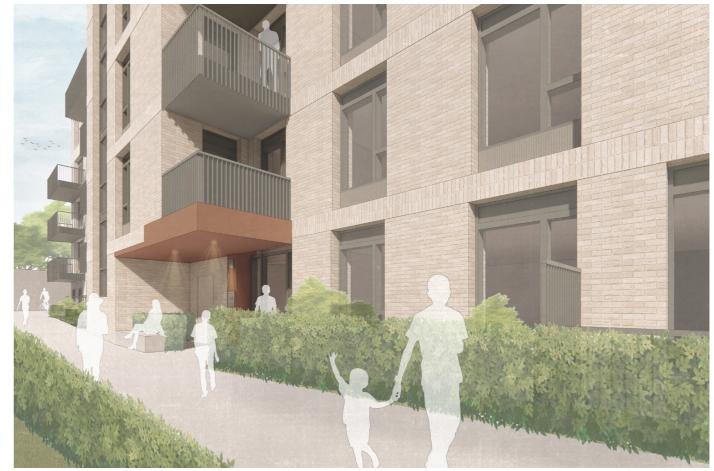
Figure 6.3.2 - Sketch View 01 of Stonetown Terrace Apartments Main Entrance

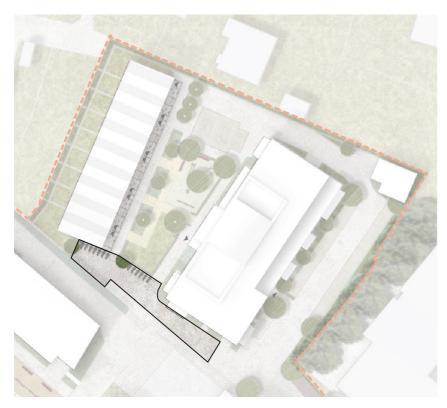
Figure 6.4.1 - Public Open Space Strategy Diagram

Public open space is incorporated along the south side of the plot, a natural vantage point overlooking the Reservoir / Quarry area below. Connectivity to the lower sites and the public realm around the Reservoir / Quarry and Flaxmill space, enable activation of the public areas of Stonetown. A universally accessible ramp in this location facilitates easy movements down to the play space available for older children adjacent to the reservoir, and also to the various amenity spaces for all ages around the reservoir /quarry and beyond to the Flaxmill plaza and Riverside

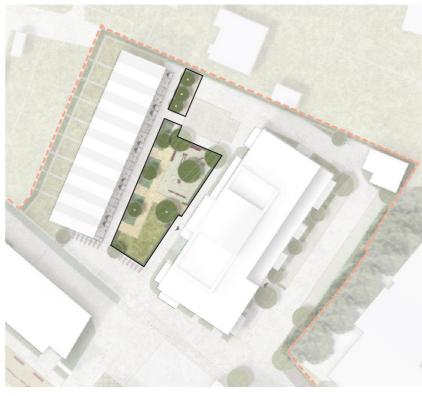
Figure 6.4.2 - Communal Open Space Strategy Diagram

A central landscaped garden forms a focus for the residents, providing shared open space for multigenerational amenity, accessible from apartments and townhouses alike. It incorporates a play space for younger children, along with places for pause and seating areas. A nature-based approach to site drainage is integrated into the landscape strategy offering amenity and bio-diversity benefits.

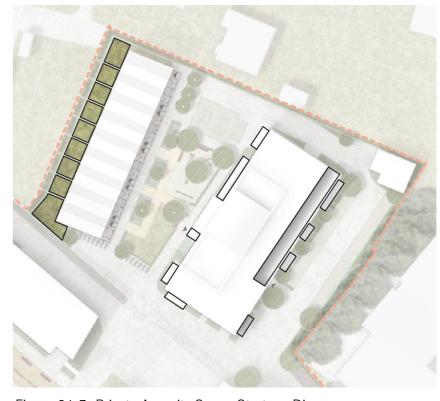
Figure 6.4.3- Private Amenity Space Strategy Diagram

Each new apartment has associated private open space in the form of a private balcony or ground floor terrace accessed off the living area (with a minimum depth of 1.5m). Top floor apartments to the north east have larger terraces where the set-back occurs. Balustrading extends to form privacy screening where private amenity spaces are adjacent. Ground foor terraces are screened with a landscaped buffer from the semi-private areas adjacent.

A private garden is provided to the rear of each townhouse, in addition to a front entrance yard. First Floor living rooms benefit from juliet balconies overlooking the communal garden. A proportion of amenity space recommended for the townhouses (not more than 50%) is accommodated within the communal open space /garden.

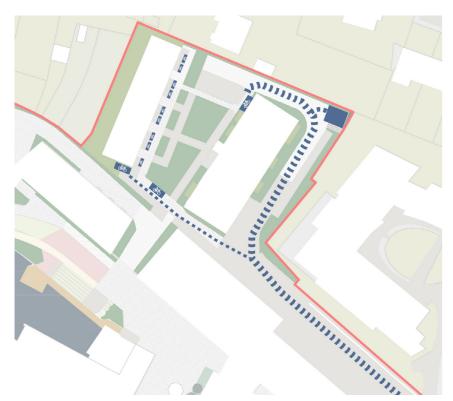
Figure 6.5.1 - Cycle Access & Storage Strategy

Pedestrian, cycle and vehicular access to Stonetown homes arrives via a shared surface from Stonetown Terrace and is segregated at the entry to the site.

Reduced car parking provision is balanced by generous cycle parking provision. Both standard and universally accessible EV car parking spaces are provided. Covered and secured cycle storage is provided in an external facility accommodating double stacked cycle parking and in individual cycle storage enclosures in front of each townhouse. Supplementary cargo cycle storage spaces are also provided along with visitor cycle parking.

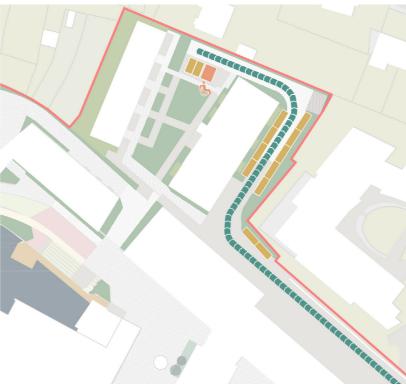
Figure 6.5.2 - Car Parking Strategy

Car parking is provided to the east and north of the site., with a combination of standard and universally accessible EV charging enabled parking spaces. A setdown space is provided for visitor set down and small van deliveries adjacent to the secondary entrance from the car parking side of the apartment block.

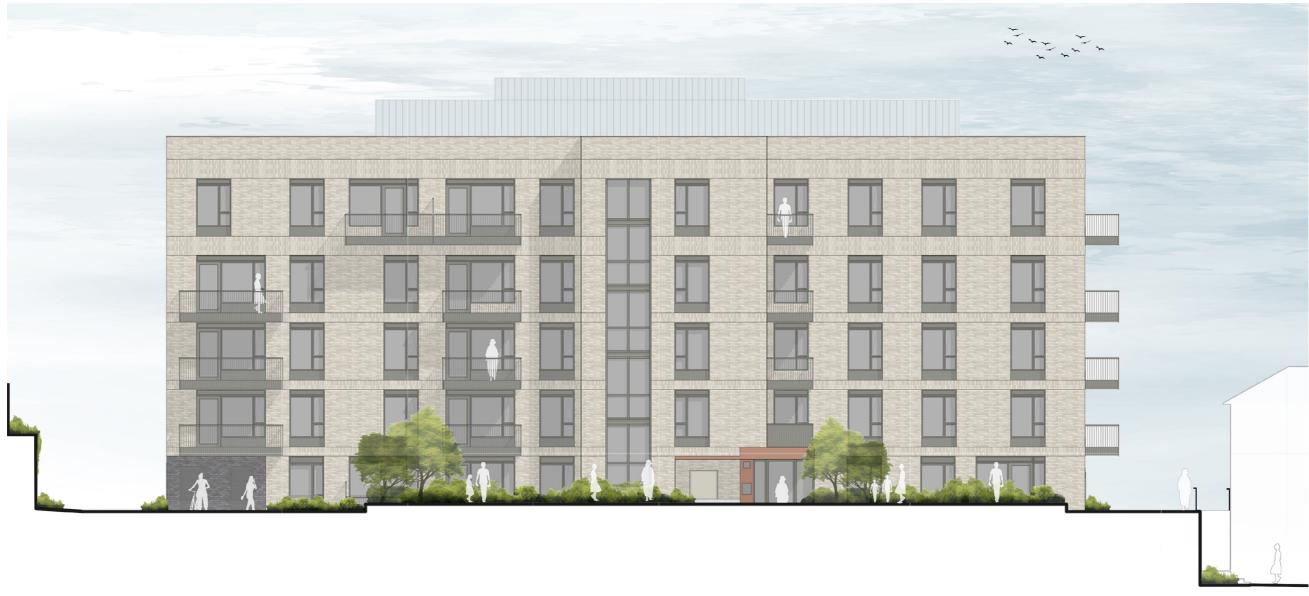
A key element is brick, with two colour blends, creating a textured backdrop. Lighter colours on this plot take a cue both from the light colours of Landsdowne Hall and the light pastel shades to be found on Clanmaurice Avenue residences. The darker grey brick matches that on the student accommodation and creates a base with a lighter colour used on the upper massing. Metal balconies, window/door surrounds, louvred doors and infill façade panels on both apartments and townhouses are similar in colour to the lighter brick colour.

Figure 6.6.1 Stonetown Terrace Apartments West Elevation

Metal in balcony balustrades and privacy screening, window/door surrounds complement the brick in a colour matching the light buff grey coloured brick. An accent colour is used on metal panel elements that frame and articulate the entrance and canopy soffits, and offer a location for entrance intercom and wayfinding etc. Terracotta colour is used here echoing the colour of weathered steel, a memory of the industrial history of Cleeves, also used on the PBSA facades and elements of the public realm.

Visual screening of vertically corrugated metal to the roof plant area enclosing the ASHPs, at the south west, incorporates acoustic attenuation. The covered plant room with a barrel vault form is clad in matching corrugated metal cladding both in anodised aluminium and referencing the forms found in the existing industrial heritage elements of the Cleeves site.

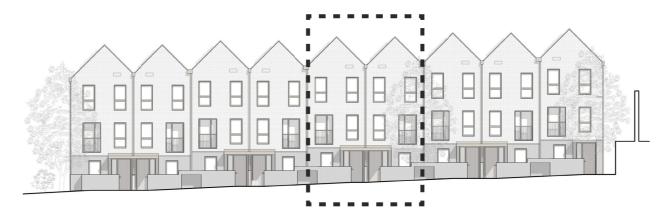
Figure 6.6.4 Stonetown Terrace Townhouses East Elevation

Pitched slate roofs with PV panels on southern side, incorporate a thin edge detail on the gable fronts.

The front yard enclosures incorporating bike, refuse storage, and those screening individual Air Source Heat Pumps are sedum covered and timber screened.

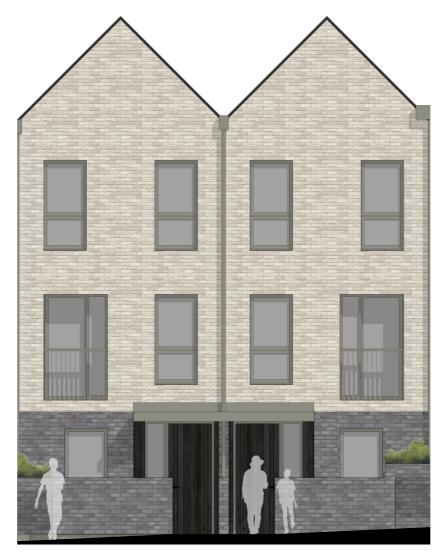
Figure 6.6.5 Stonetown Terrace Townhouses Bay Study

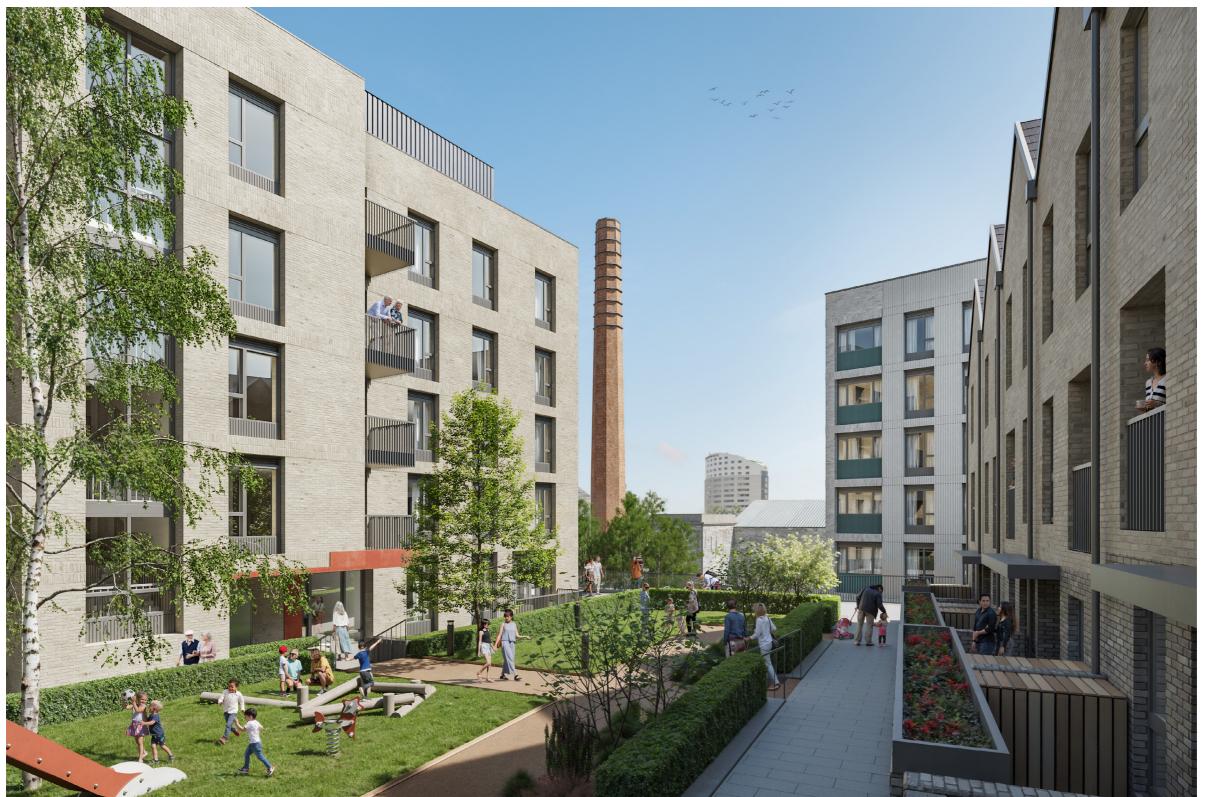
Figure 6.6.7- View of Communal Amenity Space from Northwest

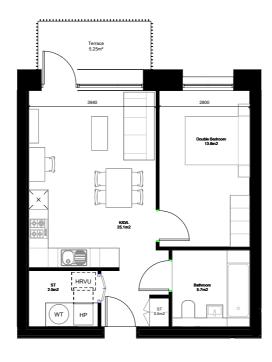
Figure 6.7.1 - Example of 1B 2P Apartment

The apartment block and townhouse terrace have been developed to suit the site layout constraints and to achieve well-proportioned homes with good daylight access, efficient space planning, and minimum areas exceeded in accordance with the client brief.

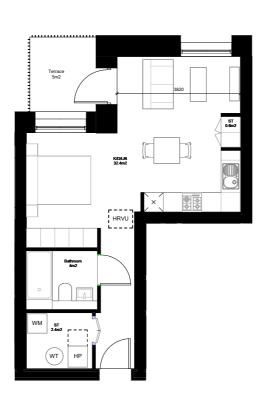
Figure 6.7.3 - Example of Studio Apartment

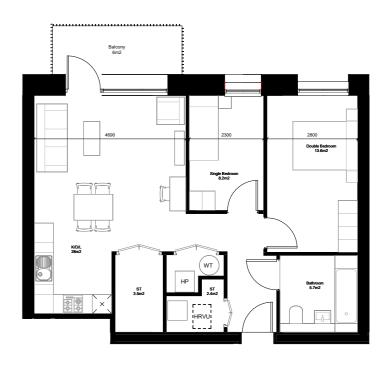
Figure 6.7.2 - Example of 2B 3P Apartment

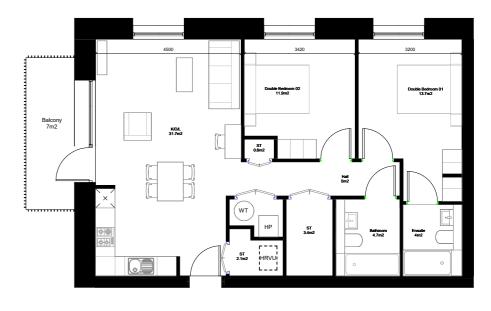
Figure 6.7.4 - Example of 2B 4P Apartment

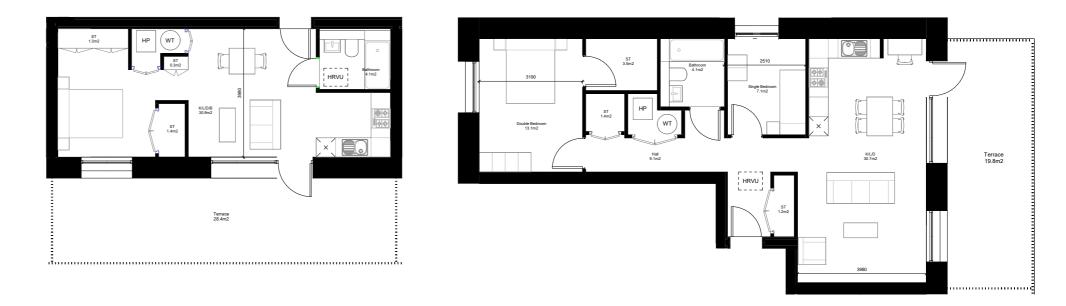
Figure 6.7.5 - Example of Studio Apartment

Figure 6.7.6 - Example of 2B 3P Apartment

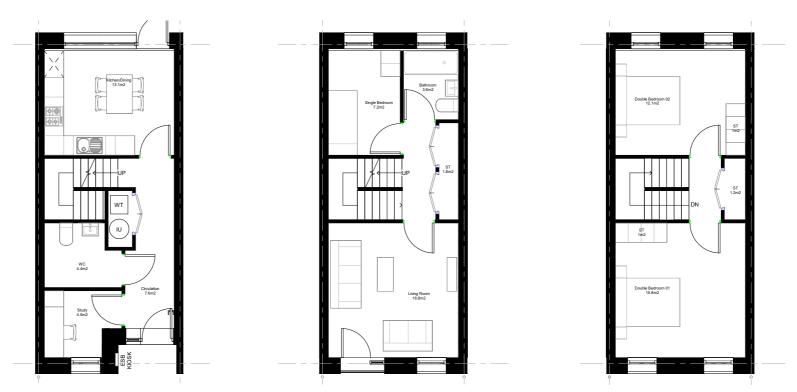
Figure 6.7.7 - 3B 5P Townhouse, over 3 levels

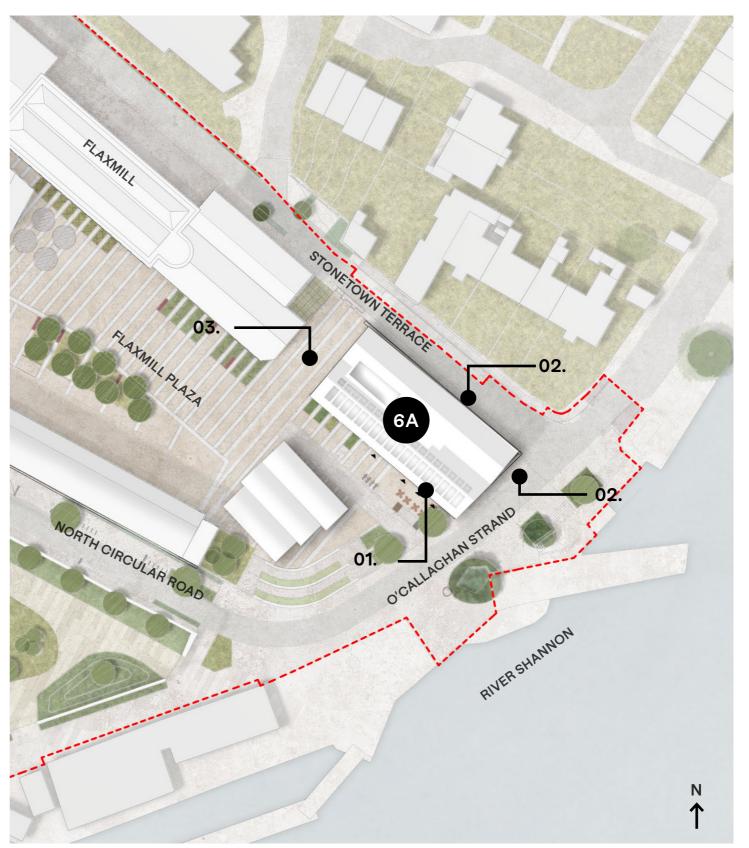
Figure 7.1.2 - O'Callaghan Strand plot site layout diagram

The new plaza is raised above the level of O'Callaghan Strand and North Circular Road, matching the +5.7m AOD of the Flaxmill. The new building is raised to the same level, to ensure adequate protection in the event of a flood. Limited maintenance access along the north-east facade is required from the lower Stone Town Terrace, but all other access into the new building will be directly from the new plaza on foot.

The location of amenity space and public uses within the scheme have been concentrated on the south and east, towards the new Flaxmill Plaza and the River Shannon. Later drawings will show how balconies, terraces, and commercial spaces have been placed to maximise activation of the public realm and minimise overlooking to the residents of Stone Town Terrace.

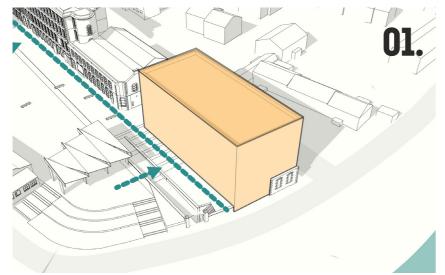
01. Aligned massing

Single four-storey apartment block aligning both the height and the south-west elevation with the flaxmill and integrated with the historic curtilage wall.

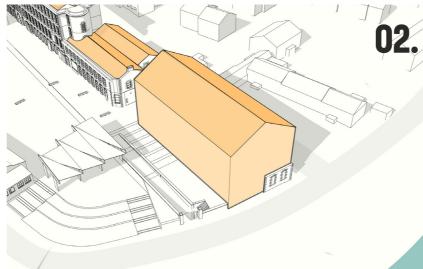
02. Pitched Roof Form

Echo the surrounding roofscapes and industrial sheds by introducing a pitched roof with a strong gable elvation to the city.

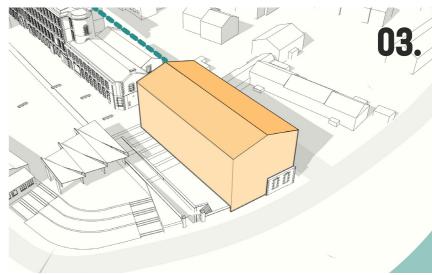
03. Keeping the height below the Flaxmill

The pitch is reduced to sit under the ridgeline of the Flaxmill, whilst trying to retain the industrial aesthetic and rooform.

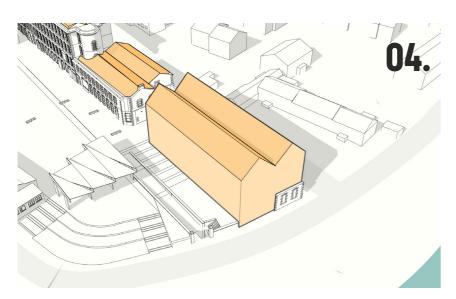
04. Double Pitch

Splitting the roof into two gables reduces its visual weight, and creates a stronger formal relationship to the Dairy Building's double gable.

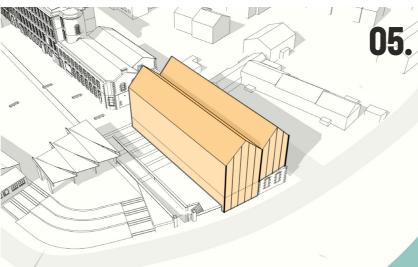
05. Proportion and Impact

Subtle changes lower the northern roof slightly and the double gable end now aligns with the end of the historic curtilage wall and integrates the building within the existing context.

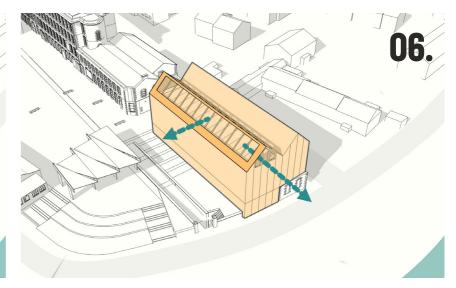
06. The Southern Range

The southern range is opened up to create a communal terrace with views of the city and river, while shielding the neighbours to the north from overlooking and noise.

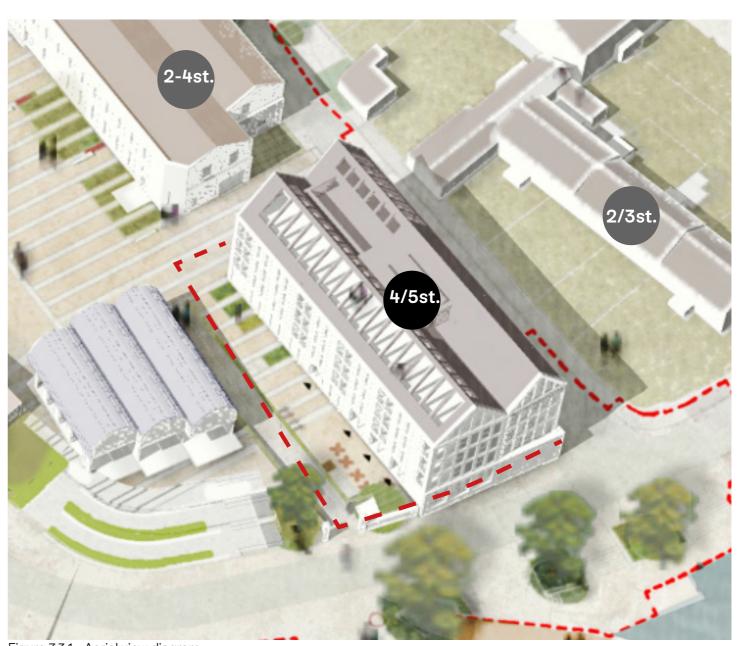
Figure 7.3.1 - Aerial view diagram

The new 4/5-storey building strikes that balance. It accommodates the mix of uses this gateway site needs and maximises the number of new homes within a massing that is responsive to the sensitive location. The double pitches, and strong gables it creates, are the defining feature of the new building's massing. The roof form works hard, discretely concealing a significant amount of plant that would otherwise be visibly obtrusive, and creates shelter for the required communal amenity space.

Visually, the pitched roof and gables establish a strong connection the heritage context of the Cleeves site, and the wider industrial context of Limerick, where there are several examples of similarly slender gables. The double pitched roof also has the benefit of reducing the overall sense of mass, reducing visual impact and improving sunlight/daylight to the surrounding neighbours. The height of the ridges remains below the Flaxmill parapet line, maintaining the primacy of this major heritage asset.

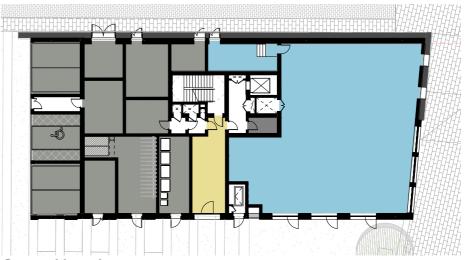
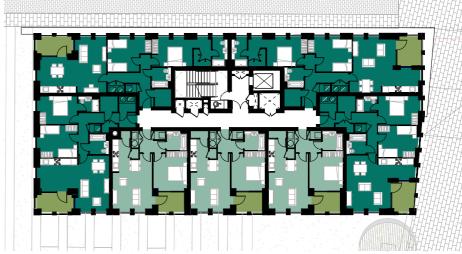
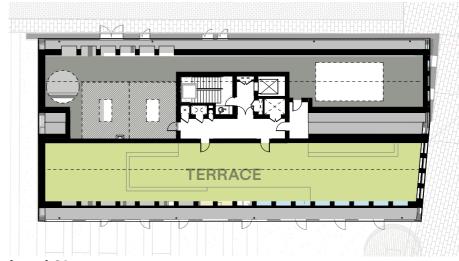
Figure 7.4.1 - O'Callaghan Strand Layout Diagrams

Ground Level

Level 01-03

Level 04

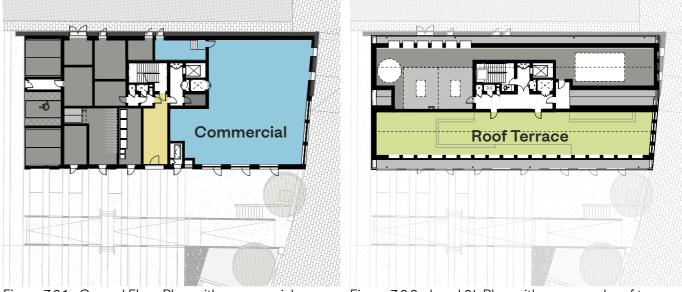
Figure 7.6.1 - Ground Floor Plan, with commercial space Figure 7.6.2 - Level 04 Plan, with communal roof terrace

The rest of the site forms part of the new Flaxmill Plaza. Besides the integrated seating and a spill-out zone for the commercial offer, space is created for a generous external canopy structure: providing shelter, generating clean energy, and enabling the public realm to host a number of large scale events.

The communal space requirements for the new residents has been located on the roof of the new building. This move frees up the ground plane for public uses and takes advantage of the plot's prime riverside setting. The pitched roof subtly transforms into a pergola structure to provide some shelter from the wind, while still maximising views of the River Shannon and the city centre beyond.

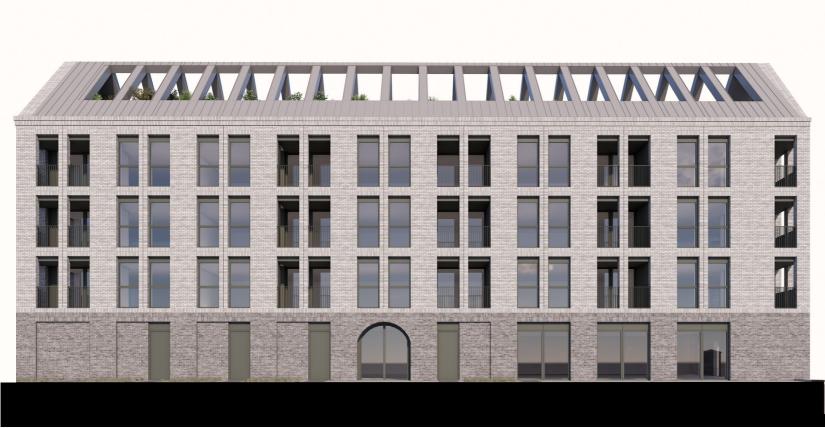
Figure 7.8.2 - Flaxmill Plaza Elevation

The paired openings are combined into a single larger bay rhythm for the ground floor. These become large glazed openings for the commercial space, and become inset brick panels with metal doors where required for the back-of-house residential spaces. The communal residential entrance announces itself within the facade in the same manner as the Flaxmill: an arched opening breaks the rhythm of rectangular openings.

The gable facade uses the same rhythm of openings, but translates it into a lighter and more frame-like language. The gables are subtly different to each other, in order to align with the geometry of the existing wall and mirroring the asymmetric pitches of the Dairy Building and Flaxmiil roofs. A shift from a 6-bay to a 5-bay rhythm is able to accommodate the difference in width. The other notable visual difference between the two gables is a result of the different uses within the pitched roofs. The northernmost pitch houses plantrooms and maintains a solid presence, while the southernmost gable forms the communal amenity terrace, so it opens up to the city and riverfront opposite.

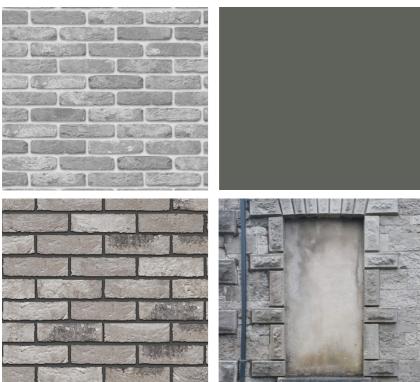
Figure 7.8.4 - Material Palette

The dark base brick and light upper brick share a language of slender piers, emphasised by their stack bonded coursing. The same detail of stack-bonded soldier courses above openings forms the basis for the frame-like architectural language of the gables. This details creates a seamless transition between areas of more open and framed, and more solid areas of elevation as the design changes around different sides of the building.

Metal elements take on a secondary role, as framing elements that differentiate the roof volume. The pitched roofs are grey, and are inset from the facade lines. The metal window frames and railings will be a rich olivegreen/grey tone, providing a warmth to the building in the colour of its detailing and referring back to some of the green metal tones evident in the historic mill site and within the proposed Salesians development.

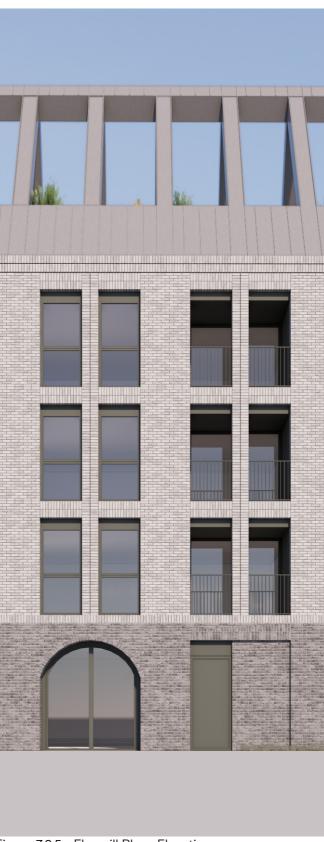
Figure 7.8.5 - Flaxmill Plaza Elevation

Variety is captured on different elevations to suit contextual responses, while maintaining the rigour of a repetitive façade rhythm. Multiple flat types with different balconies and window locations have been arranged within the façade in a way that uses a single sized opening on a regular grid to accommodate the various balconies, windows, and solid panels of different units.

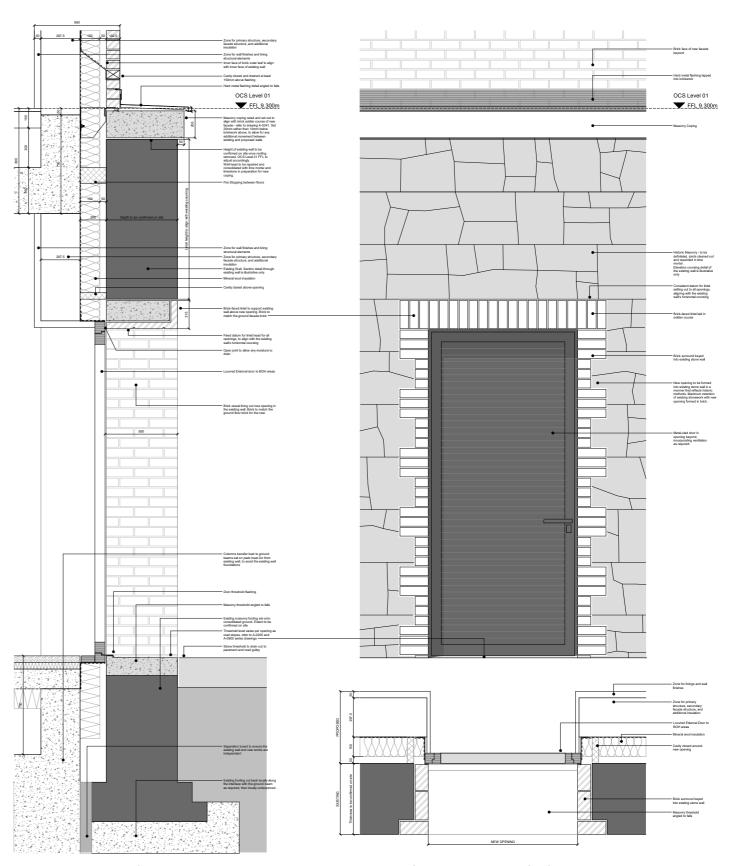
Figure 7.9.2 - Detail of a typical door opening in the existing wall. Refer to A-300 series for further details

As well as forming new windows in the blind opening, some new openings are required into the historic wall along the northern elevation to allow for plant and emergency access. These have been reduced as far as possible to retain the integrity of the Linen Store wall.

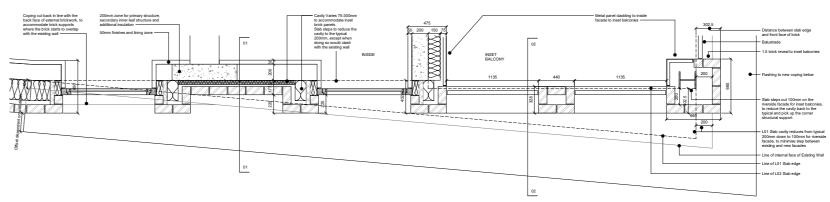
- OCS Bay Study 04 Plan Detail L01
- OCS Bay Study 04 Elevation

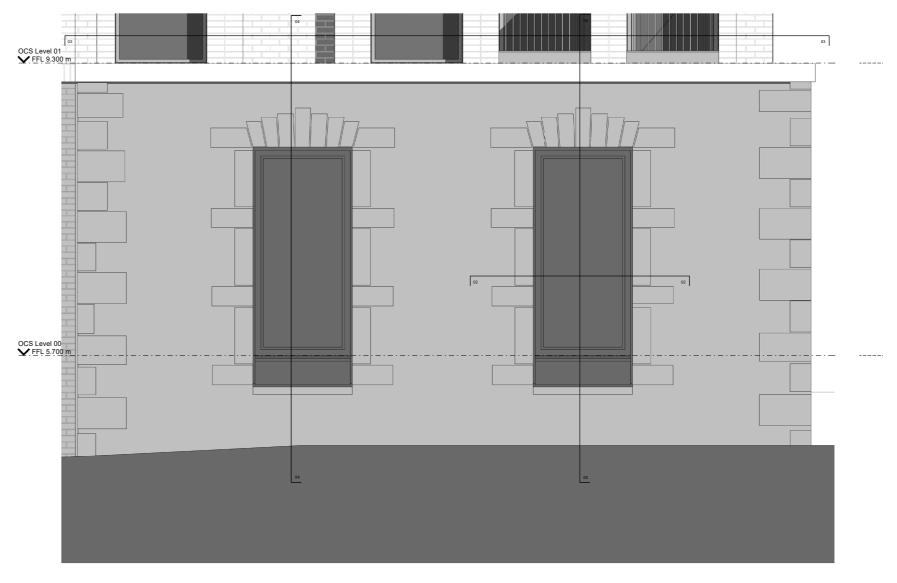
Figure 7.9.3 - Detail of the riverside elevation, including typical opening in the existing wall. Refer to A-300 series for further details

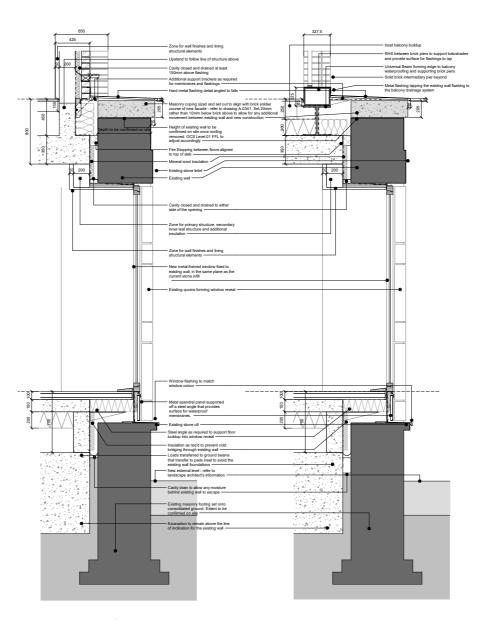
Figure 7.9.7 - Detail of the riverside elevation, including typical opening in the existing wall. Refer to A-300 series for further details

The opening up of access into the site from the southeast will be achieved by reopening of the former cart entrance. This will reinstate a former access route into the mill yard.

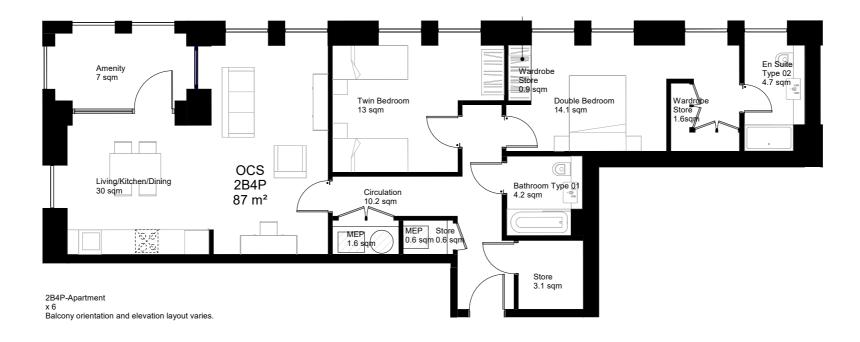
Layout Type 6_2B4P_F01 2 Bed 4 persons 87sqm

7sqm of Private Amenity

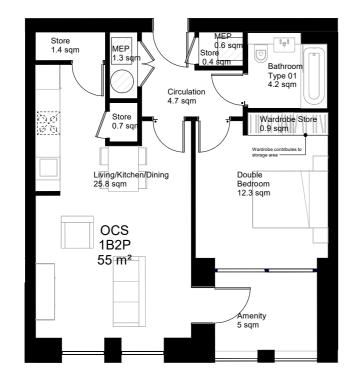
Layout Type 6_1B2P_F01 1Bed 2 persons 55sqm

5sqm of Private Amenity

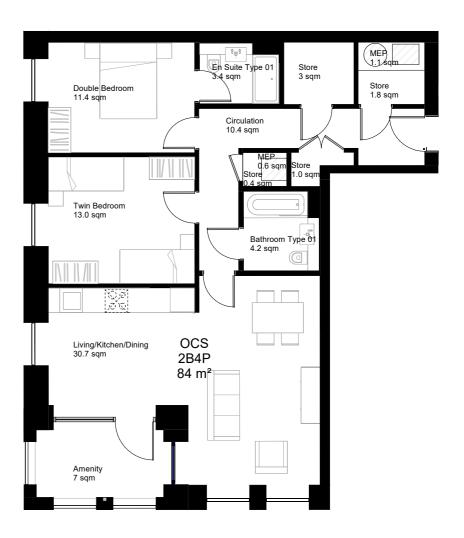
Layout Type 6_2B4P_F02 2 Bed 4 persons 84sqm

7sqm of Private Amenity

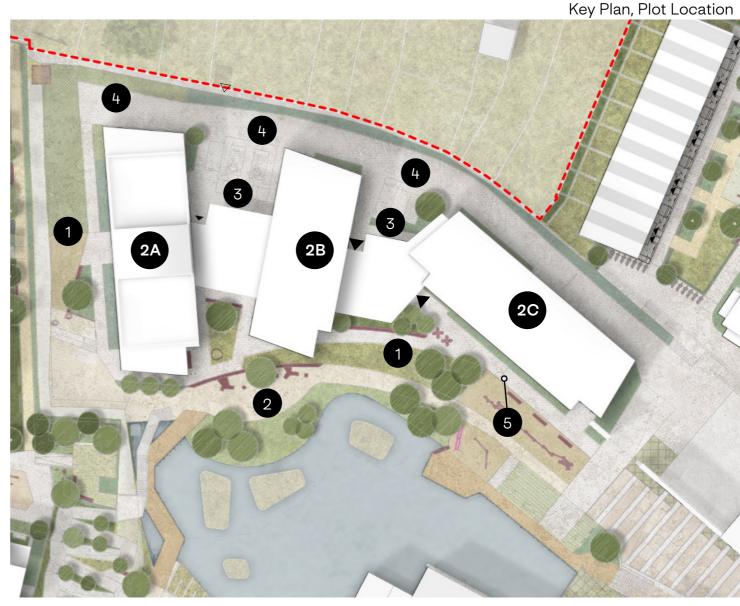
Figure 8.1.1 - Quarry Site Layout Diagram

Student Accommodation is provided at the location of the old quarry on the site adjacent to the reservoir, at a key location within the Cleeves Riverside Quarter. Integrated into this unique setting, it is organized around a south facing communal garden overlooking the reservoir. Configured in three thin building wings, it is focussed around a linking ground level that accommodates the communal entrance, reception area and shared facilities opening to the shared garden, fostering a sense of cohesion and community.

- Primary Entrance
- Secondary Entrance
- **2A** West Wing, 7 storey with roof plant
- 2B Central Wing, 7 storey
- 2C East Wing, 6 storey

- 1 External Communal Amenity Space
- 2 Public Realm
- 3 Secure Bike Parking
- 4 Car Parking Spaces
- 5 External Access Gate / Secure Line

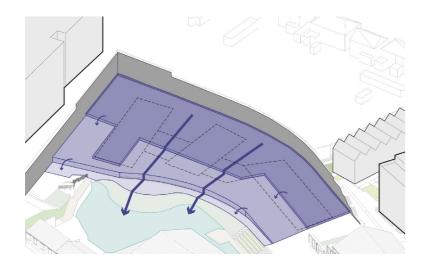
01. Stepped Site Levels

Echoing the stepped topography from the quarry wall down to the reservoir, and in order to locate student sleeping accommodation above the flood protection level (at 6.2 AOD), new site levels are set stepping down from north to south towards the reservoir edge. Student internal and external amenity spaces are located at 5.7m, with a landscaped threshold between these and the lower public route around the reservoir that connects to main Flaxmill space, NCR and upper residential sites..

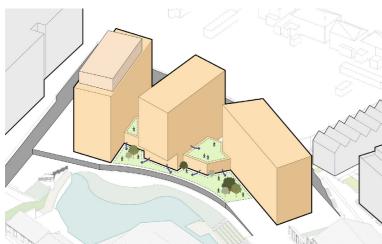
04. External Student Amenity

Communal external amenity gardens and activity spaces are located to the south and west, benefitting from views over the reservoir and access to sunlight. Arranged to be accessed from the centralised entrance and internal amenity spaces, facilitating spill out from these spaces into the garden. A first floor terrace with similar orientation and views offers further setting for interaction and engagement. Figure 8.1.2 - Quarry PBSA Design Evolution Diagrams

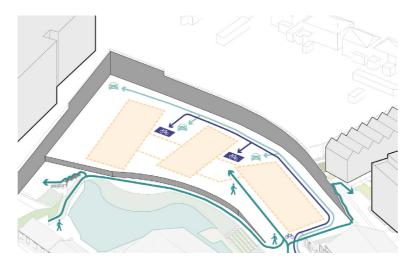
02. Pedestrian Oriented Approach

Prioritizing a pedestrian friendly approach to the student accommodation, an entrance sequence through the student garden is facilitated from a number of directions along the reservoir side, with separate vehicular and cycle approach via a shared surface from NCR. The latter arrives at the north side, adjacent to parking, with through access to the centralised entrance, accessed by pedestrians from the south side.
