ARCHITECTURAL DESIGN REPORT

Cleeves Riverside Quarter | October 2025

CRQMP-FCBS-XX-XX-RP-AA-0010 P01 - 16/10/2025

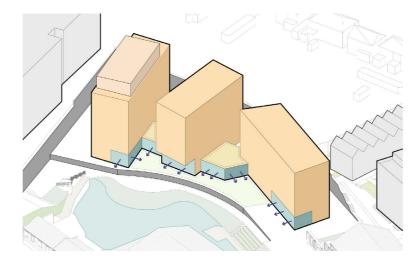
05. Internal Student Amenity

Student amenity spaces are arranged around the south facing garden façade, where activities can spill out weather permitting, promoting a sense of collegiality. Communal gathering and collaboration settings are located in the central student support area, with quieter study and recreation rooms located in the wings, also interfacing with the garden and benefitting from views over the reservoir.

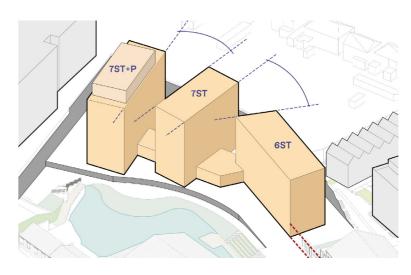
03. Massing & Orientation

The proposed massing steps up from east to west in response to the scale of the adjacent Flaxmill buildings to the east, and the higher new apartment buildings on the upper Salesians site to the west. Wings of the building are arranged in a fan-like manner, the eastern most block aligning with the Flaxmill, whilst the other wings are arranged close to the N-S axis to optimize daylight access to student rooms.

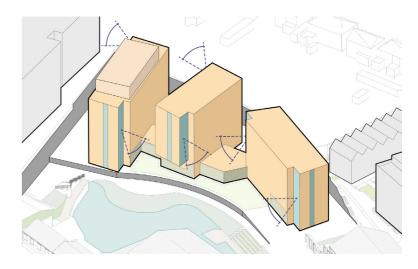
06. Shared Living Spaces

The shared living spaces at the end of each student accommodation cluster are located to benefit from views of distinctive natural and/ or industrial heritage features of this unique site (quarry, chimney, reservoir), enhancing a sense of identity and sense of place.

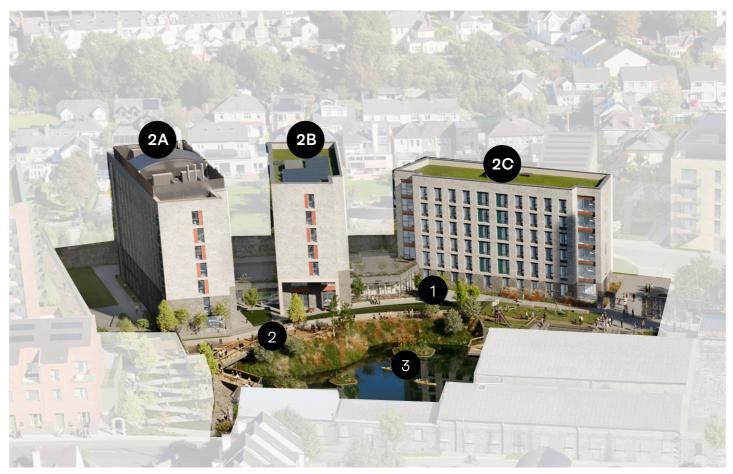
Figure 8.1.3 - Aerial Sketch View of Quarry PBSA in context

An open roof top plant area housing air source heat pumps (ASHPs) enclosed with acoustic screening, is located on the western wing (Block 2A), towards the south to reduce impact on adjacent residents. In the centre of the block a barrel vault roof form covers an internal plant room and reflects previous roof forms found on the Cleeves site.

- 2A West Wing, 7 storey with roof plant
- **2B** Central Wing, 7 storey
- **2C** East Wing, 6 storey

- 1 External Communal Amenity Space
- 2 Public Realm
- 3 Reservoir

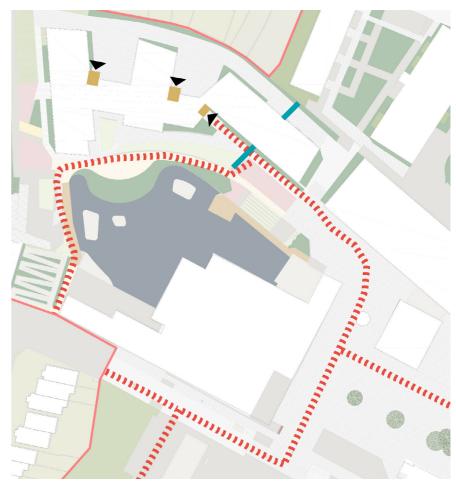
Figure 8.2.1 - Entrance Strategy Diagram

An inviting split level reception area links all the wings at ground level. with informal seating areas offers access into the south facing garden with views over the reservoir and infiltration galleries beyond.

Accommodation for a managers office and facility management, central plant and utilities rooms, are located adjacent to the main reception area. Externally a setdown space for small van deliveries is located, whilst internally a student mail area is located. The layout enables passive surveillance of entrances and approach, reducing potential for anti-social behaviour.

- Secure line for PBSA only access

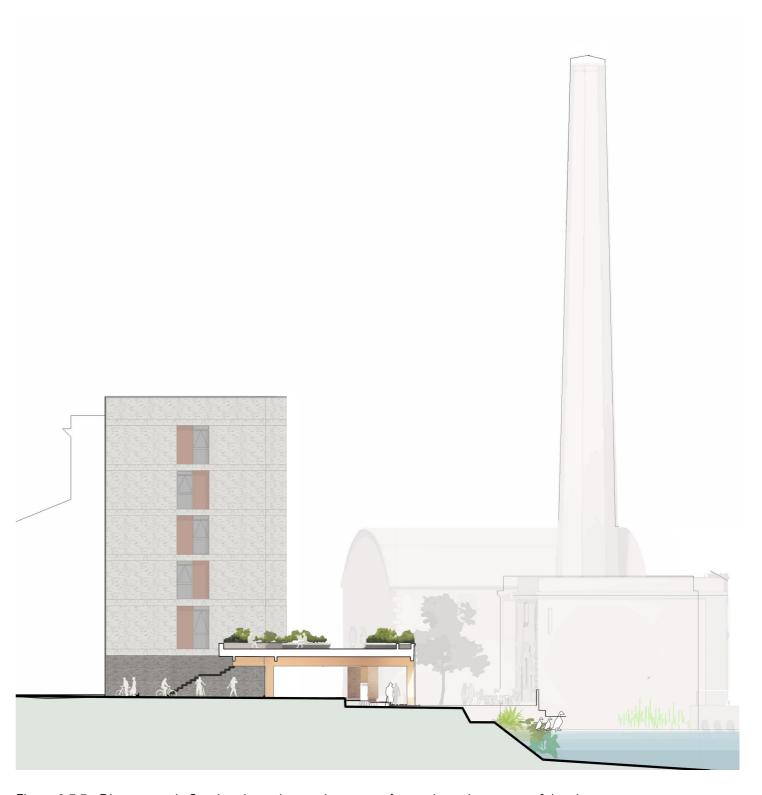
Figure 8.3.3 - Diagrammatic Section through amenity spaces for students, in context of the site

Communal student amenity facilities are provided internally on ground and first floor in the central linking element. They offer inviting spaces encouraging social integration and benefiting from daylight and views.

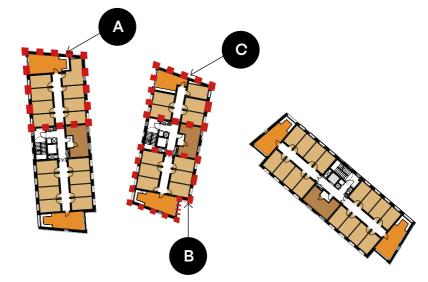
Figure 8.4.4 - Typical Upper Floor

- A Typical 8 bedroom Cluster
- B Typical 6 bedroom Cluster
- C Typical 5 bedroom Cluster

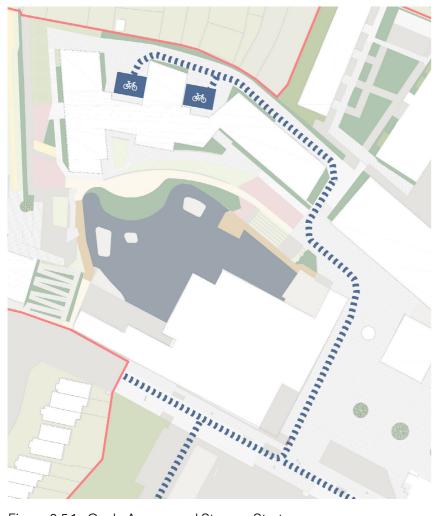
Figure 8.5.1 - Cycle Access and Storage Strategy

- Vehicular and cycle routes across the shared surfaces along the quarry edge arrive at the car and bike parking areas adjacent to the north side of the central entrance. Reduced car parking provision is balanced by generous cycle parking provision. Both standard and universally accessible EV car parking spaces are provided, alongside covered double stacked cycle parking and cargo cycle spaces.

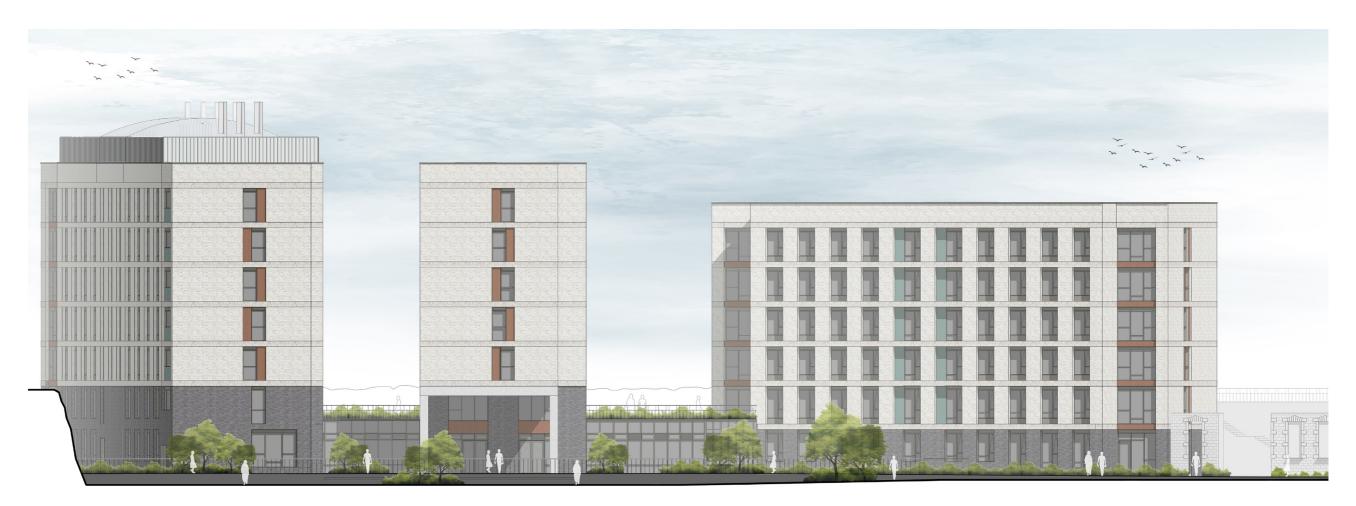
Figure 8.6.1 - South Elevation

The articulation of the base, stepping from 1 storey to 2 storey, expressed in a different colour and texture, makes reference to the scale of the original walls lining the site, rising to the scale of the quarry wall. This reflects the stepped massing rising to the West towards the quarry wall and the higher mass of the Salesians apartment blocks on the upper level. The rooftop plant enclosure on the West wing (Block 2A) is receded from the South allowing the gable facade to be expressed independently.

At the central reception and shared amenity spaces on ground and first floor, the facade is activated with full height glazing, exposing potential timber interior, its framing integrated with the railing edge of the amenity terrace above.

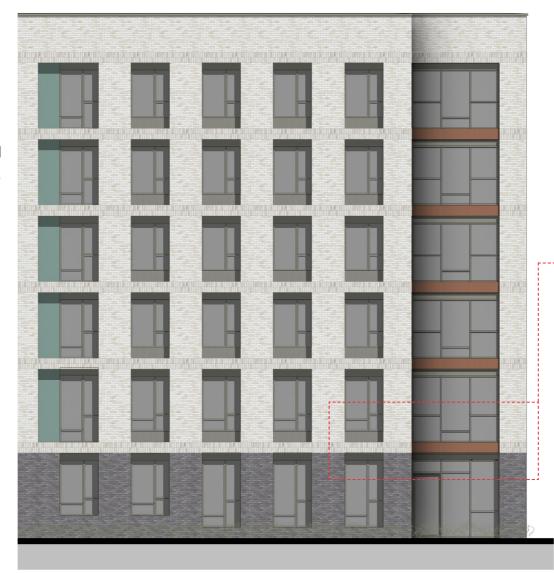
Figure 8.6.2 - South Elevation Bay Study

The façade of the study bedroom wing aligned with the Flaxmill, and the façades of the central and west wings facing the Flaxmill are clad in solid brick, wrapping around to form 'bookend' gables that extend to offer larger windows to the students' shared living rooms. On the opposite facades, fibre cement cladding in similar colour makes reference to the mineral character of the stone quarry face.

Texture is introduced in the brick façade with rotated bonding patterns at storey datum levels and below window panels. Slightly protruding bricks on end are used to provide some texture in the base at the central block. Vertically ribbed fibre cement panels bring variation to the façade, modulation of scale, interplay of light and shadow. Corrugated metal cladding aligned vertically on the rooftop plant enclosure makes reference to the corrugated metal roofs and cladding of the industrial heritage remnants of Cleeves.

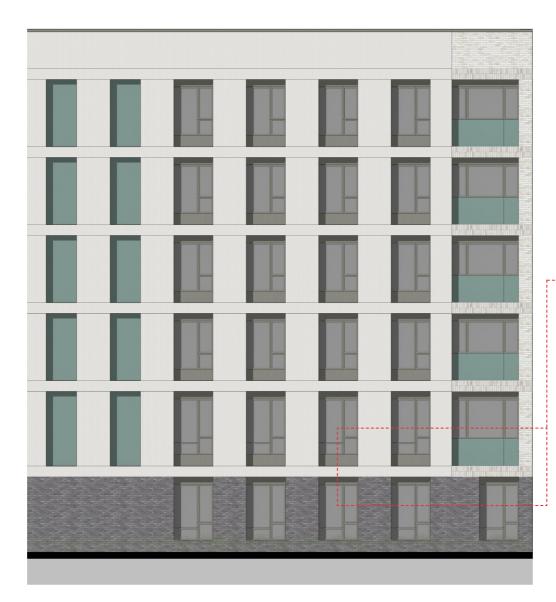
Figure 8.6.3 - North Elevation Bay Study

Fibre cement cladding in matching light grey reflects light down into the quarry base. Colour accents in fibre cement offer an opportunity to echo some of the colours of the industrial and maritime heritage of the context eg rust colour (weathered steel in corrugated roofing/industrial remnants/ moorings along the quayside/ etc), shades of blue /green (corrugated cladding).

Window /door framing, sills and jambs at fibre cement cladding, balustrading and coping, are proposed to be of selected warm grey colour to match brick colour.

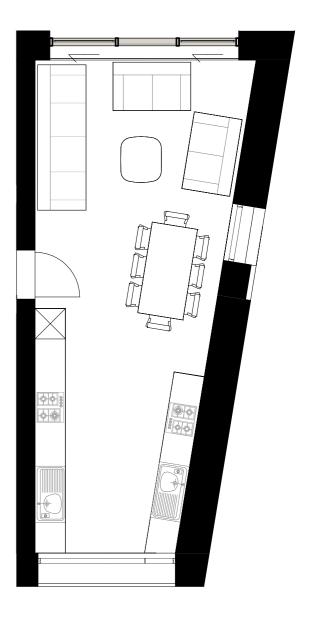
Figure 8.7.2 - Shared space for 8 bedroom cluster

As per Guidelines on Residential Developments for 3rd Level Students (Section 50 Finance Act 1999) & Update 2005, the shared kitchen/dining/living room spaces within each cluster provide a minimum of 4 sq. m per bedspace in the unit.

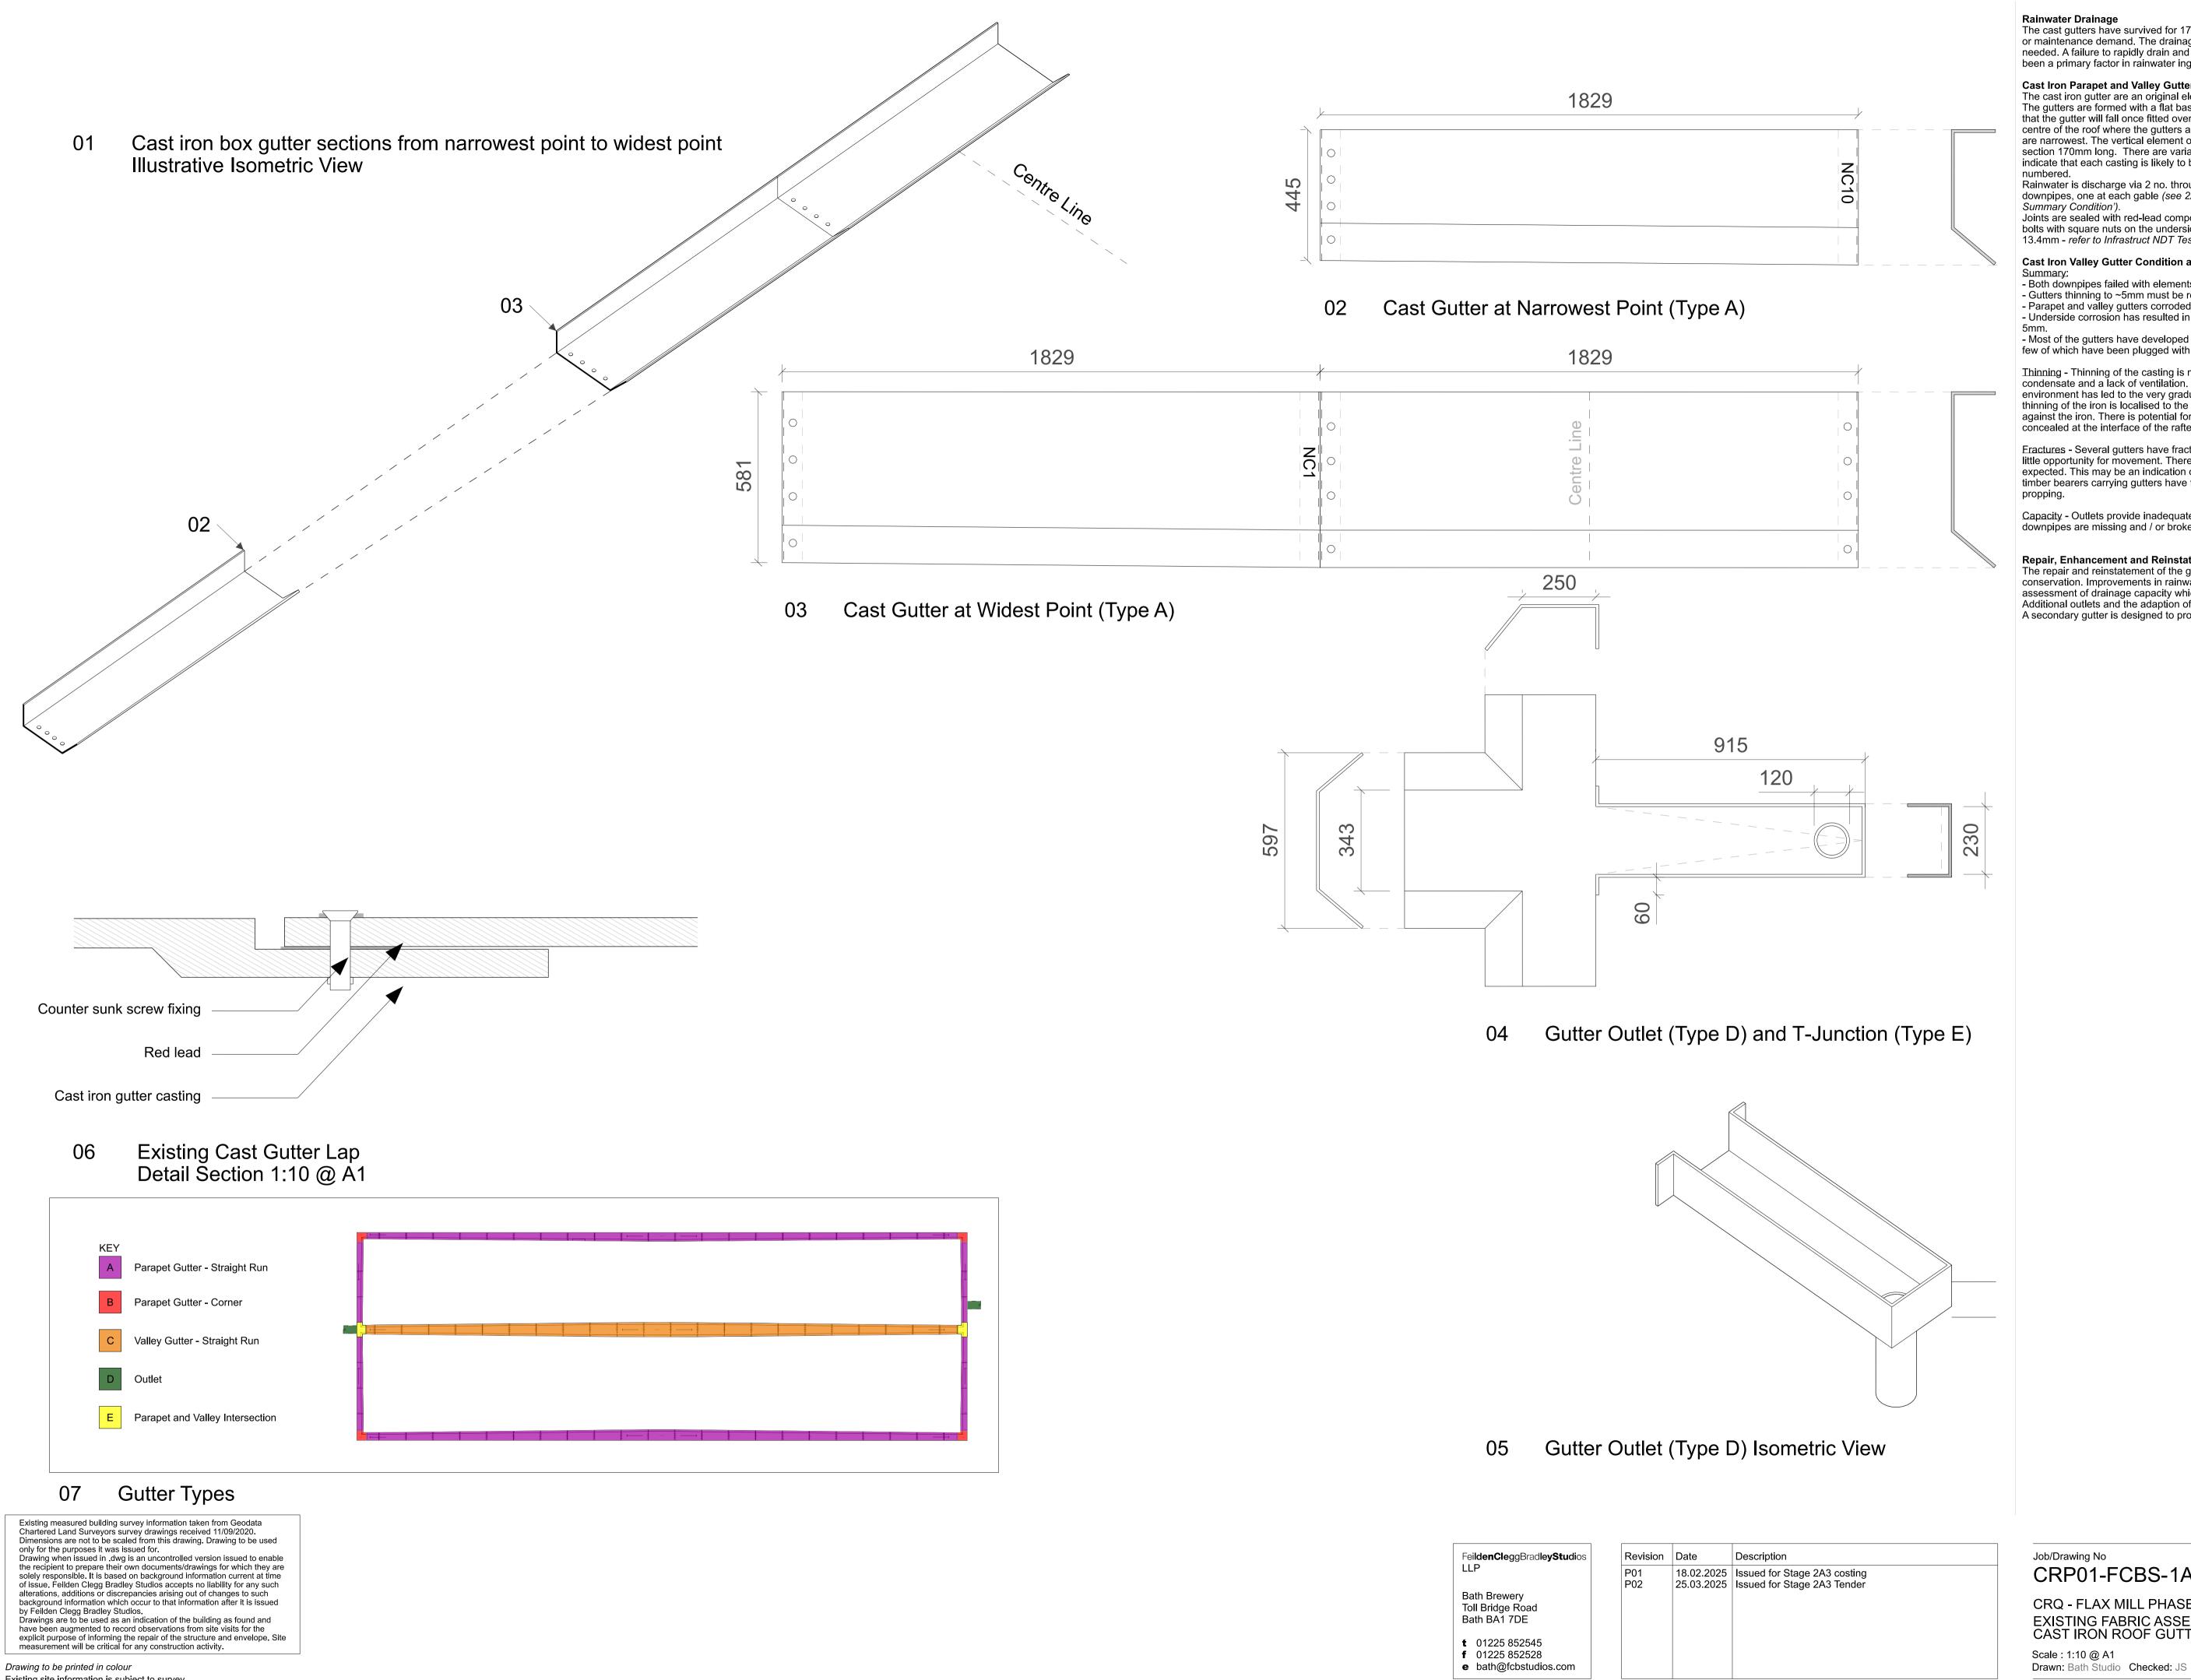
The cast gutters have survived for 170 years with little evidence of structural failure or maintenance demand. The drainage capacity is, however, significantly less than needed. A failure to rapidly drain and the subsequent overtopping of gutters has been a primary factor in rainwater ingress.

Cast Iron Parapet and Valley Gutters
The cast iron gutter are an original element of the buildings fabric.
The gutters are formed with a flat base that narrows along its length. This ensures that the gutter will fall once fitted over the 35-degree rafters. High points at the

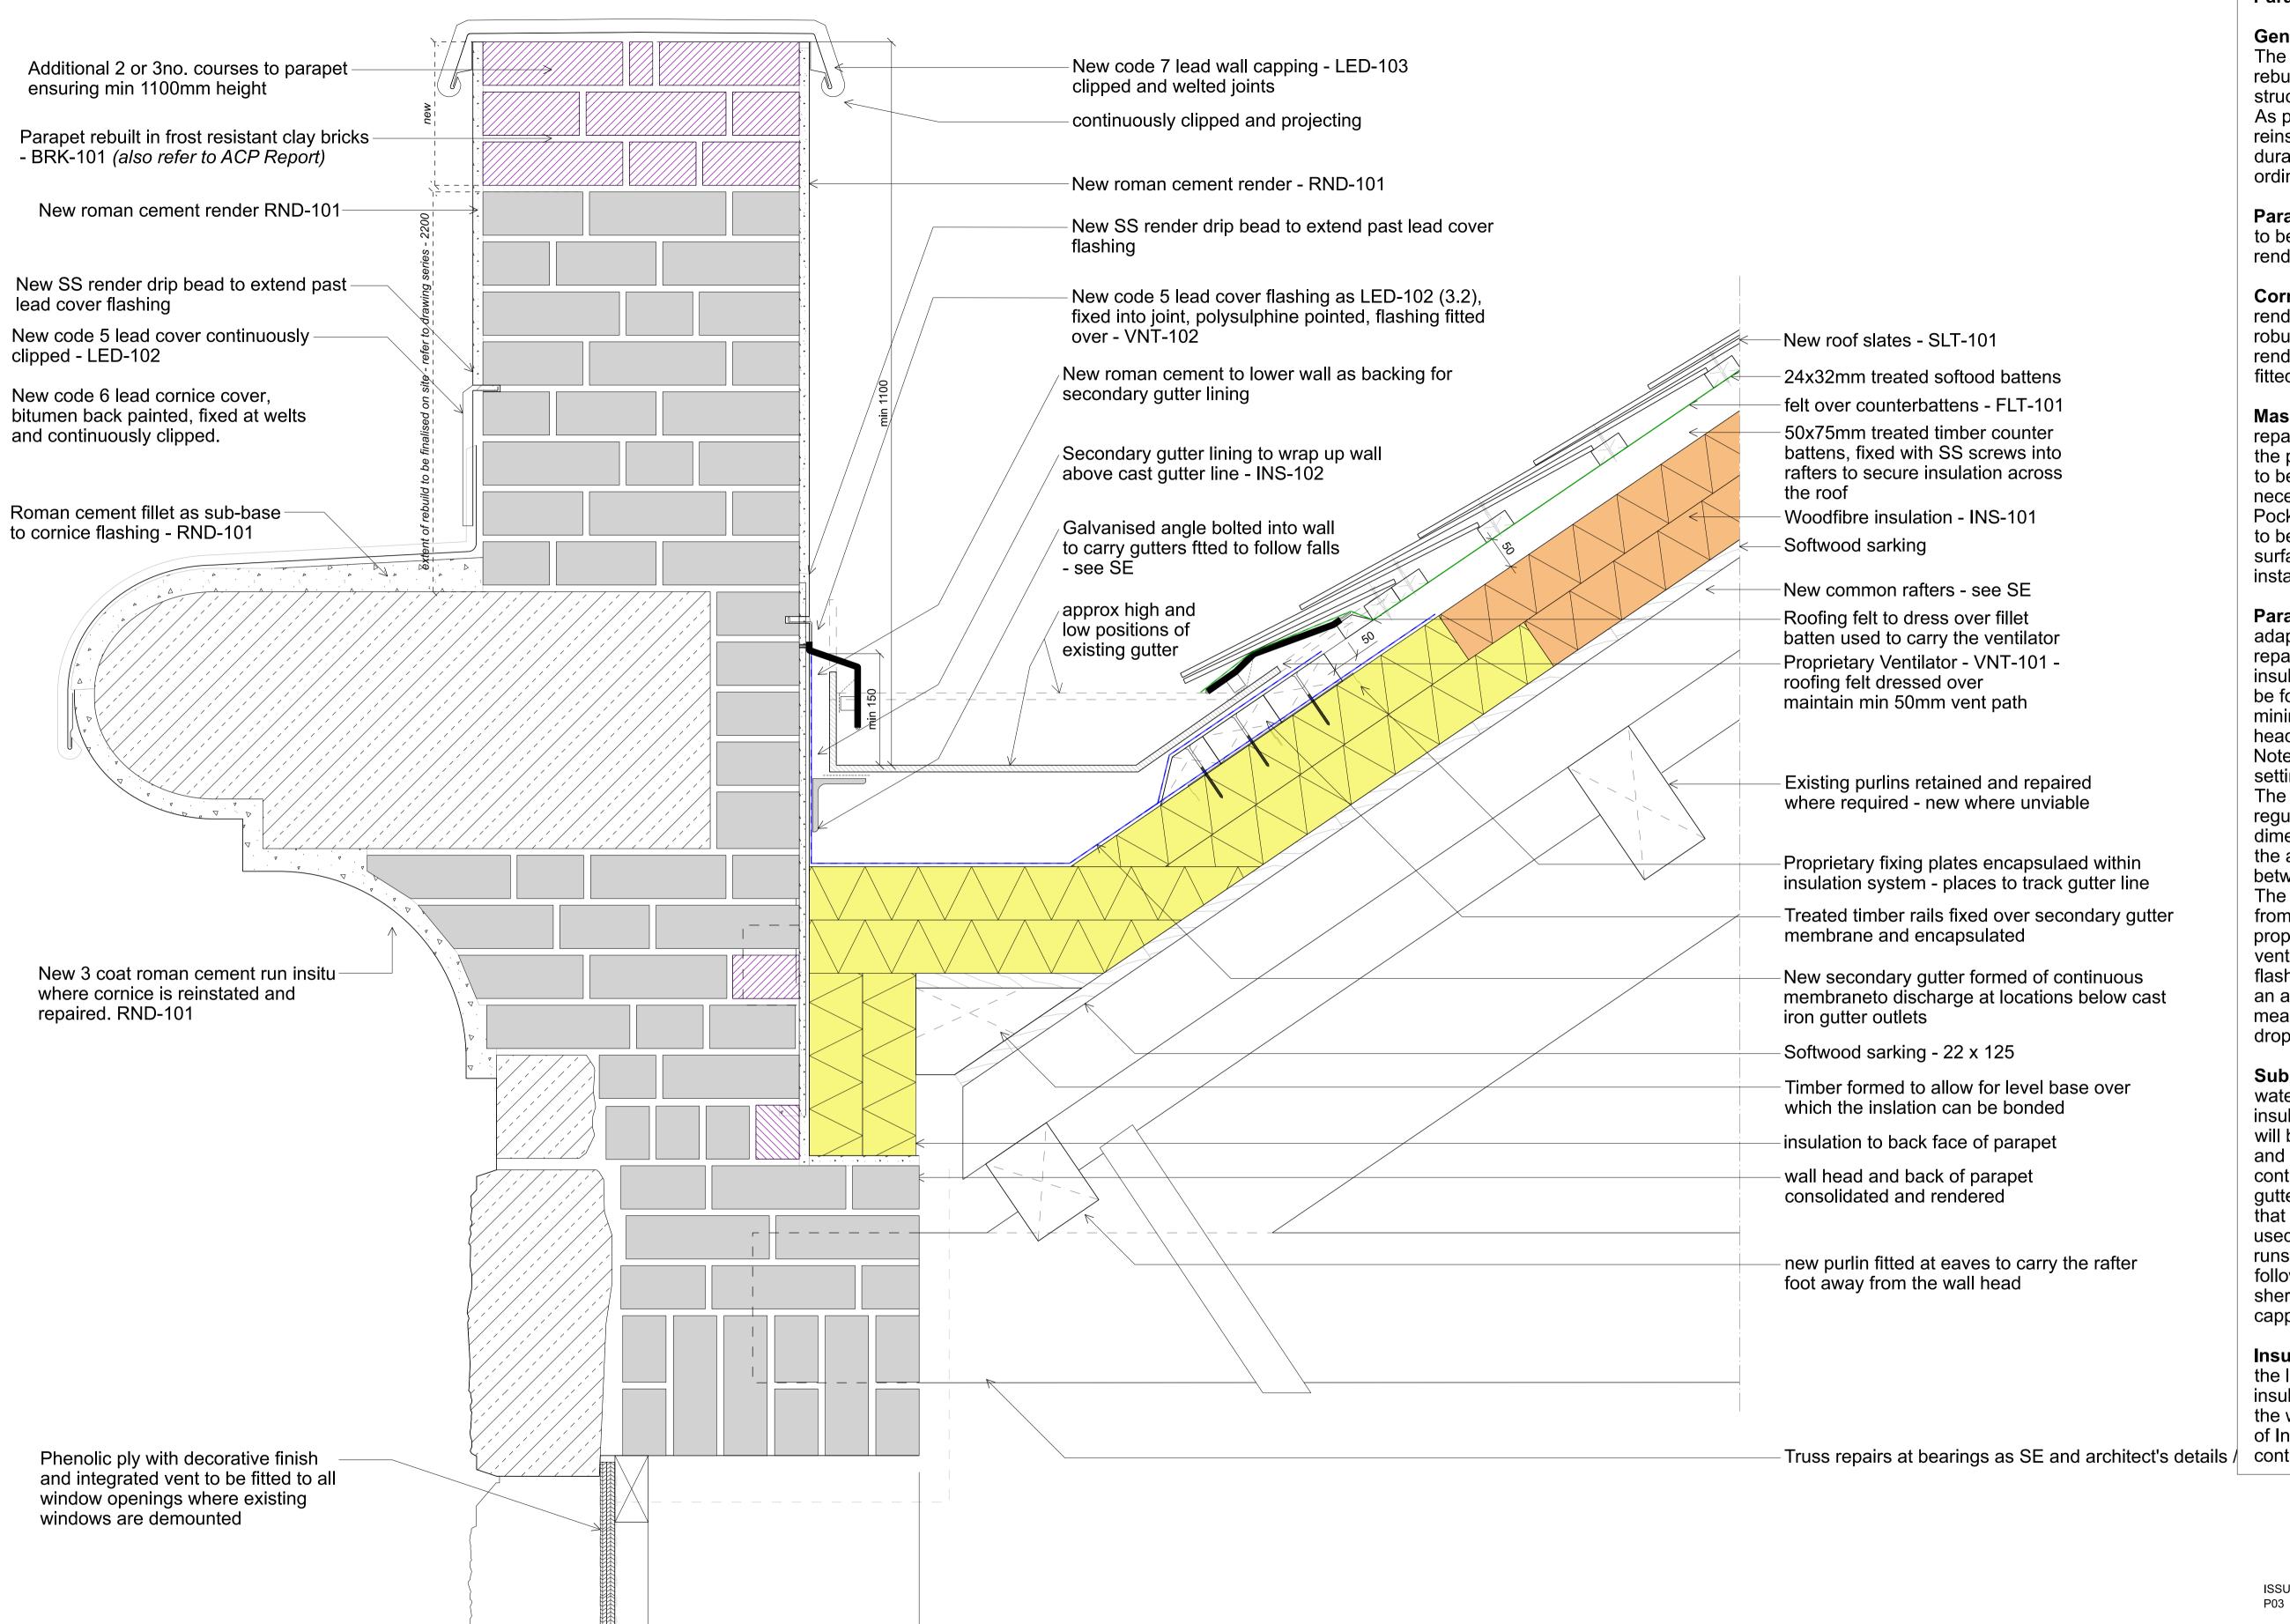
CRQ - FLAX MILL PHASE 1 REPAIR PROPOSED FABRIC ASSEMBLY WALL HEAD, ROOF and PARAPET

Parapet Assembly

General

The parapet is subject to consolidation and rebuilding to address poor condition and structural movement.

Cornice - To be rest where required. Loose render to be removed and existing to be robustly prepared. New roman cement stucco render to be run in-situ. New lead cover to be

Masonry General - To be consolidated and repaired. The lower section the inside face of the parapet and the shelf at the wall head are to be cleaned and consolidated. Where necessary the wall head is to be rebuilt Pockets and voids are to be infilled. The wall is to be rendered to achieve a smooth, flat surface of sufficient uniformity to permit the installation of the glass slab insulation boards.

Parapet Gutter - To be overhauled, repaired, adapted and reinstated. Gutters to be set over repaired and reinstated roof, formed with insulation over sarking. A new sub-gutter is to be formed at the eaves as a backup to minimise the risk of water ingress at the wall head and to protect the construction generally. Note that great care will be required to plan the setting out for the reinstatement of the gutters. The galvanized steel angle is to be fitted and regular centres to reflect the gutter dimensions. A rubber strip can be used over the angle to allow for thermal movement between the iron gutter and angle. The gutter is to be places with a 25mm gap from the wall to allow for ventilation. The proprietary flashing carrier will allow for the vent path to be maintained (VNT-101). The flashing will need to be chased into the wall in an alignment that tracks the gutter. Ensure measures are taken to prevent rubbish dropping into the sub-gutter below.

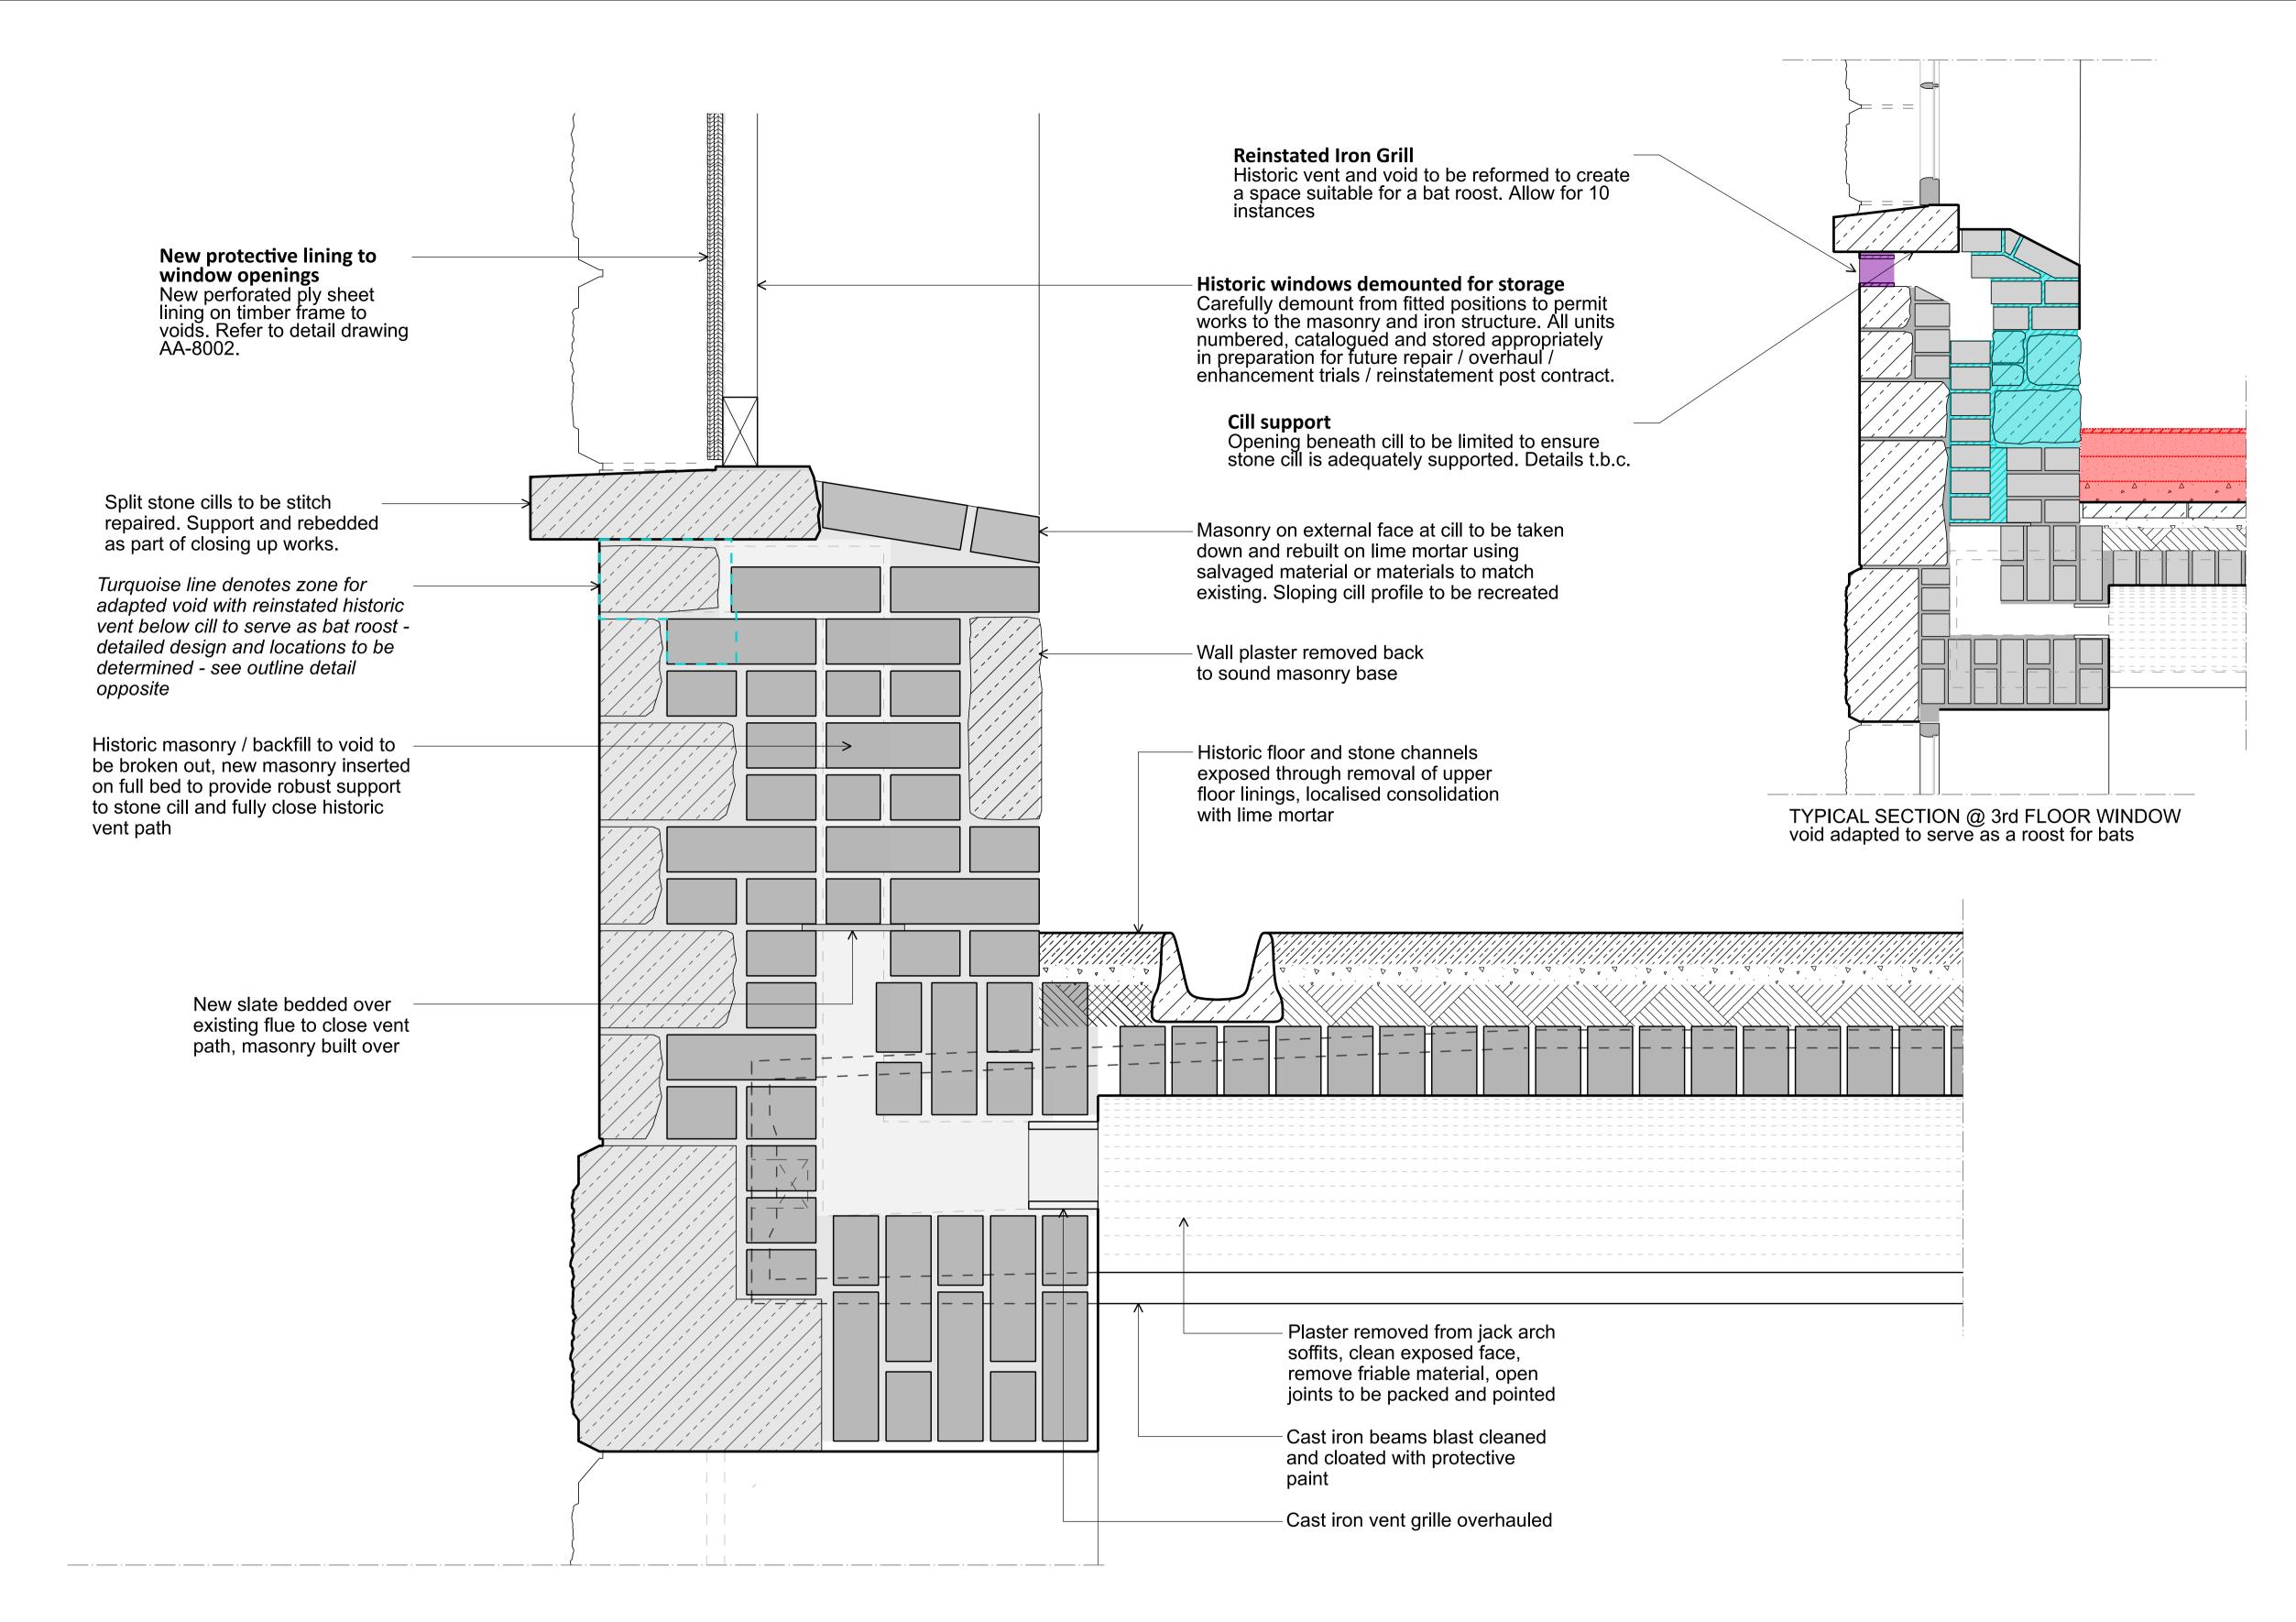
CRQ - FLAX MILL PHASE 1 REPAIR PROPOSED FABRIC ASSEMBLY WINDOW CILL and SPANDREL

Arrangement / Condition: Through-wall swan neck vents with route of flue traversing floor levels. Terminations below cill externally and above window heads on the internal face of masonry envelope via cast iron grilles. Vents informally filled historically with masonry / backfill. Grilles remain present. Spandrel historically reconstructed with new masonry and cement sloping cill on inner face. See existina detail.

Objective: Formal closure of flue to omit through-floor void. Works Description: Historic masonry / backfill to vent broken out, new masonry inserted to fully close path. Stone cills repaired and rebedded on sound masonry base. See proposed detail.

Arrangement / Condition: Cast iron grille situated above window heads forming termination of through-wall swan neck vents. Informally filled historically with masonry / backfill / plaster. See existina detail.

Works Description: Overhaul by iron foundry, off-site in workshop where required. Allow for new castings where existing have failed. See proposed detail.

HISTORIC WINDOWS DEMOUNTED FOR STORAGE
Arrangement / Condition: Typically 60-pane SG timber windows

Objective: Historic windows demounted to permit Phase 01 repair. Stored in anticipation of reinstatement in future reuse scheme. **Works Description:** Carefully demount from fitted positions to permit works to the masonry and iron structure. All units numbered, catalogued and stored appropriately in preparation for future repair / overhaul / enhancement trials / reinstatement post contract. See window schedule.

Arrangement / Condition: Various plasters / linings applied to walls and brick jack arch soffit. Some lime-based plasters and cementious renders. Refer to types and Materials Analysis. All in poor repair. Objective: Remové plasters / linings to enable future redecoration. Works Description: Remove existing plasters / linings back to sound brick base, removing friable material. Grouting to large voids. Inspections and trials to inform approach.

Arrangement / Condition: Original floor 300x300mm square fired clay tiles on backfill, stone drainage channels at floor perimeter. Later floors various including reinforced cement screed, modern tile, insulated board with bituminous bonding (see types, Infrastruct Report). Modern floors in fair condition.

Objective: Carefully strip back to and consolidate historic floor, reform level surface in advance of future fitout – Once exposed, historic floor surface will be found to be worn. It will be necessary to consolidate the surface to provide a trip free surface. Required where surface is found to be inconsistent, damaged or sections of tiles are missing. The hope is for most of the historic tiles to be found in place, bound to the substrate and in a form that does not present a risk to people accessing the area. Whilst it is not the intention of the works to leave a fully repaired finish, the floor must be level, well bound and safe to walk on.

Works Description: Carefully strip back to historic surface, consolidate and repair ready to receive new covering as part of future phase. Removal / cleaning to conservation standard, informed by trials. Grout to voids, sand-cement screed to substantial gaps.

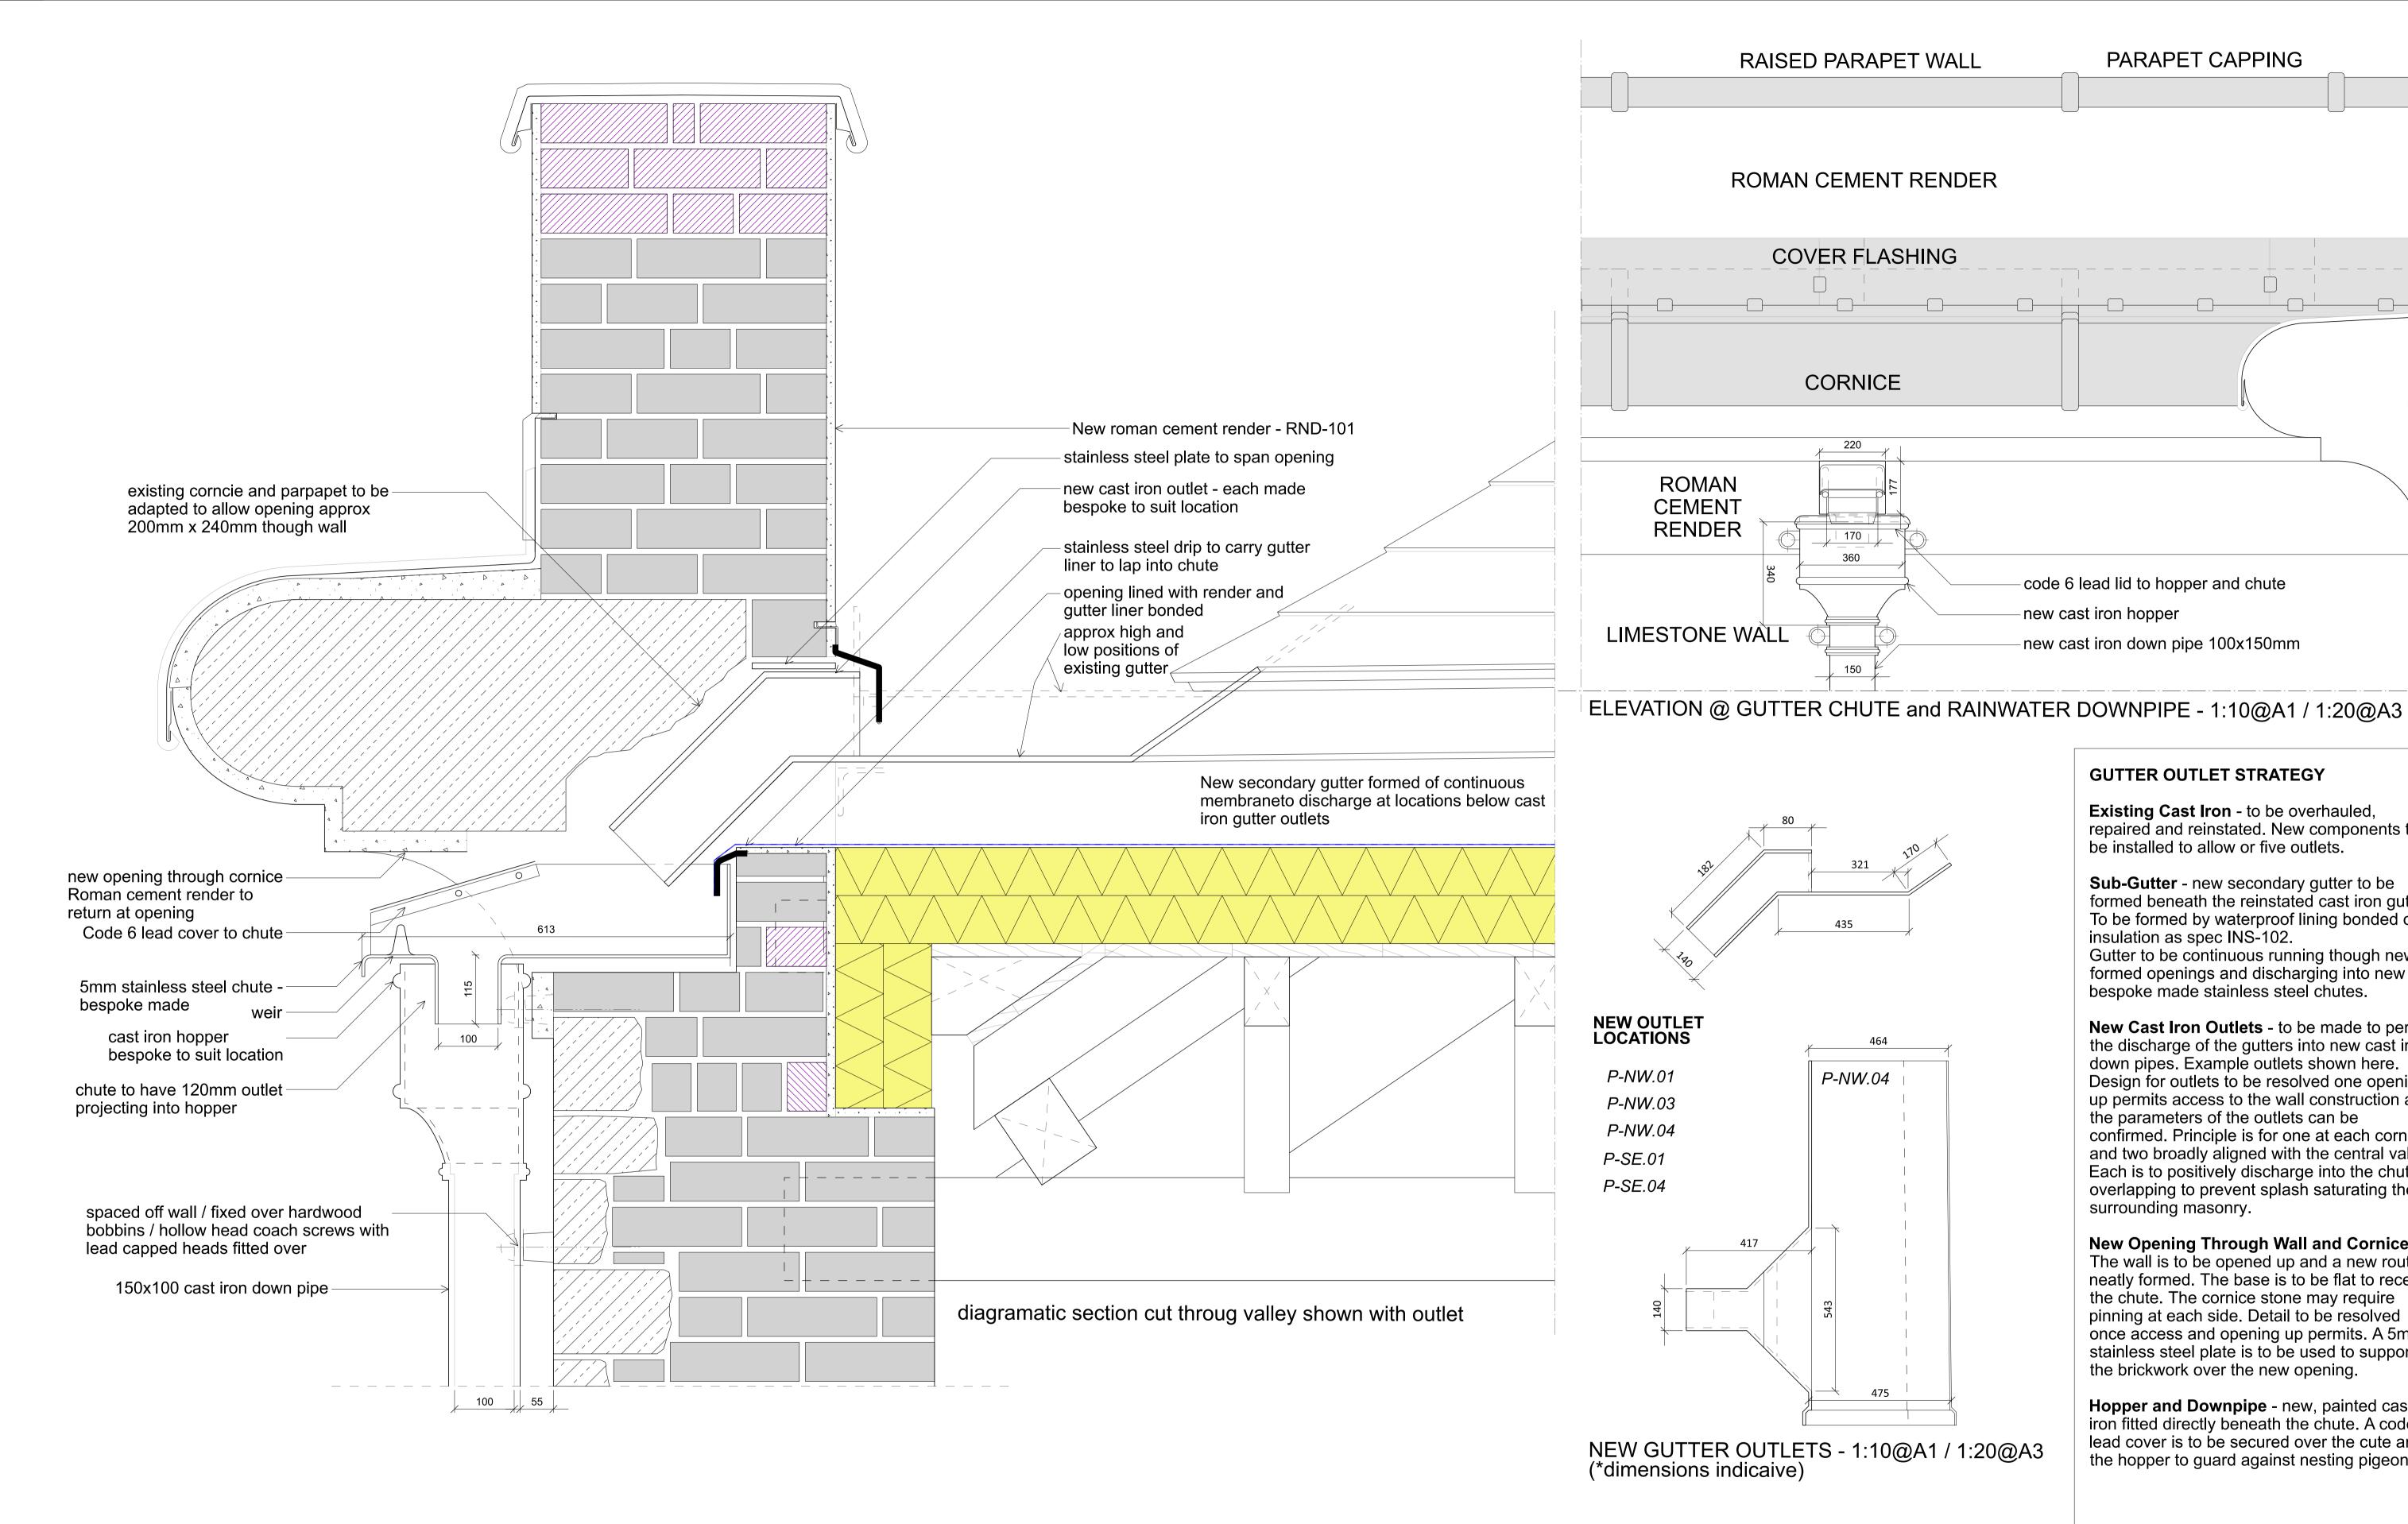
PARAPET SECTION @ GUTTER OUTFALL

Existing Cast Iron - to be overhauled, repaired and reinstated. New components to be installed to allow or five outlets.

Sub-Gutter - new secondary gutter to be formed beneath the reinstated cast iron gutter. To be formed by waterproof lining bonded over insulation as spec INS-102. Gutter to be continuous running though newly formed openings and discharging into new bespoke made stainless steel chutes.

New Opening Through Wall and Cornice The wall is to be opened up and a new route neatly formed. The base is to be flat to receive the chute. The cornice stone may require pinning at each side. Detail to be resolved once access and opening up permits. A 5mm stainless steel plate is to be used to support the brickwork over the new opening.

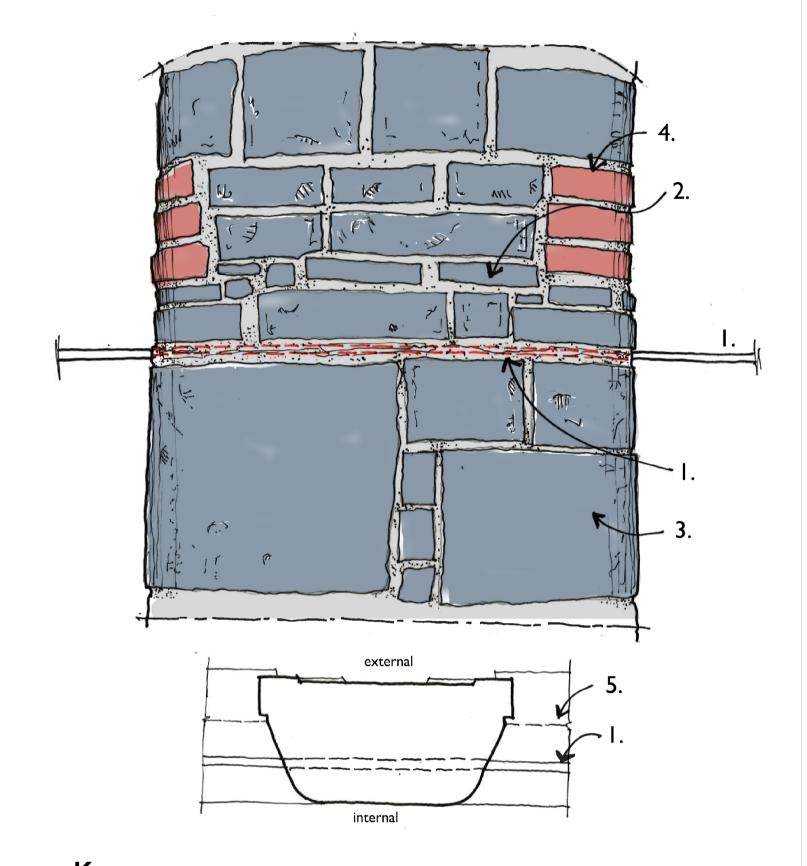
EXISTING MASONRY PIER

- 1. Iron bar embedded in wall and spanning between piers.
- 2. Smaller masonry units set above the iron bar.
- 3. Larger masonry units used to cap the pier below the iron bar.
- **4.** Red clay bricks used at corners and sides of piers.
- 5. Line of window reveal.
