ARCHITECTURAL DESIGN REPORT

Cleeves Riverside Quarter | October 2025

CRQMP-FCBS-XX-XX-RP-AA-0010 P01 - 16/10/2025

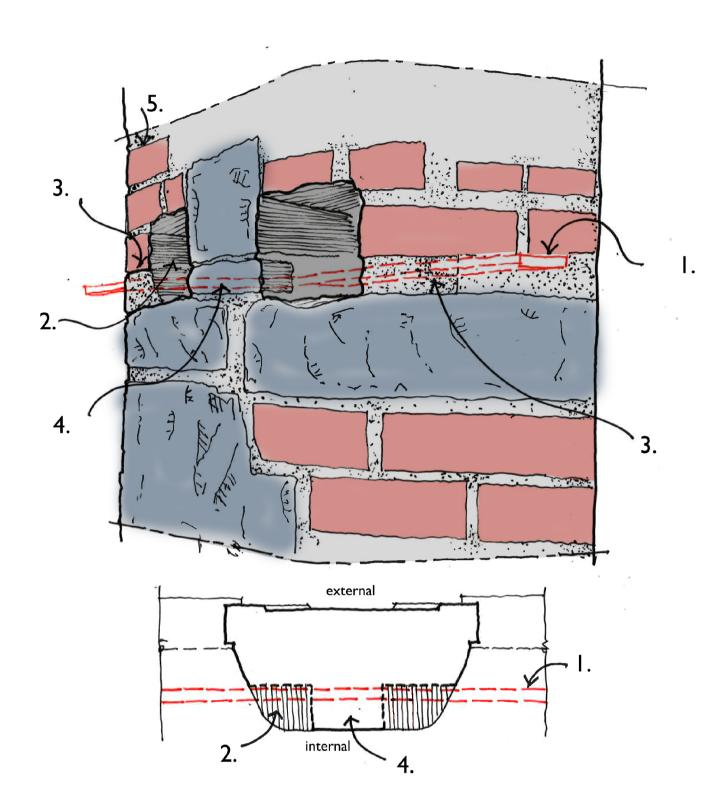
MINIMAL OPENING UP: SE REPAIR Type 4

- **1.** Iron bar to be cut to leave sufficient length projecting from the face of the masonry to allow it to be pulled from the wall.
- 2. Pocket openings to be made into the pier to expose the lap in the iron band. Lap to be cut or drilled to release the band each side and permit them to be pulled from the wall. Lap to be extracted though the pocket opening.

- **4.** Larger masonry units retained to maintain stability to the pier and reduce need for temporary works.
- **5.** Bricks and smaller masonry units typically found in the courses above the line of the bar to be retained. The preference is for the bricks to be retained in-situ where possible. Reinstated masonry to be fully packed and grouted.

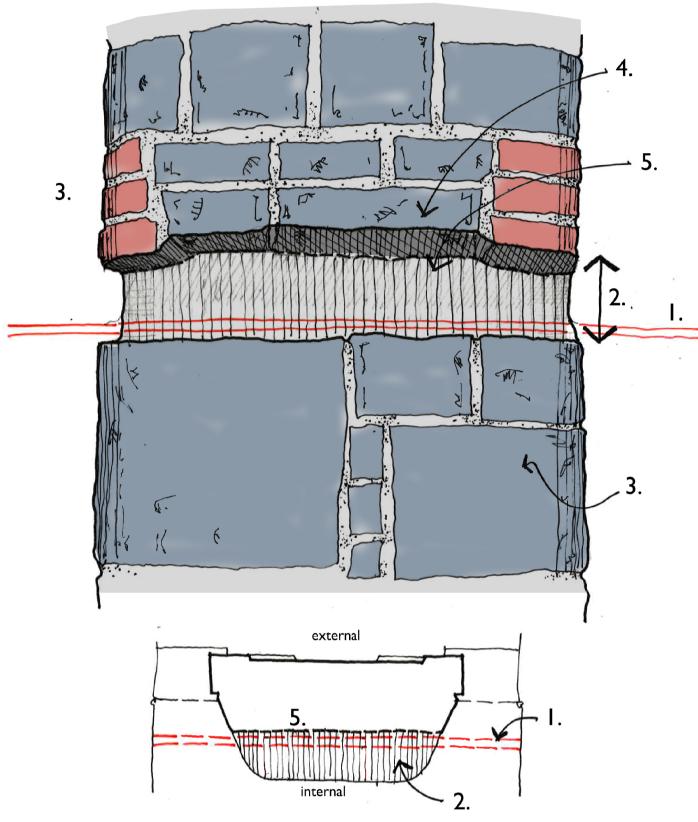
MAJOR OPENING UP: SE REPAIR Types 2 & 3

- **1.** Iron bar to be fully exposed to permit extraction.
- 2. Channel in wall opened up to allow for the bar to be removed and wall to be solidly rebuilt.
- **3.** Larger masonry units retained. Work to open up wall to expose bar to focus on smaller masonry pieces.
- **4.** Where opening up occurs seek to work out opening retaining solid masonry units before propping. This will allow for improved stability when rebuilding. Reinstatement to be deep and fully packed with voids grouted.
- **5.** Avoid excavating / opening up deeper than necessary. Seek to minimise depth.

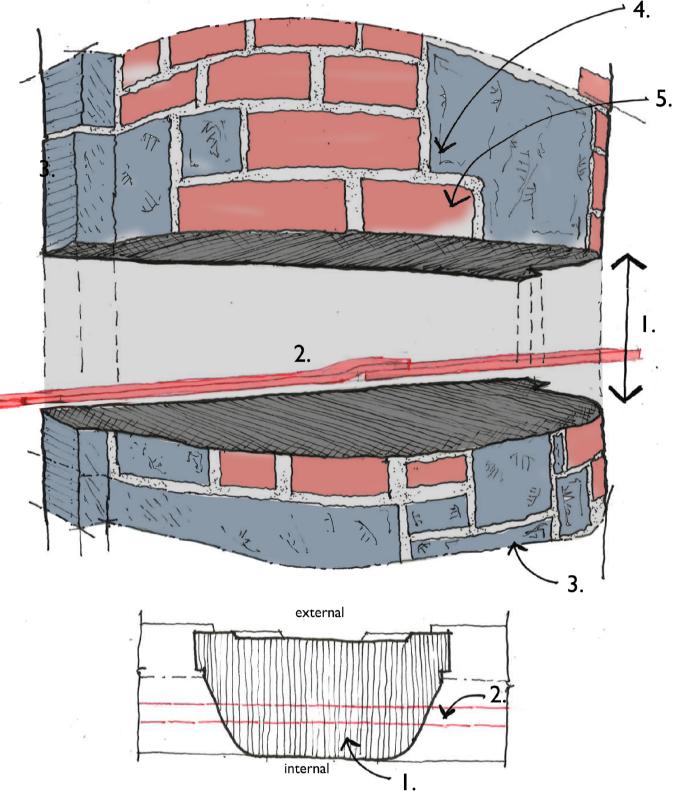
TOTAL OPENING UP: SE REPAIR Type 1

This degree of opening up and the subsequent propping of retained masonry above is shown as a worst-case scenario. The objective is to minimise the extent of opening up while enabling the complete removal of the iron band and reinstatement of masonry.

- 1. Section of masonry completely opened up with upper section temporarily supported.
- 2. Whole iron band exposed to permit removal.
- **3.** Bottom extent of takedown to stop at soonest point of stability. This may not be a level plane as illustrated.
- **4.** Upper extent of opening to work to solid and ideally substantial masonry units to avoid instability in the course of the reinstatement works.

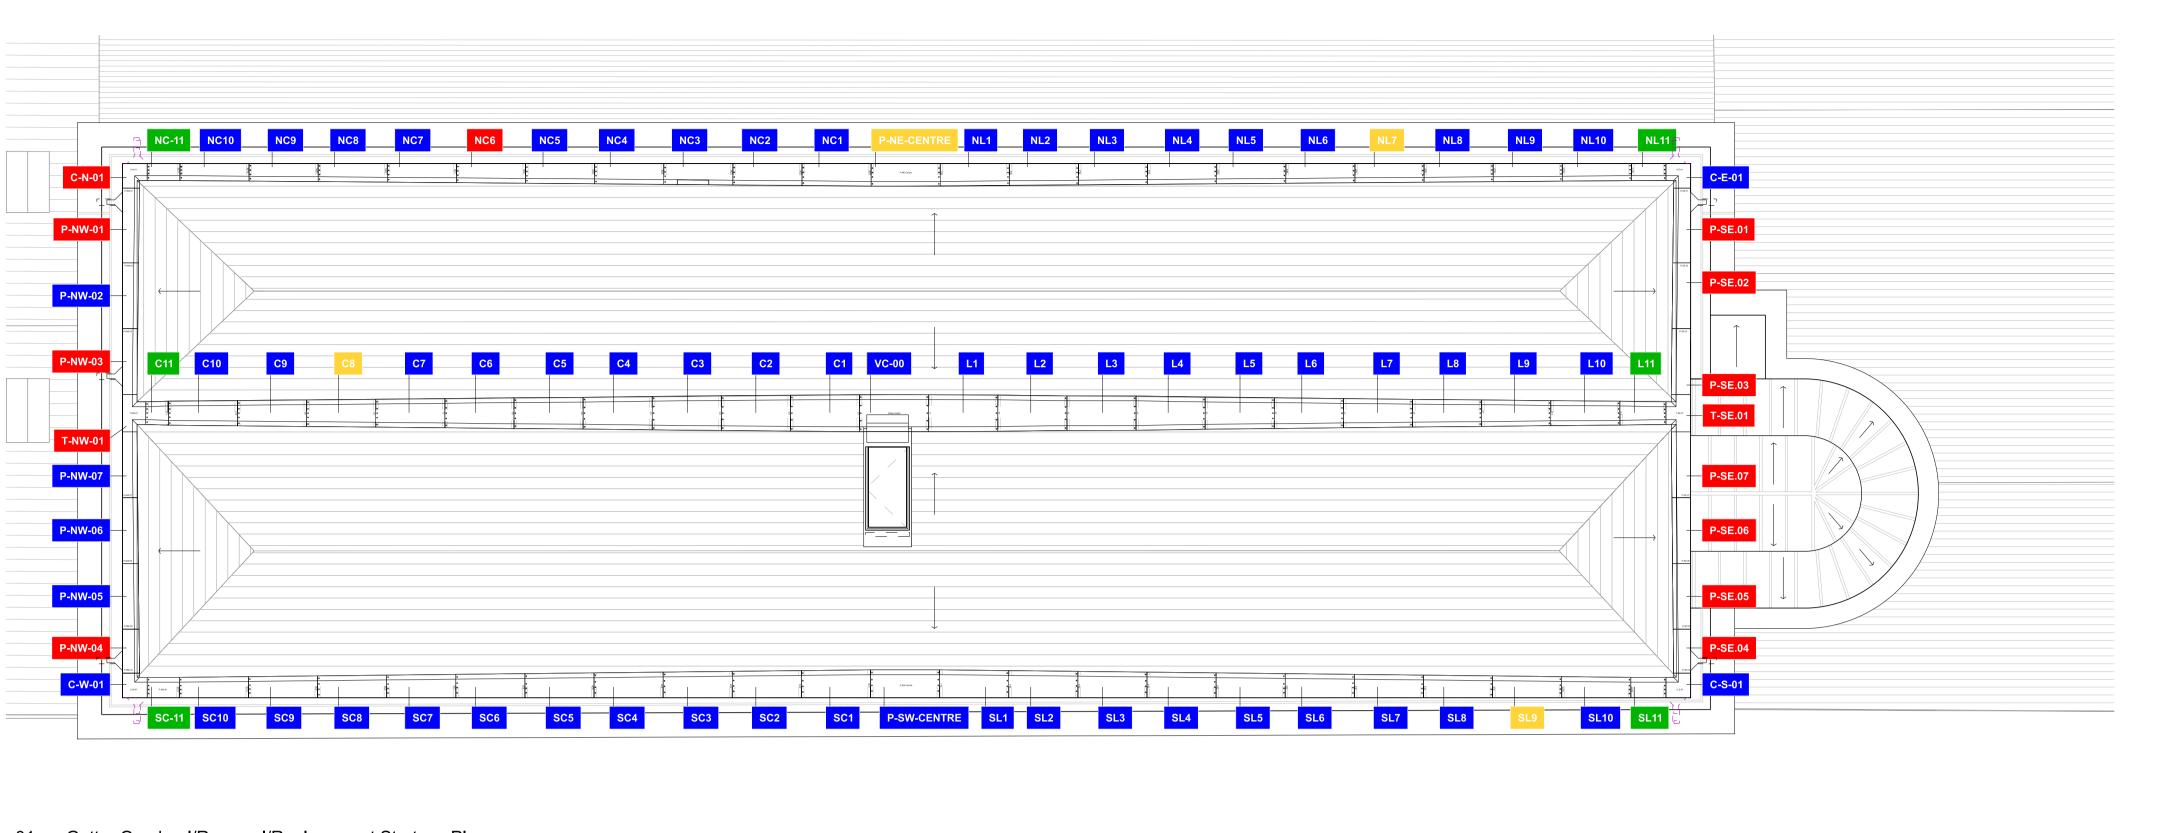
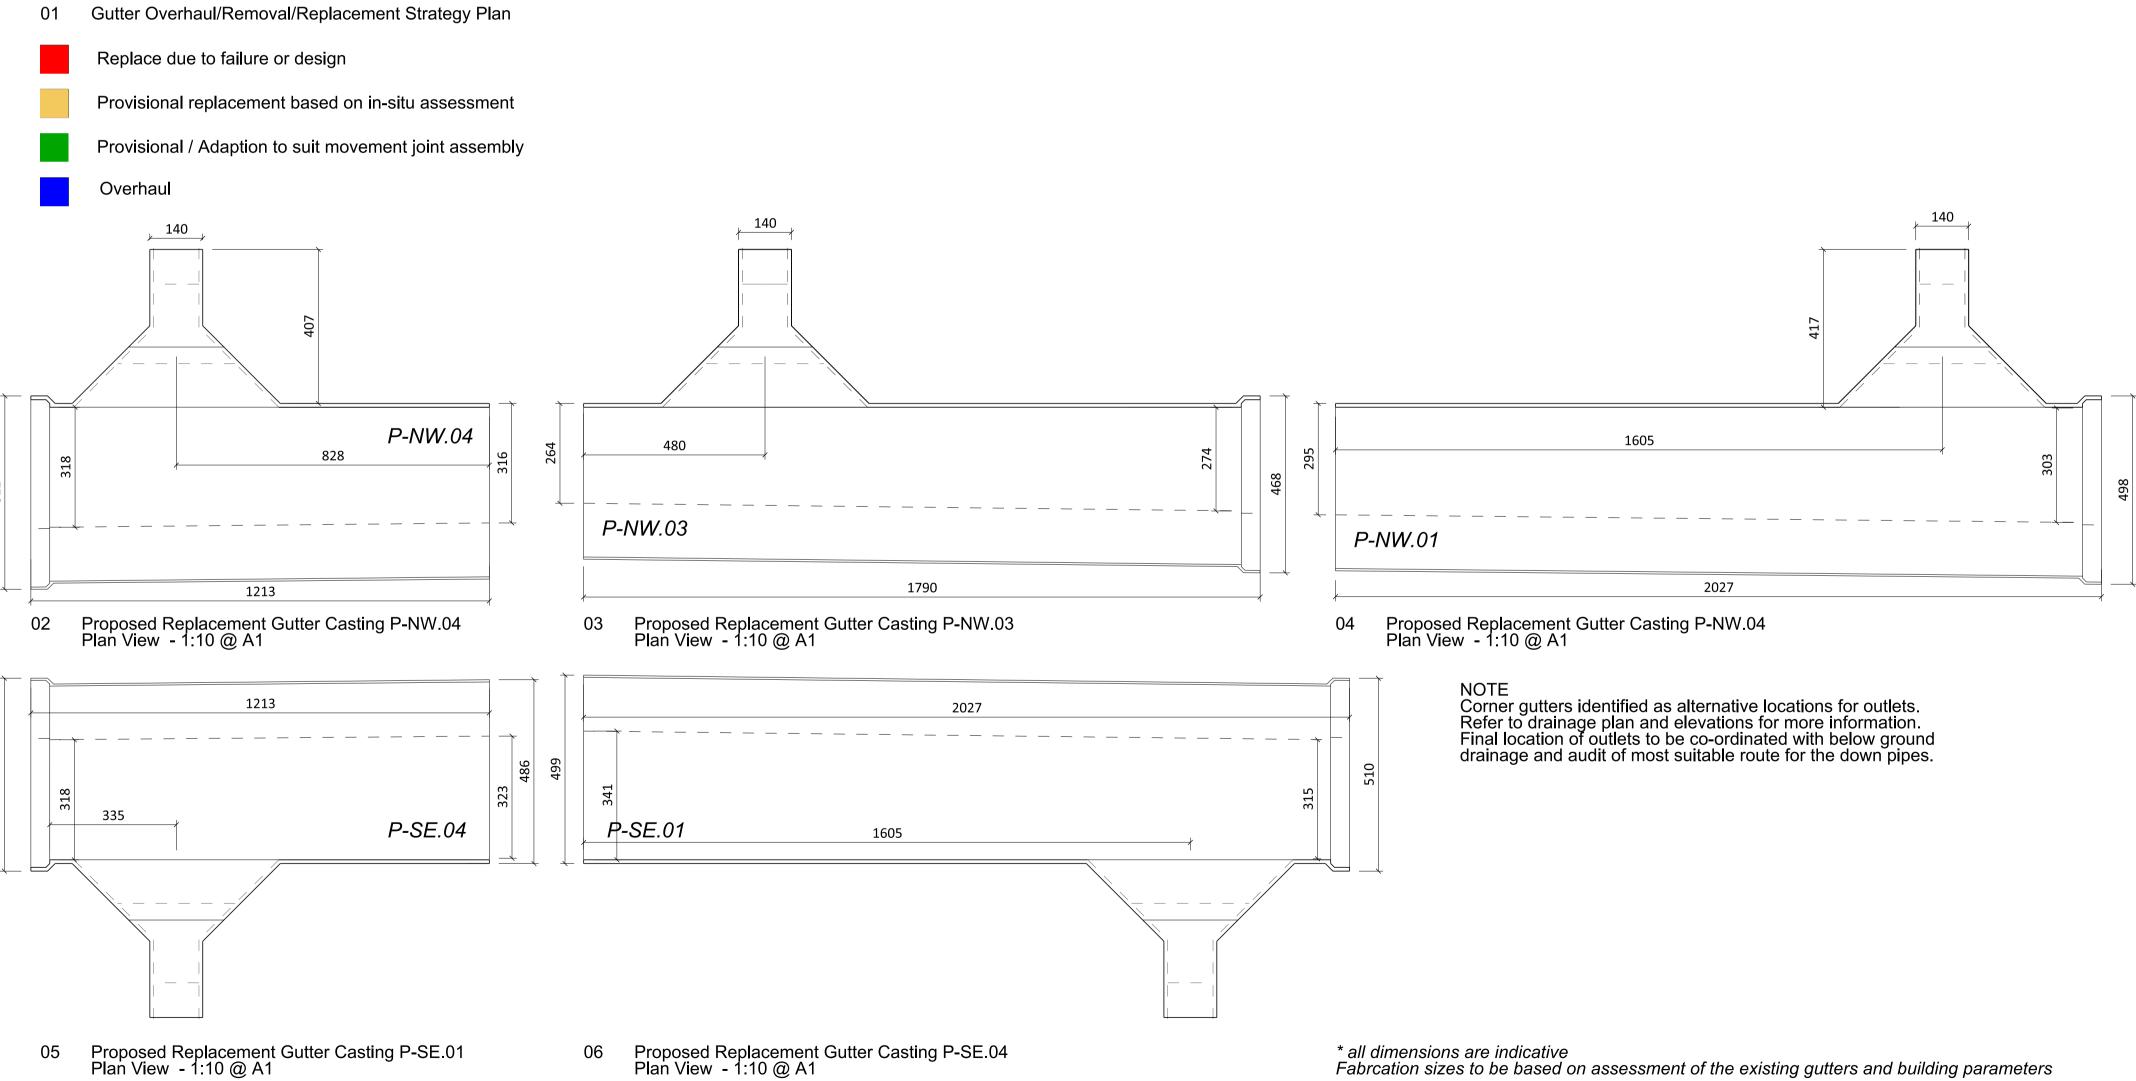
Job/Drawing No CRP01-FCBS-1A-XX-DR-AA-4604 CRQ - FLAX MILL PHASE 1 REPAIR Status PROPOSED GUTTER LAYOUT

REVISON P02 Alternative gutter location and note added
