**Re:** Proposed development N70 Waterville to Ballybrack Road Improvement Scheme  
Townlands of Waterville, Ballybrack and Eightercua, Co. Kerry

# **PROPOSED N70 WATERVILLE TO BALLYBRACK ROAD IMPROVEMENT SCHEME**

Submission made on Behalf of Eddie  
Cagney & Ann Roche-Cagney,  
6 Benjamin Close, Ballybrack

J & N Murphy Ltd., Macroom.

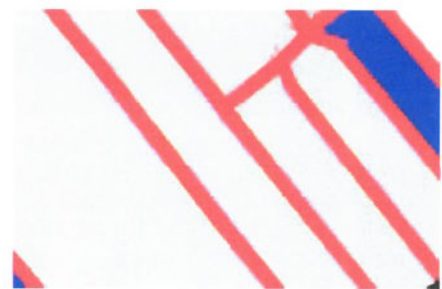
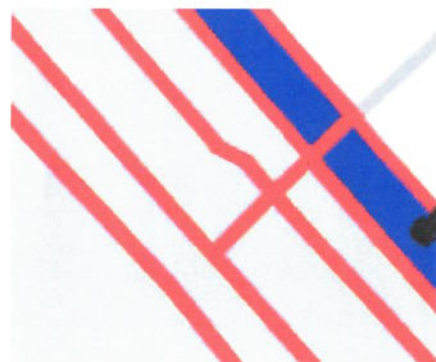
- There is a distinct “twist” shown on the Northern end of the boundary between 130-01 & T130-01 - see enlargement on Right - is it intended that there would be a matching physical Twist?

- Given the last 2 points, are we correct in assuming that our clients’ lawn would, post works, be shallower than that of the Neighbour to the North?
- As a further complication, the 130-01/130-02 boundary, which on the face of it, should coincide with the existing roadside boundary, has an unexplained kink near the Southern end – see detail on Right. This kink does not exist on the ground, nor is it reflected in either your Engineers’ detailed surveys or the OSI maps. What if anything, is its significance??

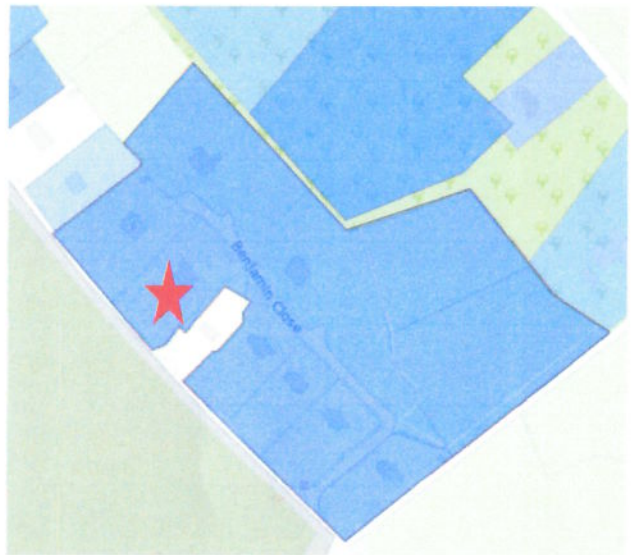
4.1: Our clients' dwelling is one of those in, or at least accessed from, "Benjamin Close" – see extract from Planning Register Map on site with our clients' plot highlighted. Note that all vehicular access to all of them is from the site road, despite 6 of them abutting the N70. The houses were initially built pre-2000, and initially had individual Septic Tanks, one per house. In more recent years, a public sewer was laid on the public road, and the houses adjacent to same, including our clients' dwelling, were connected individually to new sewer.

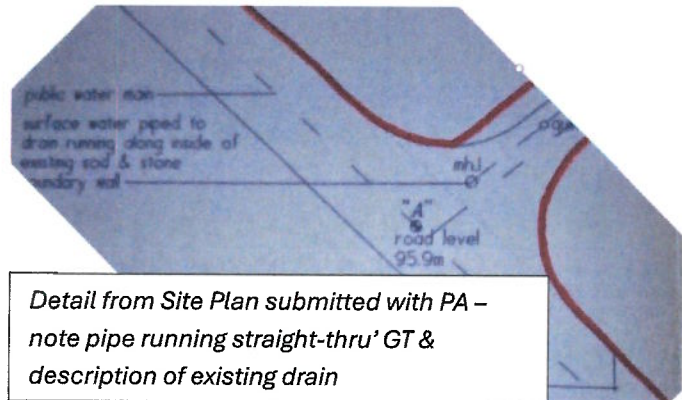
4.3: The Plans on foot of which the initial Planning (485/97) as Granted were, to put it mildly, very basic, even by the standards of the time. The surface water disposal for the individual sites was hardly mentioned, and the road drainage detail, consisted of some GTs connected to a very basic pipe, and discharging linearly one to the other

(with some shown as very basic gulley to gulley “straight-thru’ connections), starting at the Northern (inner) end, eventually discharging at the abutment of the site road with the N70 to what was described as “*drain running along inside of existing sod & stone boundary wall*”. Apart from the pipework arrangement being entirely substandard, and depending on a very effectively non-existent discharge point, this arrangement was patently unworkable on the particular site, as the gradient from what was shown as the highest manhole or gully (outside site 6) was entirely against the natural slope, with, were it to be installed as shown, a dig of up to 7m thru solid rock being required!! (The Road Level at G3 is c. 7m higher than at G5) (see Plan on Right).

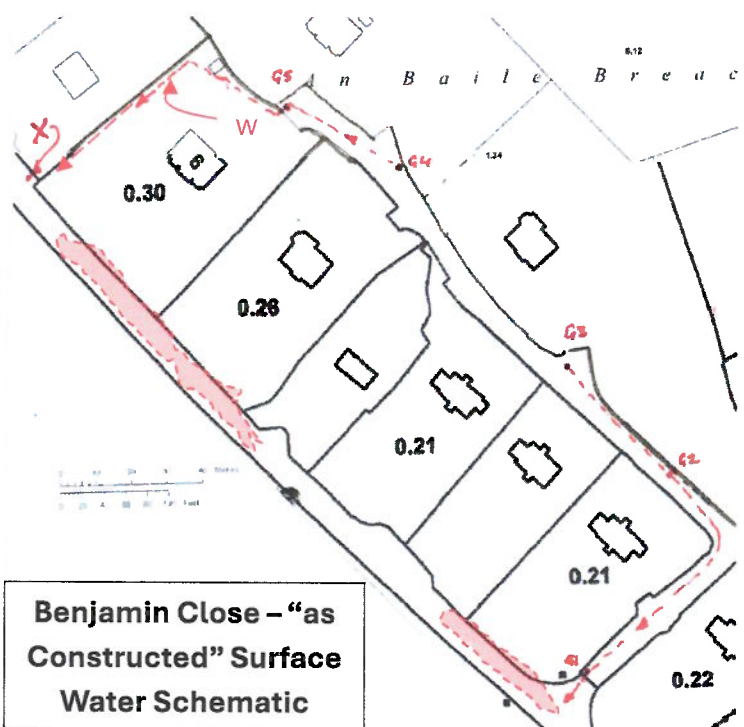
4.4: What was actually installed was two separate SW systems, both substandard & both discharging to the same non-existent drain – an outline of this arrangement, involving some assumptions/guesses, but easily accurate enough to illustrate the principles is shown on right. It shows 5 Gullies in total, 3 discharging towards the entrance, starting from G3 at the high point, and G4 & G5 discharging along our clients’ North-Western boundary via a recently partially-discovered pipe, but eventually reaching the roadside boundary thru’ a combination of pipes, stone drains and surface flow. In reality, as all the Gullies bar G5 are located on the highest side of a one-way camber, the Gullies are ineffective, and all of the water discharges onto to the original public road near

G1, or into our clients' site via G5 or the grating across their entrance (Pictured Left) which they installed themselves 3 to 4 years ago in an effort to protect their site, but which proved largely ineffective – it does "catch" some water, but this merely then flows into the same onsite network that it would eventually have reached anyway, and so in any case ends up at the North Western corner of their site. The "Bottom line" is that in even moderate rain, water ponds along the roadside boundary of their lawn, which is the lowest point, creating an unintended swale or sump of sorts which runs along the joint road frontage, but which most particularly affects our clients

(It does appear that there may have been some intention that the pipe installed along their North-Western boundary may have been intended to reach an adjacent pipe at Point "X" on the plan on the previous page, but that pipe is, firstly, effectively level with the pipe at point "W" on the same Plan, but also is of dubious capacity in itself - there is an exposed "Corripipe" drain here with the end visible down a rudimentary, and probably accidental, hole – see photo on Right showing tape projecting into hole.

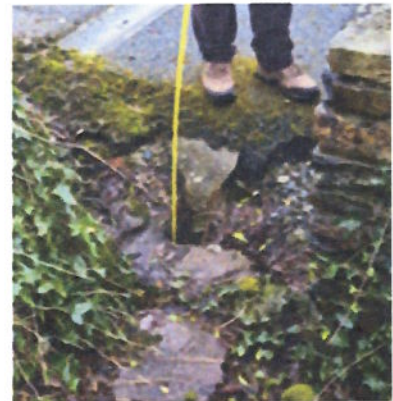
It appears that this pipe was laid as part of the Roadside setback works for the adjacent site, but it is entirely unclear what discharges to it, or where it discharges to, or even what direction it flows in (it probably falls with the road towards Waterville), but there is no confirmation of this). In addition, the pipe base is only c. 650 under road level, and, as already noted, at best level with the pipe supposedly flowing to it from Point "W" It also appears to be surrounded by less-than-ideal bedding & haunching. All in all, and for whatever reason, is it not taking any water, and instead the water "wells up" to spread along the unintended swale.

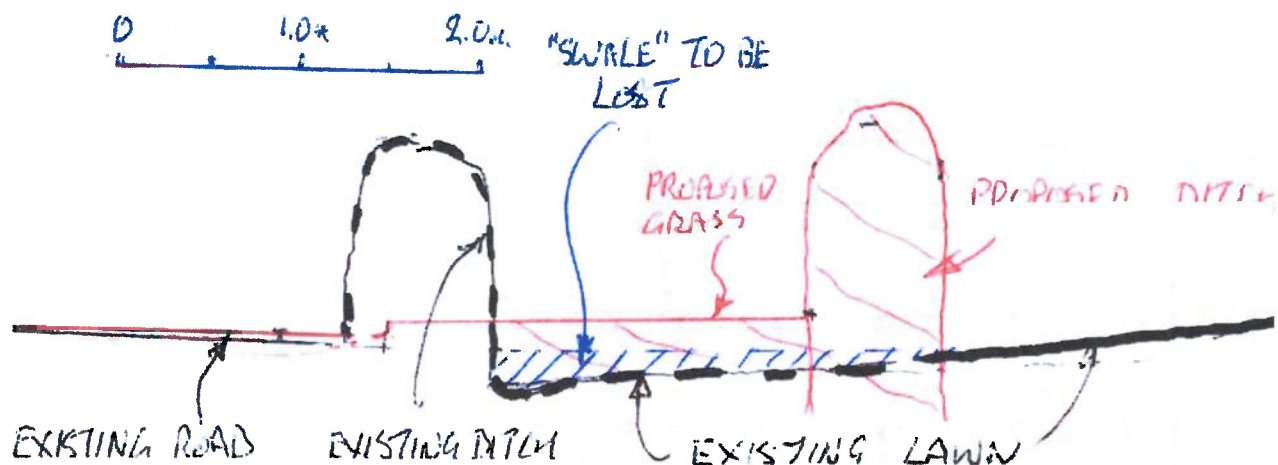
5.1: Now, to make matters worse, the same Council are proposing a road scheme that will, at once, at least potentially slightly increase the total inflow from the road into their site, but also will infill the bulk of the lowest part of their lawn, thus infilling the swale or sump described above. The Diagram below is approximately 1:50 Scale, but in any case illustrates the main issue (i.e. what is to become of the swale?) quite well. The existing road, ditch & lawn levels are shown in Black, with the new proposals in Red

5.2: Also shown is a possible “Proposed Ditch” – the need for this to be a traditional stone wall and the need to allocate sufficient space for same is separately discussed, but the question of structural stability also arises, as the wall will, to at least a limited extent, be required to act as a retaining wall.

Critically, note the identification in Blue of a “Swale” to be lost. This is as described in 4.4 above, and intentionally or otherwise, forms the essential element of the existing, albeit poor, Surface Water “disposal” regime. If this is lost, and if complete waterlogging of much of our clients’ Lawn, not to mention interference with the drainage from the entire of the site, **an alternative must be found**

6.3: As illustrated in the Section at 5.1 above, the thickness of such a wall will also be a factor in determining the exact land take required, and the Council may need to put some further thought into this.

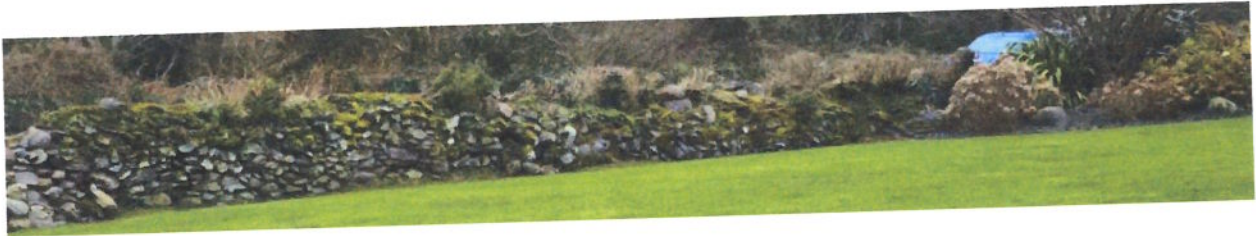
6.1: The existing roadside boundary structure is a stone & slightly sodded construction. Our Clients have, over the years, cleaned it down and made it a feature of their garden – see below. They have also, but less diligently due to the difficulty of working safely on the roadside, kept the external face clean and in good condition.

They would require that any replacement wall be of similar construction – not just the standard stone-faced blockwork. This is in part to maintain the character of their boundary, but is also in recognition of the heritage of the area, and with particular reference to the Megalithic Monument known as the Eightercua Stone Row, which is situated less than 400m. away.

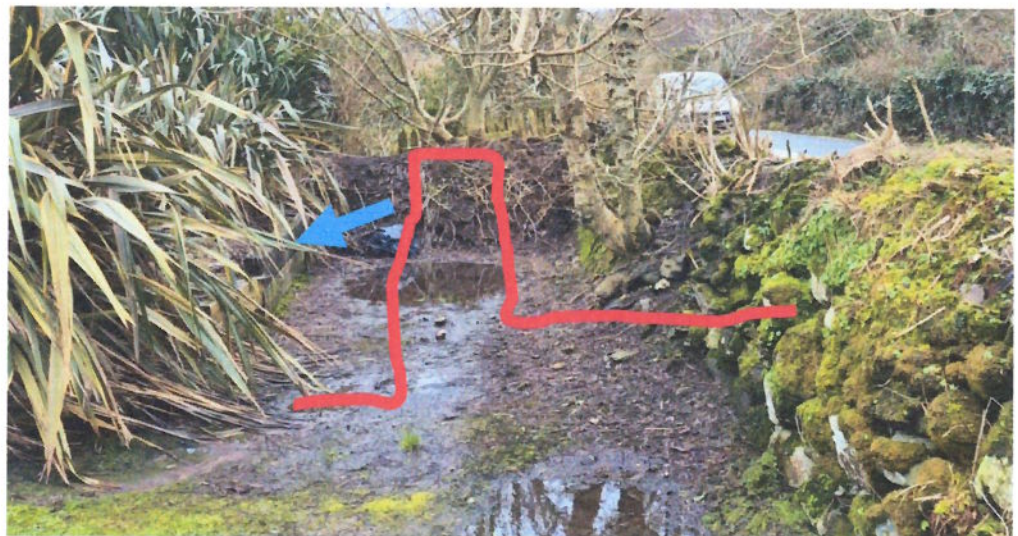
Elevation of the car on the road

The potential difficulty of access the “loading” side (blue arrow) of the compost area can clearly be seen, but in passing, it is worth noting the obvious

relative to the much lower level of the lawn, and the almost total obliteration of existence of the “swale” (as demonstrated by the ponded water) can clearly be seen.

The New Ditch and infill resulting from the above are illustrated approximately in red on the photo overleaf (Photo viewpoint shown approximated in Blue above)
