FIRE SAFETY ASSESSMENT & ADVICE REPORT

Tirawley BESS Facility, Co. Mayo

Client	Regnum Renewables Developments Limited
Project	Fire Safety Assessment and Advice Report for a proposed Battery Energy Storage System (BESS) facility in Tirawley, Co. Mayo
Our Ref:	2511224IE-FS-DM
Prepared By:	D Mullarkey BEng, BEng (Hons), MSc, MIEI
Approved By:	J Gall MSc, CEng MIFireE, CEng MIEI, APAEWE
Date:	24 April 2026
Issue:	02
Appendices:	None

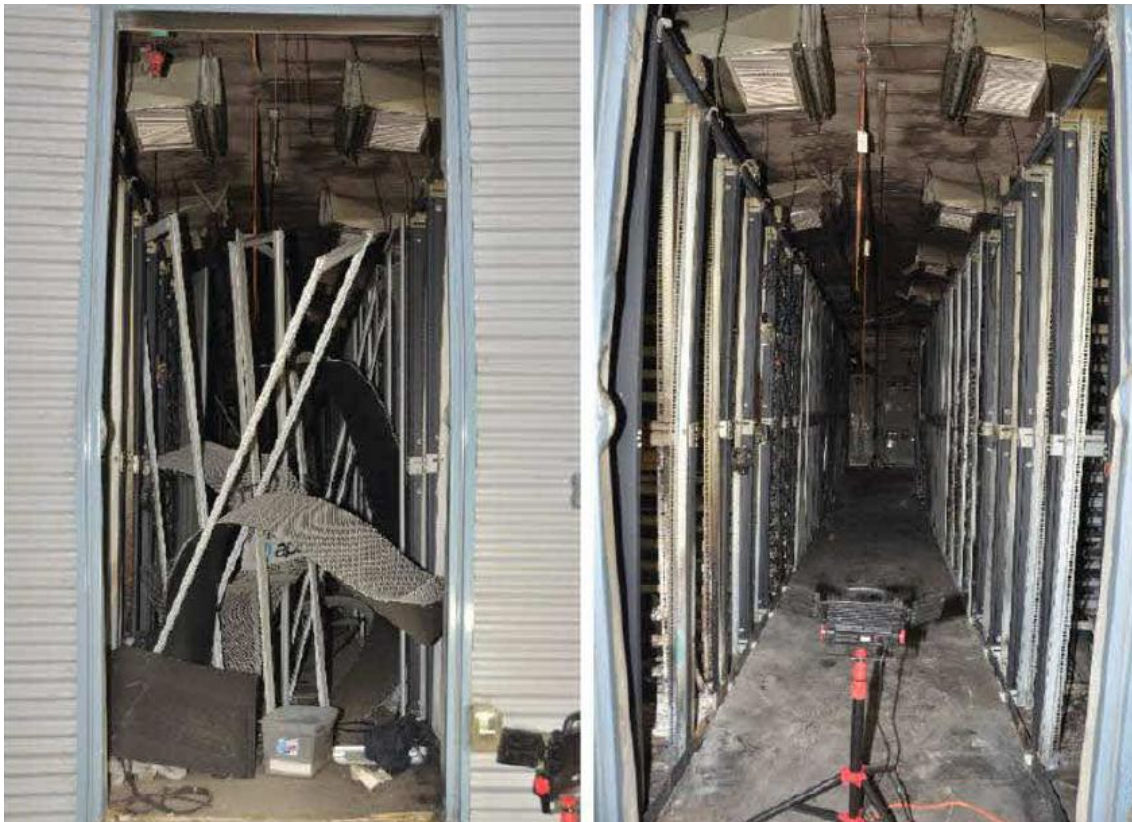
Figure 4 – BESS contained post deflagration event⁷

At circa 1700 hours on 19 April 2019, smoke was reported to be issuing from a building which housed the energy storage system at the McMicken facility. First responders arrived to investigate at circa 1748 hours. At approximately 2004 hours, responders attempted to enter the unit by opening the door. This resulted in a deflagration (explosion) event which seriously injured 4 of the first responders who attempted to enter. An image of the incident container is included below in Figure 4.

Following in-depth investigations into the incident, it was established that the cause of the incident was a single lithium-ion battery cell failure which transitioned into a cascading thermal runaway event, spreading to other cells in the module. From there, the thermal runaway event continued cascading to involve all modules on rack 15 in the container. The incident was first detected when a voltage drop occurred at circa 1654 hours on 19 April in a battery cell in module 2 of rack 15. Cell 7 module 2 entered thermal runaway phase shortly thereafter. As a result, the cell experienced off-gassing which generated smoke, activating the smoke detection and discharge of the suppression agent (Novec 1230). While the suppression agent operated as it was supposed to, it did not prevent cascading thermal runaway to the adjoining cells and adjoining modules. The continued off-gassing of lithium-ion battery cells created a flammable atmosphere within the BESS container. When first responders opted to enter the BESS container circa 3 hours after the first alarm, the flammable atmosphere was still present. Ignition occurred within 2 to 3 minutes of the door into the container being opened, agitating the flammable gas/air mixture. The specific ignition source was not known, but a deflagration occurred which caused BESS container doors and other internal materials/components to be violently discharged from the container, thus causing the injuries sustained by the 4 first responders.

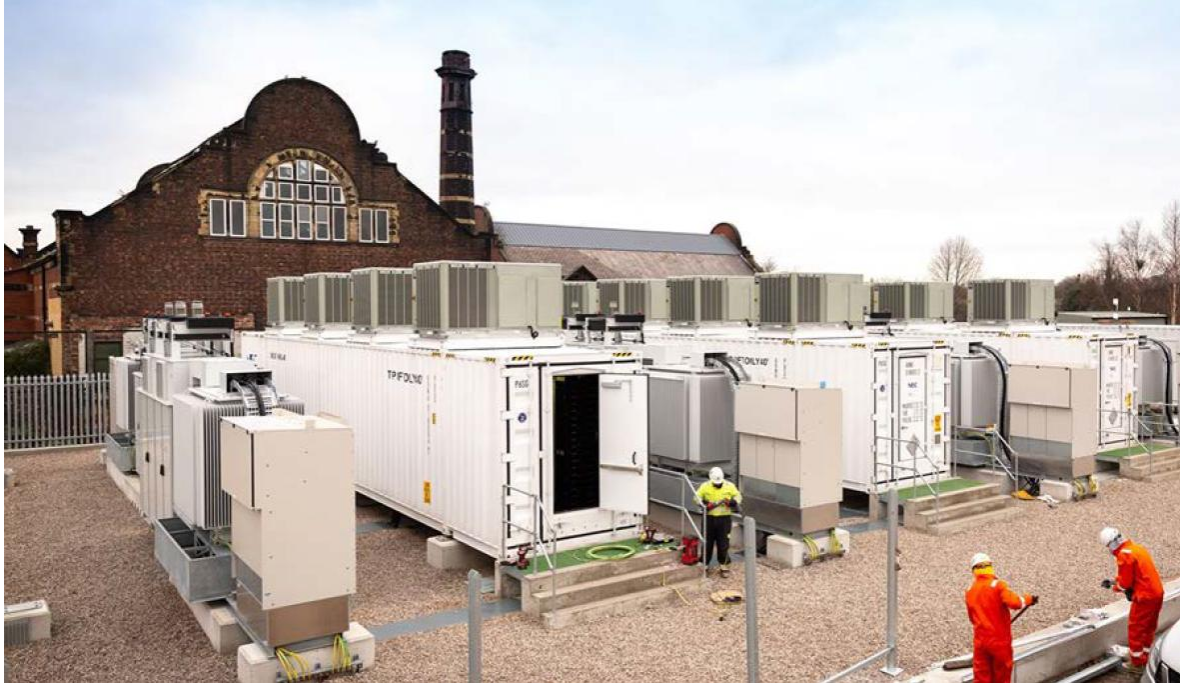
Figure 5 – Carnegie Road BESS facility ¹⁰

The BESS facility at Carnegie Road is located in Liverpool England and was first energised in December 2018. The facility was fully commissioned in May 2019 and is interconnected to the Scottish Power Energy Network at 33kV. At the time of the incident, the facility consisted of 3 containerised BESS enclosures capable of charging/discharging up to 20MW of stored power for up to 30 minutes. The BESS enclosures housed a total of 2142 lithium-ion modules over 126 racks. An image of the facility is included below in Figure 5 for reference.

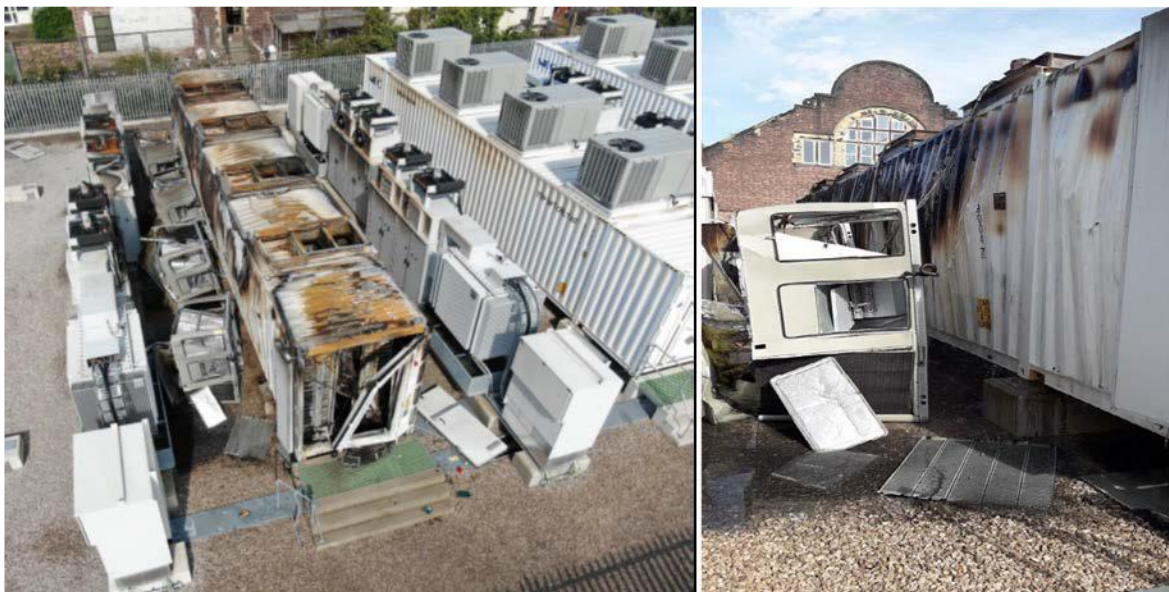
Figure 6 – Post incident photographs ¹¹

At approximately 1249 hours on 15 September 2020, the local Fire and Rescue Service were alerted to a fire at the facility. 5 appliances attended and found Container 1 of the 3 containers well alight. Post incident photographs taken by Merseyside FRS are shown below in Figure 6 and Figure 7. The extent of damage sustained by the container was consistent with that of a fire and explosion (deflagration).

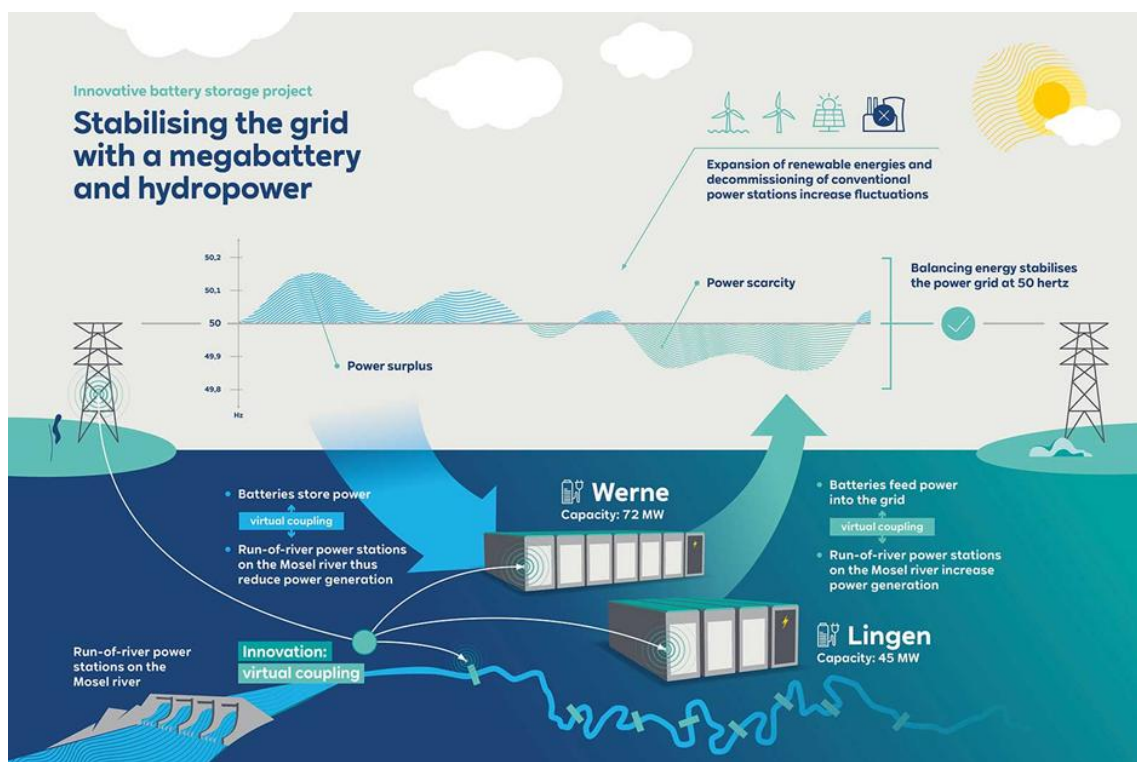
Figure 8 – BESS diagram for a scheme which combines grid stabilisation with hydropower generation ¹³

Electrical energy storage systems are designed to convert and store electrical energy such that the energy can then be re-introduced to the electrical grid when demand requires. Figure 8 below illustrates a proposed scheme in Germany whereby BESS units will be used to store both power surplus from the national grid while also storing energy which is generated from a hydropower source. The BESS units will also provide a grid balancing function.

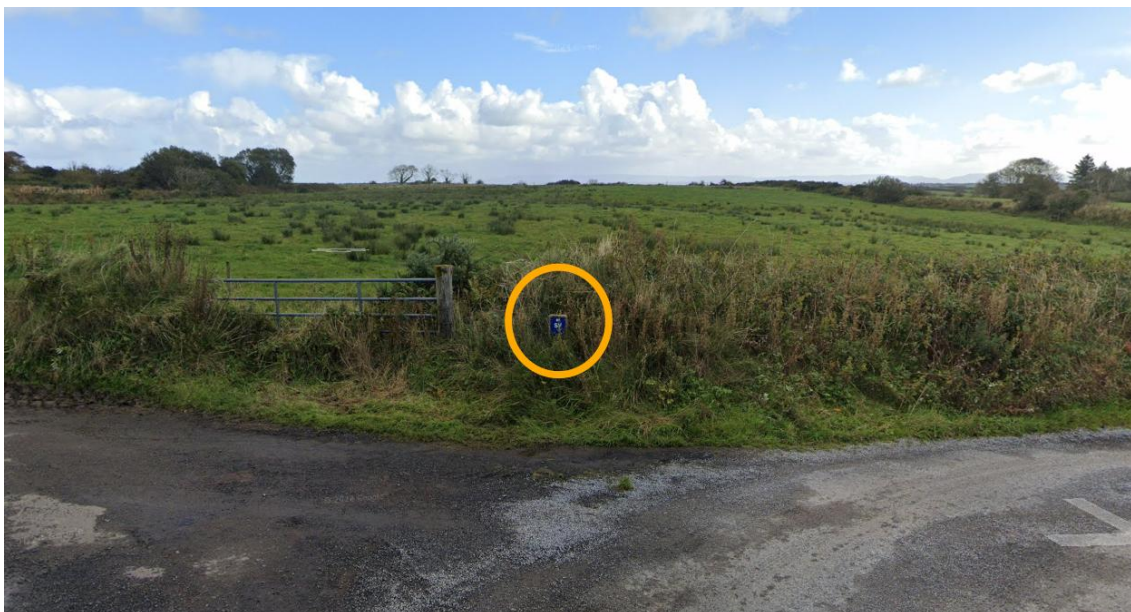
Figure 13 – Sluice valve marker post on road adjoining site ¹⁸

The proposed BESS site is located in a rural setting in Co. Mayo. Existing facilities for the Fire and Rescue Service (e.g. provision of public fire hydrants) are yet to be confirmed albeit there does appear to be a public watermain in the adjoining road (see Figure 13 below of SV marker post on adjoining road). It is noted that modern BESS containers are fitted with a combination of continuous monitoring and passive/active fire protection measures such that the design intent is to intercept faults before they transition to a fire/explosion hazard or, where a fire occurs, contain the fire to the incident container. Nevertheless, as this is an unmanned site, it is possible that the presence of the local Fire and Rescue Service may be requested in reaction to an incident.
