## 17 Architectural Built Heritage

## 17.1 Introduction

This Chapter assesses the impact of the proposed development on the Architectural Heritage of the site and of the surrounding Architectural Heritage, specifically Protected Structures, Architectural Conservation Areas and candidate Architectural Conservation Areas.

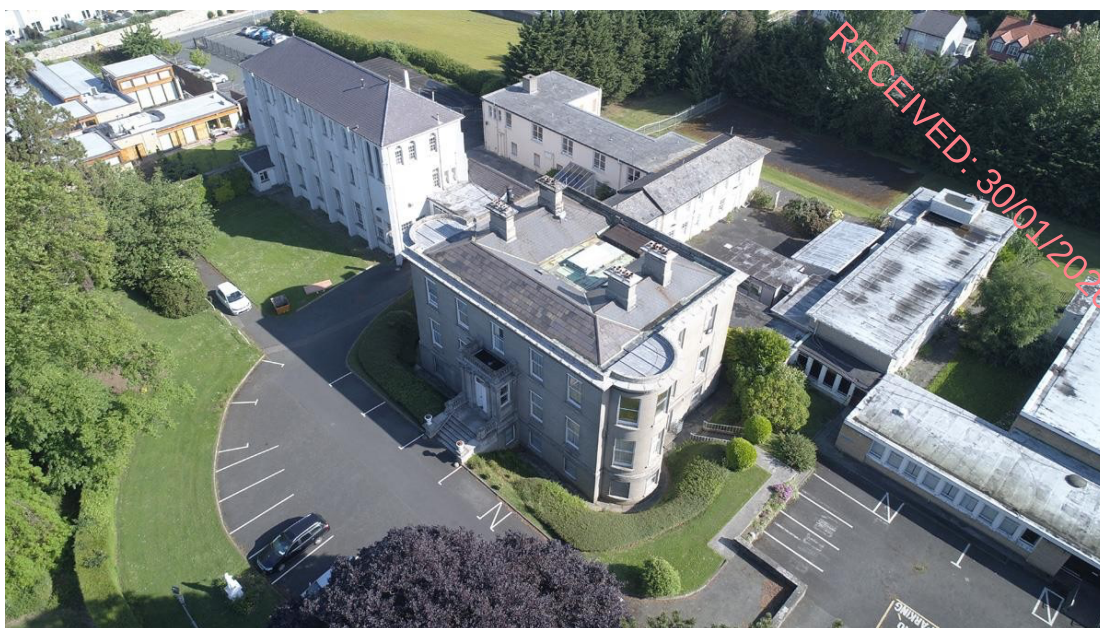
*Figure 17.6 - Aerial view from South (pre-2021 demolitions)*

St. Teresa's House is a two storey over basement detached country house, of five bays with central projecting granite porch, and semi-circular end-bays, and granite cornice, cills, and string course. The porch is reached via a flight of granite steps with granite flank walls. There is a pitched "A" roof having its ridge in a "U" shaped plan, with central flat-roofed area and rooflight above the stairs, and with lead roofs with rolls to the end bays with hip valleys valley gutters and parapet gutters rendered chimneys stacks. The external walls are rendered and lined, with one-over-one pane vertical sliding sash sliding windows.

The exterior of the building is in poor condition having many external service pipes, abutting later extensions, and some non-original windows. The render is cracked in places. The interior of the building has been somewhat altered to accommodate the institutional use, but the main features remain relatively intact. A room by room inventory and photographic record is attached.

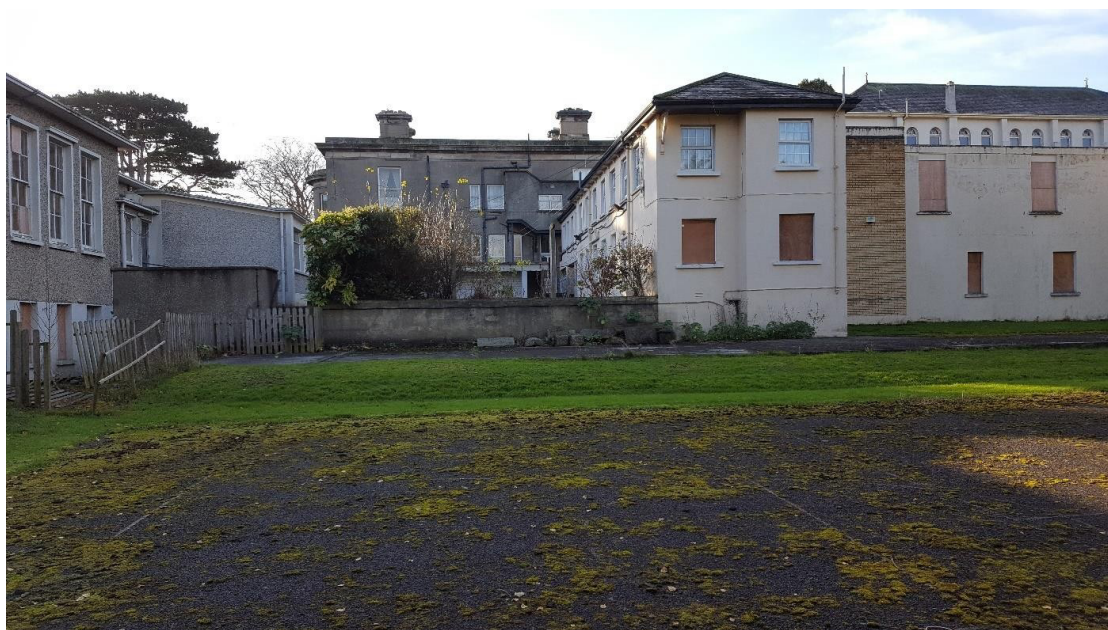
*Figure 17.7 - View from North-east (pre-2021 demolitions)*

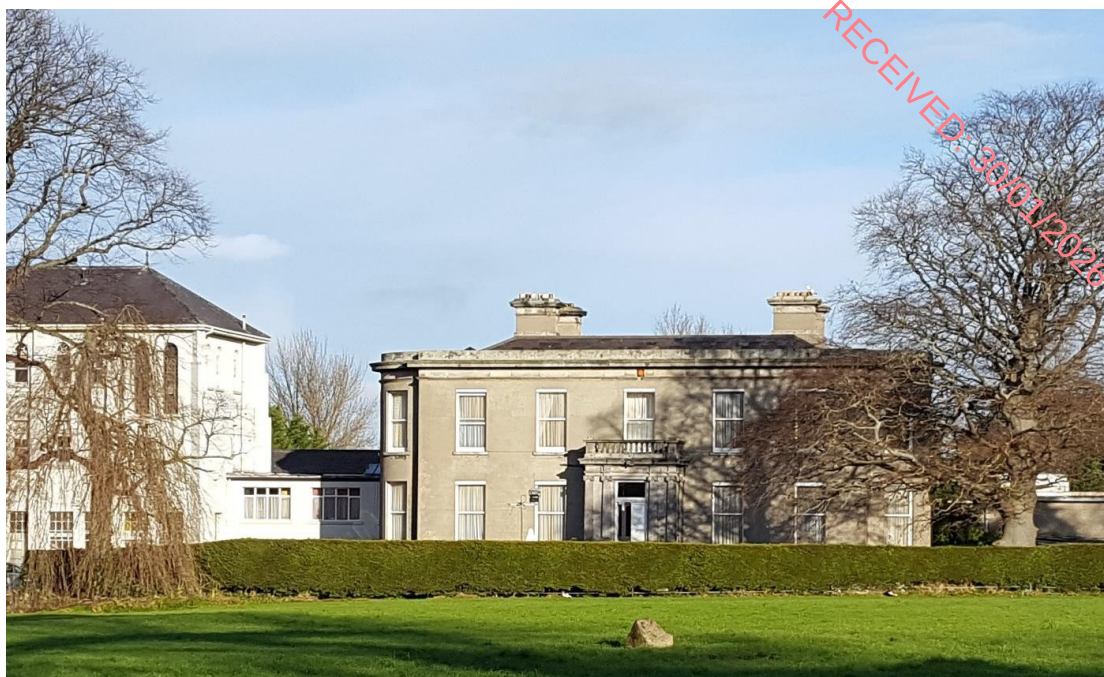
*Figure 17.8 - View from South-west (pre-2021 demolitions)*

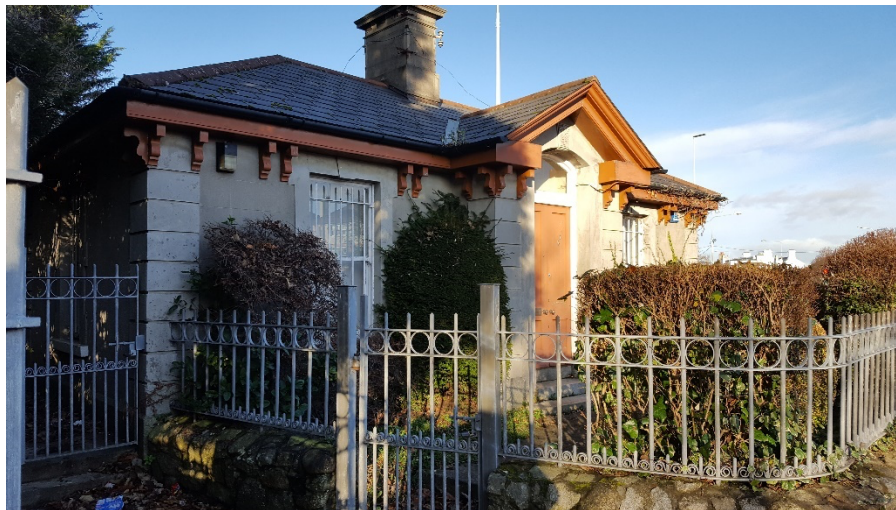
***Lodge at St Teresa's House***

The building is a single storey double-fronted lodge, open pedimented breakfront, one over one windows with granite cills and lugged architraves, granite plinth and rendered quoins. It has a hipped roof with central chimney with granite capping and plinth and double console eaves brackets. A room by room description is attached. J.A.K. Dean<sup>2</sup> describes it as being Italianate in style and of a pattern common in south Dublin, referring to similar examples in Newtownpark, Homestead and Tirbradden.
