## 17 Architectural Built Heritage

## 17.1 Introduction

This Chapter assesses the impact of the proposed development on the Architectural Heritage of the site and of the surrounding Architectural Heritage, specifically Protected Structures, Architectural Conservation Areas and candidate Architectural Conservation Areas.

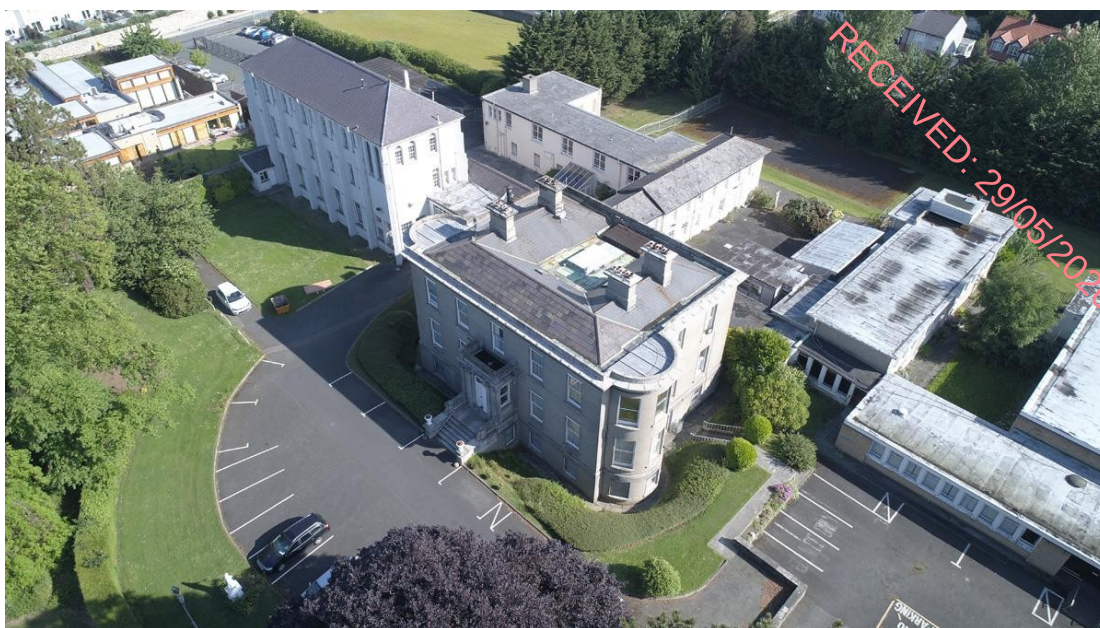
*Figure 17.6 - Aerial view from South (pre-2021 demolitions)*

St. Teresa's House is a two storey over basement detached country house, of five bays with central projecting granite porch, and semi-circular end-bays, and granite cornice, cills, and string course. The porch is reached via a flight of granite steps with granite flank walls. There is a pitched "A" roof having its ridge in a "U" shaped plan, with central flat-roofed area and rooflight above the stairs, and with lead roofs with rolls to the end bays with hip valleys valley gutters and parapet gutters rendered chimneys stacks. The external walls are rendered and lined, with one-over-one pane vertical sliding sash sliding windows.

The exterior of the building is in poor condition having many external service pipes, abutting later extensions, and some non-original windows. The render is cracked in places. The interior of the building has been somewhat altered to accommodate the institutional use, but the main features remain relatively intact. A room by room inventory and photographic record is attached.

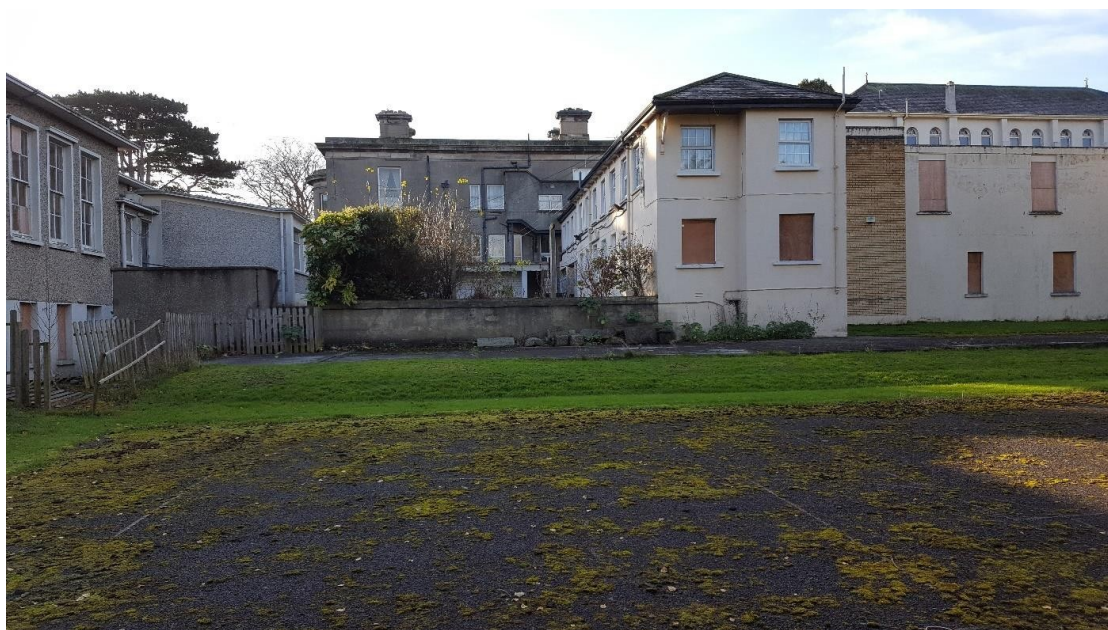
*Figure 17.7 - View from North-east (pre-2021 demolitions)*

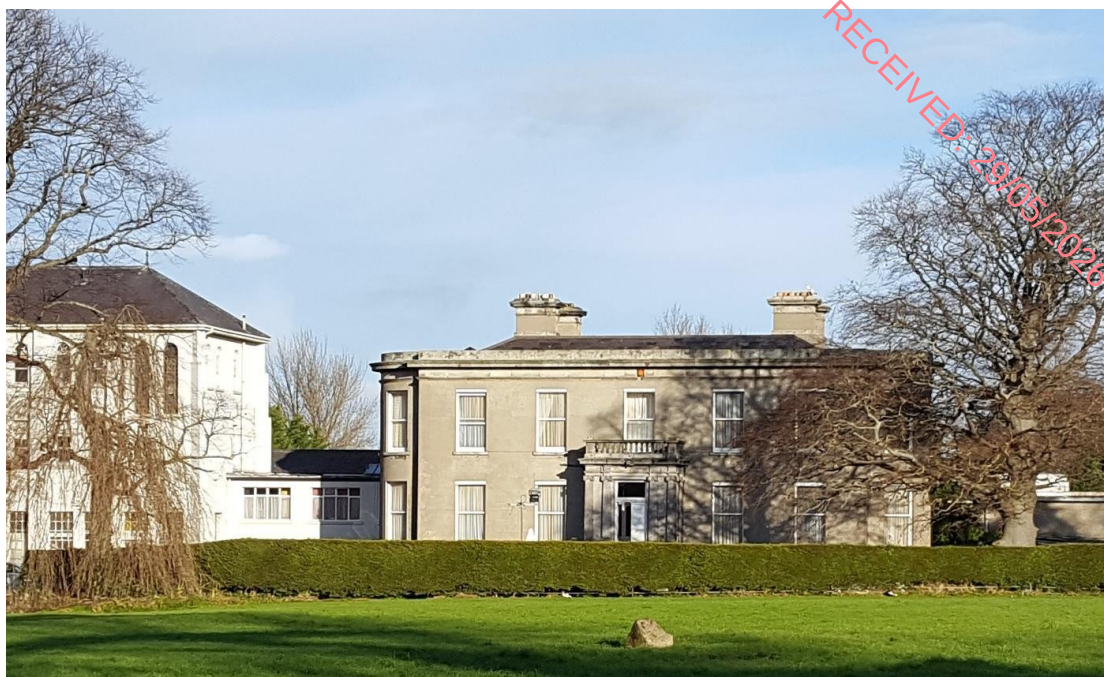
*Figure 17.8 - View from South-west (pre-2021 demolitions)*

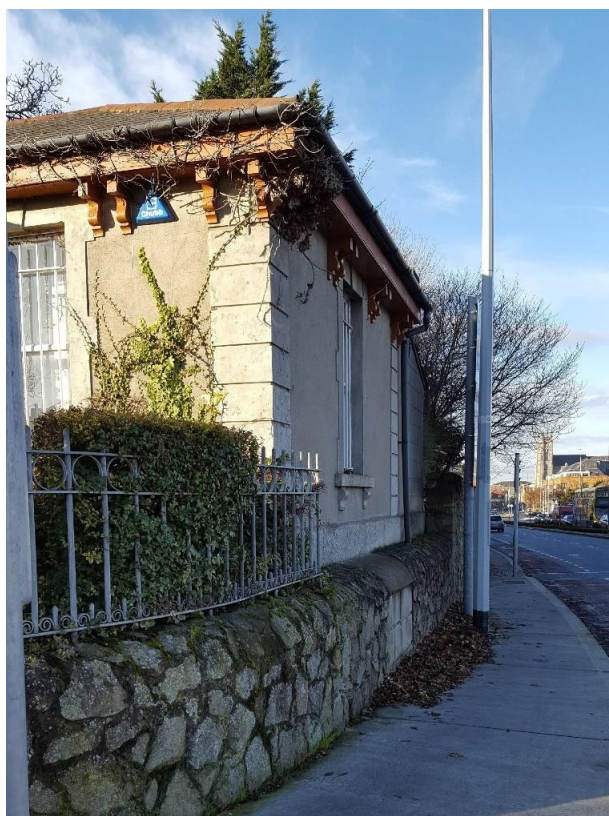
Figure 17.10 - New boundary wall

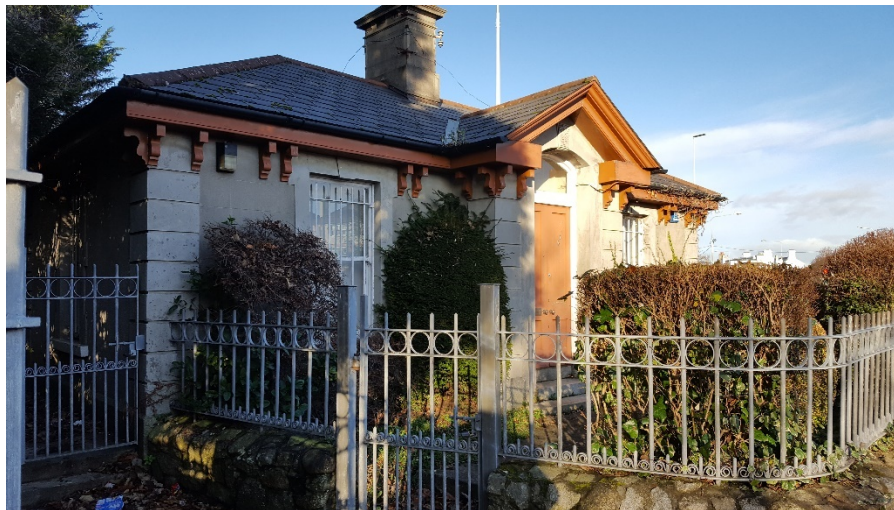
***Lodge at St Teresa's House***

The building is a single storey double-fronted lodge, open pedimented breakfront, one over one windows with granite cills and lugged architraves, granite plinth and rendered quoins. It has a hipped roof with central chimney with granite capping and plinth and double console eaves brackets. A room by room description is attached. J.A.K. Dean<sup>2</sup> describes it as being Italianate in style and of a pattern common in south Dublin, referring to similar examples in Newtownpark, Homestead and Tirbradden.
