5.3 Cultural Heritage - Architectural Heritage

The Architectural and Urban Heritage Impact Report states that the proposed development is to consist of:

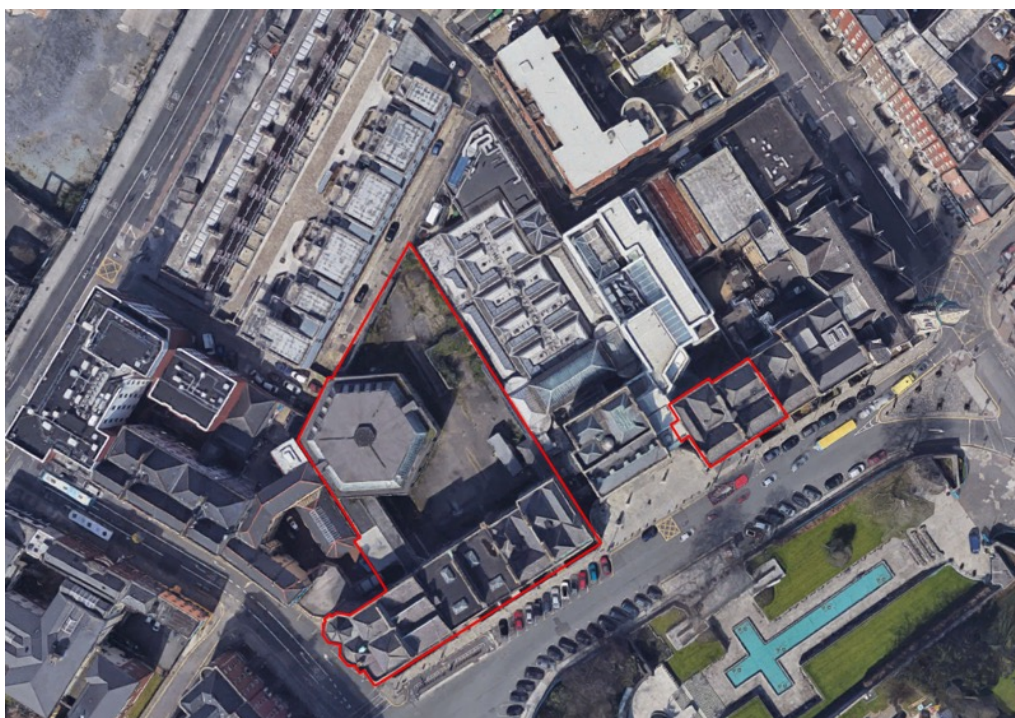
Figure 5.3.1: Aerial photograph showing the involved Protected Structures and their sites outlined in red.

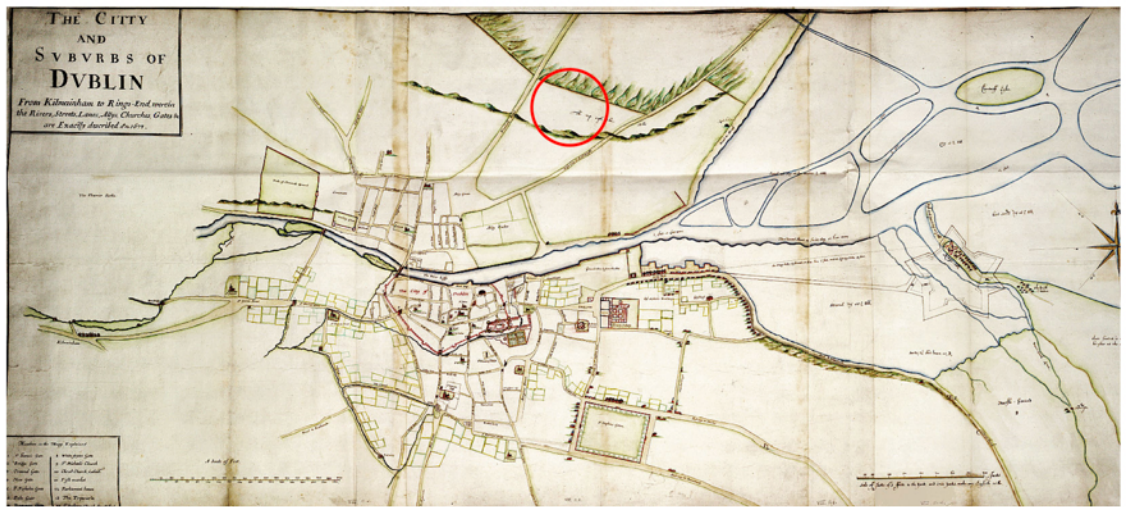
Figure 5.3.4: The City and Suburbs of Dublin, Bernard De Gomme, 1673.

Bernard de Gomme's map of 'The City and Svbrbs of Dvblin' of 1673 shows an amount of development within the core of the city recorded by Speed and the borders of the map extend to include the site where no development of any description is shown. The approximate position of the site has been circled on the copy of the map above. It is clear that the site is outside the city and is relatively undeveloped.

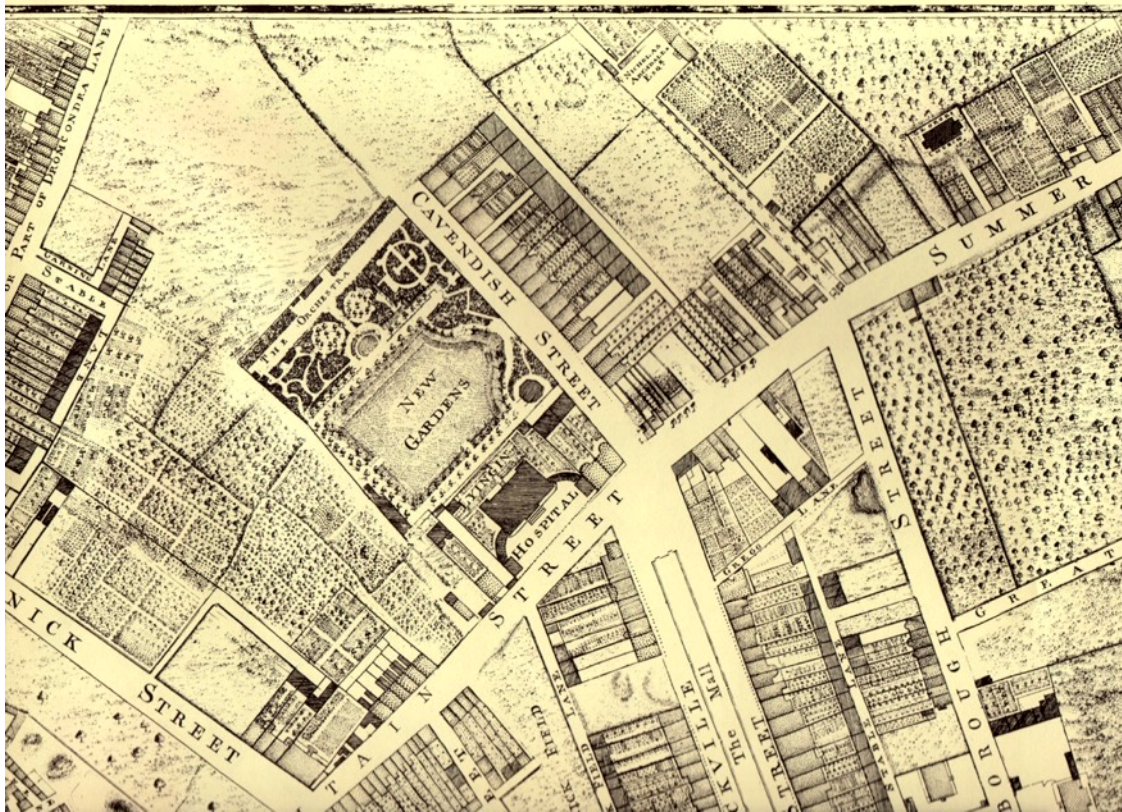
Figure 5.3.6: An Exact Survey of the City and Suburbs of Dublin, John Rocque, 1756.

Rocque's 'Exact Survey' of 1756 is one of the most important historic maps of Dublin. A significant resource in understanding the early Georgian city. It is the first map to give so great a level of detail. While not without some errors, it is remarkably accurate and differentiates houses from outbuildings and warehouses, churches and public buildings.

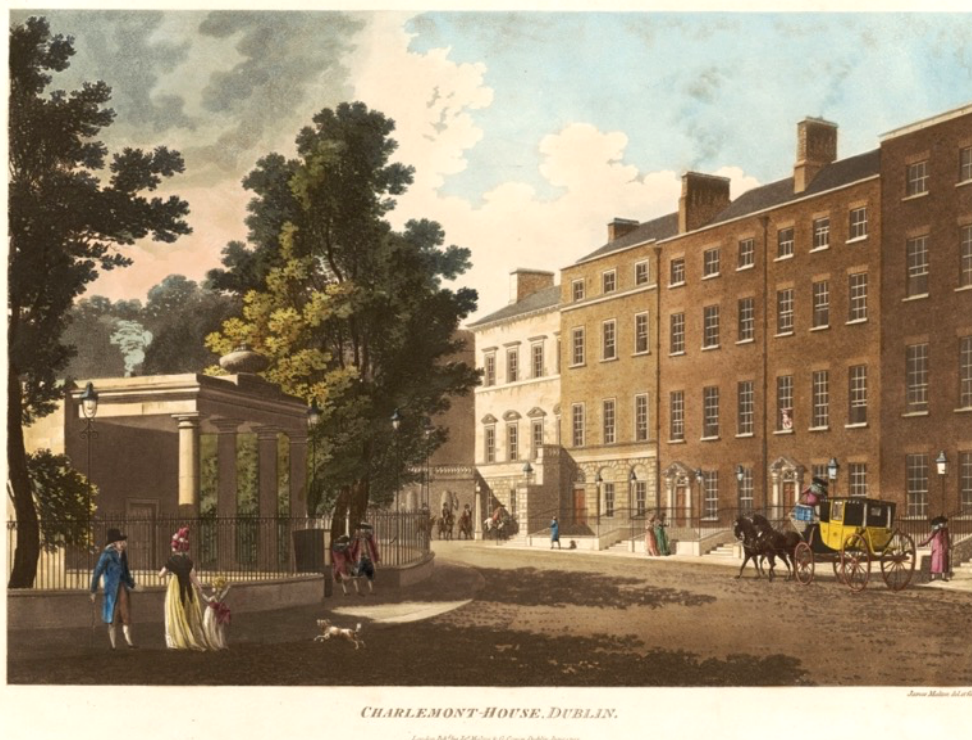
As photography had not been invented by this time, images of the period are painting and prints, all of which have a degree of artistic licence. The major resource of this period is the Malton prints and a view of Charlemont House from the east is one of these prints, which is copied on the next page. This shows Nos. 20 and 21 in some detail. It shows the stone ground floor and arched windows on No. 20 with the cantilevered cornice under the third floor windows. No. 20 is shown with a plain brick front devoid of these embellishments. Both have square headed windows at ground floor level, those of No. 20 being within the ashlar arch and No. 20 clearly forms a pair with No. 19. It is interesting to note that while

It is interesting to note that while No. 21 was the more decorative house externally, No. 20 was the more decorative internally.

Figure 5.3.8: Charlemont House, Dublin, Plate 20 - James Malton, 1793.

This view is approximately the view of Malton Plate 20. The major alterations between the existing and proposed view are the removal of the first floor balcony crossing Nos. 20 and 21, the glazing bars, the adjustments to the street layout, landscaping and paving as proposed by Bernard Seymour Landscape Architects and a very slight view of the proposed new building. The changes are generally positive. The removal of the balcony enhances the ground floor granite ashlar that crosses both houses, creating the impression of a pair at this level. However it conflicts with the upper levels where the windows and parapet are at differing levels. This also highlights the pairing conflict of No. 19 and No. 20. The symmetry concerns relating to Nos. 21 and 23 as pavilions is not visible in this view.

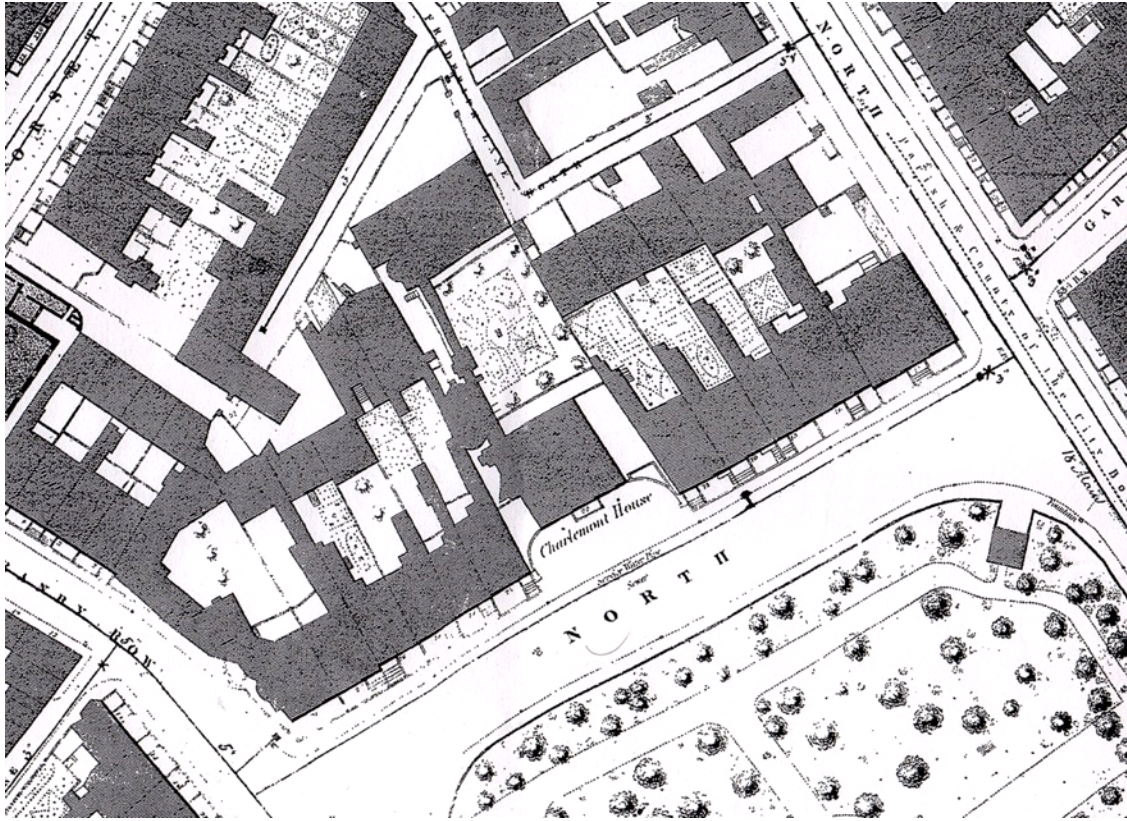
Figure 5.3.10: Ordnance Survey, City of Dublin Sheet 8, Surveyed 1838 - 47.

The Ordnance Survey City of Dublin Map Sheet 8 (Figure 5.3.10) was surveyed in 1838 - 47 and published in 1847 at a scale of 1:1056. It shows considerable detail of the houses and the layout of the rear gardens. It also shows that while only Nos. 23 and 24 had returns shown on Le Scalé's map in 1773, all except No. 28 have returns now (and there is no rear garden space for a Return in No. 28). The set of steps to the gardens, noted in Faden's Map in 1797 are shown in more detail. It is too small a scale to determine if the splay at the corner of No. 28 is present. In terms of the mews buildings, those of Nos. 23 and 24 are shown significantly larger than the other houses.

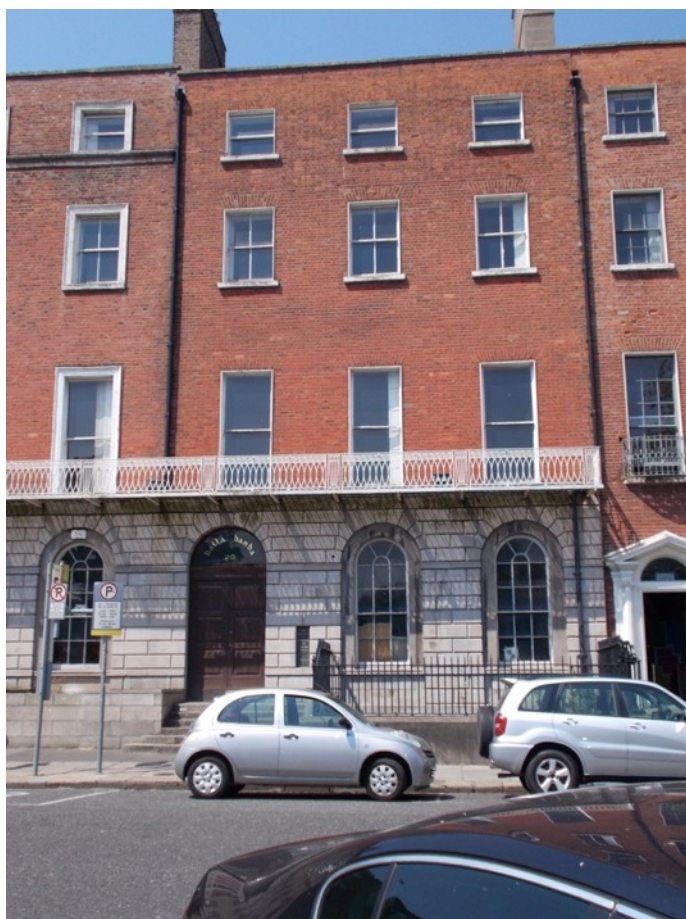
Figure 5.3.13: No. 20 Parnell Square North, Front Elevation.

Externally, No. 20 has experienced considerable change. The ground floor ashlar, arched windows and doorcase and steps and first floor balcony are 20th century fabric to visually unify the house with No. 21, but the railings appear to be 18th century. The first, second and third floor sashes are replacements. To the rear, the ground floor wall was removed to connect to the Ballroom behind, now demolished and the garden and mews are gone, now being a small terrace and modern building forming part of the Hugh Lane Gallery.

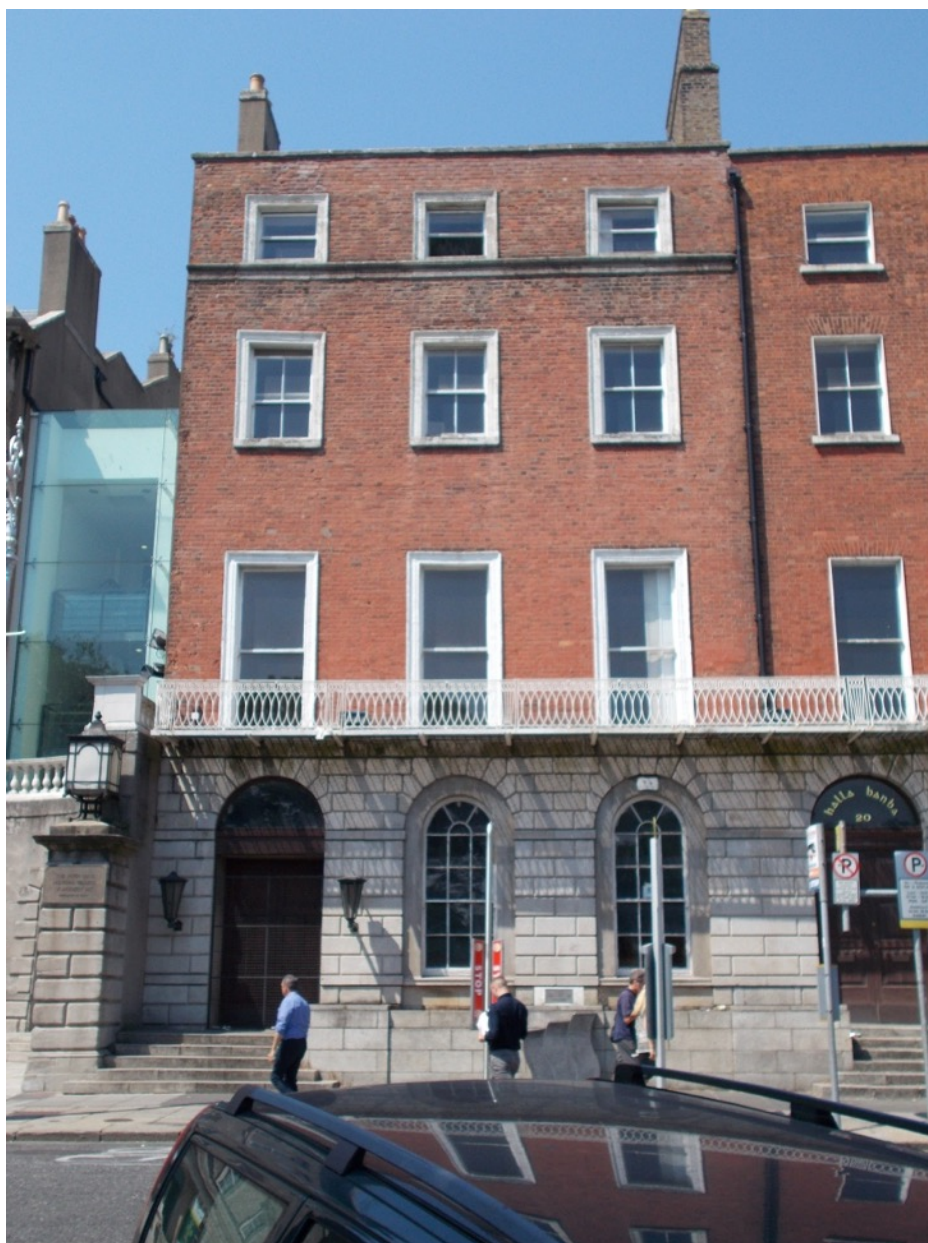
Figure 5.3.14: No. 21 Parnell Square North, Front Elevation.

Externally, No. 21 has experienced an amount of change. The ground floor granite ashlar is a 20th century replacement for the original ashlar and the door case and windows have been replaced. The cementitious render within the arches is 20th century. The balcony is a 20th century addition. Of the upper floors, the windows have been replaced but the architraves seem original being shown on Malton. To the rear, apart from alterations to access the ballroom from the stairwell, subsequently altered when the ballroom was removed and the Hugh Lane Gallery extended, the rear wall has survived reasonably intact. However, the garden and mews have been lost and the area developed as part of the Hugh Lane Gallery. Interconnections to No. 20 were formed in the 20th century.

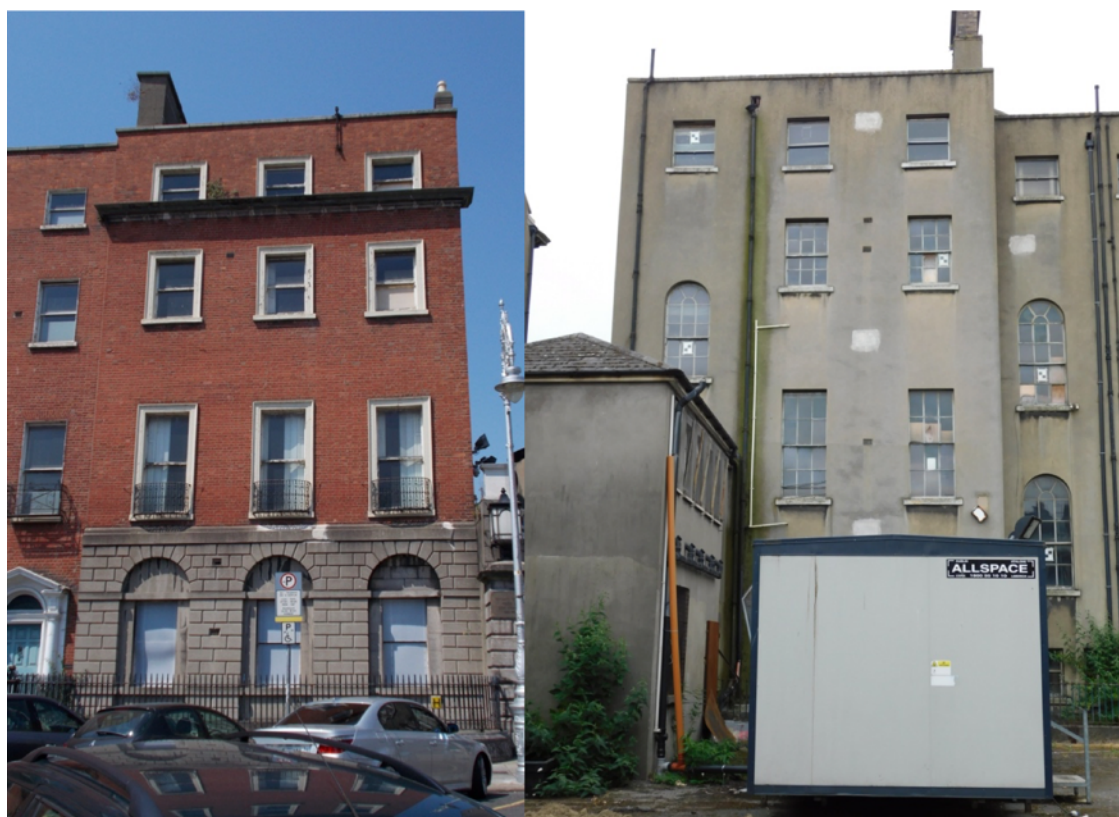
Figure 5.3.15: No. 23 Parnell Square North, Front and Rear Elevations

Externally, the front of this house has experienced an amount of change. The ground floor granite ashlar has been replaced with a cementitious mortar and the doorcase removed and a window inserted, all part of works undertaken in the late 1930's. The steps were also removed and the railing continued with a quadrant closing the basement area. The window architraves and cantilevered cornice match those of No. 21 as shown on Malton, so these are most likely original. The sashes have been replaced. The rear is rendered with cementitious render and a number of original sashes have survived. The ground floor of the Return has weathered granite sills that are probably 19th century if not original, but there are some alterations. The upper floor has been altered with a series of modern toilet windows and precast concrete sills and is more recently rendered than the ground. It is possible that the upper floor might have been re-built in the 20th century, but further opening up and research is required at pre-contract or construction stage.

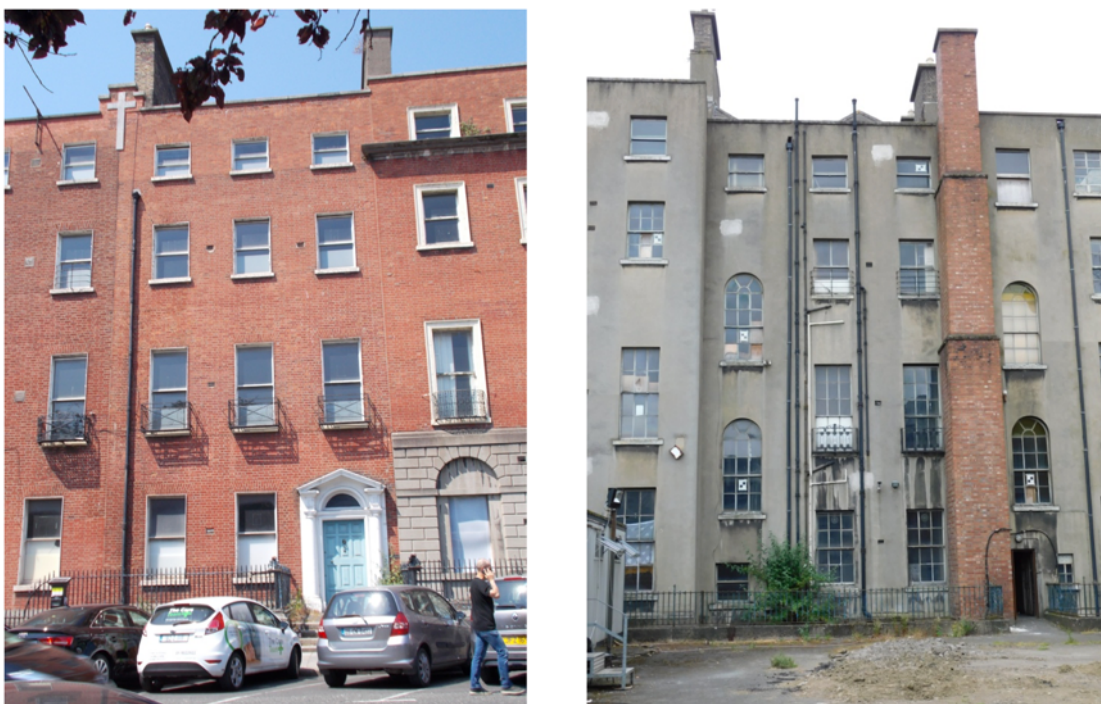
Figure 5.3.16: No. 24 Parnell Square North, Front and Rear Elevations.

Externally, the front of this house has experienced the least change of the houses apart from No.28. The sashes have been replaced and the wrought iron balconies added. The waste pipe is a 20th century addition to serve the bedrooms created on the third floor. The parapet upstand and cross are 1930's additions. To the rear, many of the original windows have survived, but the building has been rendered with a cementitious render. A large chimney stack was added at the junction with the adjoining No. 25 in the mid-20th century. There is no evidence of a Return in the past

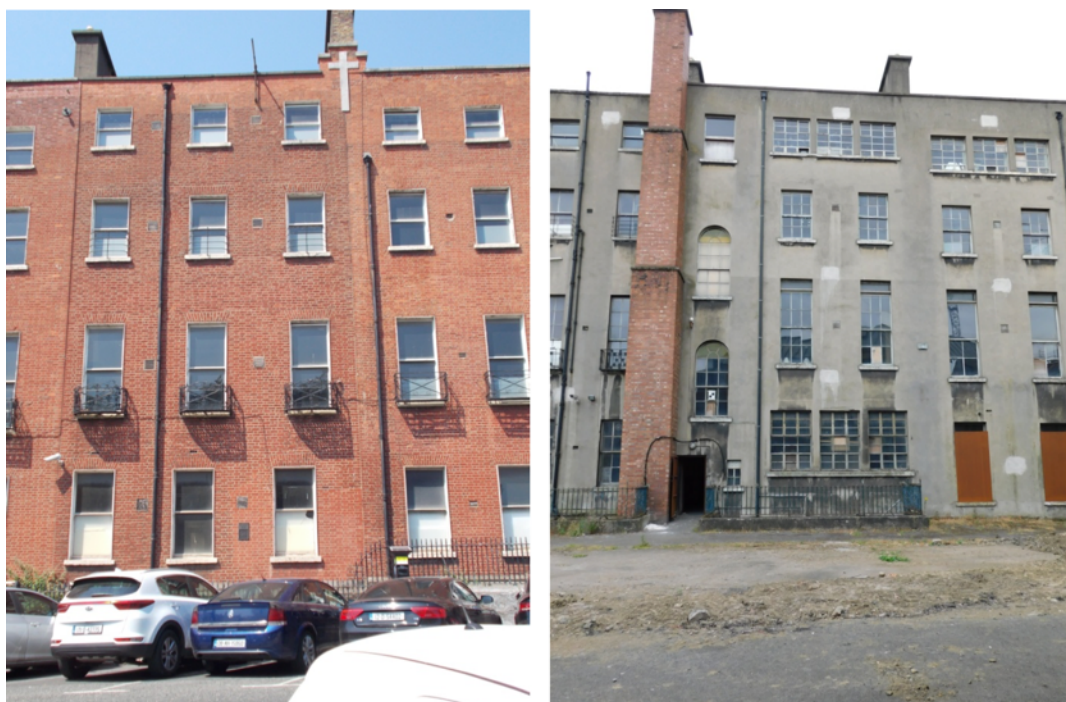
Figure 5.3.17: No. 25 Parnell Square North, Front and Rear Elevations.

Externally, the front of this house has experienced an amount of change. The doorcase has been removed and a window inserted, part of works undertaken in the late 1930's. The steps were also removed and the railing continued with a stepped closing of the basement area. The sashes have been replaced. The parapet upstand and cross are 1930's additions. The rear is rendered with cementitious render and a number of original sashes have survived, but the ground floor and third floor windows were significantly altered in the late 1930's. A large chimney of coeval date has been constructed at the party wall with No. 24.

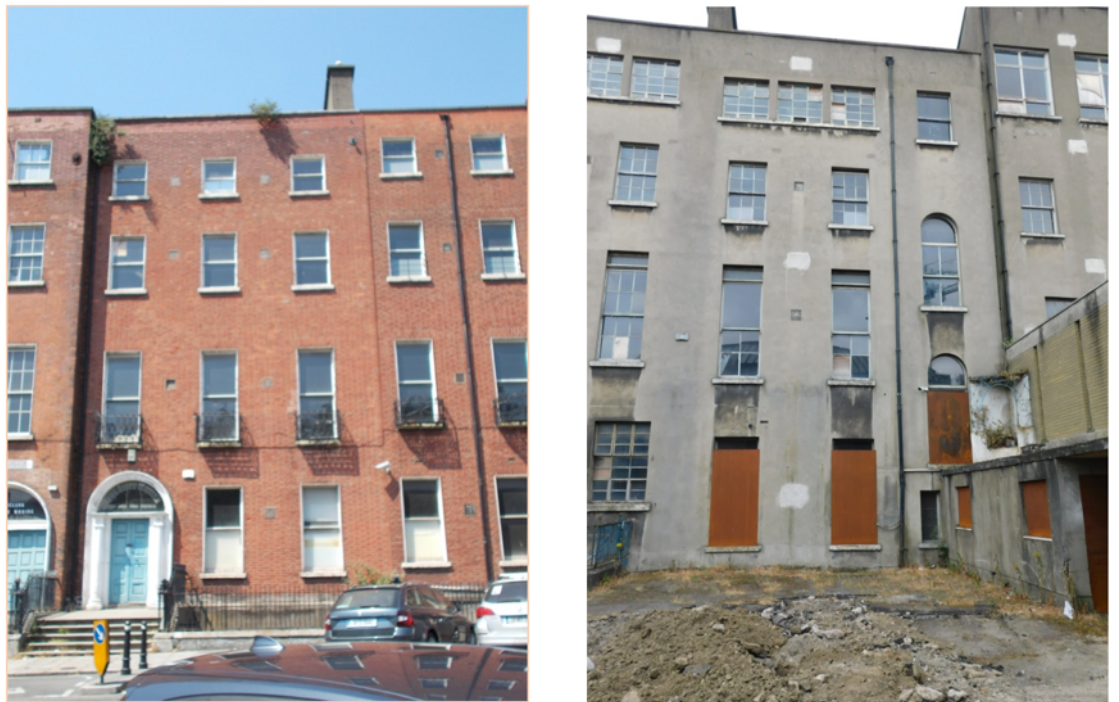
Figure 5.3.18: No. 26 Parnell Square North, Front and Rear Elevations.

Externally, the front of this house has not experienced a lot of change, although the upper floor is shown as re-built on the 1930's Robinson & Keefe drawings. The sashes have been replaced. The rear is rendered with cementitious render and the Robinson & Keefe drawings show the rear wall to be re-built from first floor window sill level up, so no original windows have survived. The roof has been replaced with a modern flat roof.

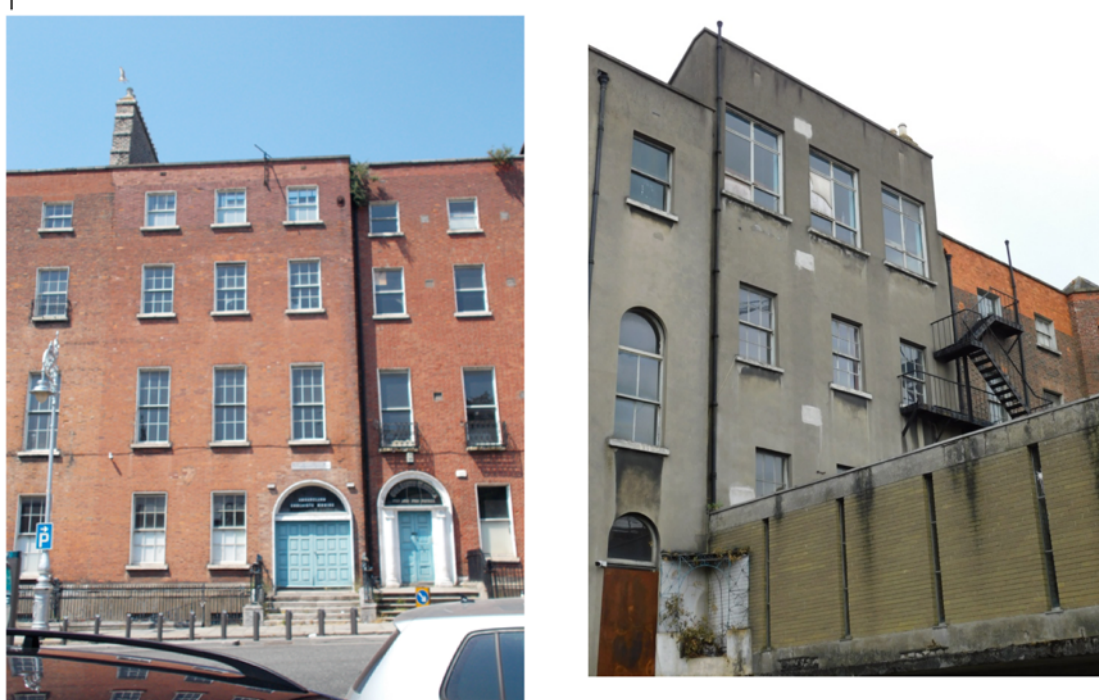
Figure 5.3.19: No. 27 Parnell Square North, Front and Rear Elevations.

Externally, the front of this house has seen limited change, principally the replacement of the original doorcase. The date of this alteration has not been established, but the brickwork used to enlarge the door is characteristic of the latter half of the 20th century and probably relates to the construction of the Amharclann building to the rear in the 1960's. The sashes have been replaced. The rear is rendered with cementitious render and three large windows, probably dating to the mid-20th century, have replaced the third floor originals. The lower levels are obscured by the modern corridor connecting the building to the Hexagonal Amharclann building.

Internally, the house has been very significantly altered, and the original staircase has been removed. In the basement, the original barrel vault under the Hall and former Stair Hall has survived intact as has the cross vaulting in the front room. Therefore this level has survived relatively intact. While most of the rooms above have been stripped, the ceilings and cornices have survived in some. In other locations, modern coves have been installed and, as far as can be identified, the ceilings replaced by typical construction of the 1950's and 1960's. The 1924 survey shows the Entrance Hall occupying the full width of the building and while this is currently sub-divided, it is possible this is a 20th century alteration coeval with the entrance door alterations. The original roof has been removed and a modern 'north light truss' type roof is installed in the now single space of the third floor.

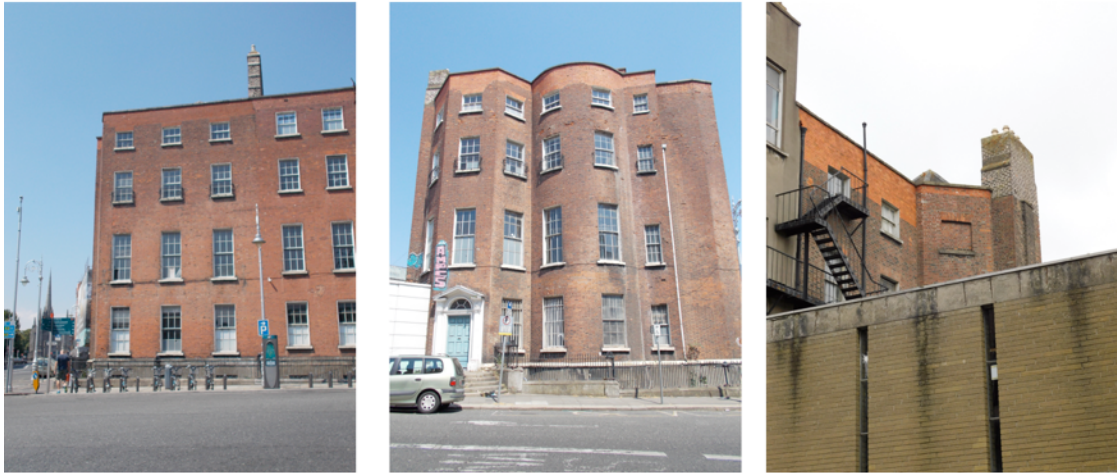
Figure 5.3.20: No. 28 Parnell Square North, Front, Granby Row and Rear Elevations.

Externally, the house has fronts on both Parnell Square North and Granby Row. While the Parnell Square facade is the simple brick elevation consistent with the remainder of the Square, the Granby Row elevation combines a Bow and Bay which embellish the facade and a splay or chamfer articulates the corner. The Bay forms the entrance hall with octagonal rooms above and the Bow accommodates the main stairs, the flights following the curve of the bow while the landings cross the straight rear. While essentially a land locked corner building, it did have a rear garden which is now fully covered. Its rear wall and Bay can be seen rising above the adjoining the Amharclann Corridor with blind windows decorating the flat panels and a visually prominent chimney stack. The rear wall continuing the line of No. 27 has retained exposed brickwork rather than the cementitious render of the other houses.

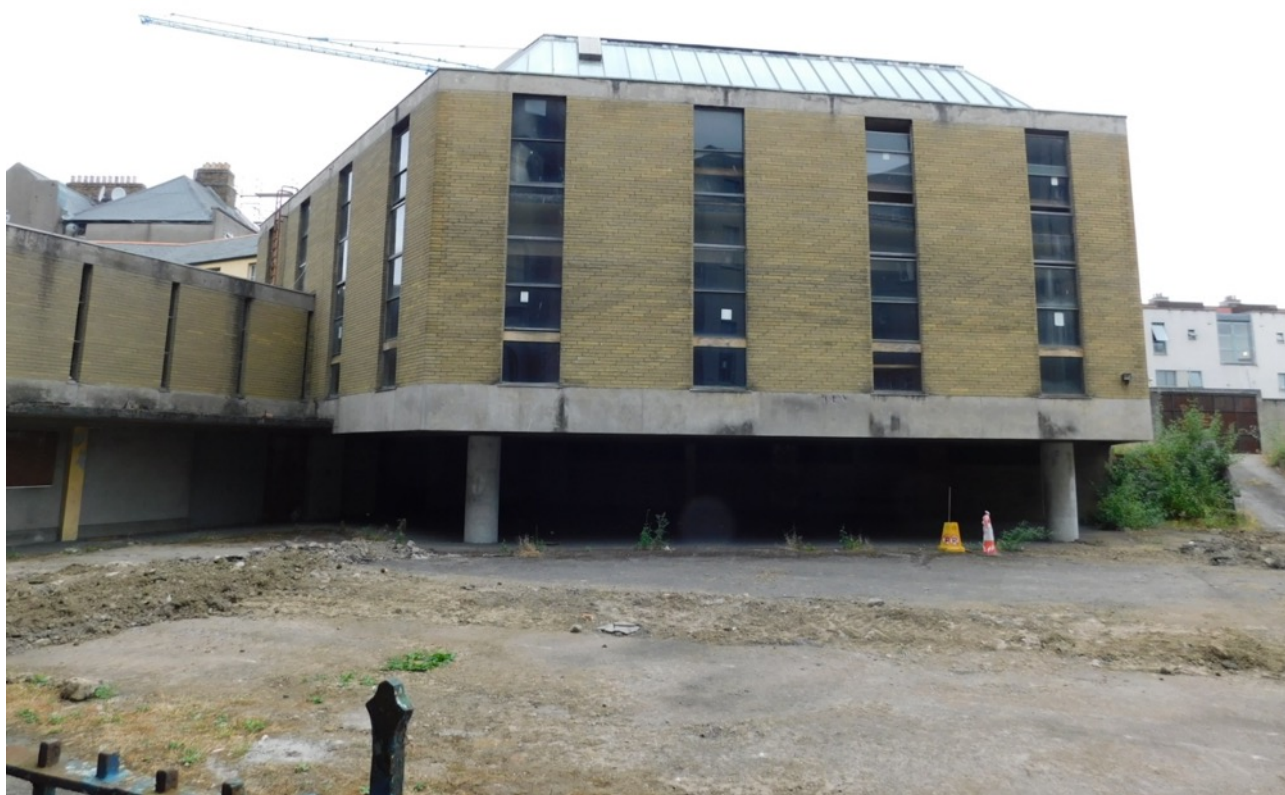
Figure 5.3.21: The Hexagonal Amharclann Building from the yard area.

This building dates to the 1960's. It is similar to many of the secondary level educational buildings of the time. This is the period when government financing of educational buildings was being extended from National Schools to Secondary Schools and Modular Coordination was seen as the way forward. It is not included in the NIAH Survey of Dublin City, nor is it listed among the 109 buildings dating between 1953 and 1978 in *A Guide to Modern Architecture in Dublin*.

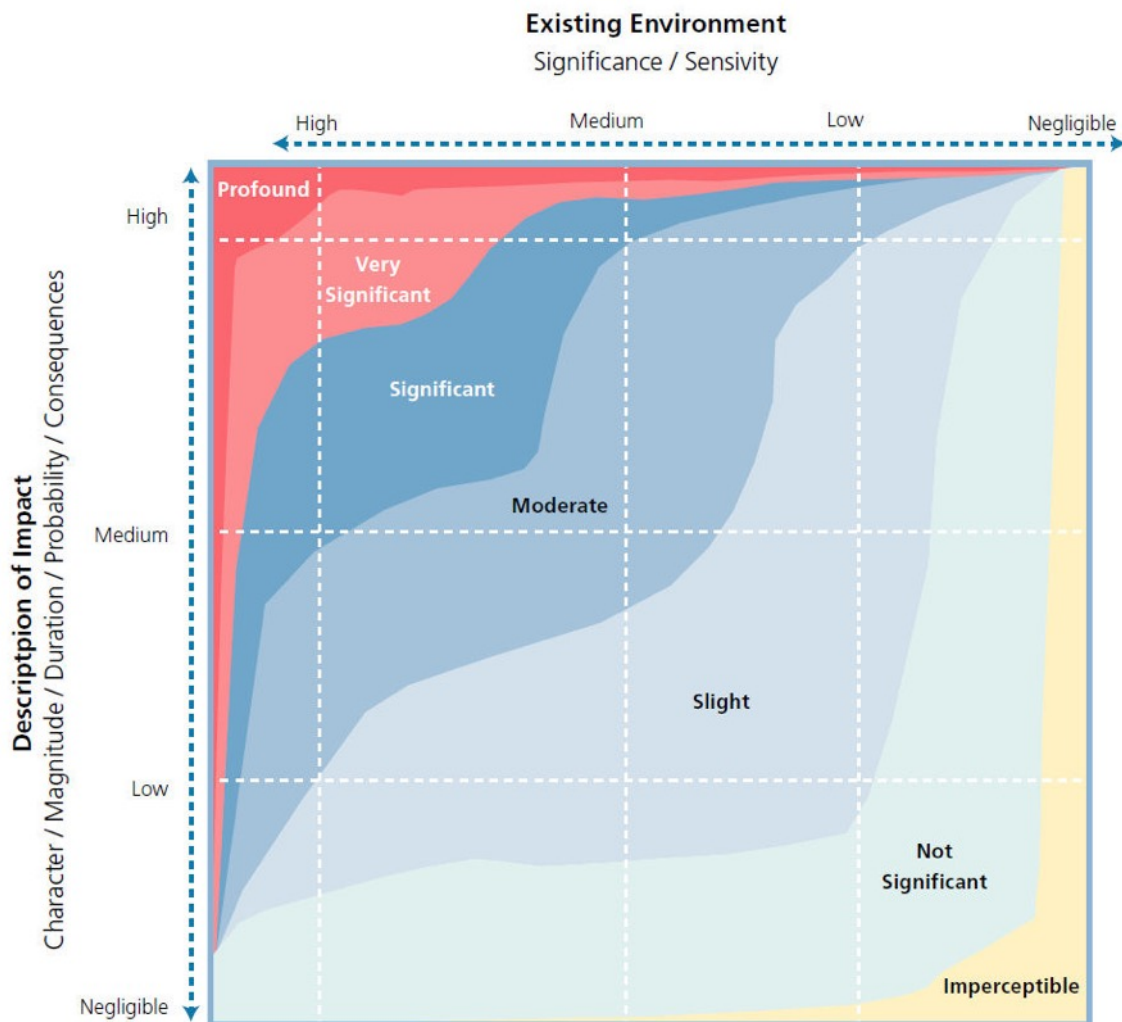
Figure 5.3.22: Diagram showing typical classification of the significance of impact. (Extract from EPA Guidelines on the Information to be Contained in Environmental Impact Assessment Reports - DRAFT - August 2017, page 53 Figure 3.5.)

In particular, the diagram (Figure 5.3.22) showing the typical classification of the significance of impact on page 53 of that document have been followed. A copy of the chart is given below for reference.
