## **7.5 Outline Schedule of Proposed Works - Existing Buildings**

**NEW DUBLIN CENTRAL LIBRARY - PARNELL SQUARE CULTURAL QUARTER: OUTLINE SCOPE OF WORKS FOR EXISTING BUILDINGS/PROTECTED STRUCTURES**

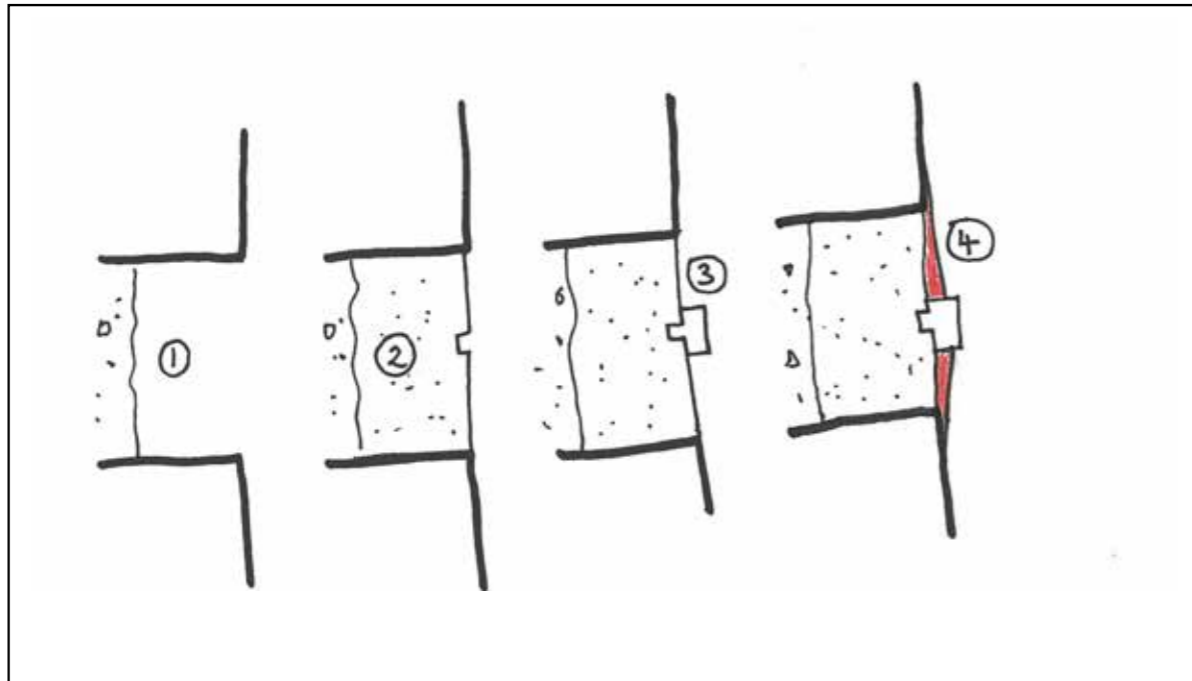
1. Joint raked out
2. Joint pointed with white stopping mortar
3. White ribbon inserted and formed
- 4 Wigg (coloured mortar) applied to joint face to overlap with brick

Tests removal shall determine appropriate method and tools for removal of pointing to prevent damage to brick. Test will demonstrate proficiency with joint raking tools and ability to not cause significant damage to brick units with either hand or power tools. A certain amount of chipping of brick edge will occur but adhering to agreed methodology will minimise loss Generally pointing removal will be using of masons fl at headed quirks or similarly appropriate tools. Where pointing is of a hard dense nature a power tool shall be used to cut a centre groove to allow removal of remainder using careful action and with prior sample approved by Architect.

The bed joint will be raked out using quirks to depth of 25mm to provide a square face. Loose dirt and debris shall be removed using a stiff bristle brush or blowing the joints clean with low-pressure compressed air (40-60 psi). Thoroughly flush out joint with clean, Clearwater.
