Parnell Square Cultural Quarter

DATE:
October 2018

Purpose:
For Planning

Title
Existing Sections J&K

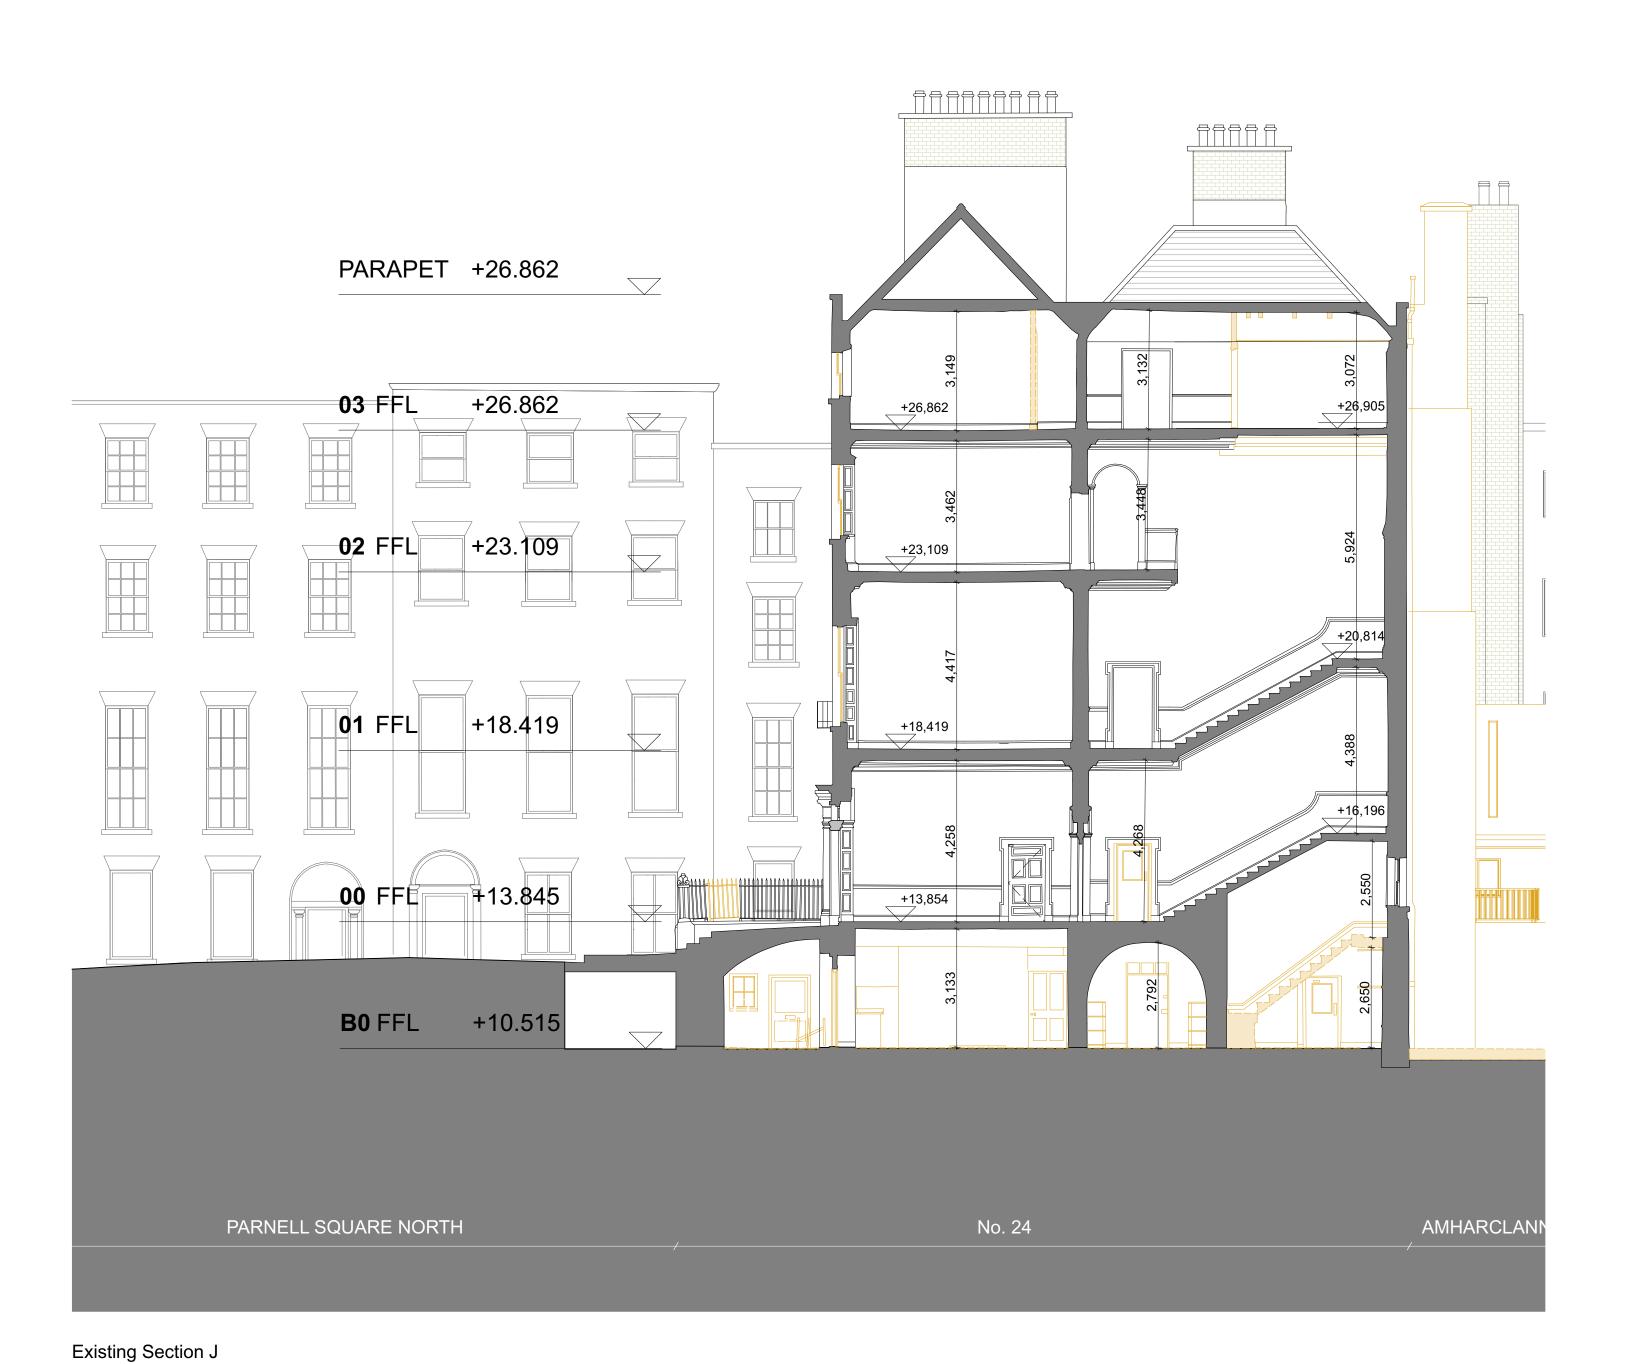
Existing Section J

## PARAPET +30.16 03 FFL +22.351 00 FFL +17.963 17.889 17.899 19.899
