LEVEL:		REV.:	DATE: DRWN.: DESCRIPTION:	INT:			FIGURED DIM		TO BE USED					THIS DRAWIN	
	NORTH:						PROJECT TITLE :					DATE	: ber 2018		
,					grafton architects	12 -14 COLLEGE GREEN DUBLIN 2 (T) ++ 353-1-671 3365 (F) ++ 353-1-671 3178 email : pscq@graftonarchitects.ie	Parnell Square Cultural Quarter								
													For P	For Planning	
					SHAFFREY ASSOCIATES ARCHITECTS		TitlePage SizeProposed Basement, Ground & First Floor Plans_20&21A0					Size	Scale 1:100		
							Project	Sub Project	-		Level	Туре			tability Revision
							PSCQ	P	GASA	XX	ZZ	DR		0107	S2 PA1

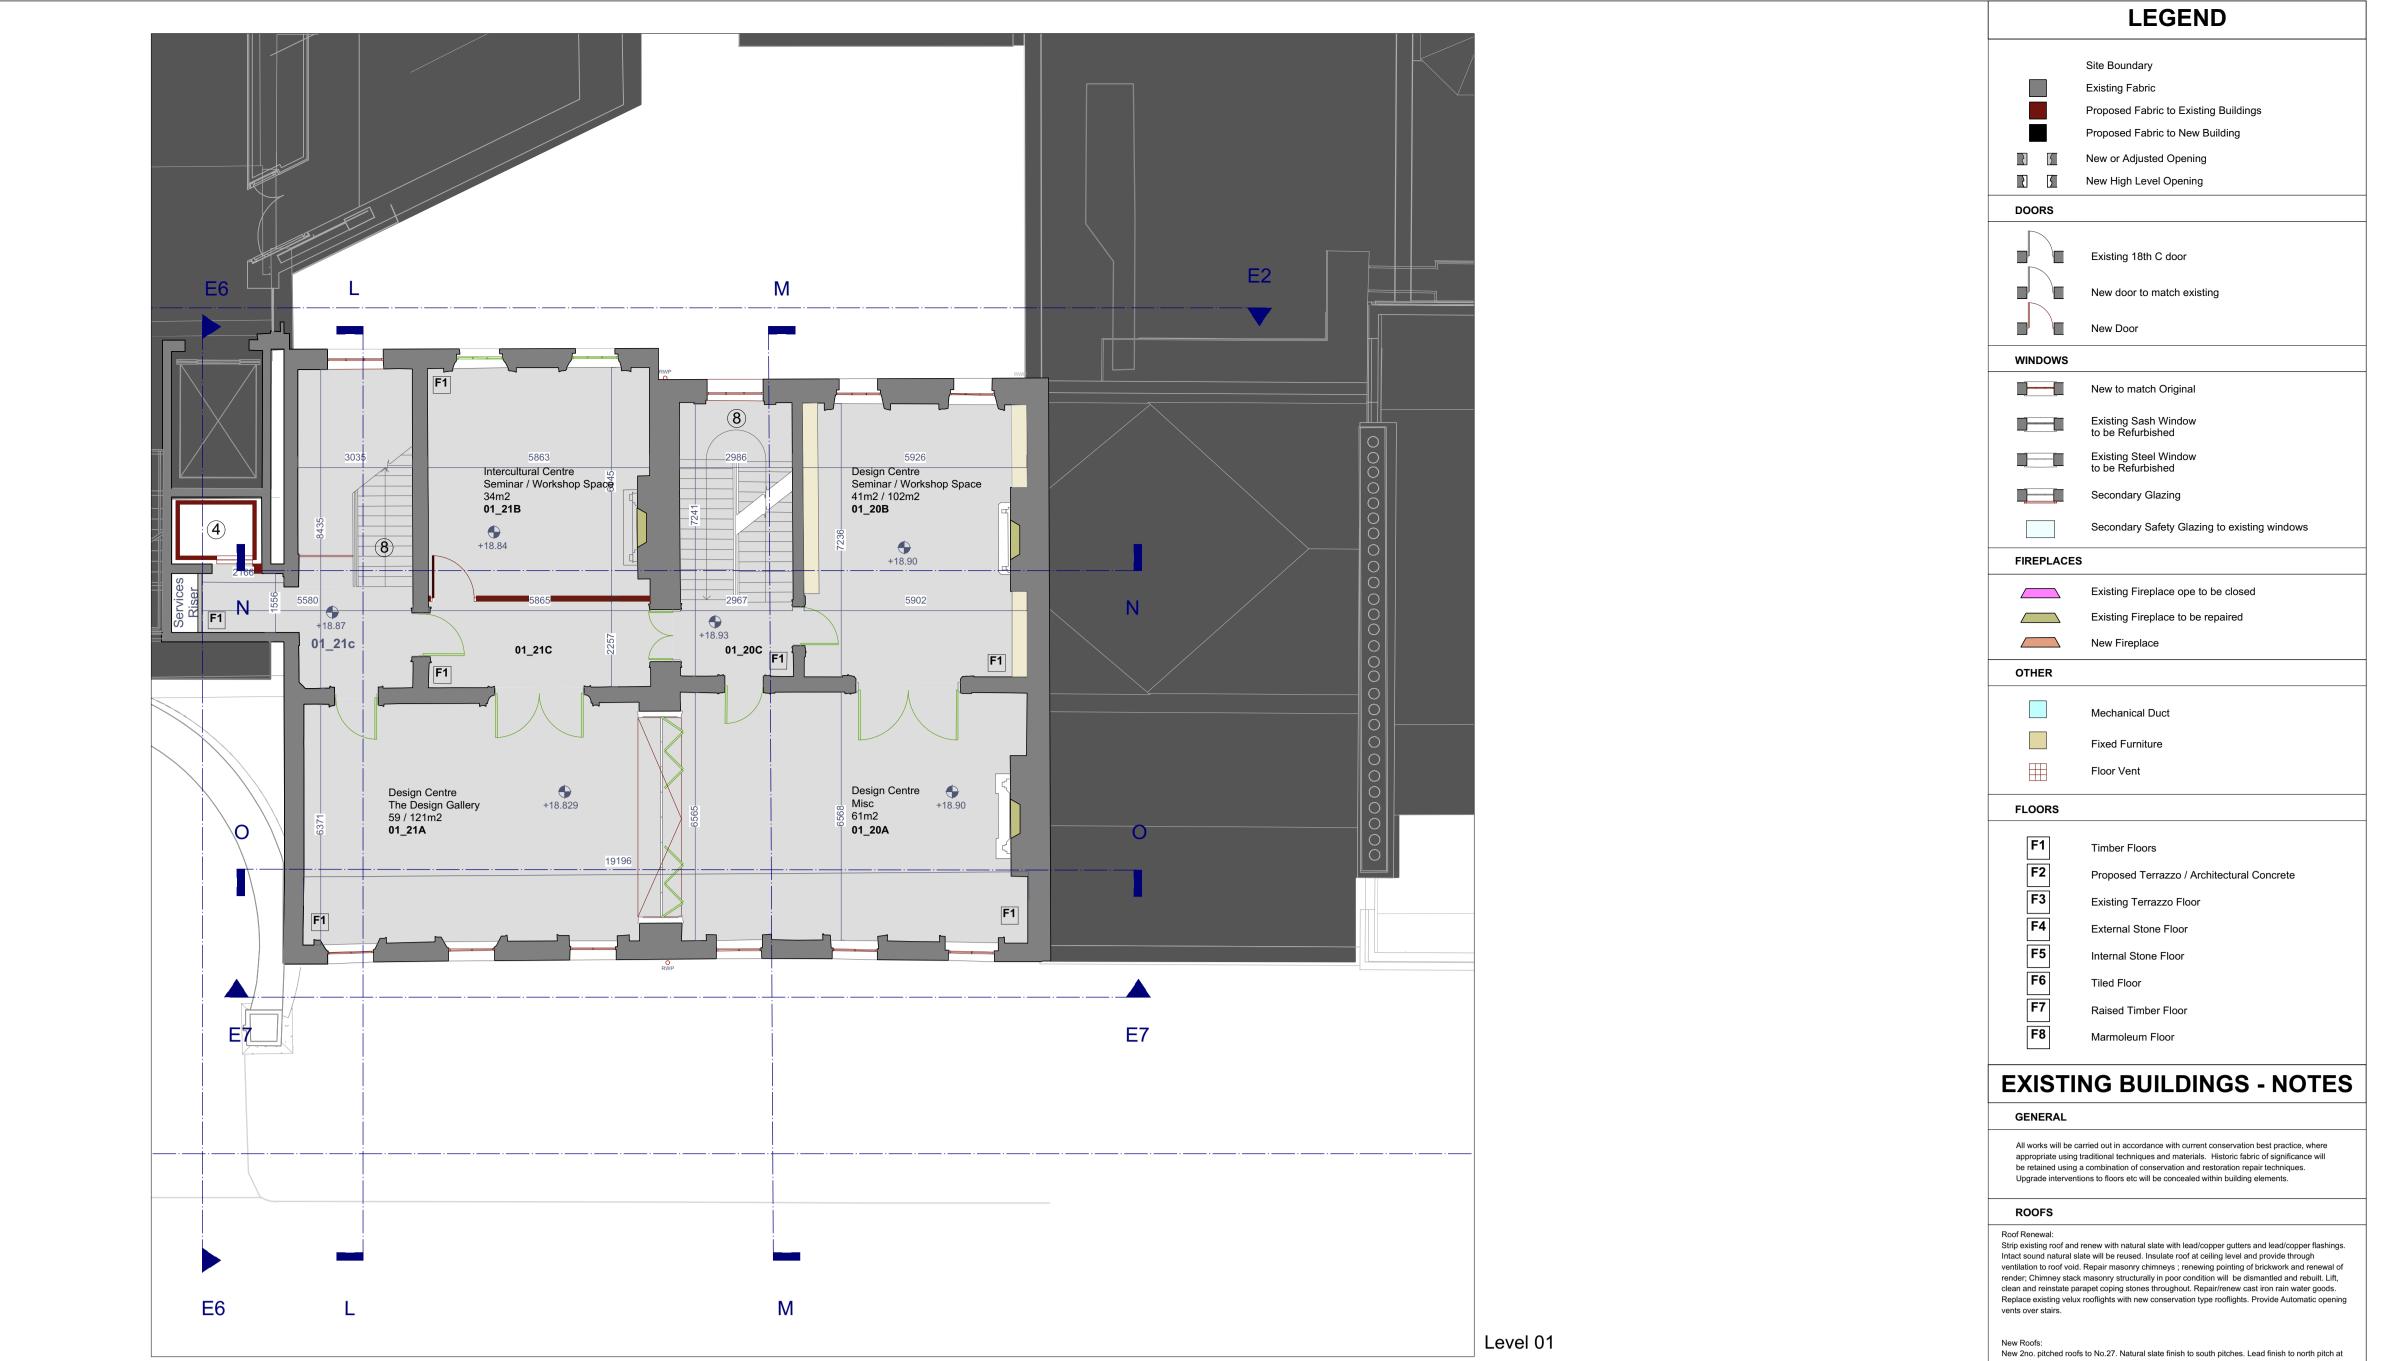
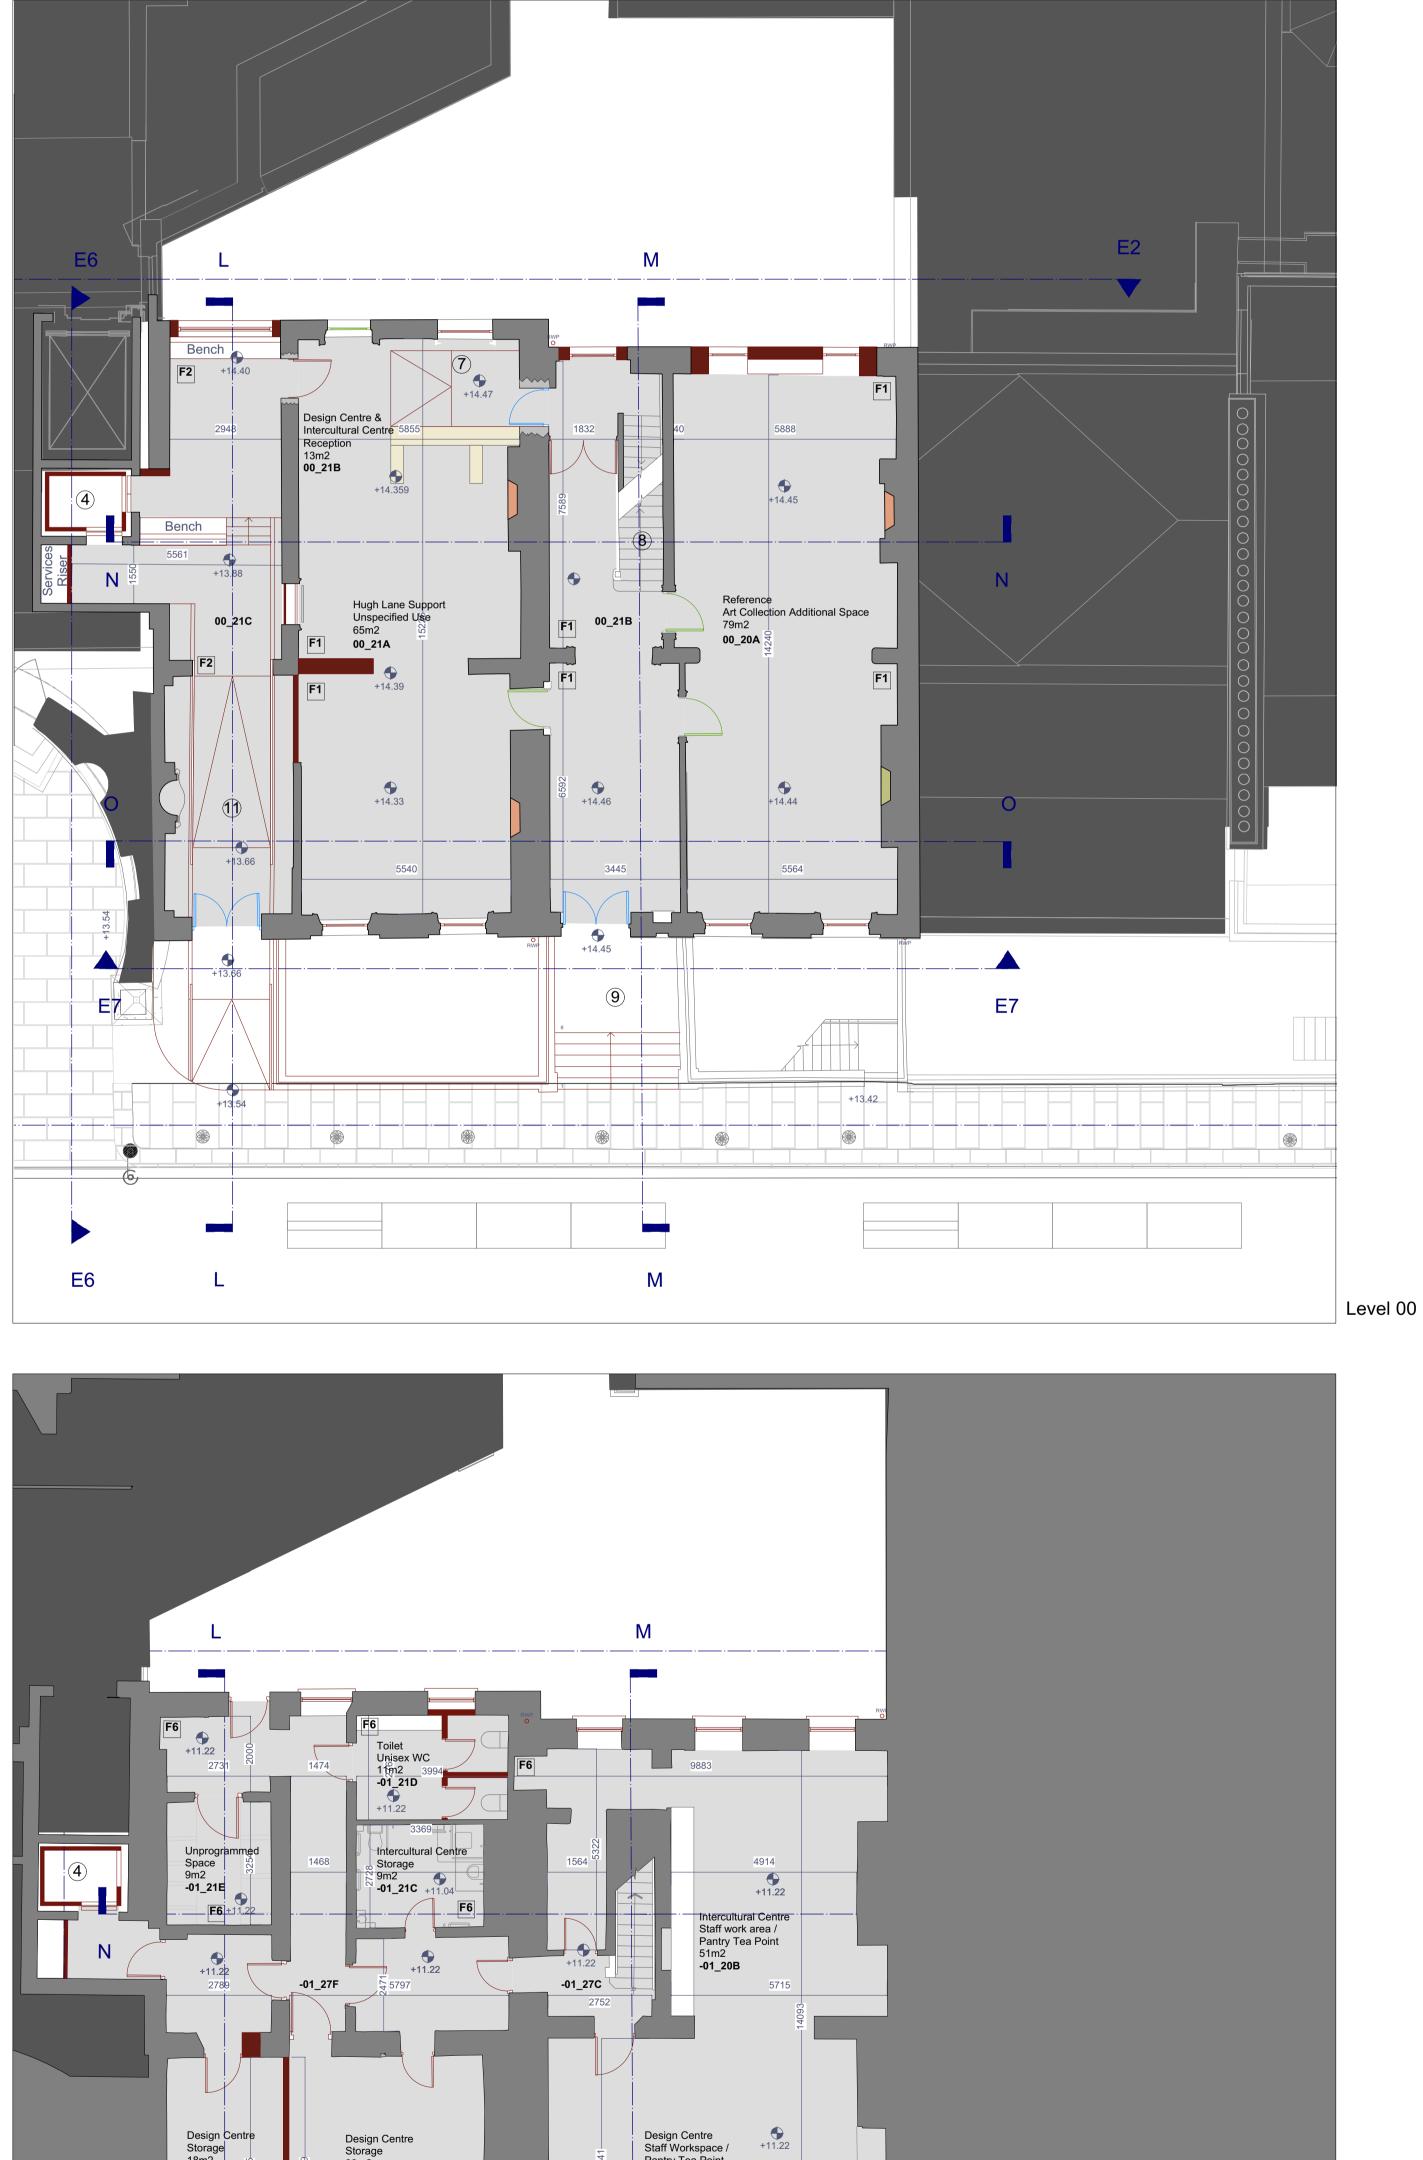
rear. Rooflight to north of front pitch. New roof terrace to roofs of No.25 & 26 with planters and benches to architect's specification. Hard landscaped paver finish to terrace. New guard rail to be stepped back from front parapet.

South Facade Work: Rake out pointing, replace unsound brick and renew pointing with wig tuck pointing techniques. Walls will be structurally stitched where required. Clean stone cills using appropriate conservation

cleaning techniques. Remove paint from door surrounds using appropriate conservation cleaning techniques. Alter entrance to provide ramped access providing new concrete/stone door surround to no.27. Reinstate entrance steps, entrance door and surround in No.23 to match historic detail. Alter entrance to provided ramped access to no.21, Replace existing doors to no.22 & 21. Repair decayed stonework string to No.21 & 23 between 2nd and 3rd floors. A vapour permeable transparent coating will be applied to surface where cleaned surface is susceptible to further deterioration. Remove render overlayer on ground floor of No.23 and reinstate stone to match historic. Clean down, repair stone window surrounds to No.21 & 23. Remove render at basement level, rake out joints and repair masonry before finishing with new NHL render. Remove, repair and reinstate existing metal balconies in No.23-26. Reinstate brick as necessary following removal of balconies. Remove balcony at first floor level to No.20 -21 and repair façade.

Junction of North Facade and New Build: Enlarge openings in existing rear facade as shown in drawings to provide pedestrian bridge connections from new build to existing buildings on various floors of No 23-26. Brick to be repaired at the surround of new opes. New building junction to rear facade to finish behind the parapet on the north facade to create an environmental seal. Existing parapet height is retained with reinstatement of original parapet height to rear of No.27.

North Facade Work: North Facade Work: Existing areas of cementitious render finish to be removed. Depending on the condition of the underlying brickwork, it may be feasible and desirable to repair and present the brick. Alternatively, the condition of brick may be so damaged that render renewal using lime plasters will be necessary . There are three options proposed for rear façade renewal: 1 Brick repairs and re-render with lime render with 3-coat vapour permeable silica paint finish 2Brick repairs, pointing renewal and apply 3-coat vapour permeable silica paint finish directly to brick masonry.

New brick infill to existing opes in various locations as shown in drawings. Remove existing balconies / fire stairs, rain water goods and brick chimney. Walls will be structurally stitched where required. New cast iron rainwater goods to architect's specification. Clean stone sills using appropriate conservation cleaning techniques. Replace/repair damaged and broken cills using matching stone for grafts and replacement cills. New cills to match existing.

No.27 to the new build. Remove render at basement level, rake out joints and repair masonry before finishing with new NHL render. Remove upper section of façade of No.27 above 3rd floor level, reinstate original rear wall alignment with part original fenestration of 2no. windows and new concrete lined opening. Remove existing brickwork and windows to 3rd floor of No.27 at rear facade as shown in drawings. Reinstate 2no. windows and opes and create new concrete lined ope above entrance. New ope and concrete frame to rear of No.21 Alter existing openings providing new fenestration pattern at junction of previously removed returns, opening to be framed with stone / concrete Reinstate original fenestration pattern to the rear of No.20 as shown in drawings.
