EXISTING BUILDINGS - NOTES

Proposed South Elevation (E1)_20-21

Proposed West Elevation (E6)_20-21

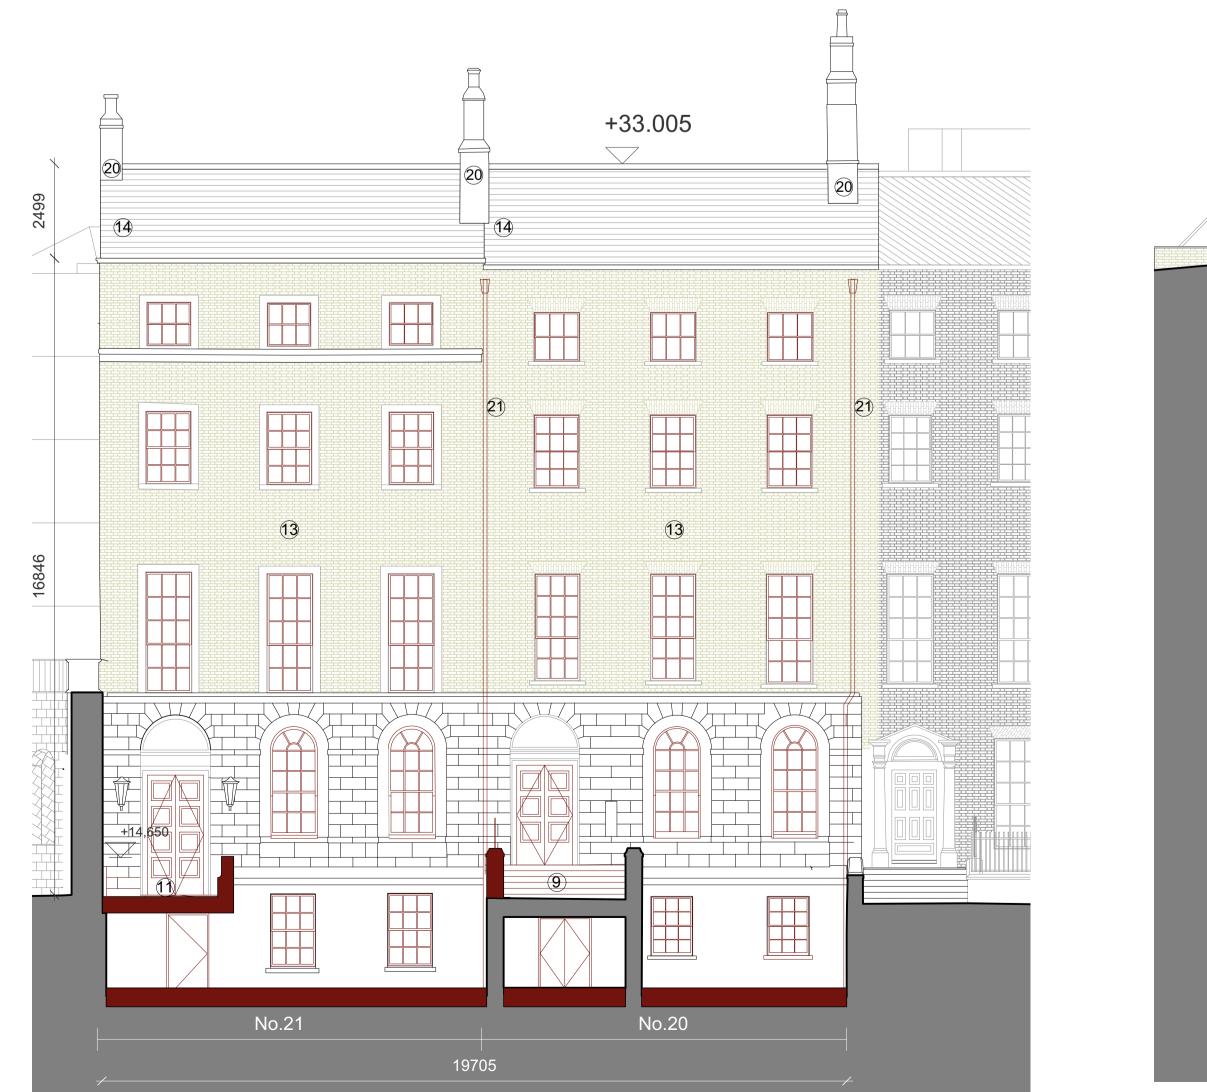
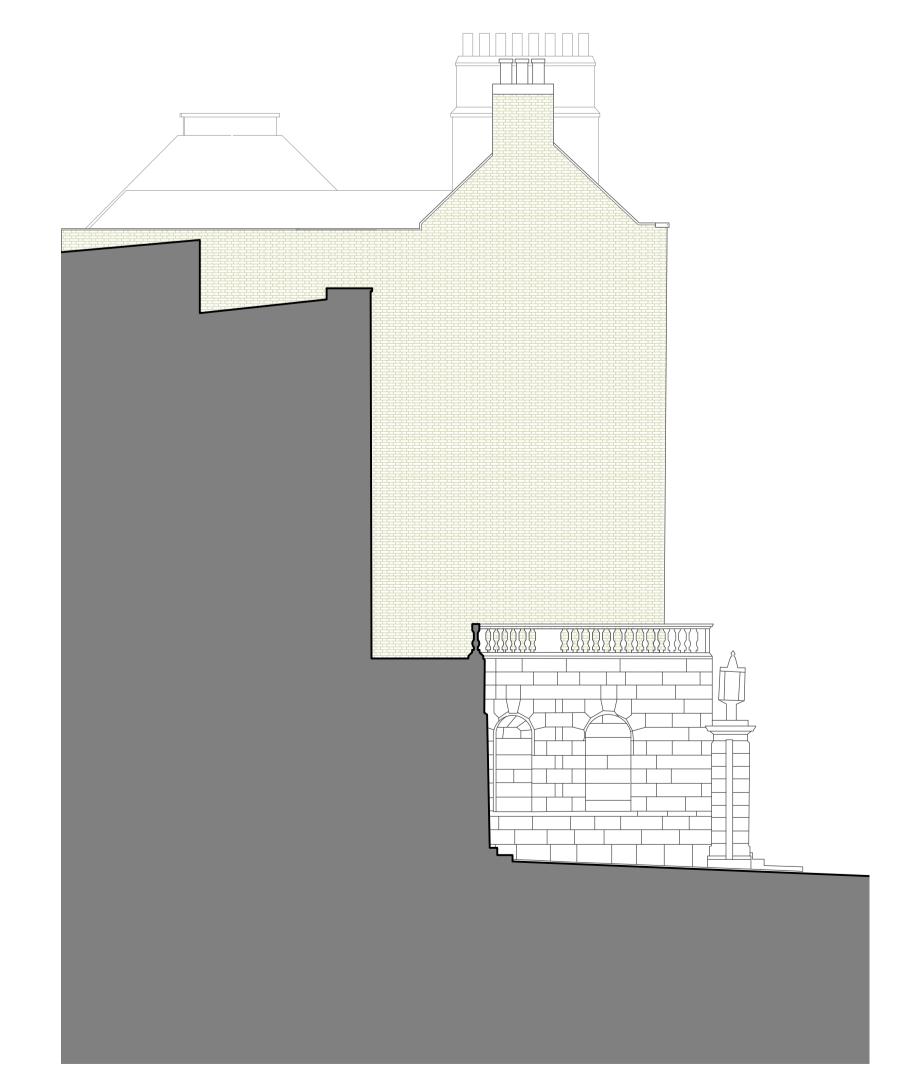
West Facade (Of No.28) Work: Rake out pointing, replace unsound brick and renew pointing with wig tuck pointing techniques. Walls will be structurally stitched where required. Clean stone sills using appropriate conservation

West Facade (Of No.21) Work:

Remove existing sand and cement render, rake out joints, replace damaged brick whe
