Schedule Of Building Fabric Repair Works

Opera Site

Limerick City and County Council

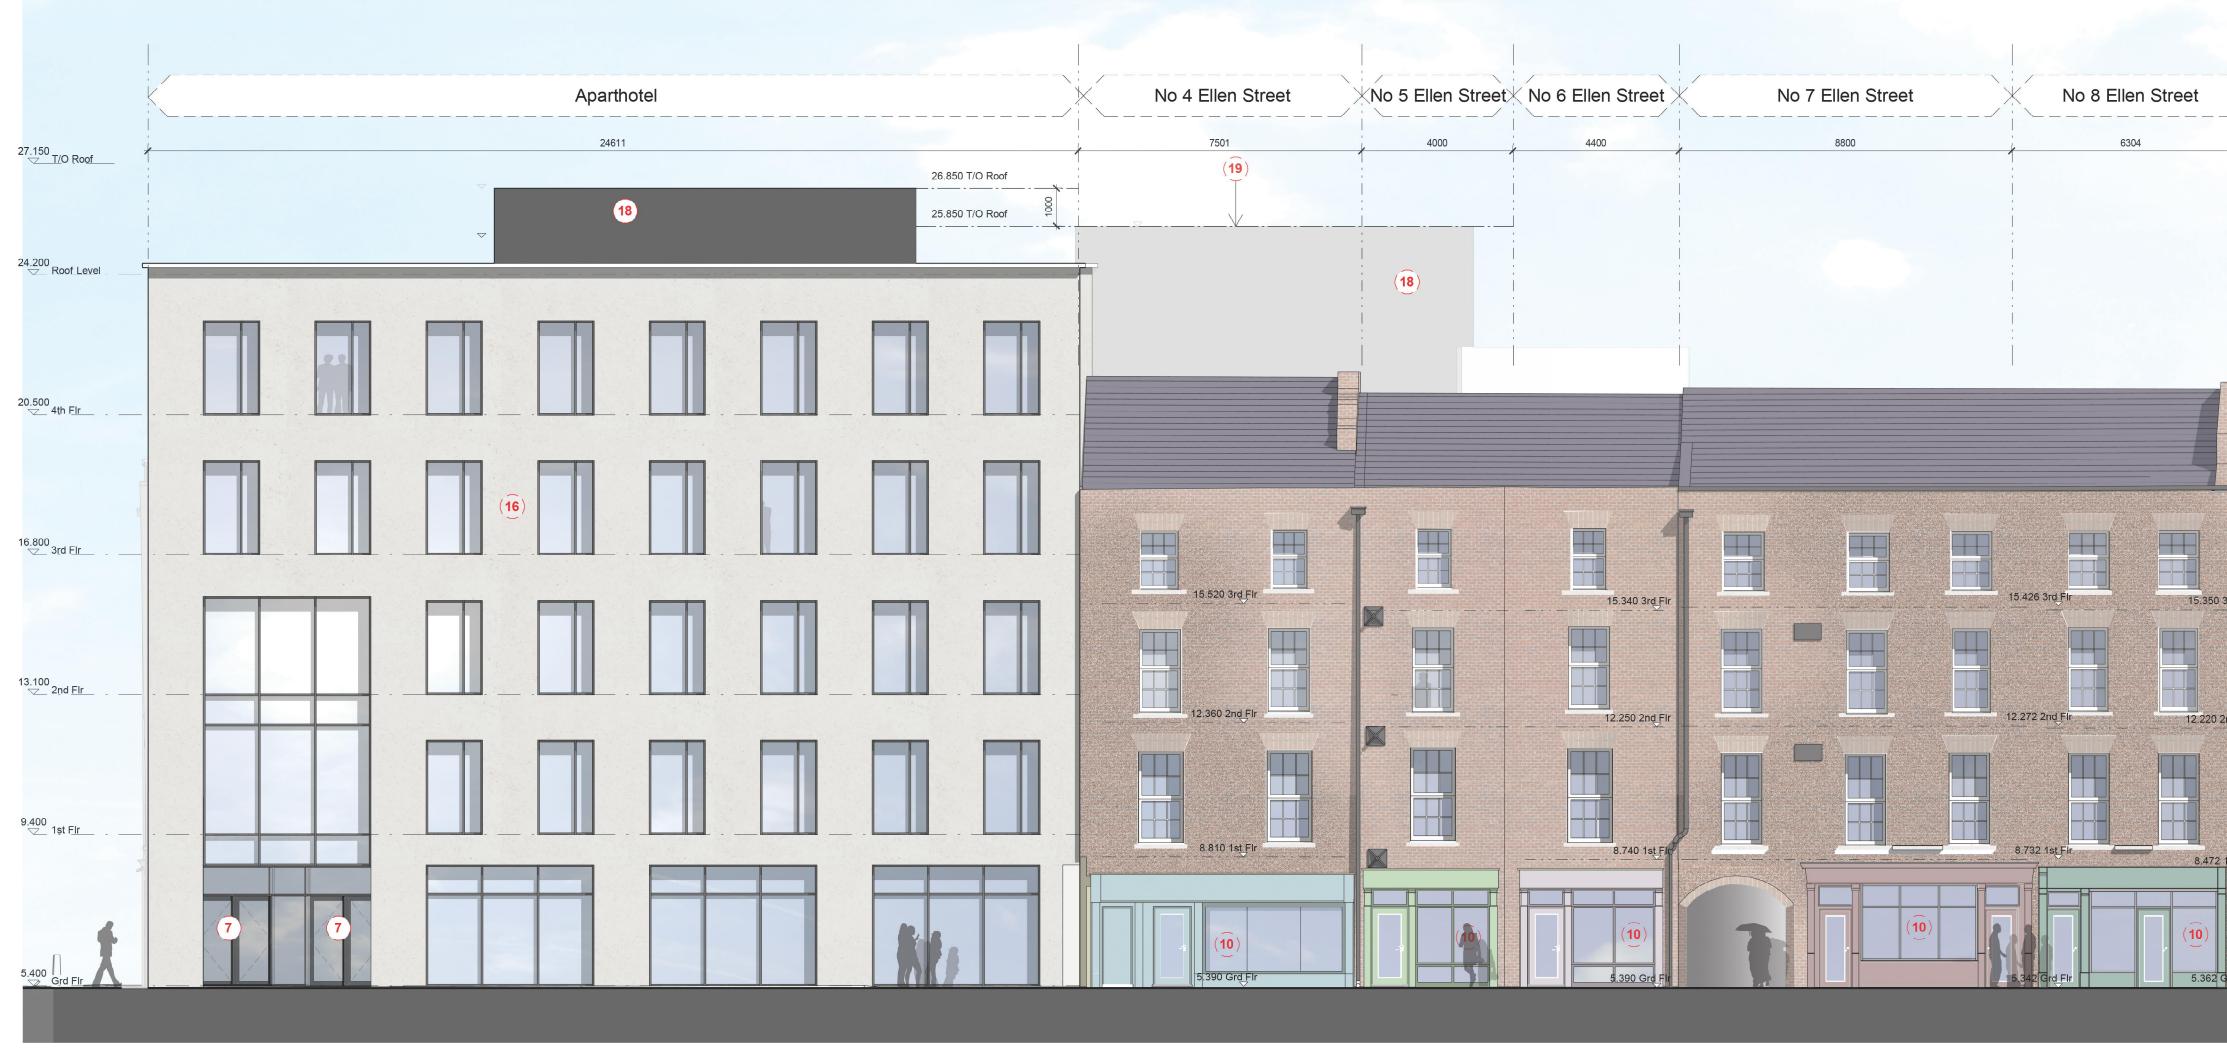
1 South Elevation - Ellen Street SCALE: 1:100

No 4 Patrick Street 26.850 T/O Roof 25.850 T/O Roof 24.850 T/O Roof at Stairs 23.650 T/O Roof 2nd F<u>lr</u> 3.100

2 | West Elevation - Patrick Street SCALE: 1 : 100
