Schedule Of Building Fabric Repair Works

Please note, all works to historic buildings will be carried out in accordance with the Conservation Architects recommendations.

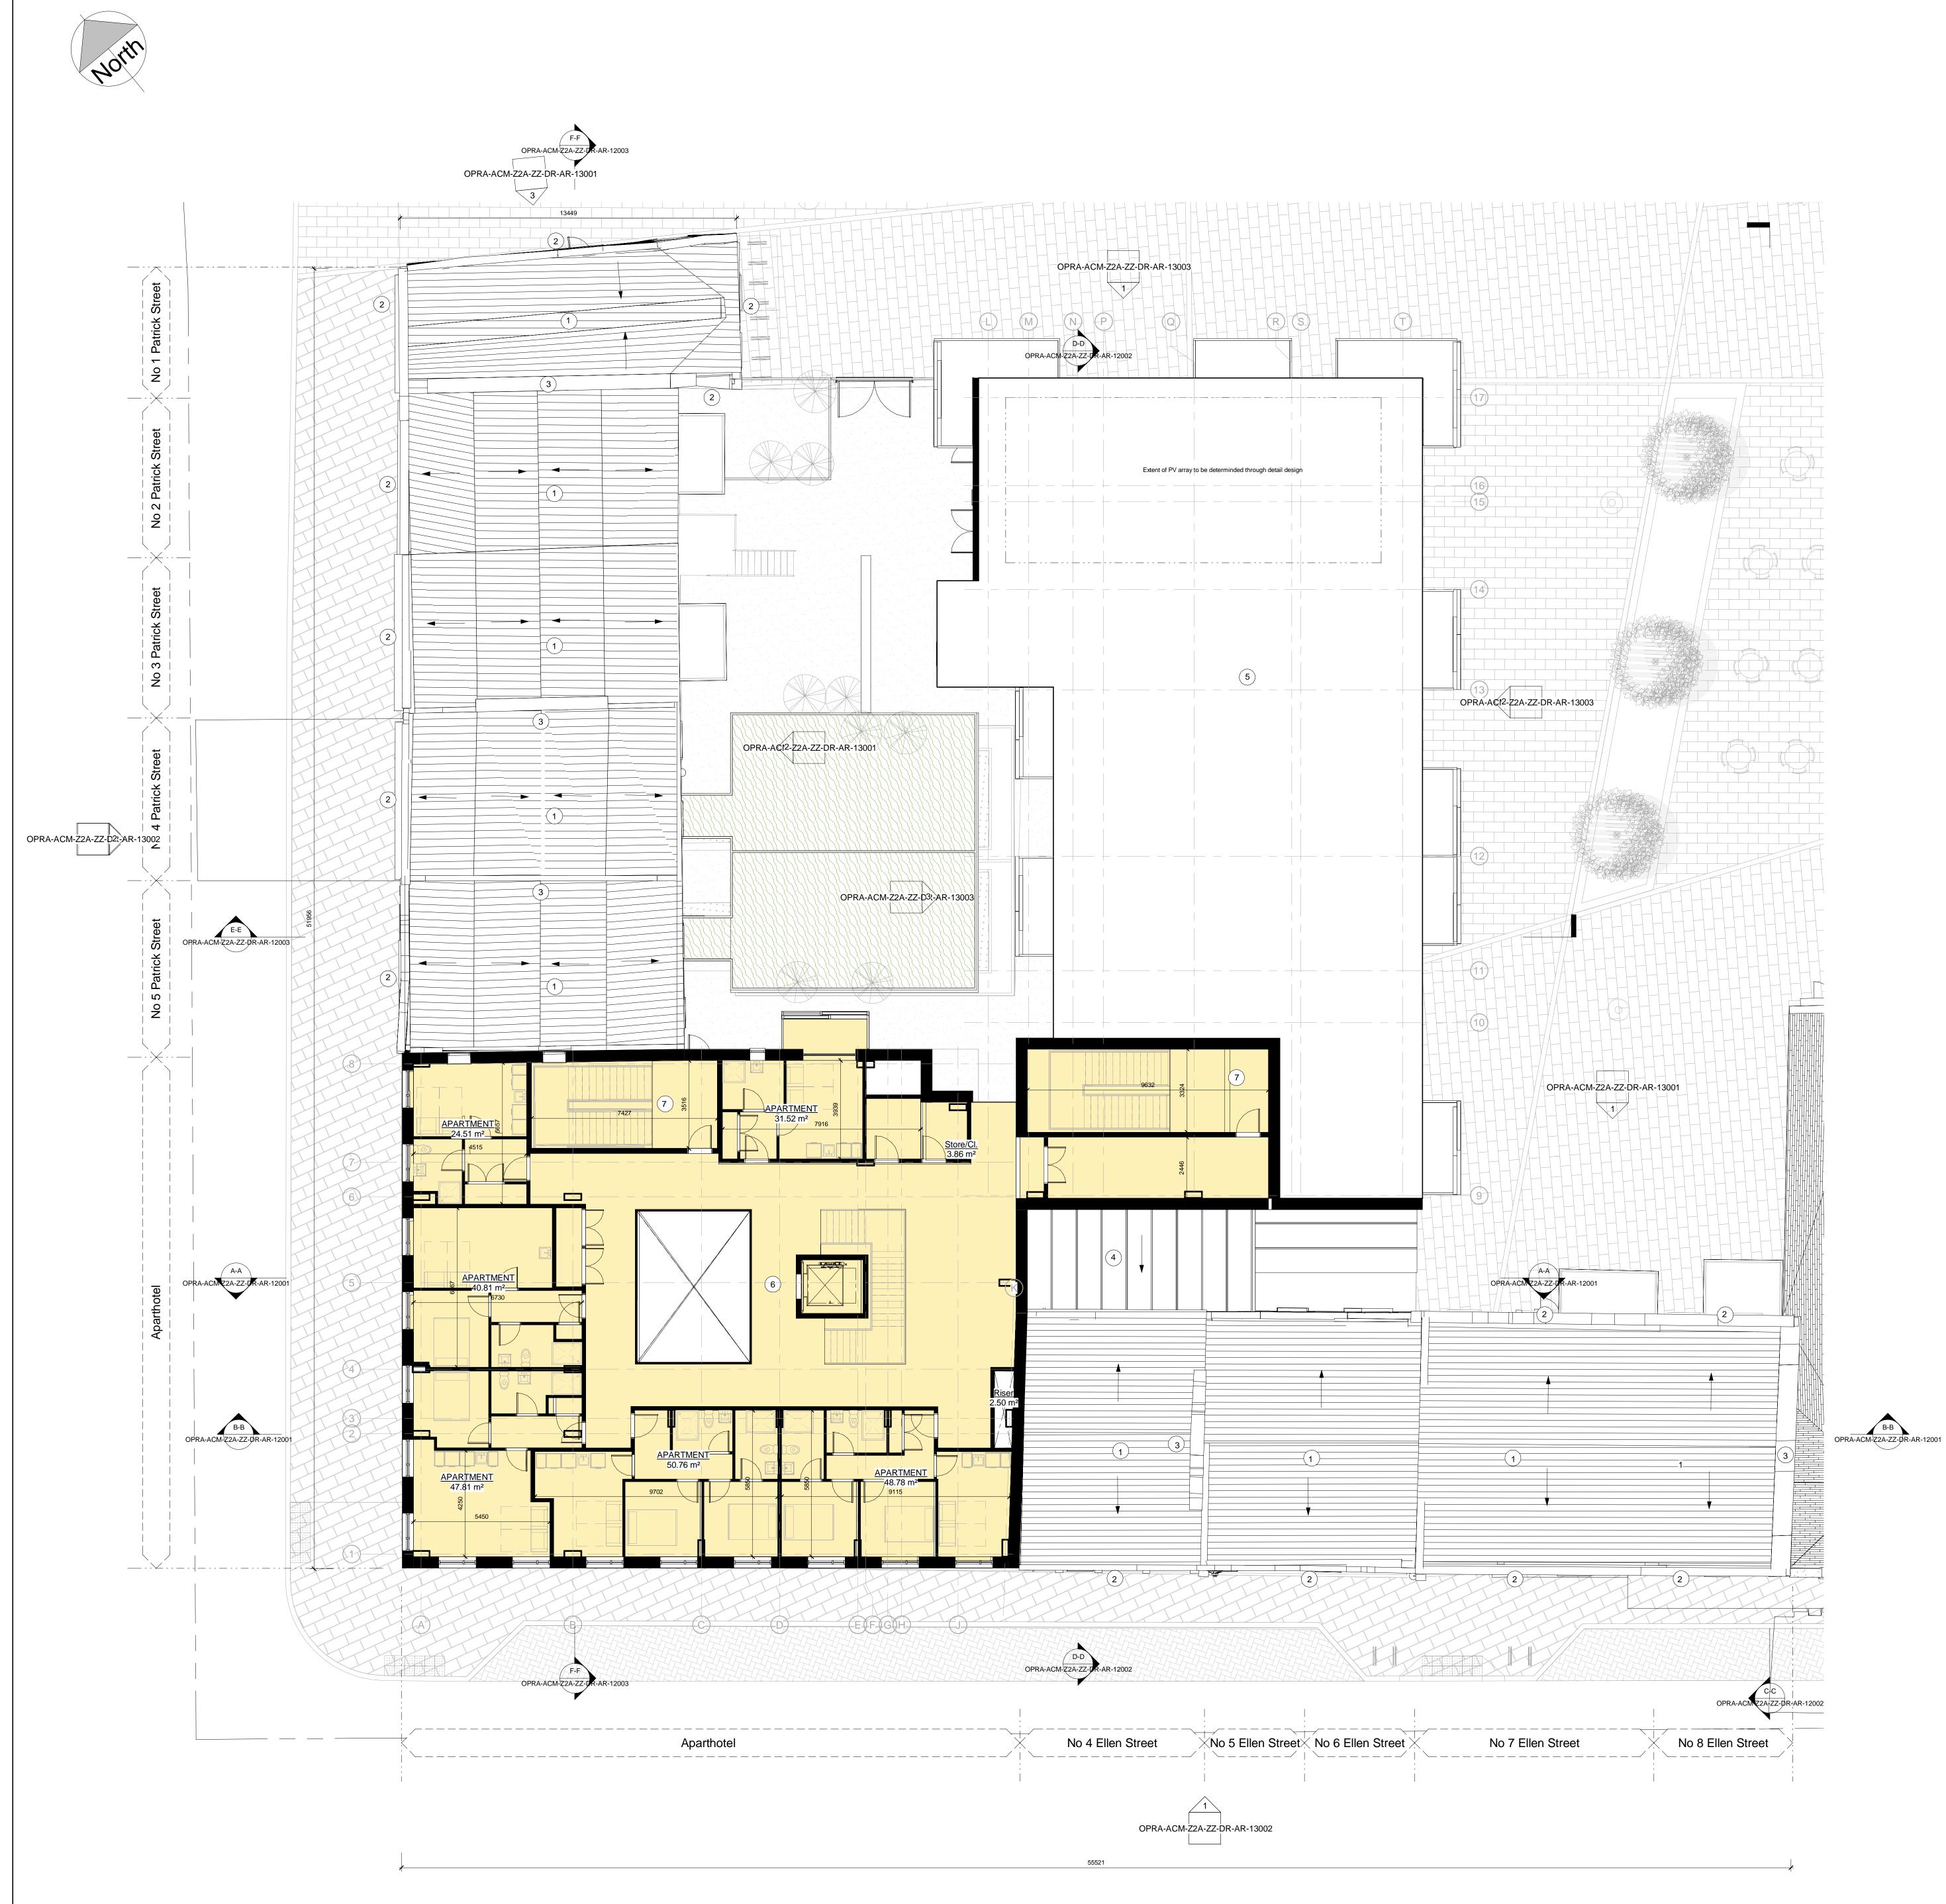
Windows:

Early timber windows to remain in situ following repair by specialist joiners.

All blocked openings and missing windows within the existing facade to be replaced with multi-pane vertical sliding sash in box frames unless otherwise stated.

Roof Salvage all existing stone slate on the historic structures for reuse on the building. Remove all concrete roof tiles and other contemporary roof finishes, repair, replace and treat roofing elements as necessary, and finish with salvaged and replacement stone slates.

Chimney Repair Generally all existing brick chimneys are to be repaired and repointed. Chimneys that are plaster rendered are to have render removed, flashings replaced and rerendered.

Rainwater Goods Replace all circular down pipes & decorative hopper heads with heritage cast iron rainwater goods.
