LANDSCAPE AND VISUAL ASSESSMENT

VIEWPOINT 9

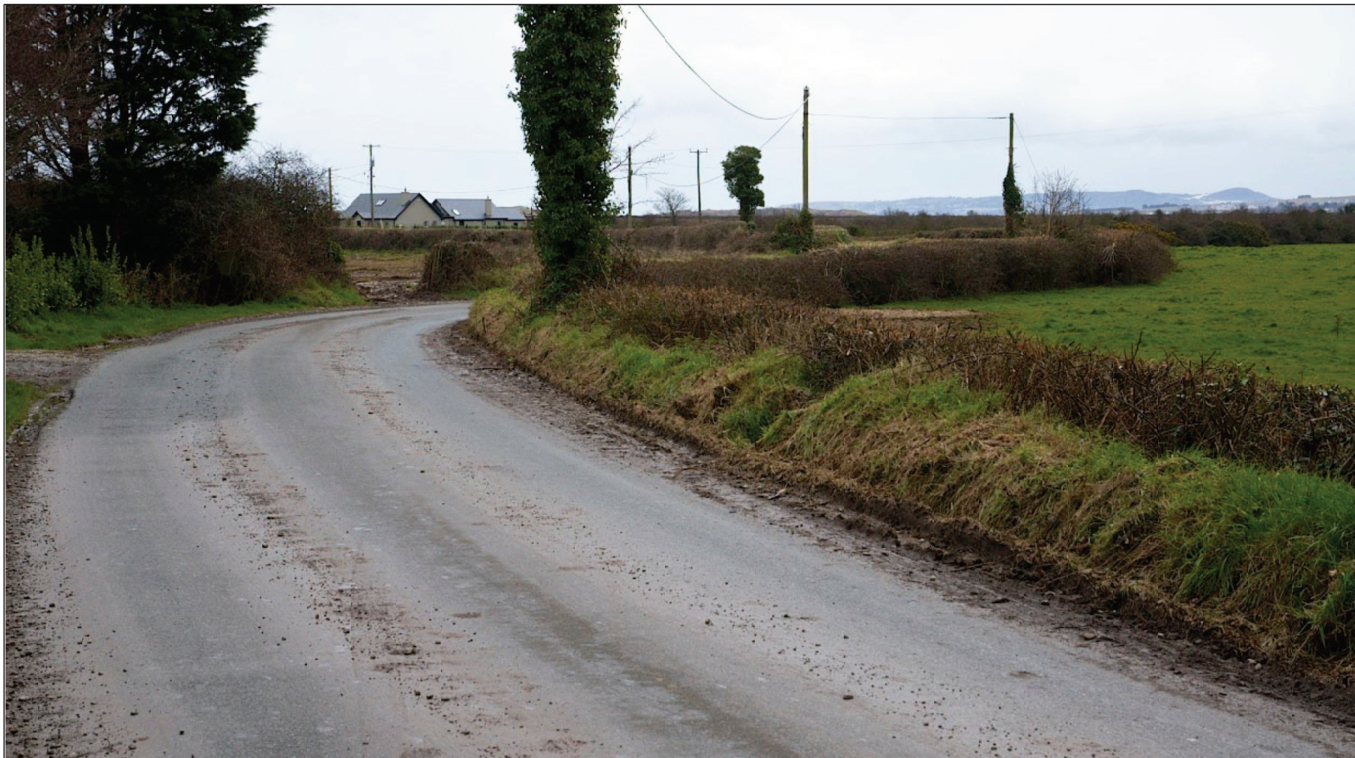
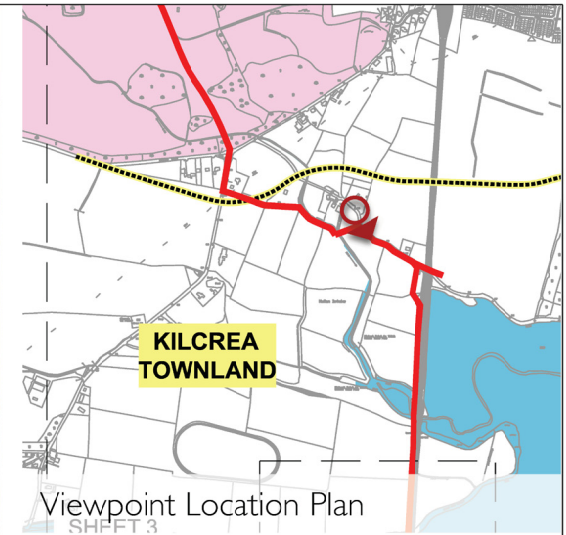
Viewpoint Location	Corballis Cottages south and east of the farm complex.
Height AOD (approx)	
Distance from Route	40m

View Description	Corballis Cottages road winds southwards towards the residential property adjacent to the railway embankment. The hills to the south of the estuary are visible on the skyline. At the apex of the second bend, the route would leave the road to strike westwards across the fields, resulting in the loss of a short length of hedgerow.
View during Construction	Being adjacent to the road, construction works would be readily visible, but not overlooked by residential properties. The loss of hedgerows would be negligible.
View on Completion	Users of the greenway would be visible from the road and would introduce new movement crossing the fields. The proposed lighting would extend the urban character of the residential properties, however the effects of the lighting would be greatly reduced with the establishment of the new hedgerow vegetation.
Mitigation Measures	The establishment of hedgerow planting alongside the greenway would quickly integrate the greenway into the receiving landscape.
