Broadmeadow Way Proposed Greenway
Between Malahide Demesne and
Newbridge Demesne

Volume 4C
EIAR Appendices 3-18
May 2019

Site Investigation Report

Geotechnical Report

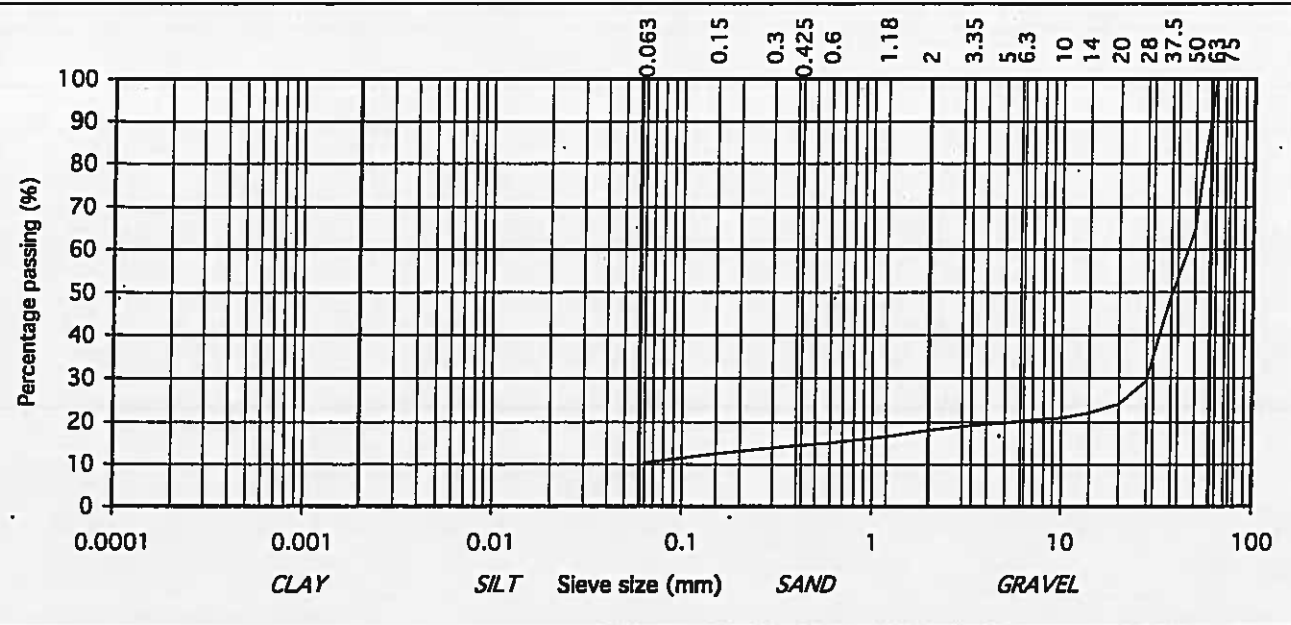
Contract No: 16912 Report No. R52684
 Contract: Broadmeadow Cycle Route
 BH: 5
 Sample No. 3135 Lab. Sample No. A13/2037
 Sample Type: D
 Depth (m): 2.00 Customer: Clifton Scannell Emerson, Seafort Lodge, Castledawson Avenue, Blackrock, Co. Dublin.
 Date Received 24/06/2013 Date Testing started 24/06/2013
 Description: Grey brown silty, sandy, GRAVEL

Remarks: Sample size did not meet the requirement of BS1377

The grading curves for samples of both glacial till and gravel deposits have been established by wet sieve analysis and hydrometer analysis where appropriate. The straight line grading of the glacial till is typical of the deposit. The granular deposits are graded in the sand gravel zones with little fines noted.

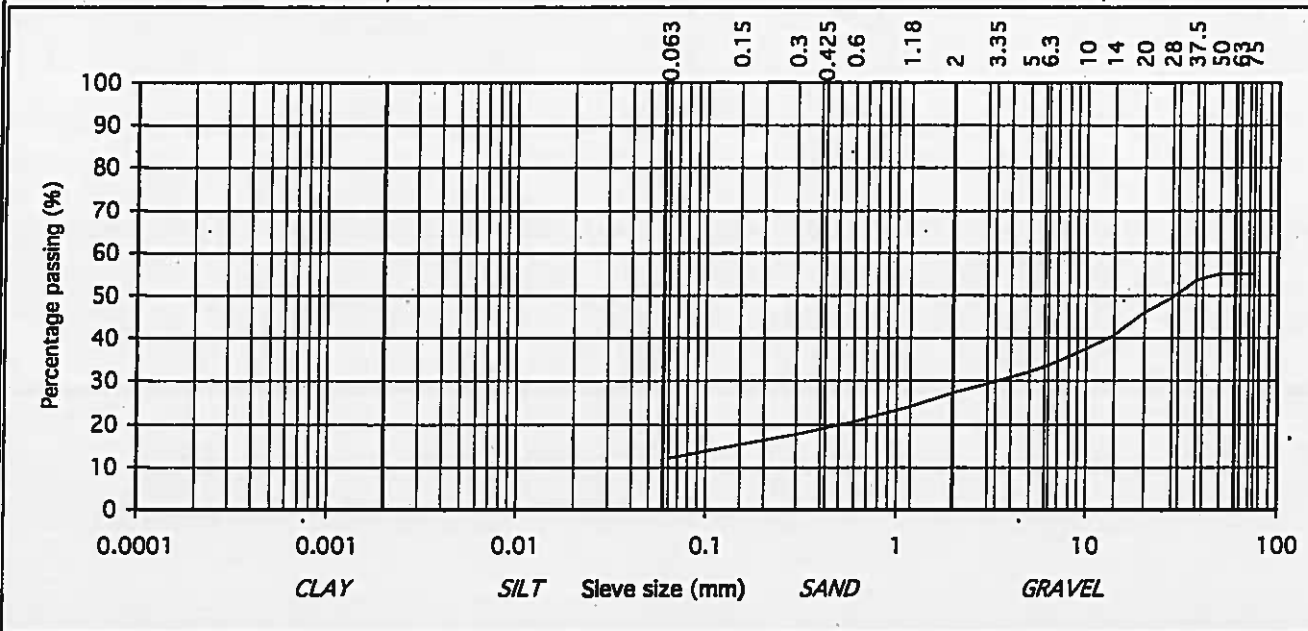
Contract No: 16912 Report No. R52689
 Contract: Broadmeadow Cycle Route
 BH: 8
 Sample No. 3151 Lab. Sample No. A13/2043
 Sample Type: D
 Depth (m): 2.00 Customer: Clifton Scannell Emerson, Seafort Lodge, Castledawson Avenue, Blackrock, Co. Dublin.
 Date Received 24/06/2013 Date Testing started 24/06/2013
 Description: Grey brown clayey/silty, sandy, GRAVEL with many cobbles

Remarks: Sample size did not meet the requirement of BS1377

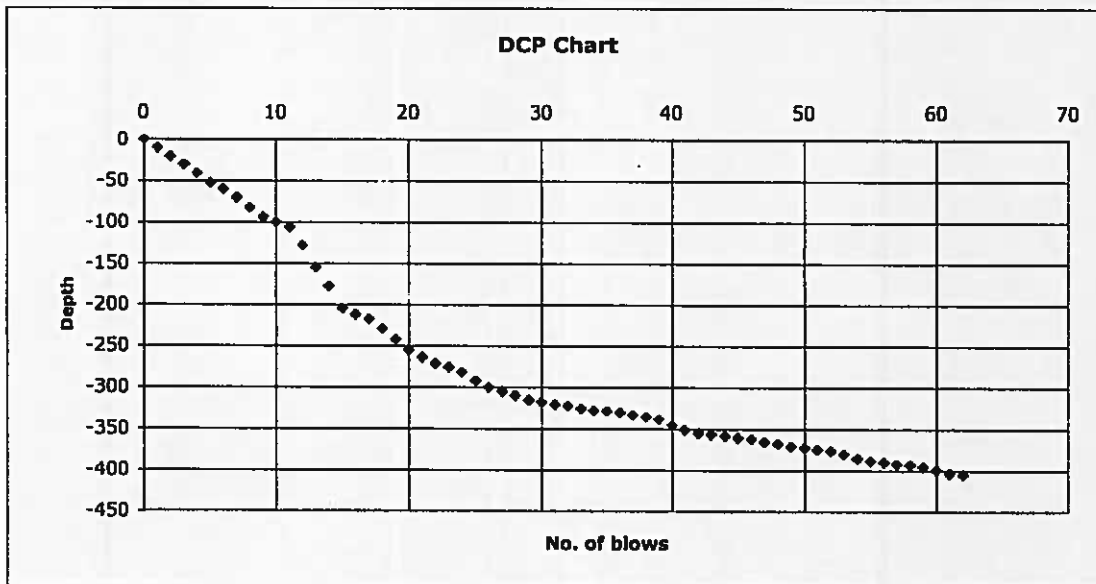
Contract Broadmeadow Cycle Route			Date: 19/07/2013		Test No. DCP7			
Ref No. 16912								
Client Clifton Scannell Emerson			DCP Zero Reading 105 mm					
Location BH7			Start of Test at: 0.3m below GL					
Direction			Approximate Chainage					
Soil Description MADE GROUND (cobbles and boulders) / Soft, brown, sl. sandy sl. gravelly CLAY with cobbles								
No of Blows	Total Blows	Reading mm	No of Blows	Total Blows	Reading mm	No of Blows	Total Blows	Reading mm
0	0	105	1	21	368	1	42	460
1	1	115	1	22	375	1	43	461
1	2	125	1	23	380	1	44	463
1	3	135	1	24	386	1	45	465
1	4	146	1	25	397	1	46	467
1	5	157	1	26	405	1	47	470
1	6	165	1	27	410	1	48	472
1	7	175	1	28	414	1	49	475
1	8	187	1	29	420	1	50	477
1	9	199	1	30	422	1	51	479
1	10	205	1	31	425	1	52	481
1	11	211	1	32	427	1	53	485
1	12	233	1	33	430	1	54	490
1	13	260	1	34	432	1	55	493
1	14	282	1	35	433	1	56	495
1	15	310	1	36	435	1	57	497
1	16	317	1	37	438	1	58	498
1	17	322	1	38	440	1	59	500

Depth range (mm) Blows	From	to	Penetration 395 61	mm / blow 6.4754
	115	510

TRRL RN8 $\text{Log}_{10}(\text{CBR}) = 2.48 - 1.057 * \text{Log}_{10}(\text{mm/blow})$

CBR values were determined in-situ at each borehole location in the depth range 0.30 to 0.50 metres using the TRL Dynamic Cone Penetrometer. Results are presented in Appendix III with CBR values in the range 10 to 71 % obtained. It should be noted that testing was carried out at relatively depths during very dry conditions on quite granular clay soils and the very high CBR values obtained in places may be unrepresentative of soil moisture content at construction stage. We would suggest that the lower range of values (between 10 and 15%) is more representative of more normal conditions.

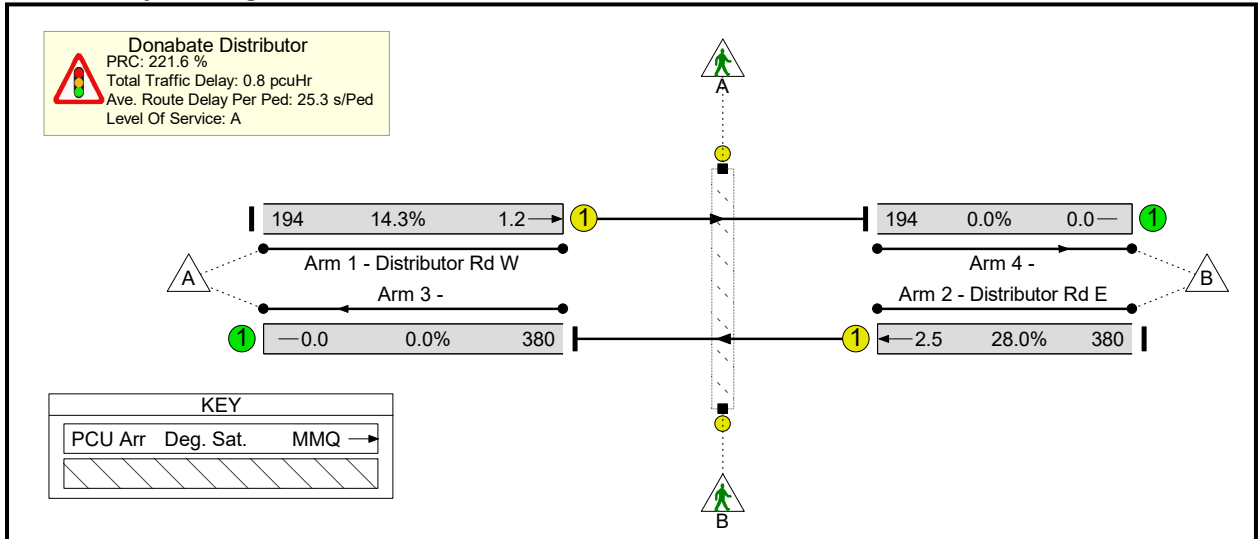
Network Layout Diagram

Scenario 1: '2013 AM' (FG1: '2013 AM', Plan 1: 'Network Control Plan 1')

Total Network Delay: 0.79 pcuHr
Worst PRC: 221.63 % (On Lane 2/1)
Level Of Service: A

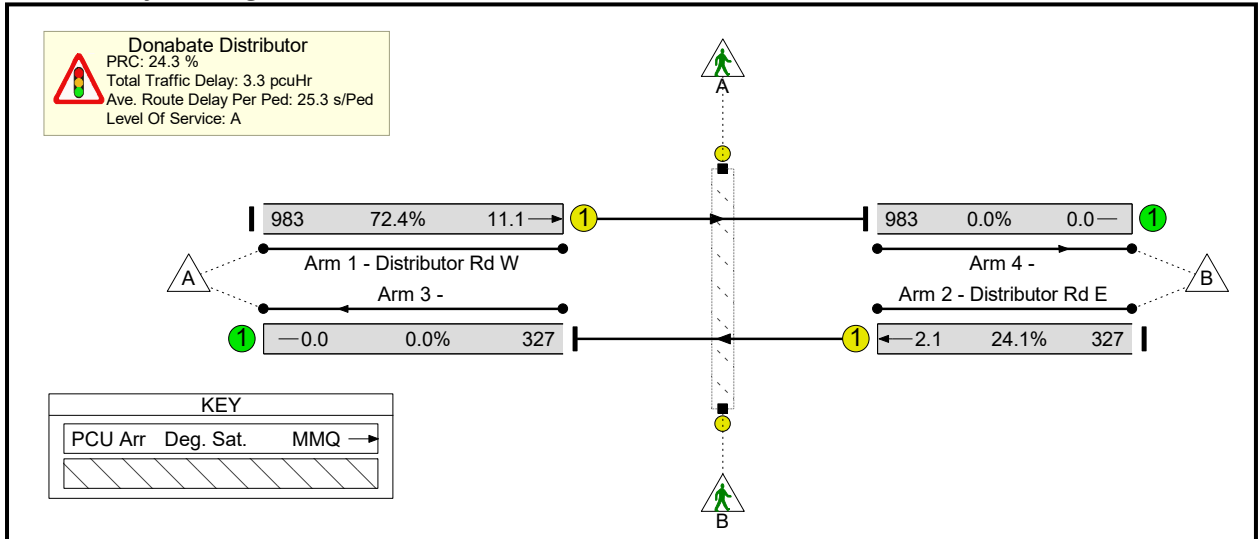
Network Layout Diagram

Scenario 2: '2013 PM' (FG2: '2013 PM', Plan 1: 'Network Control Plan 1')

Total Network Delay: 3.25 pcuHr
Worst PRC: 24.33 % (On Lane 1/1)
Level Of Service: A

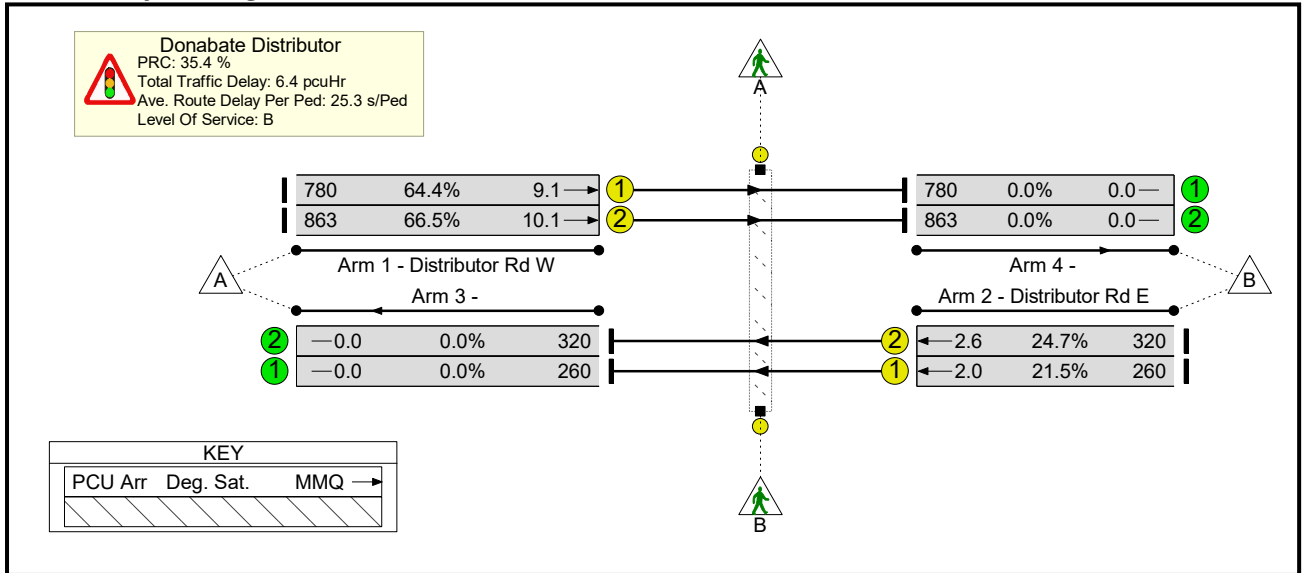
Network Layout Diagram

Scenario 4: '2028 PM' (FG4: '2028 PM', Plan 1: 'Network Control Plan 1')

Total Network Delay: 6.39 pcuHr
Worst PRC: 35.37 % (On Lane 1/2)
Level Of Service: B

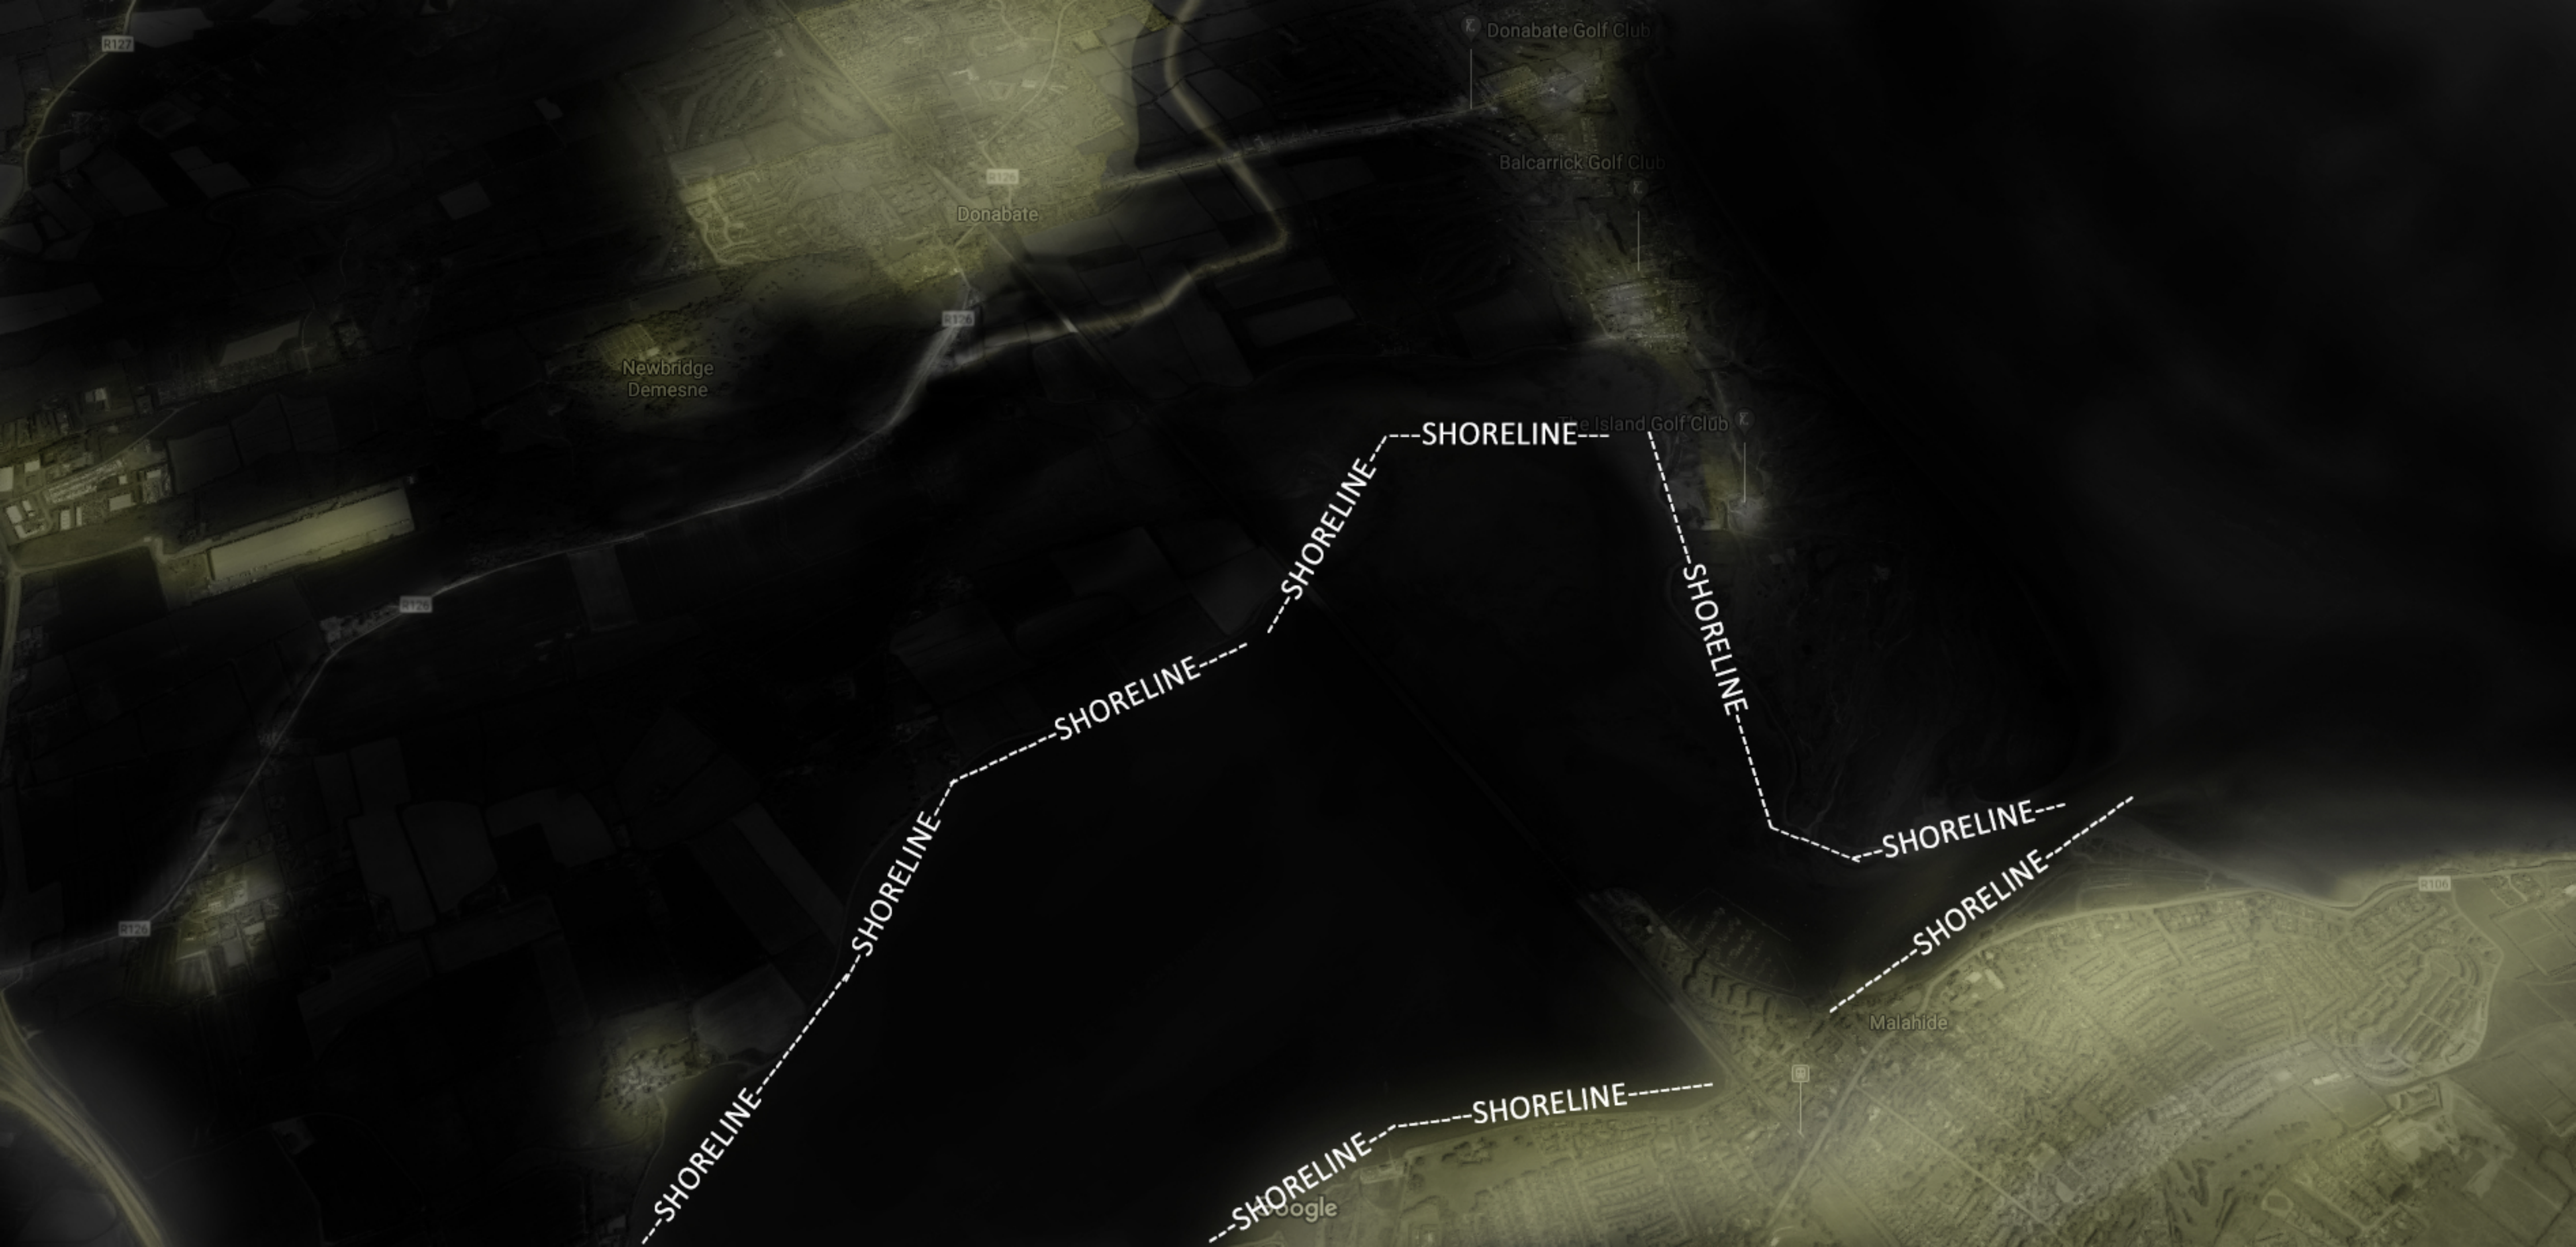
APPENDIX A

Illustrative Glow Plan of the Area including the effect of the new Donabate Distributor Road and ignoring the effects of passing traffic on unlit roads and passing train traffic on the causeway.

- Appendix A – Illustrative Glow Plan of the general area including the effect of the new Donabate Distributor Road and ignoring the effects of passing traffic on unlit roads and passing train traffic on the causeway.
- Appendix B – Illustrative Glow Plan of the general area including the effect of the new Donabate Distributor Road and including the effects of passing traffic on unlit roads and passing train traffic on the causeway.
- Appendix C – Illustrative Glow plan of the area following luminaire installation
- Appendix D - Illuminance levels on typical sections on the surface of the trail.
- Appendix E – Illustrative rendering of resulting lighting levels on the trail following installation in comparison with the resulting lighting levels on the new Donabate Distributor Road.

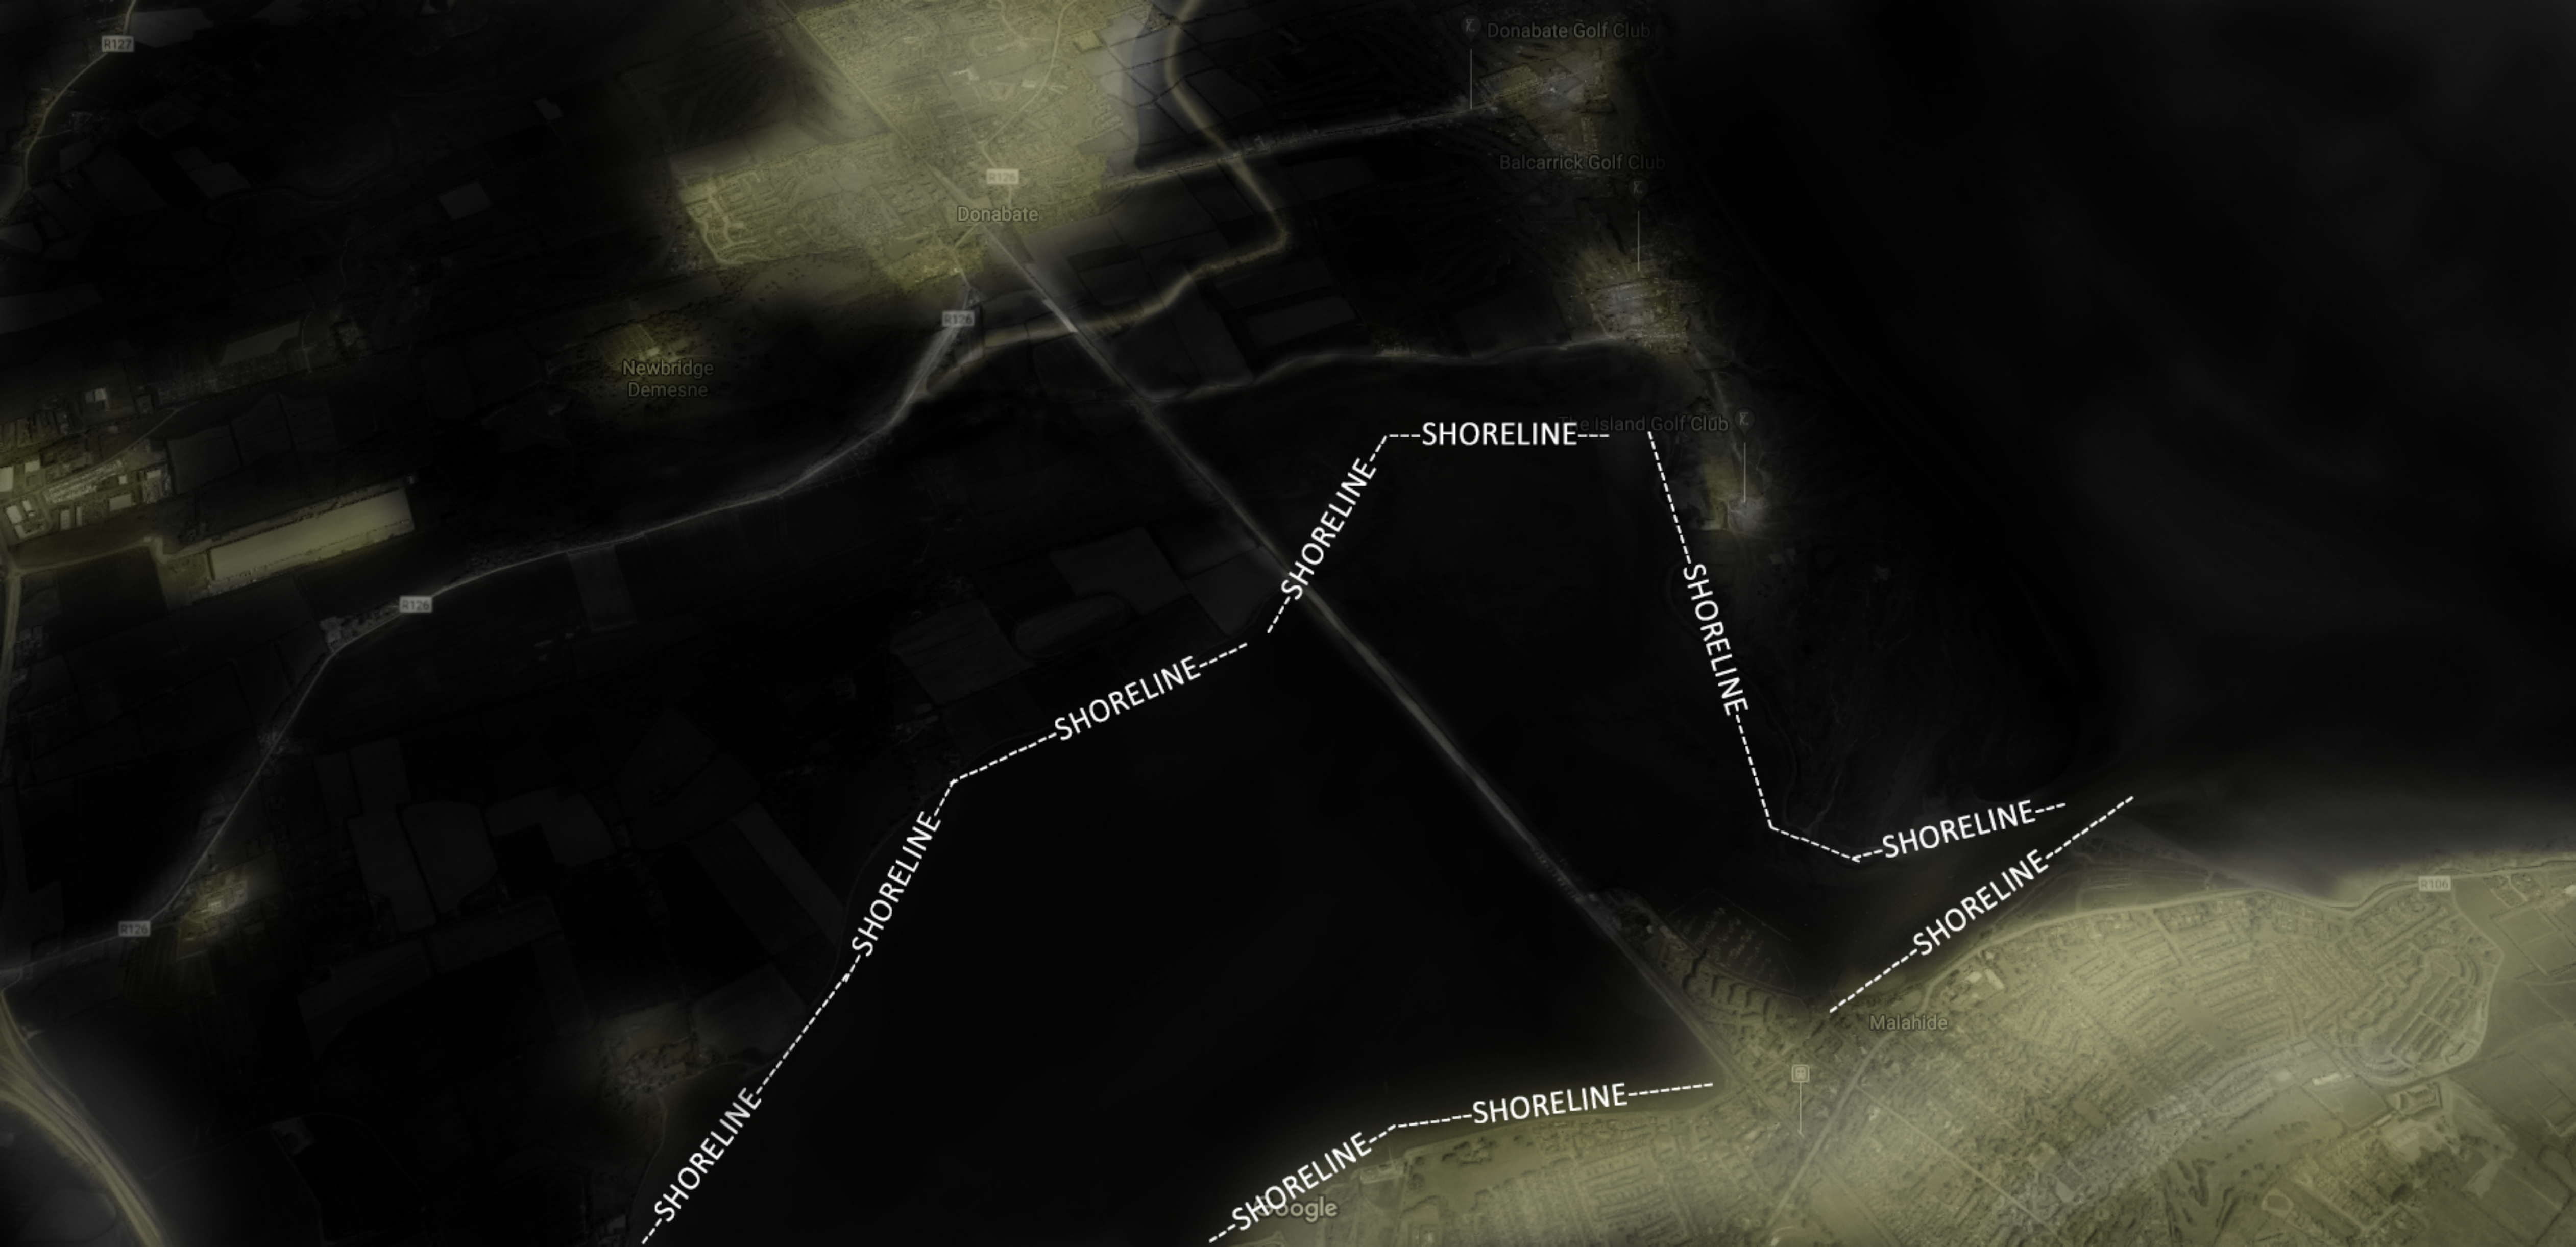
APPENDIX B

Illustrative Glow Plan of the Area including the effect of the new Donabate Distributor Road and including the effects of passing traffic on unlit roads and passing train traffic on the causeway.

The causeway is used by the Commuter and Intercity rail services. This usage introduces a high ambient light level due to the headlights of the trains as well as the spill light from the carriage windows. Services are frequent and are projected to become more frequent with the proposed extension of the DART system to Balbriggan. We would estimate that the illumination as a result of the headlights on a moving train would give similar illumination results than that of the car illustrated above (20 lux for dipped lights and 30 lux for full beam headlights).

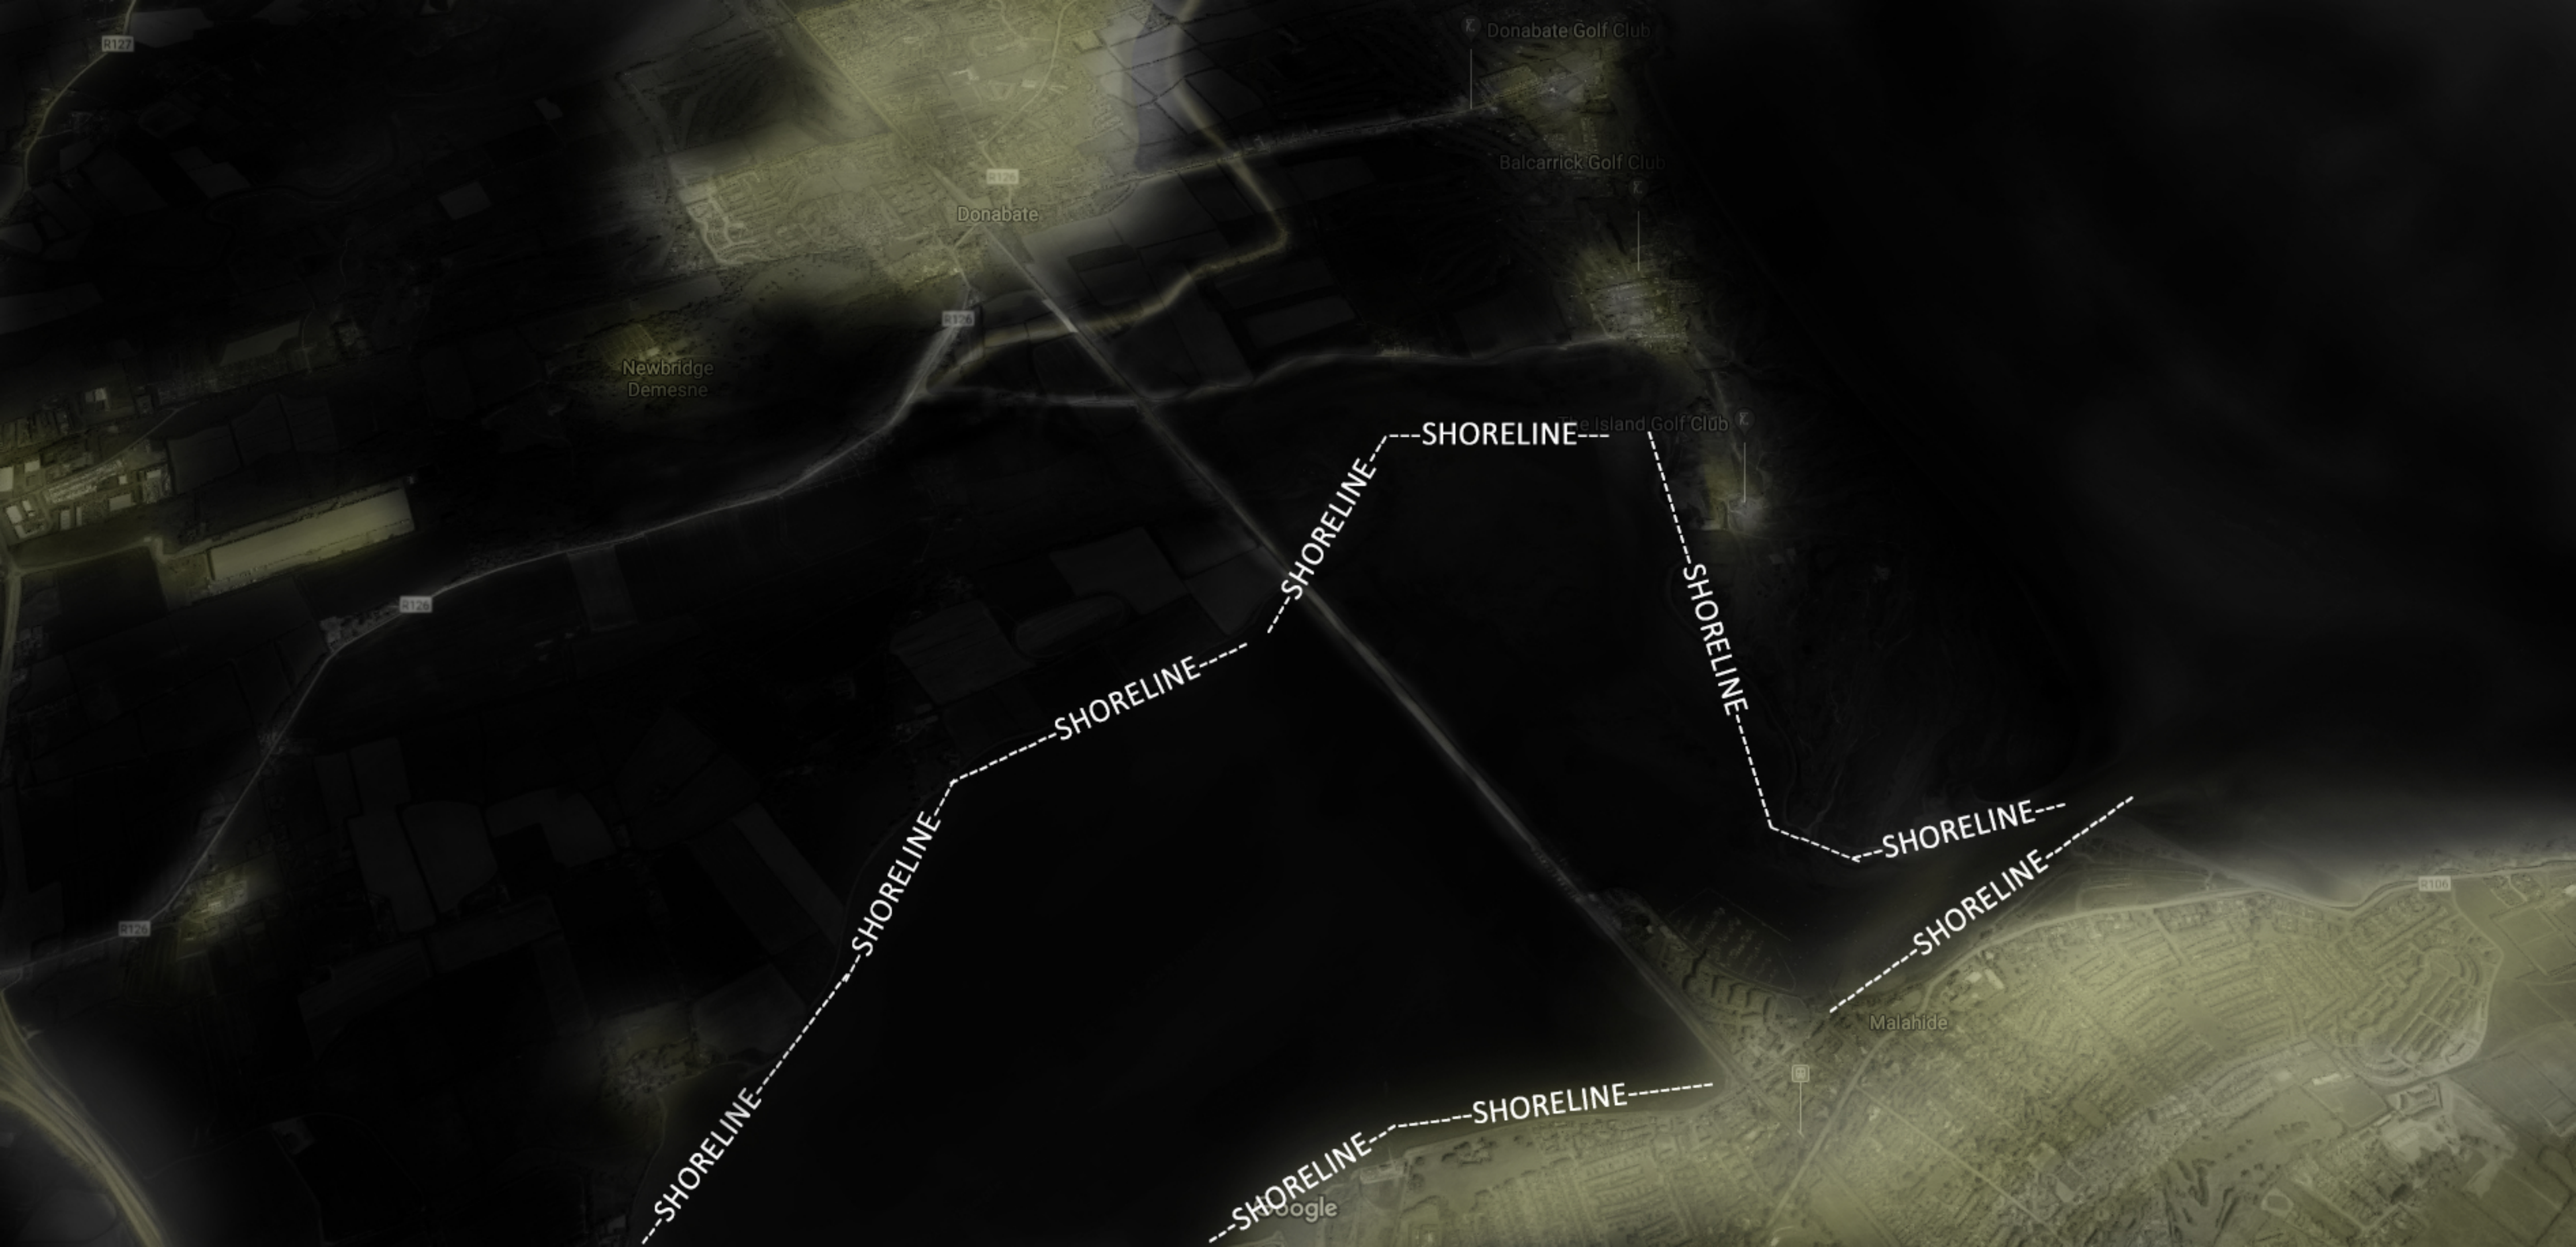
APPENDIX C

Illustrative Glow Plan of the area following luminaire installation

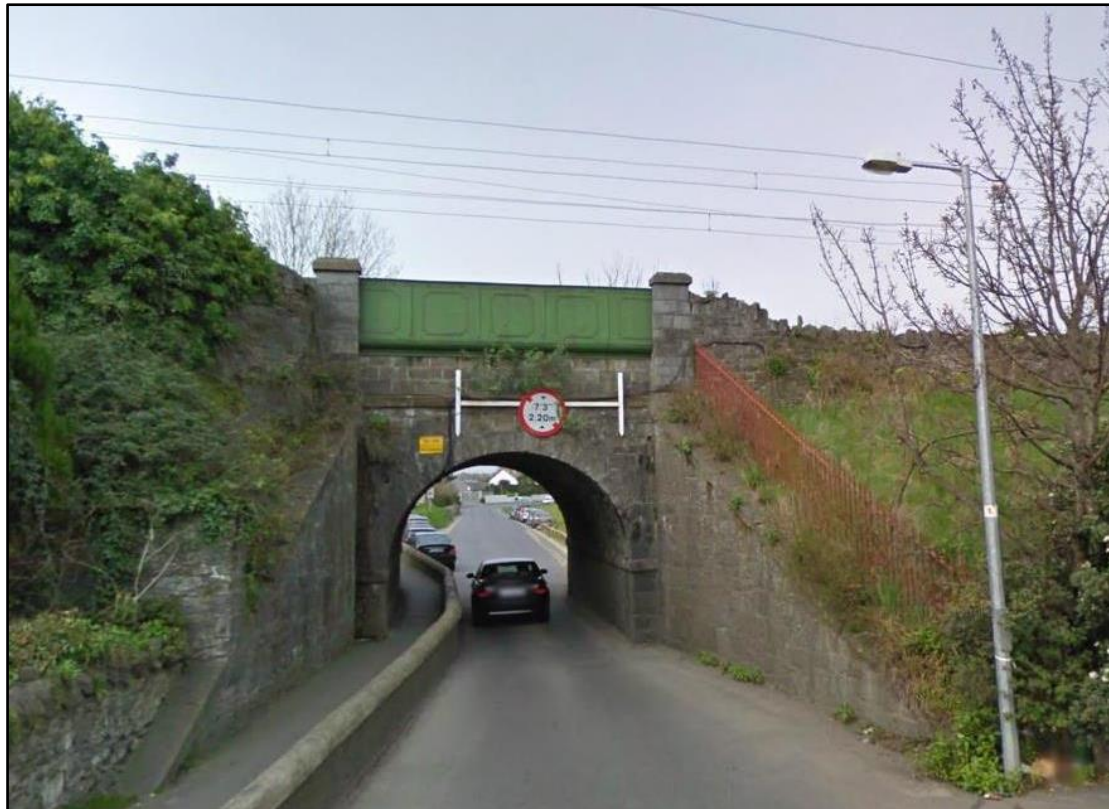
Site 11 – AHC022: Railway Bridge, Malahide.

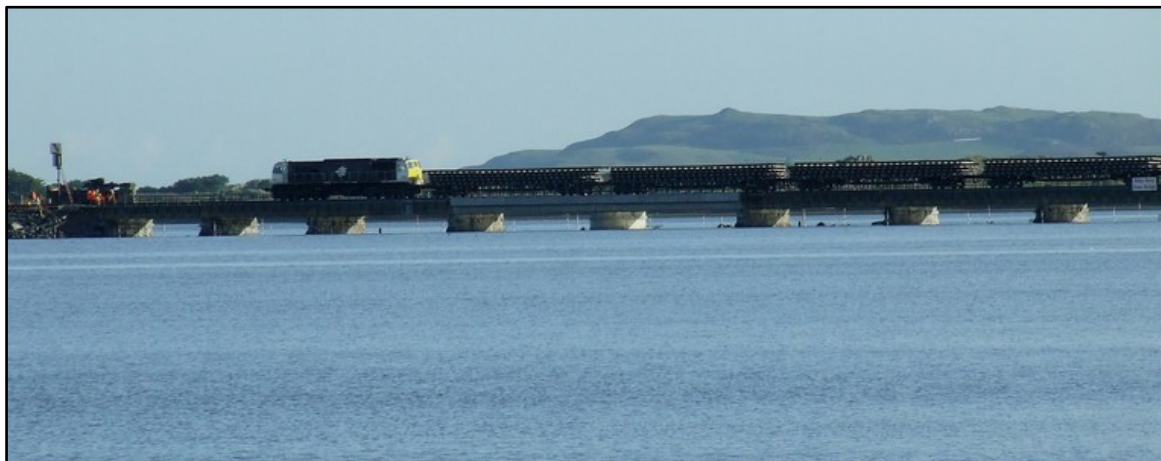
Site 12 – AHC023: Malahide Railway Viaduct, Malahide.

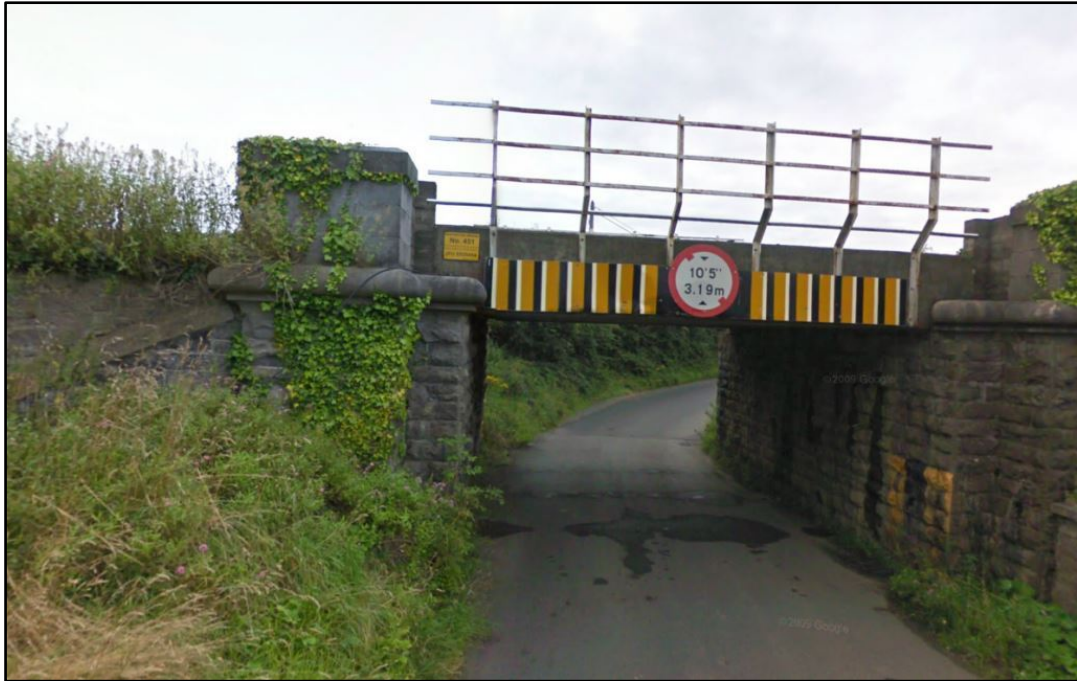
Site 13 – AHC031: Railway Bridge, Kilcrea.

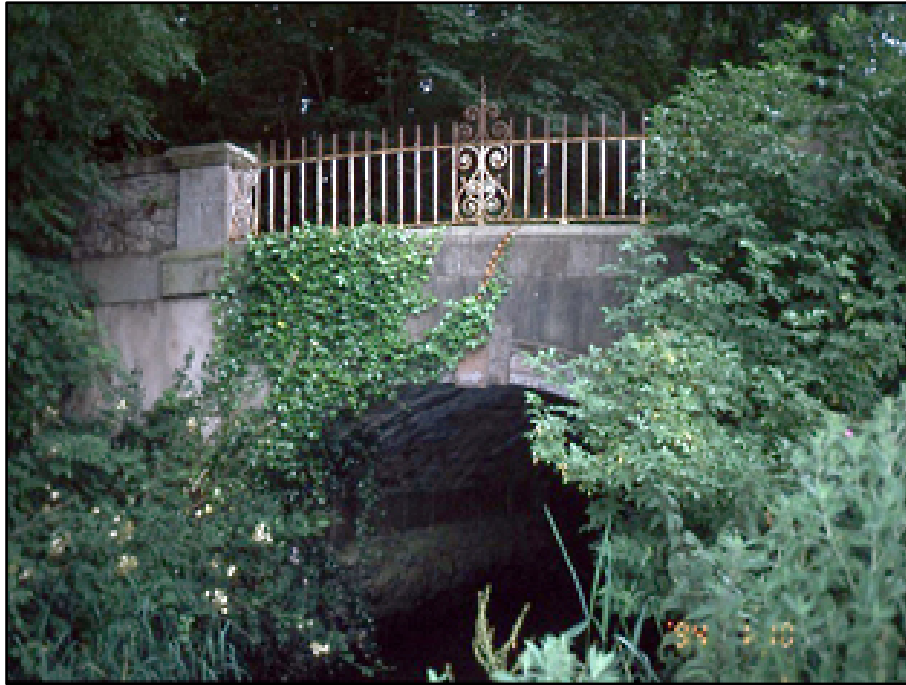
Site 15 – AHC045: Mack's Bridge, Newbridge Demesne.

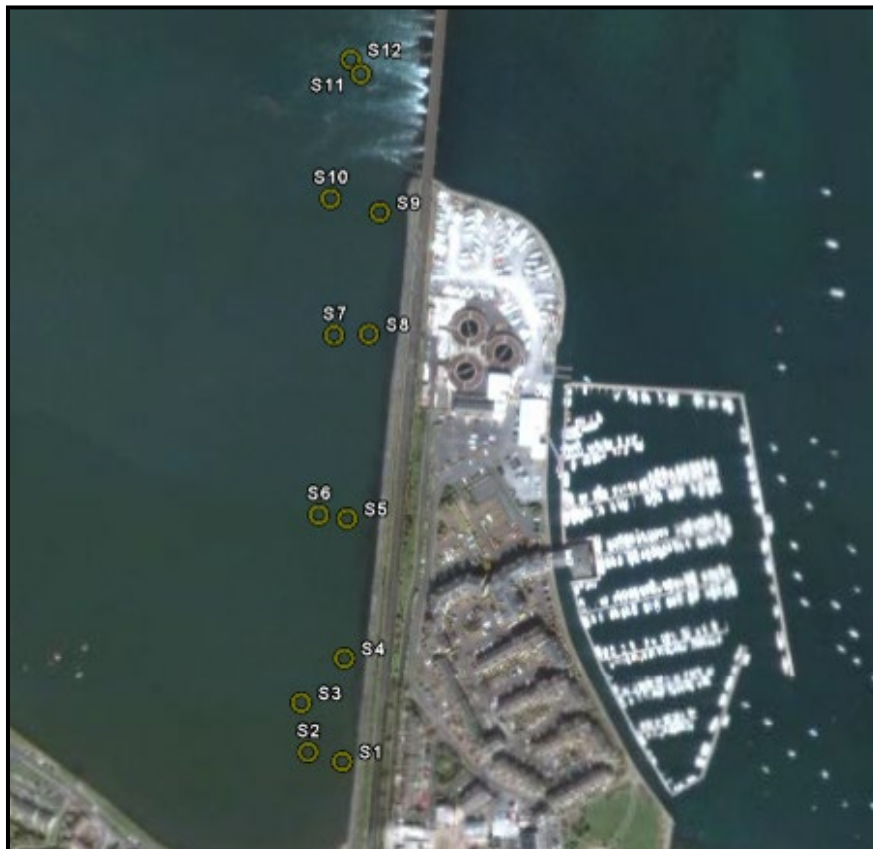
Figure 1. Map showing locations of subtidal grab samples along the inner estuary at Malahide, Co. Dublin.

A soft sediment survey was undertaken in September 2009 which covered the sites within the footprint of the weir maintenance track. Fieldwork was carried out on the 21st September 2009. All sampling stations were positioned using a differential GPS (Trimble Geo XM). A complete list of stations sampled are presented in Table 1 and these stations are displayed on a map (Figure 1).

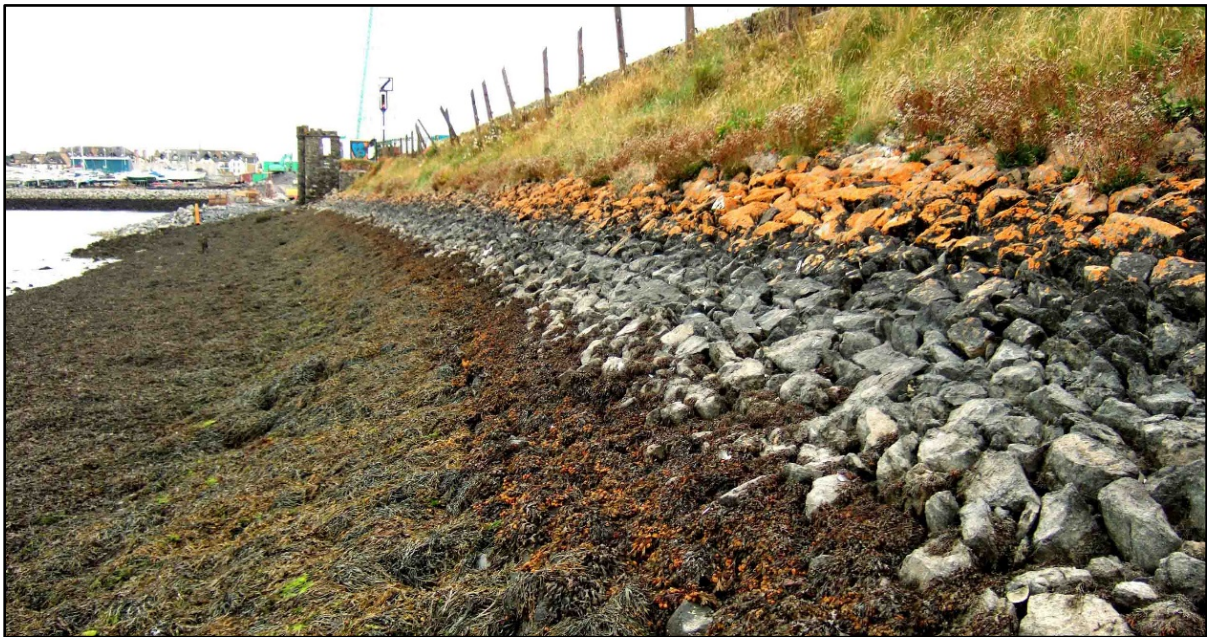
Plate 2: View of distinct vertical zonation pattern along Malahide railway embankment – outer (eastern) face.

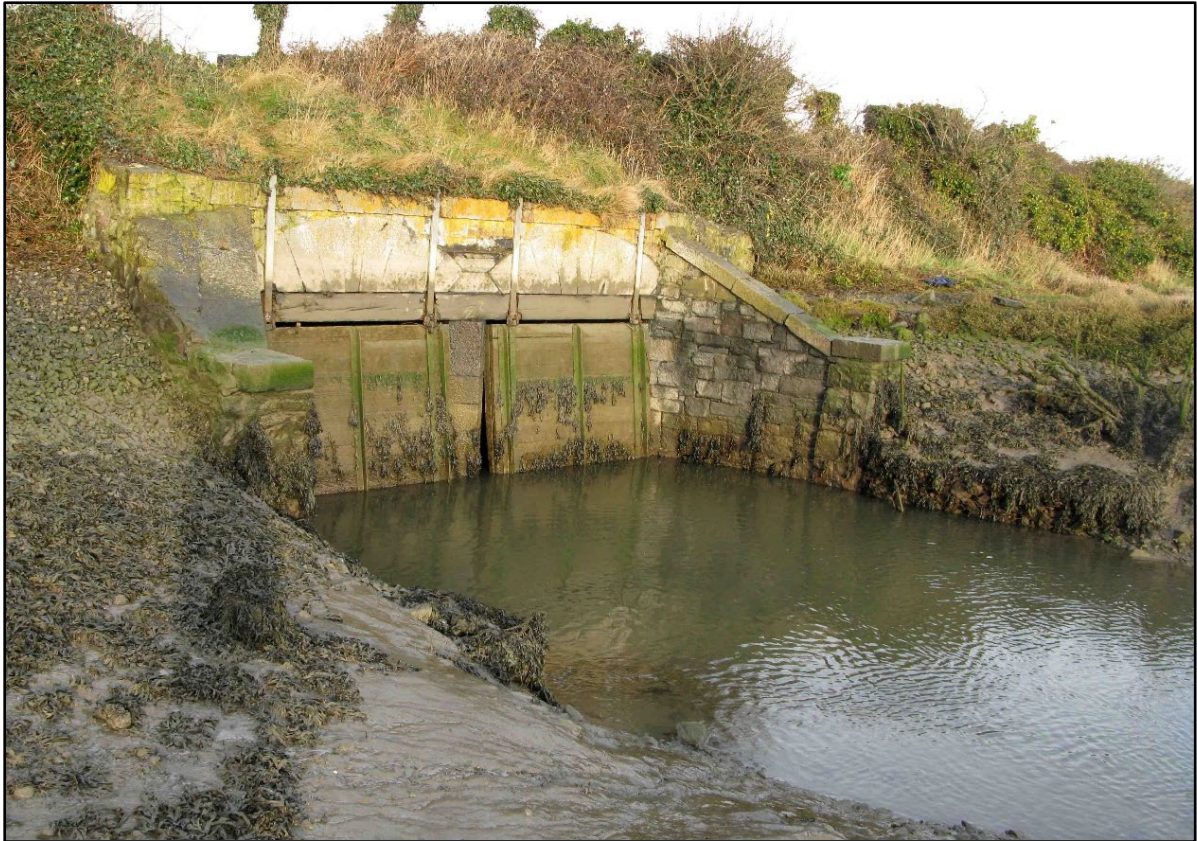
Plate 3: View of the tidal flaps on the River Pill outlet beneath the railway embankment viewed from the Malahide Estuary side.

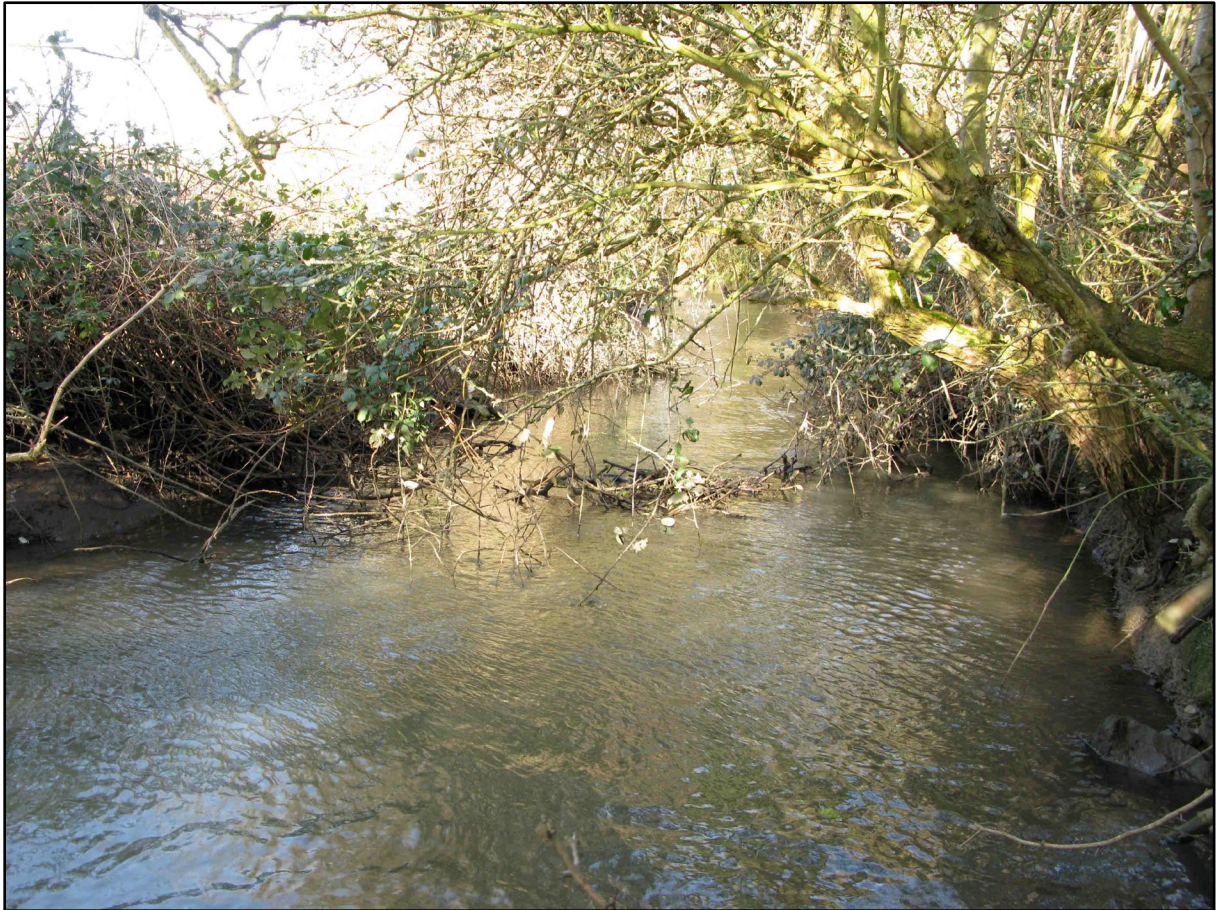
Plate 7: View of Pill River channel at approximate position of proposed pedestrian bridge crossing point - view upstream.

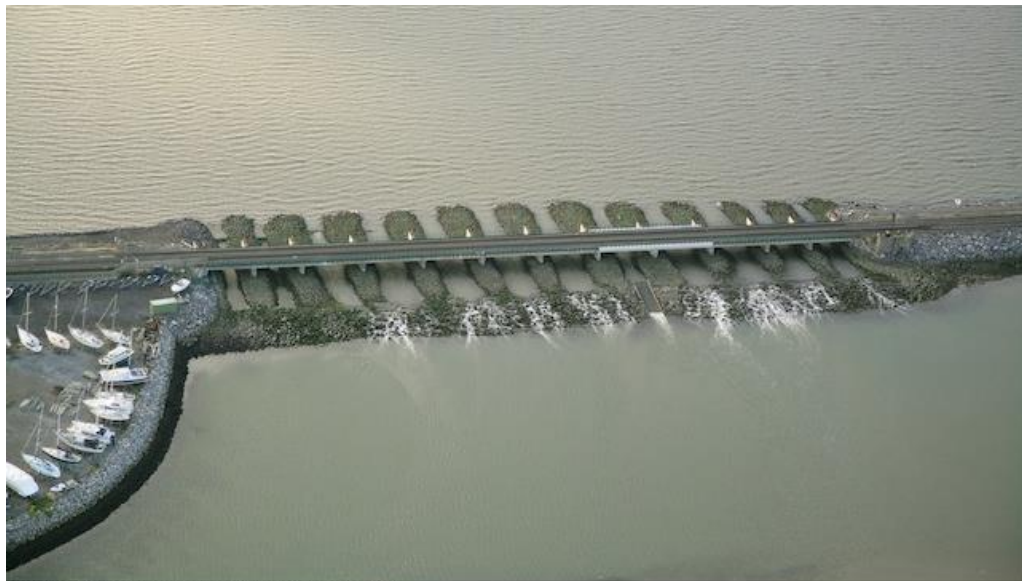
Figure 1. New Design Weir at Malahide Viaduct during ebb tide, looking west

The performance of the New Design Weir was hydraulically tested and elaborated in University College Cork report from July 2012 [7]. A comparison of the recorded and historic water levels showed that the weir replicates the hydrodynamic conditions on entire Broadmeadows estuary and throughout the tidal cycle that occurred before the collapse of the weir.
