Broadmeadow Way Proposed Greenway
Between Malahide Demesne and
Newbridge Demesne

Volume 4C
EIAR Appendices 3-18
May 2019

Site Investigation Report

Geotechnical Report

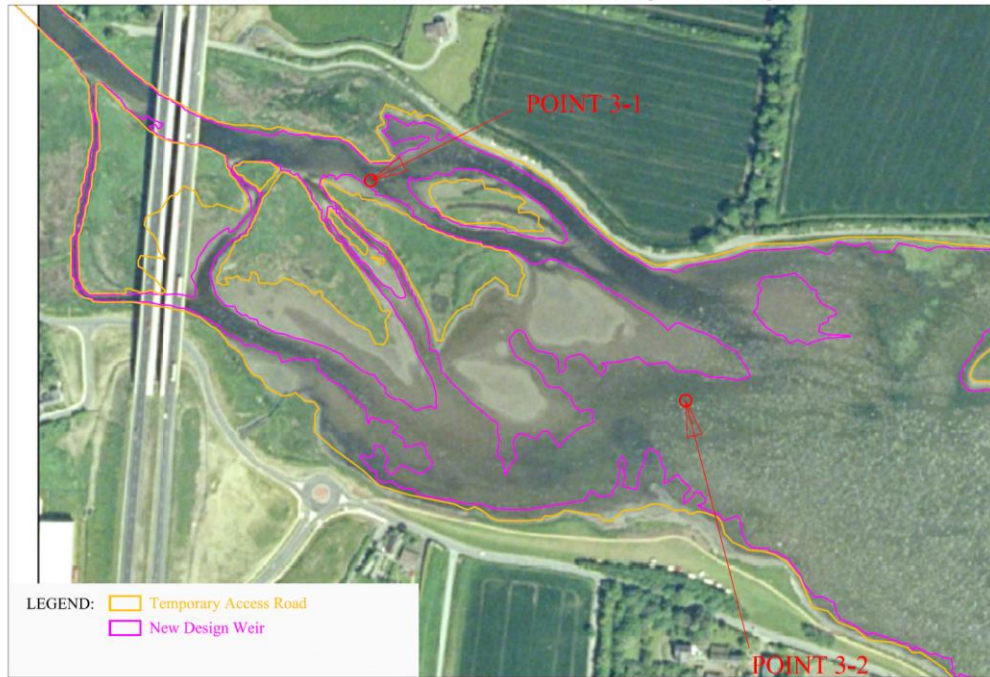
Malahide Viaduct Reinstatement - Water surface comparison at neap low

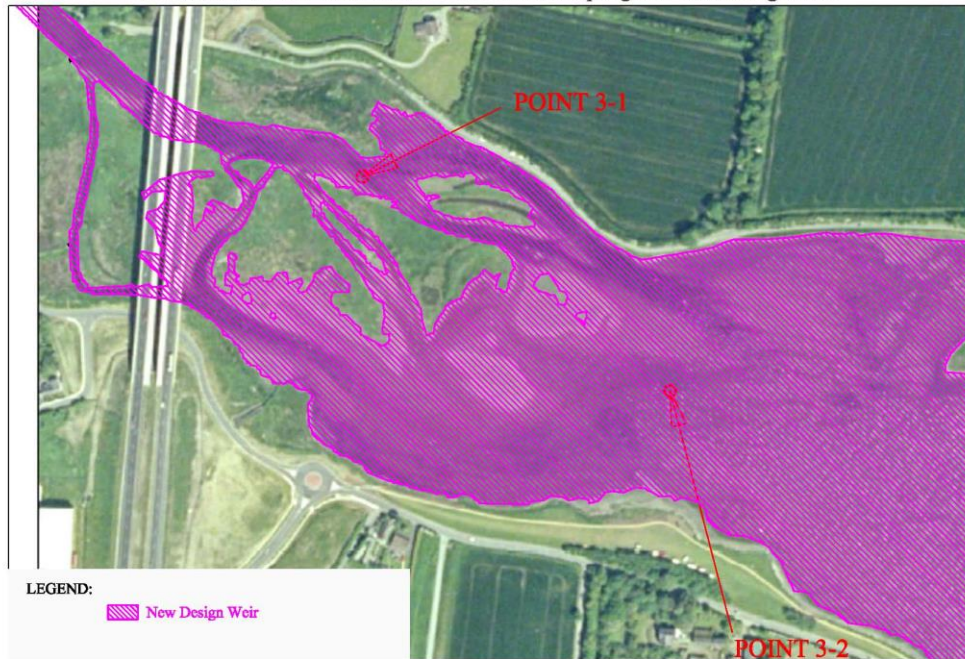
Time of presentation: 20th March 2011, 09:34 hrs

Malahide Viaduct Reinstatement - Water surface at spring low - New Design Weir

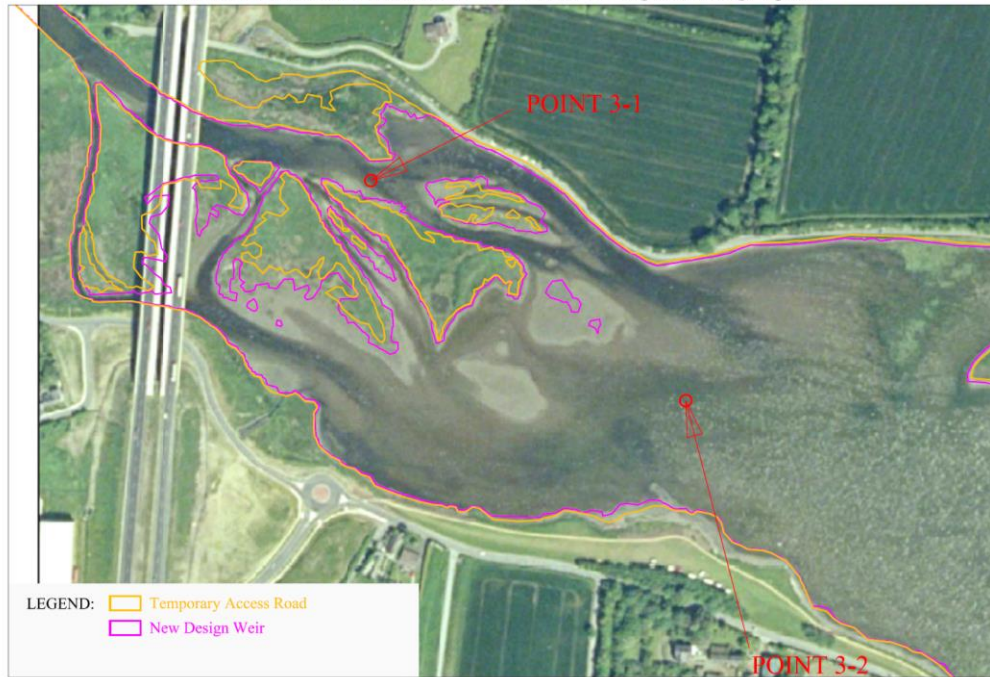
Malahide Viaduct Reinstatement - Water surface comparison at spring low

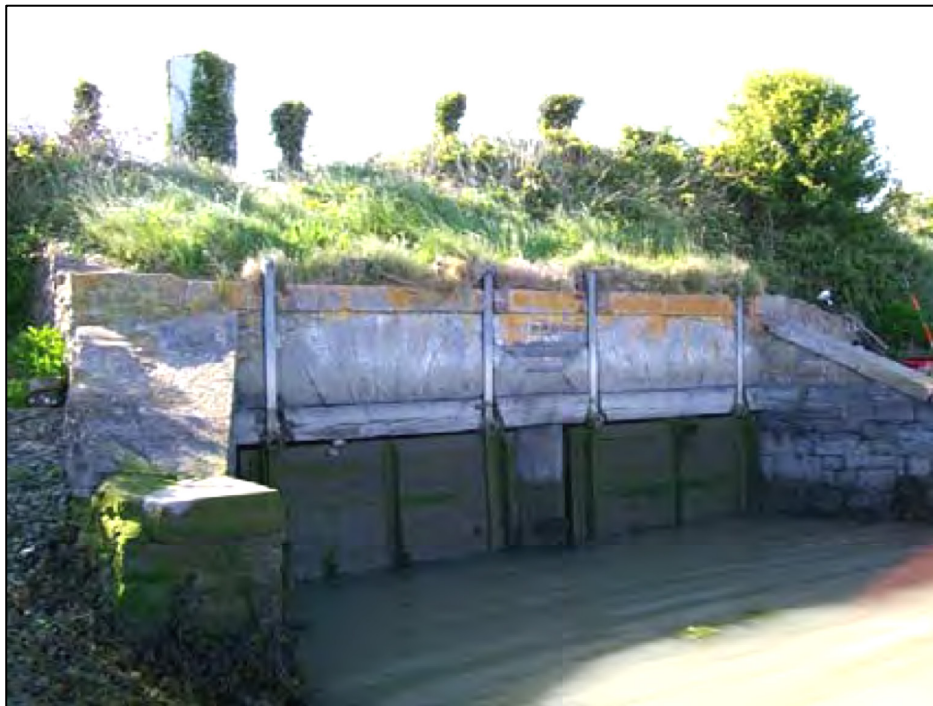
It should be noted that the presence of the flapped outfall at the estuary (shown in Figure 8) will lead to a reduction in the risk of such high tidal flooding or storm surge event from propagating into the river through the Kilcrea Lands. The effect of the flapped outfall was discussed in detail in FEM-FRAMS Hydraulic Report. It was stated that *“The flapped outfall at the downstream end of the model is considered a formal flood defence. The flapped outfalls prevent the high tides from propagating upstream at any modelled AEP event.”* (Ref. FEMFRAMS Hydraulics Report). The area benefitting from the operation of the flapped outfall is highlighted as *Defended Areas* in the FEM-FRAMS flood risk maps (see Figure 9).

Figure 8 Photo of the flapped outfall at Malahide Estuary – River Turvey mouth (Extracted from FEM-FRAMS, hydraulic Report, 2011)
