8.0 LAND AND SOILS

8.1 INTRODUCTION

This chapter of the EIAR assesses the impact on the geological environment of the proposed development. The objectives are to provide a review of baseline geological conditions across the footprint of the site, to assess the potential impact of the proposed development on the underlying soils and geology and to provide appropriate mitigation measures for any identified potential impacts, if deemed necessary.

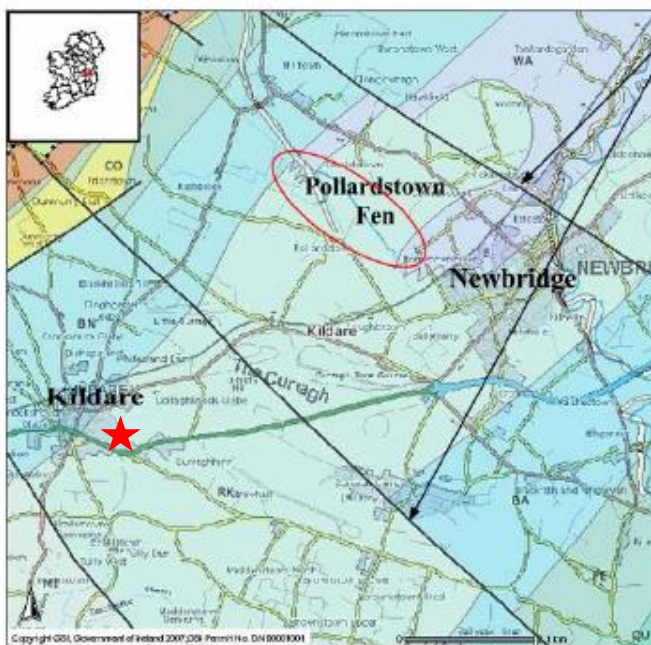
Fig. 8.1: Bedrock geology map of the area surrounding (a) the Curragh Aquifer and (b) Pollardstown Fen. The former Magee Barracks site is marked with a red star.

According to GSI sheet 11, the main rock unit underlying the study area is the Rickardstown Formation ((RK) – see Figure 8.1). Rickardstown Limestone is cherty and often dolomitised. The GSI have identified two distinct horizons within this formation. The lower horizon is varied and includes thin interbedded units of nodular crinoidal, cherty micrite and fossiliferous shale. The upper part consists primarily of quite uniform, moderately dark grey, fine grained dolomite with abundant chert.

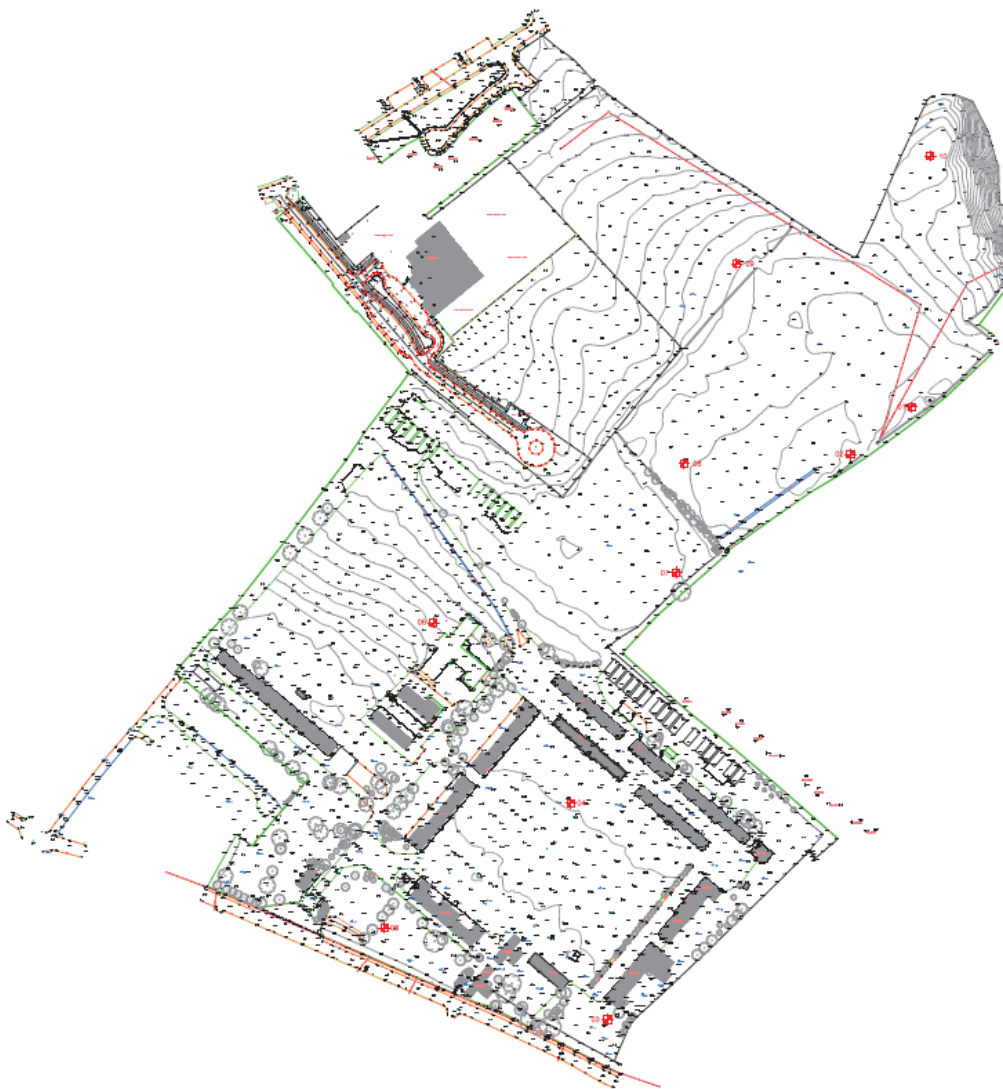
Fig. 8.4: 2016 site investigation locations

- Groundwater was not encountered in any of the trial pits.
- Infiltration testing undertaken within each trial pit was recorded. Infiltration rates of 6.78×10^{-5} , 2.63×10^{-4} , 7.0×10^{-6} , 2.07×10^{-5} and 1.17×10^{-5} m/s respectively were calculated for the soakaway locations SA01, SA03, SA04, SA06 and SA07. SA03 could not be filled completely as water flowed too quickly out of it. At the locations of SA02, SA05, SA08, SA09 and SA010 the water level dropped too slowly to allow calculation of 'f' – the soil infiltration rate and therefore these tests failed and were therefore unsuitable for soakaway design and construction.

All trial pit and infiltration test locations are presented in Figure 8.4 and the report is included within Appendix A to the Phase 1 Environmental Site Assessment Report (Appendix 8.1).

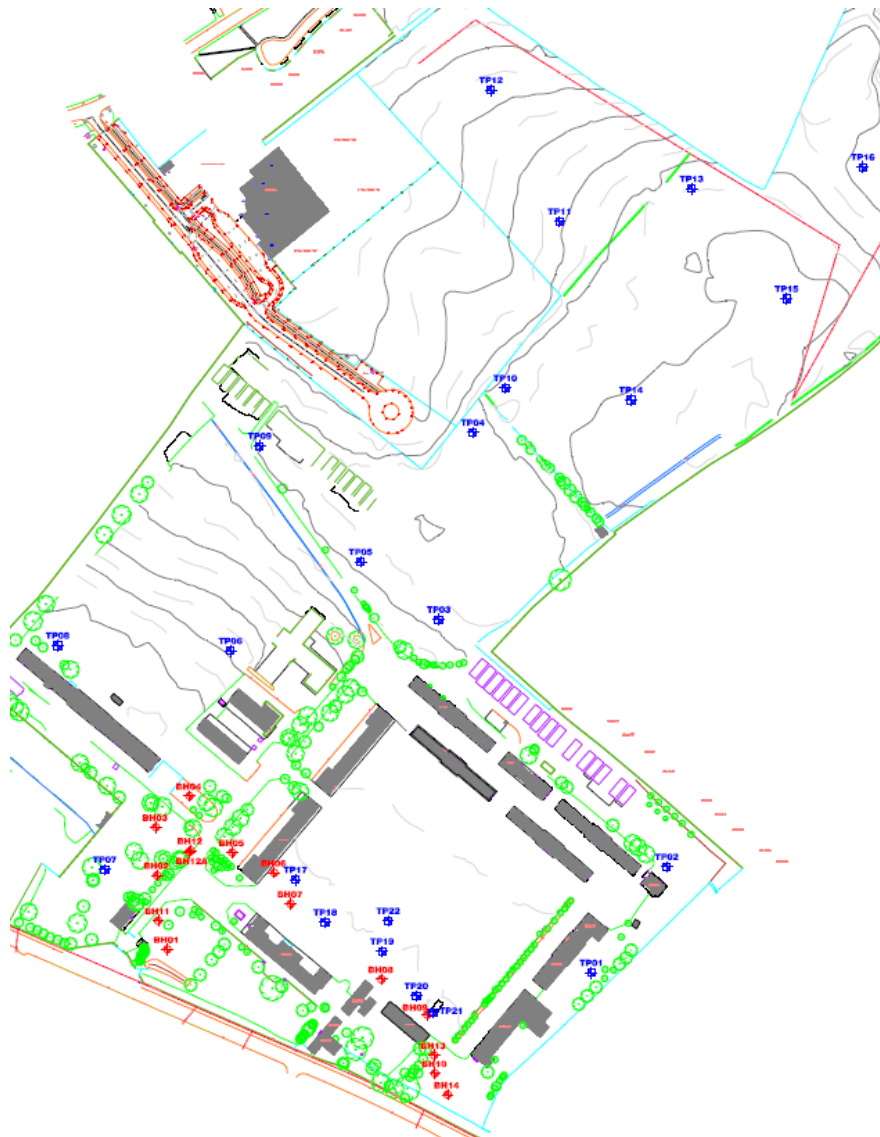
Fig. 8.5: 2017 site investigation locations

The locations of investigations across the site are outlined in Figure 8.5 and the report is included within Appendix A to the Phase 1 Environmental Site Assessment Report (Appendix 8.1).

- Cohesive till deposits were identified comprising of brown slightly sandy slightly gravelly clay with occasional cobbles with a strength increasing from firm to stiff or stiff with depth up to 9.7 metres in places. These deposits had some occasional or frequent cobble and boulder content where noted on the exploratory logs.

- Groundwater was not encountered in any of the boreholes or trial pits across the site, although it is acknowledged that no monitoring wells were installed within any of the boreholes to facilitate groundwater monitoring over time.

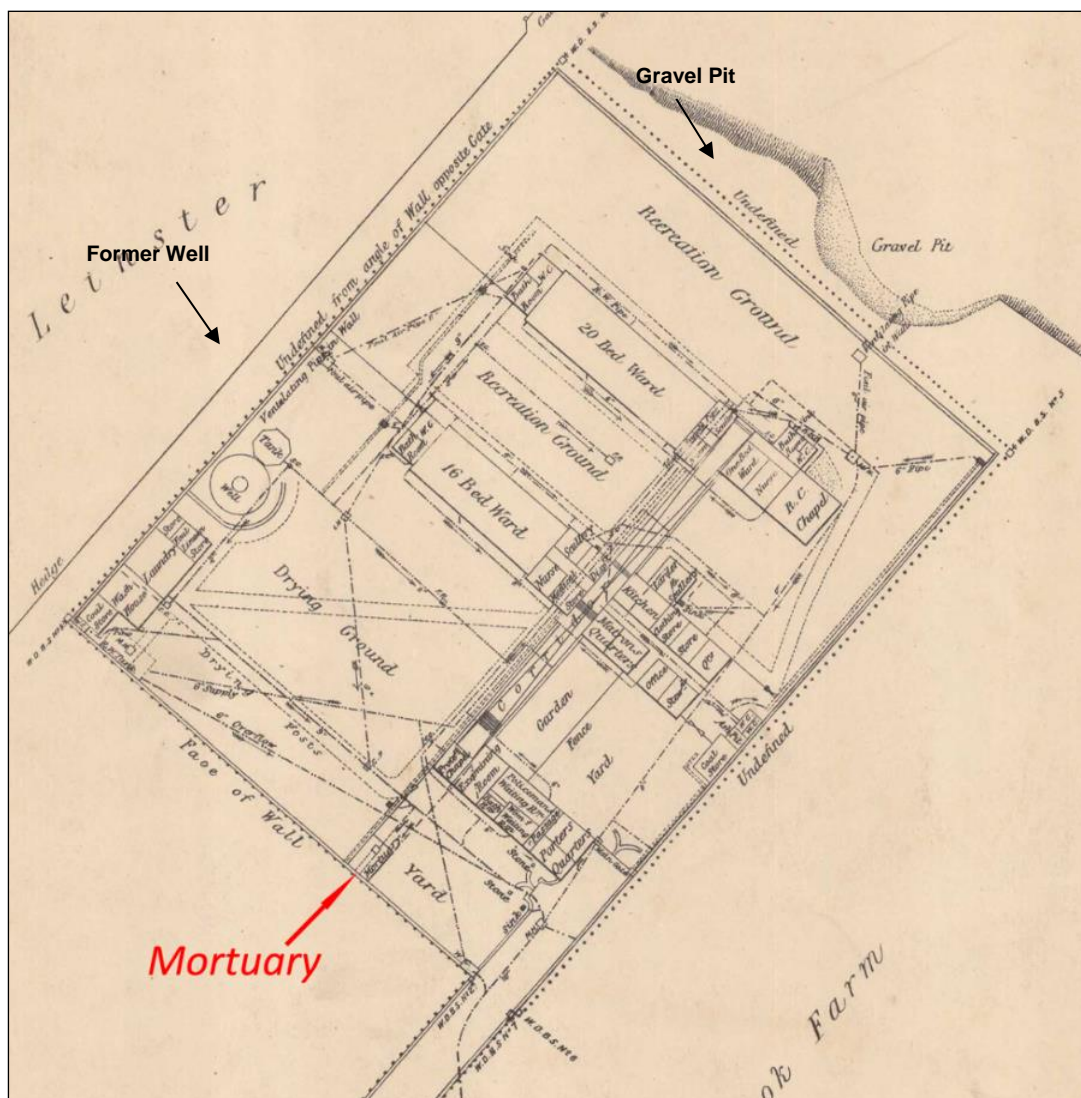
Fig. 8.6: Locations of former gravel pit and water well associated with the to the former Lock Hospital

- The north-eastern corner of the former barracks site is formed by a high gravel ridge, with a mature hedgerow running along the top of it. The ridge slope has been at least partly augmented by construction waste material, with a large mound extending east from it just outside the former barracks site boundary. This area will require further assessment as part of future redevelopment activities.
- A gravel pit is shown on historic maps to the north of the former hospital on site (see Figure 8.6 below – sourced from the Phase 1 ESA report in Appendix 8.1). The material used to backfill this pit is unclear and additional testing in this area should be undertaken to confirm the type of material present.

- A water well, reportedly 62 feet in depth, was located on the grounds of the former hospital (see Figure 8.6). If not appropriately sealed or backfilled, this well may provide a preferential vertical

pathway of possible contaminants within the shallow subsoils to the underlying sand and gravel aquifer and should be appropriately identified and assessed during any redevelopment activities.

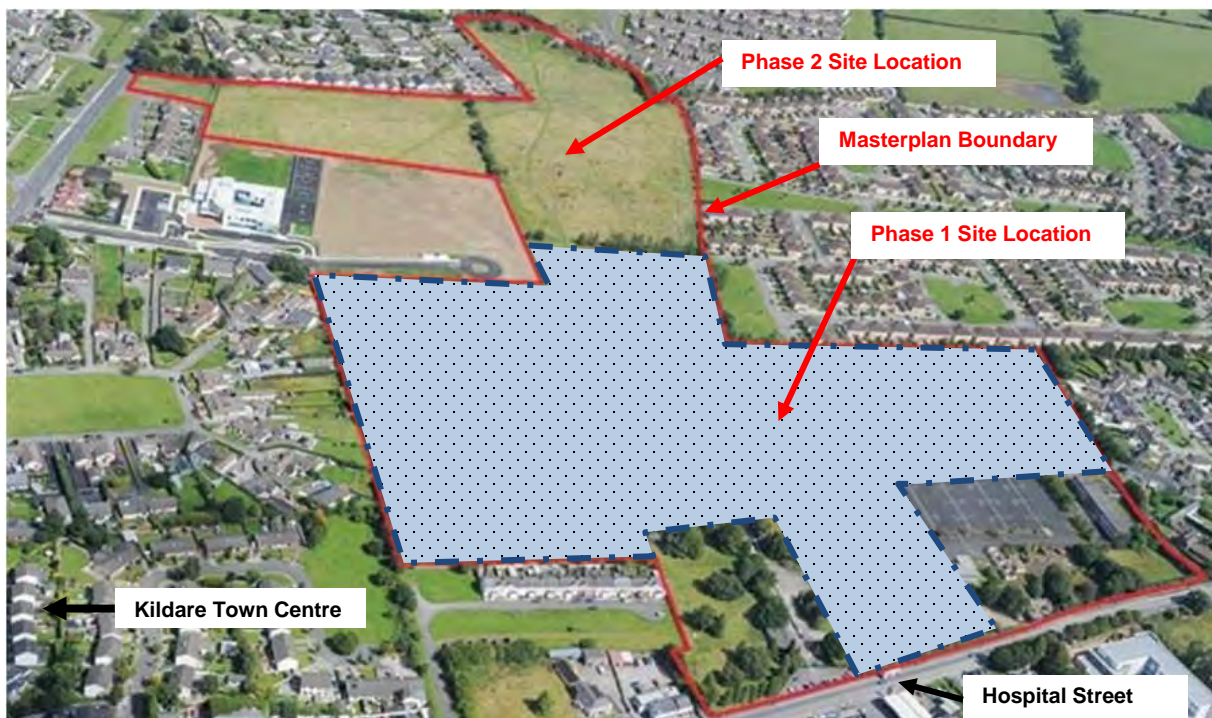
Figure 2.1 Current Site Location & Layout

The site in question is located within Kildare town on Hospital street (see Figure 2.1). It was formerly known as Magee Barracks, comprising of abandoned army barracks and attached green field areas.

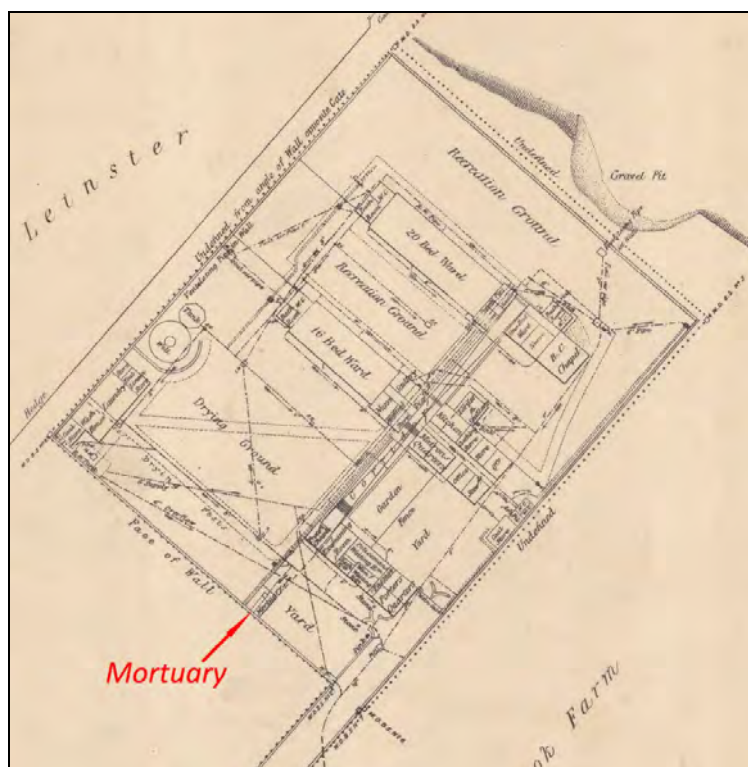
Figure 2.2 Extract of War Office Plan showing Lock Hospital, 1878

The building design consisted of a long corridor linking three blocks widely spaced using a single-storey pavilion principle (see Figure 2.2). A brief section of Crawford (2005)¹ describes the construction and layout of the hospital:

There is a mortuary depicted on the 1878 plan (see Figure 2.2) but it is not known whether the hospital had its own burial ground, official or otherwise. The hospital was closed in April 1887 following the passing of the Contagious Disease Repeal Act in 1886. Soon after the closure, the War Department acquired additional land around the site and incorporated the former hospital buildings into a new artillery barracks.

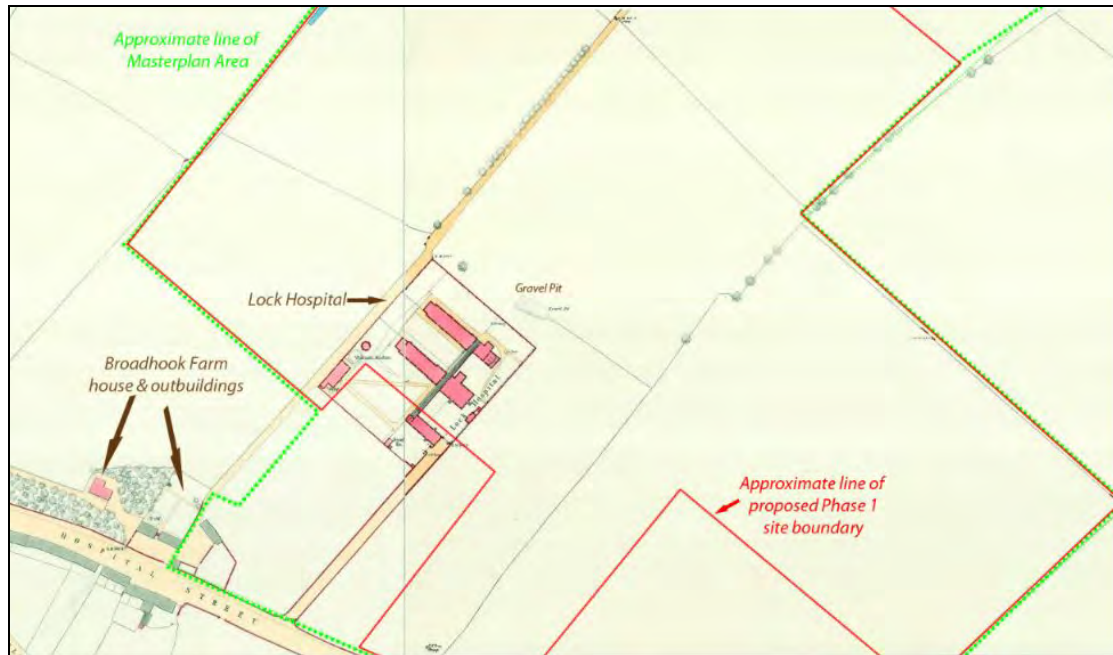
Figure 2.5 Extract of Ordnance Survey Town Plan of Kildare, 1870-72

The 1870-72 town plan shows the recently constructed Lock Hospital, on the newly-named Hospital Street. The laneway depicted on the first edition OS map is still in place (see Figure 2.5), running along the northwestern boundary of the hospital, but a new entrance avenue has been created off Hospital Street further to the southeast. A gravel pit is marked and annotated at the rear of the hospital. The hospital occupied a relatively small and contained site (for the most part within the proposed development site) and the surrounding field and property boundaries remained unchanged.

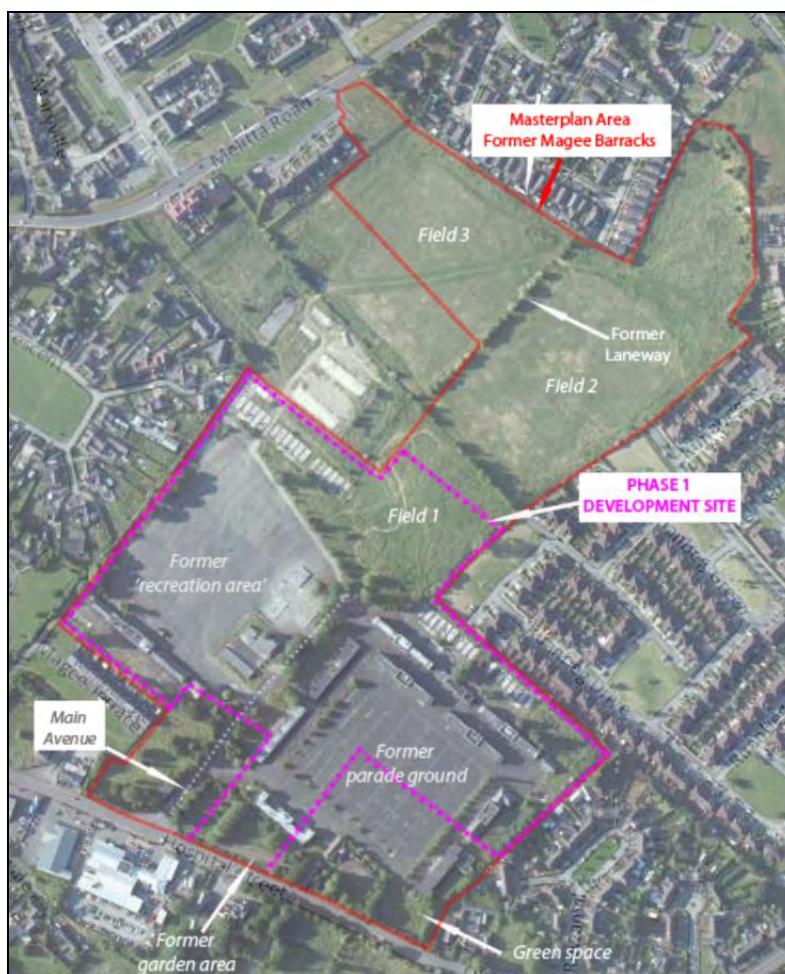
Figure 2.9 Aerial photograph showing proposed development site

The northern half of the Masterplan comprises two large fields, or parts thereof (Fields 2 & 3 and a narrow strip of Field 1) – see Figure 2.9. For the most part the land slopes gently in a north /

- The main barracks was located to the east of the main avenue and includes the former Parade Ground, an expansive area with tarmac surface and the outer boundaries lined with mature trees (see Figures 2.9 and 2.10). Long, narrow building ranges (mostly two-storey) occupy the sides of the parade ground, housing accommodation blocks, the Officers Mess, administration, and training schools. There is also a number of smaller related structures to the rear of the main buildings on the northeast side (e.g. gun sheds and an 'electronics' building of recent origin). Most of the buildings are in poor condition. Houses back onto the eastern and northeastern boundaries of this part of the site.

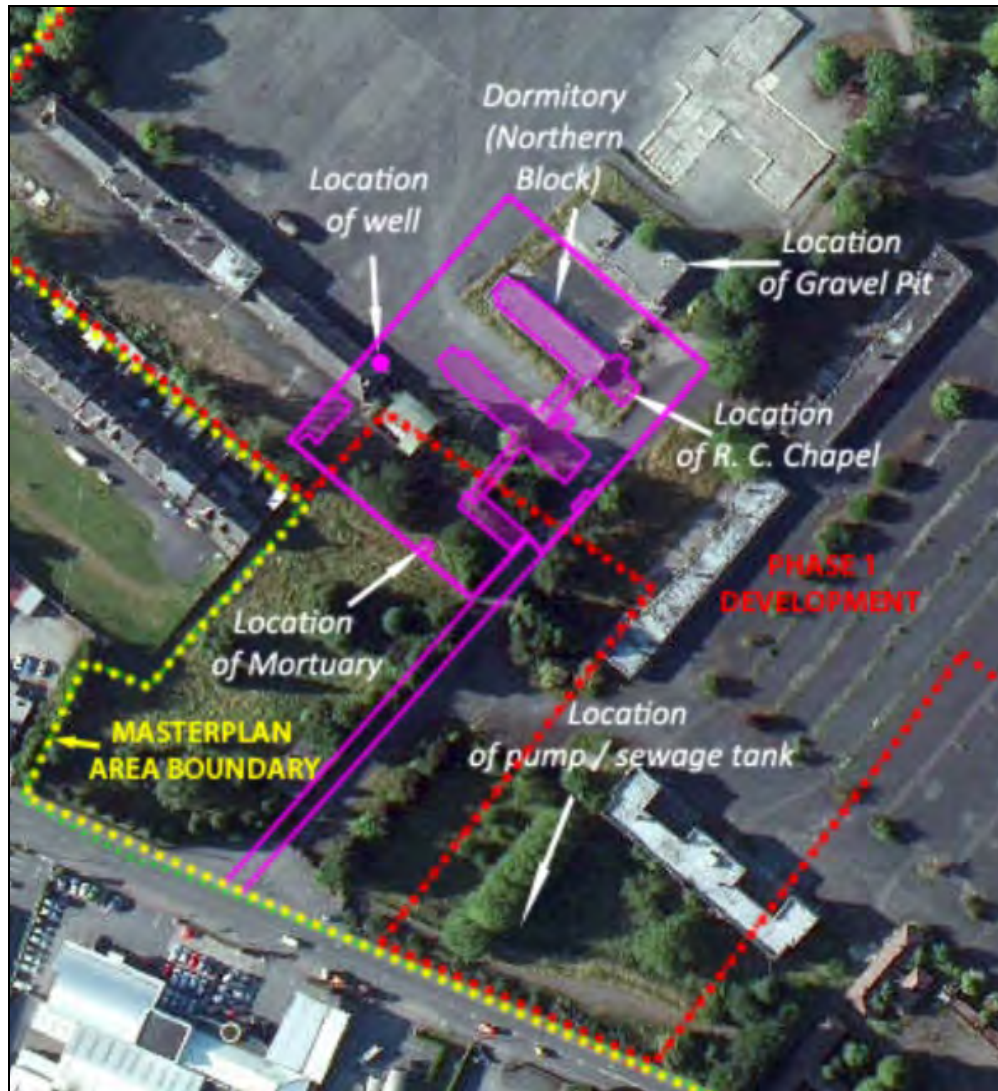
Figure 2.10 Overlay of Lock Hospital plan (1872) onto modern aerial imagery

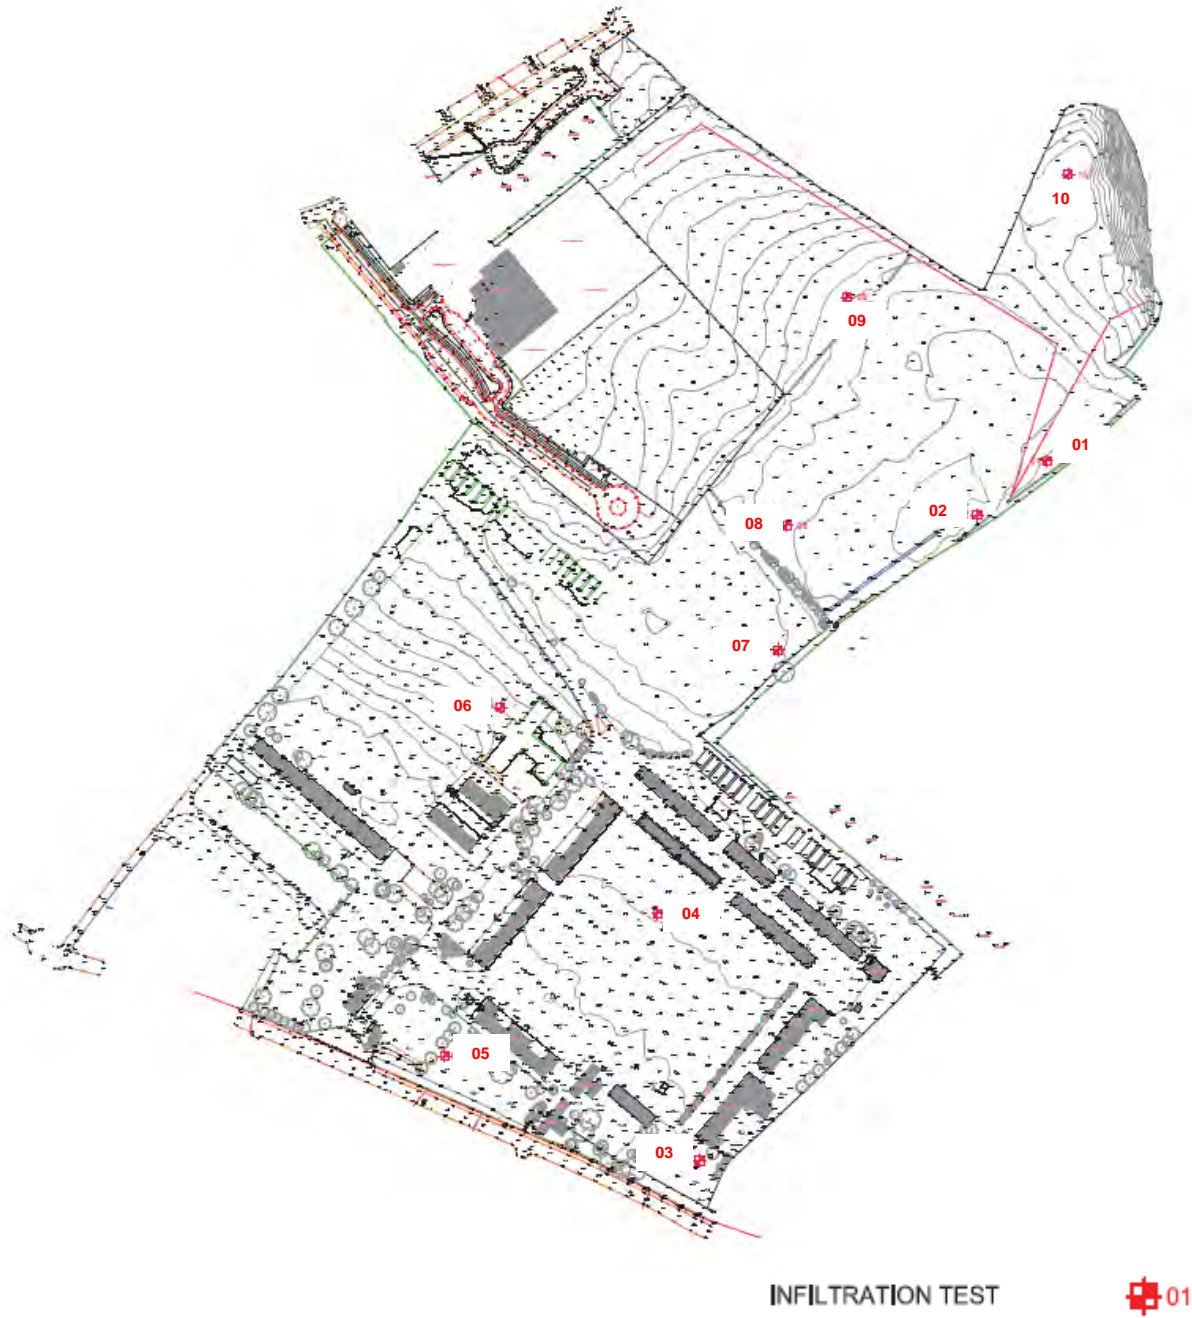
Figure 4.1 2016 Site Investigation Locations in proximity to the Phase 1 site

Details of the site investigation results are provided Appendix A. All trial pits, boreholes and infiltration test locations are presented in Figures 4.1 and 4.2 respectively.

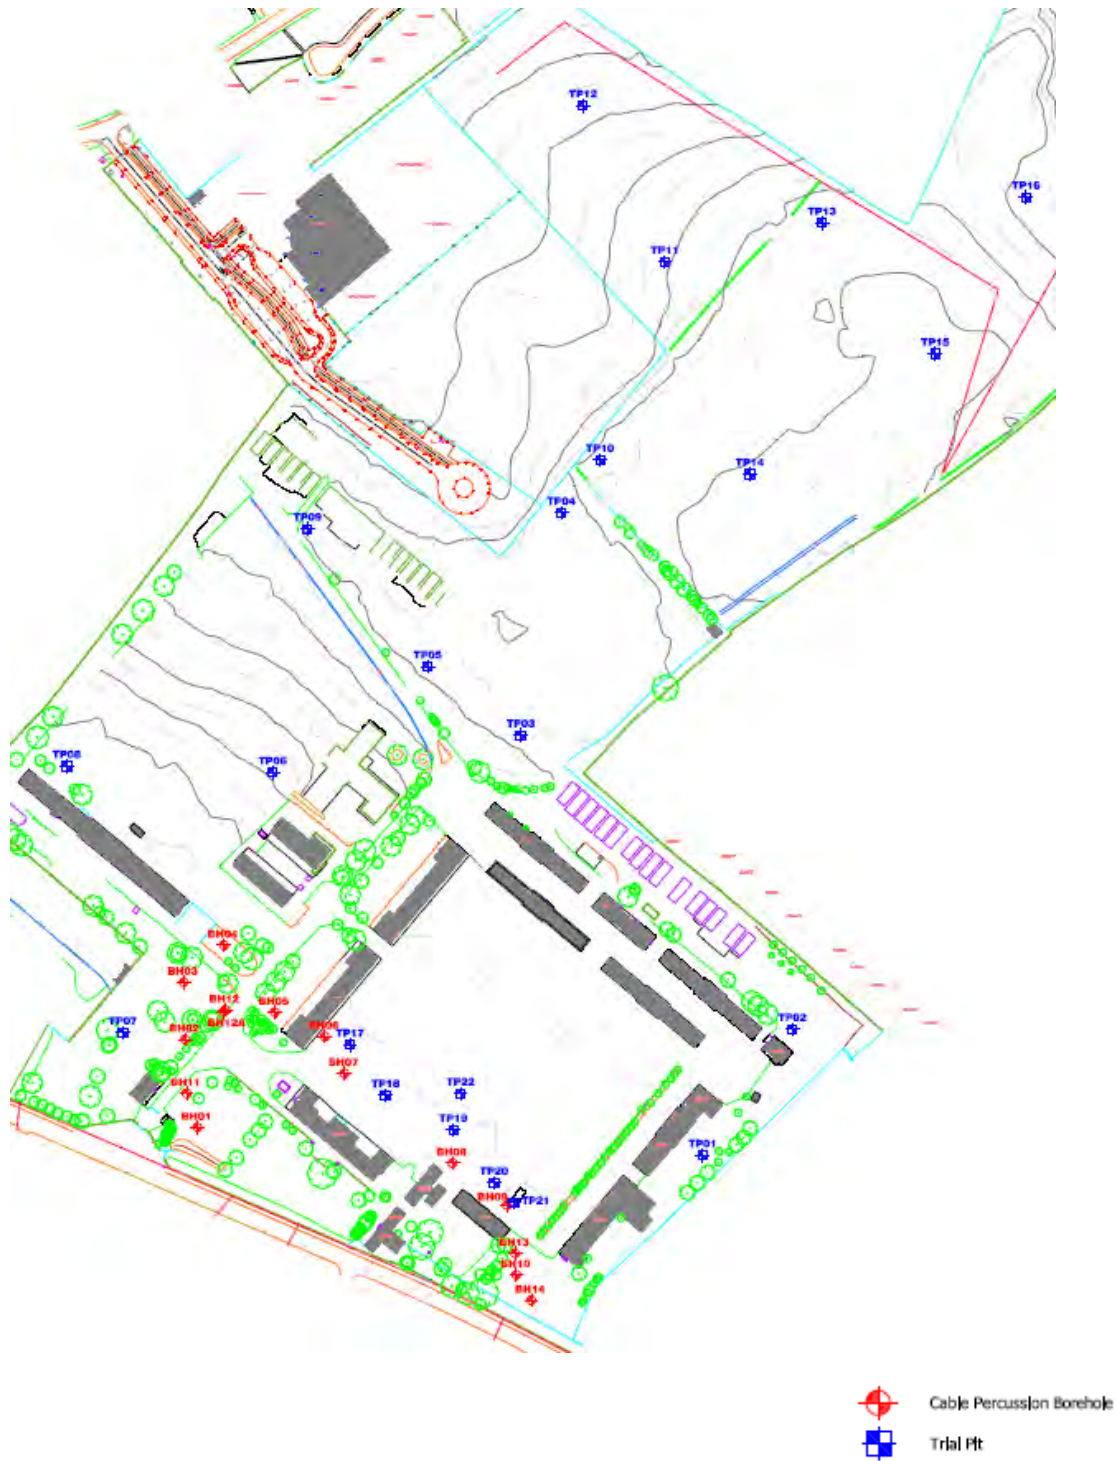
Figure 4.2 2017 Site Investigation Locations

- **Granular Till Deposits** comprising sand and gravel deposits were encountered across the site although not as a continuous body. The average thickness was 0.7 metres and the greatest thickness was recorded up to 4.3 metres within TP19 and TP20 in the southern region of the site. Deeper gravel deposits were encountered in the southeastern region of the site only and within the deepest borehole BH10. The gravel deposits encountered at this location were encountered between 9 and 15 mbgl and may be representative of the regional sand and gravel body that forms part of the Curragh gravel aquifer body. The gravel deposits encountered at shallower depths are considered unlikely to be part of this same gravel body given the presence of the low permeability clays underlying this shallow material and the detections of the material across the site.

- **Groundwater** strikes or seepages were not encountered in any of the boreholes or trial pits across the site, although it is acknowledged that no monitoring wells were installed within any of the boreholes to facilitate groundwater monitoring over time.

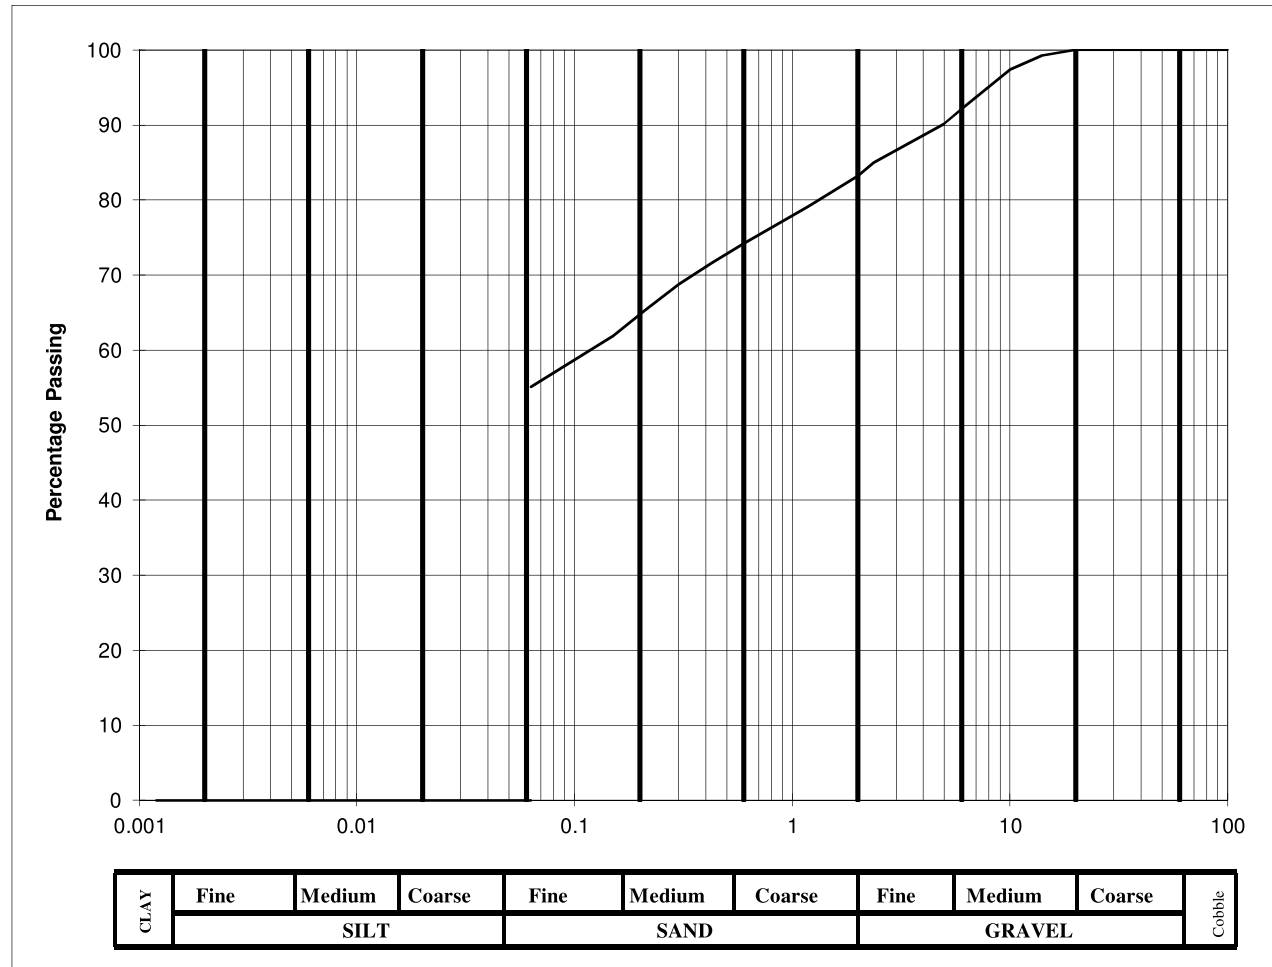
Lab. No :	17/1257
Sample No :	IS48

BS Sieve size, mm	Percent passing	Hydrometer analysis	
		Diameter, mm	% passing
100	100	0.0630	
90	100	0.0200	
75	100	0.0060	
63	100	0.0020	
50	100		
37.5	100		
28	100		
20	100		
14	99.3		
10	97.4		
6.3	92.6		
5.0	90.2		
2.36	85		
2.00	83.2		
1.18	79.1		
0.600	74.2		
0.425	71.6		
0.300	68.8		
0.212	65.4		
0.150	61.9		
0.063	55

Cobbles, %	0
Gravel, %	17
Sand, %	28
Clay / Silt, %	55

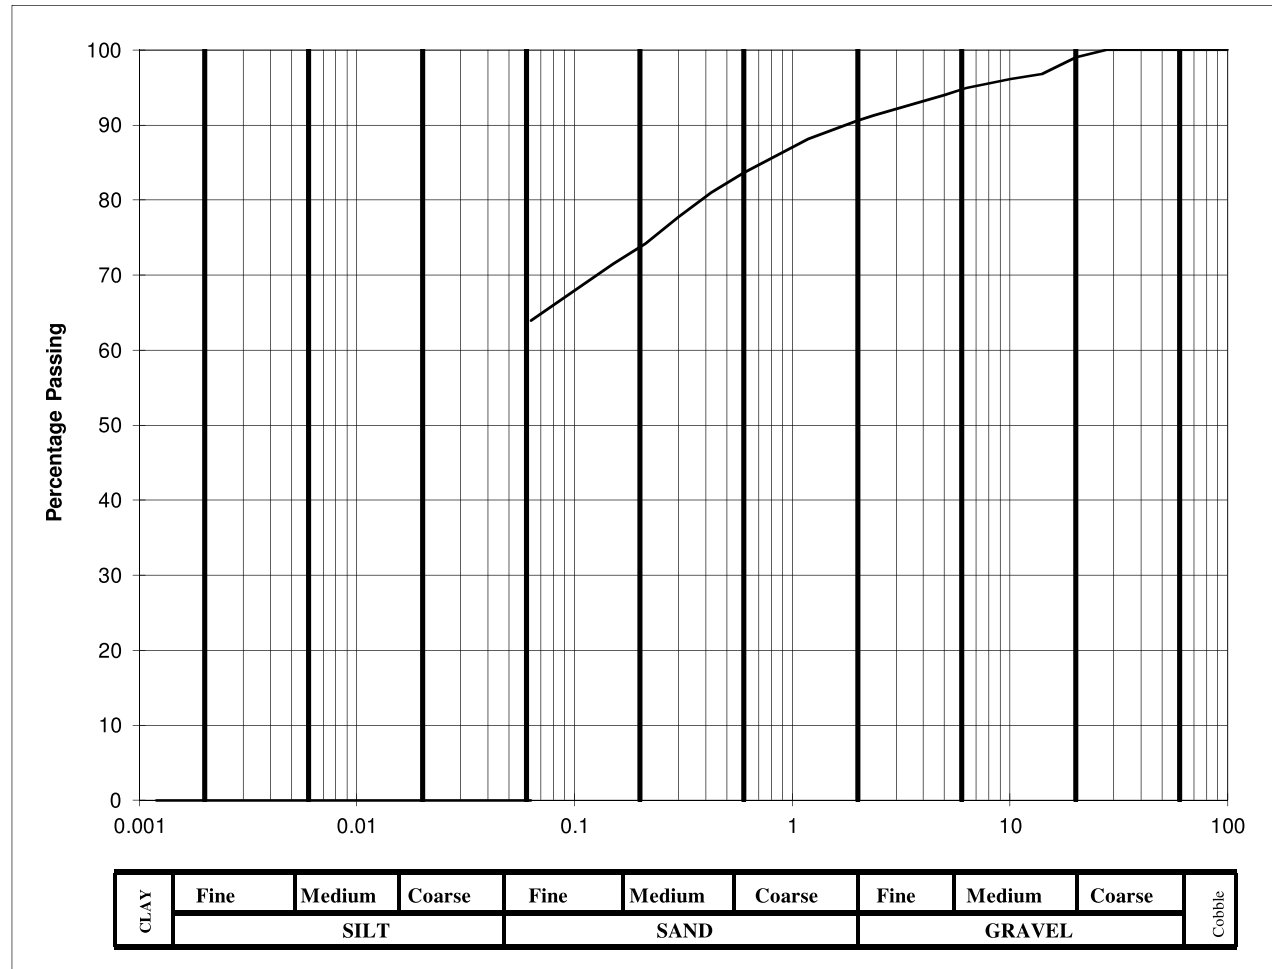
Lab. No :	17/1259
Sample No :	IS42

BS Sieve size, mm	Percent passing	Hydrometer analysis	
		Diameter, mm	% passing
100	100	0.0630	
90	100	0.0200	
75	100	0.0060	
63	100	0.0020	
50	100		
37.5	100		
28	100		
20	99		
14	96.8		
10	96.1		
6.3	94.9		
5.0	94		
2.36	91.3		
2.00	90.6		
1.18	88.1		
0.600	83.6		
0.425	81		
0.300	77.8		
0.212	74.2		
0.150	71.5		
0.063	64

Cobbles, %	0
Gravel, %	9
Sand, %	27
Clay / Silt, %	64

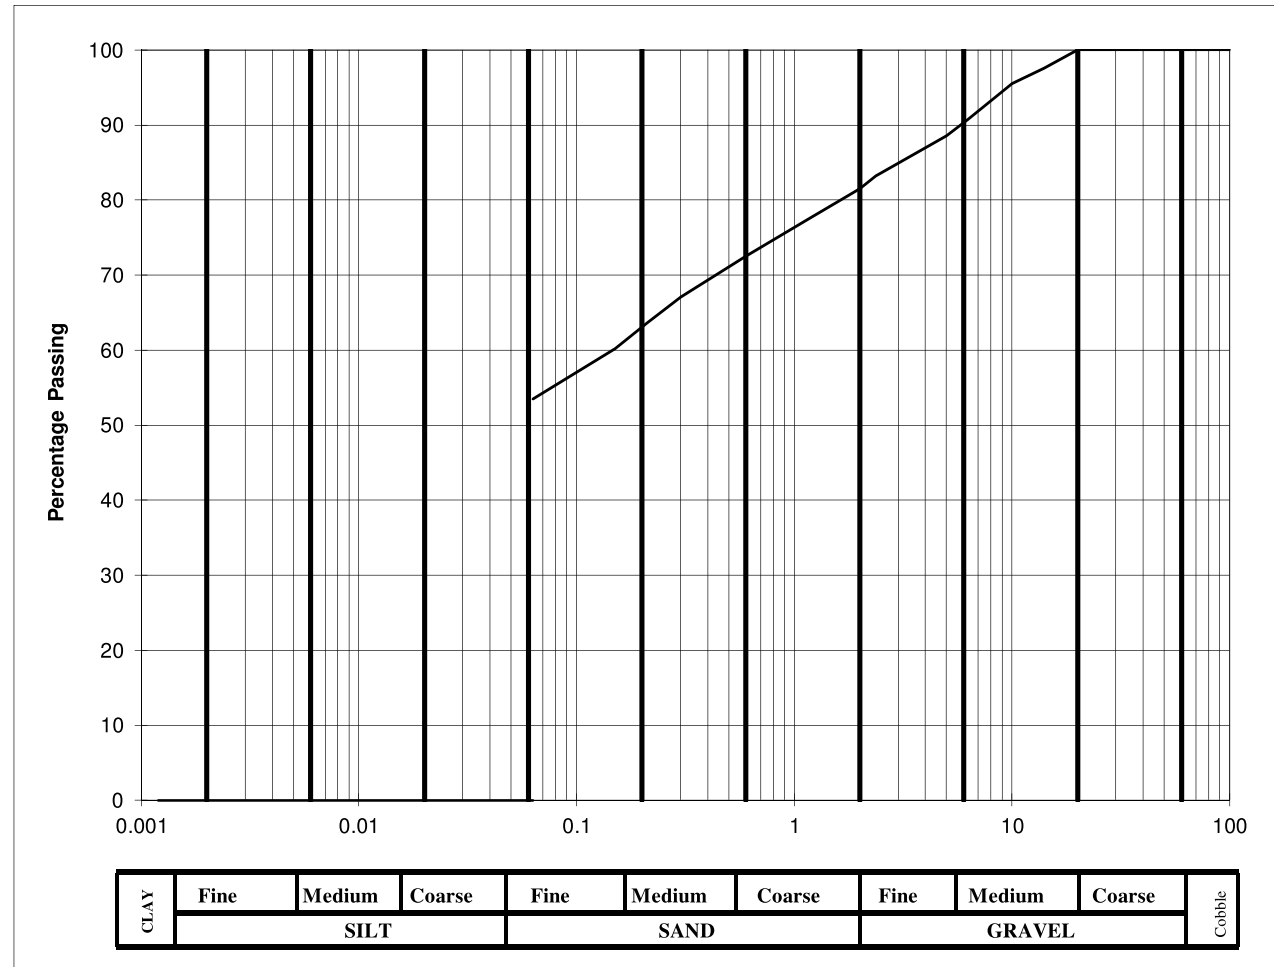
Lab. No :	17/1261
Sample No :	IS33

BS Sieve size, mm	Percent passing	Hydrometer analysis	
		Diameter, mm	% passing
100	100	0.0630	
90	100	0.0200	
75	100	0.0060	
63	100	0.0020	
50	100		
37.5	100		
28	100		
20	100		
14	97.6		
10	95.5		
6.3	90.8		
5.0	88.6		
2.36	83.2		
2.00	81.5		
1.18	77.6		
0.600	72.5		
0.425	69.8		
0.300	67.1		
0.212	63.7		
0.150	60.2		
0.063	54

Cobbles, %	0
Gravel, %	19
Sand, %	28
Clay / Silt, %	54

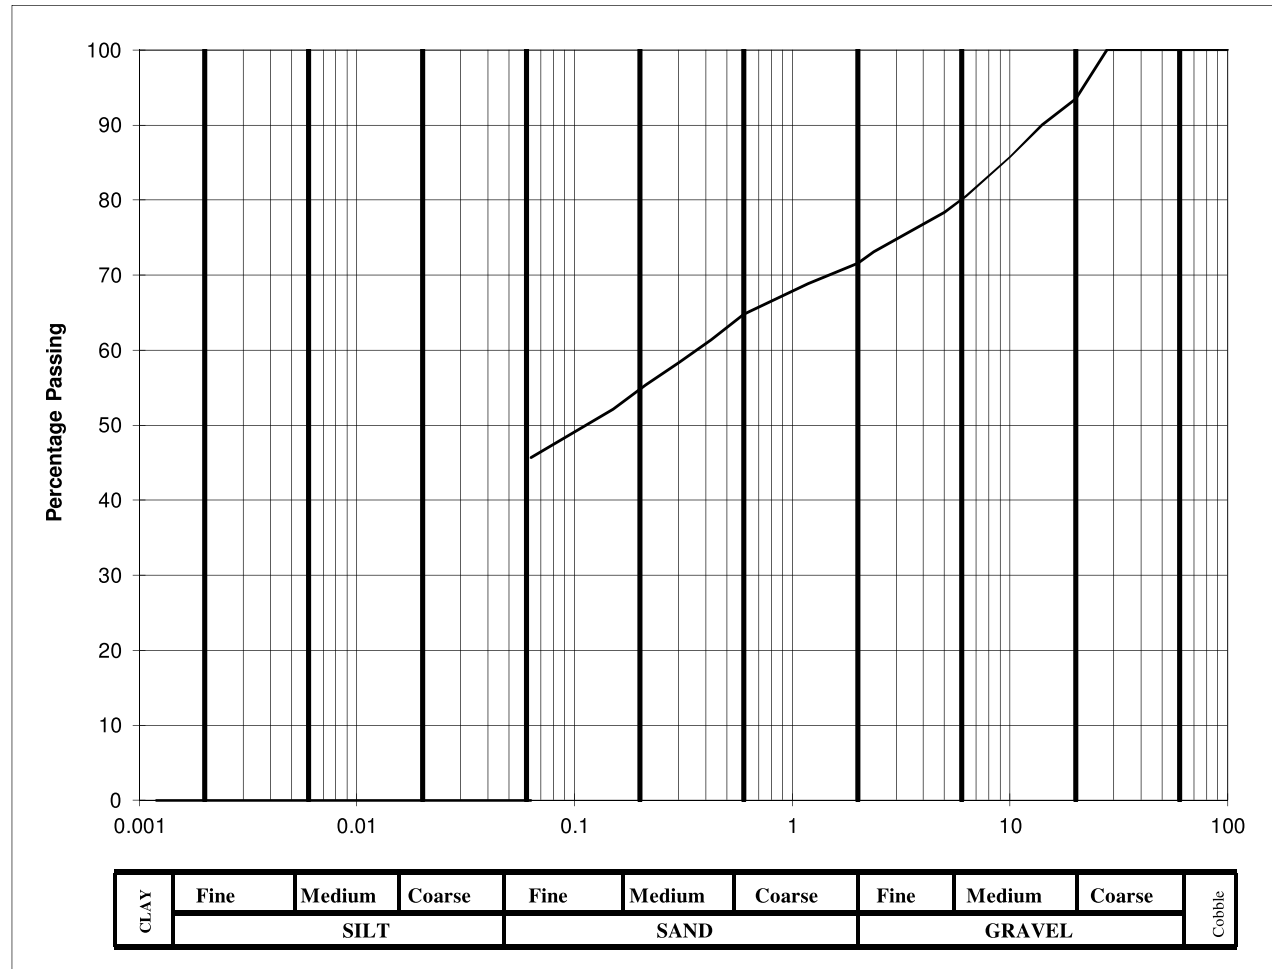
Lab. No :	17/1262
Sample No :	IS25

BS Sieve size, mm	Percent passing	Hydrometer analysis	
		Diameter, mm	% passing
100	100	0.0630	
90	100	0.0200	
75	100	0.0060	
63	100	0.0020	
50	100		
37.5	100		
28	100		
20	93.5		
14	90		
10	85.8		
6.3	80.5		
5.0	78.4		
2.36	73.1		
2.00	71.6		
1.18	68.9		
0.600	64.8		
0.425	61.4		
0.300	58.3		
0.212	55.4		
0.150	52.1		
0.063	46

Cobbles, %	0
Gravel, %	28
Sand, %	26
Clay / Silt, %	46

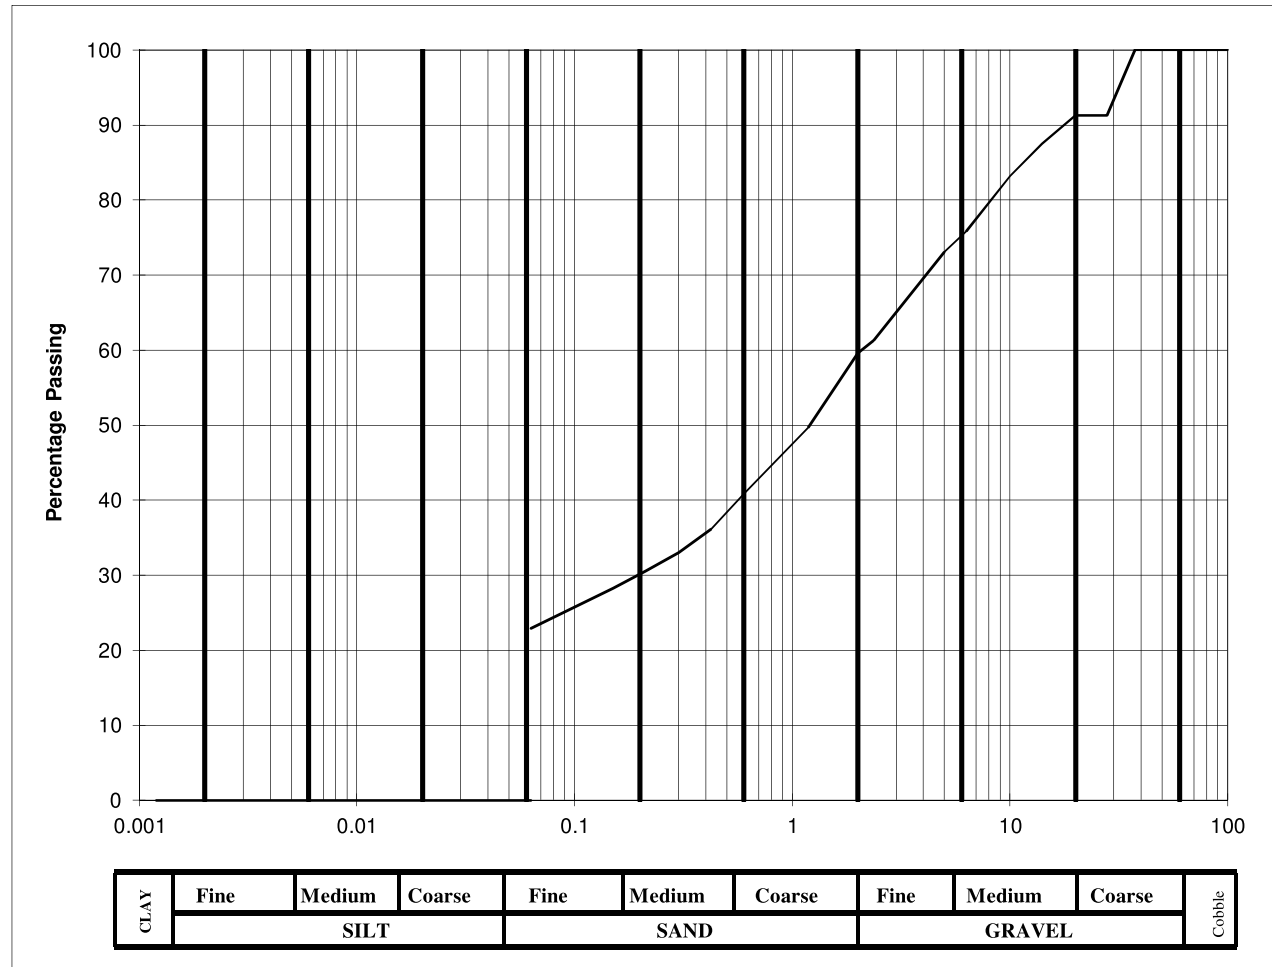
Lab. No :	17/1263
Sample No :	IS22

BS Sieve size, mm	Percent passing	Hydrometer analysis	
		Diameter, mm	% passing
100	100	0.0630	
90	100	0.0200	
75	100	0.0060	
63	100	0.0020	
50	100		
37.5	100		
28	91.3		
20	91.3		
14	87.5		
10	83.2		
6.3	75.8		
5.0	73.1		
2.36	61.3		
2.00	59.6		
1.18	49.7		
0.600	40.8		
0.425	36.2		
0.300	33		
0.212	30.6		
0.150	28.3		
0.063	23

Cobbles, %	0
Gravel, %	40
Sand, %	37
Clay / Silt, %	23

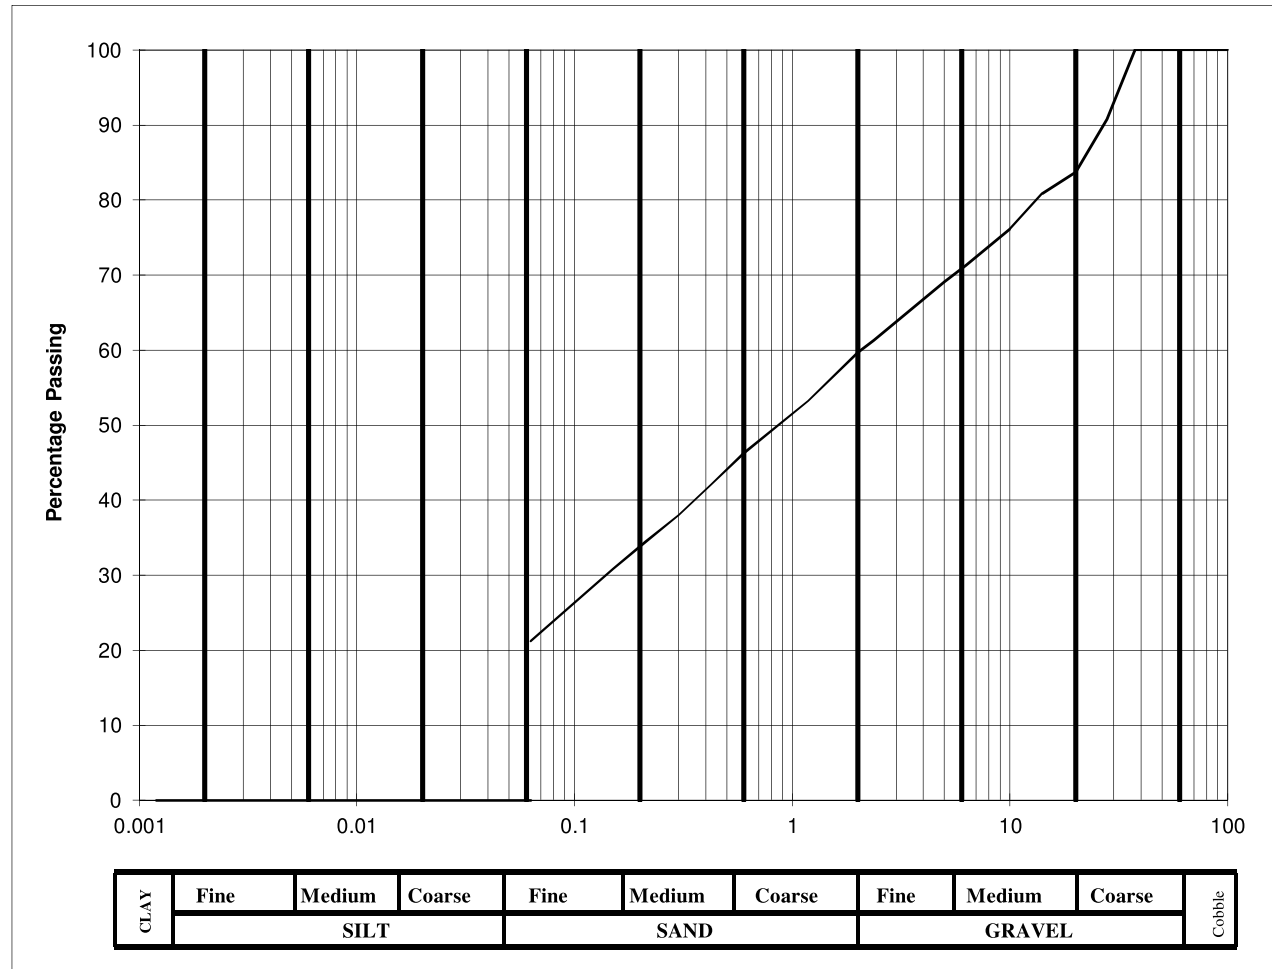
Lab. No :	17/1265
Sample No :	IS19

BS Sieve size, mm	Percent passing	Hydrometer analysis	
		Diameter, mm	% passing
100	100	0.0630	
90	100	0.0200	
75	100	0.0060	
63	100	0.0020	
50	100		
37.5	100		
28	90.8		
20	83.7		
14	80.8		
10	76.2		
6.3	71.3		
5.0	69.1		
2.36	61.3		
2.00	59.7		
1.18	53.2		
0.600	46.3		
0.425	42.1		
0.300	38		
0.212	34.5		
0.150	30.8		
0.063	21

Cobbles, %	0
Gravel, %	40
Sand, %	39
Clay / Silt, %	21

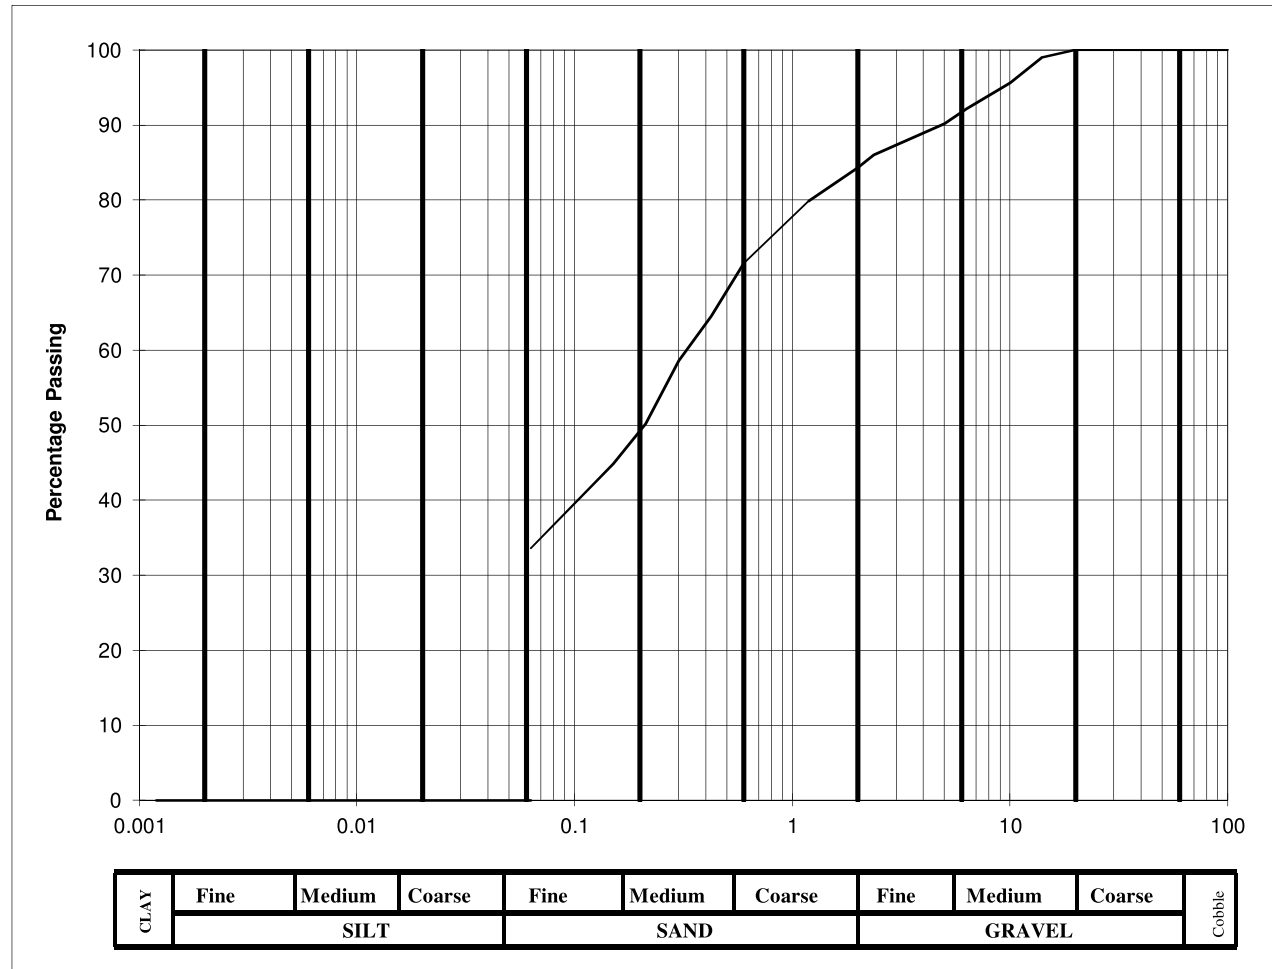
Lab. No :	17/1267
Sample No :	IS17

BS Sieve size, mm	Percent passing	Hydrometer analysis	
		Diameter, mm	% passing
100	100	0.0630	
90	100	0.0200	
75	100	0.0060	
63	100	0.0020	
50	100		
37.5	100		
28	100		
20	100		
14	99		
10	95.6		
6.3	92.1		
5.0	90.2		
2.36	86		
2.00	84.3		
1.18	79.8		
0.600	71.6		
0.425	64.5		
0.300	58.6		
0.212	50.2		
0.150	44.8		
0.063	34

Cobbles, %	0
Gravel, %	16
Sand, %	50
Clay / Silt, %	34
