8.0 LAND AND SOILS

8.1 INTRODUCTION

This chapter of the EIAR assesses the impact on the geological environment of the proposed development. The objectives are to provide a review of baseline geological conditions across the footprint of the site, to assess the potential impact of the proposed development on the underlying soils and geology and to provide appropriate mitigation measures for any identified potential impacts, if deemed necessary.

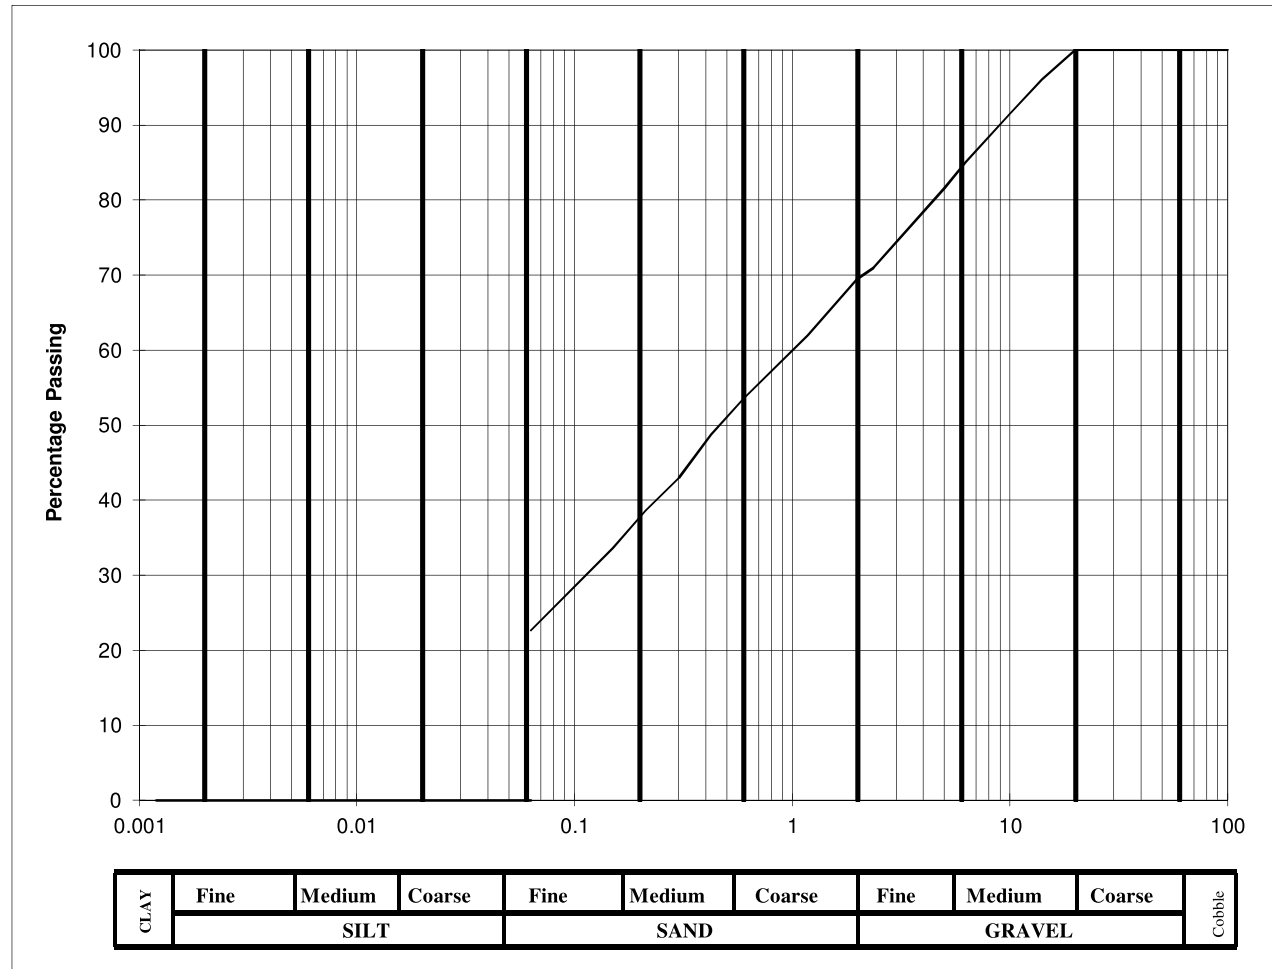
Lab. No :	17/1268
Sample No :	IS02

BS Sieve size, mm	Percent passing	Hydrometer analysis	
		Diameter, mm	% passing
100	100	0.0630	
90	100	0.0200	
75	100	0.0060	
63	100	0.0020	
50	100		
37.5	100		
28	100		
20	100		
14	96		
10	91.5		
6.3	85.1		
5.0	81.6		
2.36	71		
2.00	69.5		
1.18	62		
0.600	53.6		
0.425	48.7		
0.300	43		
0.212	38.6		
0.150	33.6		
0.063	23

Cobbles, %	0
Gravel, %	31
Sand, %	47
Clay / Silt, %	23

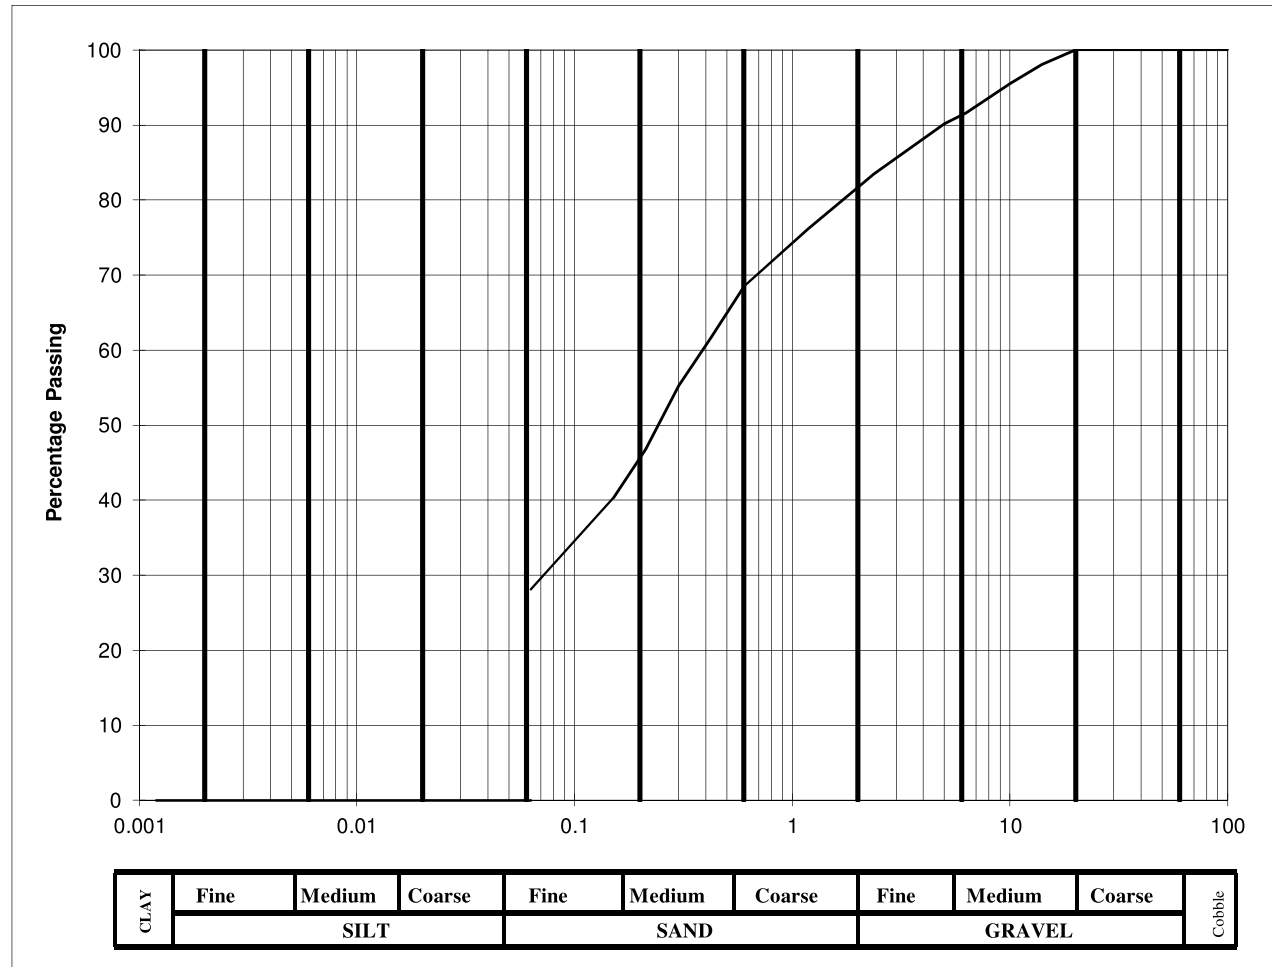
Lab. No :	17/1269
Sample No :	IS05

BS Sieve size, mm	Percent passing	Hydrometer analysis	
		Diameter, mm	% passing
100	100	0.0630	
90	100	0.0200	
75	100	0.0060	
63	100	0.0020	
50	100		
37.5	100		
28	100		
20	100		
14	98.1		
10	95.5		
6.3	91.6		
5.0	90.2		
2.36	83.5		
2.00	81.7		
1.18	76.2		
0.600	68.4		
0.425	61.7		
0.300	55.3		
0.212	46.8		
0.150	40.2		
0.063	28

Cobbles, %	0
Gravel, %	18
Sand, %	54
Clay / Silt, %	28

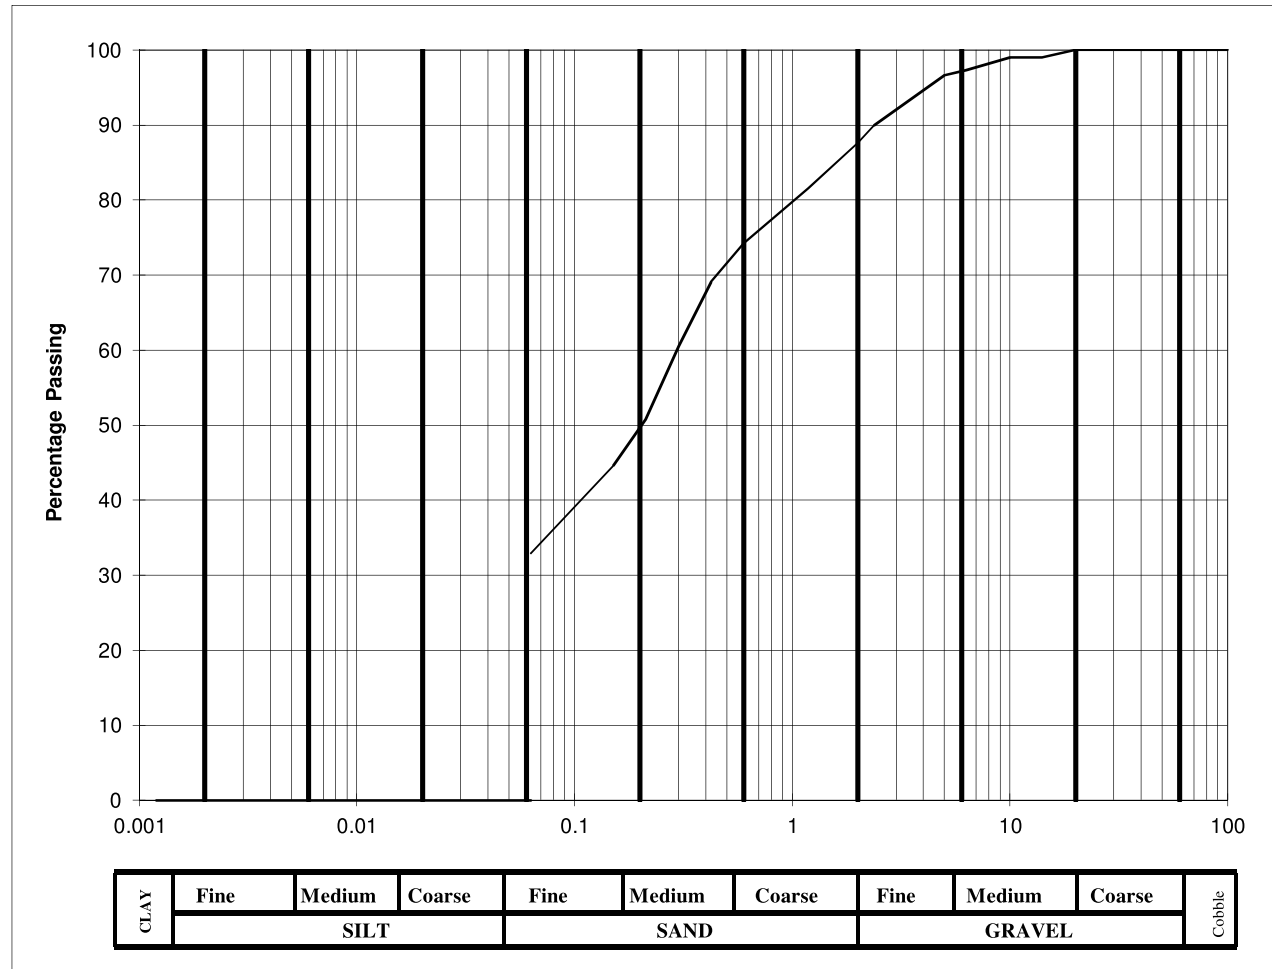
Lab. No :	17/1270
Sample No :	IS08

BS Sieve size, mm	Percent passing	Hydrometer analysis	
		Diameter, mm	% passing
100	100	0.0630	
90	100	0.0200	
75	100	0.0060	
63	100	0.0020	
50	100		
37.5	100		
28	100		
20	100		
14	99		
10	99		
6.3	97.3		
5.0	96.6		
2.36	89.9		
2.00	87.6		
1.18	81.5		
0.600	74.2		
0.425	69.1		
0.300	60.5		
0.212	50.8		
0.150	44.6		
0.063	33

Cobbles, %	0
Gravel, %	12
Sand, %	55
Clay / Silt, %	33

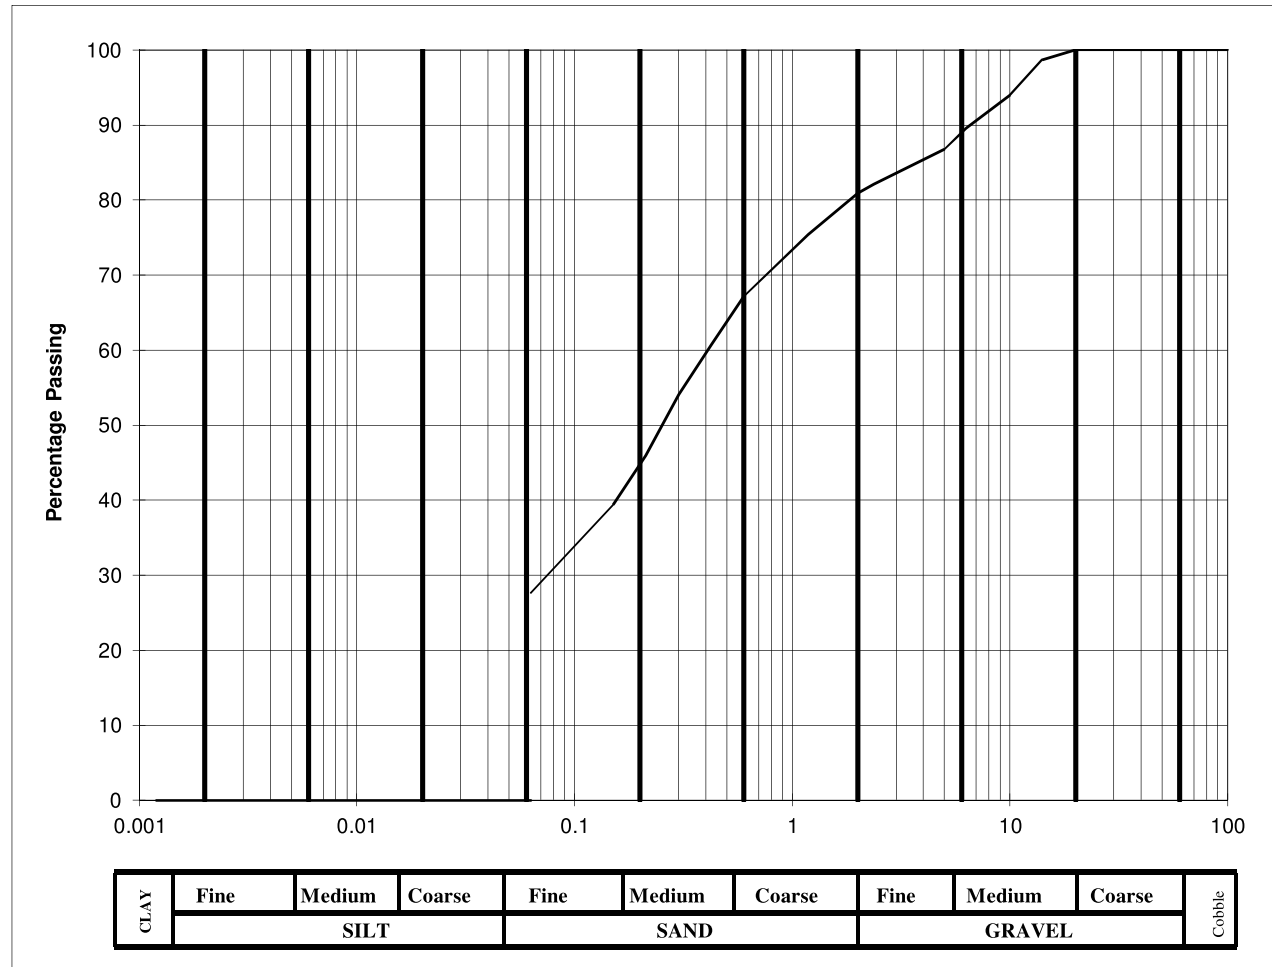
Lab. No :	17/1184
Sample No :	PM03

BS Sieve size, mm	Percent passing	Hydrometer analysis	
		Diameter, mm	% passing
100	100	0.0630	
90	100	0.0200	
75	100	0.0060	
63	100	0.0020	
50	100		
37.5	100		
28	100		
20	100		
14	98.7		
10	94		
6.3	89.6		
5.0	86.8		
2.36	82.1		
2.00	80.9		
1.18	75.4		
0.600	67.2		
0.425	60.7		
0.300	54.1		
0.212	45.9		
0.150	39.4		
0.063	28

Cobbles, %	0
Gravel, %	19
Sand, %	53
Clay / Silt, %	28

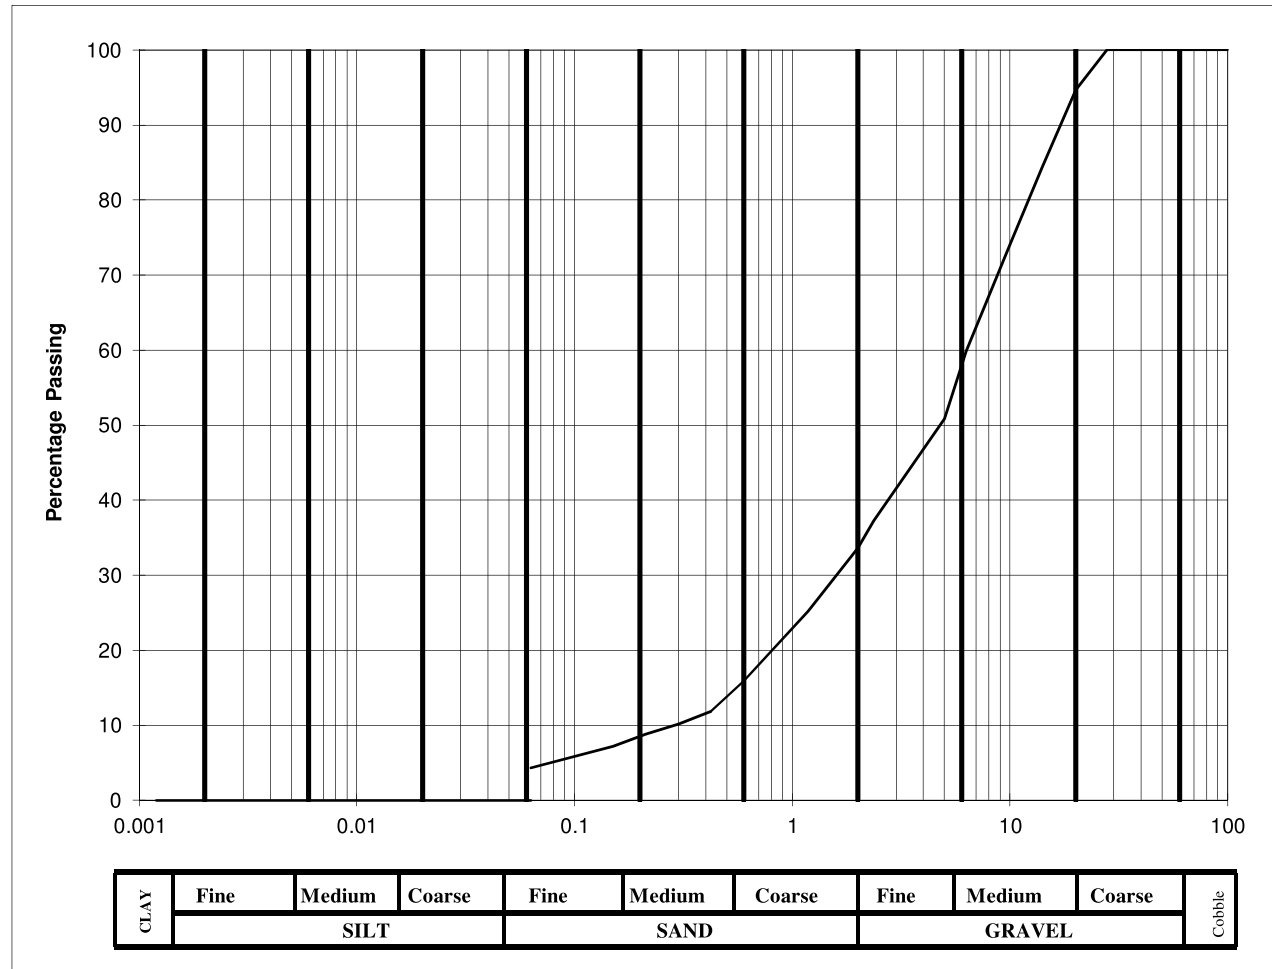
Lab. No :	17/1186
Sample No :	PM08

BS Sieve size, mm	Percent passing	Hydrometer analysis	
		Diameter, mm	% passing
100	100	0.0630	
90	100	0.0200	
75	100	0.0060	
63	100	0.0020	
50	100		
37.5	100		
28	100		
20	94.7		
14	84.3		
10	74.1		
6.3	59.9		
5.0	50.9		
2.36	37.3		
2.00	33.6		
1.18	25.2		
0.600	15.9		
0.425	11.9		
0.300	10.2		
0.212	8.8		
0.150	7.2		
0.063	4

Cobbles, %	0
Gravel, %	66
Sand, %	30
Clay / Silt, %	4

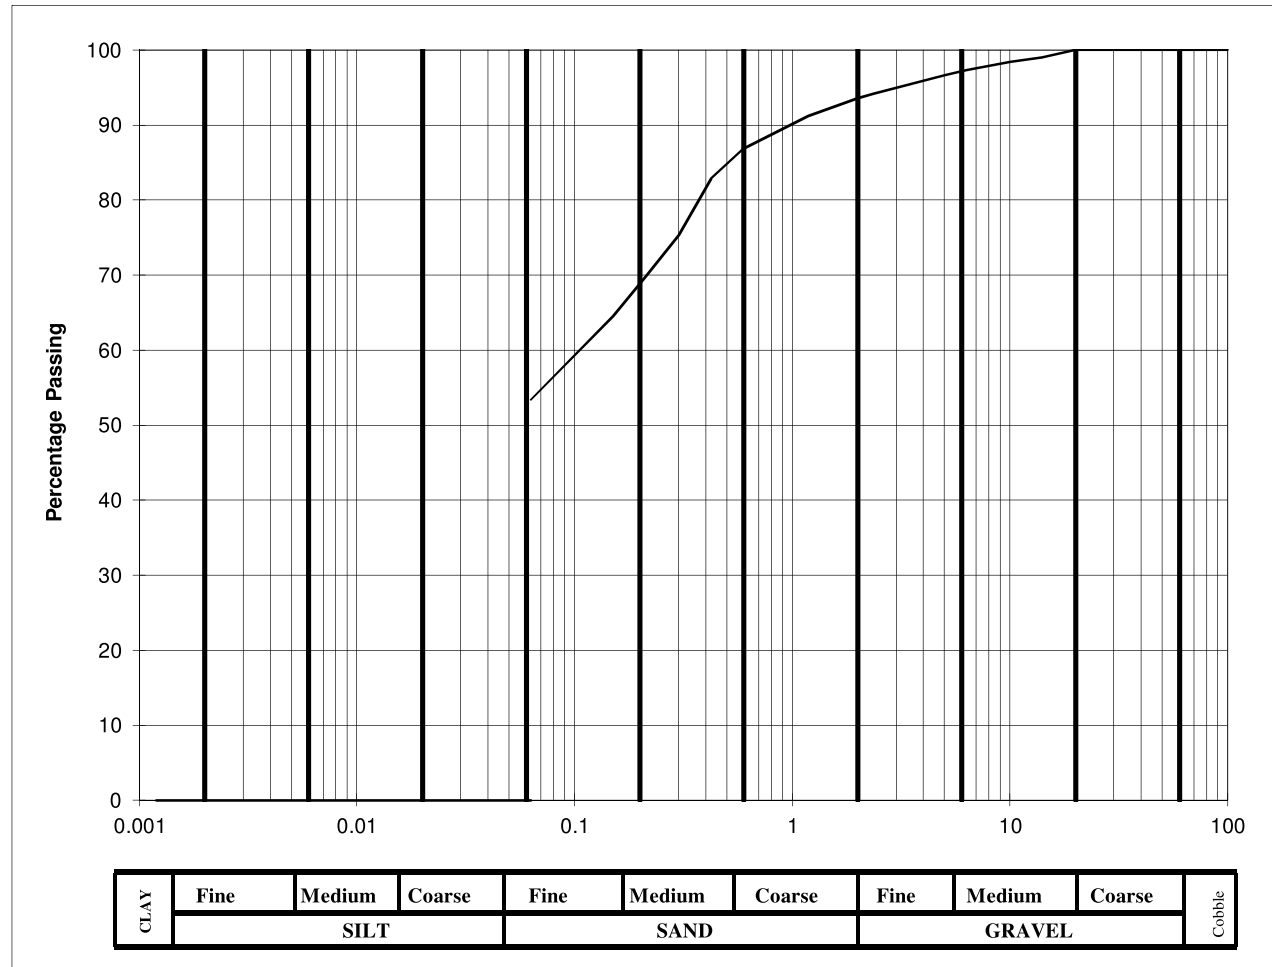
Lab. No :	17/1188
Sample No :	MK25

BS Sieve size, mm	Percent passing	Hydrometer analysis	
		Diameter, mm	% passing
100	100	0.0630	
90	100	0.0200	
75	100	0.0060	
63	100	0.0020	
50	100		
37.5	100		
28	100		
20	100		
14	99		
10	98.4		
6.3	97.3		
5.0	96.6		
2.36	94.2		
2.00	93.6		
1.18	91.2		
0.600	86.9		
0.425	82.9		
0.300	75.3		
0.212	69.8		
0.150	64.5		
0.063	53

Cobbles, %	0
Gravel, %	6
Sand, %	41
Clay / Silt, %	53

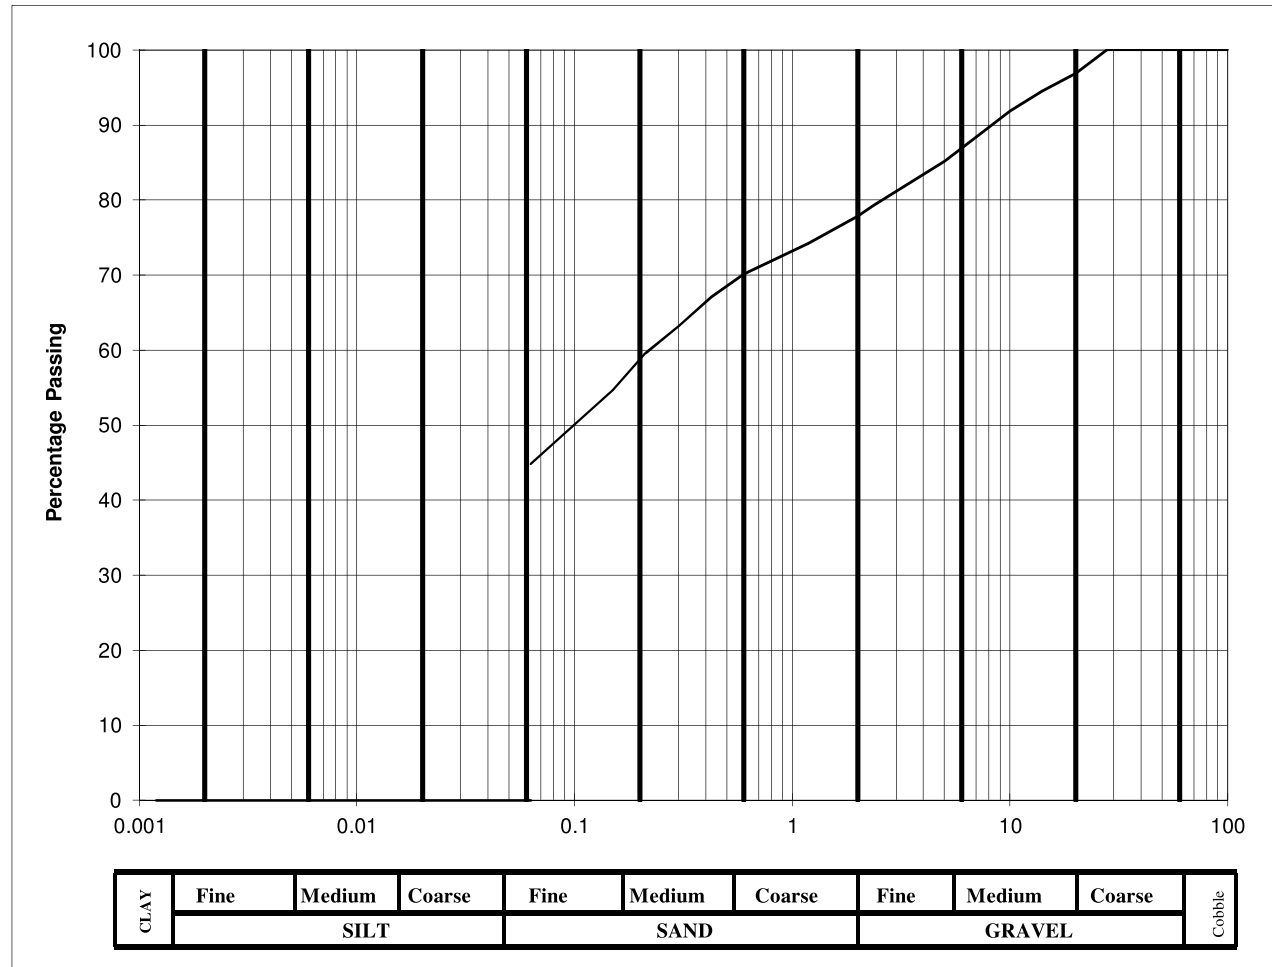
Lab. No :	17/1193
Sample No :	MK06

BS Sieve size, mm	Percent passing	Hydrometer analysis	
		Diameter, mm	% passing
100	100	0.0630	
90	100	0.0200	
75	100	0.0060	
63	100	0.0020	
50	100		
37.5	100		
28	100		
20	96.9		
14	94.5		
10	91.9		
6.3	87.4		
5.0	85.2		
2.36	79.3		
2.00	77.9		
1.18	74.2		
0.600	70.1		
0.425	67.1		
0.300	63.2		
0.212	59.6		
0.150	54.7		
0.063	45

Cobbles, %	0
Gravel, %	22
Sand, %	33
Clay / Silt, %	45

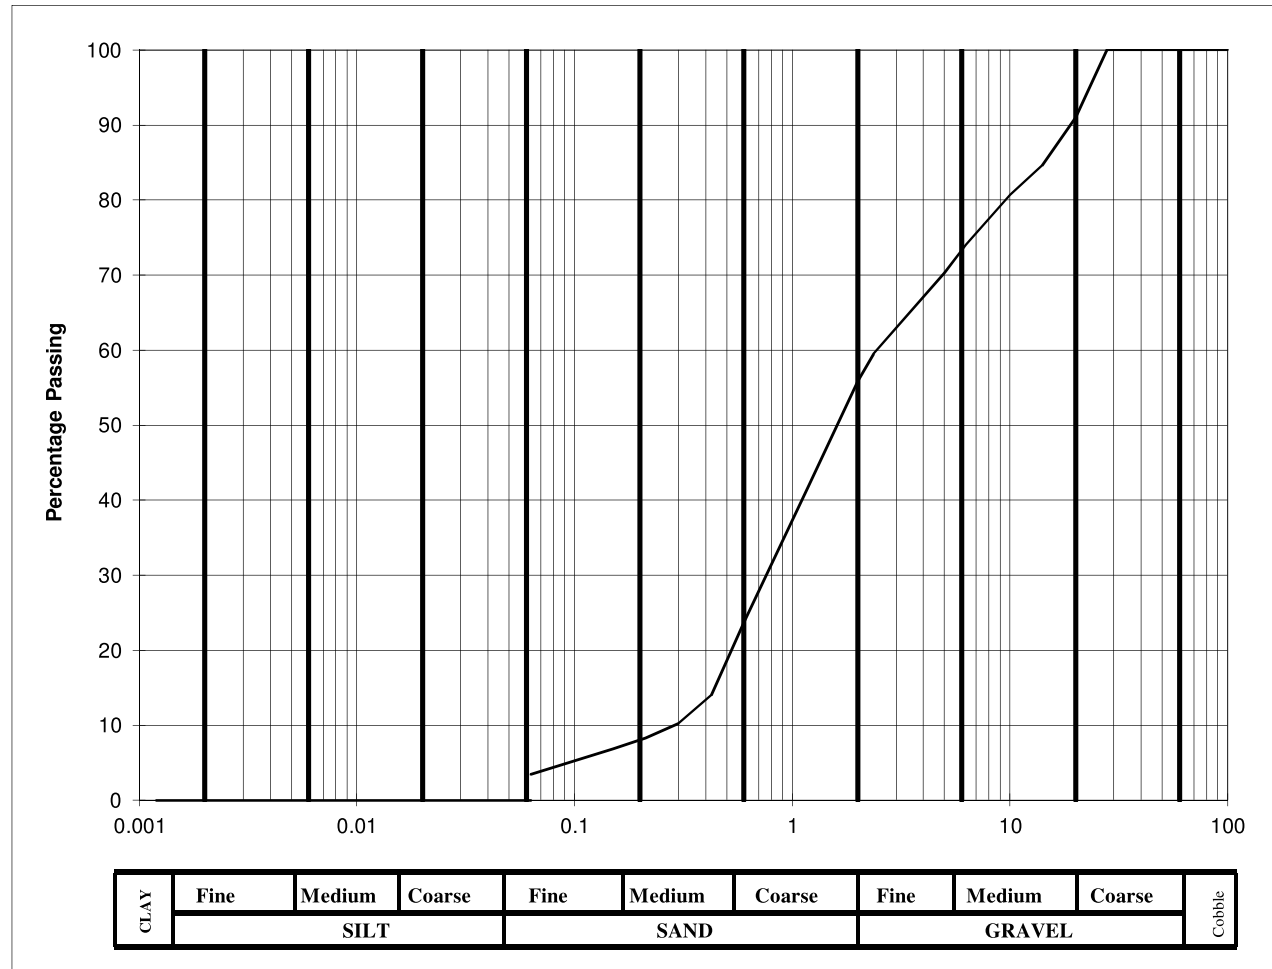
Lab. No :	17/1195
Sample No :	MK09

BS Sieve size, mm	Percent passing	Hydrometer analysis	
		Diameter, mm	% passing
100	100	0.0630	
90	100	0.0200	
75	100	0.0060	
63	100	0.0020	
50	100		
37.5	100		
28	100		
20	91		
14	84.6		
10	80.7		
6.3	74		
5.0	70.3		
2.36	59.5		
2.00	55.9		
1.18	41.8		
0.600	23.7		
0.425	14		
0.300	10.3		
0.212	8.3		
0.150	6.9		
0.063	4

Cobbles, %	0
Gravel, %	44
Sand, %	52
Clay / Silt, %	4

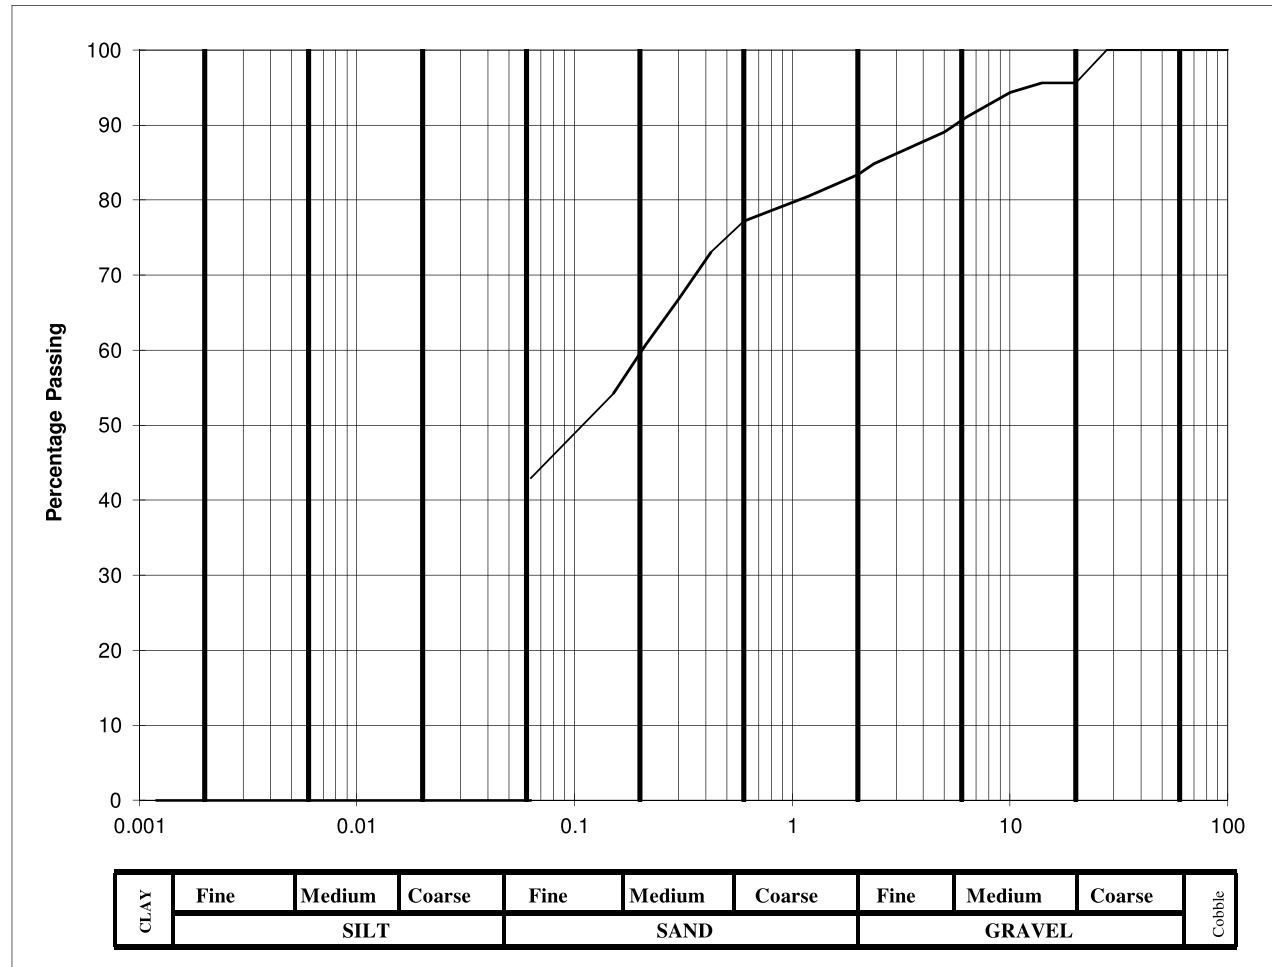
Lab. No :	17/1196
Sample No :	MK13

BS Sieve size, mm	Percent passing	Hydrometer analysis	
		Diameter, mm	% passing
100	100	0.0630	
90	100	0.0200	
75	100	0.0060	
63	100	0.0020	
50	100		
37.5	100		
28	100		
20	95.6		
14	95.6		
10	94.3		
6.3	91		
5.0	89.1		
2.36	84.8		
2.00	83.4		
1.18	80.5		
0.600	77.2		
0.425	73.1		
0.300	66.8		
0.212	60.7		
0.150	54.2		
0.063	43

Cobbles, %	0
Gravel, %	17
Sand, %	40
Clay / Silt, %	43

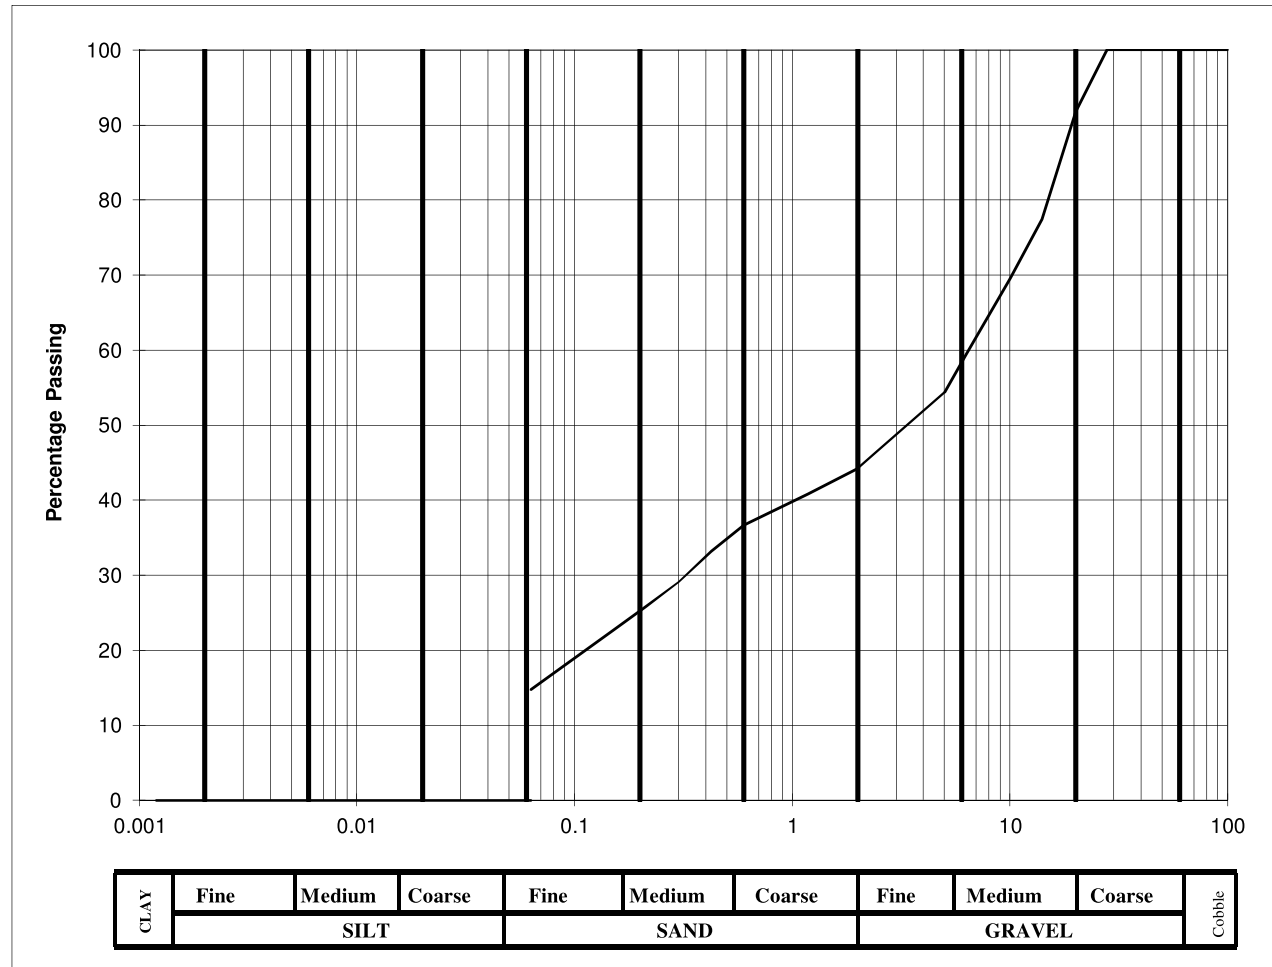
Lab. No :	17/1198
Sample No :	MK15

BS Sieve size, mm	Percent passing	Hydrometer analysis	
		Diameter, mm	% passing
100	100	0.0630	
90	100	0.0200	
75	100	0.0060	
63	100	0.0020	
50	100		
37.5	100		
28	100		
20	91.8		
14	77.4		
10	69.5		
6.3	59.4		
5.0	54.3		
2.36	46.1		
2.00	44.2		
1.18	40.8		
0.600	36.7		
0.425	33.2		
0.300	29.1		
0.212	25.8		
0.150	22.7		
0.063	15

Cobbles, %	0
Gravel, %	56
Sand, %	29
Clay / Silt, %	15

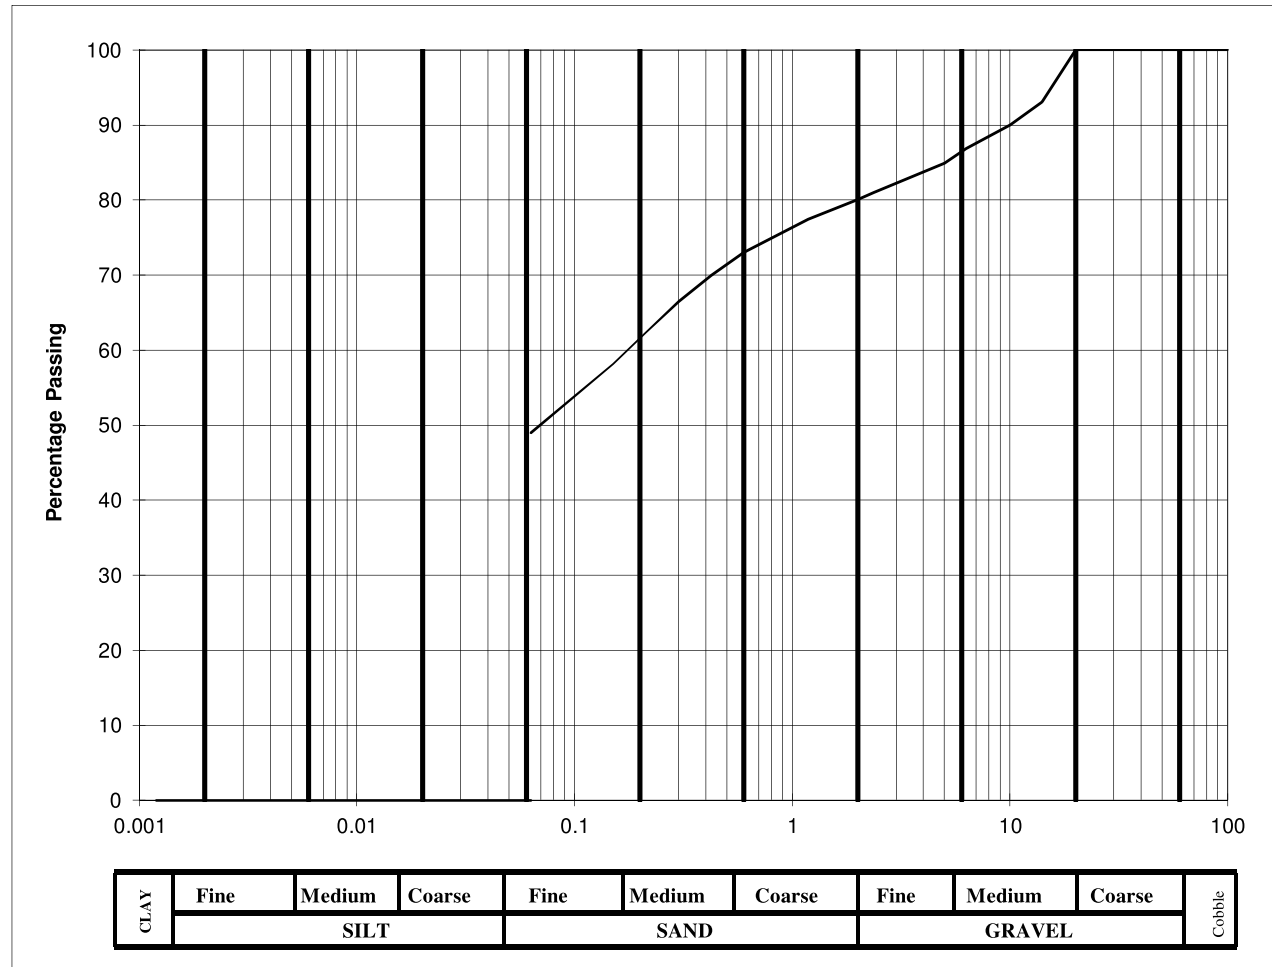
Lab. No :	17/1201
Sample No :	PM24

BS Sieve size, mm	Percent passing	Hydrometer analysis	
		Diameter, mm	% passing
100	100	0.0630	
90	100	0.0200	
75	100	0.0060	
63	100	0.0020	
50	100		
37.5	100		
28	100		
20	100		
14	93.1		
10	90		
6.3	86.9		
5.0	84.9		
2.36	81		
2.00	80.1		
1.18	77.4		
0.600	73		
0.425	70		
0.300	66.5		
0.212	62.3		
0.150	58.2		
0.063	49

Cobbles, %	0
Gravel, %	20
Sand, %	31
Clay / Silt, %	49

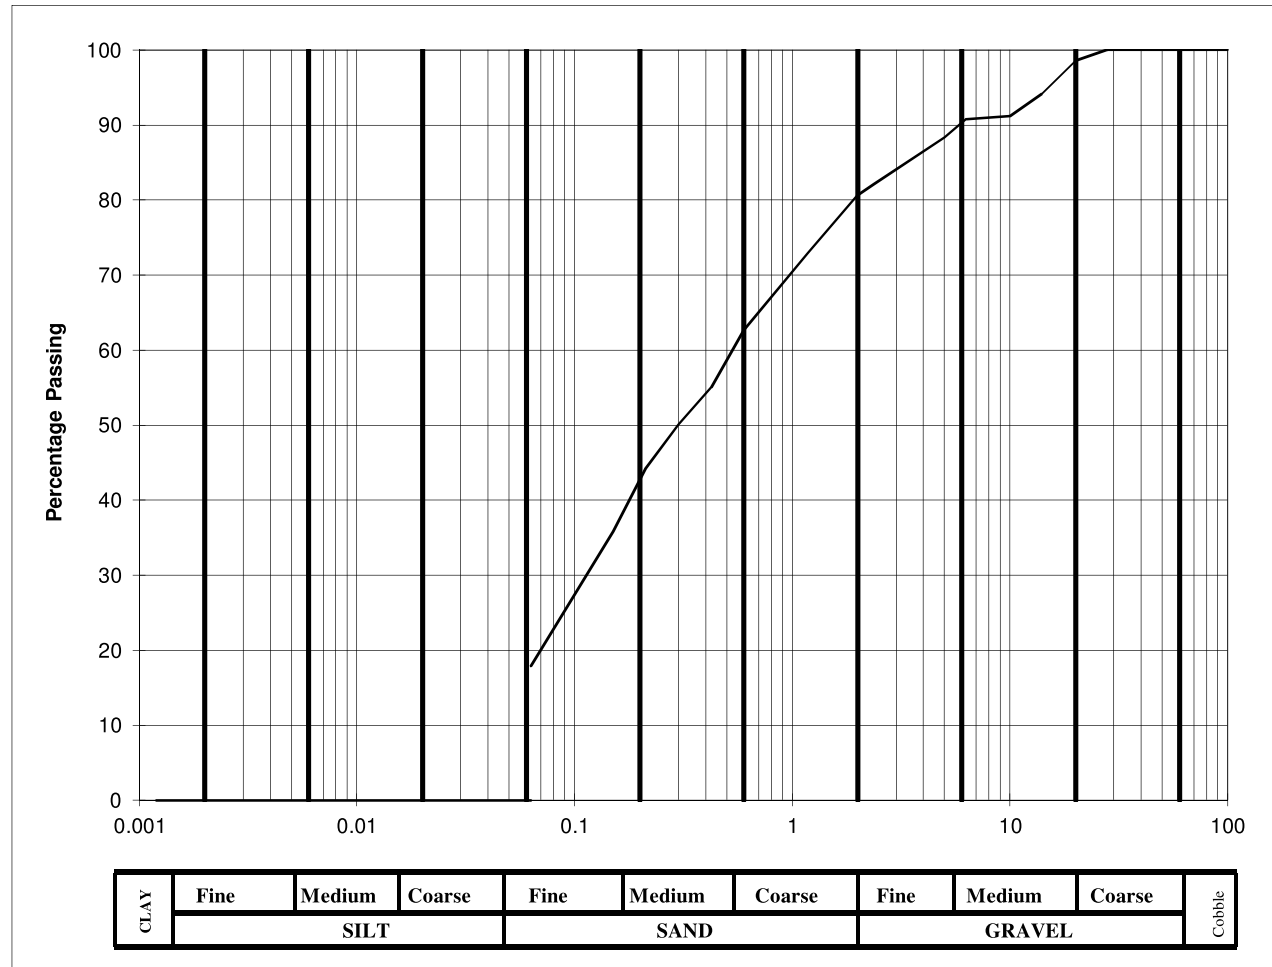
Lab. No :	17/1205
Sample No :	PM14

BS Sieve size, mm	Percent passing	Hydrometer analysis	
		Diameter, mm	% passing
100	100	0.0630	
90	100	0.0200	
75	100	0.0060	
63	100	0.0020	
50	100		
37.5	100		
28	100		
20	98.6		
14	94.2		
10	91.2		
6.3	90.8		
5.0	88.3		
2.36	82.1		
2.00	80.7		
1.18	72.9		
0.600	62.7		
0.425	55		
0.300	50.1		
0.212	44.2		
0.150	35.8		
0.063	18

Cobbles, %	0
Gravel, %	19
Sand, %	63
Clay / Silt, %	18

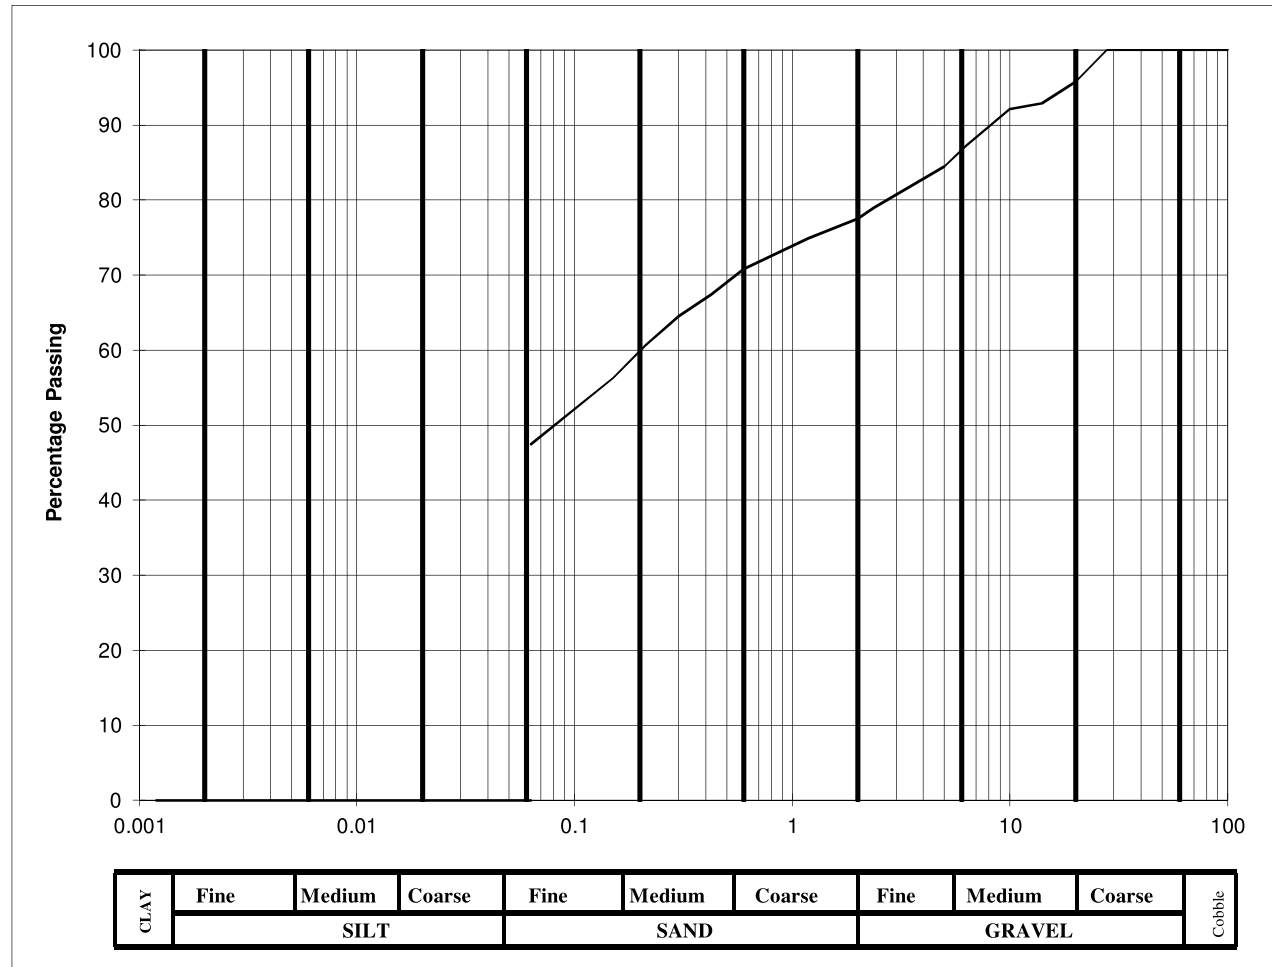
Lab. No :	17/1208
Sample No :	PM29

BS Sieve size, mm	Percent passing	Hydrometer analysis	
		Diameter, mm	% passing
100	100	0.0630	
90	100	0.0200	
75	100	0.0060	
63	100	0.0020	
50	100		
37.5	100		
28	100		
20	95.8		
14	92.9		
10	92.1		
6.3	87.2		
5.0	84.5		
2.36	79		
2.00	77.5		
1.18	74.9		
0.600	70.8		
0.425	67.4		
0.300	64.5		
0.212	60.6		
0.150	56.3		
0.063	48

Cobbles, %	0
Gravel, %	23
Sand, %	30
Clay / Silt, %	48

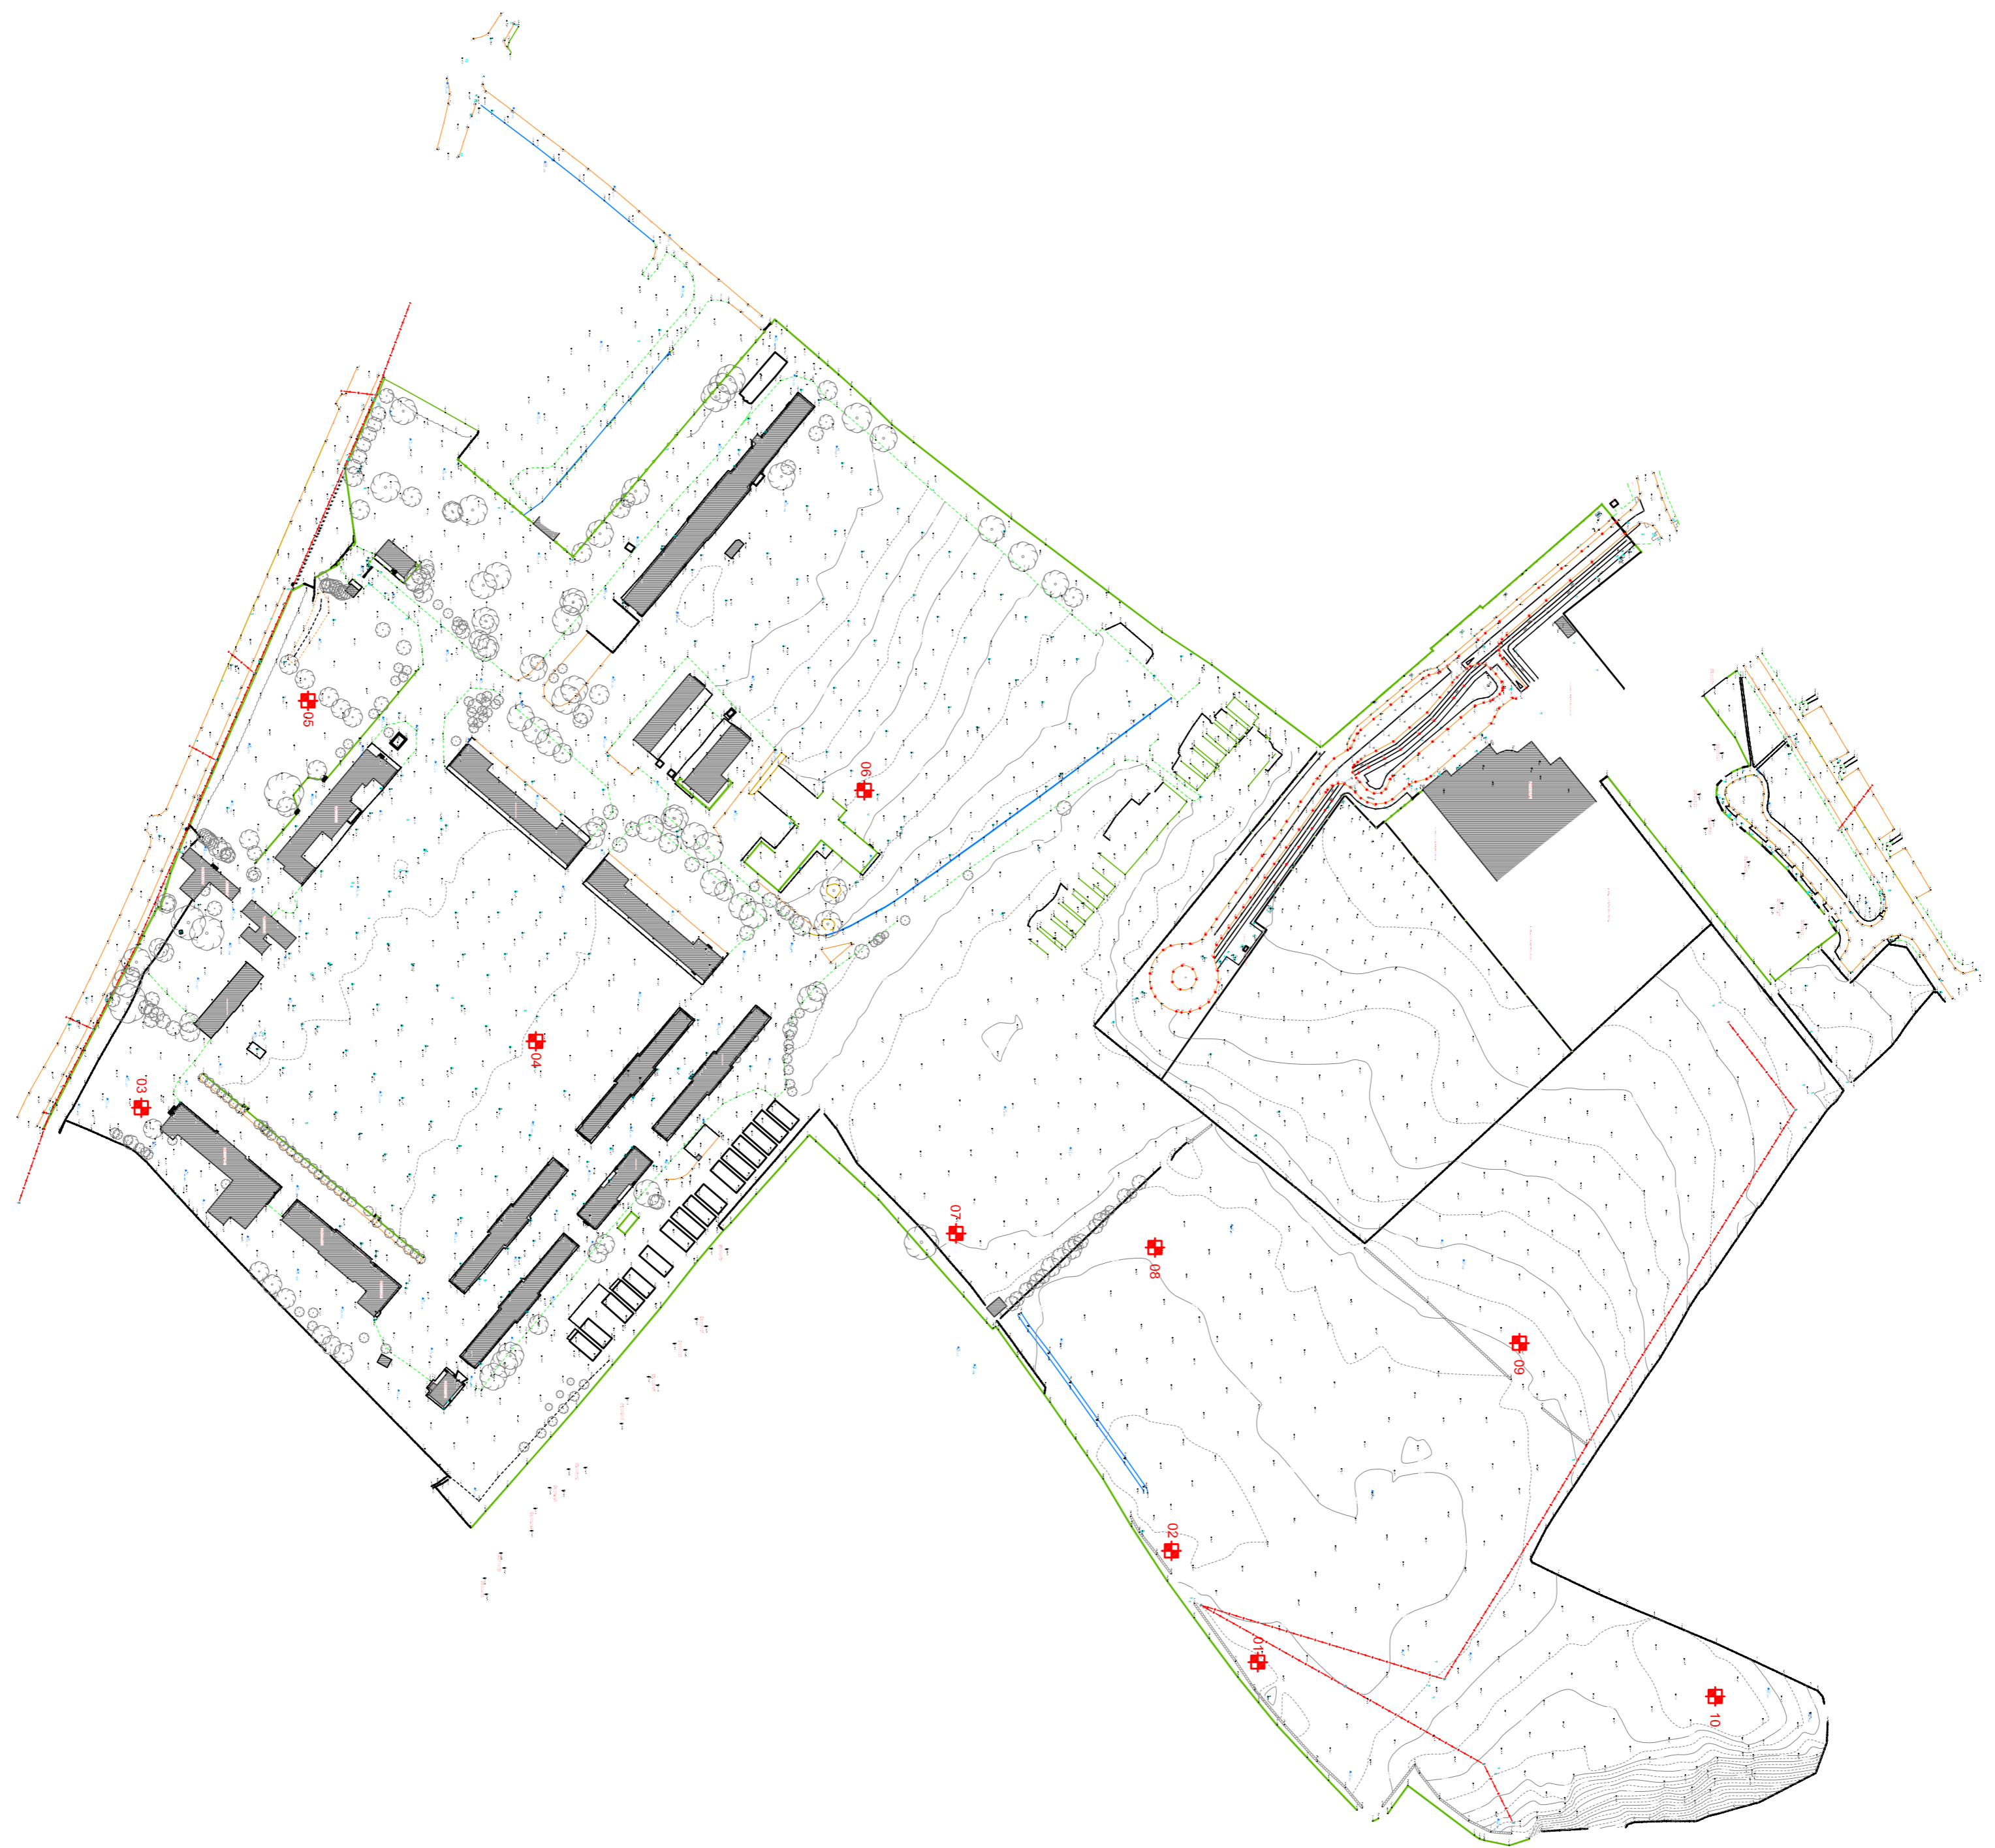
TITLE:
 INFILTRATION TEST LOCATIONS

INFILTRATION TEST No		IRISH TRANSVERSE MERCATOR (ITM)	
TEST No	X VALUE	Y VALUE	
01	6737689	712859	
02	6737224	712524	
03	673544	712106	
04	673517	712286	
05	673379	712174	
06	673416	712399	
07	673595	712436	
08	673601	712517	
09	673640	712885	
10	673783	712744

The soakaway testing was carried out in selected trial pits at the locations shown in the exploratory hole location plan in Appendix 1. These pits were carefully excavated and filled with water to assess the infiltration characteristics of the proposed site. The pits were allowed to drain and the drop in water level was recorded over time as required by BRE Digest 365. The pits were logged prior to completing the soakaway test and were backfilled with arising's upon completion. The soakaway test results are provided in Appendix 4 of this Report.

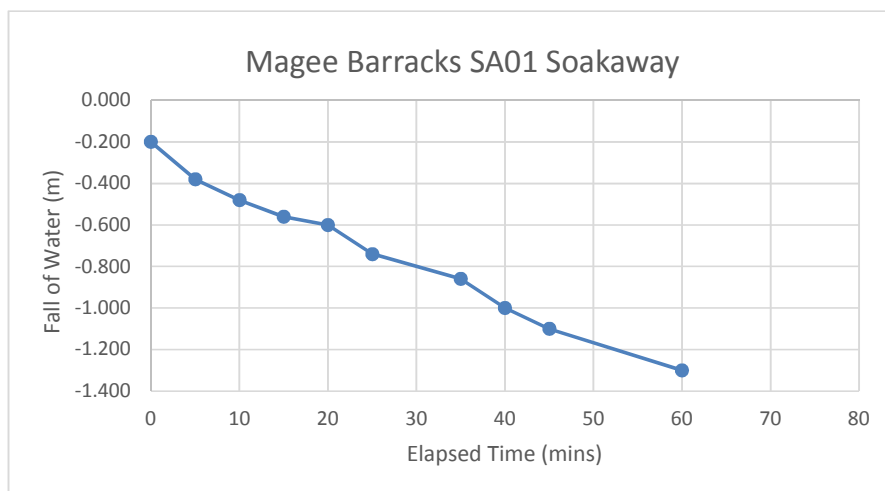
Magee Barracks - Soakaway Tests

f = 0.0000678 m/s

Elapsed Time (mins)	Fall of Water (m)
0	-0.330
8	-0.360
18	-0.380
28	-0.400
43	-0.430
58	-0.470
78	-0.470
108	-0.490
123	-0.490
138	-0.490
153	-0.500
168	-0.500
183	-0.500
198	-0.500
213	-0.500

Infiltration rates of 6.78×10^{-5} , 2.63×10^{-4} , 7.0×10^{-6} , 2.07×10^{-5} and 1.17×10^{-5} m/s respectively were calculated for the soakaway locations SA01, SA03, SA04, SA06 and SA07. SA03 could not be filled completely as water flowed too quickly out of it. At the locations of SA02, SA05, SA08, SA09 and SA10 the water level dropped too slowly to allow calculation of 'f' the soil infiltration rate. These locations are therefore unsuitable for soakaway design and construction.

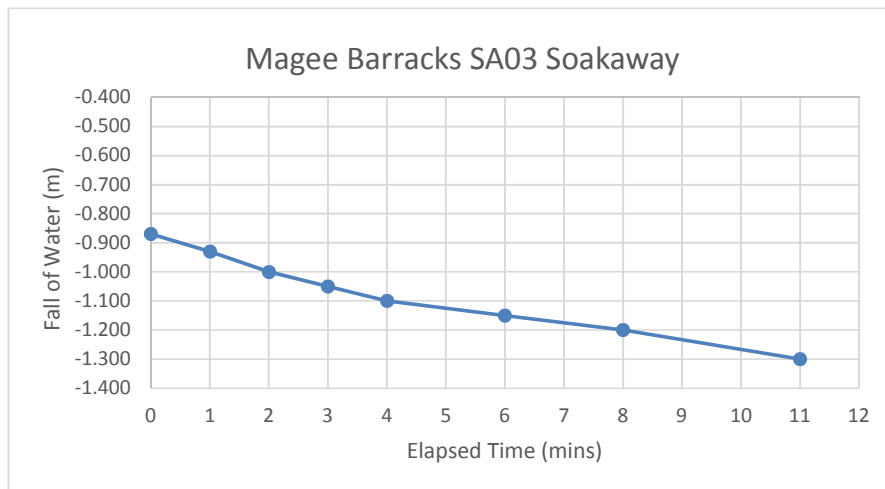
Magee Barracks - Soakaway Tests

f = 0.0002628 m/s

Elapsed Time (mins)	Fall of Water (m)
0	-0.590
20	-0.720
40	-0.850
60	-0.890
80	-0.900
105	-1.000
120	-1.080
140	-1.120
150	-1.160
170	-1.200
190	-1.230
200	-1.260
210	-1.270
220	-1.270
250	-1.290
300	-1.320
340	-1.350
