8.0 LAND AND SOILS

8.1 INTRODUCTION

This chapter of the EIAR assesses the impact on the geological environment of the proposed development. The objectives are to provide a review of baseline geological conditions across the footprint of the site, to assess the potential impact of the proposed development on the underlying soils and geology and to provide appropriate mitigation measures for any identified potential impacts, if deemed necessary.

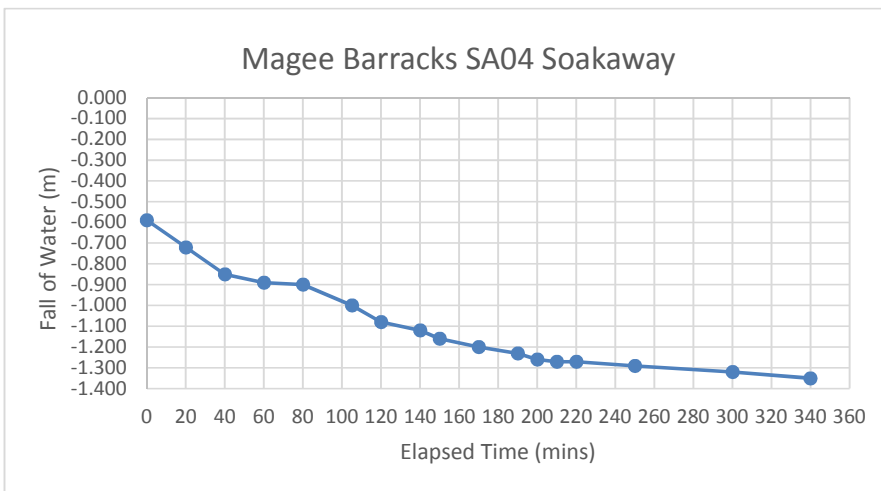
Magee Barracks - Soakaway Tests

f = 0.0000070 m/s

Elapsed Time (mins)	Fall of Water (m)
0	-0.700
5	-0.740
10	-0.780
15	-0.800
20	-0.830
35	-0.860
55	-0.870
80	-0.910
95	-0.960
105	-0.980
125	-1.010
145	-1.050
180	-1.060
195	-1.080
220	-1.080
235	-1.080

Infiltration rates of 6.78×10^{-5} , 2.63×10^{-4} , 7.0×10^{-6} , 2.07×10^{-5} and 1.17×10^{-5} m/s respectively were calculated for the soakaway locations SA01, SA03, SA04, SA06 and SA07. SA03 could not be filled completely as water flowed too quickly out of it. At the locations of SA02, SA05, SA08, SA09 and SA10 the water level dropped too slowly to allow calculation of 'f' the soil infiltration rate. These locations are therefore unsuitable for soakaway design and construction.
