## Chapter 15

## Architectural Heritage

This chapter assesses the potential impact on architectural heritage of the proposed Dursey Island Cable Car and Visitor Centre. The history of the proposed development location is summarised and the historic buildings and other structures in the vicinity are identified and described. Where it is assessed that there could be a significant impact, mitigation measures are proposed.

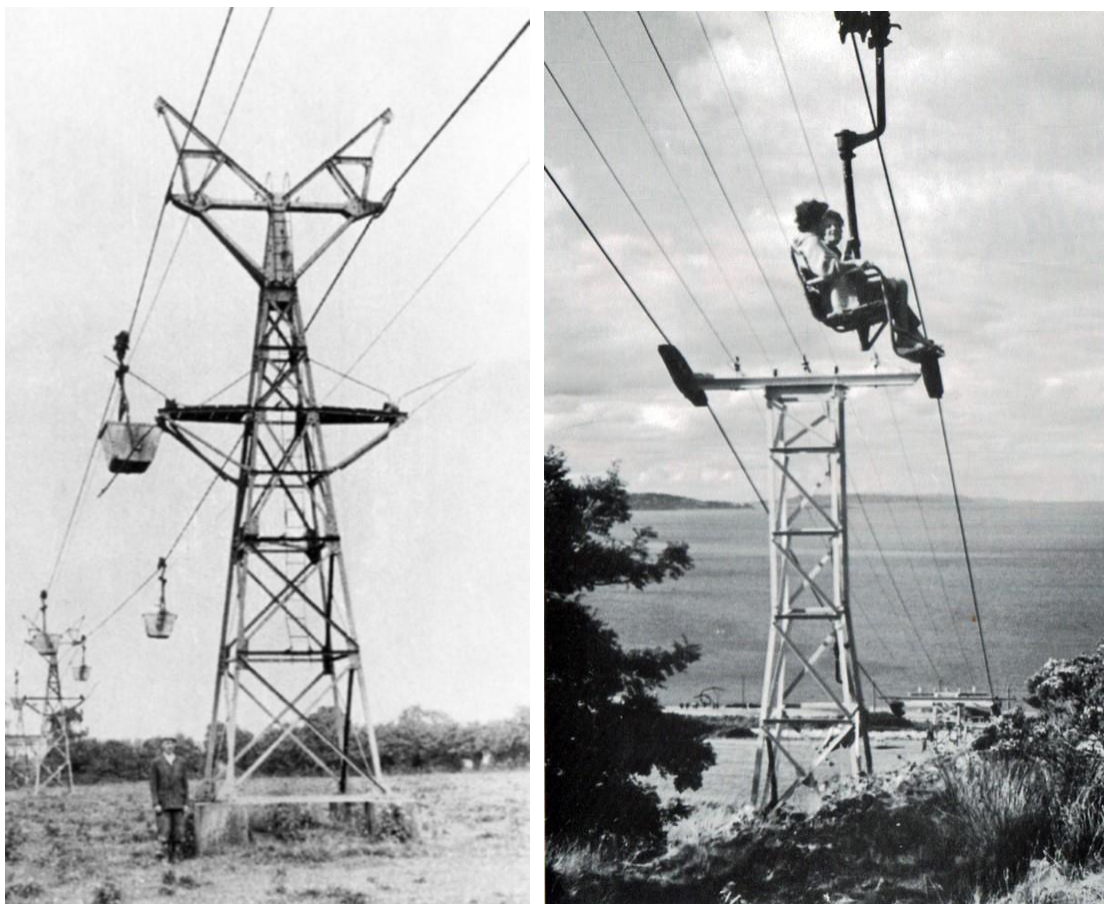
**Plate 15.1      The Drogheda Aerial Ropeway (left) and Bray Head Chair Lift (right).**

There have been other facilities of similar nature in this country, including the cement aerial ropeway outside Drogheda, which operated between 1938 and 1958, transporting limestone from quarries to a cement factory. Additionally, a chair lift operated in Bray between 1950 and 1970, bringing visitors from the seafront to the Eagle's Nest Hotel, high on the slopes of Bray Head. The Dursey Island Cable Car was the first true cable car in the country and was opened by the Taoiseach, Jack Lynch, in December 1969. It was constructed by British Chairlifts Ltd.

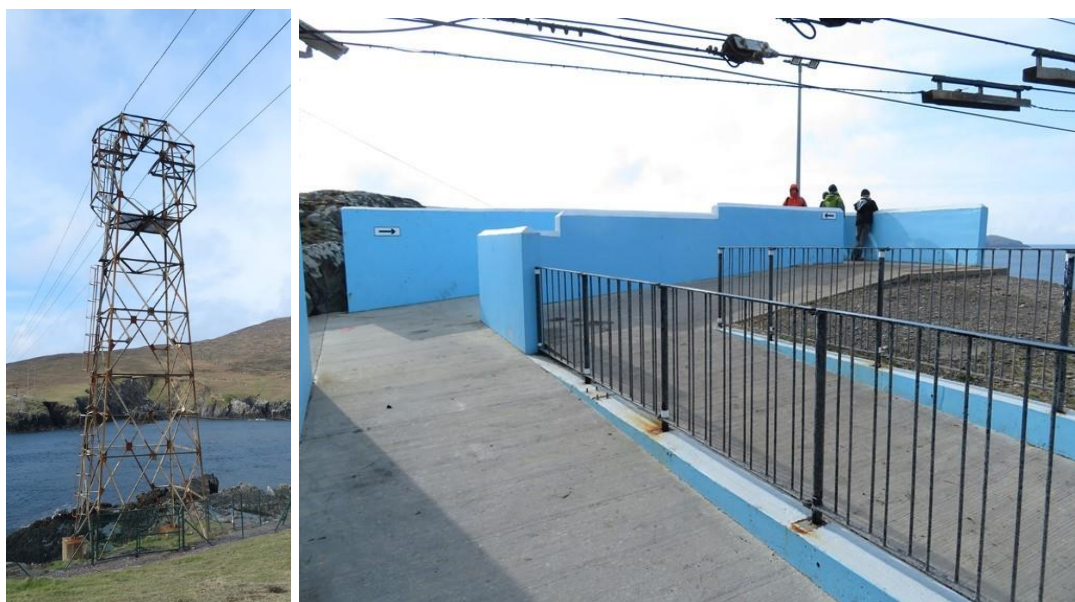
The supporting line structures (pylons) consist of lattice steelwork. Each has a frame ('eye') at the top through which the cabin passes.

On the mainland, there is a concrete landing platform, bounded by concrete walls and approached via concrete ramps bounded by steel railings. The concrete walls are painted. The platform serves as a waiting area and boarding/embarking area for those using the cable car.

**Plate 15.2** Mainland-side pylon (left) and landing platform (right).

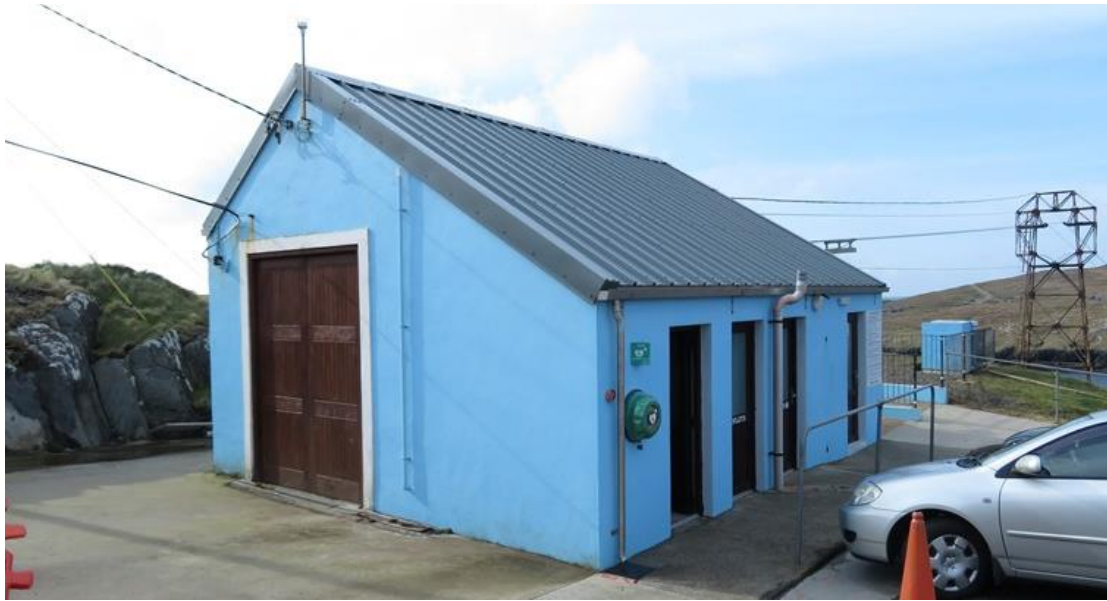
The line station building on the mainland (Plate 15.3) provides office space for staff, along with a ticket office, and it also houses the machinery that operates the cableway. This building is constructed with concrete, is painted and has a roof of profiled steel.

**Plate 15.3 Mainland-side line station building**

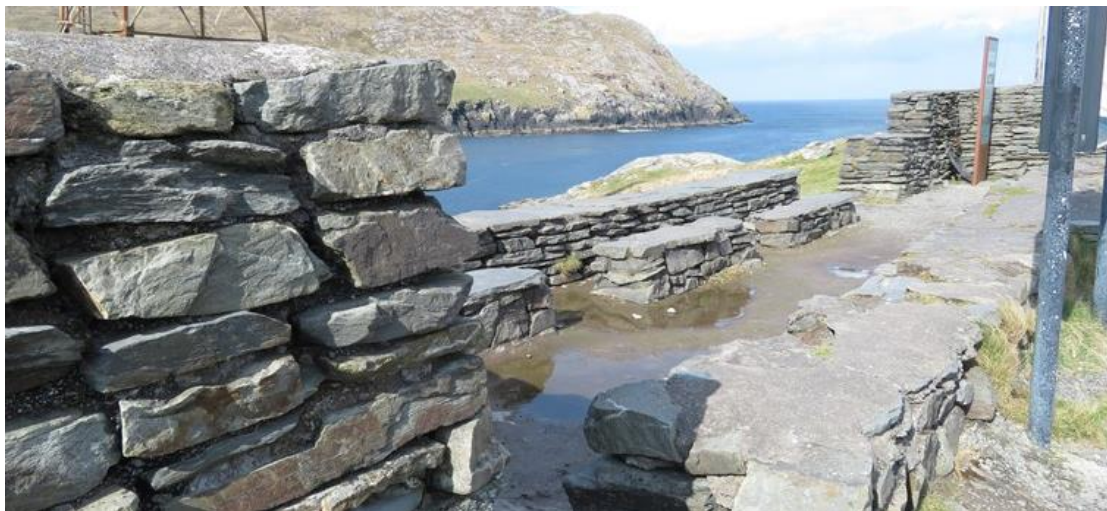
The existing cable car site is approached via an access road that branches off the R572 regional road. At the mainland side of the site, the roadway broadens to become an informal car park. On the seaward side of the mainland site, there is a group of stone-faced walls and benches (Plate 15.4) that allow visitors to sit and watch the cable car and take in the view.

**Plate 15.4 Stone walls and benches on the mainland side of the site**

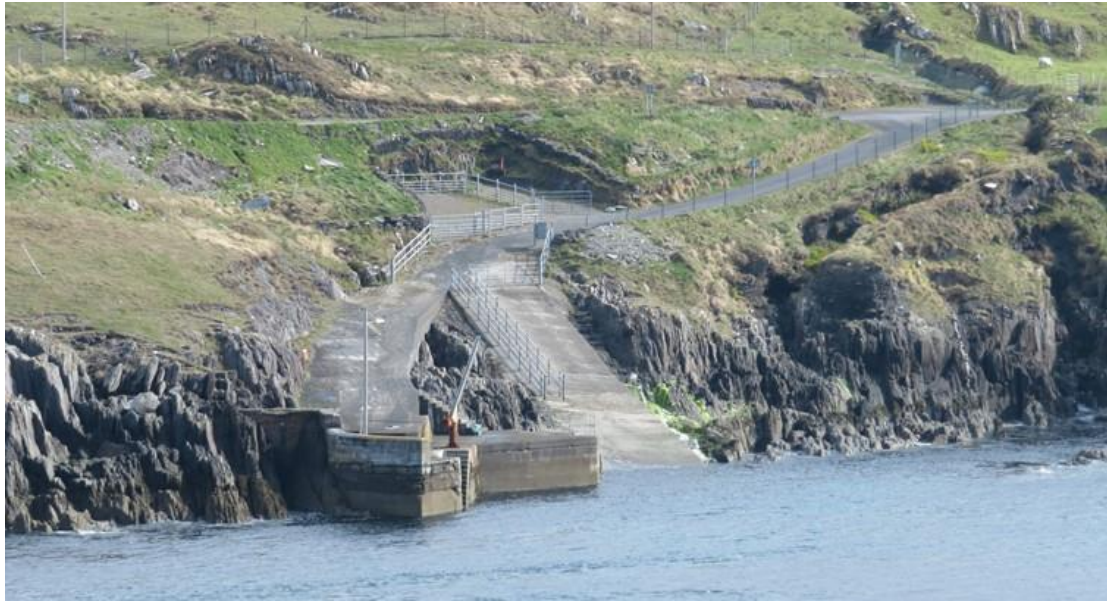
South-east of the cable car is a slipway (Plate 15.5). This consists of a concrete ramp that descends into the sea, alongside which a roadway runs down to a concrete quay to allow boats to tie up.

**Plate 15.5 Mainland-side slipway**

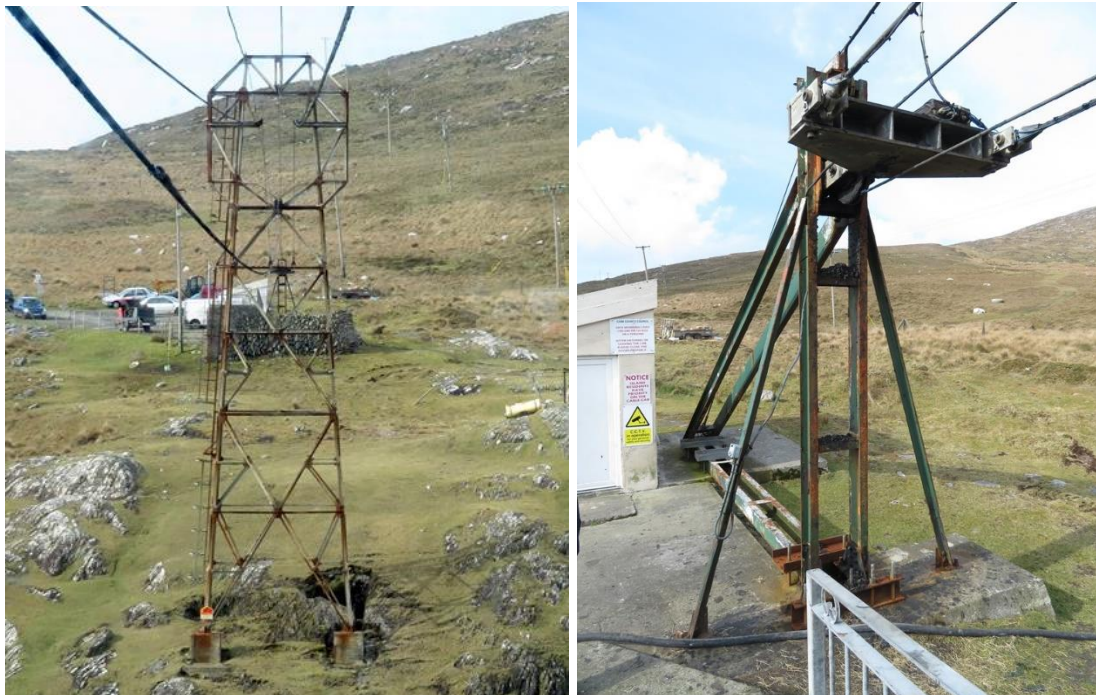
The supporting line structure (pylon) on Dursey Island (Plate 15.6) is similar to that on the mainland, also being constructed of lattice steel. Both pylons have their seaward legs encased in concrete to provide a platform of similar height to the ground on which the rear legs stand.

The ropeway cables are attached to an anchor point fabricated with steel I-beams in a triangular arrangement, for strength. This is fixed to a concrete platform. As noted above, the cables run around pulley wheels on this anchor point.

**Plate 15.6 Island-side pylon (left) and anchor point (right).**

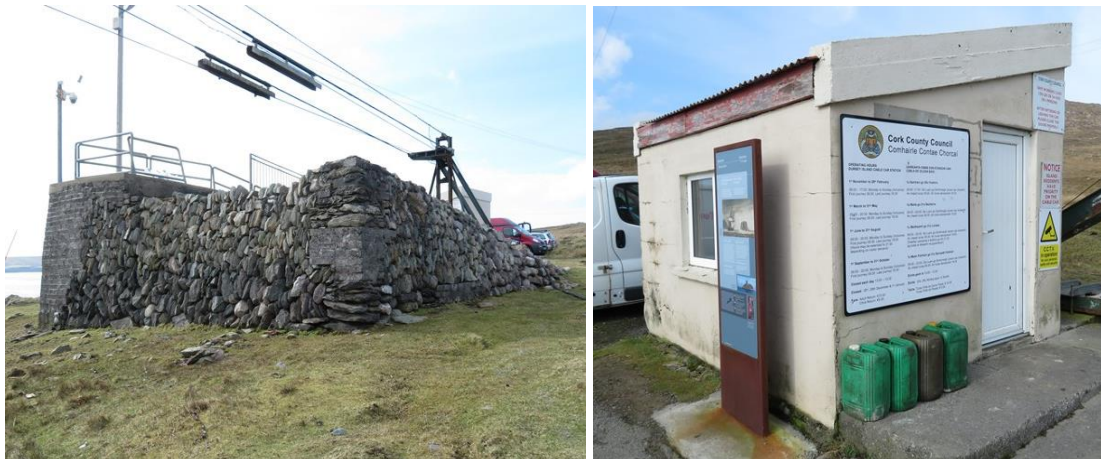
The landing platform on Dursey Island is in the form of a ramp rising from the ground level at the rear. On either side and on the downhill end the ramp is partly faced with

dry-stone walling, with the stones generally set vertically, while parts of the ramp have been repaired with concrete blockwork, chiefly at the corners. The upper surface of the ramp is grassed. Passengers disembark onto a concrete platform adjacent to the ramp and this is guarded with tubular-steel railings.

At the landward end of the ramp there is a small line station building constructed of concrete and with a corrugated-steel roof.

**Plate 15.7** Island-side landing platform (left) and line station building (right).

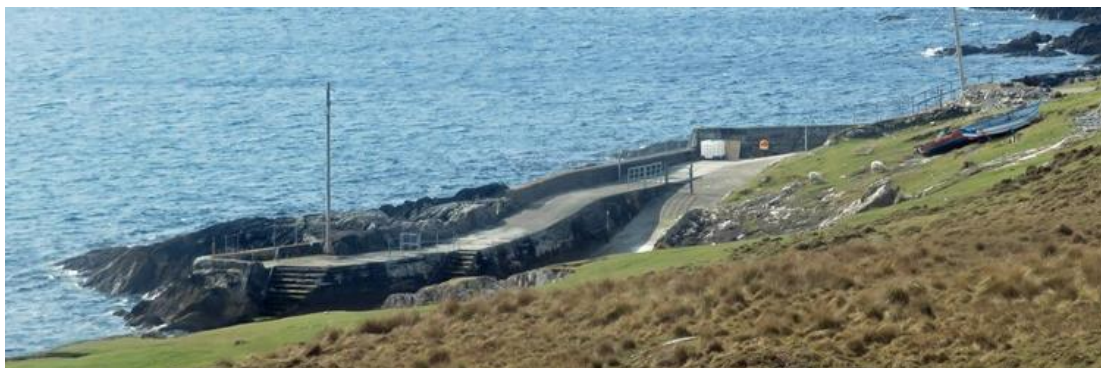
A slipway is located to the south-west of the cable car on Dursey Island. The slipways on the mainland and the island allow for the movement of goods by boat, including goods that cannot be transported in the cable car, such as cars, groceries and building materials. In the past, cattle were transported one-by-one in the cable car but now they are moved by sea between the two slipways.

**Plate 15.8** Island-side slipway

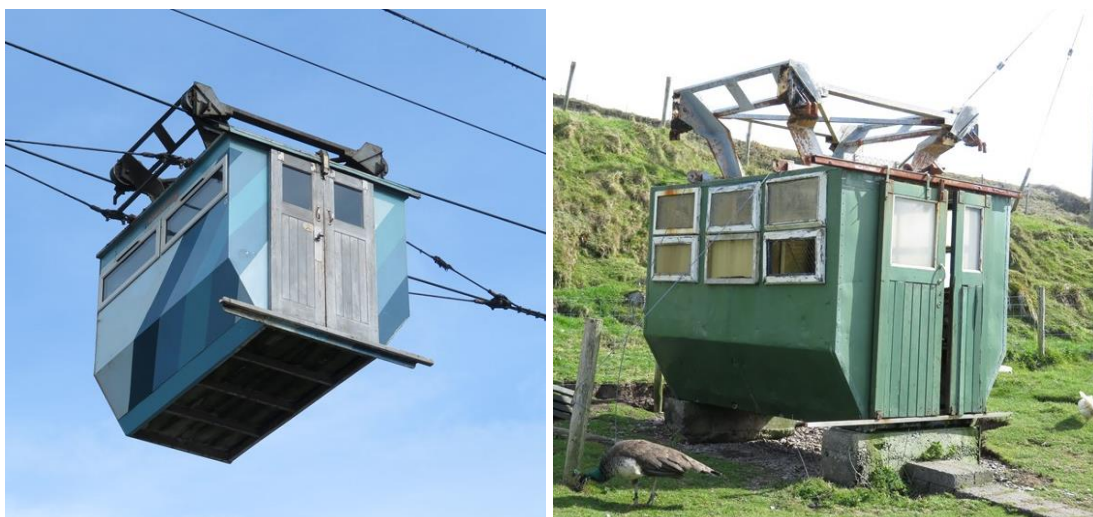
The cable car is a modest-sized structure with sliding doors on one side and with paired horizontal windows facing the two landing platforms. A disused car is situated in a hen run associated with a private residence alongside the road that approaches the site.

**Plate 15.9 Existing cable car (left) and disused cable car (right).**

While the Dursey Island Cable Car is not of significance in comparison with similar projects carried out over a very long period in other parts of the world, it has a significance in being the only cable car in Ireland. In view of this significance it is recommended that the existing cable car and its ancillary facilities be recorded through photographic and written description prior to removal and that an exhibition that

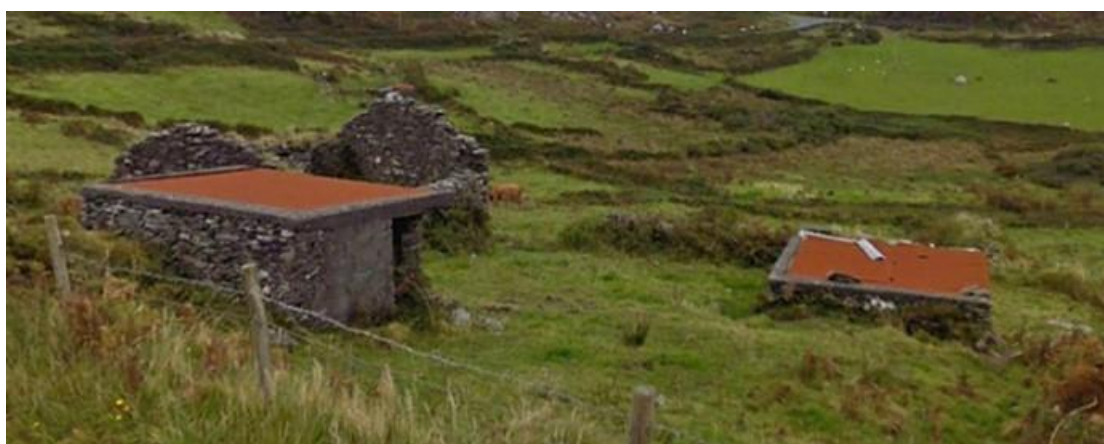
**Plate 15.10 Three buildings at site of easternmost passing bay**

Near to the site of the easternmost passing bay there are three stone-built structures (Plate 15.10). Two are roofed with corrugated iron and appear to be agricultural buildings, while the third is an unroofed ruin, the gables of which suggest a possible house. None of these buildings were shown on the first-edition Ordnance Survey map of 1842, while only the ruined house appears on the 1903 edition. Two of these structures will be demolished in order to facilitate the construction of the proposed

passing bay. These buildings are not of significant architectural heritage importance and, therefore, significant adverse effects will not occur as a result of this element of the proposed works.

It is also recommended that should any of the vernacular structures alongside the R572 be demolished to facilitate the passing bay these should be recorded through photography and written description.

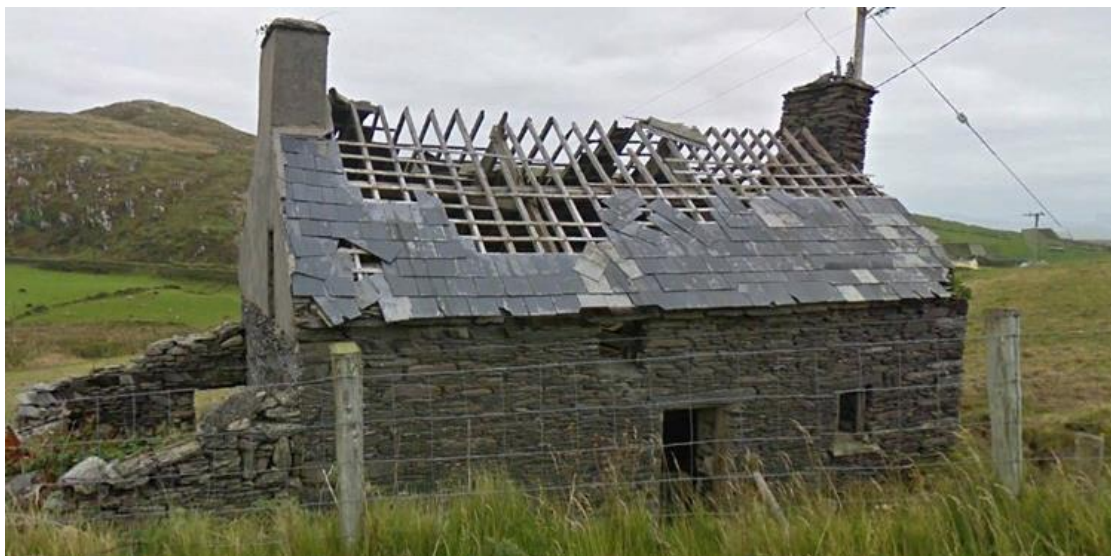
**Plate 15.11** Derelict house at second passing bay from the east

Near to the site of the second proposed passing bay from the east, there is a derelict building that appears to have been a house. This is single storey, though with rooms in the roof space, and there is a ruined outbuilding on the northern gable. The house is slated and gable ended. This house dates from the early twentieth century and was not shown on the Ordnance Survey map of 1903.
