## Chapter 8

## Land and Soils

JOB NAME:  
**Durey Island Cable Car & Visitor Centre Development**

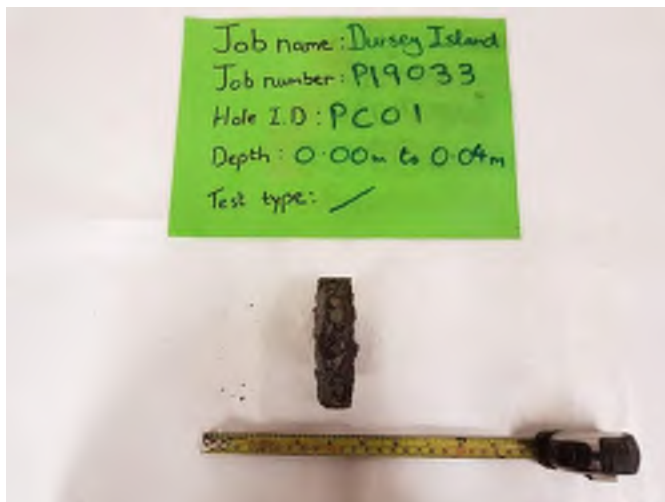
# Pavement Core Photographic Record and Log

Layer No.	Depth		Thickness, mm	Material Description **	Binder	Aggregate	
	From	To				Agg'	Type
1	0.00	0.04	40	Bitumen with crushed rock and gravel. Gravel is varied lithology. Max clast size 20mm.	B	20	CR & G

\*\* Layer descriptions based on assumed function within the pavement structure. Based on visual inspection only.

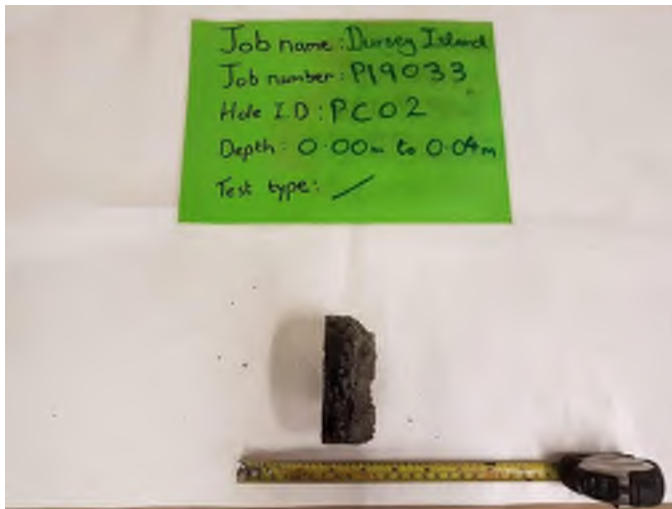
# Pavement Core Photographic Record and Log

Layer No.	Depth		Thickness, mm	Material Description **	Binder	Aggregate	
	From	To				Agg'	Type
1	0.00	0.04	40	Bitumen with gravel. Gravel is varied lithology. Max clast size is 40mm.	B	40	CR

\*\* Layer descriptions based on assumed function within the pavement structure. Based on visual inspection only.

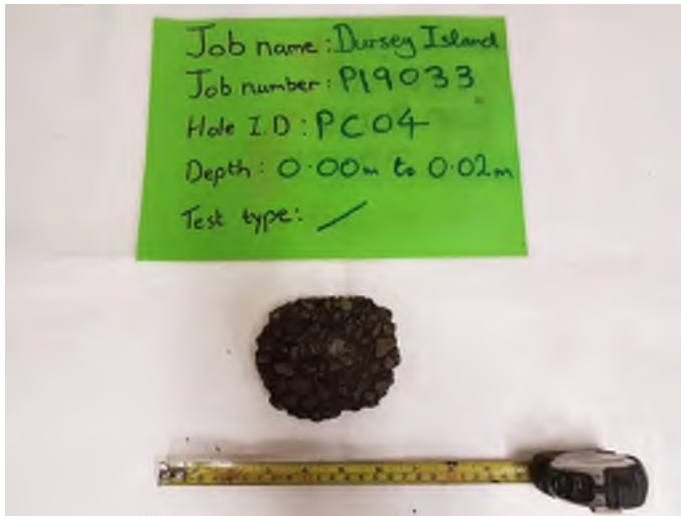
# Pavement Core Photographic Record and Log

Layer No.	Depth		Thickness, mm	Material Description **	Binder	Aggregate	
	From	To				Agg'	Type
1	0.00	0.02	20	Bitumen with gravel. Gravel is varied lithology. Max clast size is 20mm.	B	20	GR

\*\* Layer descriptions based on assumed function within the pavement structure. Based on visual inspection only.

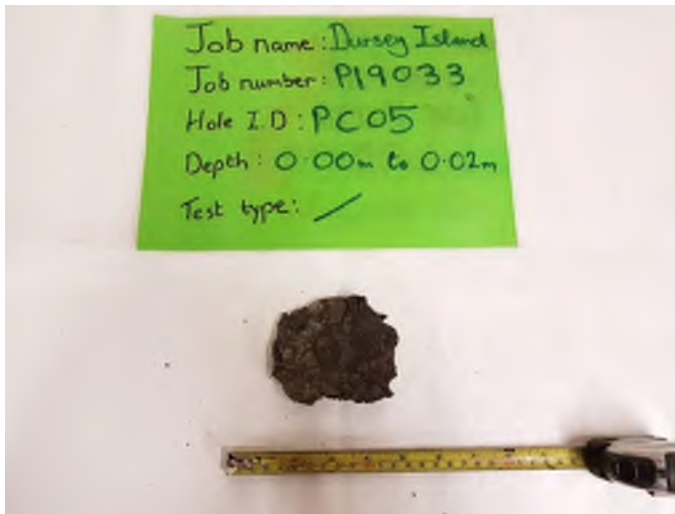
# Pavement Core Photographic Record and Log

Layer No.	Depth		Thickness, mm	Material Description **	Binder	Aggregate	
	From	To				Agg'	Type
1	0.00	0.02	20	Bitumen with gravel. Max clast size is 20mm.	B	20	GR

\*\* Layer descriptions based on assumed function within the pavement structure. Based on visual inspection only.

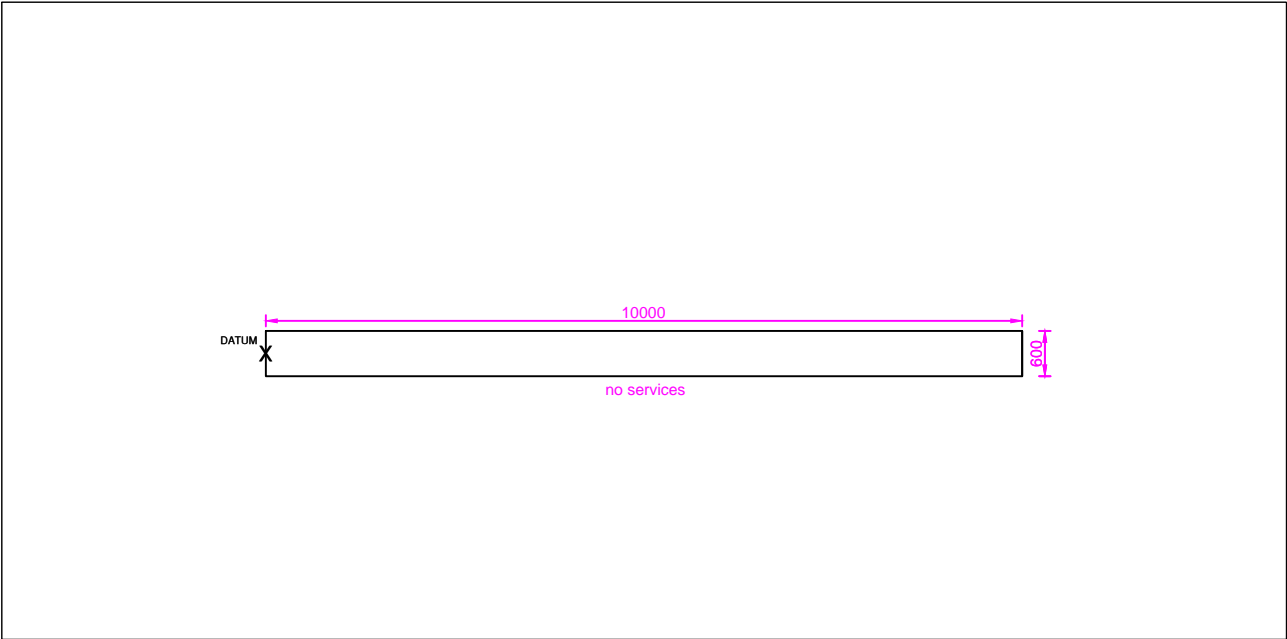
SLIT TRENCH PLAN, 1:100 ON A4

DATUM COORDINATES: EASTING: 50811.8 NORTHING: 41855.3 LEVEL: 20.8mAOD		SLIT TRENCH NUMBER: <b>ST01</b>
KEY: DATUM: X		JOB NAME: Dursey Island Cable Car & Visitor Centre Development
SLIT TRENCH DIMENSIONS: LENGTH: 10.0m WIDTH: 0.60m DEPTH: 1.30m		JOB NUMBER: P19033
STRATA SHOWN ON DETAILED LOG		
DRAWN BY: Gary Curtin	DATE: 17/04/2019	DRAWING NUMBER: P19033-ST01
LOGGED BY: A.O.	DATE: 11/04/2019

**Remarks:** Slit trench terminated at 1.30m bgl. Refer to DWG P19033 ST01 for cross sectional detail.

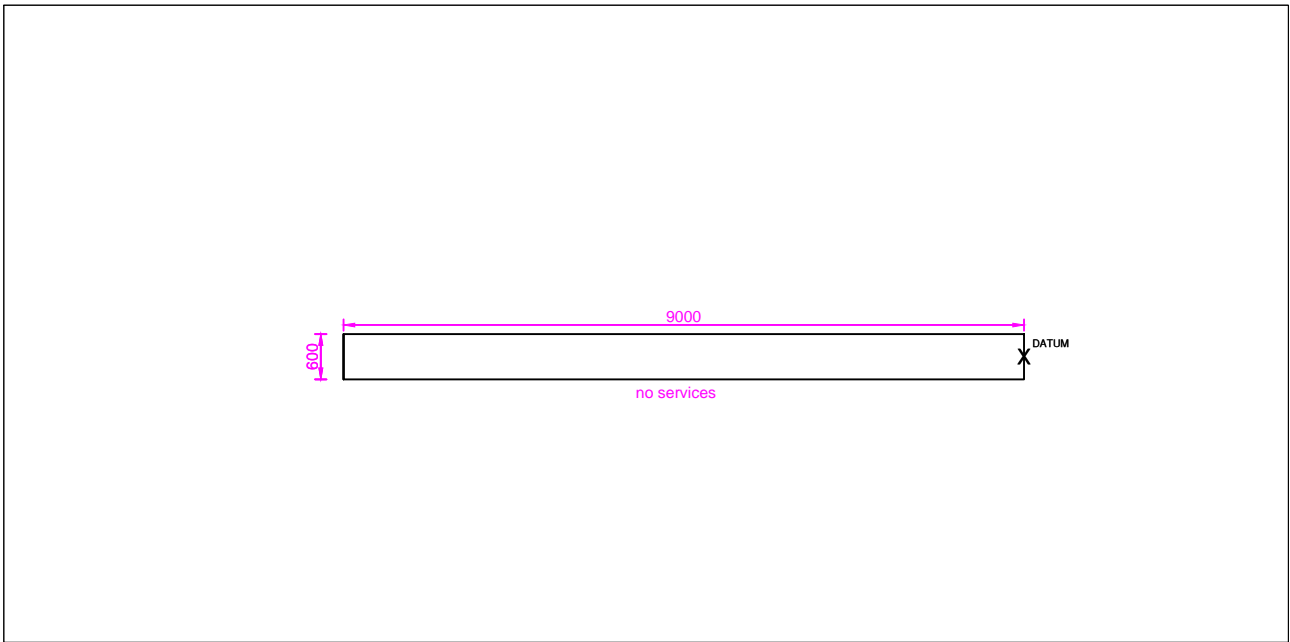
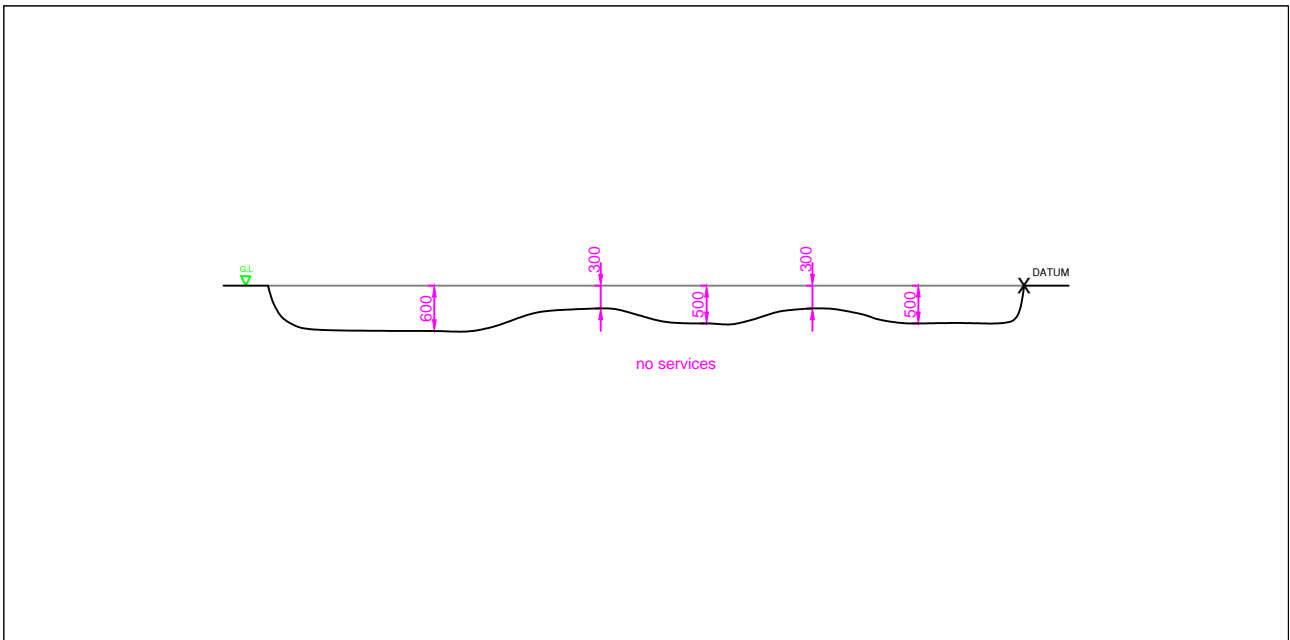
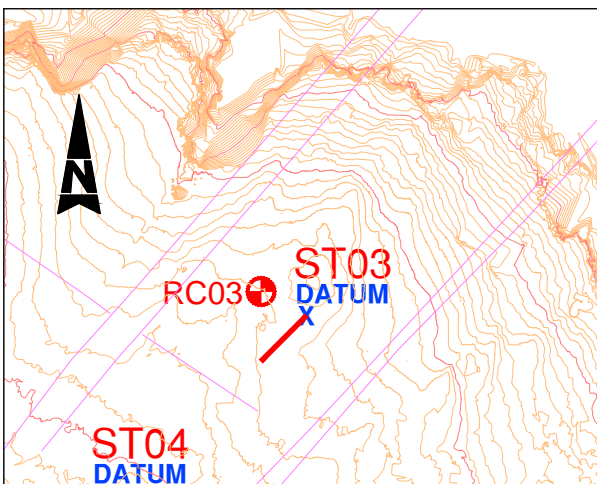
SLIT TRENCH PLAN, 1:100 ON A4

SLIT TRENCH SECTION, 1:100 ON A4

SLIT TRENCH LOCATION PLAN, 1:1000 ON A4

DATUM COORDINATES: EASTING: 50550.0 NORTHING: 41648.3 LEVEL: 17.467mAOD		SLIT TRENCH NUMBER: <b>ST03</b>
KEY: DATUM: X		JOB NAME: Dursey Island Cable Car & Visitor Centre Development
SLIT TRENCH DIMENSIONS: LENGTH: 9.00m WIDTH: 0.60m DEPTH: 0.60m		JOB NUMBER: P19033
STRATA SHOWN ON DETAILED LOG		
DRAWN BY: Gary Curtin	DATE: 17/04/2019	DRAWING NUMBER: P19033-ST03
LOGGED BY: A.O.	DATE: 09/04/2019	
SCALE: AS STATED	APPROVED: GH

**Remarks:** Slit trench terminated at 0.60m bgl. Refer to DWG P19033 ST03 for cross sectional detail.

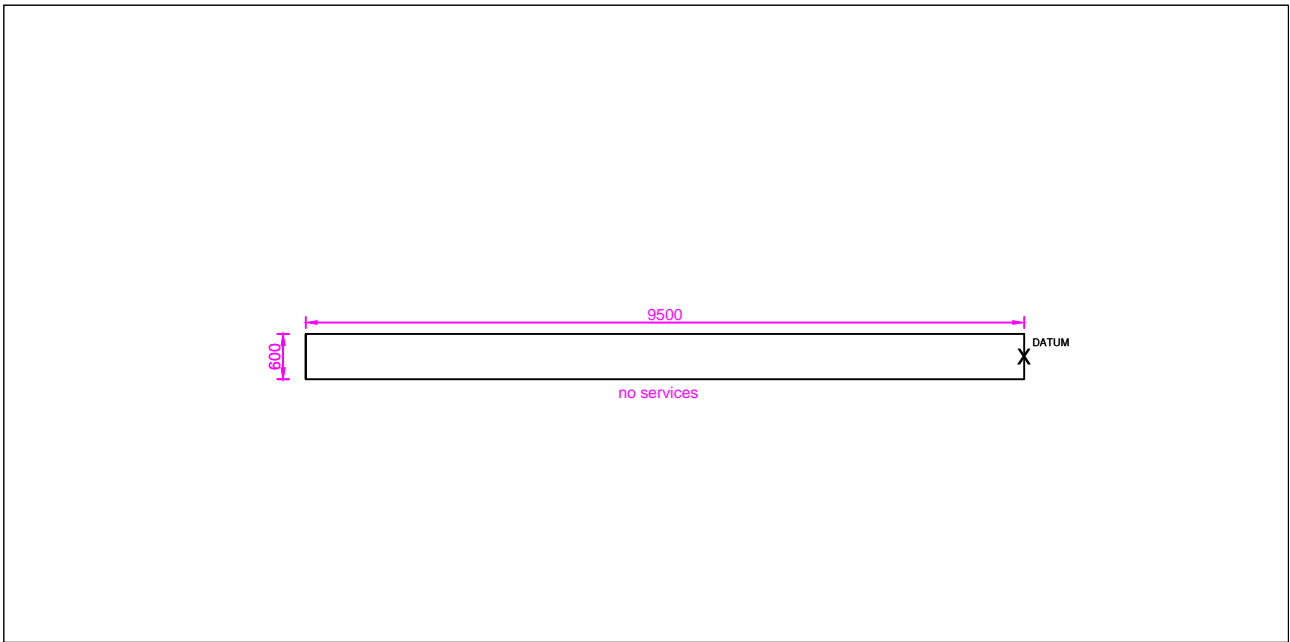
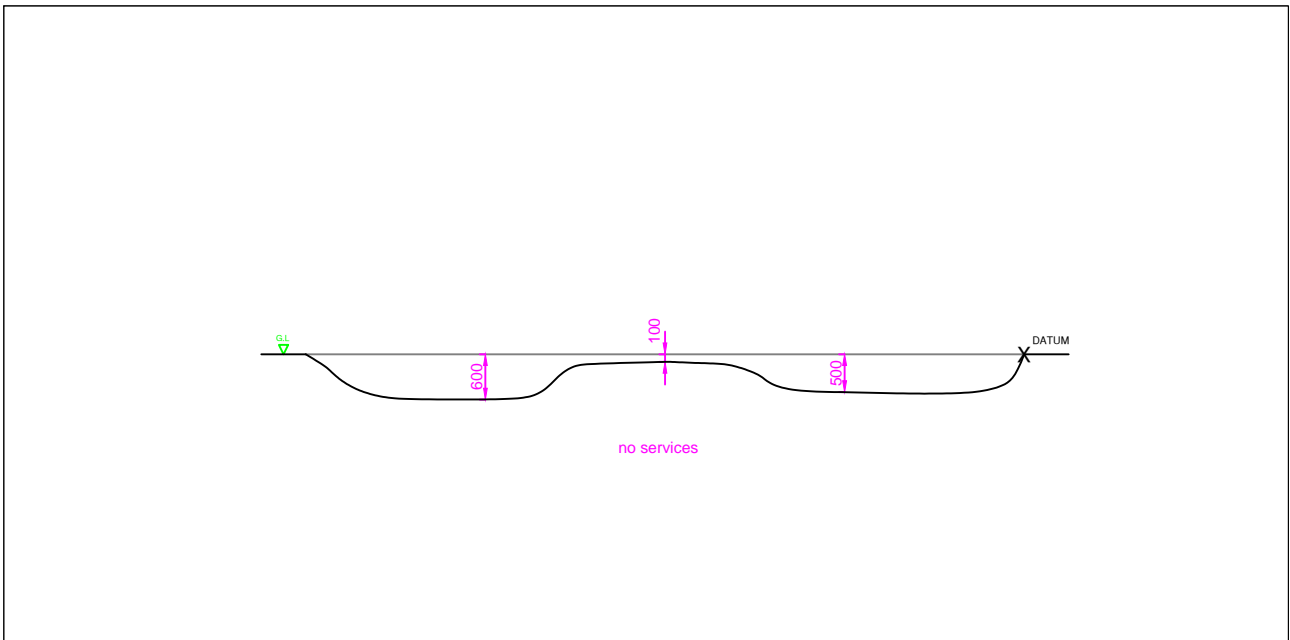
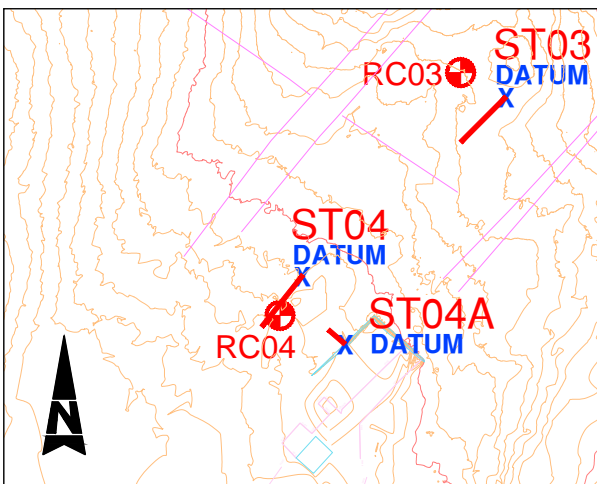
SLIT TRENCH PLAN, 1:100 ON A4

SLIT TRENCH SECTION, 1:100 ON A4

SLIT TRENCH LOCATION PLAN, 1:1000 ON A4

DATUM COORDINATES: EASTING: 50523.1 NORTHING: 41624.6 LEVEL: 20.362mAOD		SLIT TRENCH NUMBER: <b>ST04</b>
KEY: DATUM: X		JOB NAME: Dursey Island Cable Car & Visitor Centre Development
SLIT TRENCH DIMENSIONS: LENGTH: 9.50m WIDTH: 0.60m DEPTH: 1.20m		JOB NUMBER: P19033
STRATA SHOWN ON DETAILED LOG		
DRAWN BY: Gary Curtin	DATE: XX/XX/2019	DRAWING NUMBER: P19033-ST04
LOGGED BY: A.O.	DATE: YY/YY/2019	 
SCALE: AS STATED	APPROVED: GH

**Remarks:** Slit trench terminated at 0.60m bgl. Refer to DWG P19033 ST04 for cross sectional detail.

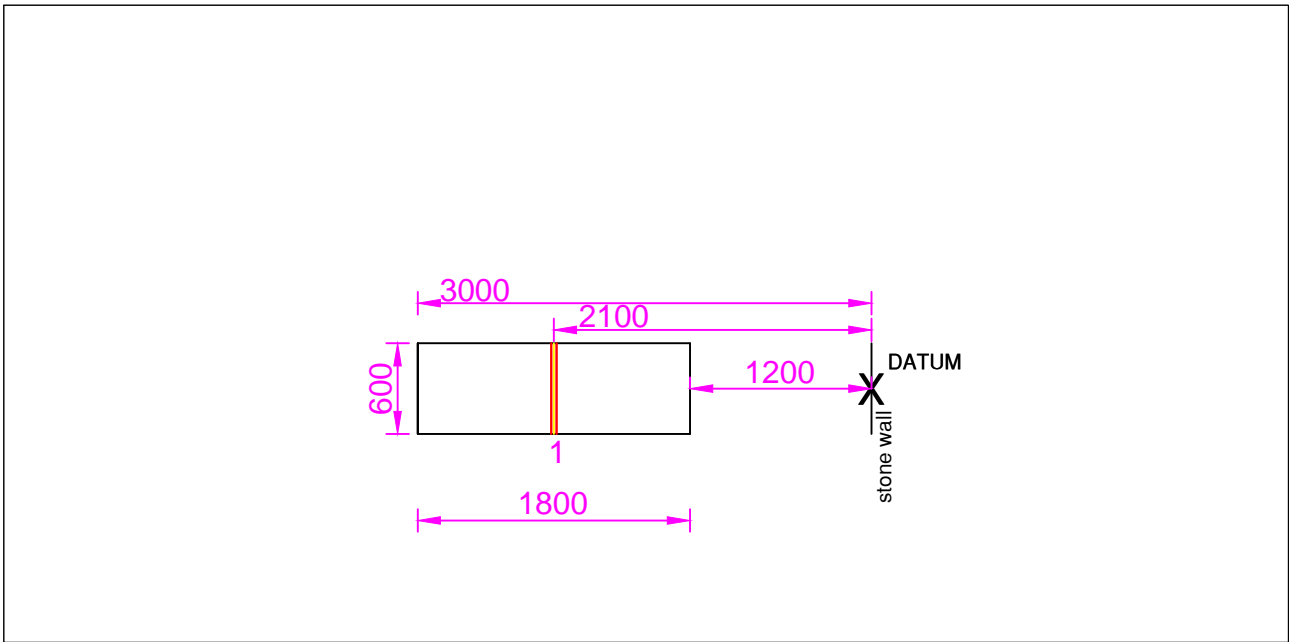
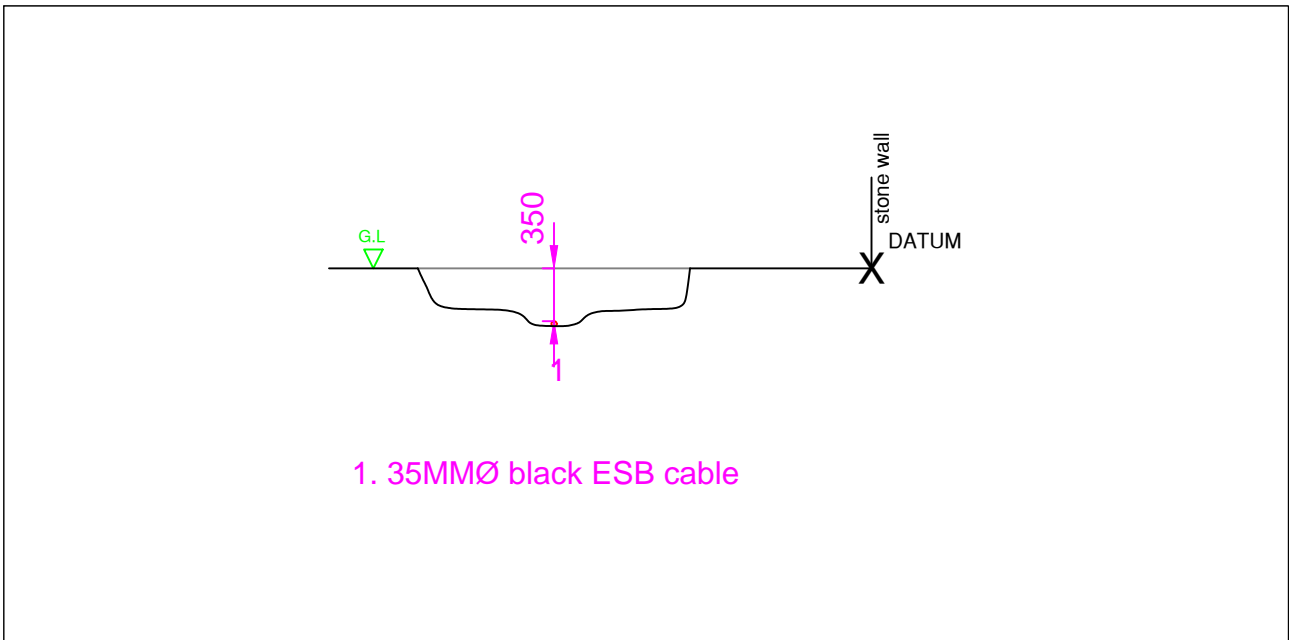
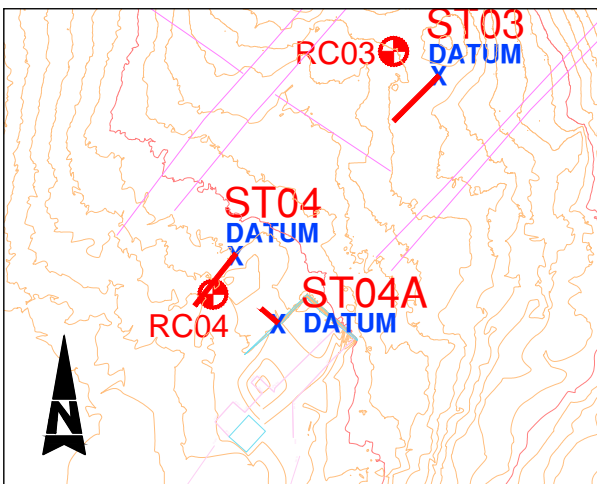
SLIT TRENCH PLAN, 1:100 ON A4

SLIT TRENCH SECTION, 1:100 ON A4

SLIT TRENCH LOCATION PLAN, 1:1000 ON A4

DATUM COORDINATES: EASTING: 50528.7 NORTHING: 41615.6 LEVEL: 20.502mAOD		SLIT TRENCH NUMBER: <b>ST04A</b>
KEY: DATUM: X		JOB NAME: Dursey Island Cable Car & Visitor Centre Development
SLIT TRENCH DIMENSIONS: LENGTH: 1.80m WIDTH: 0.60m DEPTH: 0.35m		JOB NUMBER: P19033
STRATA SHOWN ON DETAILED LOG		
DRAWN BY: Gary Curtin	DATE: 17/04/2019	DRAWING NUMBER: P19033-ST04A
LOGGED BY: A.O.	DATE: 09/04/2019	
SCALE: AS STATED	APPROVED: GH

**Remarks:** Slit trench terminated at 0.40m bgl. Refer to DWG P19033 ST04A for cross sectional detail.

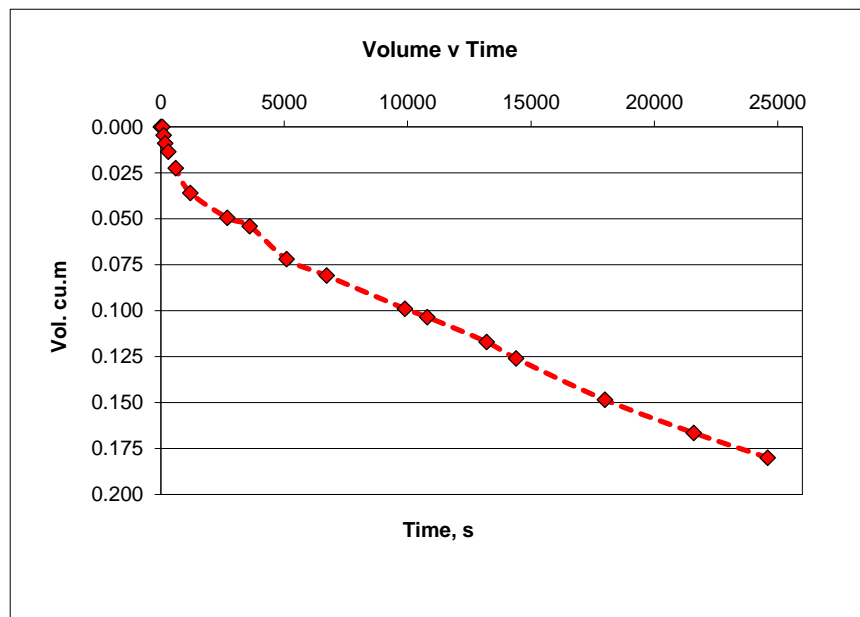
Area 0.45 m<sup>2</sup>  $V_{p75-25 \text{ theory}}$  volume 0.1125 m<sup>3</sup>  
 50% Area\_eff,  $a_{p50}$  1.35 m<sup>2</sup>  $V_{p75-25 \text{ actual}}$  volume 0.18 m<sup>3</sup>  
 50% Area\_act,  $a_{p50}$  1.17 m<sup>2</sup>  $t_{p75-25 \text{ actual}}$  time 13590.00 s

Infiltration Coefficient  $f$  1.13E-05 ms<sup>-1</sup>

See TP01 log for detailed soil description.

No waterstrike encountered. Pit assumed unsaturated.

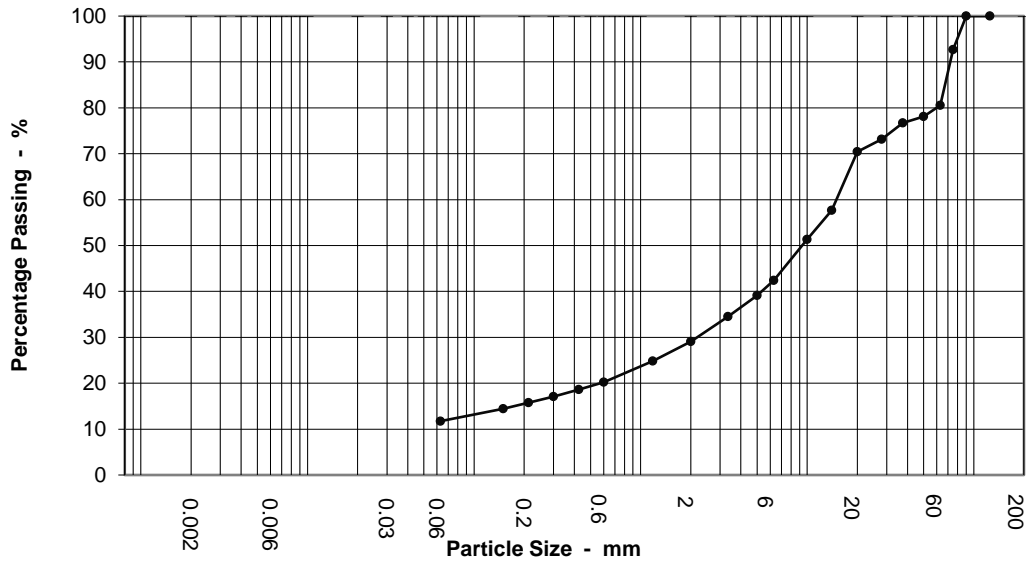
**Soil Description**      **Silty very sandy GRAVEL with medium cobble content**

Sieving		Sedimentation	
Particle Size mm	% Passing	Particle Size mm	% Passing
125	100		
90	100		
75	93		
63	81		
50	78		
37.5	77		
28	73		
20	70		
14	58		
10	51		
6.3	42		
5	39		
3.35	34		
2	29		
1.18	25		
0.6	20		
0.425	19		
0.3	17		
0.212	16		
0.15	14		
0.063	12

Test Method	
BS 1377 : Part 2 : 1990	
Sieving	Clause 9.3
Sedimentation	N/A

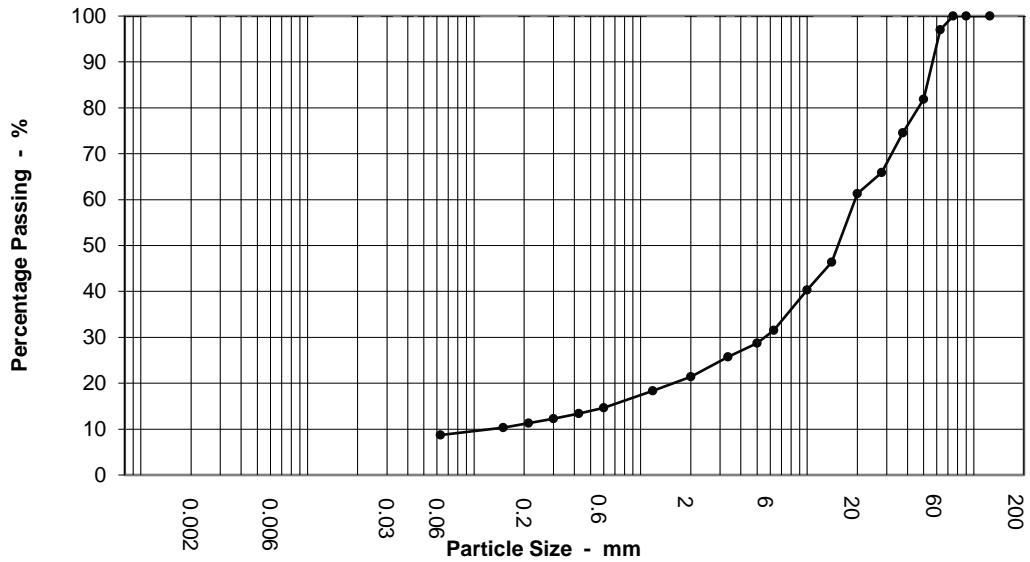
Sieving		Sedimentation	
Particle Size mm	% Passing	Particle Size mm	% Passing
125	100		
90	100		
75	100		
63	97		
50	82		
37.5	75		
28	66		
20	61		
14	46		
10	40		
6.3	32		
5	29		
3.35	26		
2	21		
1.18	18		
0.6	15		
0.425	13		
0.3	12		
0.212	11		
0.15	10		
0.063	9

Test Method	
BS 1377 : Part 2 : 1990	
Sieving	Clause 9.3
Sedimentation	N/A

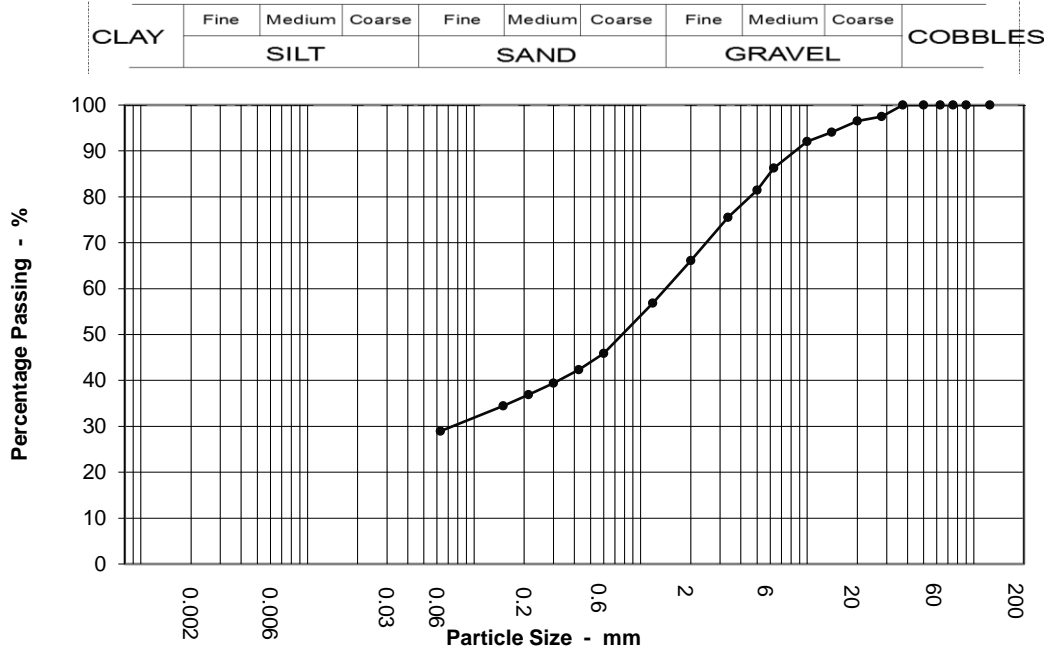
Sieving		Sedimentation	
Particle Size mm	% Passing	Particle Size mm	% Passing
125	100		
90	100		
75	100		
63	100		
50	100		
37.5	100		
28	98		
20	97		
14	94		
10	92		
6.3	86		
5	81		
3.35	76		
2	66		
1.18	57		
0.6	46		
0.425	42		
0.3	39		
0.212	37		
0.15	34		
0.063	29

Test Method	
BS 1377 : Part 2 : 1990	
Sieving	
Sedimentation	N/A

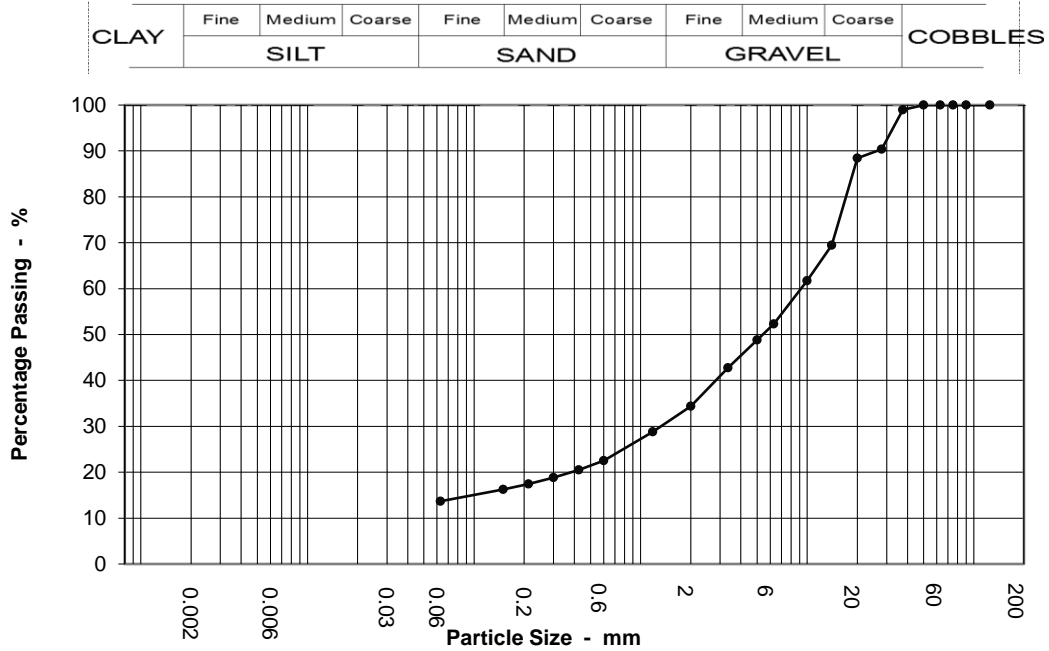
**Soil Description: Silty very sandy GRAVEL**

Sieving		Sedimentation	
Particle Size mm	% Passing	Particle Size mm	% Passing
125	100		
90	100		
75	100		
63	100		
50	100		
37.5	99		
28	90		
20	88		
14	69		
10	62		
6.3	52		
5	49		
3.35	43		
2	34		
1.18	29		
0.6	23		
0.425	21		
0.3	19		
0.212	17		
0.15	16		
0.063	14

Test Method	
BS 1377 : Part 2 : 1990	
Sieving	
Sedimentation	N/A

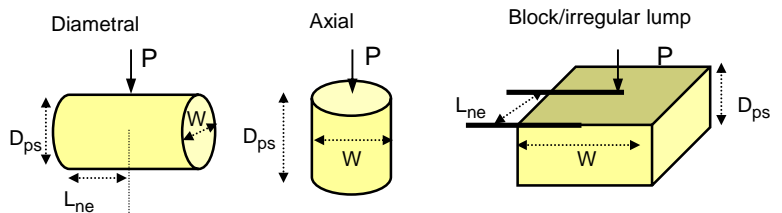
Test Type  
D - Diametral, A - Axial, I - Irregular Lump, B - Block  
Direction  
L - parallel to planes of weakness  
P - perpendicular to planes of weakness  
U - unknown or random  
Dimensions  
Dps - Distance between platens ( platen separation )  
Dps' - at failure ( see ISRM note 6 )  
Lne - Length from platens to nearest free end  
W - Width of shortest dimension perpendicular to load, P

Test performed in accordance with ISRM Suggested Methods : 2007, unless noted otherwise Detailed legend for test and dimensions, based on ISRM, is shown above. Size factor, F = (De/50)0.45 for all tests.	Date Printed 06/04/2019 00:00	Approved By  Cilla	Table  sheet 1 1
---	----------------------------------	--------------------------	------------------------------

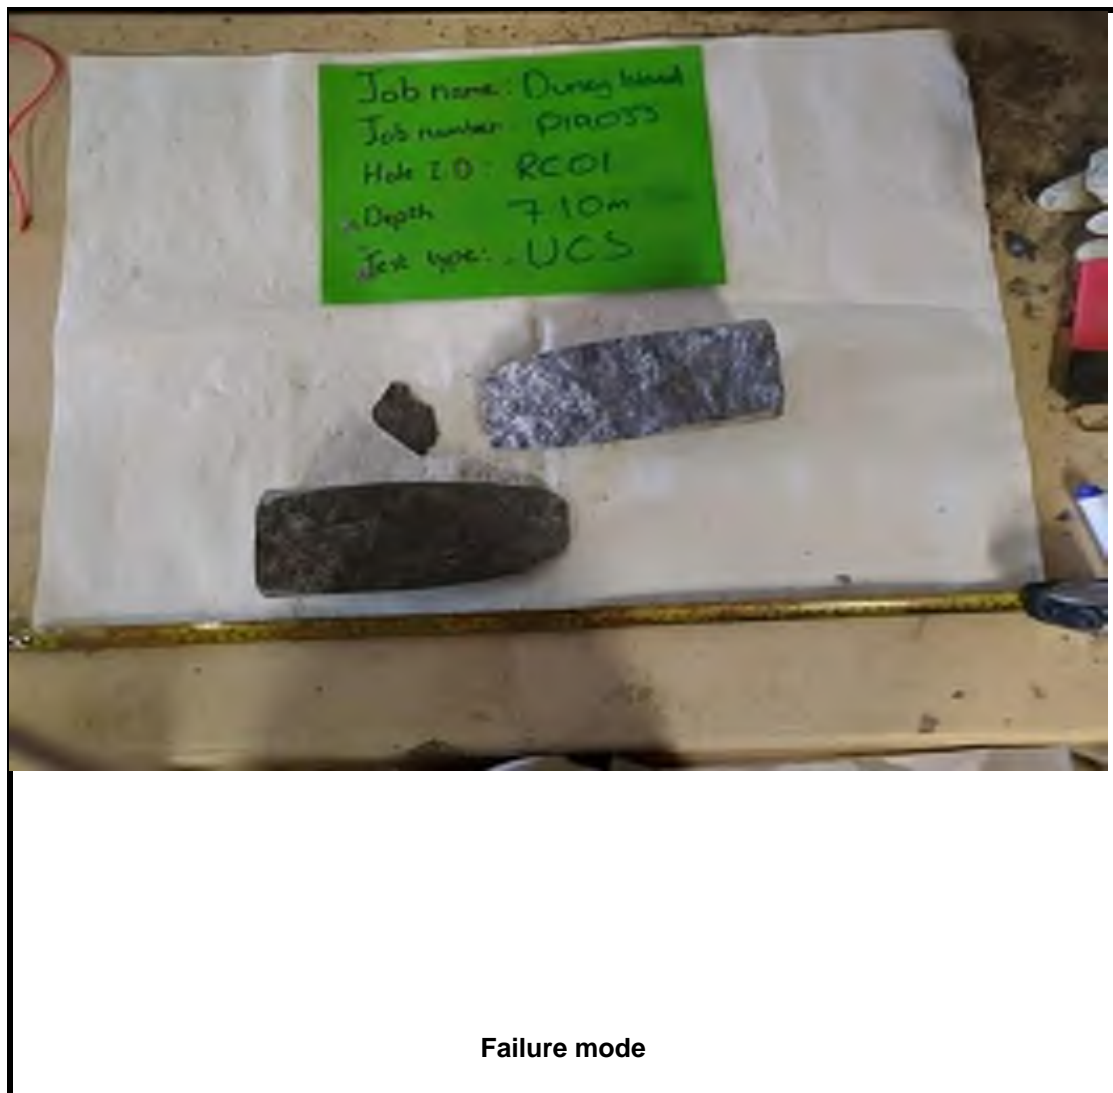
# Unconfined Compressive Strength, UCS

Job Name **Dursey Island Cable Car & Visitor Centre**  
Job Number **P19033**

Bulk Density **2.78** Mg/m<sup>3</sup>  
Load at Failure, P **91.6** kN

Stress at Failure **20.77** MPa

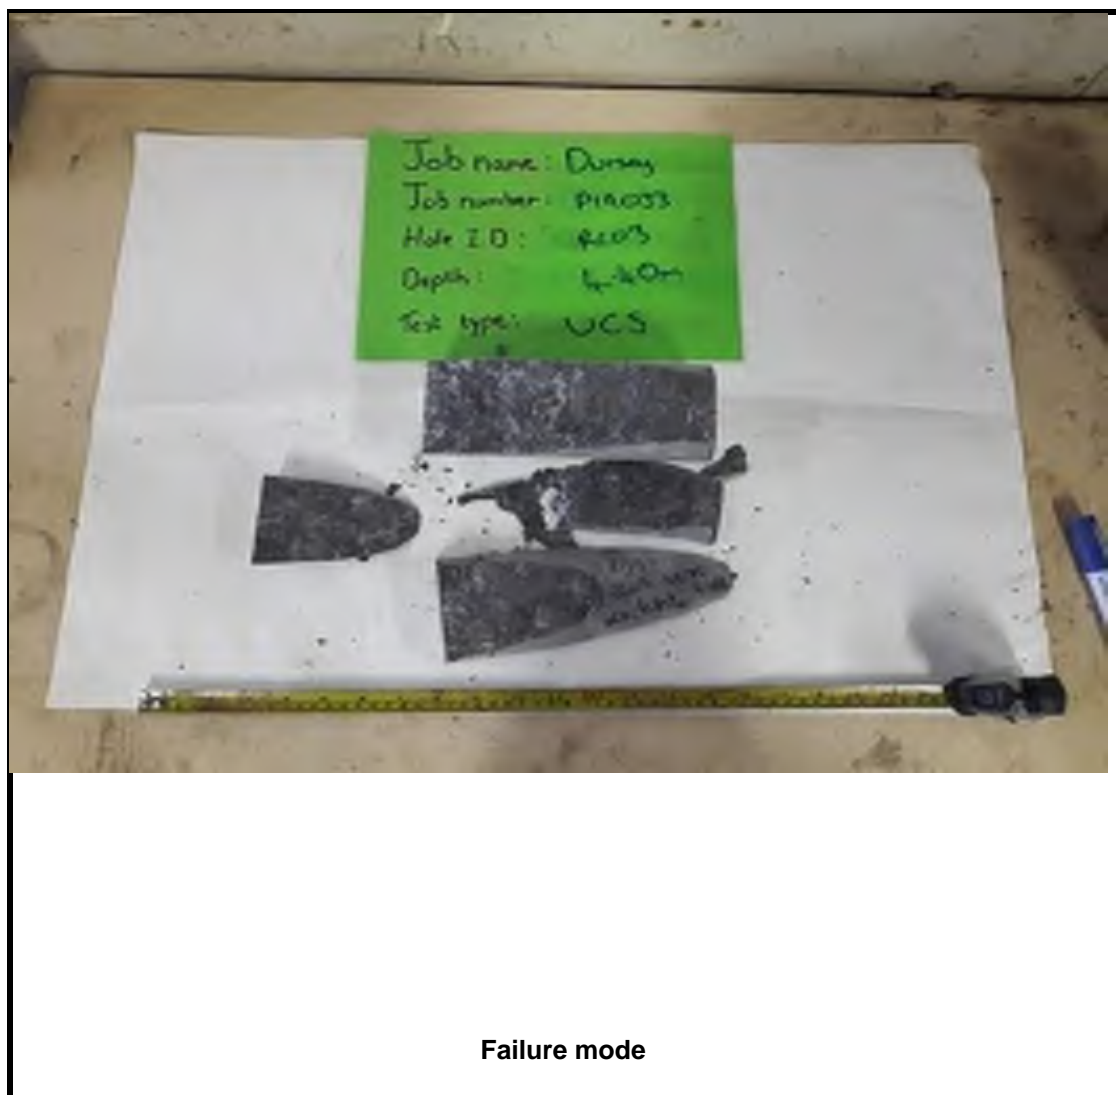
# Unconfined Compressive Strength, UCS

Job Name **Dursey Island Cable Car & Visitor Centre**  
Job Number **P19033**

Bulk Density **2.81** Mg/m<sup>3</sup>  
Load at Failure, P **42.6** kN

Stress at Failure **9.67** MPa

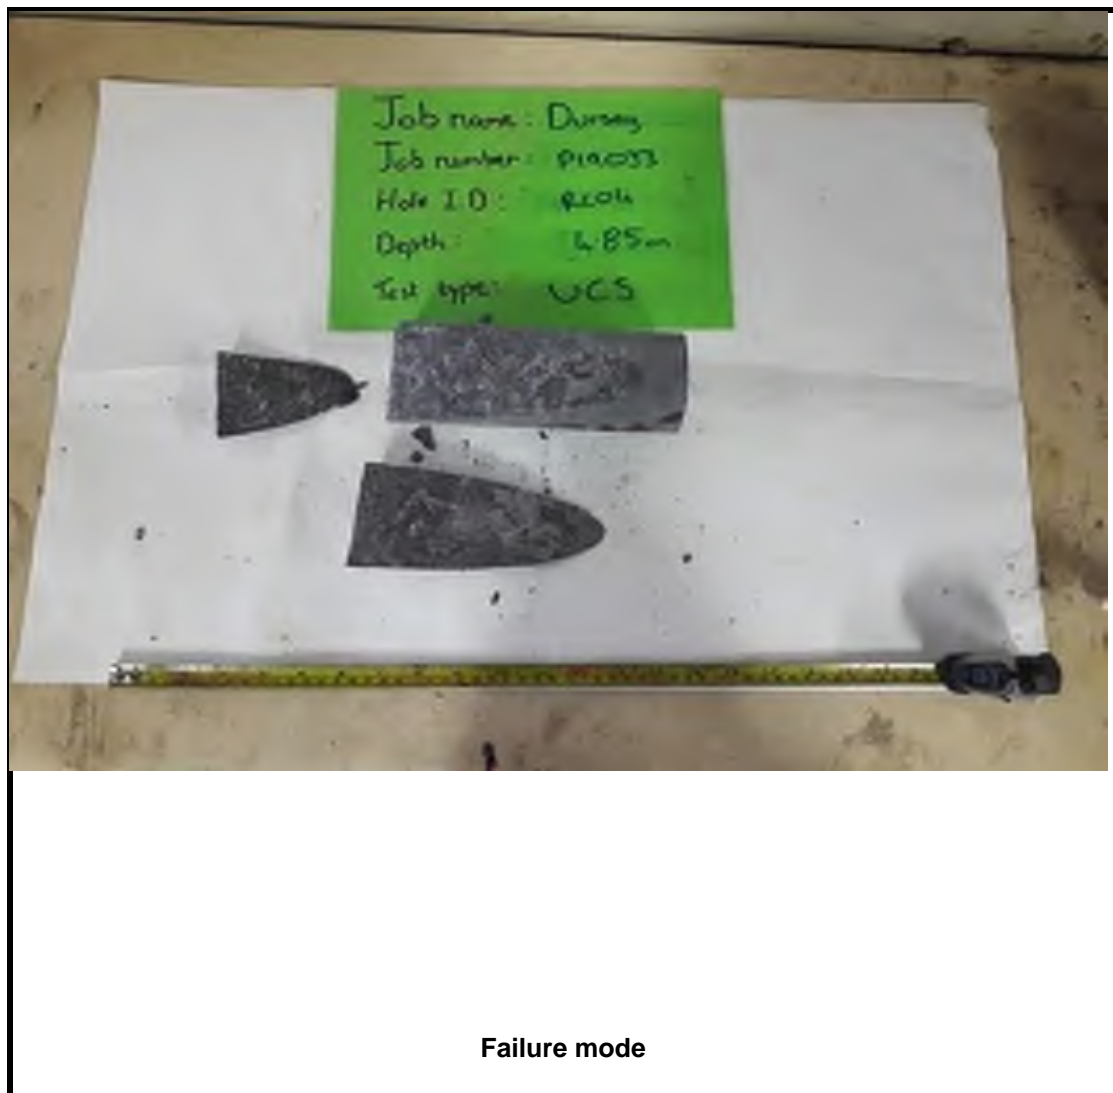
# Unconfined Compressive Strength, UCS

Job Name **Dursey Island Cable Car & Visitor Centre**  
Job Number **P19033**

Bulk Density **2.79** Mg/m<sup>3</sup>  
Load at Failure, P **43.4** kN

Stress at Failure **13.77** MPa

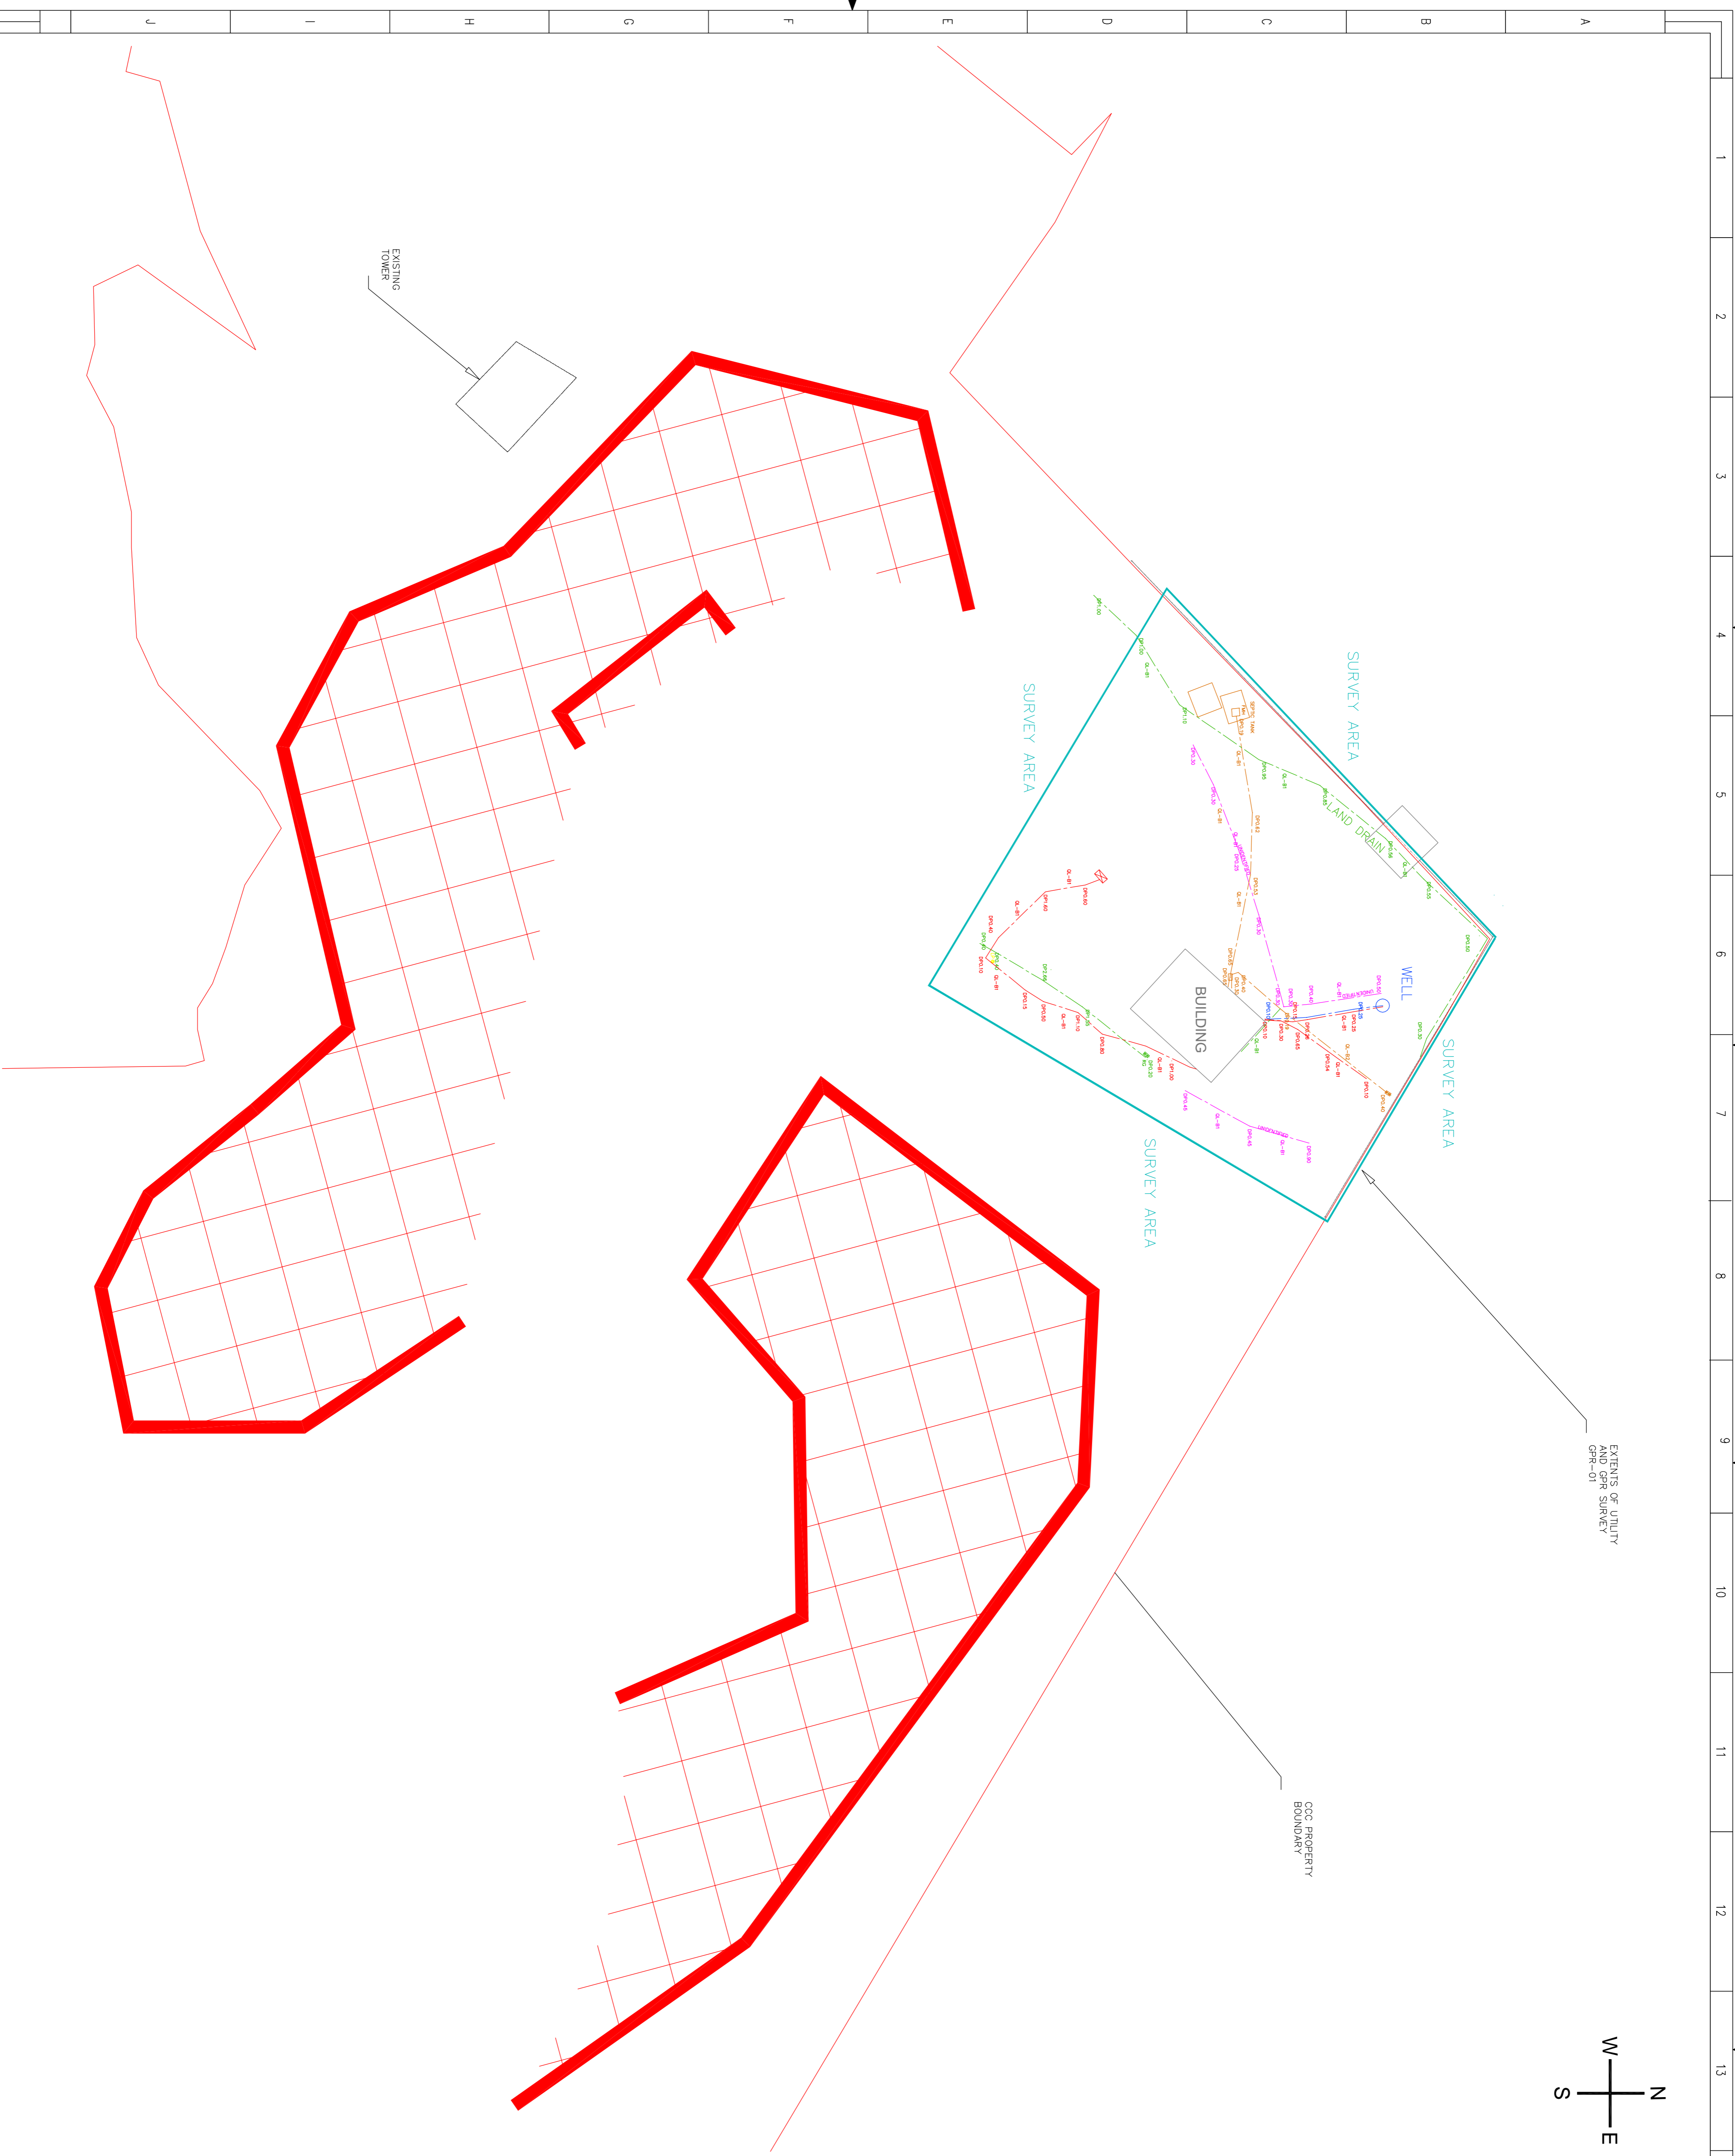
<b>Client Name:</b> Priority Geotechnical	<b>Site Address:</b> Dursley Island Cable Car
<b>Drawing Title:</b> Underground Services Plan	<b>Drawing No.:</b> 1
<b>Date:</b> 21st March 2019	<b>Sheet No.:</b> 1
<b>Scale:</b> 1:250 @ A1 (ITM Coordinates)	<b>Revision No.:</b>

1. GPR scanning frequency 250 and 700 mhz
2. Depth of investigation 2.5m, self calibrating
3. Vixar Metrotech Products / RDT7000
4. GPR scanning limited to smooth surfaces only no obstruction.
5. Survey area marked on drawing
6. All depths stated are a indication of depth
7. Accurate requires more scanning
8. All Utilities are displayed 0m - 5m unless noted otherwise.
