KING'S ISLAND
FLOOD RELIEF SCHEME

**King's Island Flood Relief Scheme
Environmental Impact Assessment Report
Volume 2 - EIA Appendices**

A Outline Construction Method Statement

Project title	Kings Island Flood Relief Scheme	Job number	265545-00
cc	Bernadette O'Connell Samuel McKeever	File reference	
Prepared by	Phoebe Watson Ken Leahy	Date	18 December 2019
Subject	Outline Method Statements

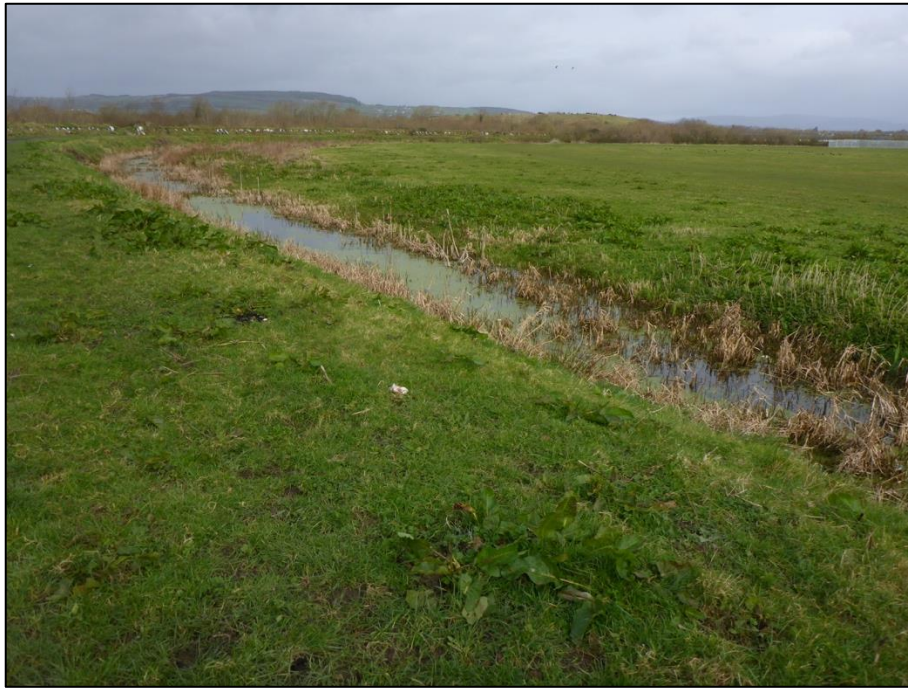
Photograph 1.1. Project survey area (drainage ditch). View to north (March 2019).

level (Photograph 1.2). The western bank is relatively steep, but the eastern bank has a shallow gradient which floods near the ditch in winter (Photographs 1.1 and 1.2). The wet grassland to the east is grazed by horses and the embankment to the west is used for recreation (e.g. dog walking). Nearby borehole and trial pit investigations have shown that the ditch is located in an area of relatively impermeable clay, underlain by sands and gravels. The existing ditch is fed both by surface water run-off from surrounding lands and groundwater through the lower sand/ gravels layer. The invert level of the ditch is c. 1.14mOD and there is an outfall (via a non-return valve) to the River Shannon to the south of the population of *Groenlandia densa*. It is not significantly influenced by the tidal waters in the River Shannon. Further details and photographs are shown in Appendix A. Water sampling shows that the ditch has a pH between 7.5 and 8 (highly calcareous) and is neither brackish nor highly polluted.

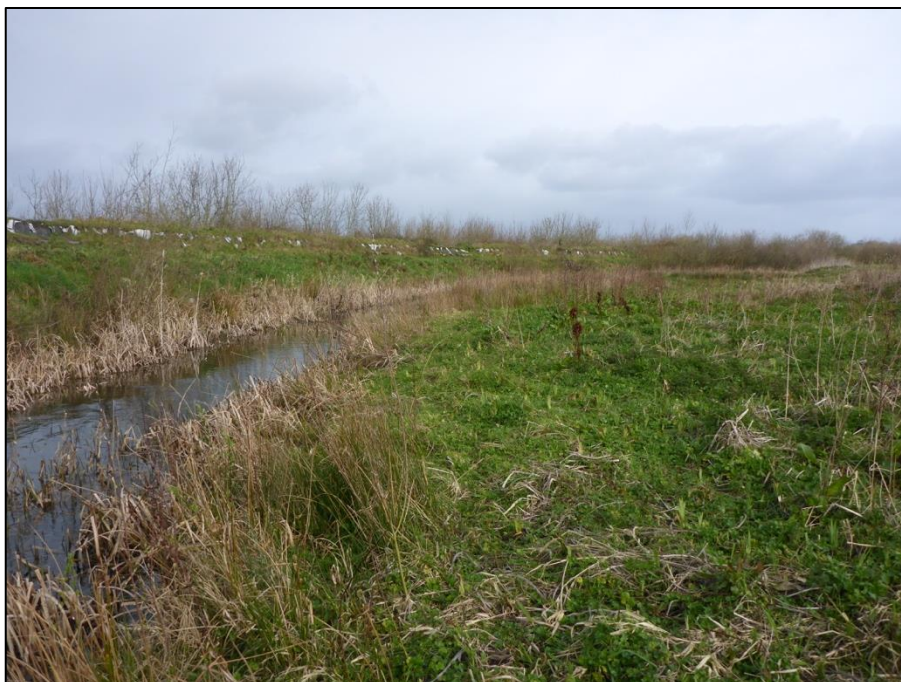
Photograph 1.2. Drainage ditch showing steep western bank and shallow eastern bank. View to north-west (March 2019).

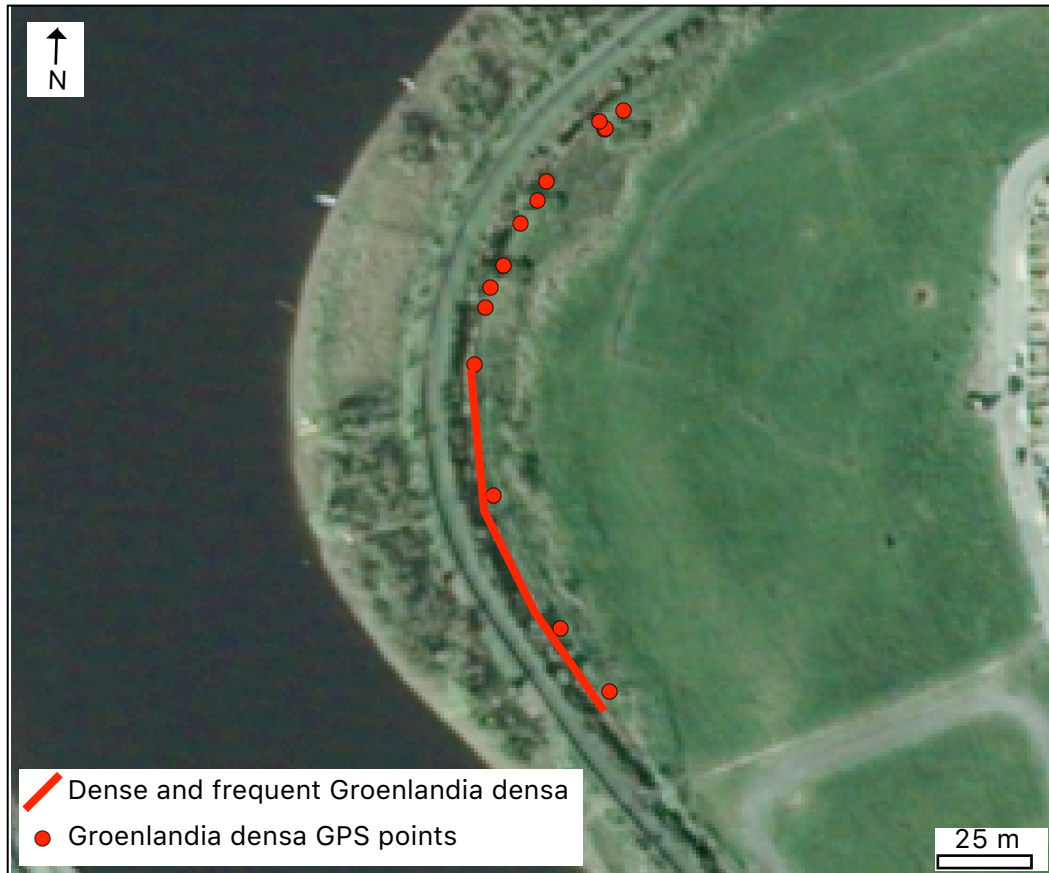
GPS points: *Groenlandia densa* is abundant between the GPS locations R 57386 58700 (N) and R 57396 58521 (S) (red line on map)

Figure 2. Location of main areas of *Groenlandia densa* plants mapped using GPS

Groenlandia densa is abundant in a ditch section approximately 200m in length (e.g. Photographs 3 and 4). Figure 2 shows the main areas of *Groenlandia densa* plants (mapped using GPS). In the southern section of the ditch (where the transect was located), *Groenlandia densa* was present throughout the channel and only particularly dense populations have been mapped. The plants appeared healthy at the time of survey and had been present in the ditch during January, suggesting they had overwintered in the ditch.

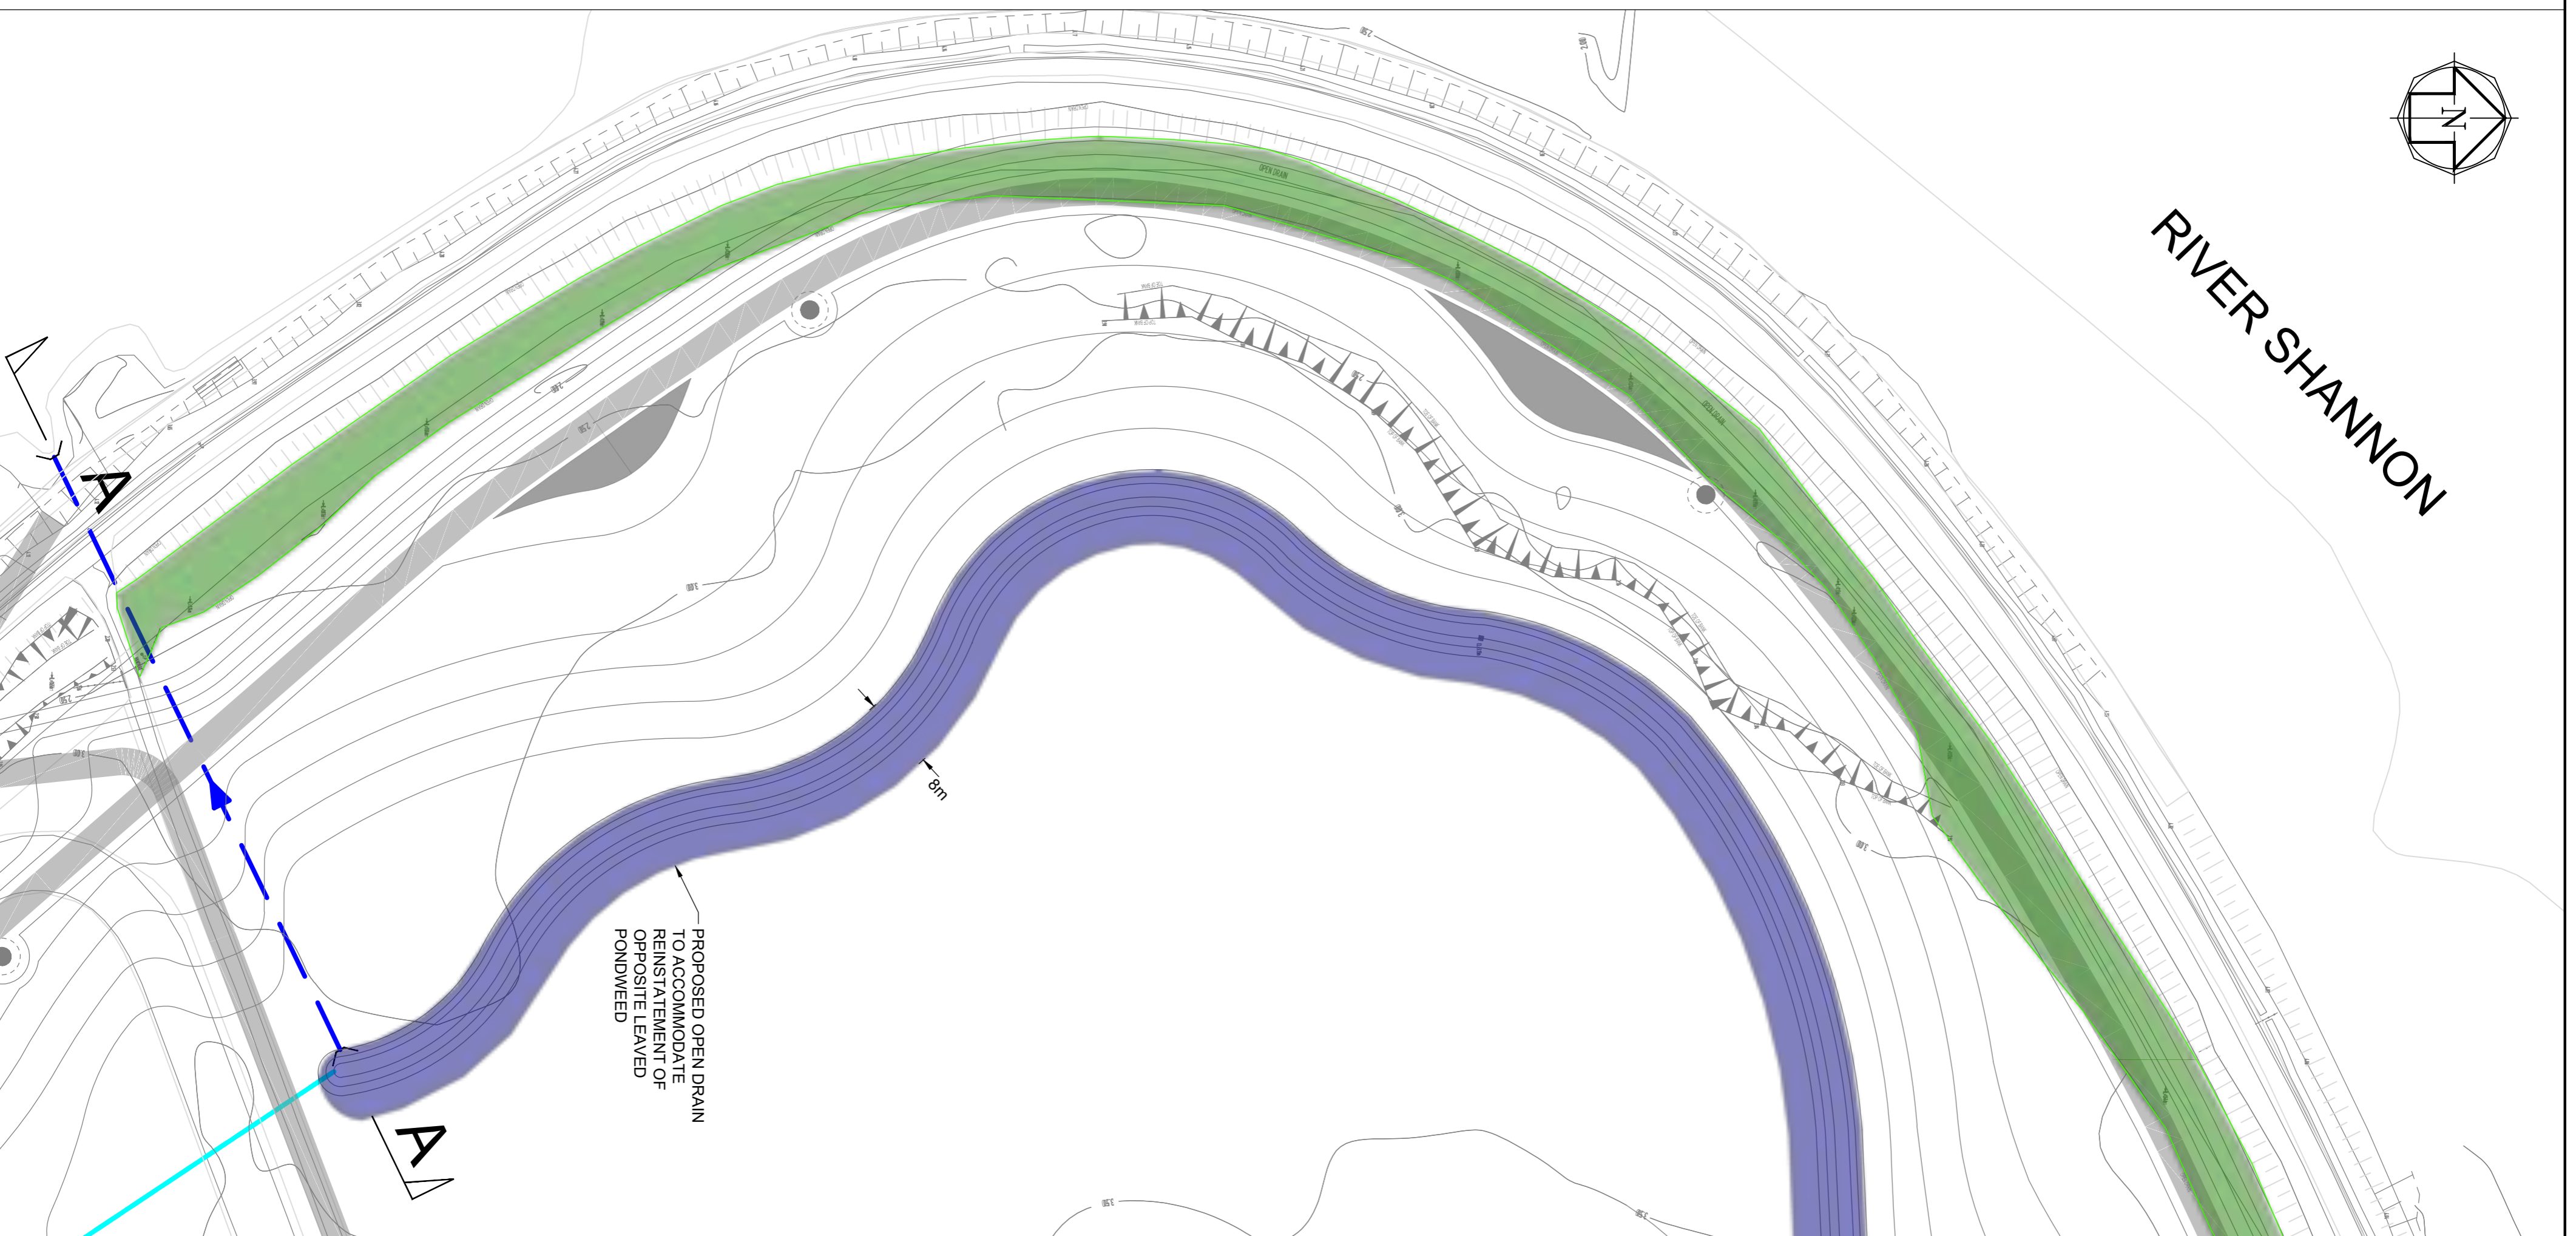
Drawing Number: 012 Rev.: D1 Sheet No.: 1 OF 1 Status: NPWS SUBMISSION

EXISTING STORM SEWER
	EXISTING FOUL SEWER
	REDUNDANT SEWER
	PROPOSED STORM SEWER
	PROPOSED FOUL SEWER
	PROPOSED FILTER DRAIN
	PROPOSED SWALE
	EXISTING OPEN DRAIN
	PROPOSED OPEN DRAIN TO ACCOMMODATE REINSTATEMENT OF OPPOSITE LEAVED FOUNDED

APPENDIX B – DESIGN OF REPLACEMENT (NEW) DITCH

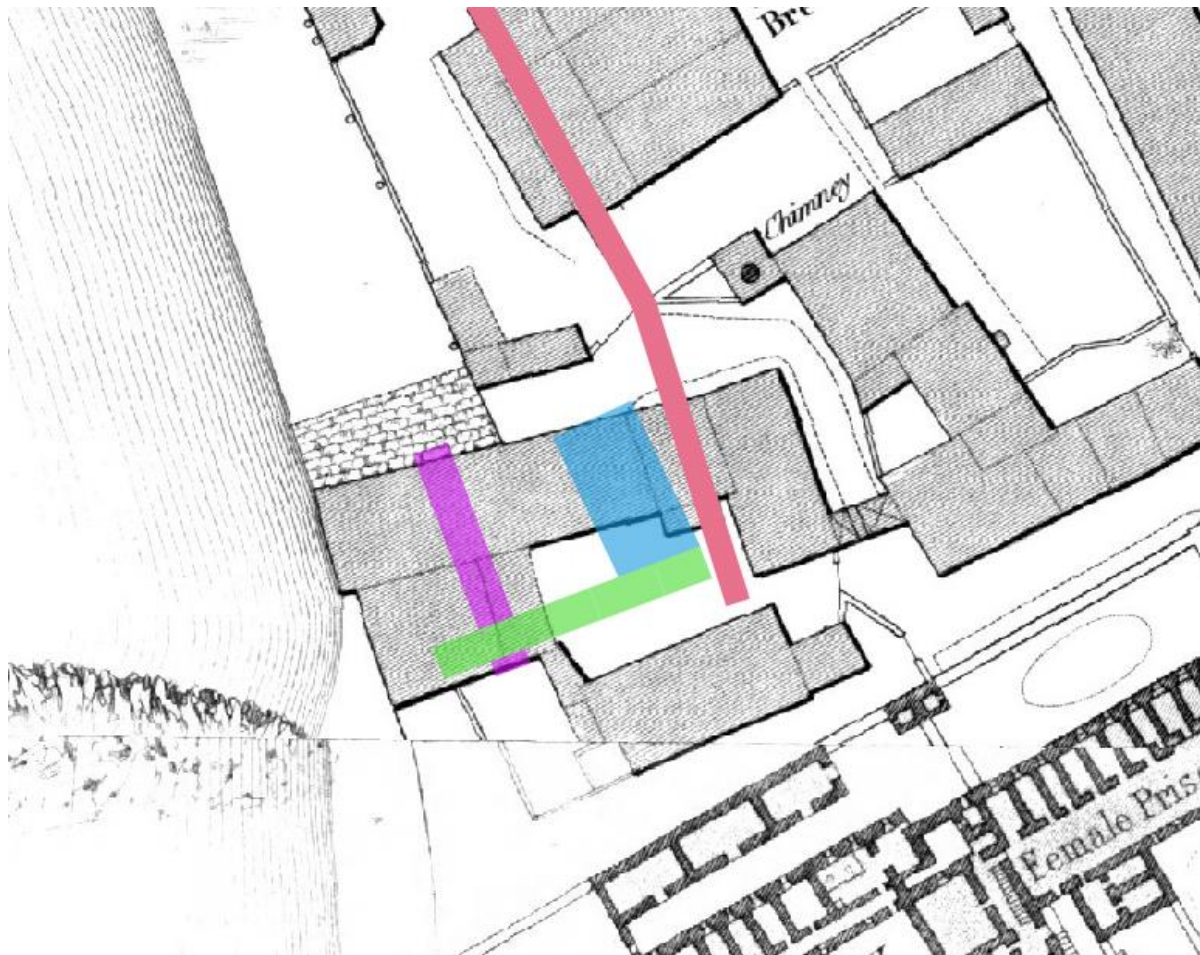
Figure 9. Extract from OSI 1870 mapping¹.

The purpose of TT1-1 is identify the northern extent of the tunnel noted by O’Rahilly. The dimensions for the length of the tunnel recorded by O’Rahilly appear to coincide with OSI 1870 mapping of mill walls in the area (Figure 9). To the north of the mill is what appears to be a slipway into the river.

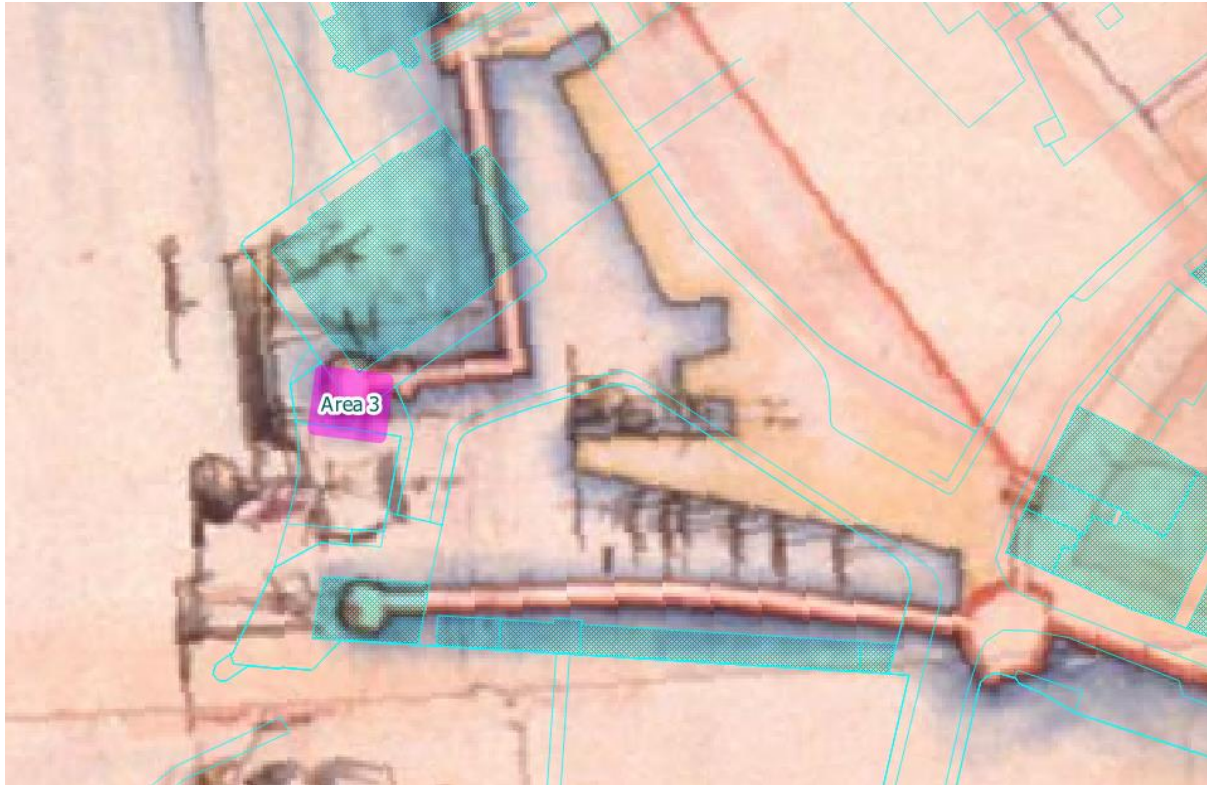
Figure 15. Extract from *Limerick, 1685* by Thomas Phillips (National Library of Ireland) (*Irish Historic Towns Atlas No. 21 Limerick, Map 12*) showing entrance to the harbour.

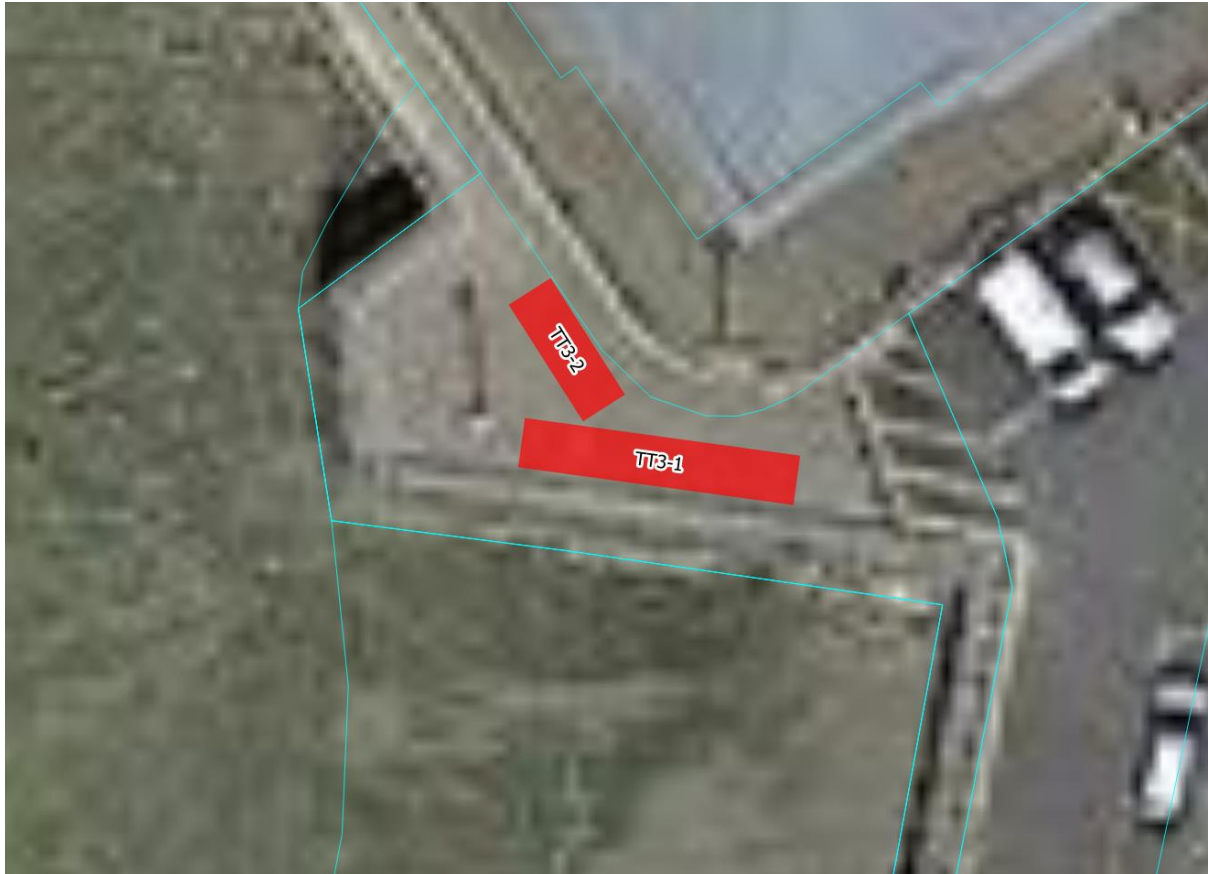
Figure 16. Proposed test trench in Area 3 – TT3-1 and TT3-2.

Two test trenches are proposed in Area 3, TT3-1 and TT3-2. Their extent is constrained by iron rail fencing around the Court House and a bench seat which is located parallel with the western face of the quay. The purpose of the test trenches (TT3-1 and TT3-2) is to ascertain whether there are any remains of the City Wall still extant.

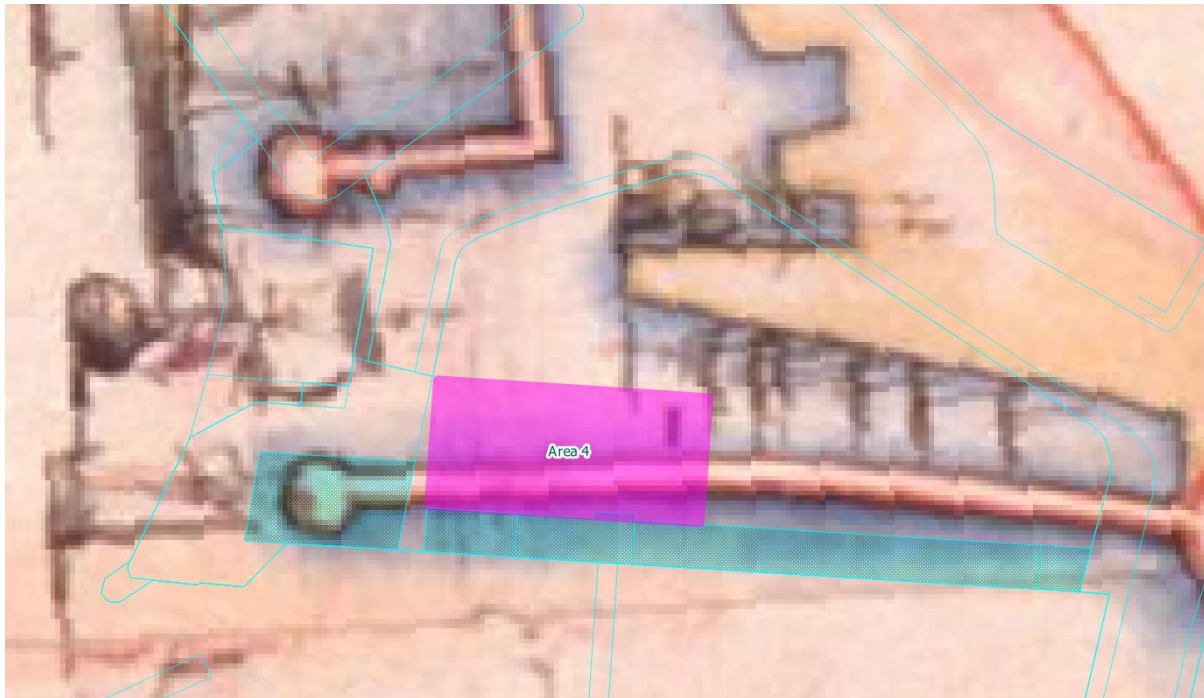
Figure 17. Extract from *Limerick, 1685* by Thomas Phillips (National Library of Ireland) (*Irish Historic Towns Atlas No. 21 Limerick, Map 12*) with Area 4 indicated.

Early mapping, such as Colles' map from 1685, indicates that the southern range of the City Wall at the entrance into the harbour was located within the Potato Market (Figure 17). It would also appear that this area changed significantly towards the end of the 18th Century, with the construction of the new quays as indicated on Colles' Map (Figure 13).

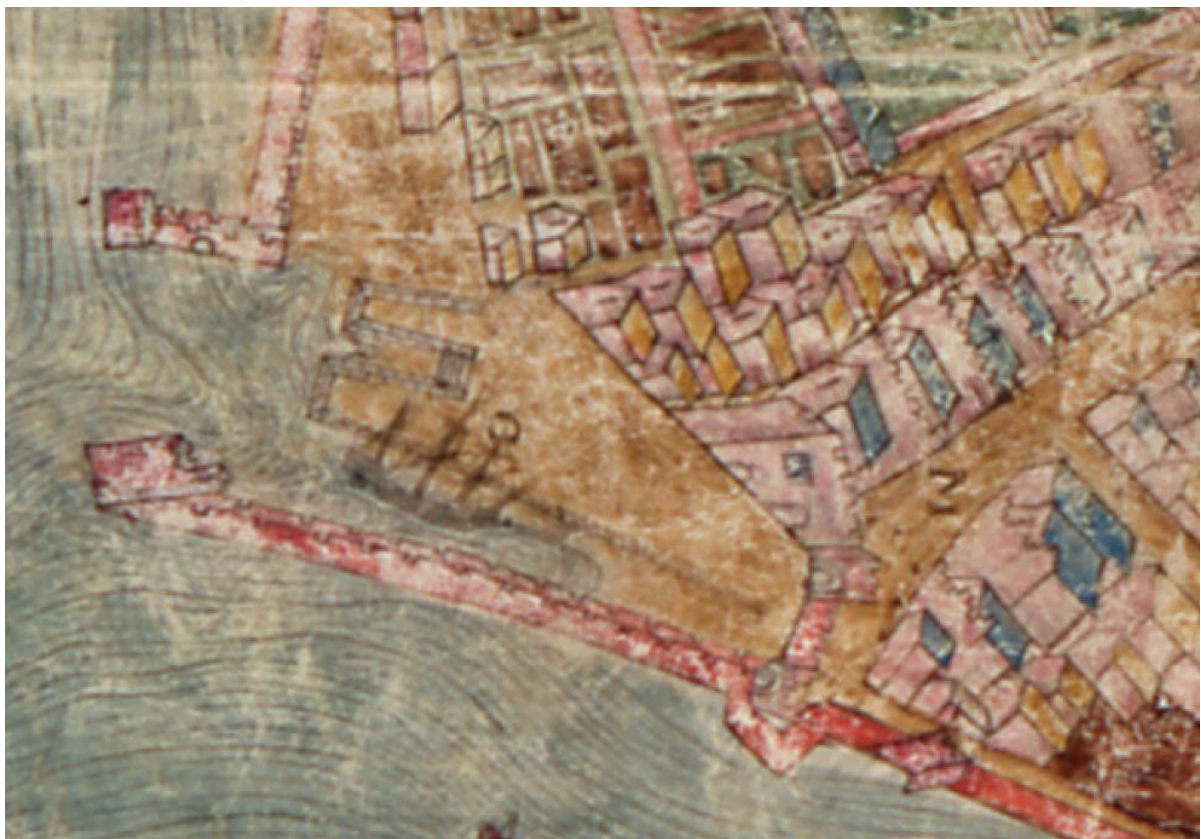
Figure 20. Extract from Limerick c. 1590 by Hardiman (Trinity College Dublin) (Irish Historic Towns Atlas No. 21 Limerick, Map 6) show the quays area.

Area 3, to the south of the Court House, is indicated as having been a quay area on Phillips' map of 1685 (Figure 19). Phillips' map is a good guide as it is spatially the most accurate of the 17th Century maps. However, even earlier maps, such as Hardiman's from 1590 (Figure 20), shows an extensive quays area to the east of the City Wall and north of the harbour entrance. It is interesting to note that Phillips indicates a second bounding wall further to the east that appears to enclose the quays area. This is likely a further layer of defence that may be part of the City's defences.

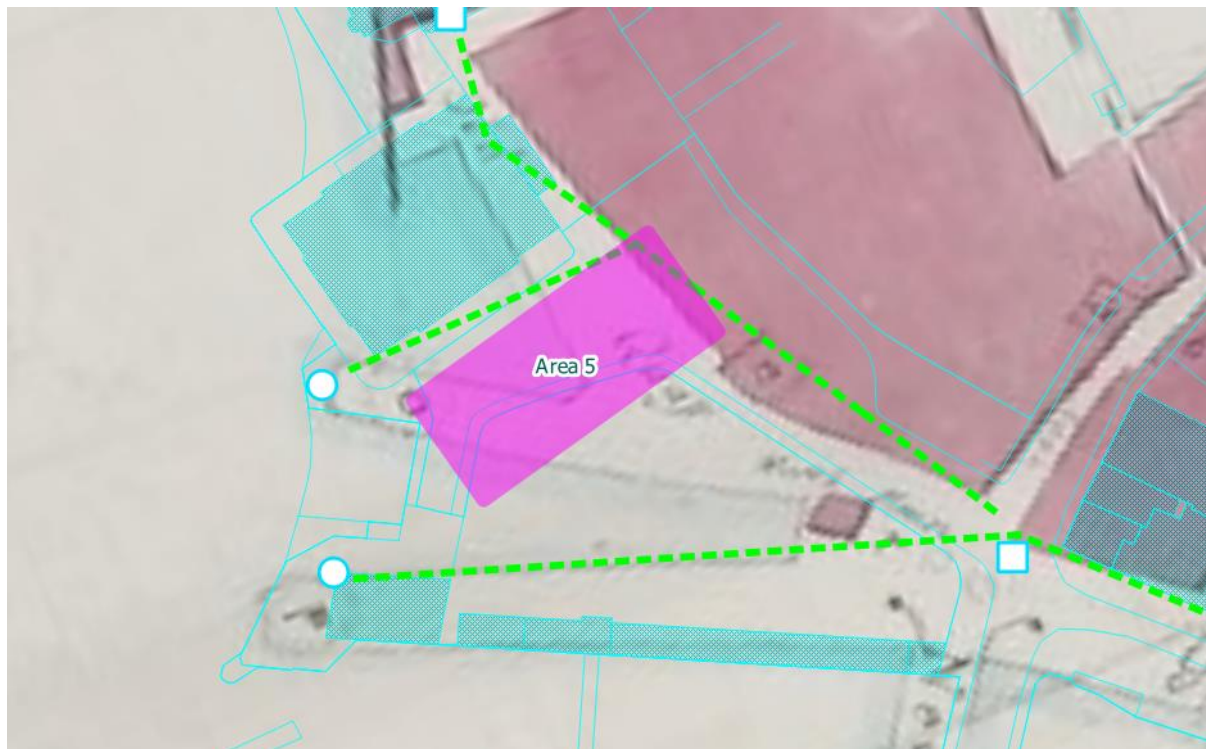
Figure 21. Extract from *Limerick, 1769* by Christopher Colles (British Library) (*Irish Historic Towns Atlas No. 21 Limerick, Map 18*) overlaid with recent OSI Survey, showing Area 5.

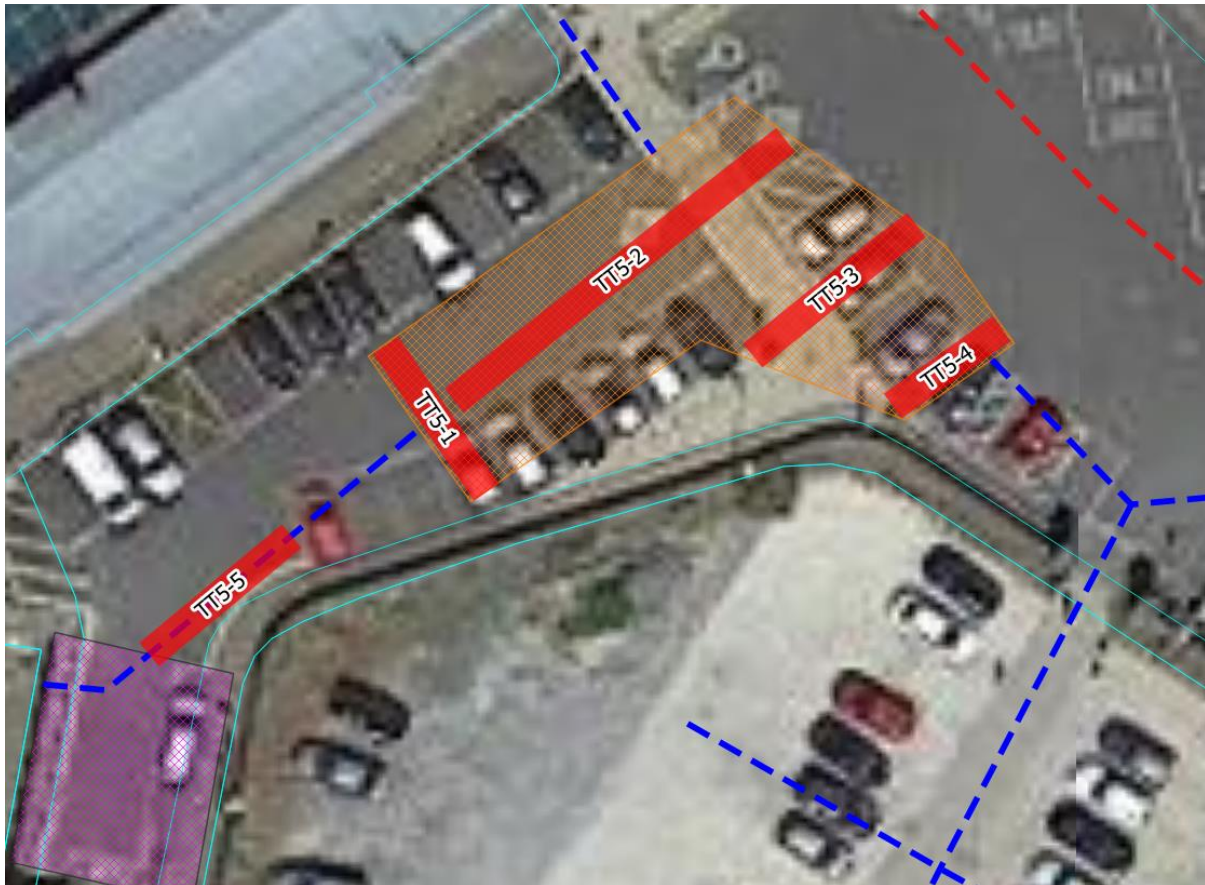
Figure 22. Proposed test trenches in Area 5 – TT5-1 to TT5-5.

The purpose of TT5-1 is to investigate the archaeological potential of the proposed outfall and oil interceptor.

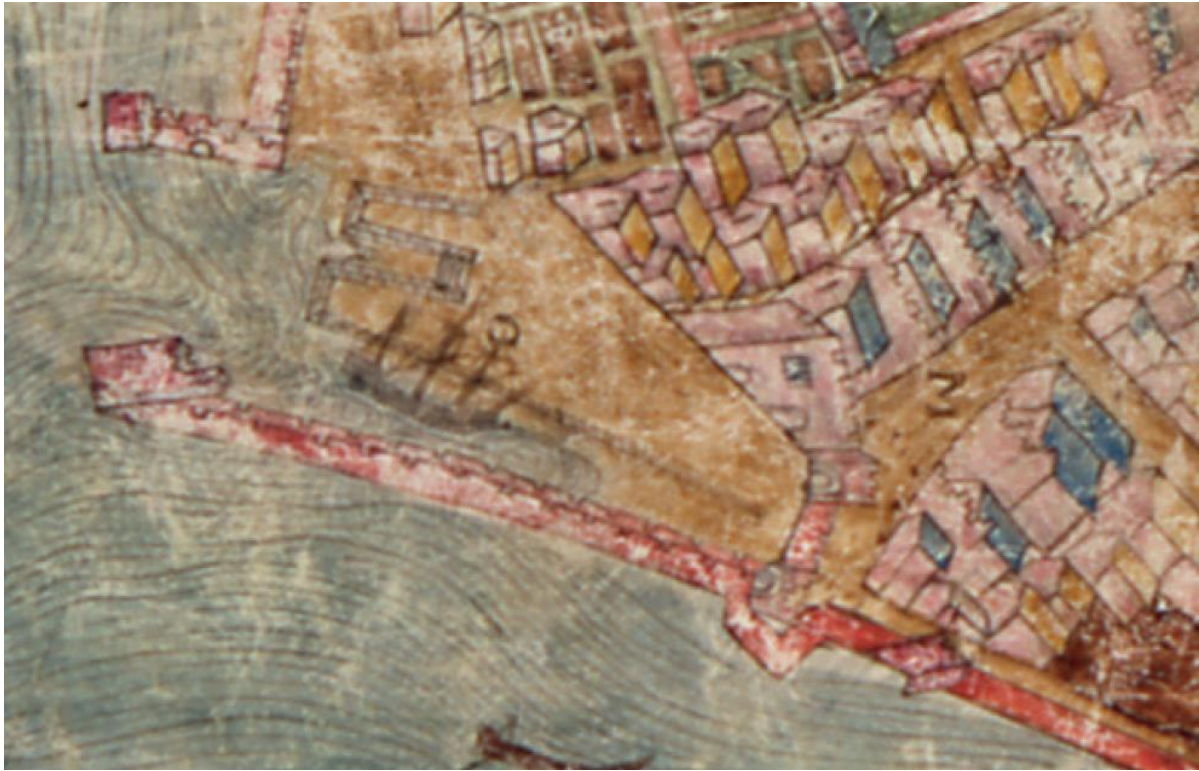
Figure 23. Extract from *Limerick c. 1590* by Hardiman (Trinity College Dublin) (*Irish Historic Towns Atlas No. 21 Limerick, Map 6*) showing the quays area, with gated entrance from the east evident.

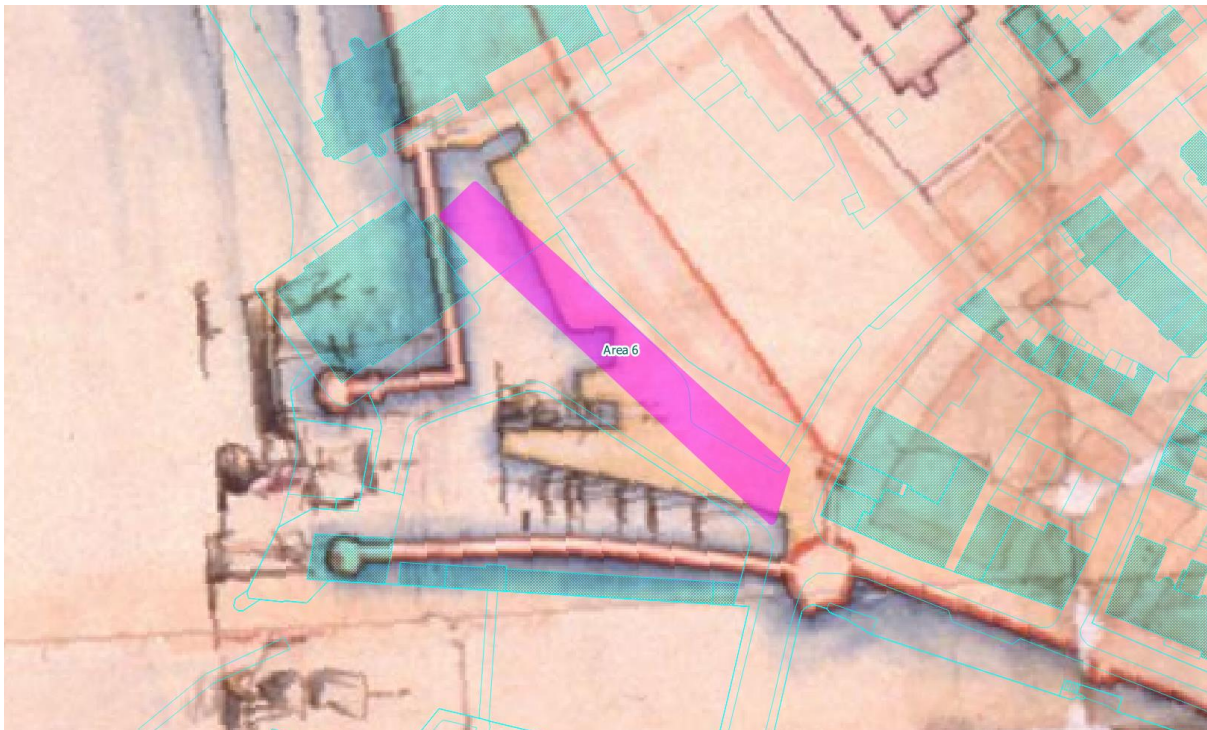
Figure 24. Extract from *Limerick, 1685* by Thomas Phillips (National Library of Ireland) (*Irish Historic Towns Atlas No. 21 Limerick, Map 12*) with area 6 indicated.

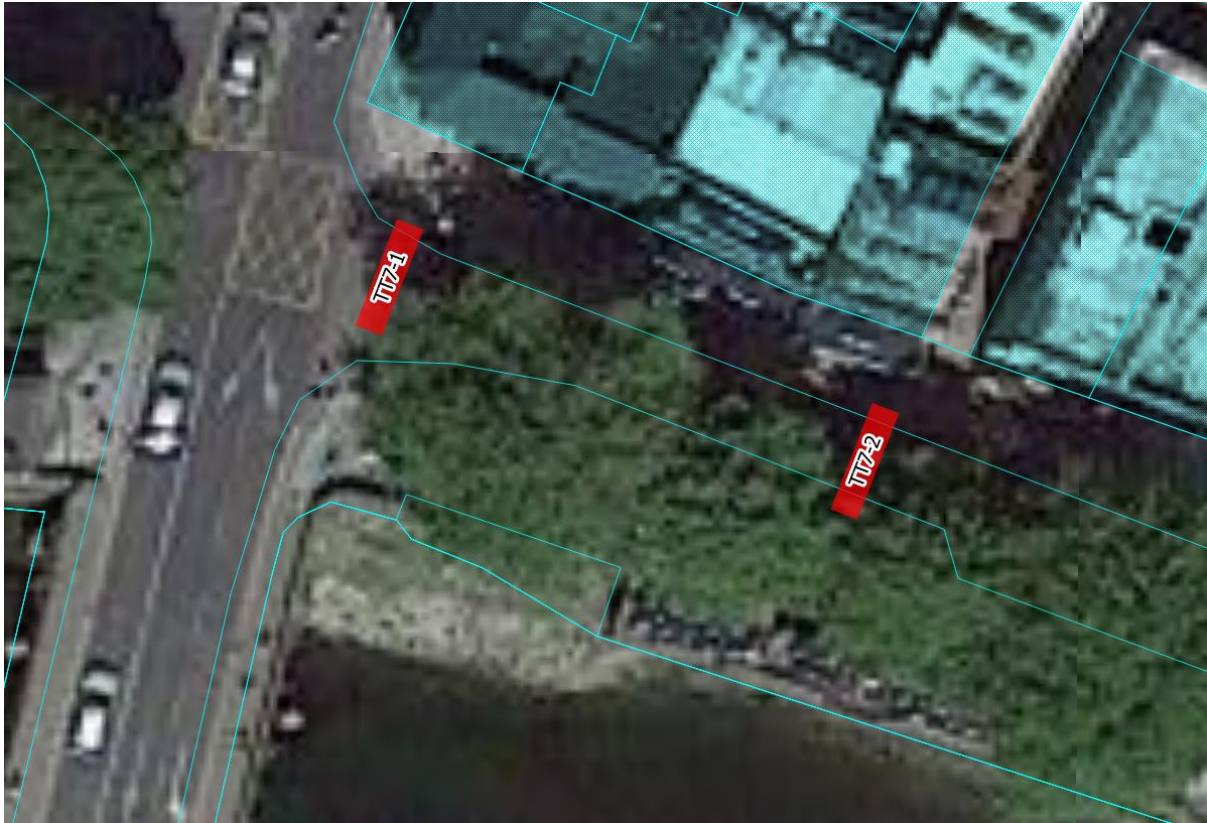
Figure 28. Proposed testing in Area 7 – TT7-1 and TT7-2.

There are two test trenches proposed in Area 7 (Figure 28), these are orientated roughly north south along the alignment of the proposed gravity sewer. The purpose of these test trenches is to try and ascertain whether there are any features associated with the City Wall located along the proposed route of the sewer and in the vicinity of Bridge Street.
