7 LAND, SOIL & GEOLOGY

This section of the Environmental Impact Assessment Report (EIAR) has been prepared by Waterman Moylan and provides a review of the impact that this proposed development will have on the land and soils in the area.

In summary, the proposed Strategic Housing Development (SHD) broadly comprises: -

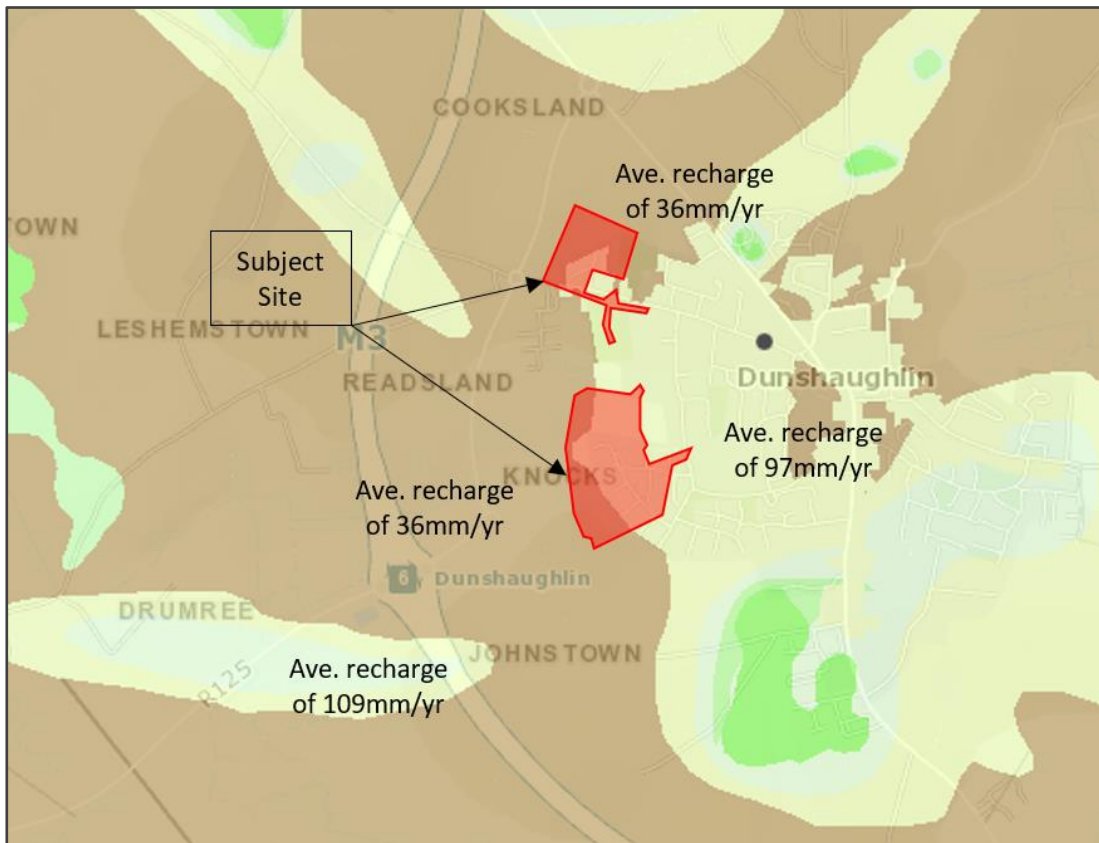
Figure 7.3 below is an extract from the GSI web mapping of underlying aquifers in the region which shows the corresponding average recharge rates (mm/yr) of the subject site and surrounding areas.

Figure 7.3: Groundwater Recharge Map Extract from GSI.

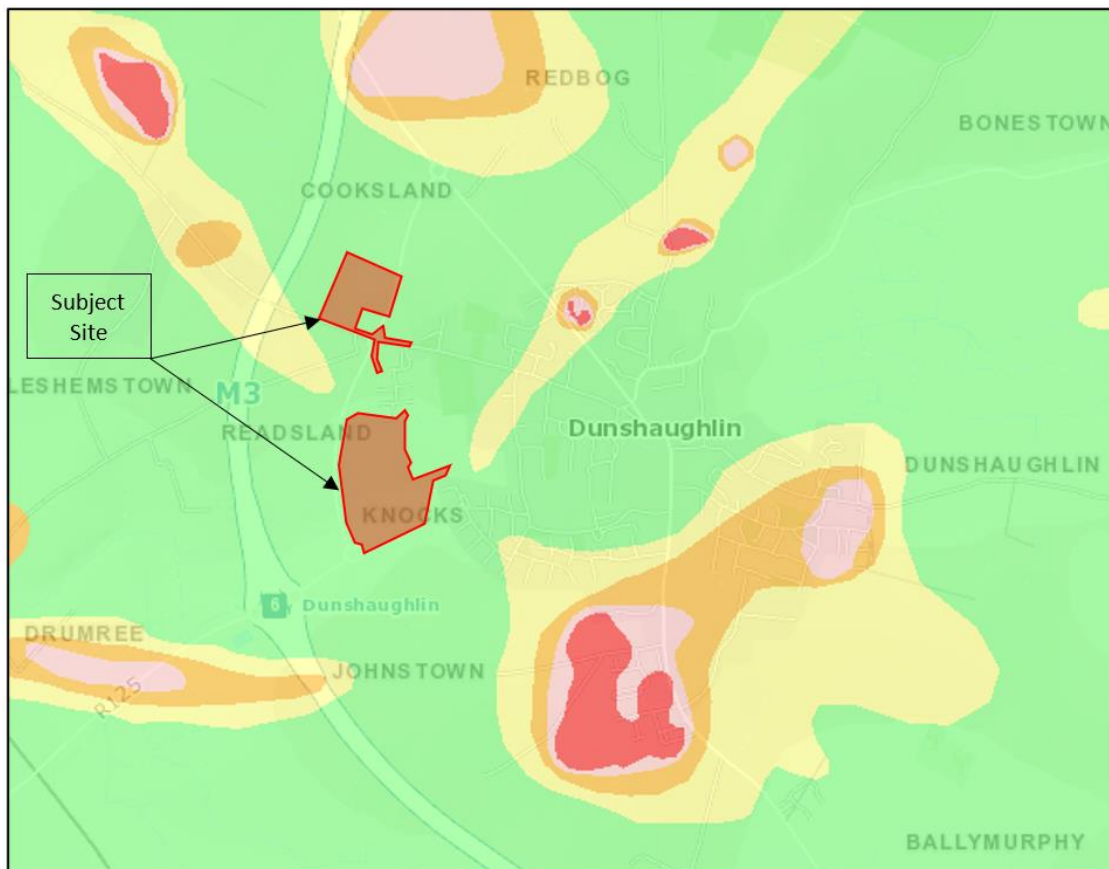
Similarly, Figure 7.4 below shows that the subject site is in the area of Low aquifer vulnerability.

Figure 7.4: Aquifer Vulnerability Map Extract from GSI.
