## Flood Risk Assessment Report

Proposed Strategic  
Housing Development,  
Kenelm, Deer Park,  
Howth, Co. Dublin

**Document Title** Flood Risk Assessment Report

**Document No.** 19.196 – IR – 02

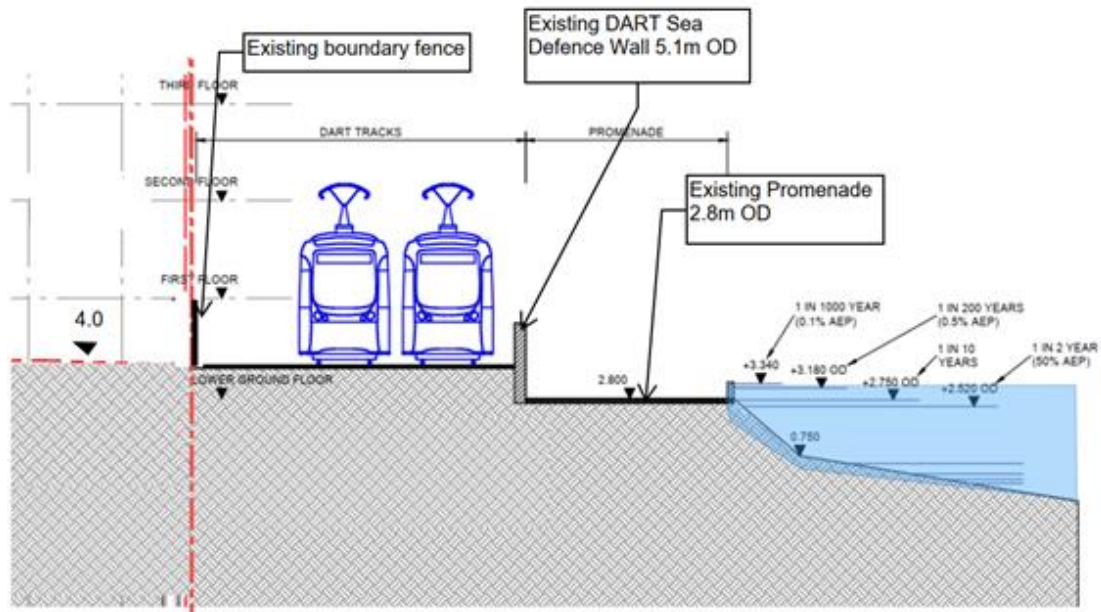
Figure 5 – Current Sea Defense

The closest location of the coast to the site is approximately 150m to the north. The coast itself is protected by the existing promenade and DART line defense wall. The promenade is at 2.8m OD and the defense wall at 5.1m OD, therefore providing a freeboard of 2.3m. (Figure 5 – Current Sea Defense). The proposed site itself is on higher ground and has a ground floor level FFL of 8.0m OD. Therefore, the current likelihood of flooding on the proposed site is very unlikely.

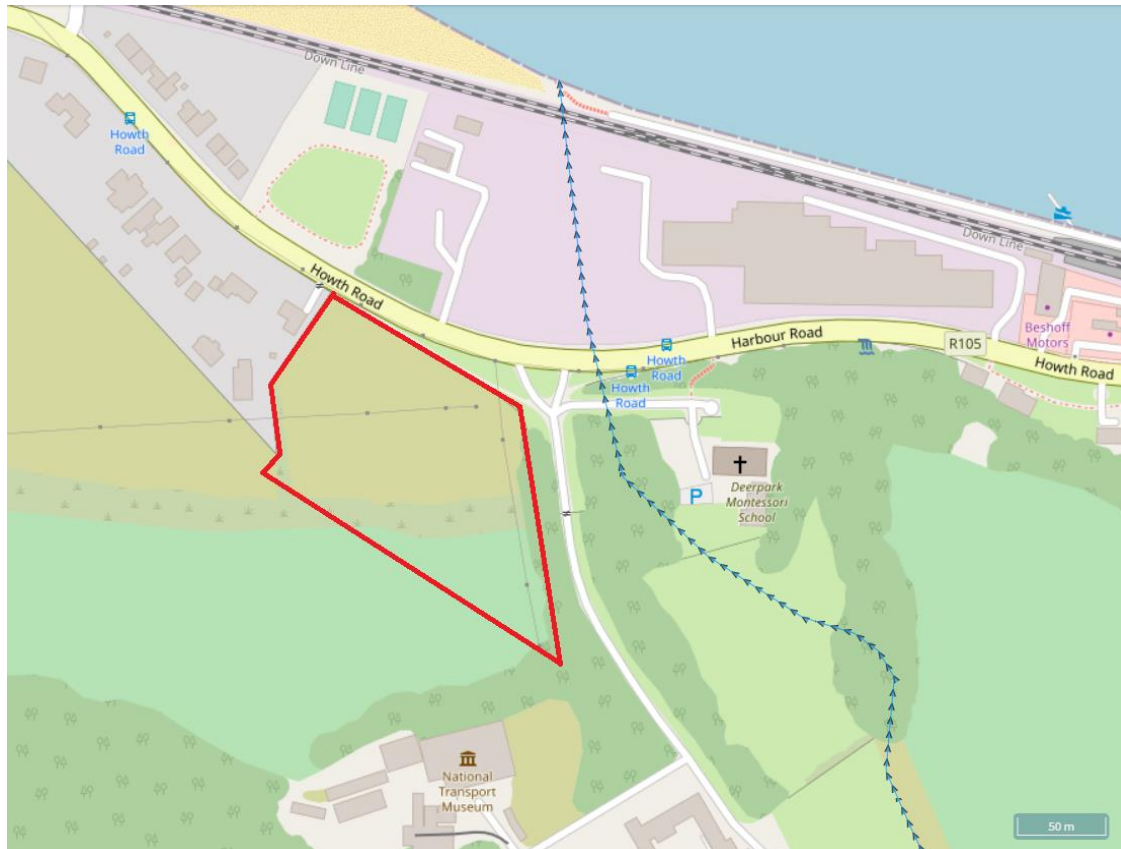
Figure 6 – Approximate Bloody Stream Route (source [gis.epa.ie/EPAMaps](http://gis.epa.ie/EPAMaps))

The Bloody stream route as shown in Figure 6 below, does not culvert across the proposed site. Site boundary shown indicatively in red.

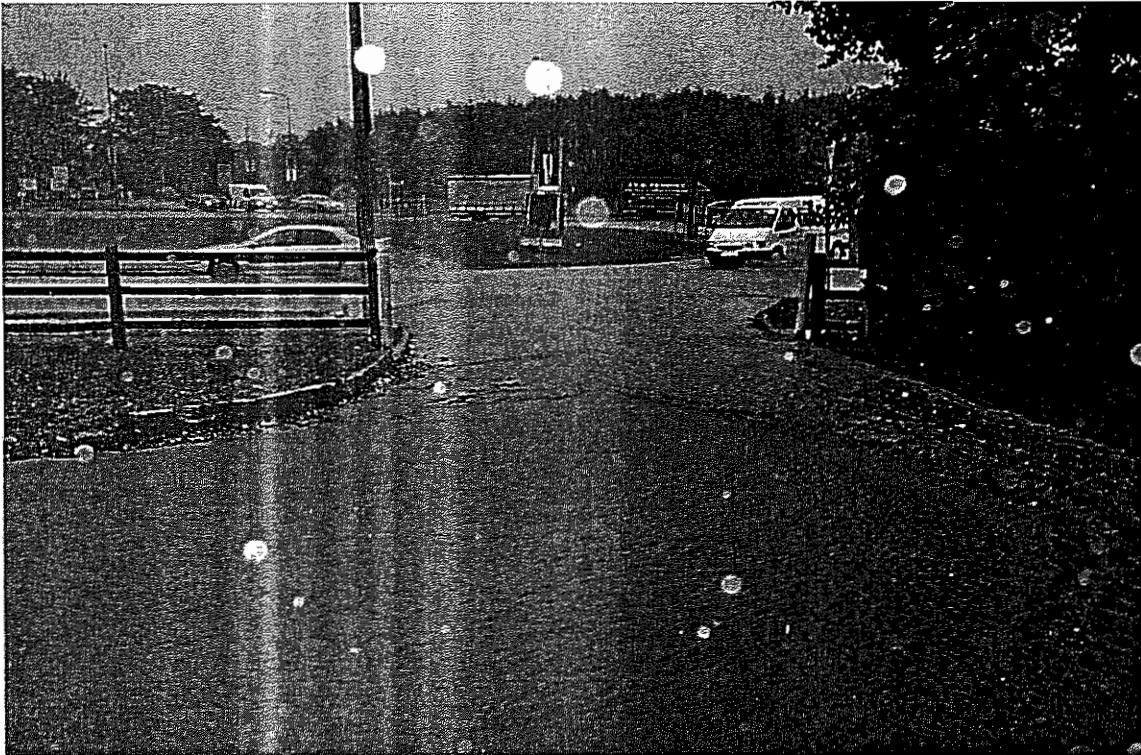
Flooding of Dublin/Belfast Roundabout at Little Chef

The surface water screens in \_\_\_\_\_ property are unable to take the volume of surface water and overflowed (see Area Engineer report 10/2/01), this in turn floods the Little Chef. In order to prevent flooding of Little Chef the surface water is diverted on to Dublin/Belfast Road as can be seen from photographs. The Drainage Section provided sandbags to the Little Chef.

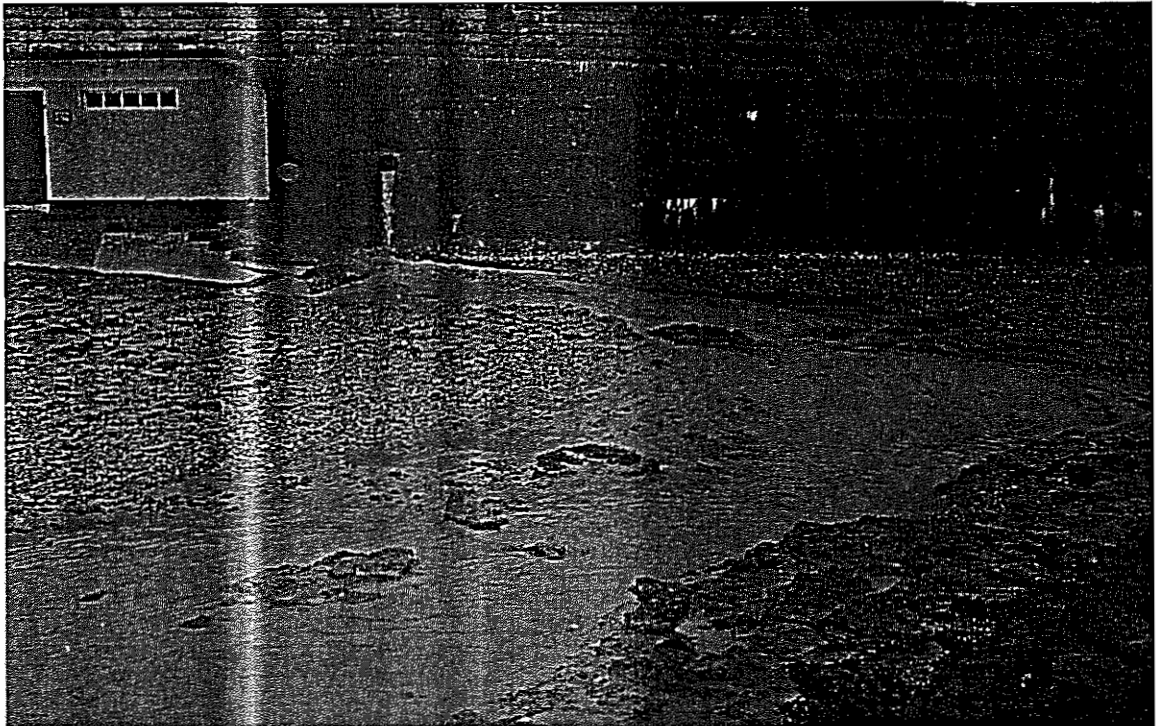
Surface water run-off in vicinity of Biscayne, Coast Road.

Surface water run off flowed into sea, with large quantities of silt. This also caused the Coast Road to be flooded in areas.

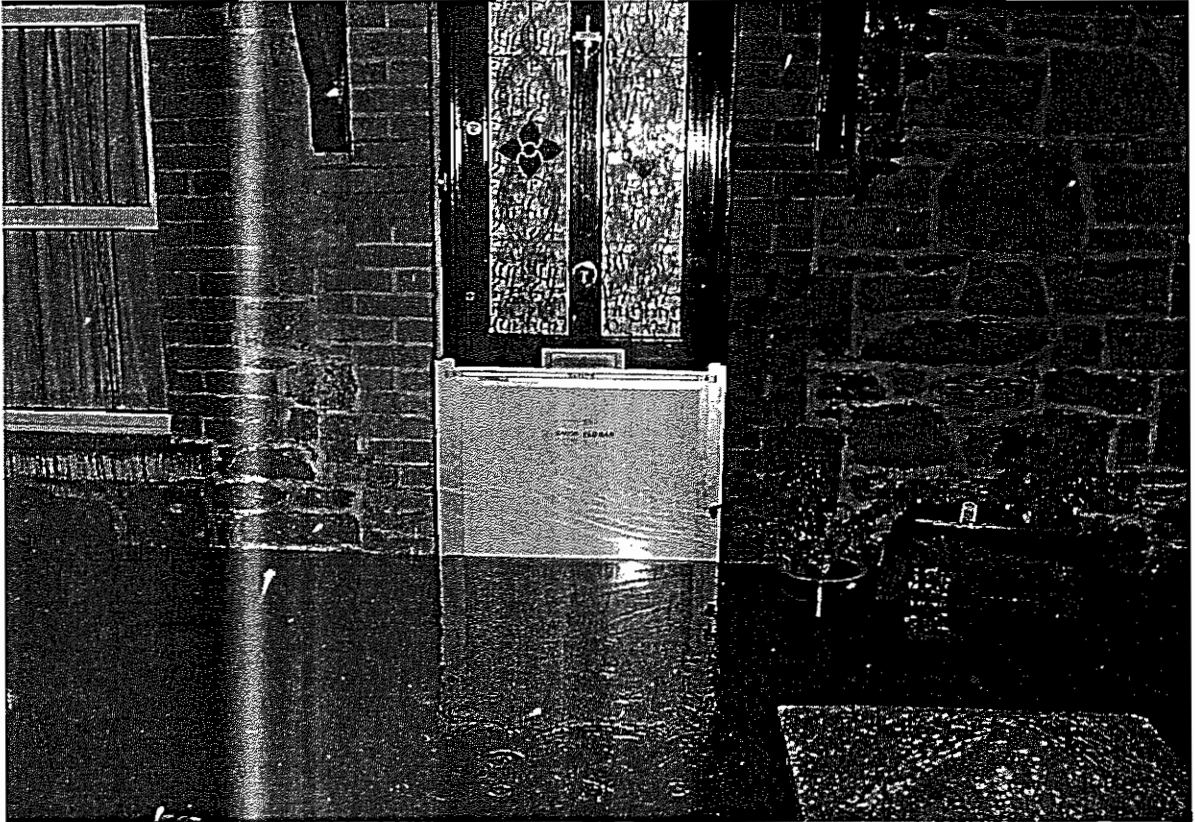
Flooding of houses just off Kinsaley Lane

Two houses on this road were flooded due to the overflowing of the Sluice River. The Drainage Section provided sandbags, but were unable to prevent river water entering the houses.

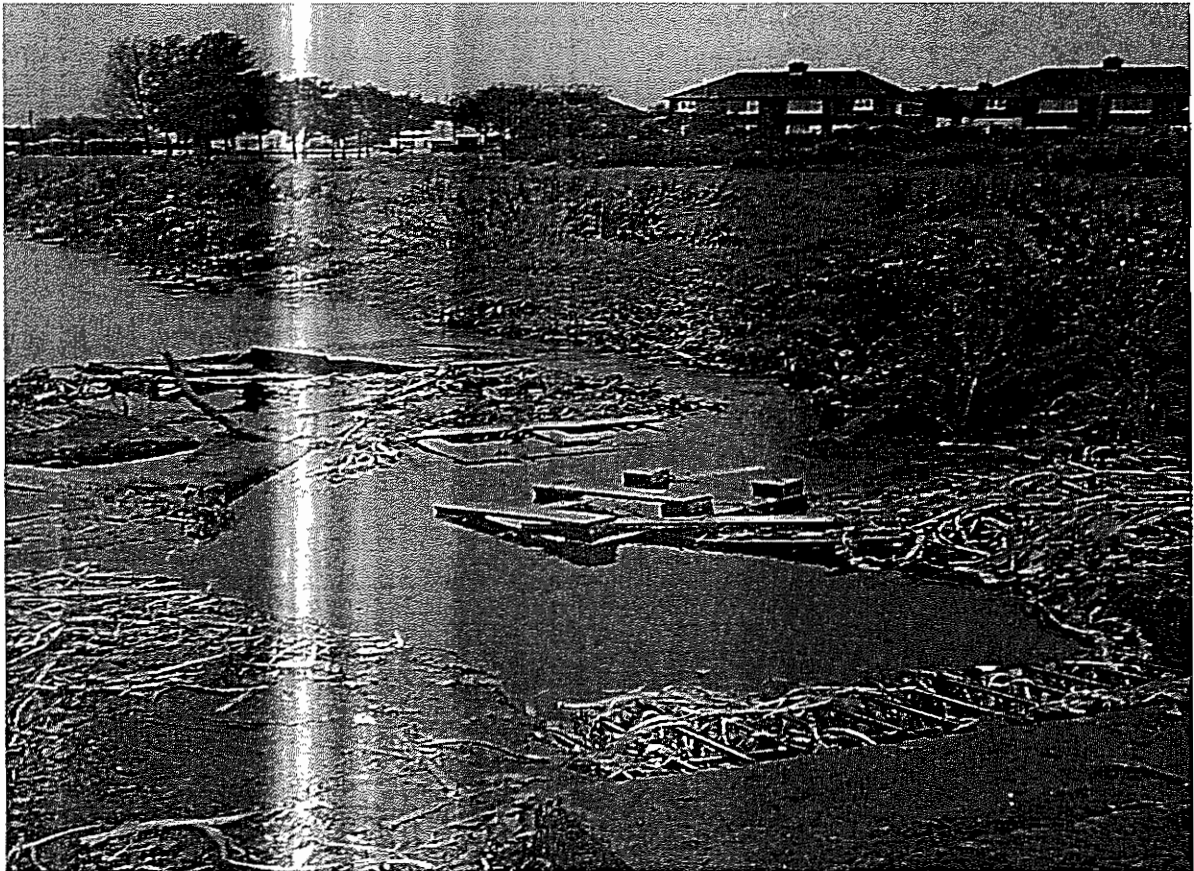
Surface Water Screen at Seagrang Park, Baldoyle.

The surface water screens in Seagrang Park were obstructed with material, which contributed to the flooding of the Grange Road. The main cause of the flooding was blocked gullies. The Drainage Section provided sandbags to some houses on Brookstone Road to prevent surface water from the road entering the house.

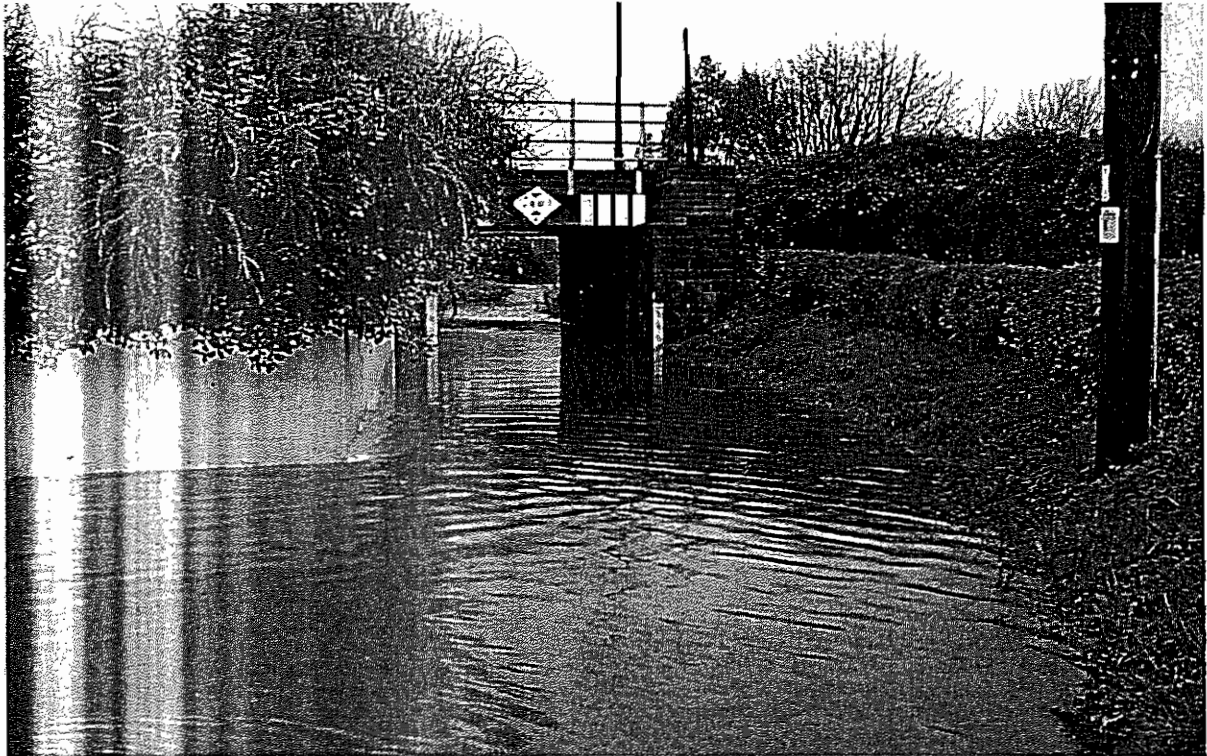
S.W. flooding at Railway in Ballisk.

Surface water floods the road under the main Dublin-Belfast railway line. The S.W. is overflowing from ditch onto the road and also causes the foul sewer to surcharge. The Drainage Section cut an open channel from the road to a dry ditch, with a J.C.B, which solved the problem. The drives of a number of houses were flooded and the use of toilets was not possible.

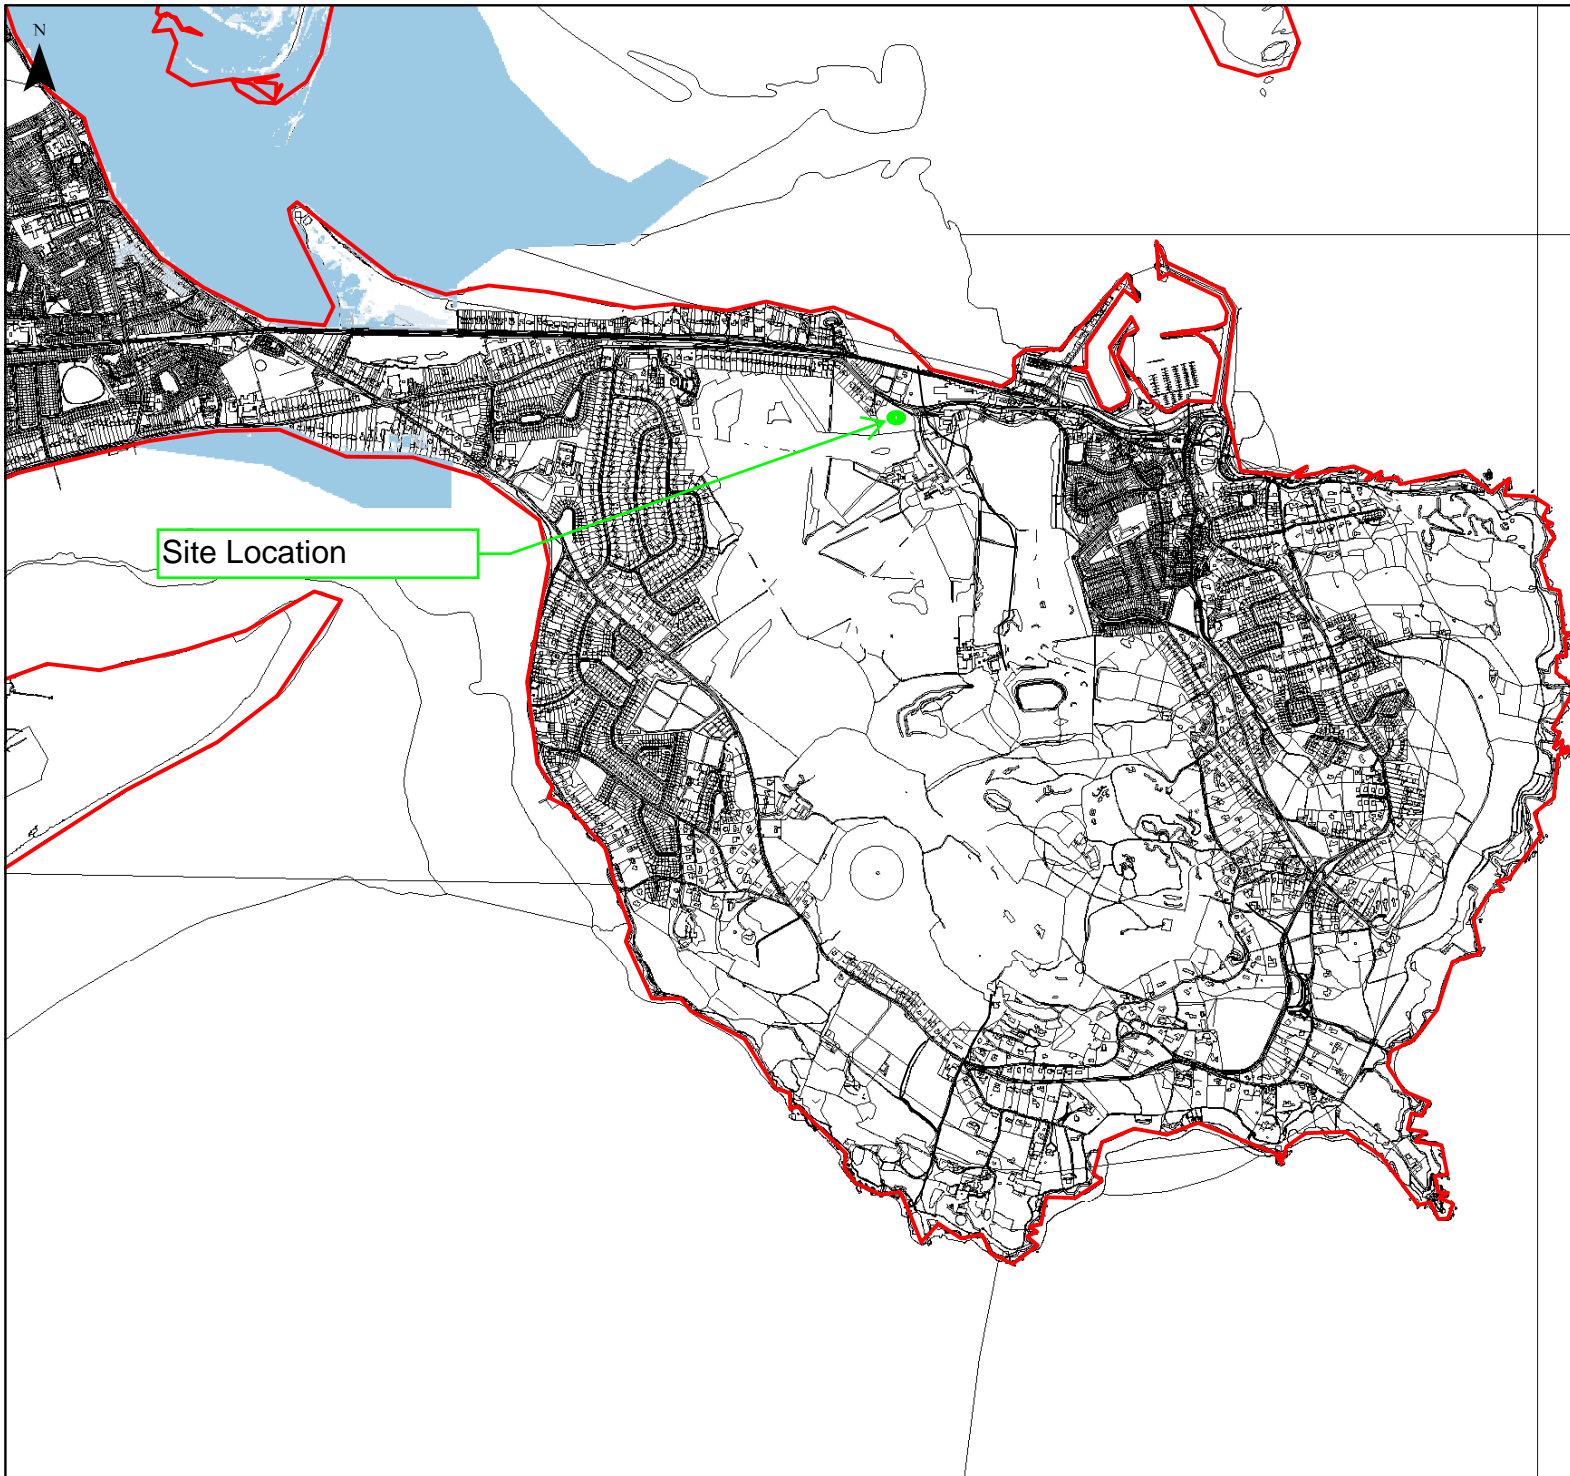
### Fluvial Flood Plan & Coastal Flood Plan

- Fingal County Boundary
- Watercourse Centreline
- Defended Area
- Flood Zone A - 1% AEP Flood Extent (1 in 100 chance in any given year)
- Flood Zone B - 1% AEP Flood Extent (1 in 1000 chance in any given year)
- Indicative Flood Extents
