**Engineering Services Report
Strategic Housing Development
Baldoyle-Stapolin Growth Area 3,
Baldoyle, Dublin 13**

ENGINEERING SERVICES REPORT

STRATEGIC HOUSING DEVELOPMENT

BALDOYLE-STAPOLIN GROWTH AREA 3, BALDOYLE, DUBLIN 13

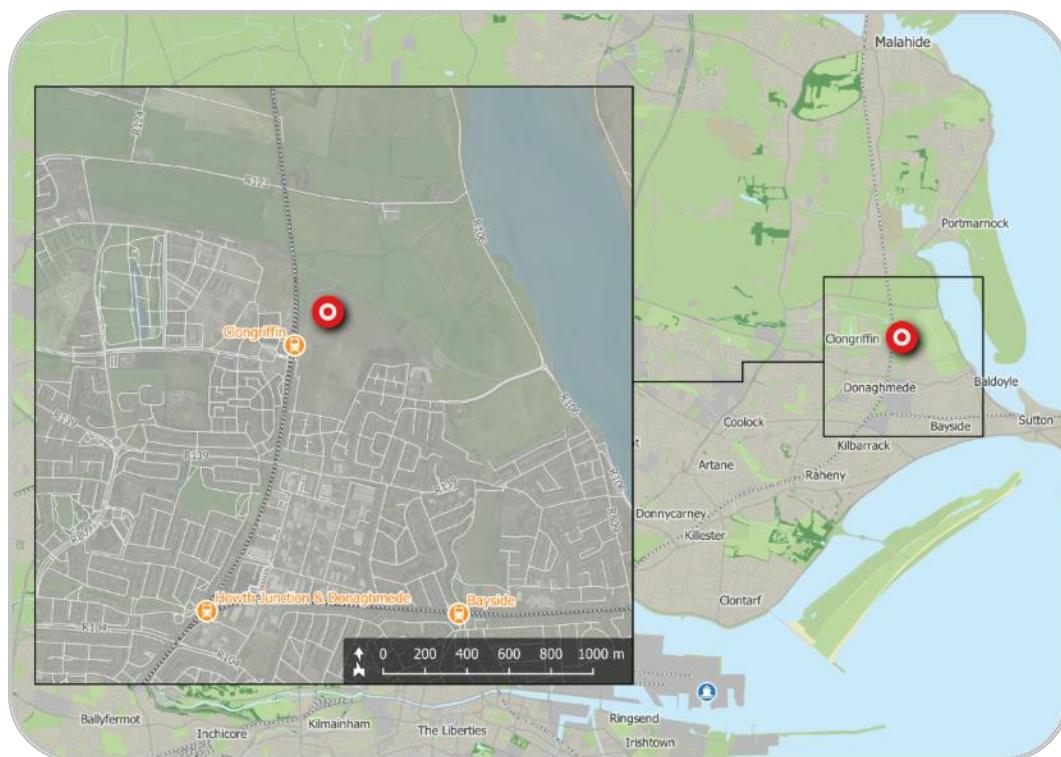
Figure 1 – Location of proposed development site
(map data & imagery: EPA, OSM Contributors, Google)

The location of the proposed development site is shown in Figure 1 above; The site is bounded generally to the west by The Dublin-Belfast rail line, to the north High Amenity Lands and to the east and south zoned lands . There is currently no vehicular access to the subject site from the public road

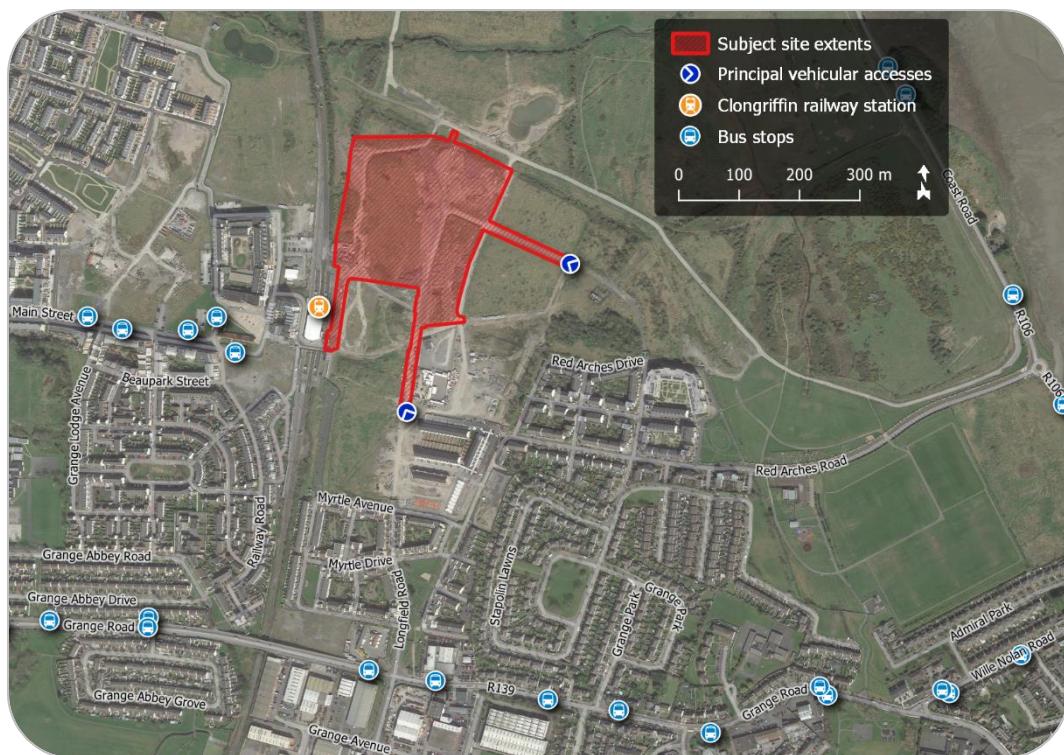
Figure 2 – Site extents and environs
 (map data & imagery: NTA, OSM Contributors, Google)

network. Longfield Road connects to Grange Road (R139) approx. 650m to the south of the subject site; Red Arches Avenue connects to Red Arches Road, which in turn connects to Coast Road (R106) approx. 950m to the east of the subject site.

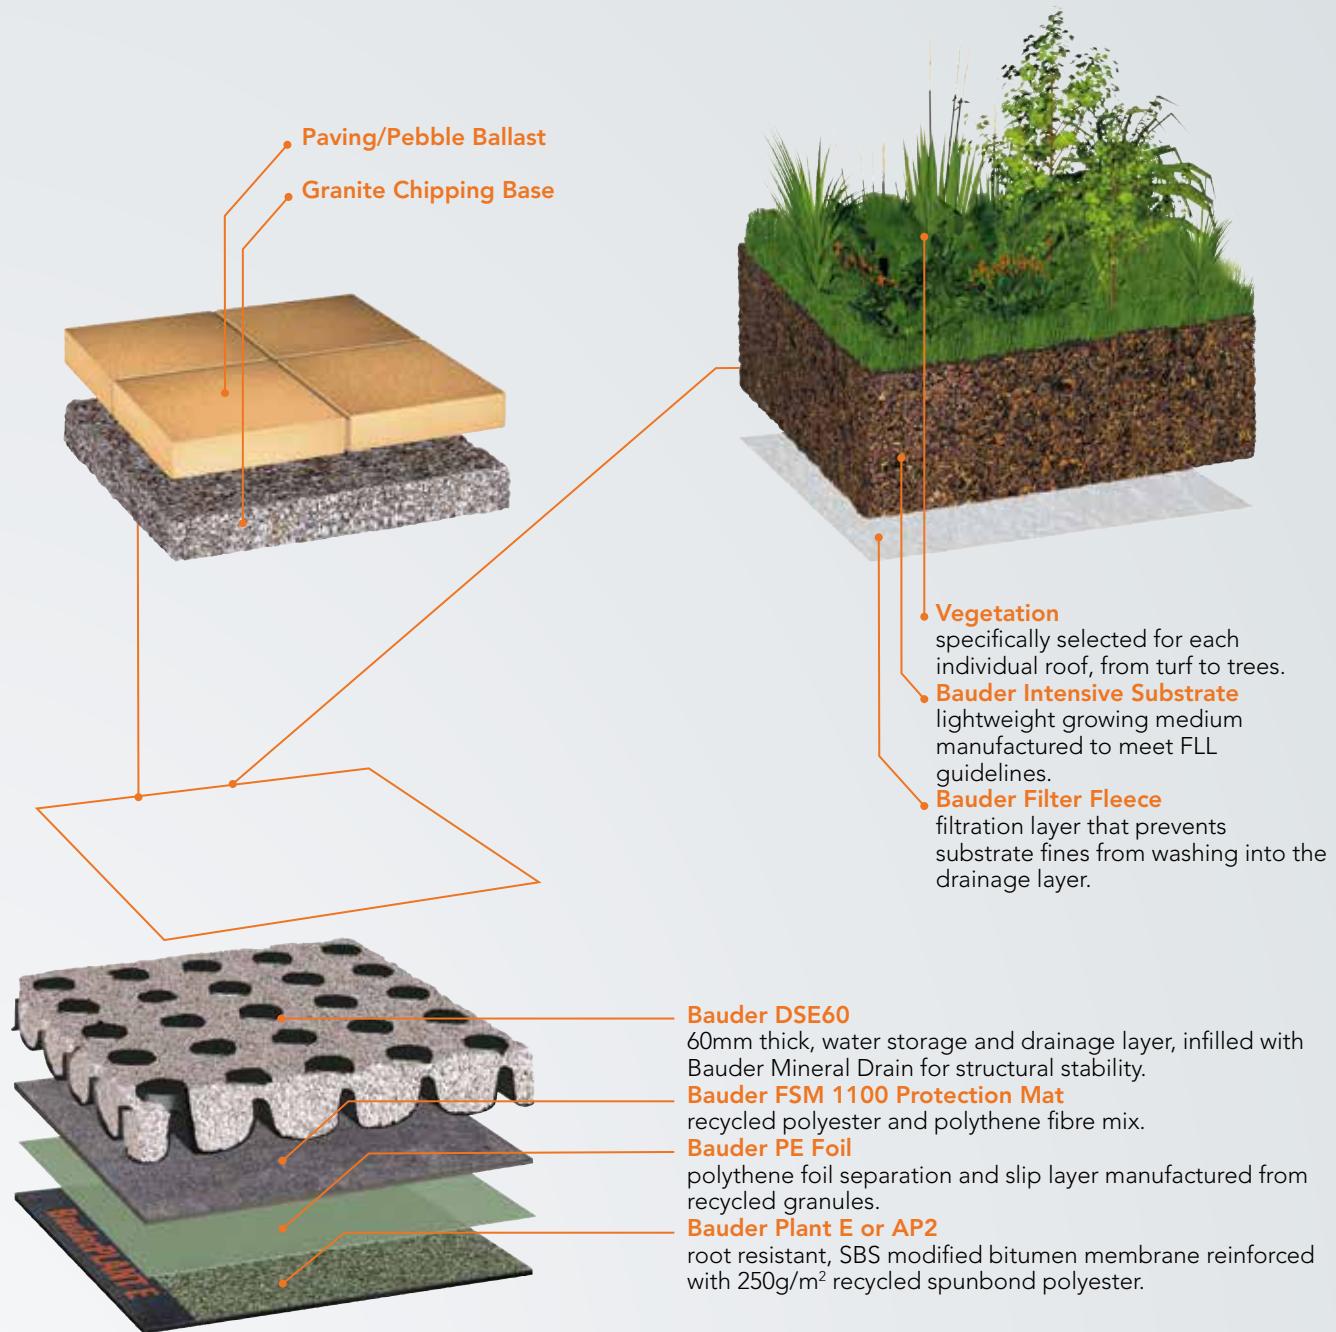
SUBSTRATE GREEN ROOFS

These extensive green roof systems are primarily used for their ecological benefits or aesthetic appearance rather than for general access or for leisure purposes.

A traditional extensive substrate green roof system provides a depth of growing medium usually around 80-120mm to allow for the specification of a broader range of species and planting schemes. The plants are generally low maintenance, wind, frost and drought resistant and can be installed by different methods, including plug planting, vegetation mat and seeding.

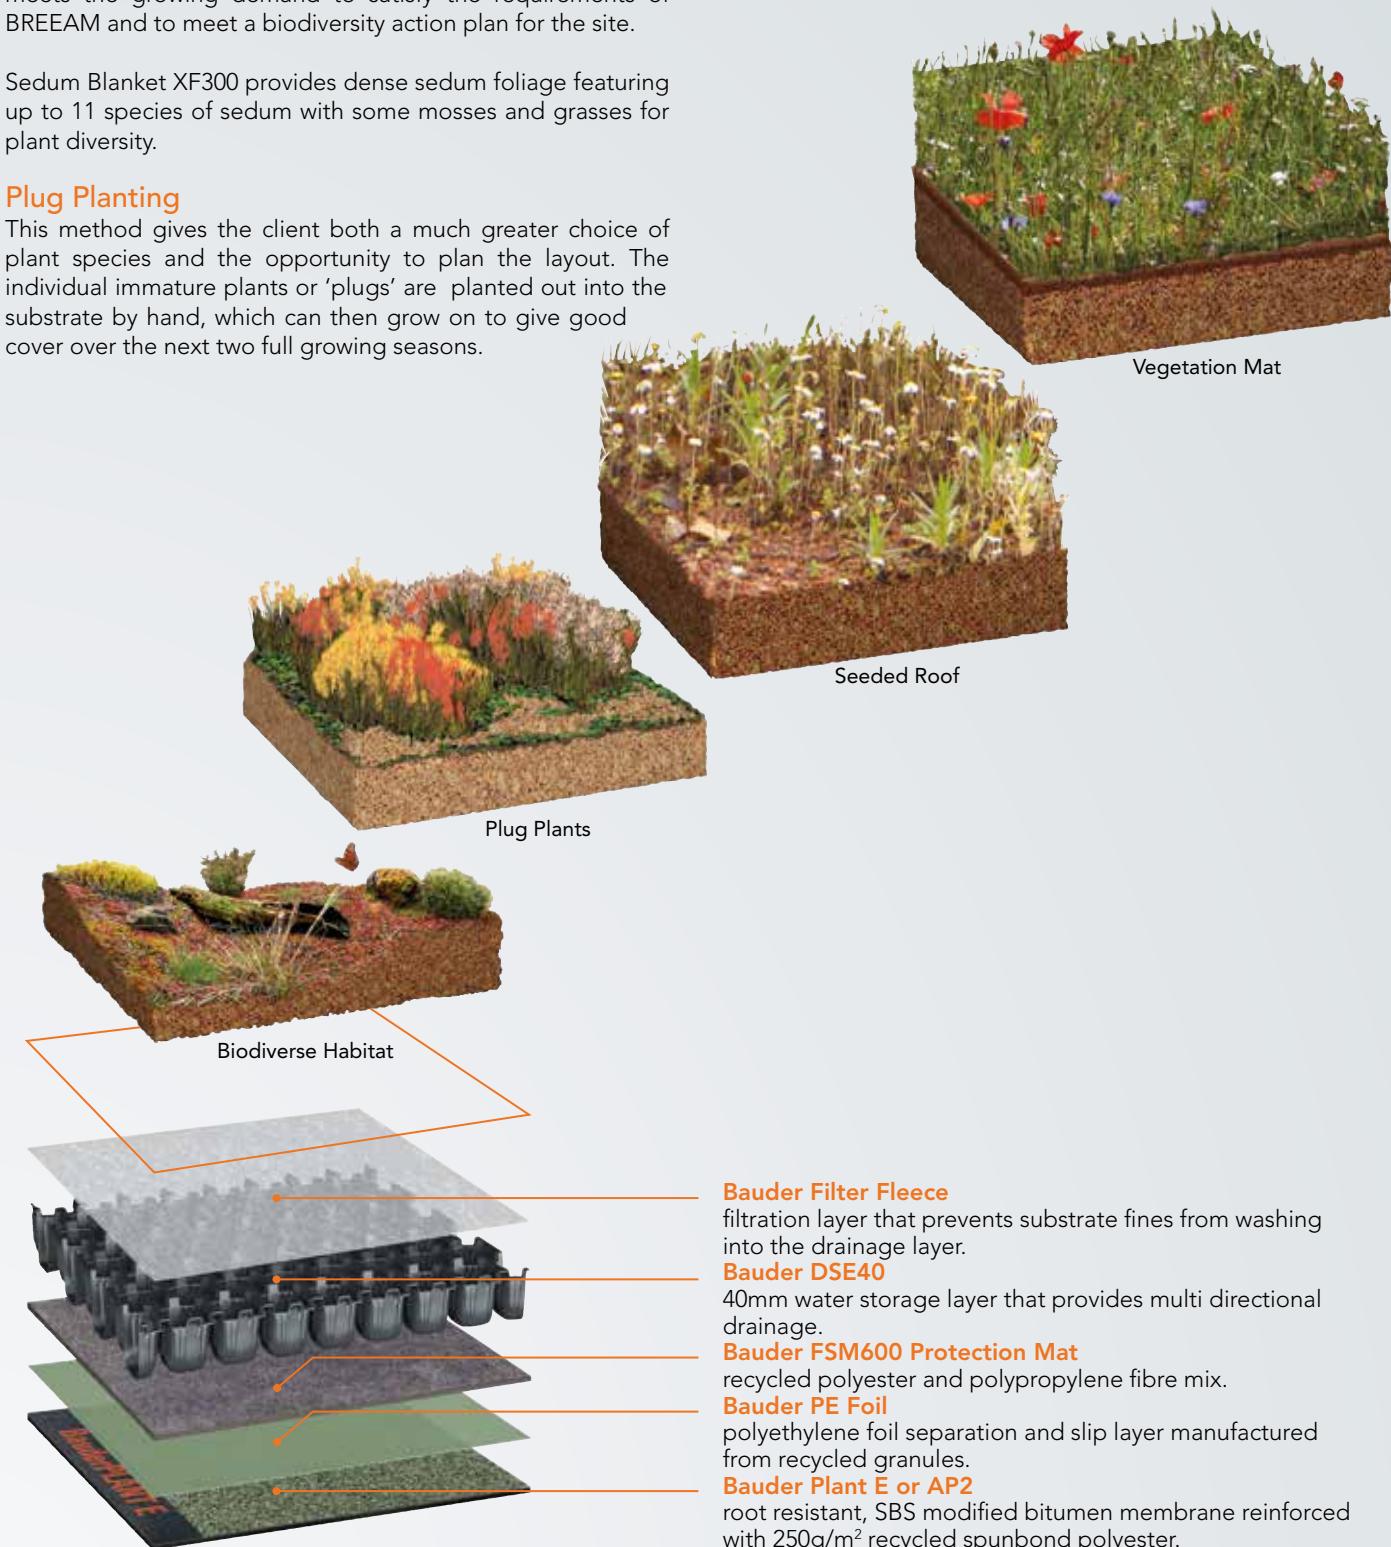
Substrate Pitch Roof Systems - Configurations Over 10°

An extensive substrate system on a pitch greater than 10° requires a water retention and storage board that will hold the substrate firmly in place and be sufficiently rigid to prevent board flexure and manage the imposed sheer load.

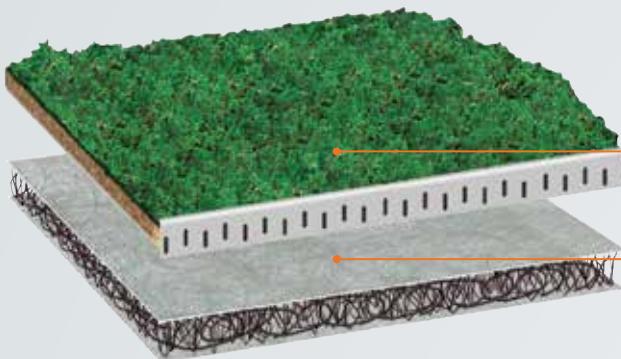
Bauder XF301 Sedum System

pre-cultivated vegetation blanket on a patented nylon loop and geo-textile base carrier with special substrate and a pre-attached integral 8mm moisture retention fleece.

multifunctional drainage, filtration and protection layer manufactured from ultraviolet resistant nylon woven loops which are thermally bonded to geo-textile filter fleece facings.

The multi-functional XF301 sedum system combines the vegetation support layer with a moisture retention fleece to provide the perfect base for all roofing scenarios with a labour efficient installation.

The pre-attached fleece is a unique feature of our XF301 sedum system, retaining moisture after rainfall and thus allowing the plants to take up the water for future use. The sedums are grown to maturity before being harvested, thus ensuring that they acclimatise quickly to their new rooftop location.

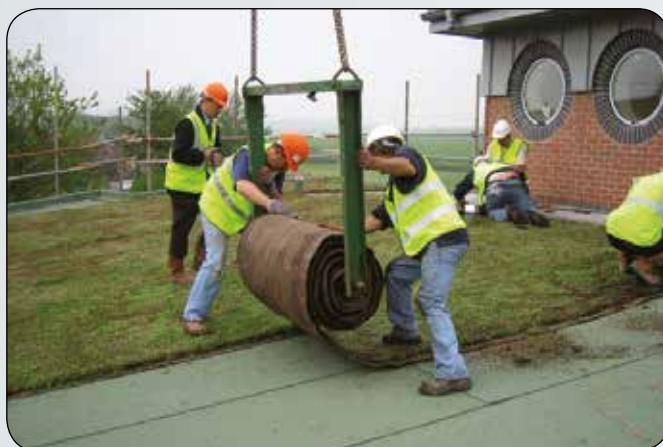
Long length rolls being craned into position and installed.

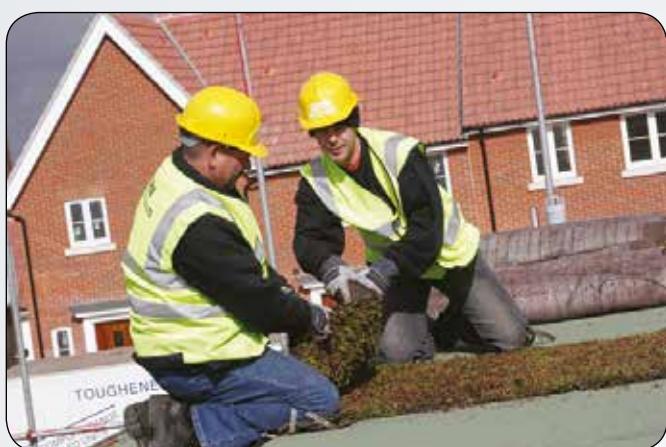
Short 2m rolls of XF301 Sedum System installed by hand.

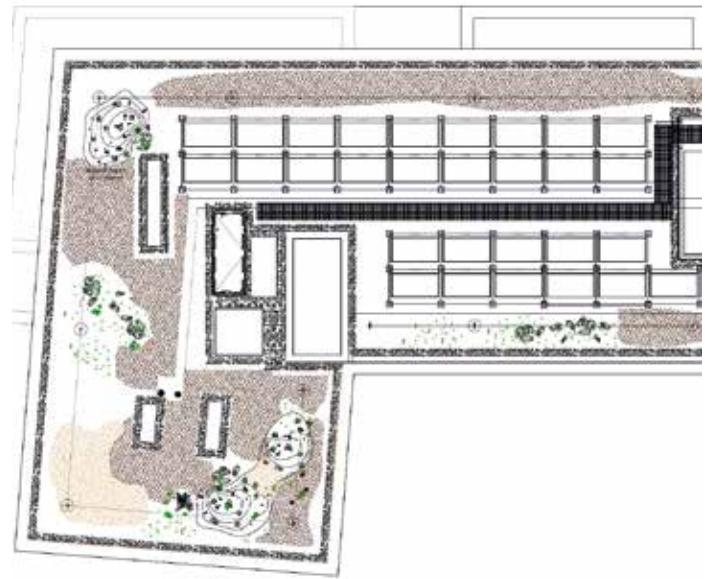
Biodiverse Roof Plans

In discussions with architects we can interpret the ecological requirements to show a detail 'layout' drawing for the mounding of substrate and location of planting and surface finishes, ensuring the loading of the roof is compatible with the roof structure.

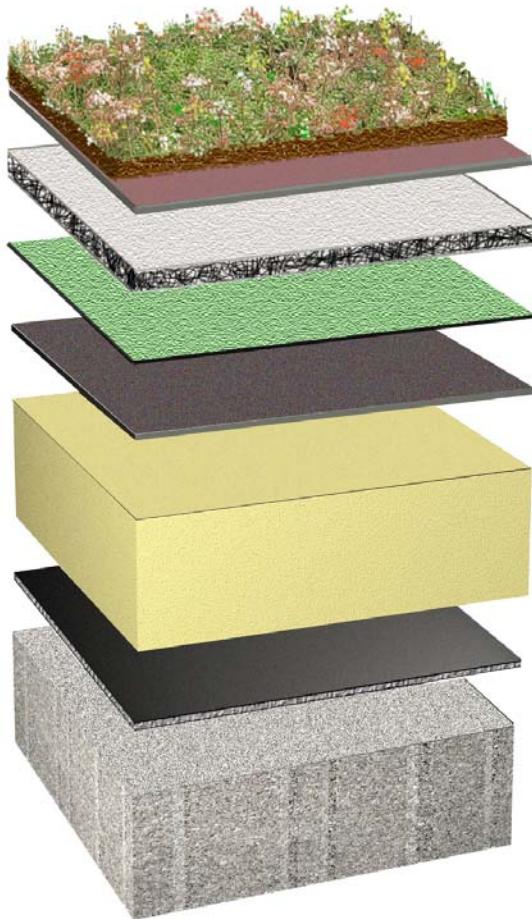
**Xero Flor sedum blanket system – Construction and Saturated loading
Insulated with roof fall of 1° -2°**

**Bauder Xeroflor XF301
Sedum combination blanket**

Bauder SDF mat
