Residential Development, Sandford Road, Dublin 6

Site Specific Flood Risk Assessment

Sandford Living Limited

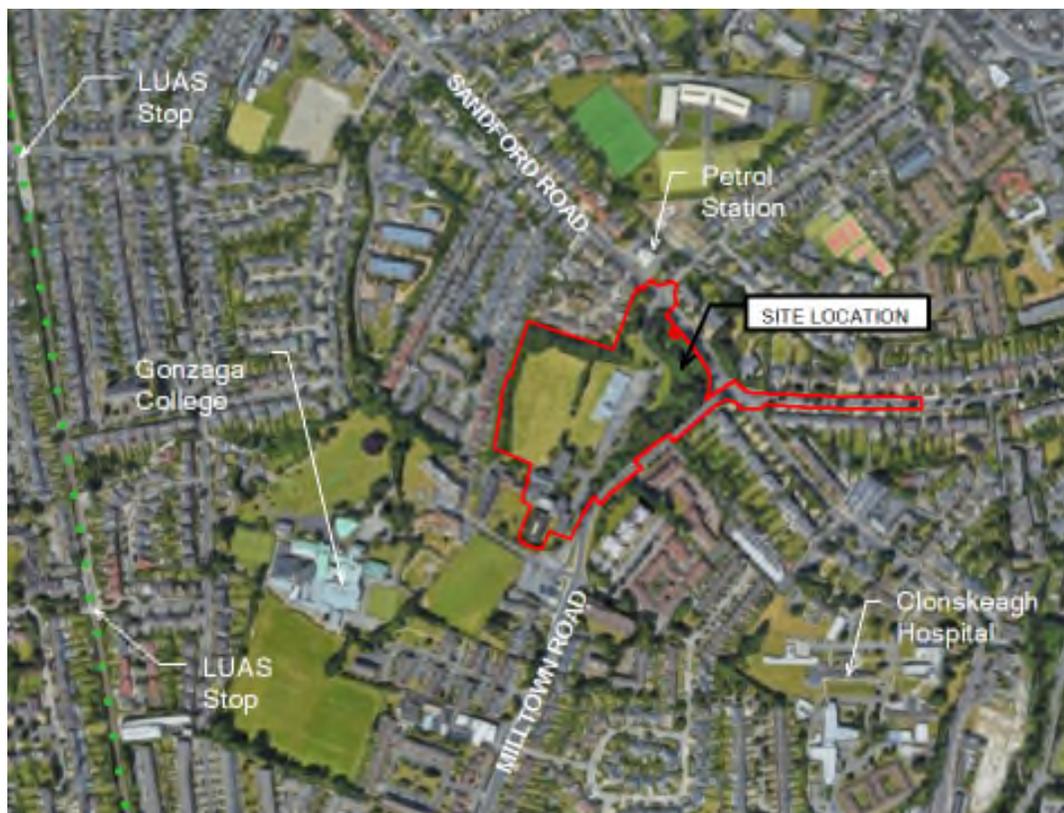
The site is bound by existing residential developments to the North and West, Sandford Road to the North East and Milltown Road to the South East (refer to Figure 1.1 below).

Figure 1.1 Site Location (Developable Site Boundary Indicative Only).

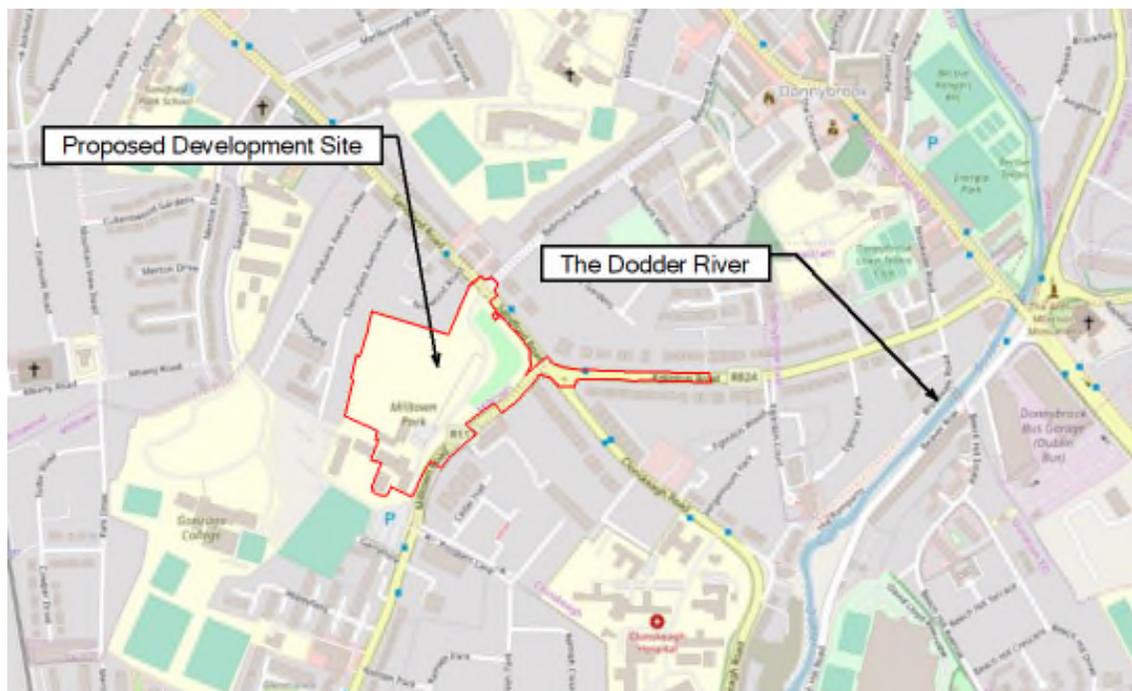
The closest river network as identified on the EPA's map viewer is the Dodder River located approximately 500m east of the site (refer to Figure 1.2 below).

Figure 1.2 Extract from EPA Online Mapping Service.

Source	Pathway	Receptor	Likelihood	Consequence	Risk
Fluvial	Overbank from Dodder River approx. 500m east of the site (refer to Figure 1.2)	People and Property (the proposed development).	Remote	Medium	Low
Surface Water (Pluvial)	Blockage and / or surcharging of the surface water drainage network	People and Property (the proposed development).	Possible	Medium	Medium
Human / Mechanical Error (Pluvial)	Failure of SuDS measures (e.g. Hydrobrake failure)	People and Property (the proposed development).	Possible	Medium	Medium
Groundwater	Rising groundwater levels within the site	People and Property (the proposed development).	Remote	Low	Low

The location of the Dodder River in relation to the site is shown in Figure 1.2.

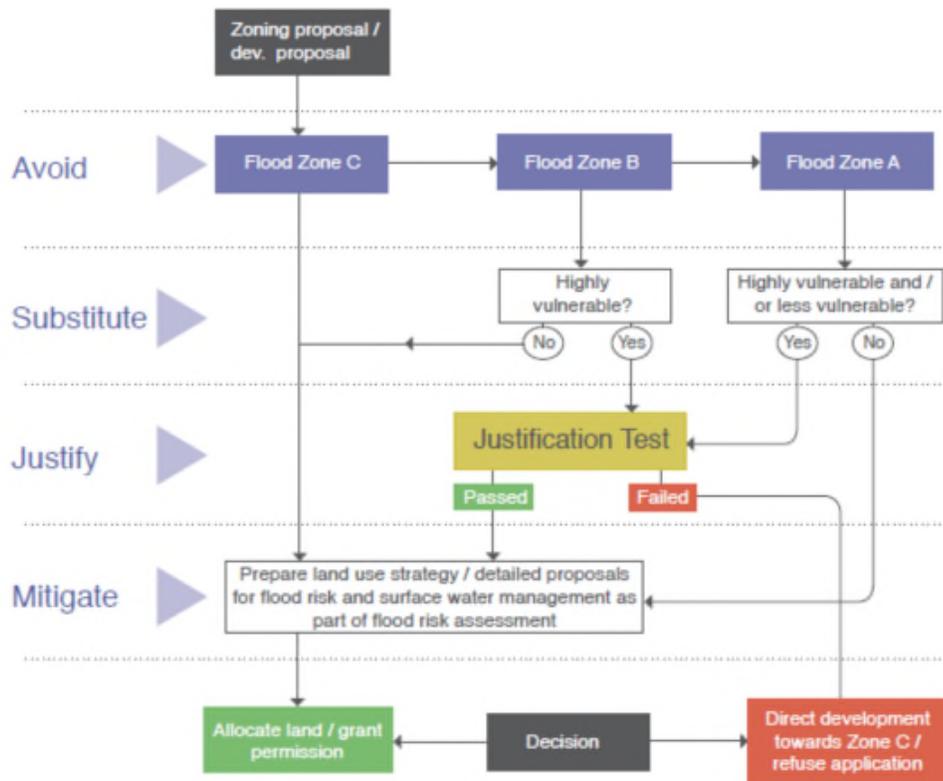
This SSFRA will initially use existing flood risk information to determine the flood zone category of the site i.e. to determine whether the development is considered appropriate or whether a justification test is required (see Figure 2.1 below).

Figure 2.1 – Extract from *The Planning System and Flood Risk Management Guidelines* (Fig. 3.2 Sequential Approach Mechanism in the Planning Process)

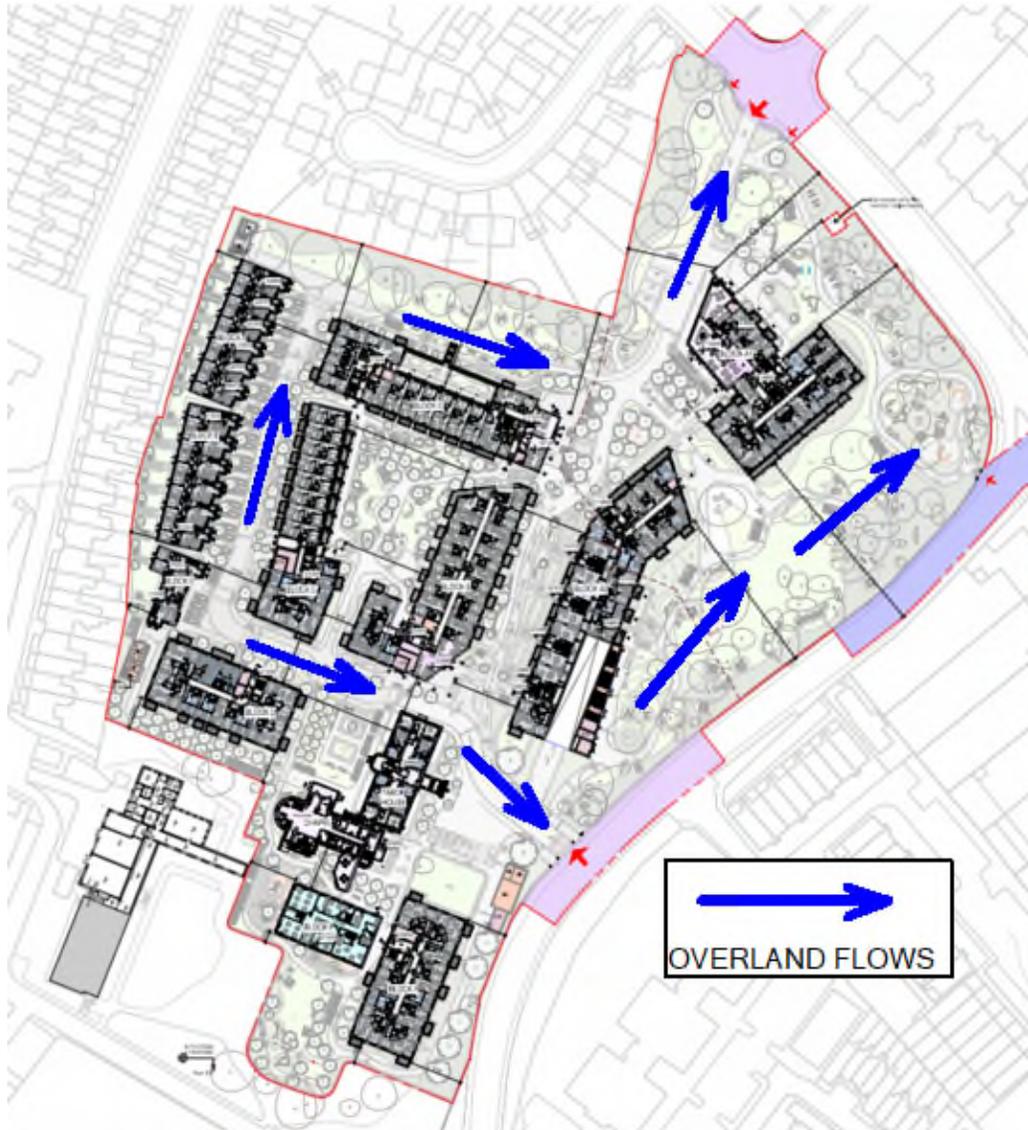
Proposed site levels fall towards the site's northern and eastern boundaries. Overland flow is therefore directed towards the open space areas and public roads located north and east of the site (refer to Figure 5.1).

Figure 5.1 – Flood Exceedance (>1%AEP) Overland Flow Routes

For storms greater than the 1%AEP pluvial event, the development's drainage network design will be exceeded and areas with low ground levels may begin to flood.

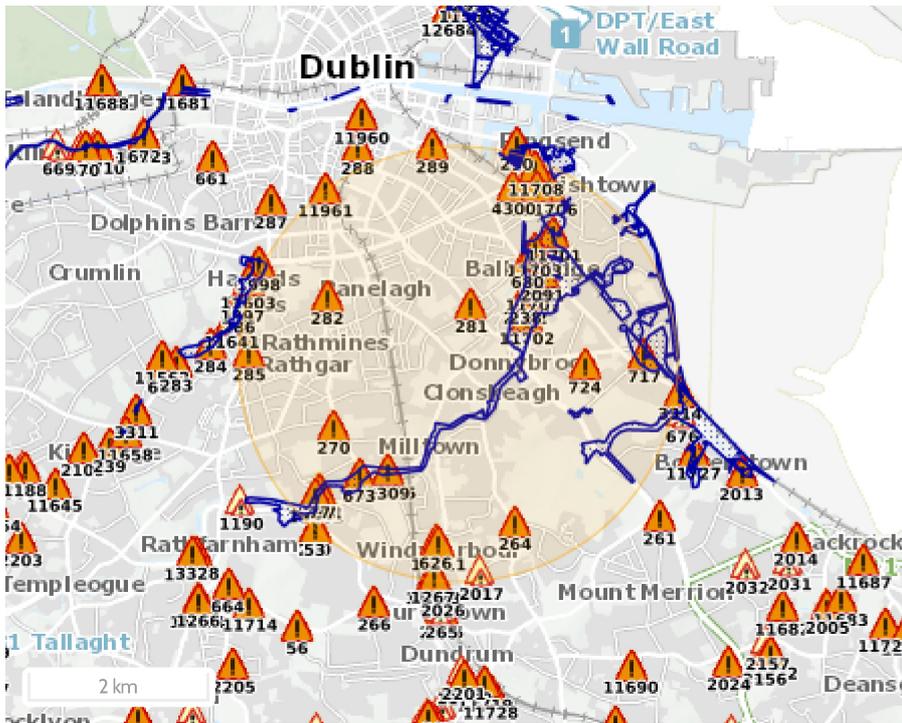
This Past Flood Event Summary Report summarises all past flood events within 2.5 kilometres of the map centre.

OPW's Summary Local Area Report is included in Appendix A (Flood Hazard Information). This report is sourced from the OPW website ([www.floodmaps.ie](http://www.floodmaps.ie)) and summarises all flood events within 2.5 km of the site. No flood events are noted in the immediate vicinity of the site.

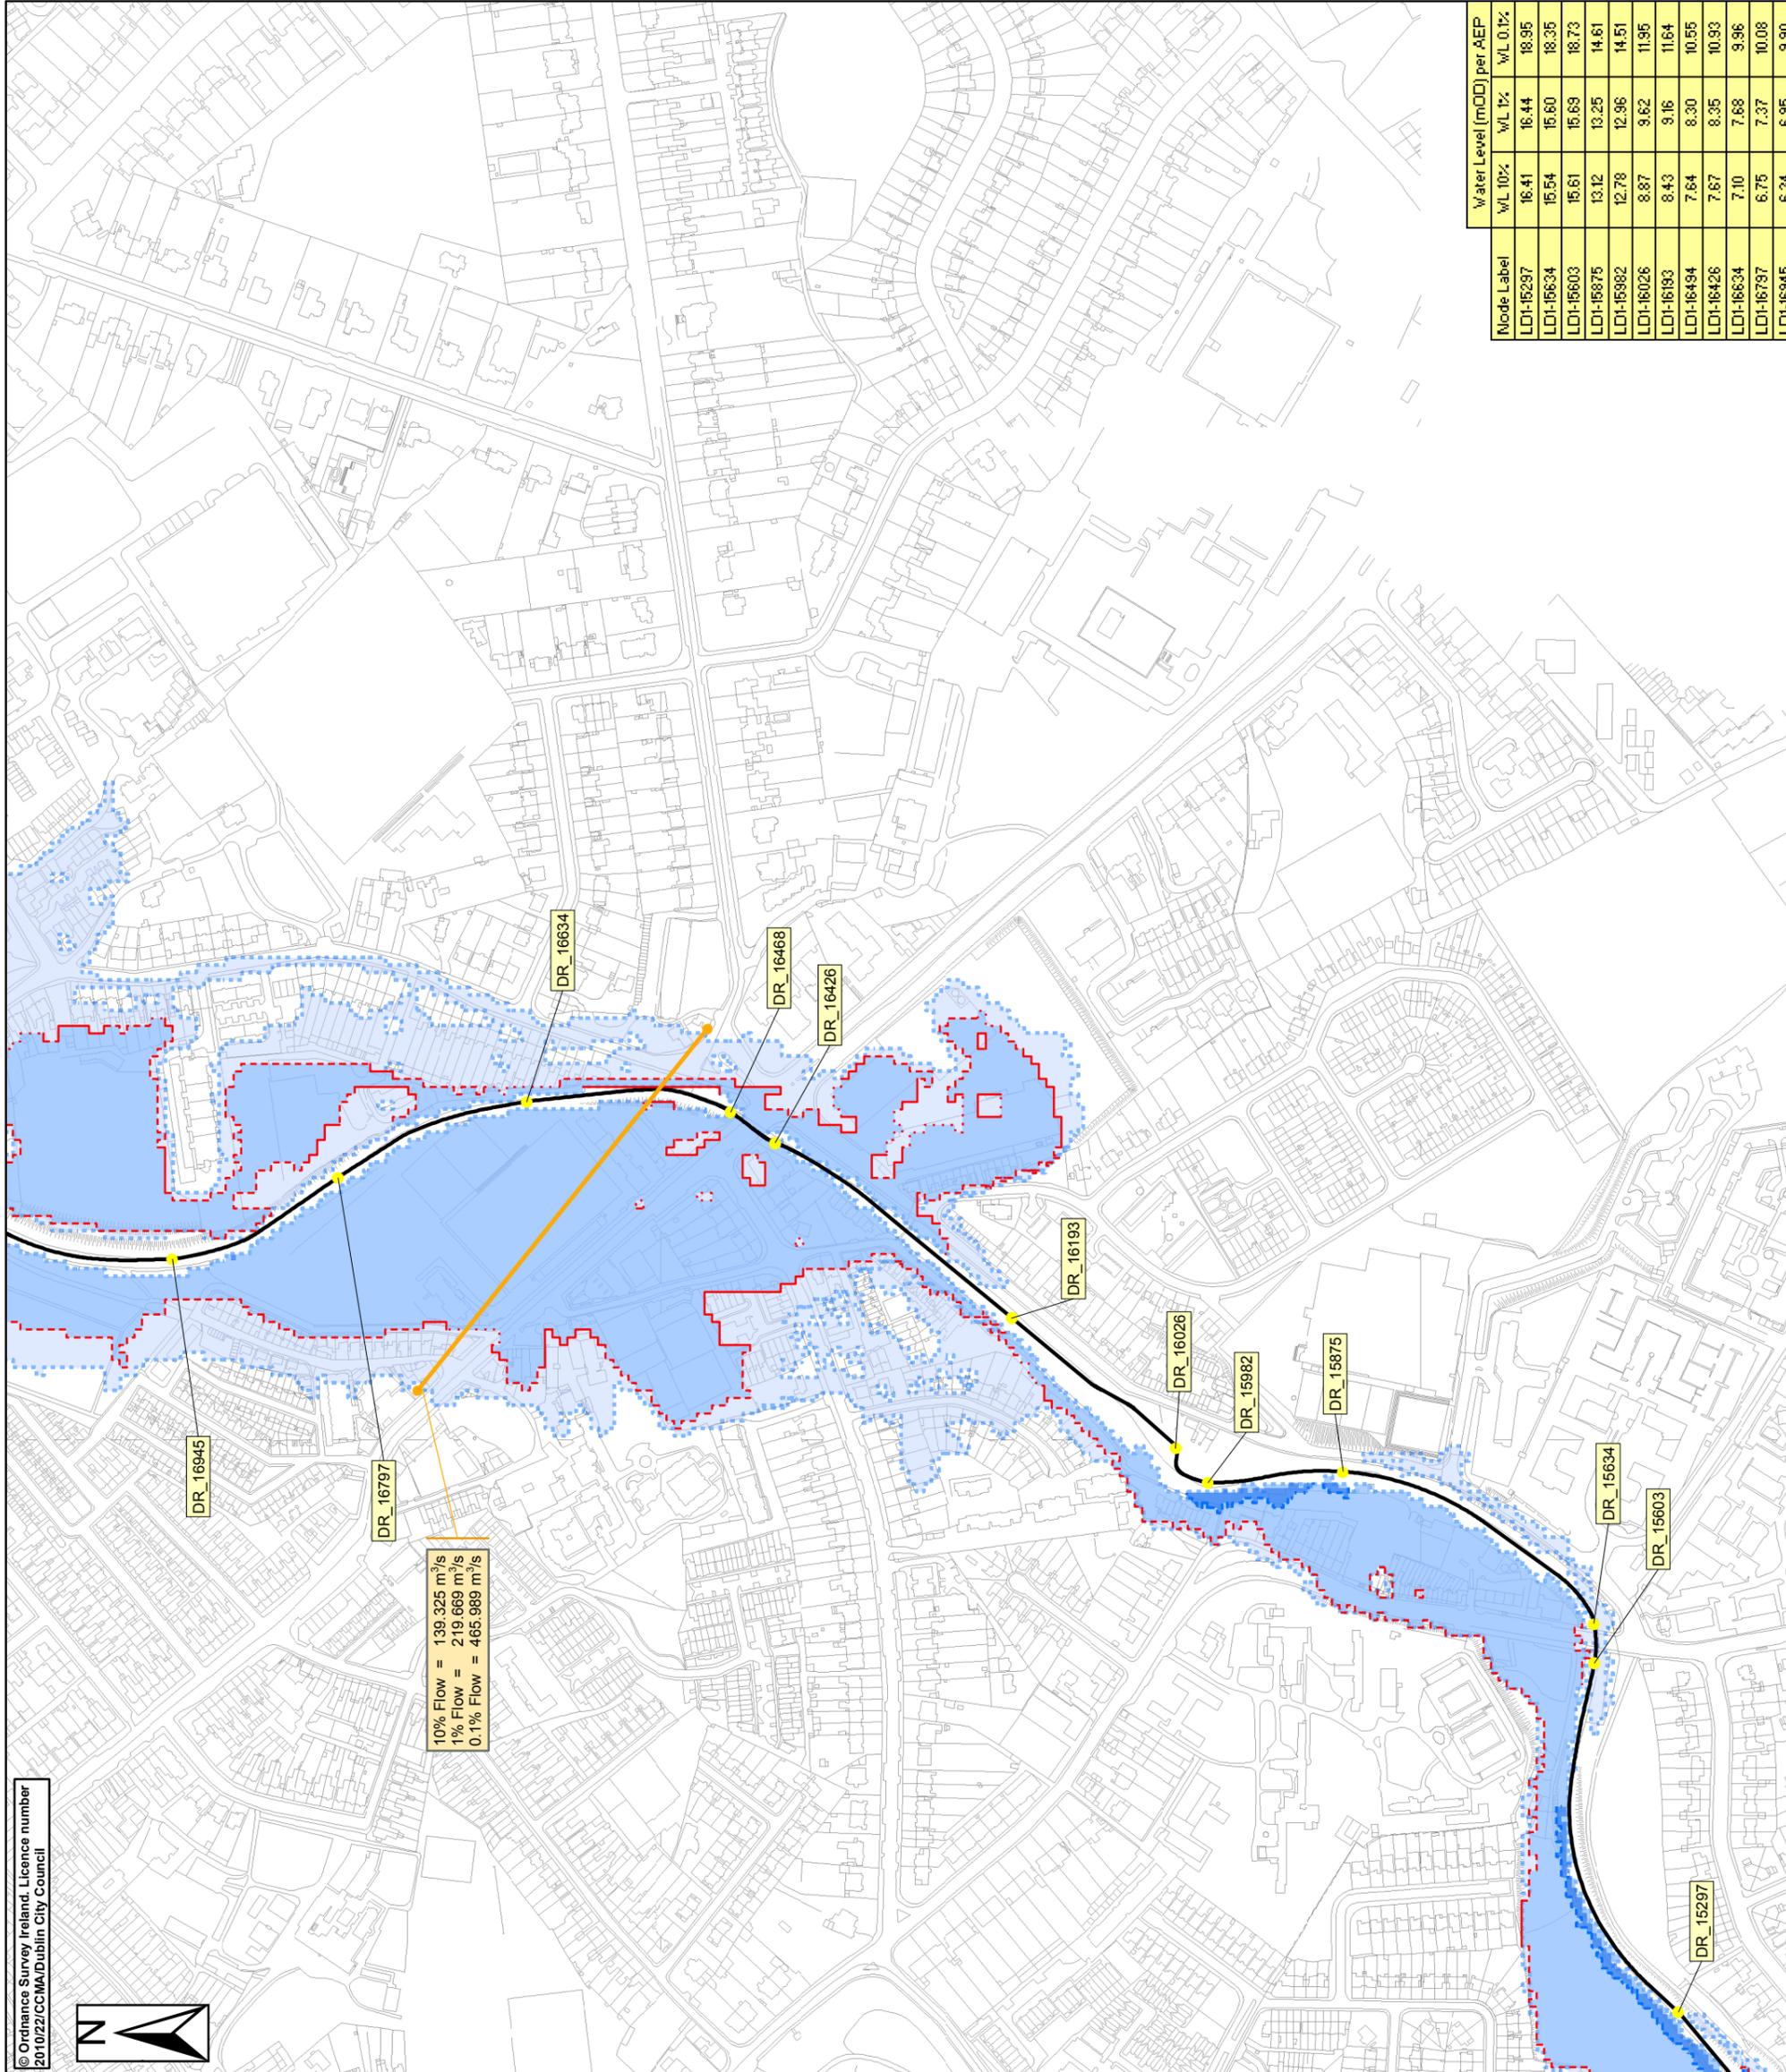
10% Flow = 139.325 m<sup>3</sup>/s  
1% Flow = 219.669 m<sup>3</sup>/s  
0.1% Flow = 465.989 m<sup>3</sup>/s

Node Label	Water Level (mOD) per AEP	
	W/L 10%	W/L 0.1%
LD1-15297	16.41	18.95
LD1-15634	15.54	18.35
LD1-15603	15.61	18.73
LD1-15875	13.12	14.61
LD1-15982	12.78	14.51
LD1-16026	8.87	11.95
LD1-16193	8.43	11.64
LD1-16494	7.64	10.55
LD1-16426	7.67	10.33
LD1-16634	7.10	9.96
LD1-16797	6.75	10.08
LD1-16945	6.34	9.90

Extracts from the Dodder CFRAM Study (Fluvial Flood Extent and Fluvial Flood Depth Plans) are included in Appendix A (Flood Hazard Information) which indicates the extent of fluvial flooding in the area. No fluvial flooding is indicated in the vicinity of the site.

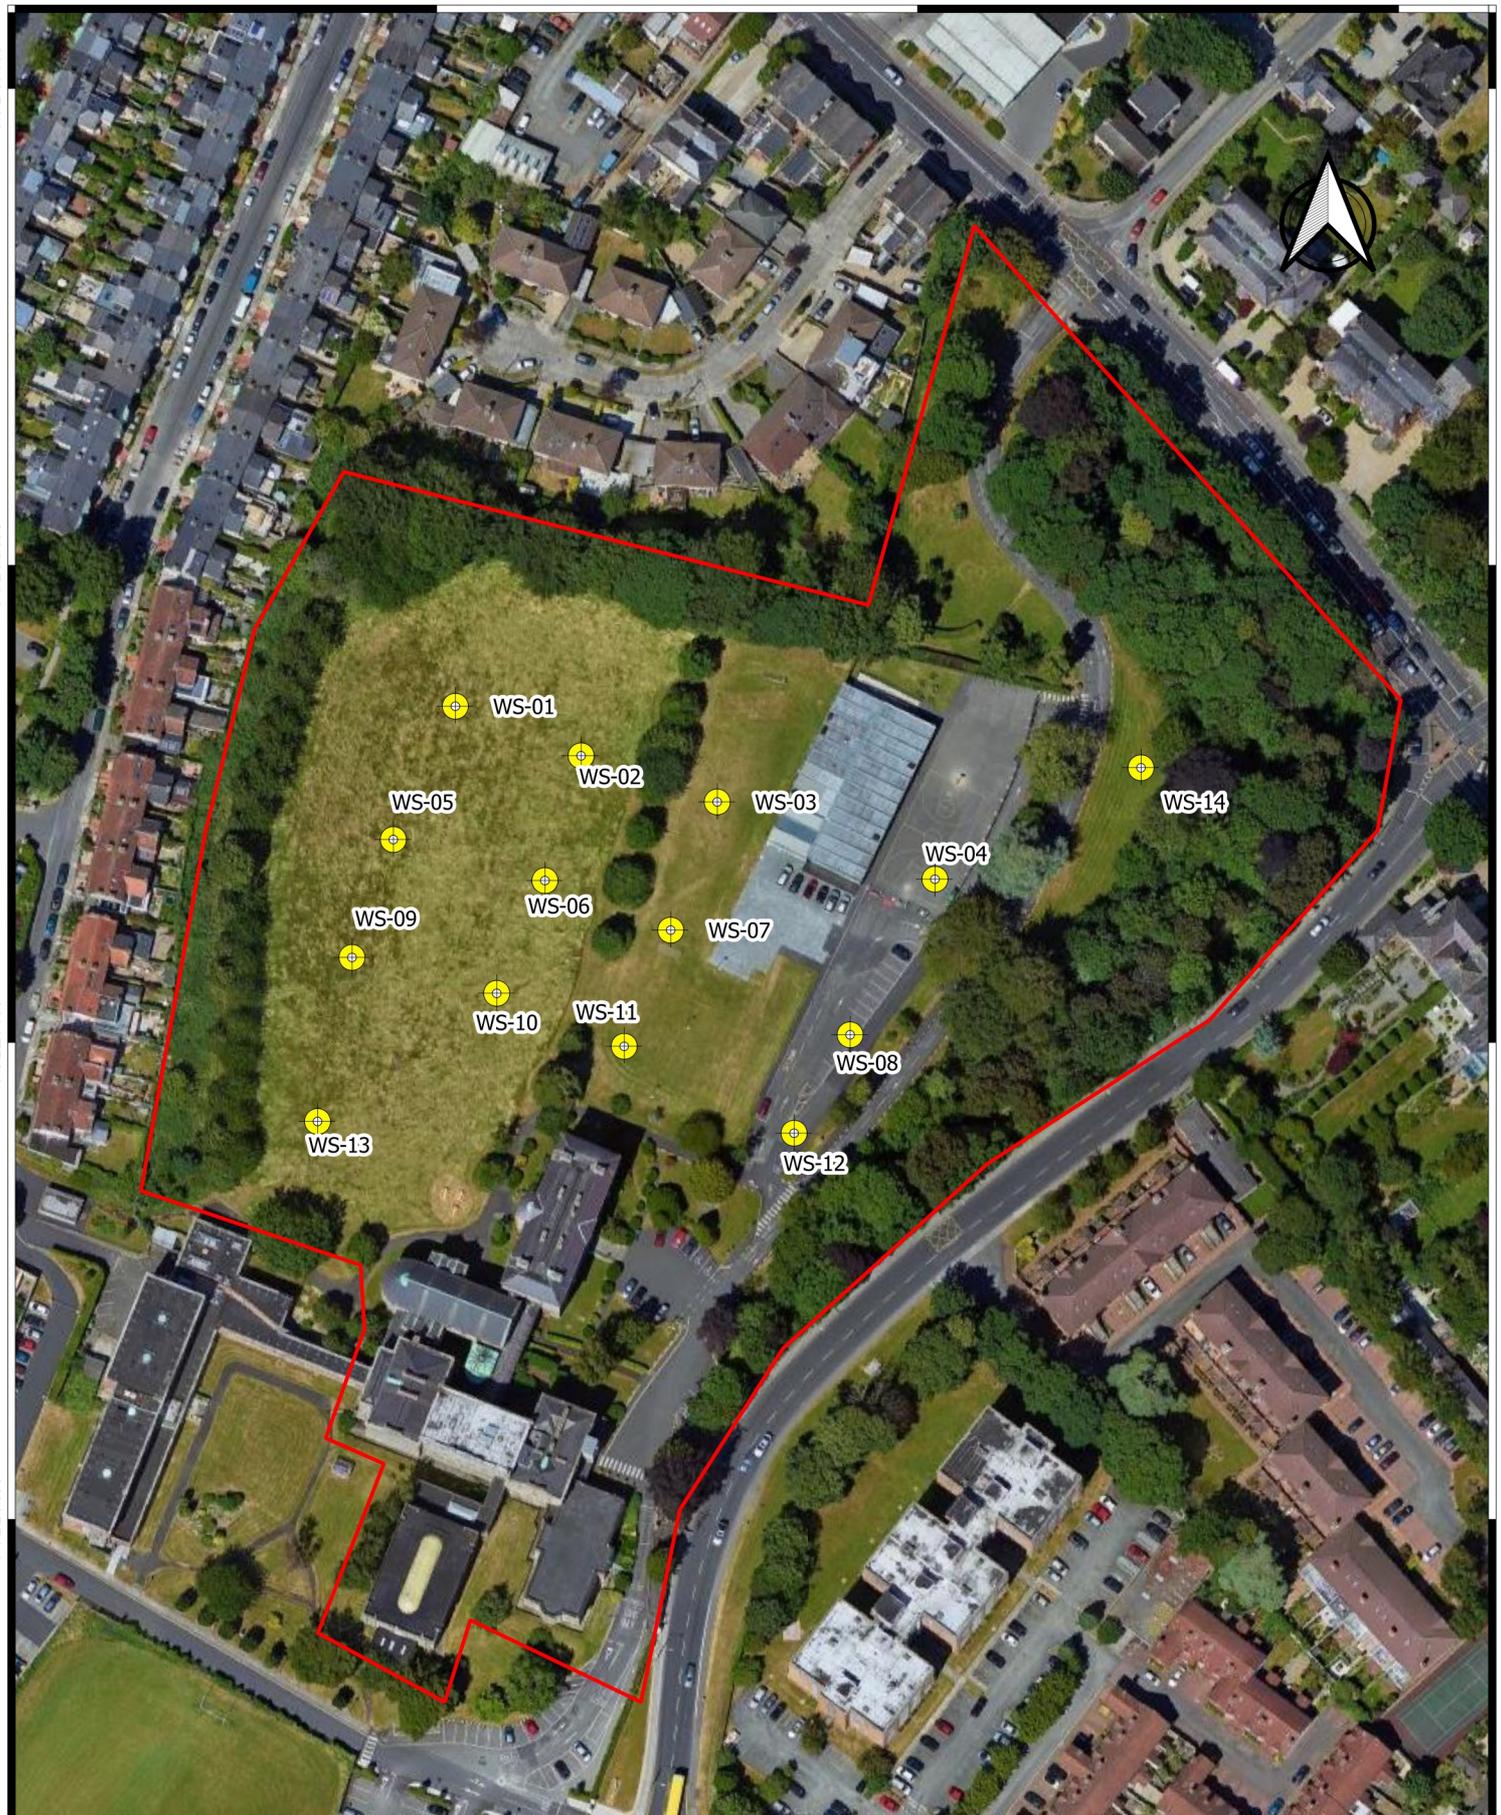
- Indicative Site Boundary
- Borehole
- CBR
- Dynamic Probe
- Trial Pit
- Window Sample
- Soakaway

The trial pits were excavated using a JCB 3CX or 3T excavator at the locations shown in the exploratory hole location plan in Appendix 1. The locations were checked using a CAT scan to minimise the potential for encountering services during the excavation. The trial pits were sampled, logged and photographed by a Geotechnical Engineer/Engineering Geologist prior to backfilling with arisings. Notes were made of any services, inclusions, pit stability, groundwater encountered and the characteristics of the strata encountered and the exposed foundations were logged and sketched prior to backfilling and reinstatement. The logs and sketches are provided in Appendix 2 of this Report.

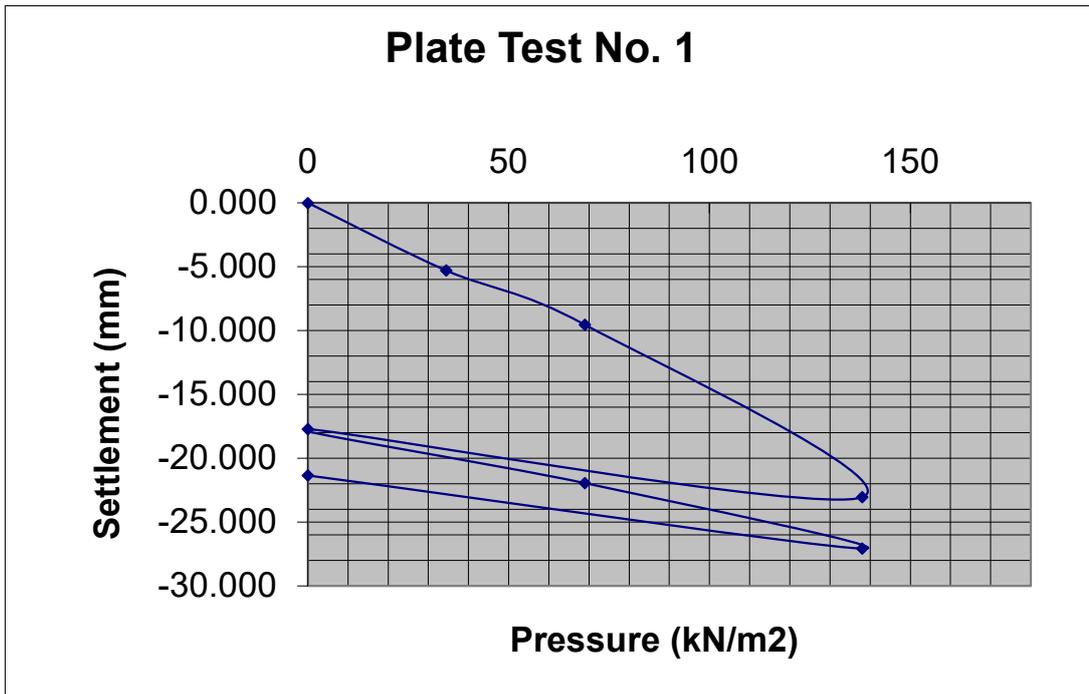
<b>LOCATION</b>	Sandford Park Milltown	<b>MATERIAL</b>	MADE GROUND: Light brown slightly sandy slightly gravelly Clay with rootlets and small redbrick and mortar fragments.
<b>CONTRACT NO.</b>	9338-12-19	<b>DEPTH</b>	0.40m
<b>DATE</b>	21/01/2020	<b>NOTES</b>	
<b>CLIENT</b>	DBFL	<b>SAMPLES</b>	
<b>PLATE DIAMETER</b>	457mm		
<b>TEST NO.</b>	CBR01

Modulus of subgrade reaction, K (Initial) = **4.89 MN/m<sup>2</sup>/m**  
 Modulus of subgrade reaction, K (Reload) = **11.01 MN/m<sup>2</sup>/m**

Equivalent CBR(initial)in accordance with HD25/94 volume7 section2 = **0.15 %**  
 Equivalent CBR(reload)in accordance with HD25/94 volume7 section2 = **0.62 %**

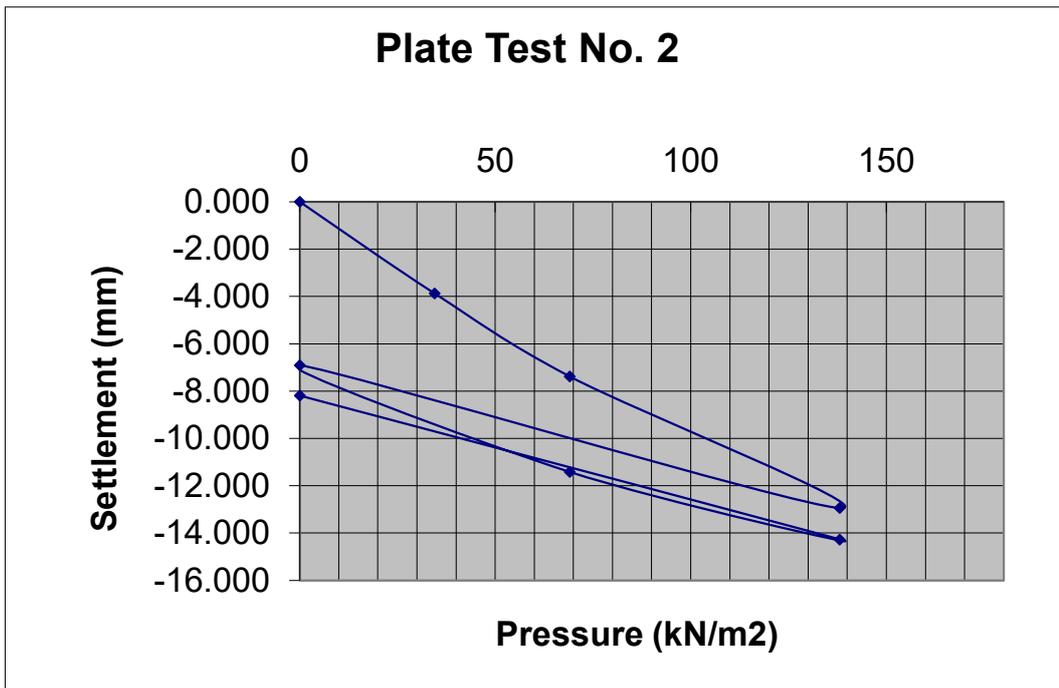
<b>LOCATION</b>	Sandford Park Milltown	<b>MATERIAL</b>	MADE GROUND: Light brown slightly sandy slightly gravelly Clay with rootlets and small redbrick fragments.
<b>CONTRACT NO.</b>	9338-12-19	<b>DEPTH</b>	0.40m
<b>DATE</b>	21/01/2020	<b>NOTES</b>	
<b>CLIENT</b>	DBFL	<b>SAMPLES</b>	
<b>PLATE DIAMETER</b>	457mm		
<b>TEST NO.</b>	CBR02

Modulus of subgrade reaction, K (Initial) = **6.32 MN/m<sup>2</sup>/m**  
 Modulus of subgrade reaction, K (Reload) = **10.33 MN/m<sup>2</sup>/m**

Equivalent CBR(initial)in accordance with HD25/94 volume7 section2 = **0.24 %**  
 Equivalent CBR(reload)in accordance with HD25/94 volume7 section2 = **0.55 %**

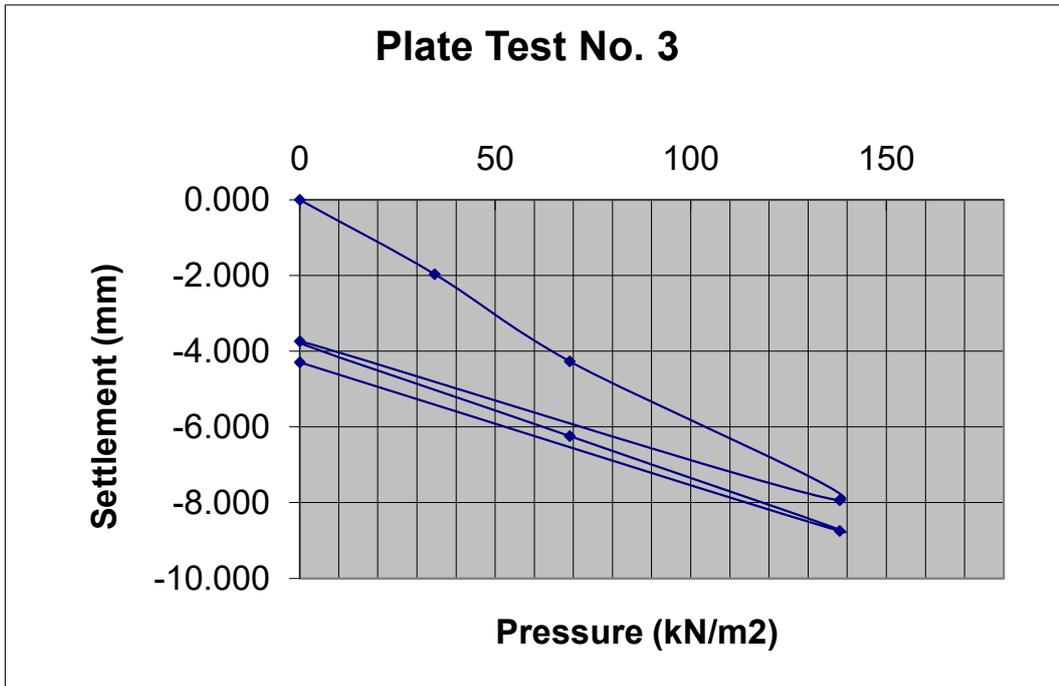
<b>LOCATION</b>	Sandford Park Milltown	<b>MATERIAL</b>	POSSIBLE MADE GROUND: Light brown slightly sandy slightly gravelly Clay with rootlets.
<b>CONTRACT NO.</b>	9338-12-19	<b>DEPTH</b>	0.40m
<b>DATE</b>	21/01/2020	<b>NOTES</b>	
<b>CLIENT</b>	DBFL	<b>SAMPLES</b>	
<b>PLATE DIAMETER</b>	457mm		
<b>TEST NO.</b>	CBR03

Modulus of subgrade reaction, K (Initial) =	<b>10.93 MN/m<sup>2</sup>/m</b>
Modulus of subgrade reaction, K (Reload) =	<b>18.58 MN/m<sup>2</sup>/m</b>

Equivalent CBR(initial)in accordance with HD25/94 volume7 section2 =	<b>0.61 %</b>
Equivalent CBR(reload)in accordance with HD25/94 volume7 section2 =	<b>1.53 %</b>

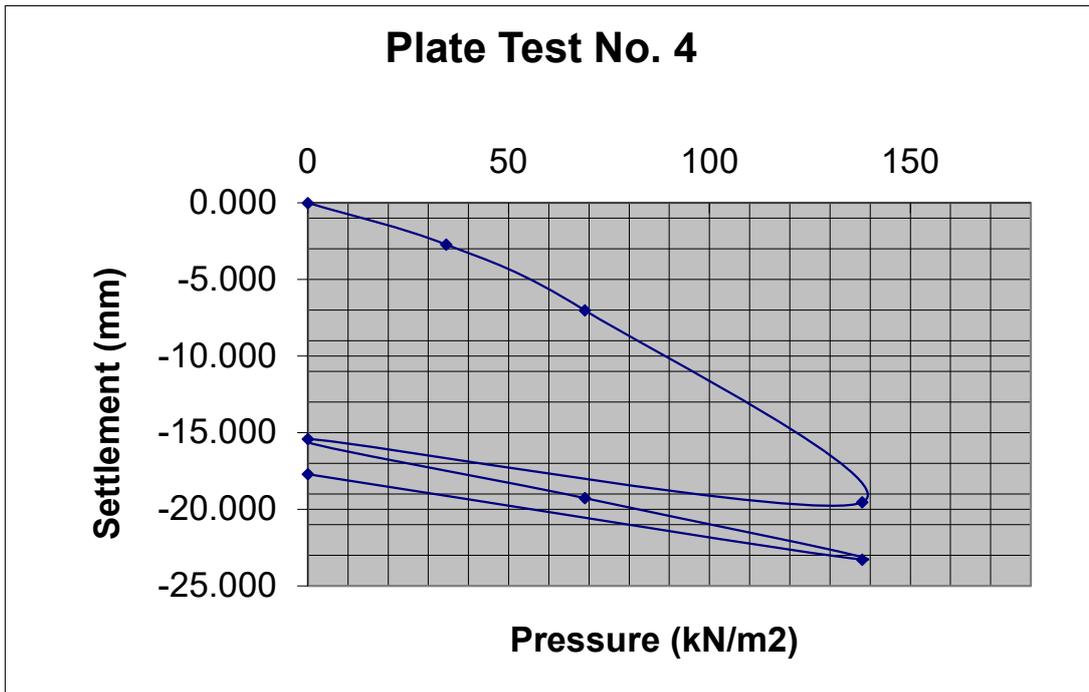
<b>LOCATION</b>	Sandford Park Milltown	<b>MATERIAL</b>	POSSIBLE MADE GROUND: Light brown slightly sandy slightly gravelly Clay with rootlets
<b>CONTRACT NO.</b>	9338-12-19	<b>DEPTH</b>	0.30m
<b>DATE</b>	20/01/2020	<b>NOTES</b>	
<b>CLIENT</b>	DBFL	<b>SAMPLES</b>	
<b>PLATE DIAMETER</b>	457mm		
<b>TEST NO.</b>	CBR04

Modulus of subgrade reaction, K (Initial) = **6.65 MN/m<sup>2</sup>/m**  
 Modulus of subgrade reaction, K (Reload) = **12.06 MN/m<sup>2</sup>/m**

Equivalent CBR(initial)in accordance with HD25/94 volume7 section2 = **0.26 %**  
 Equivalent CBR(reload)in accordance with HD25/94 volume7 section2 = **0.72 %**

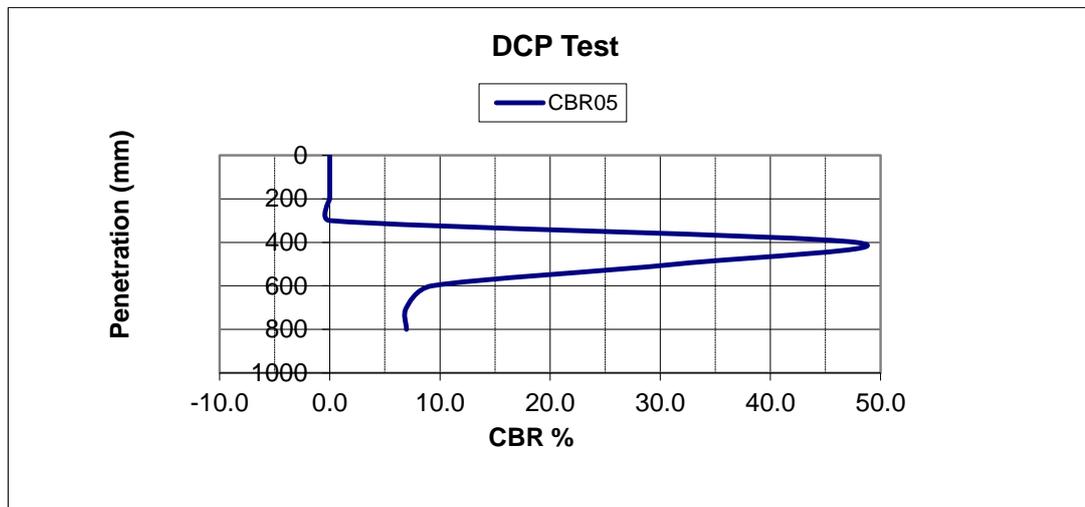
Depth (mm bgl)	No. of Blows per 100mm	Penetration per Blow (mm)	CBR (%)
0	-	-	0.0
100	-	-	0.0
200	-	-	0.0
300	-	-	0.0
400	18	5.6	47.7
500	13	7.7	31.5
600	5	20.0	9.3
700	4	25.0	7.0
800	4	25.0	7.0
900	4	25.0	7.0
1000	-	-	-
1100	-	-	-
1200	-	-	-
1300	-	-	-
1400	-	-	-
1500	-	-	-

**Reference** Kleyn and Van Heerden (60° Cone)  
**Formula**  $\text{Log}_{10}(\text{CBR}) = 2.632 - 1.28 \text{Log}_{10}(\text{mm/blow})$

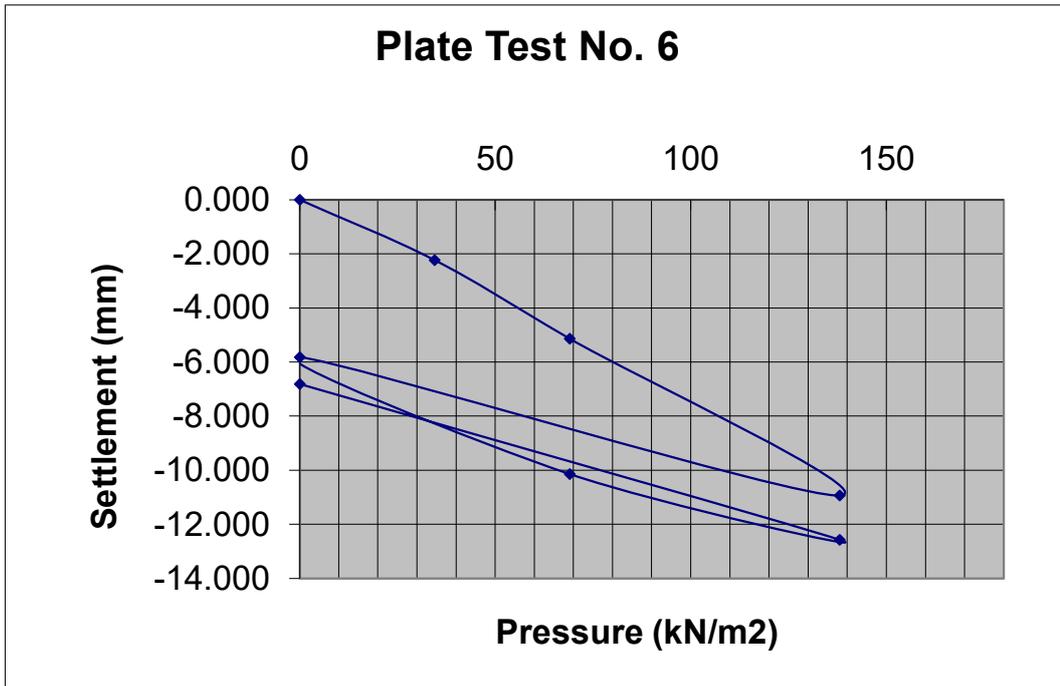
<b>LOCATION</b>	Sandford Park Milltown	<b>MATERIAL</b>	Possible MADE GROUND: Light brown slightly sandy slightly gravelly Clay with rootlets.
<b>CONTRACT NO.</b>	9338-12-19		
<b>DATE</b>	21/01/2020		
<b>CLIENT</b>	DBFL	<b>DEPTH</b>	0.40m
<b>PLATE DIAMETER</b>	457mm	<b>NOTES</b>	
<b>TEST NO.</b>	CBR06	<b>SAMPLES</b>

Modulus of subgrade reaction, K (Initial) =	<b>9.08 MN/m²/m</b>
Modulus of subgrade reaction, K (Reload) =	<b>10.78 MN/m²/m</b>

Equivalent CBR(initial)in accordance with HD25/94 volume7 section2 =	<b>0.44 %</b>
Equivalent CBR(reload)in accordance with HD25/94 volume7 section2 =	<b>0.59 %</b>

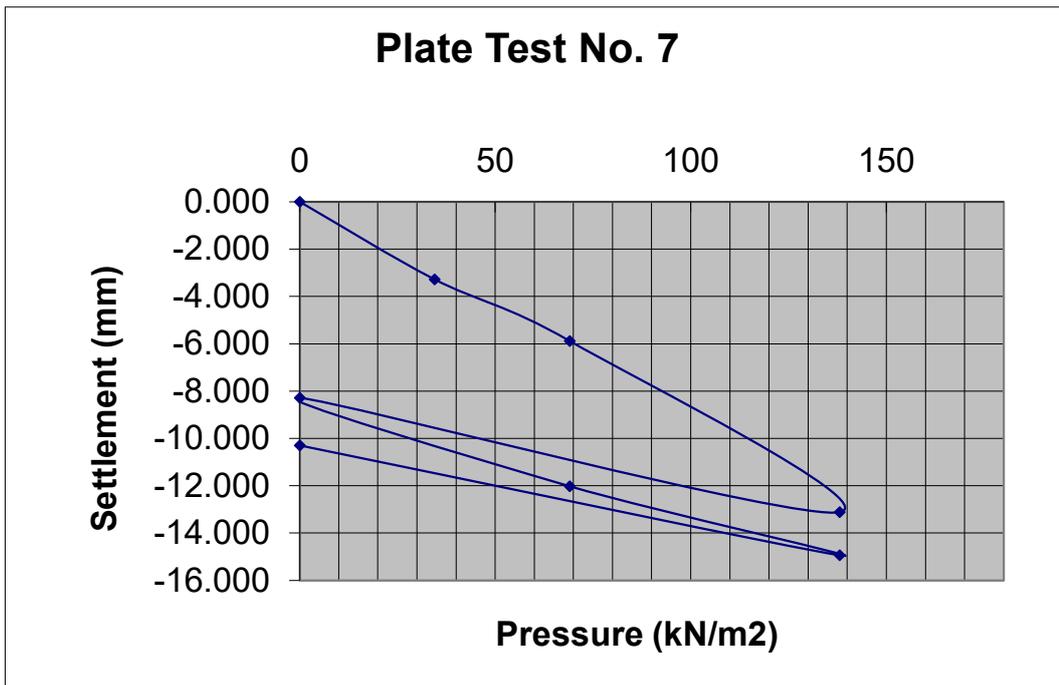
<b>LOCATION</b>	Sandford Park Milltown	<b>MATERIAL</b>	MADE GROUND: Light brown slightly sandy slightly gravelly Clay with rootlets redbrick mortar and bone fragments.
<b>CONTRACT NO.</b>	9338-12-19	<b>DEPTH</b>	0.45m
<b>DATE</b>	21/01/2020	<b>NOTES</b>	
<b>CLIENT</b>	DBFL	<b>SAMPLES</b>	
<b>PLATE DIAMETER</b>	457mm		
<b>TEST NO.</b>	CBR07

Modulus of subgrade reaction, K (Initial) =	<b>7.93 MN/m<sup>2</sup>/m</b>
Modulus of subgrade reaction, K (Reload) =	<b>12.47 MN/m<sup>2</sup>/m</b>

Equivalent CBR(initial)in accordance with HD25/94 volume7 section2 =	<b>0.35 %</b>
Equivalent CBR(reload)in accordance with HD25/94 volume7 section2 =	<b>0.76 %</b>

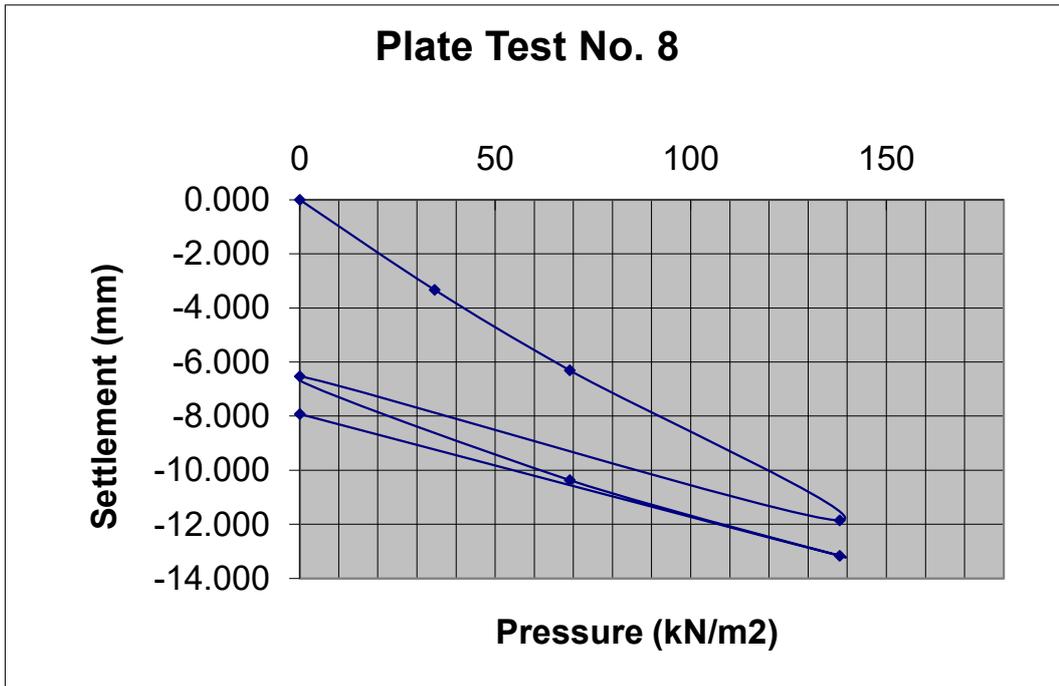
<b>LOCATION</b>	Sandford Park Milltown	<b>MATERIAL</b>	POSSIBLE MADE GROUND: Light brown slightly sandy slightly gravelly Clay with rootlets.
<b>CONTRACT NO.</b>	9338-12-19	<b>DEPTH</b>	0.40m
<b>DATE</b>	21/01/2020	<b>NOTES</b>	
<b>CLIENT</b>	DBFL	<b>SAMPLES</b>	
<b>PLATE DIAMETER</b>	457mm		
<b>TEST NO.</b>	CBR08

Modulus of subgrade reaction, K (Initial) =	<b>7.39 MN/m<sup>2</sup>/m</b>
Modulus of subgrade reaction, K (Reload) =	<b>12.14 MN/m<sup>2</sup>/m</b>

Equivalent CBR(initial)in accordance with HD25/94 volume7 section2 =	<b>0.31 %</b>
Equivalent CBR(reload)in accordance with HD25/94 volume7 section2 =	<b>0.73 %</b>

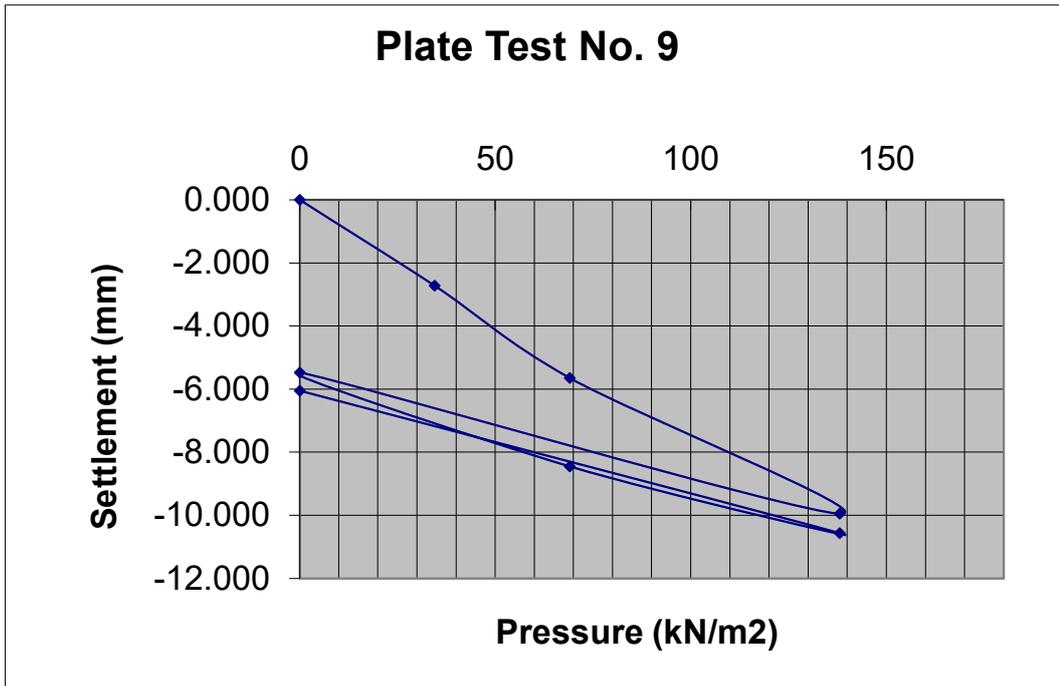
<b>LOCATION</b>	Sandford Park Milltown	<b>MATERIAL</b>	MADE GROUND: Light brown slightly sandy slightly gravelly Clay with rootlets and small redbrick and plastic fragments.
<b>CONTRACT NO.</b>	9338-12-19	<b>DEPTH</b>	0.30m
<b>DATE</b>	21/01/2020	<b>NOTES</b>	
<b>CLIENT</b>	DBFL	<b>SAMPLES</b>	
<b>PLATE DIAMETER</b>	457mm		
<b>TEST NO.</b>	CBR09

Modulus of subgrade reaction, K (Initial) =	<b>8.27 MN/m<sup>2</sup>/m</b>
Modulus of subgrade reaction, K (Reload) =	<b>15.67 MN/m<sup>2</sup>/m</b>

Equivalent CBR(initial)in accordance with HD25/94 volume7 section2 =	<b>0.38 %</b>
Equivalent CBR(reload)in accordance with HD25/94 volume7 section2 =	<b>1.14 %</b>

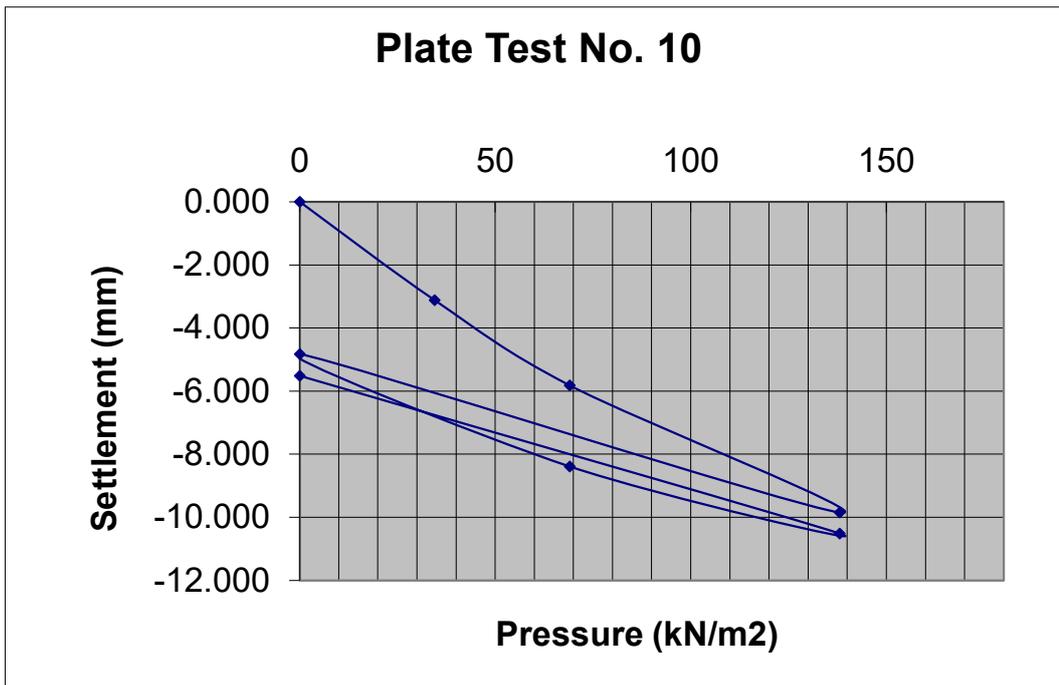
<b>LOCATION</b>	Sandford Park Milltown	<b>MATERIAL</b>	MADE GROUND: Light brown slightly sandy slightly gravelly Clay with rootlets and small redbrick and plastic fragments.
<b>CONTRACT NO.</b>	9338-12-19	<b>DEPTH</b>	0.30m
<b>DATE</b>	21/01/2020	<b>NOTES</b>	
<b>CLIENT</b>	DBFL	<b>SAMPLES</b>	
<b>PLATE DIAMETER</b>	457mm		
<b>TEST NO.</b>	CBR10

Modulus of subgrade reaction, K (Initial) = **8.01 MN/m<sup>2</sup>/m**  
 Modulus of subgrade reaction, K (Reload) = **13.08 MN/m<sup>2</sup>/m**

Equivalent CBR(initial)in accordance with HD25/94 volume7 section2 = **0.36 %**  
 Equivalent CBR(reload)in accordance with HD25/94 volume7 section2 = **0.83 %**
