GREATER DUBLIN DRAINAGE PROJECT

ElAR Addendum Chapter 11A (Biodiversity (Terrestrial and Freshwater Aquatic))
Appendix A11.1 Terrestrial Baseline Survey Report

IE000258
S4P01
October 2023

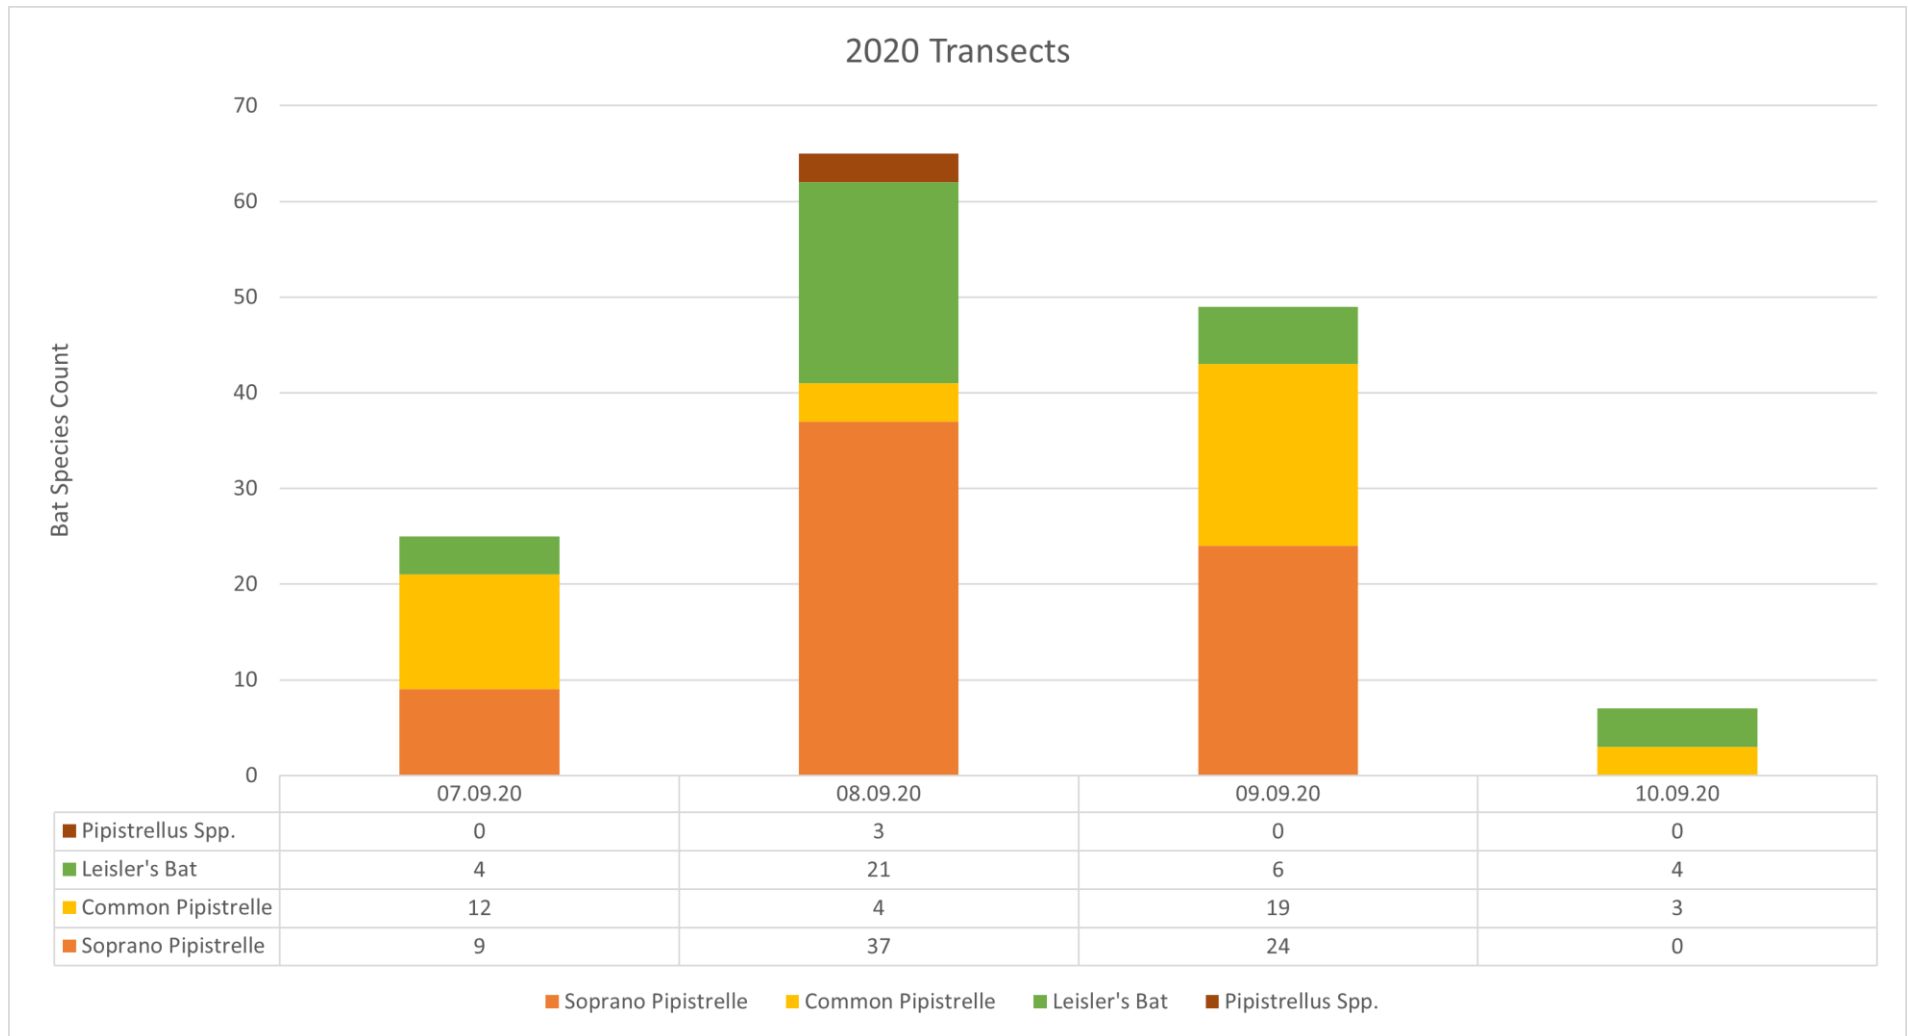
Figure 3-6: Bat counts by species on 2020 transects

Soprano pipistrelle (*Pipistrellus pygmaeus*) was the most common species occurrence during the 2020 transects, with Leisler’s bat (*Nyctalus leisleri*), and common pipistrelle (*Pipistrellus pipistrellus*) frequently occurring across the four days (see **Figure 3-6**). A species count of 65 was recorded on 8 September, 49 on 9 September, 25 on 7 of September, and 7 on 10 of September.

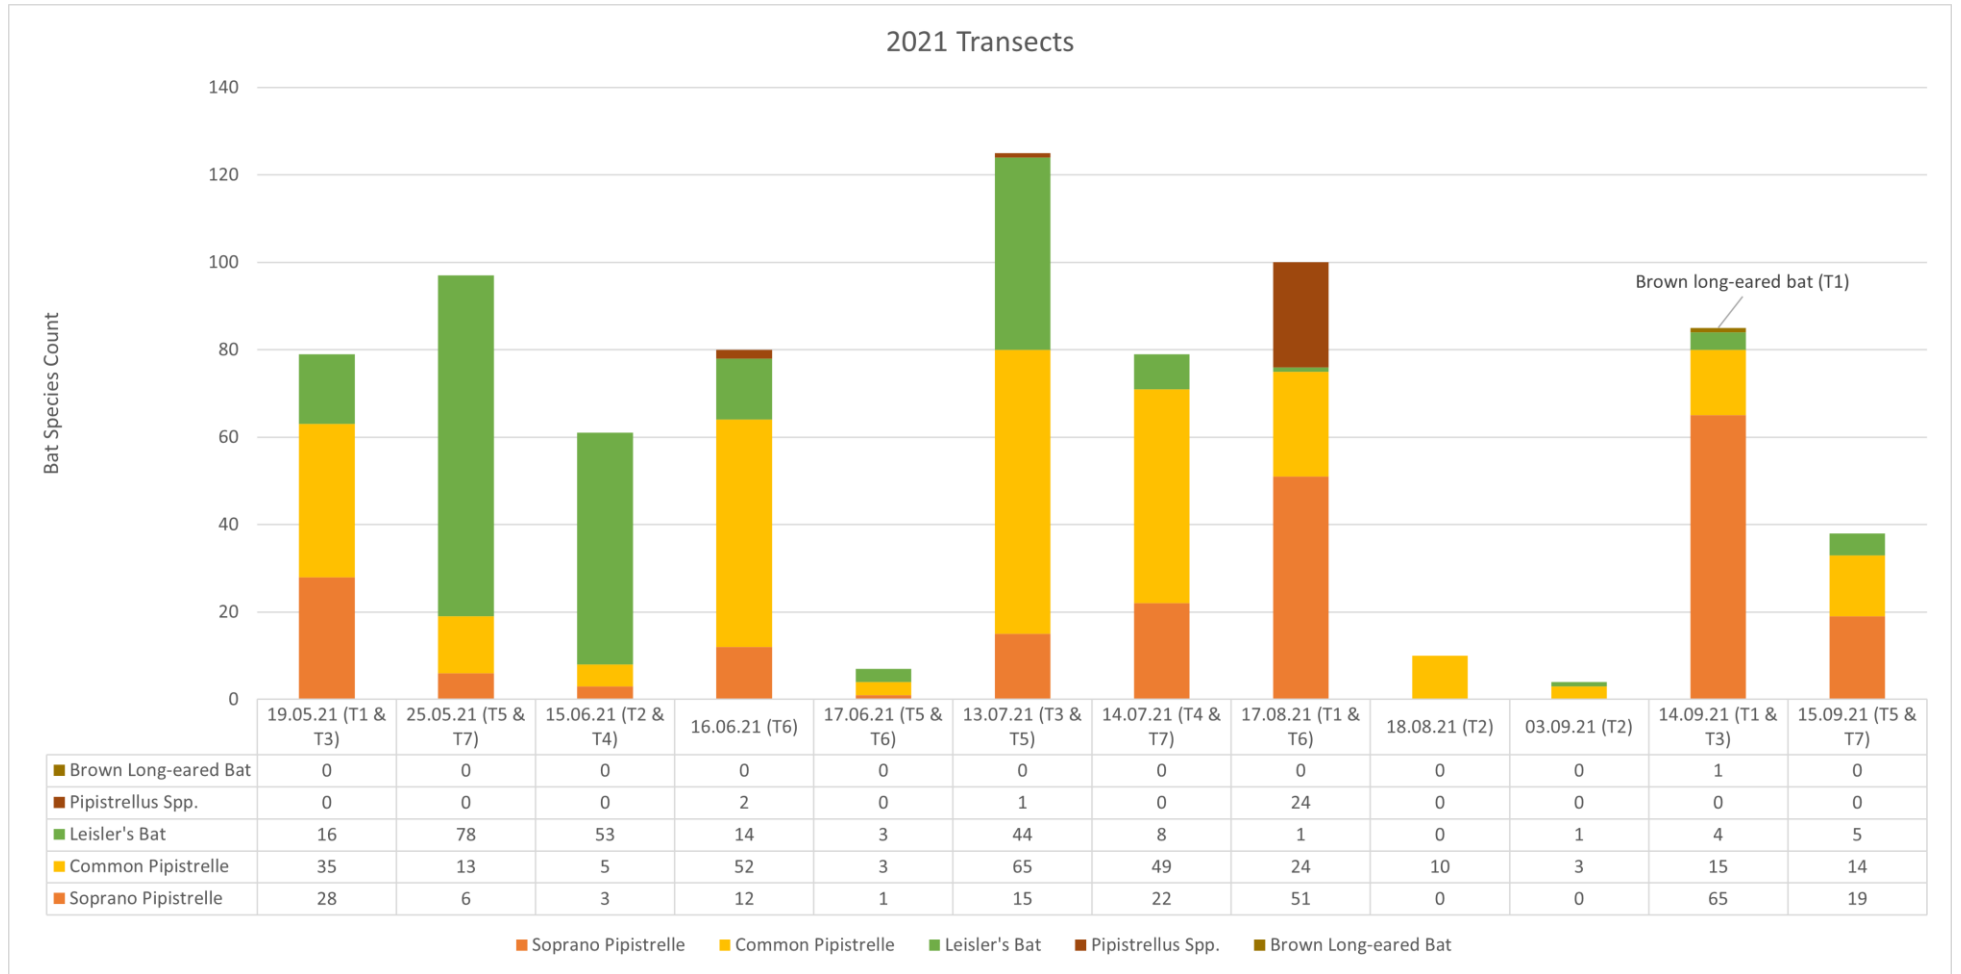
Figure 3-7: Bat counts by species on transects during 2021

In 2021, aside from data collected on 17 June, 18 August, and 3 September which had low counts (<10), species counts ranged between 38 and 125 per transect (see **Figure 3-7**). As transect 2 data was only collected on 18 August and 3 September, the total species count for transect 2 was 14, of which 13 were common pipistrelle. The species compositions varied across the transects, with common pipistrelle, Leisler’s bat, and soprano pipistrelle the most common. There was one recording of a brown long-eared bat (*Plecotus auritus*) on 14 September at transect 1 (see **Figure 3-7**). In total, 70% of the species recorded were in the *Pipistrellus* family.

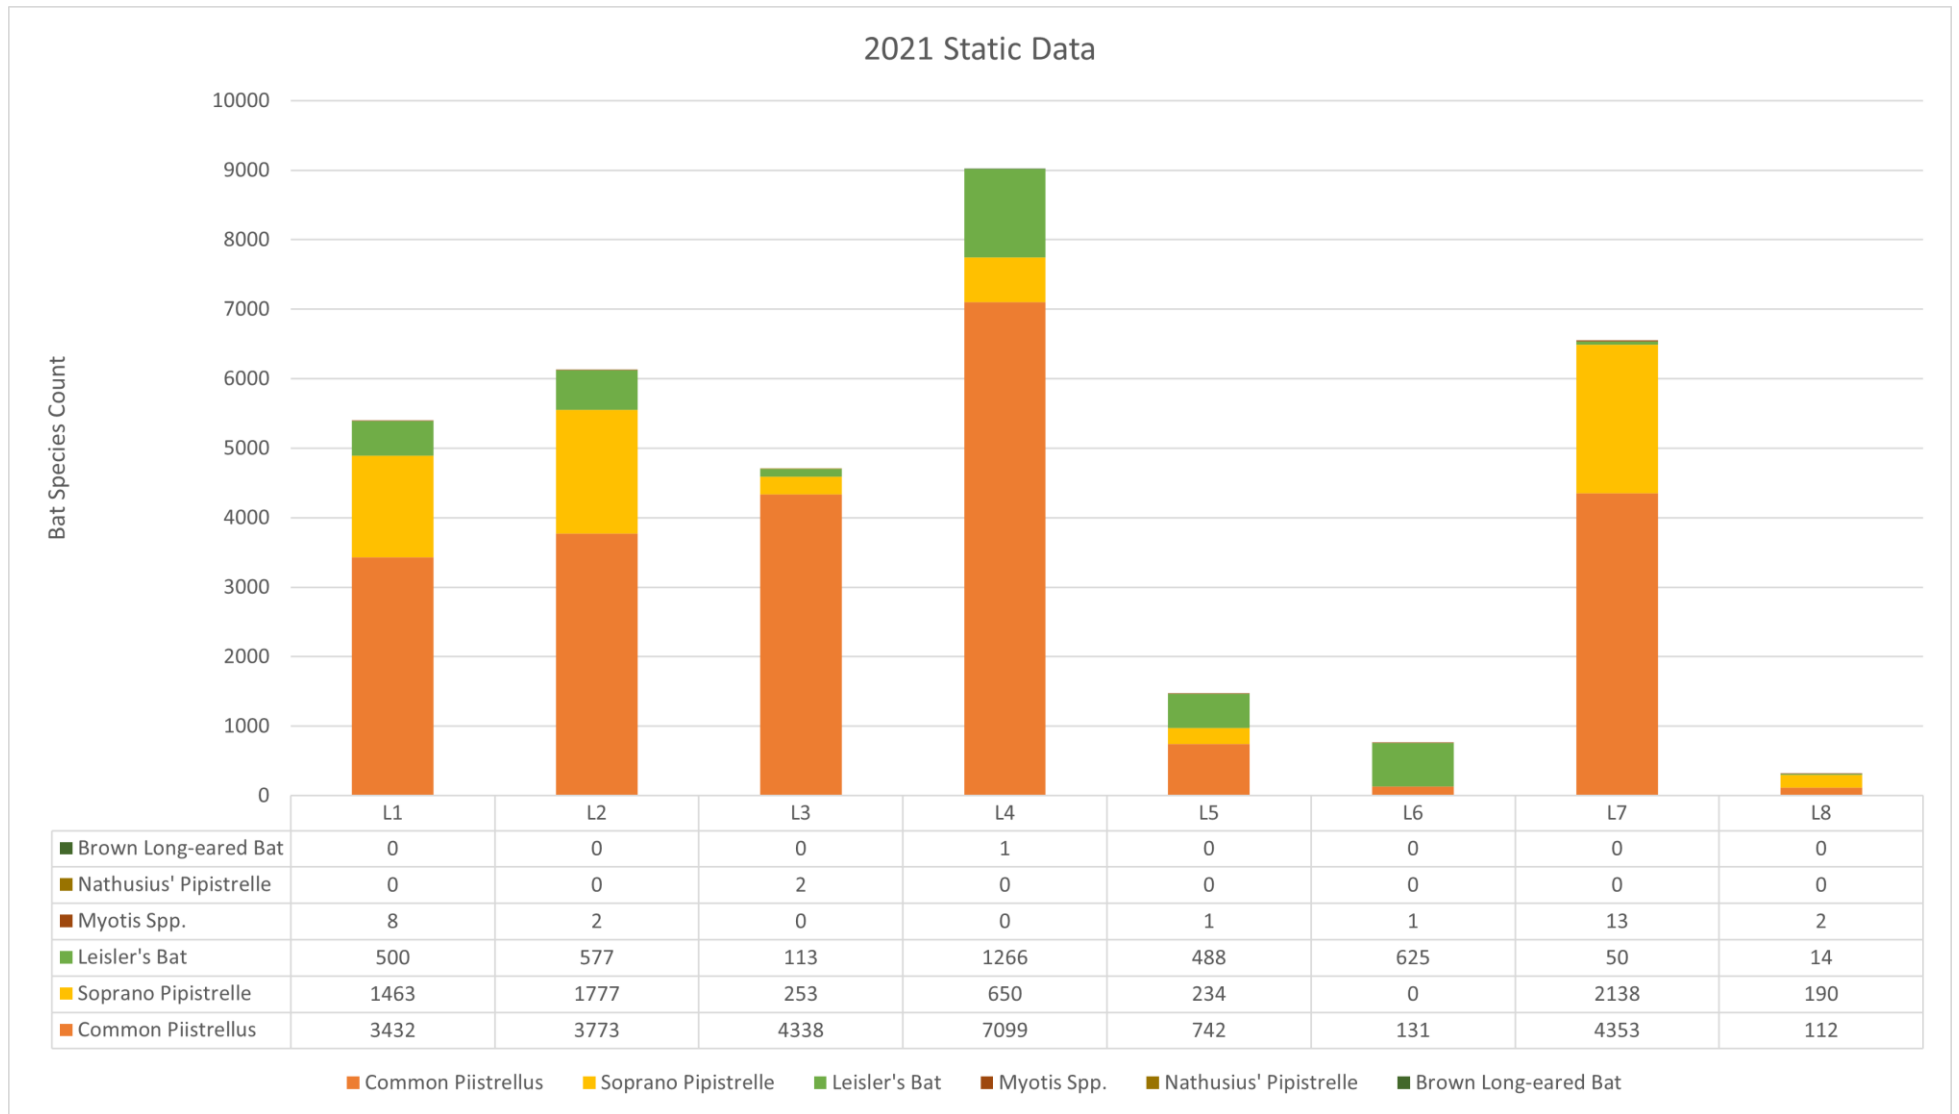
Figure 3-8: Bat counts by species at static detector locations along Proposed Project Boundary 2021

The highest individual count was observed at location four, where 9,258 was the max count (**Figure 3-8** and **Table 3-4**). Locations 1, 2, 3 and 7 max counts were spread across a range of 1,548, with location 7 displaying the highest with 6,254. Locations 5, 6, and 8 had a max count of 1,453, 757, and 321; respectively.

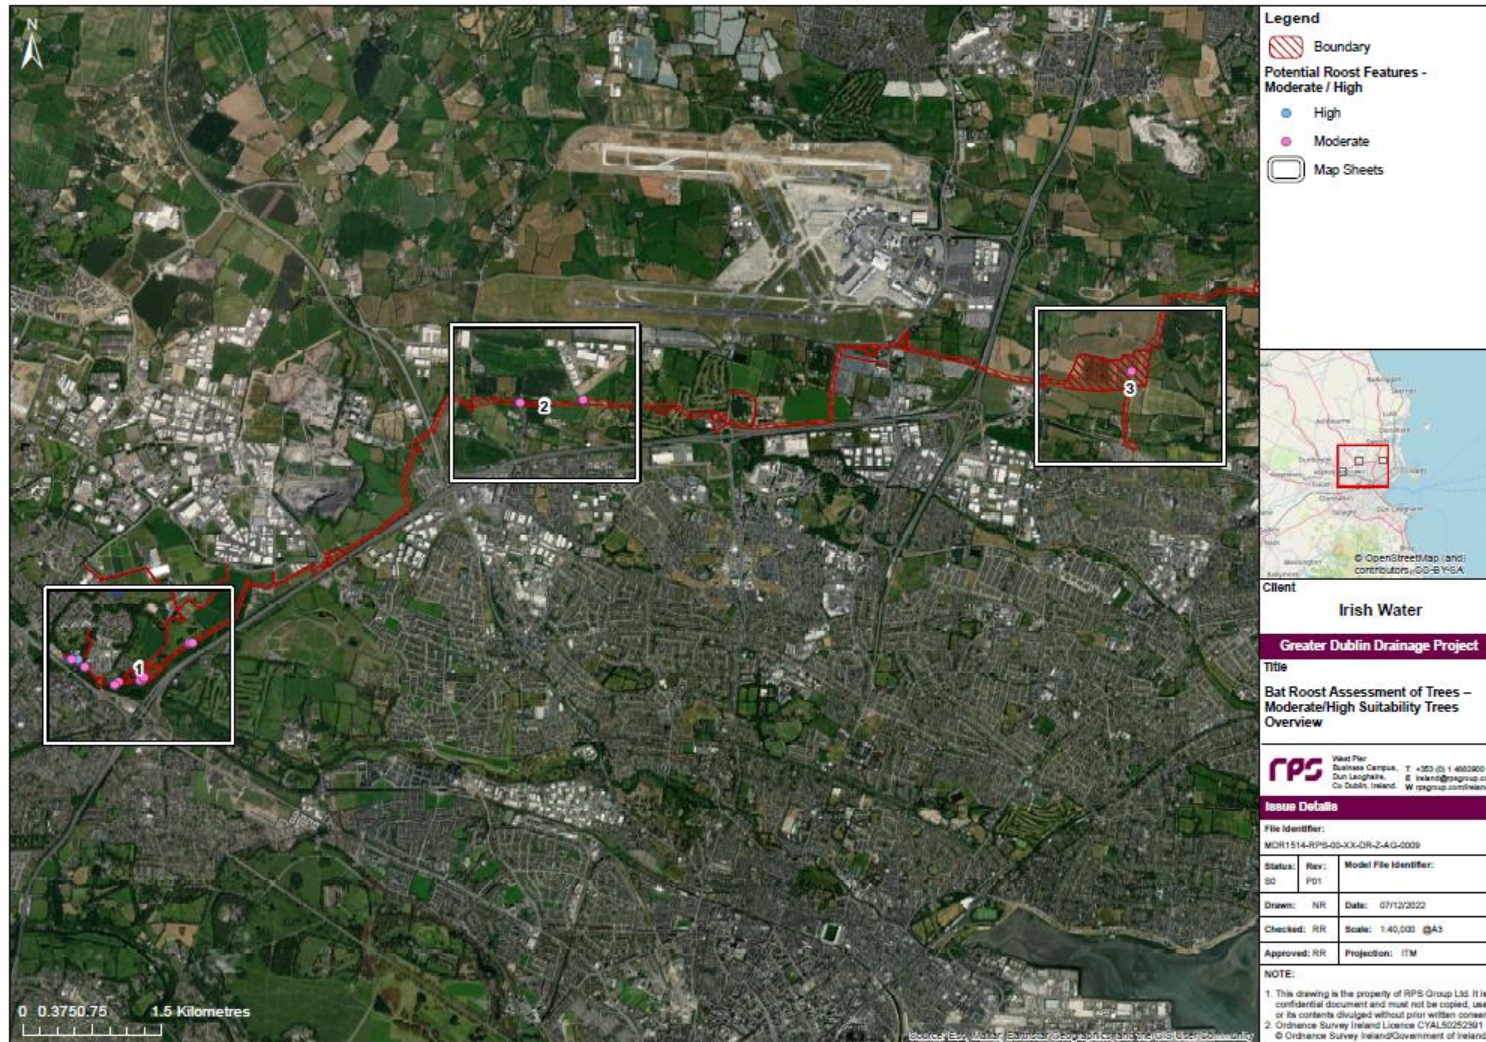
Figure 3-9: Tree locations of moderate/high bat roost potential (Sheet 1)

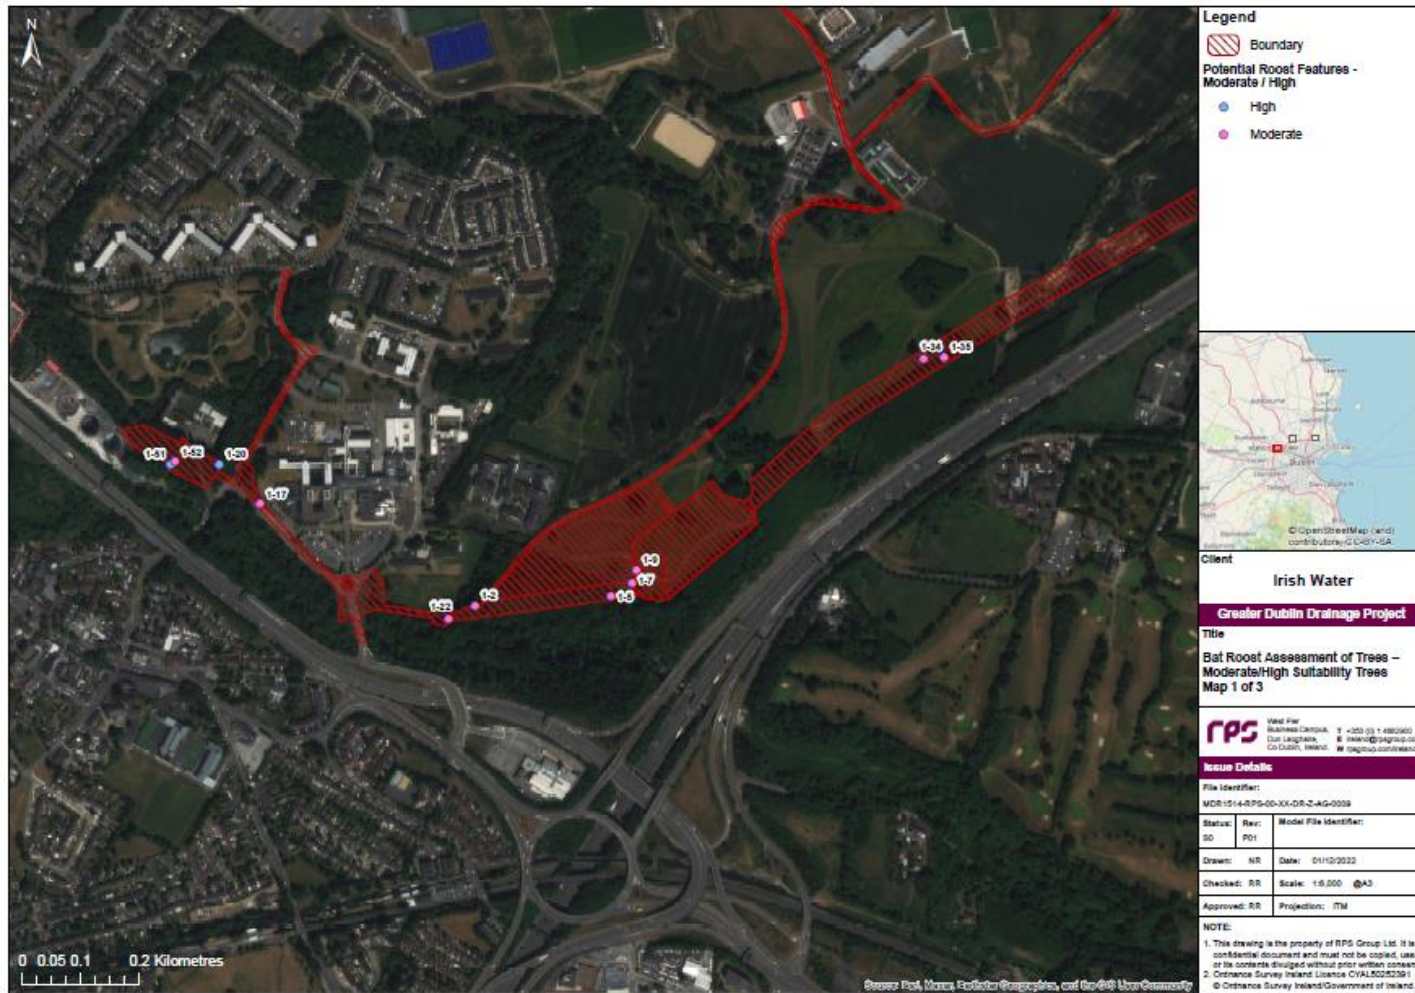
Figure 3-9: Tree locations of moderate/high bat roost potential (Sheet 2)

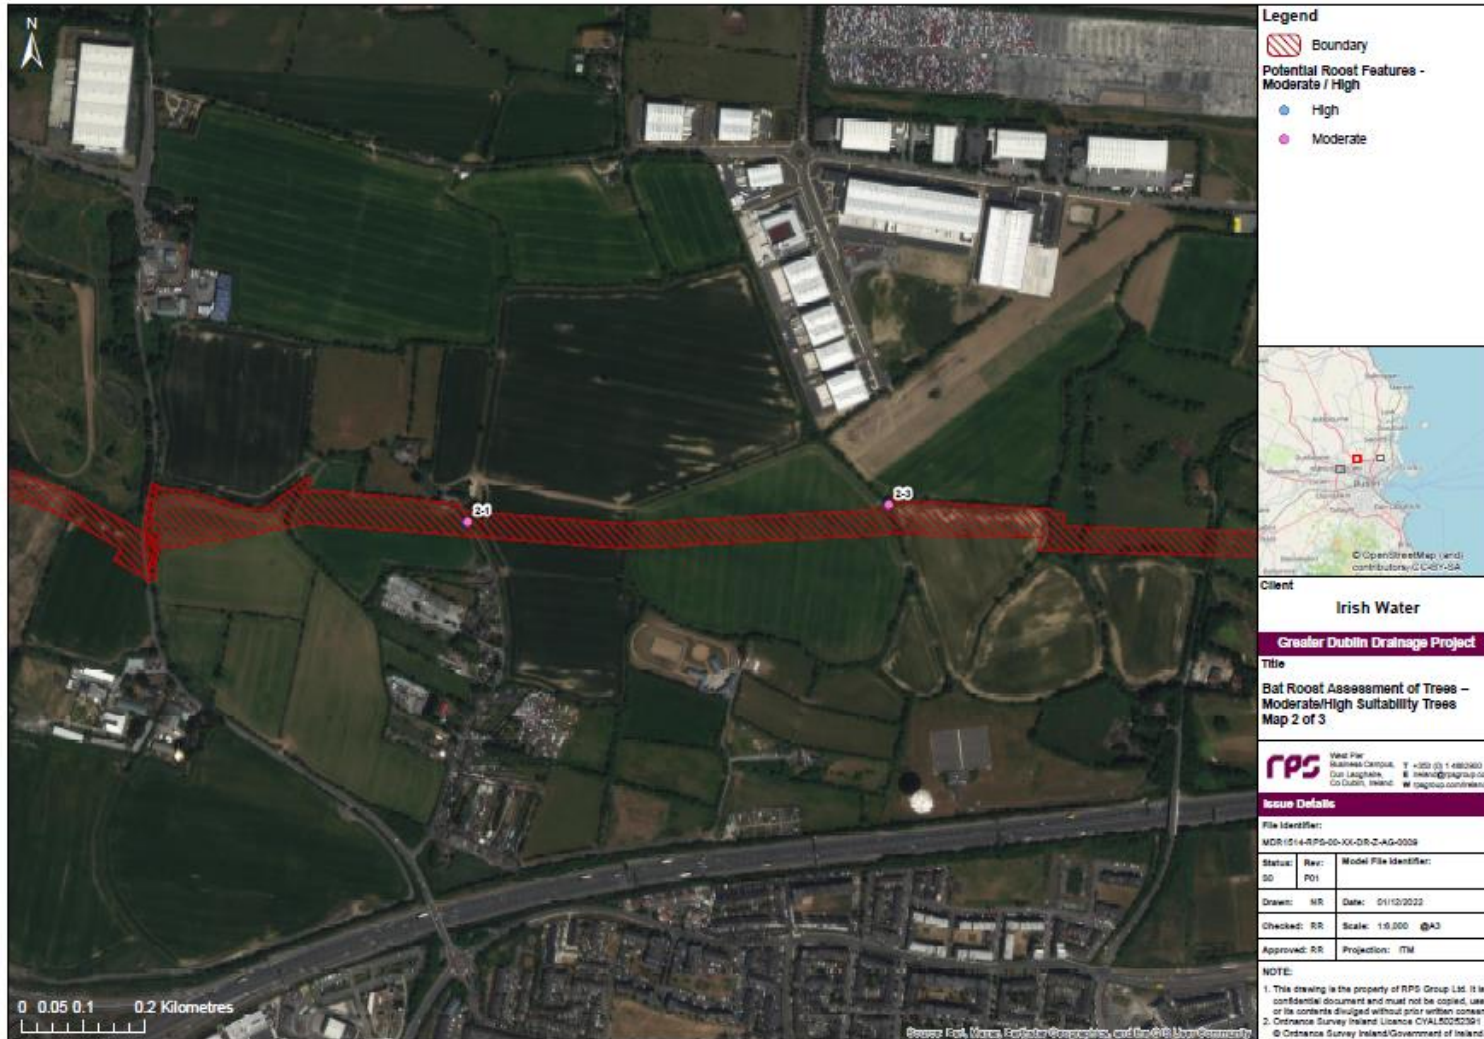
Figure 3-9: Tree locations of moderate/high bat roost potential (Sheet 3)

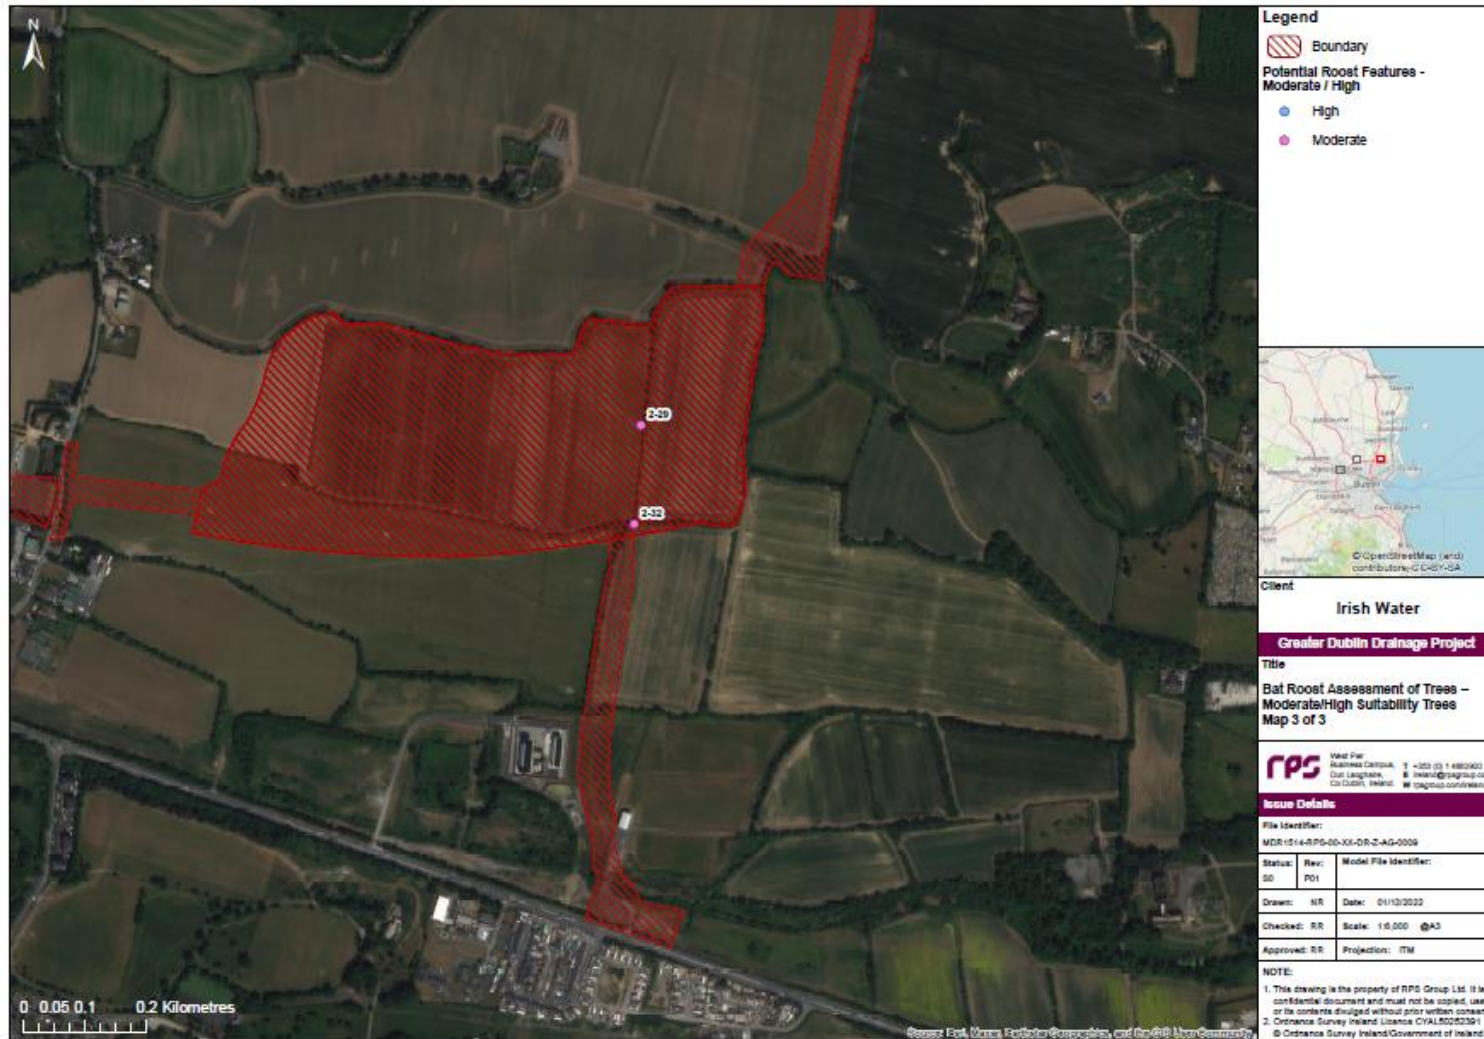
Figure 3-9: Tree locations of moderate/high bat roost potential (sheet 4)

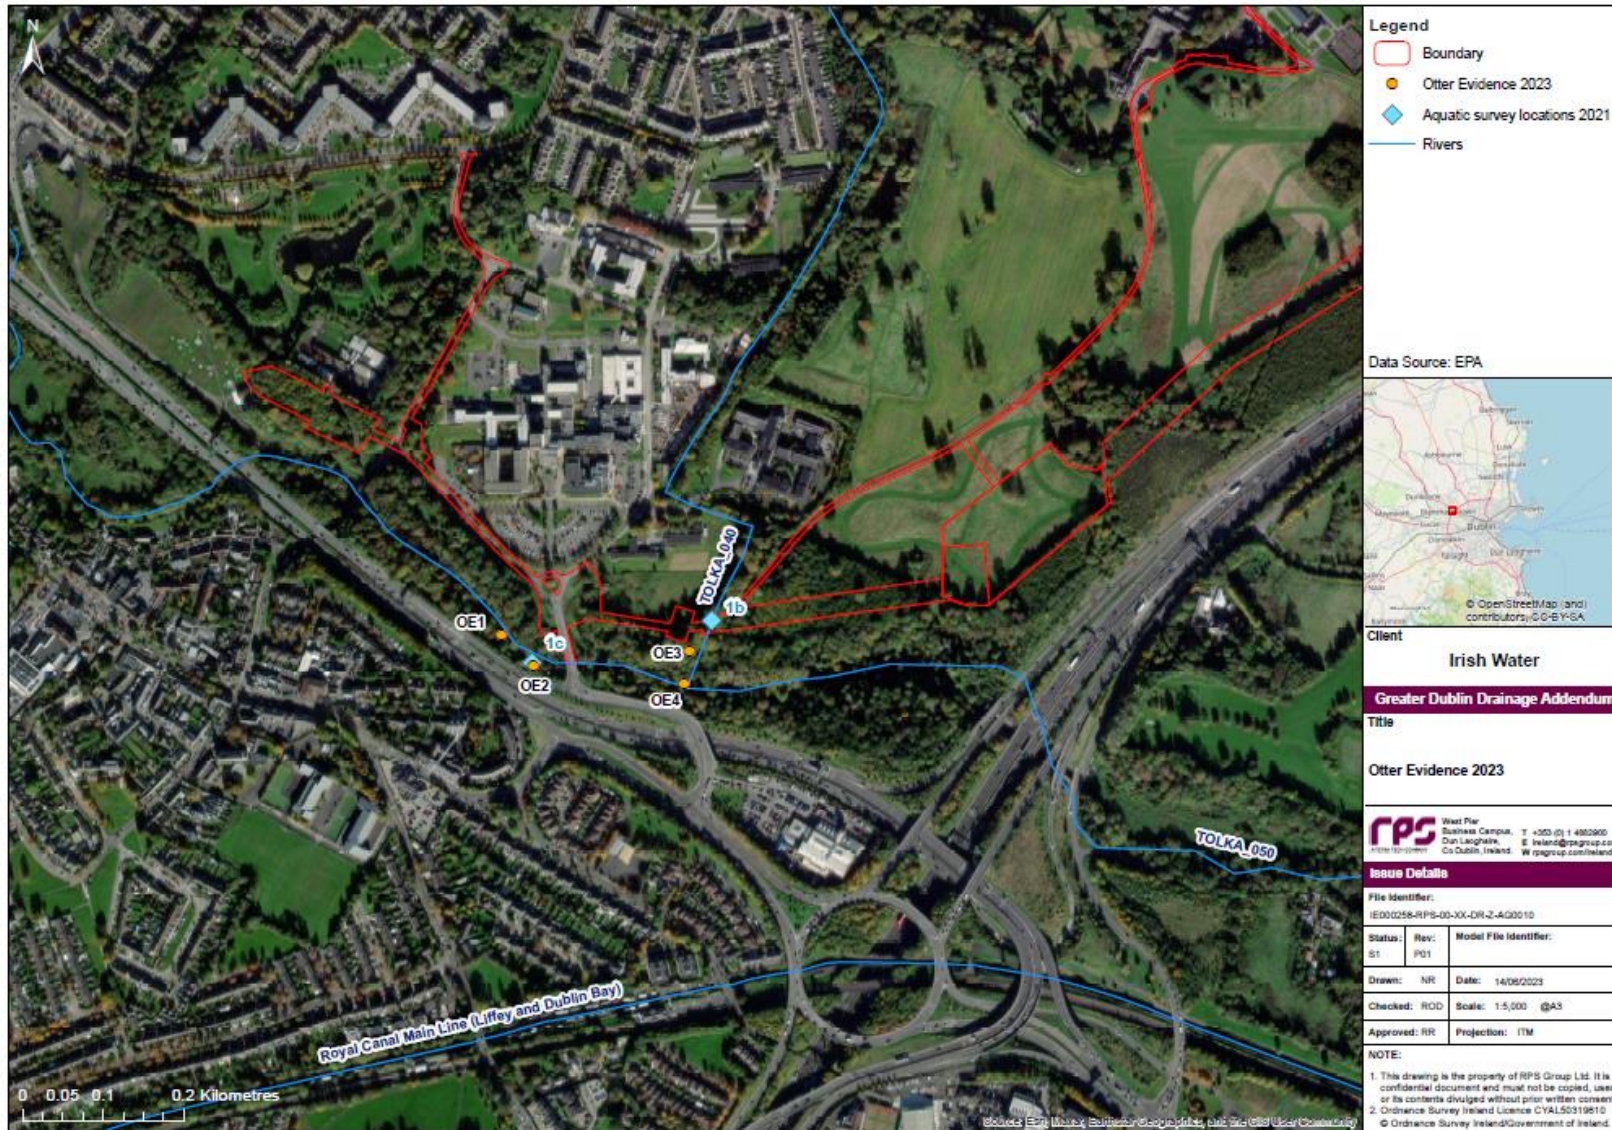
Figure 3-10: Otter Evidence during 2023 freshwater aquatic survey.

As part of the freshwater aquatic habitat surveys (see **Section 3.3**), sections of river 150m either side of the sampling locations were walked and checked for otter signs. No otter signs were recorded in 2021. In 2023, a number of otter signs were recorded on either side of survey locations 1b and 1c (**Table 3-11** and **Figure 3-10**). These consisted of spraints and a slide. No holt or resting sites were identified.

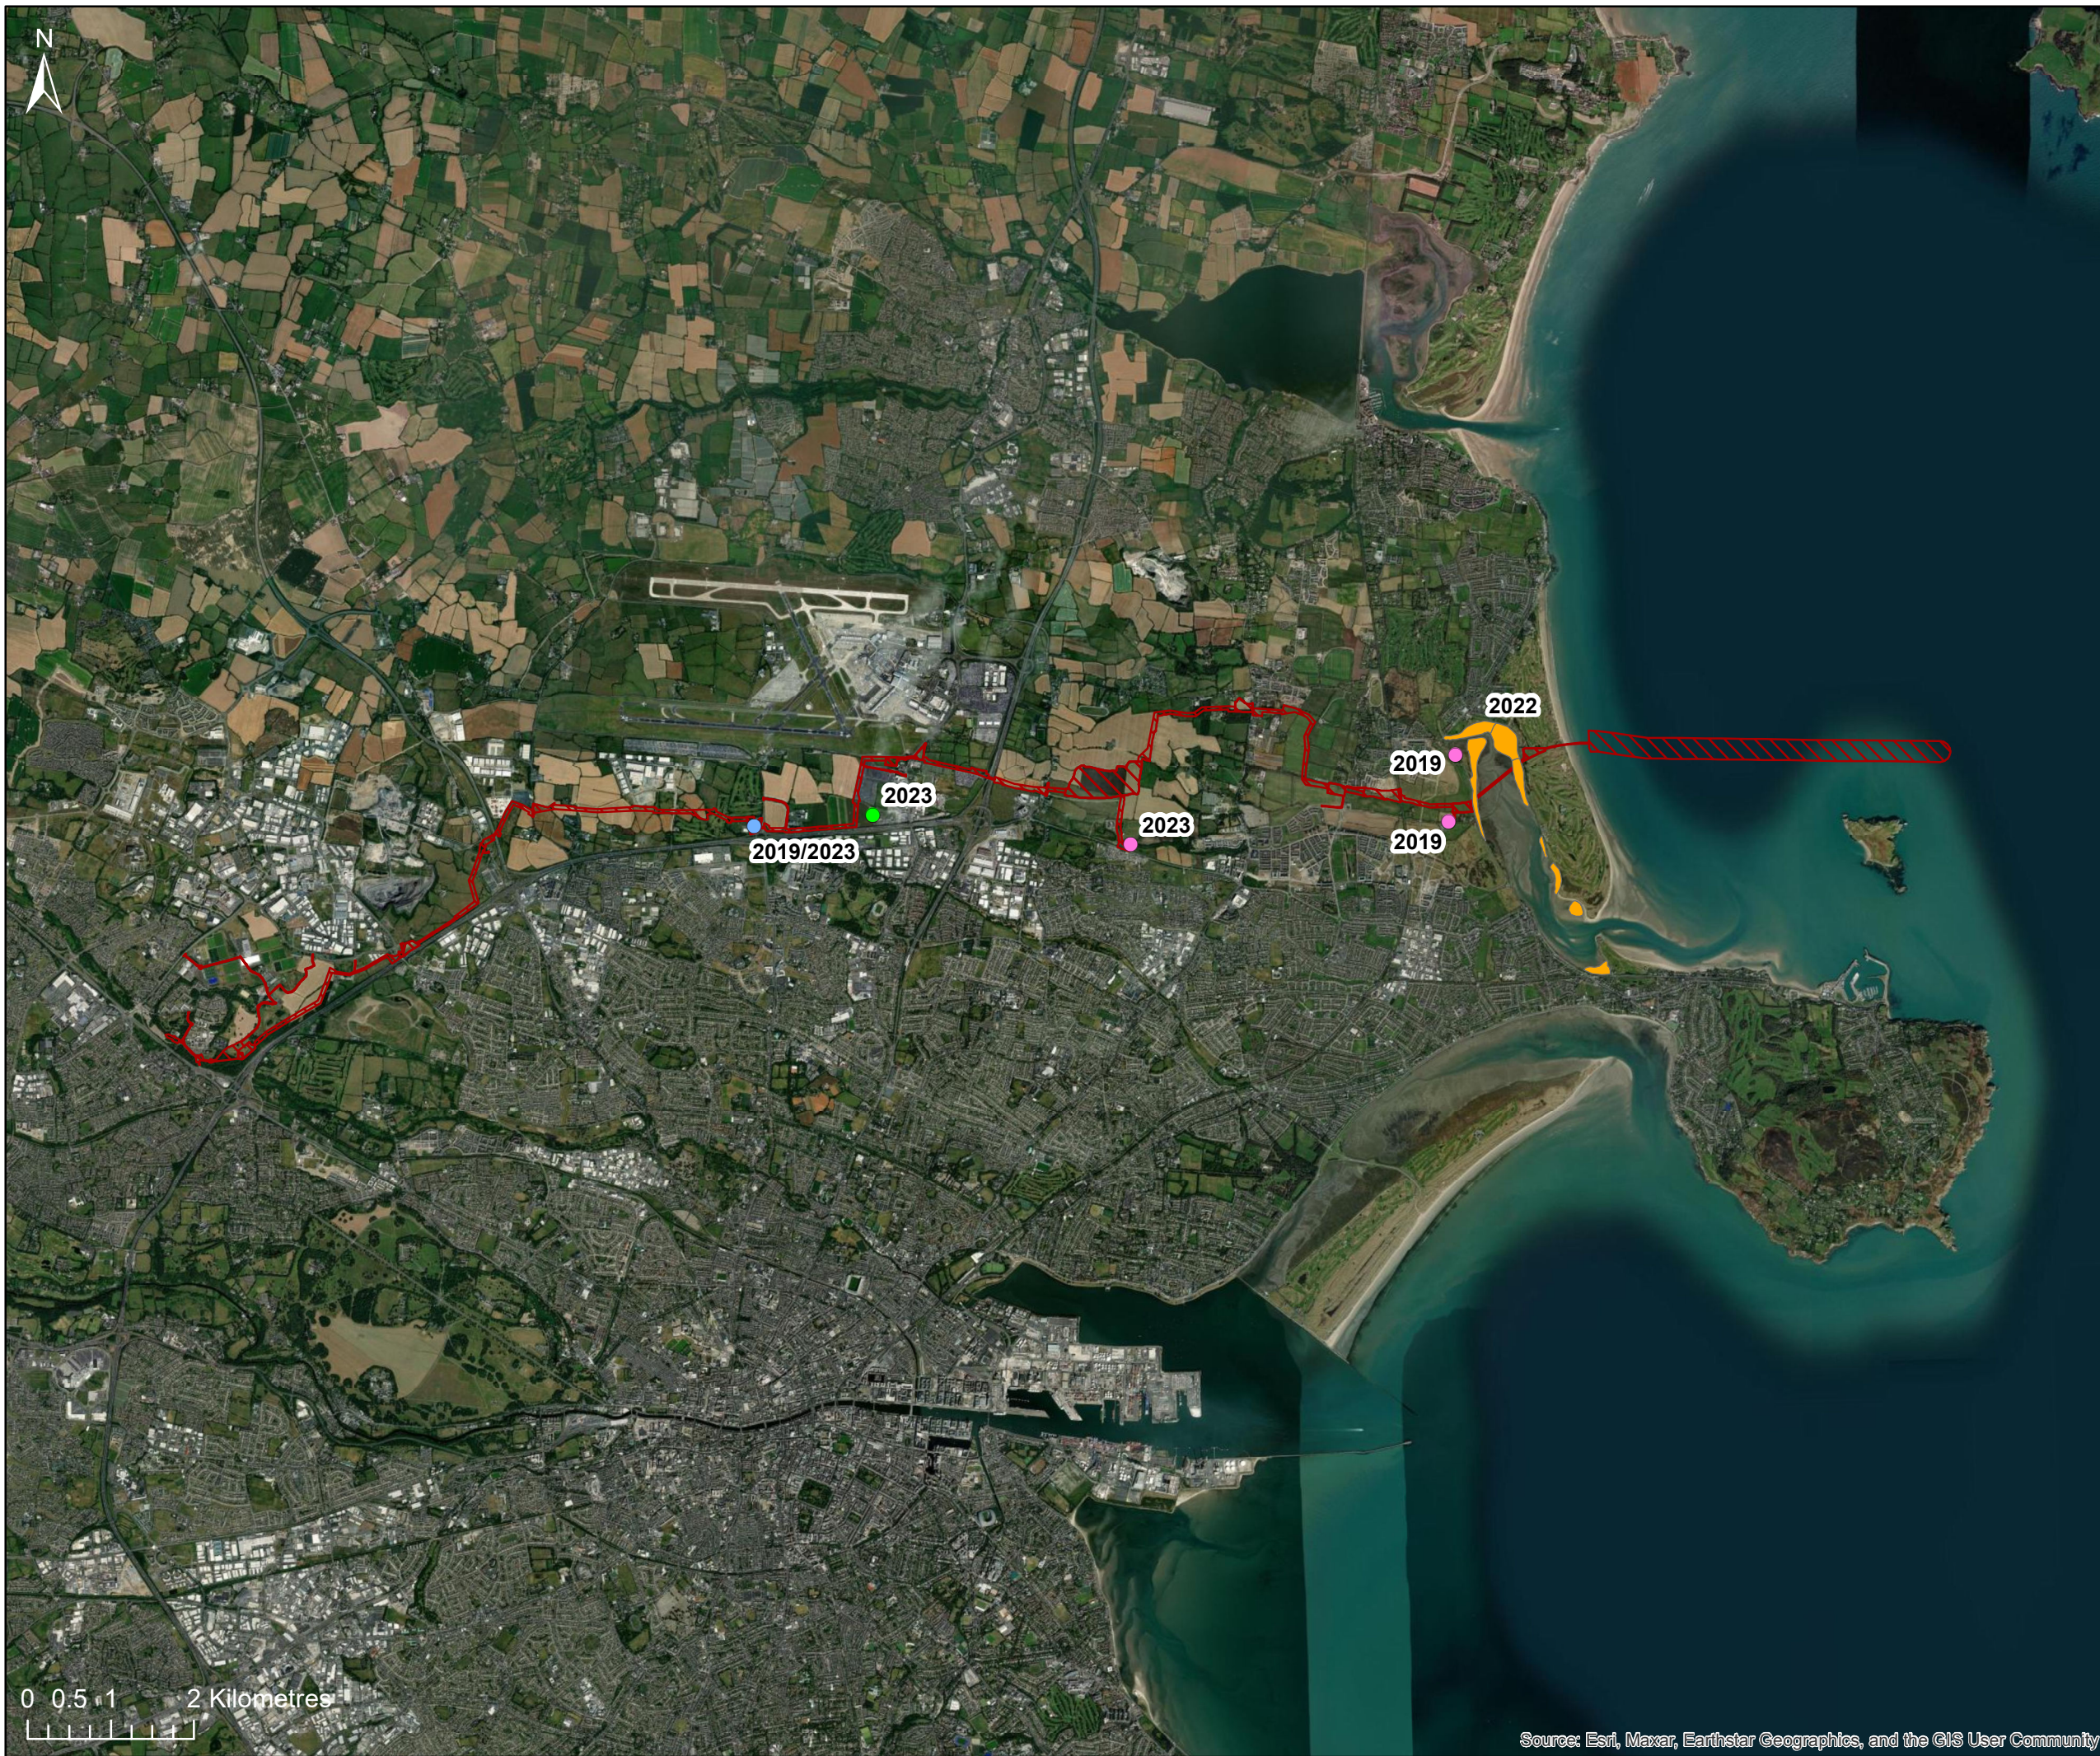
Title
Figure 3 5:
IAPS survey 2019 (Giant Hogweed & Japanese Knotweed), 2022 (Spartina sp.), 2023 (Japanese and Bohemian Knotweed, Giant Hogweed)

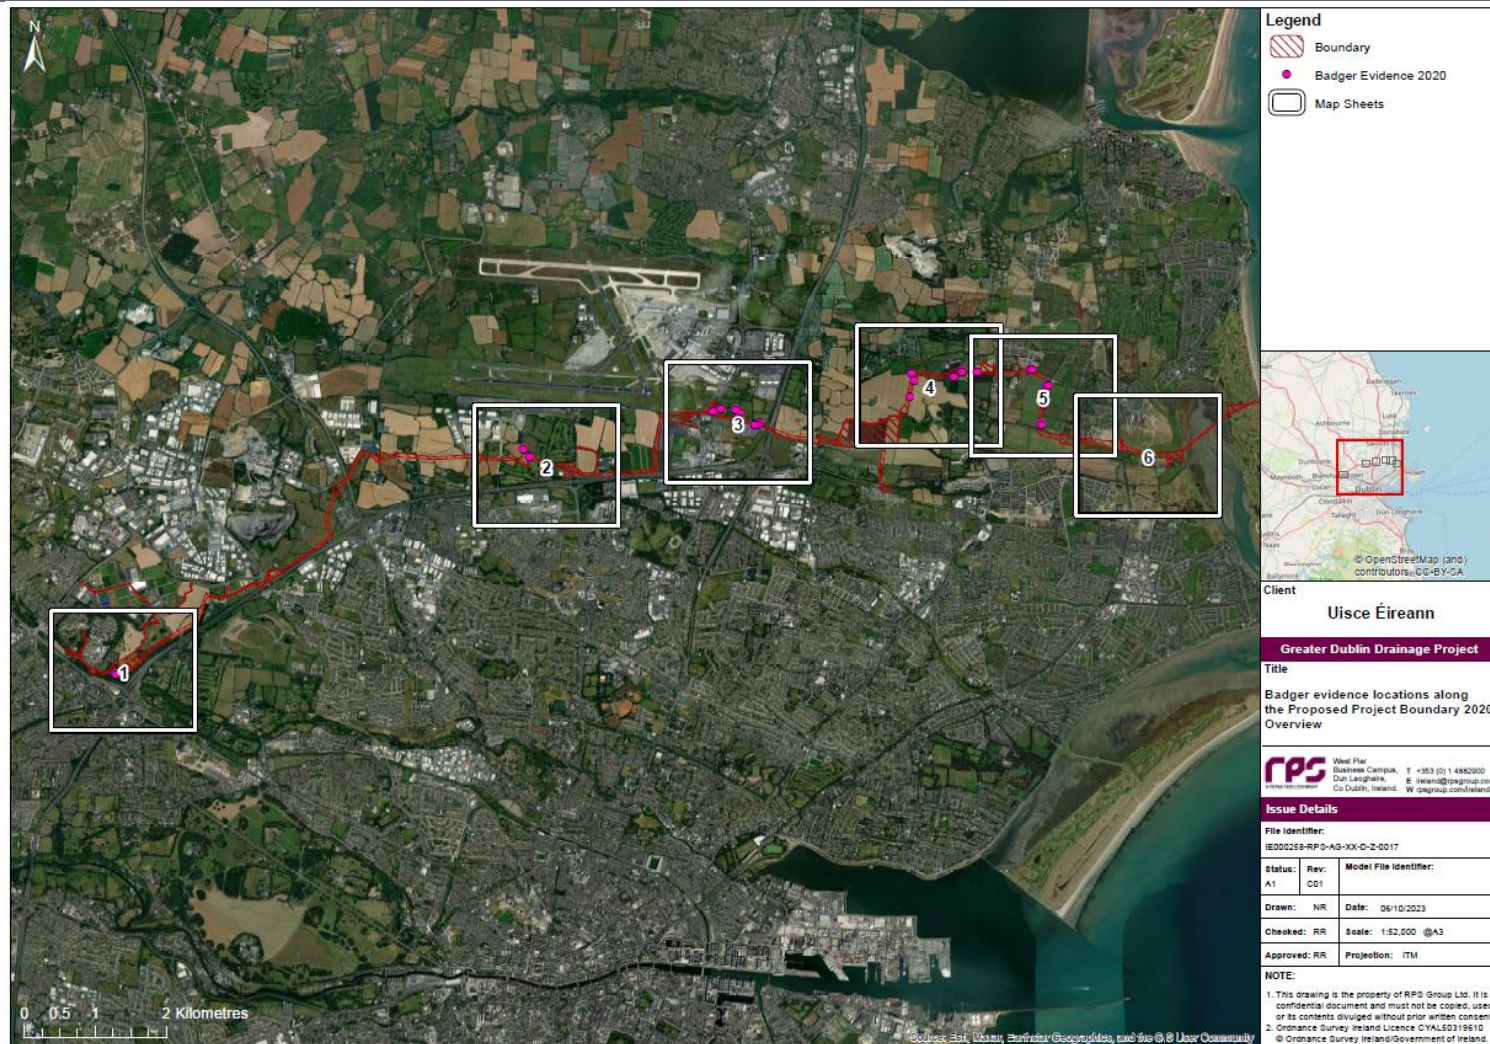
Figure B-1 Badger evidence locations along the Proposed Project Boundary 2020 (Overview)

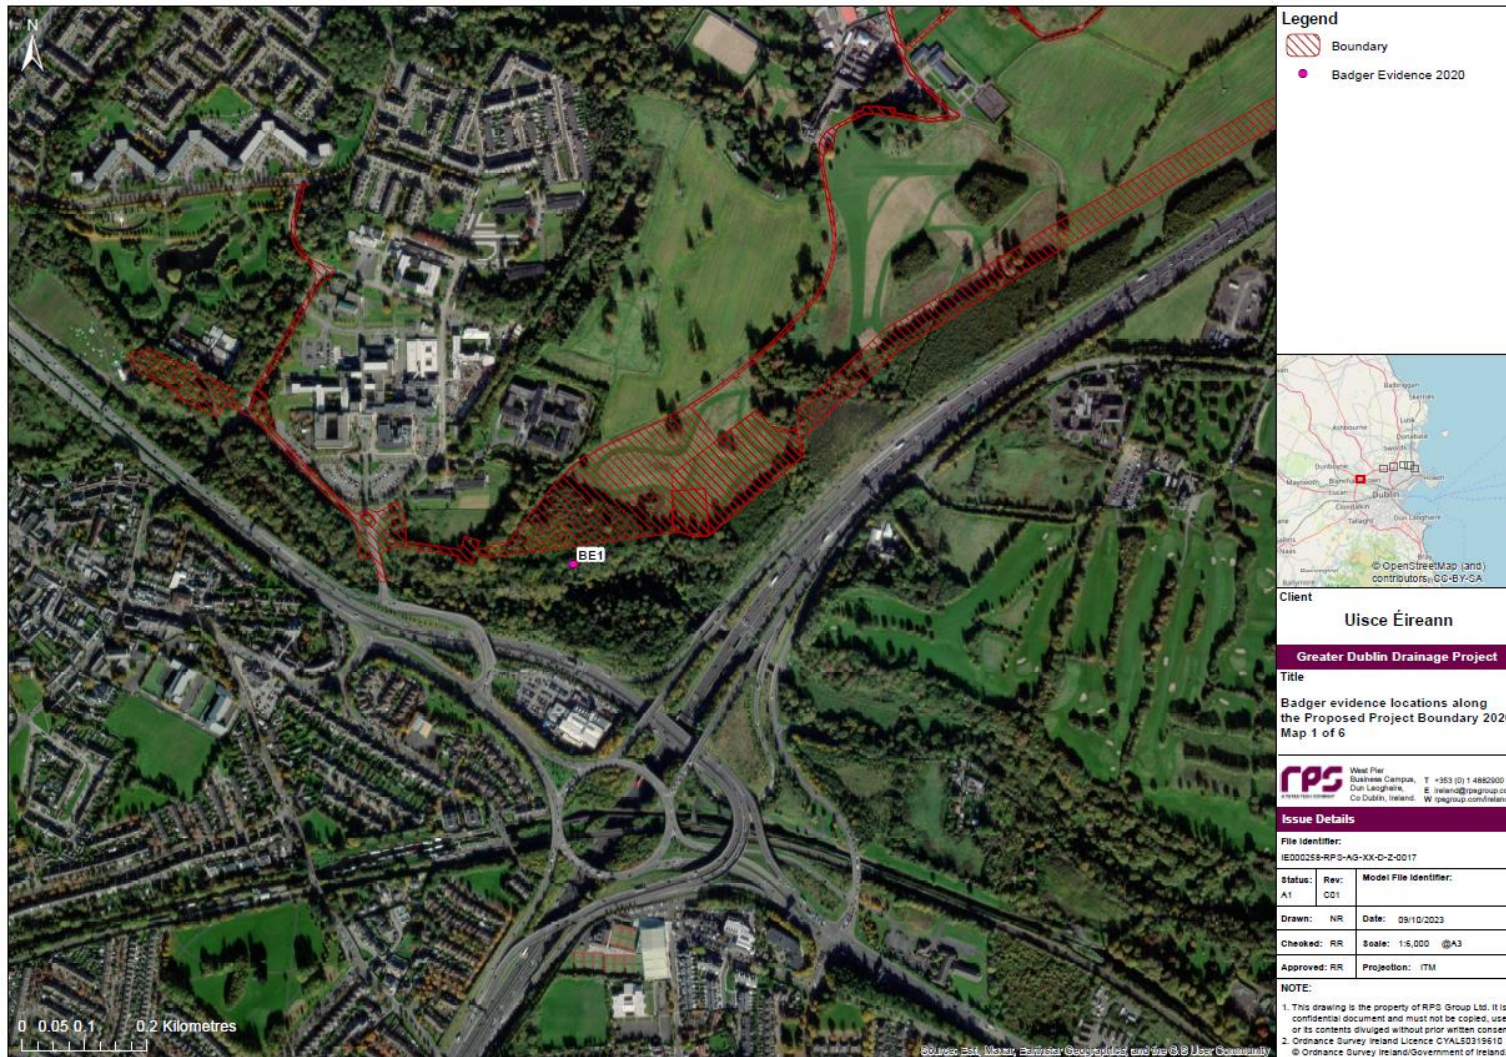
Figure B-2 Badger evidence locations along the Proposed Project Boundary 2020 (1)

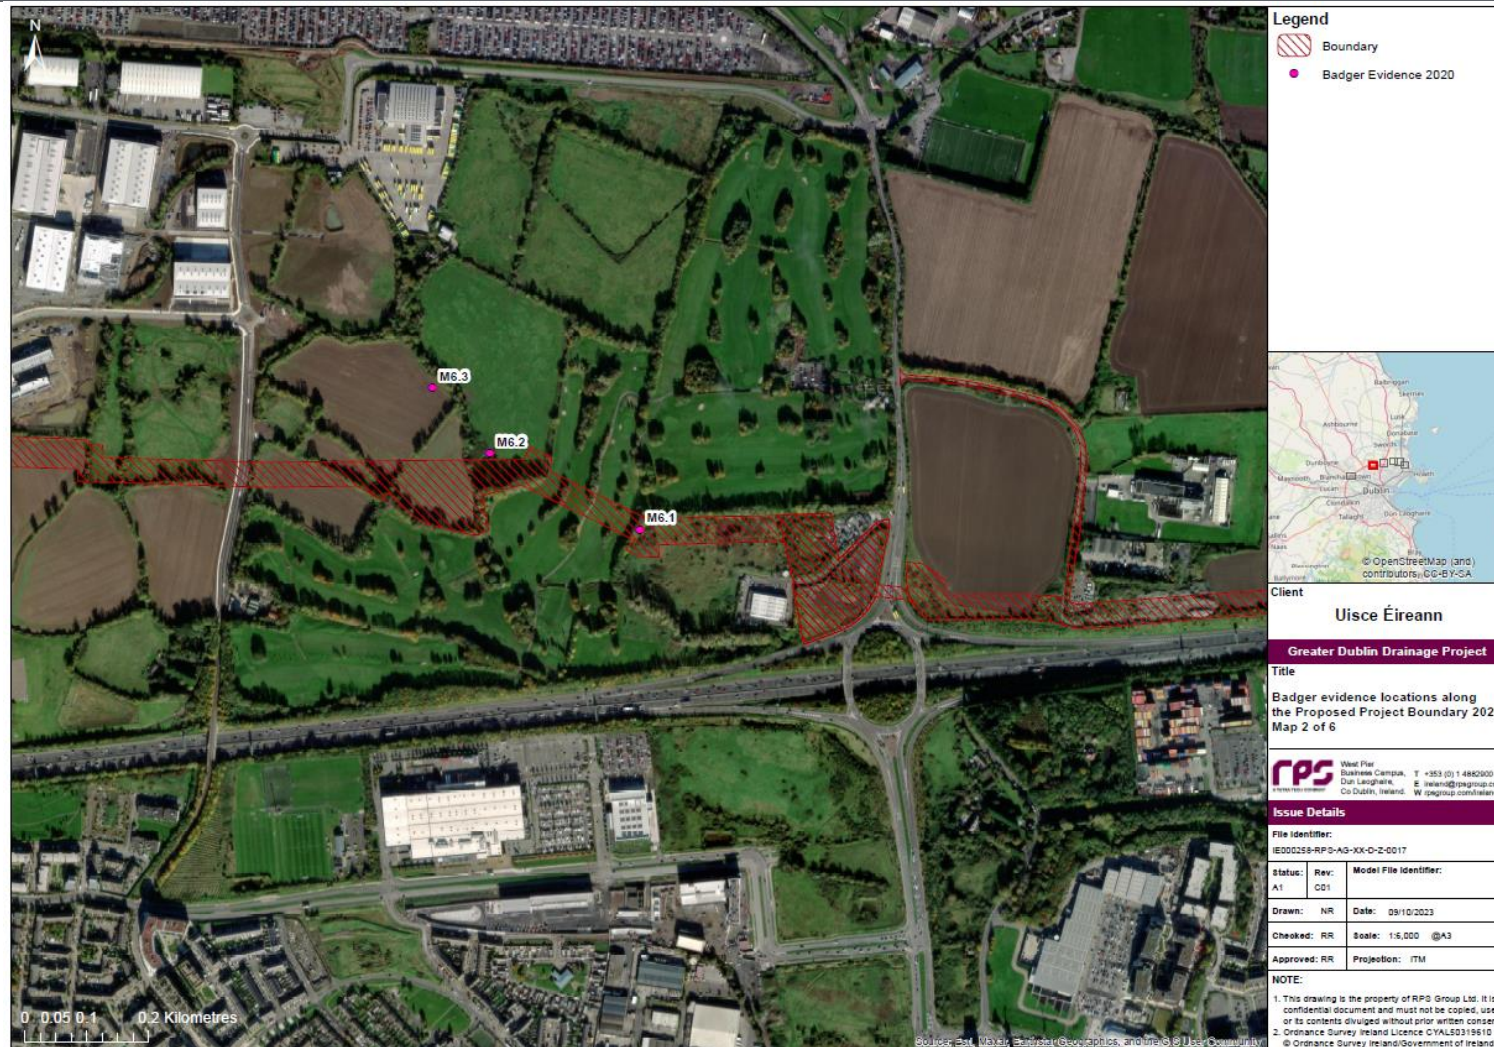
Figure B-3 Badger evidence locations along the Proposed Project Boundary 2020 (2)
