GREATER DUBLIN DRAINAGE PROJECT

ElAR Addendum Chapter 11A (Biodiversity (Terrestrial and Freshwater Aquatic))
Appendix A11.1 Terrestrial Baseline Survey Report

IE000258
S4P01
October 2023

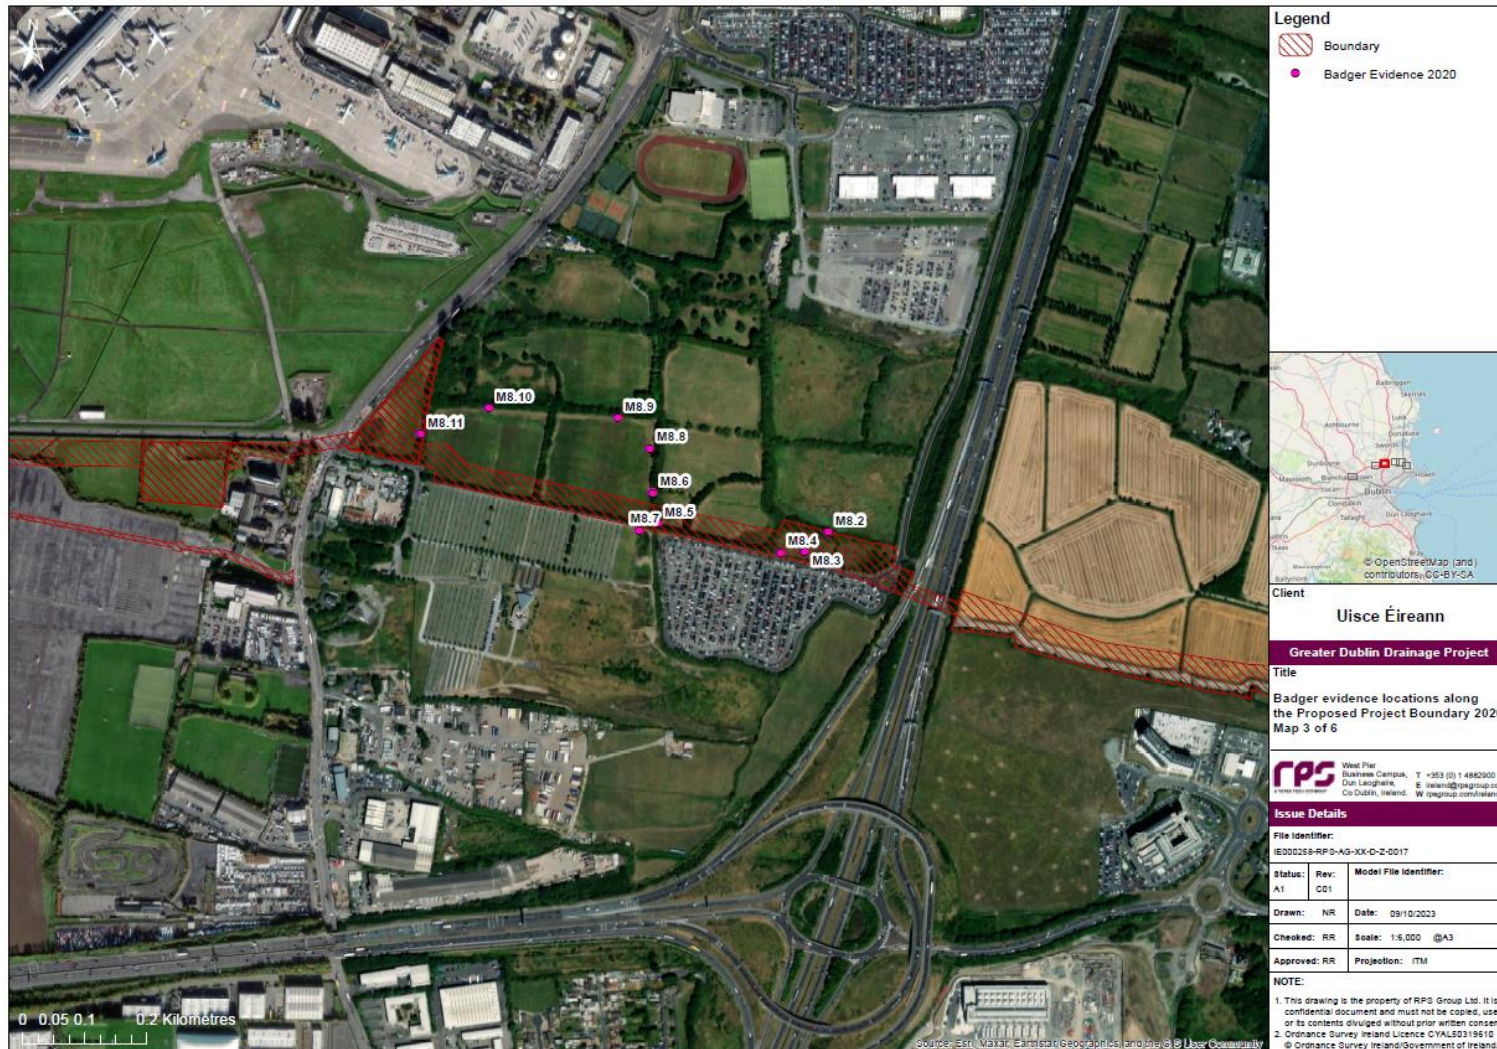
Figure B-4 Badger evidence locations along the Proposed Project Boundary 2020 (3)

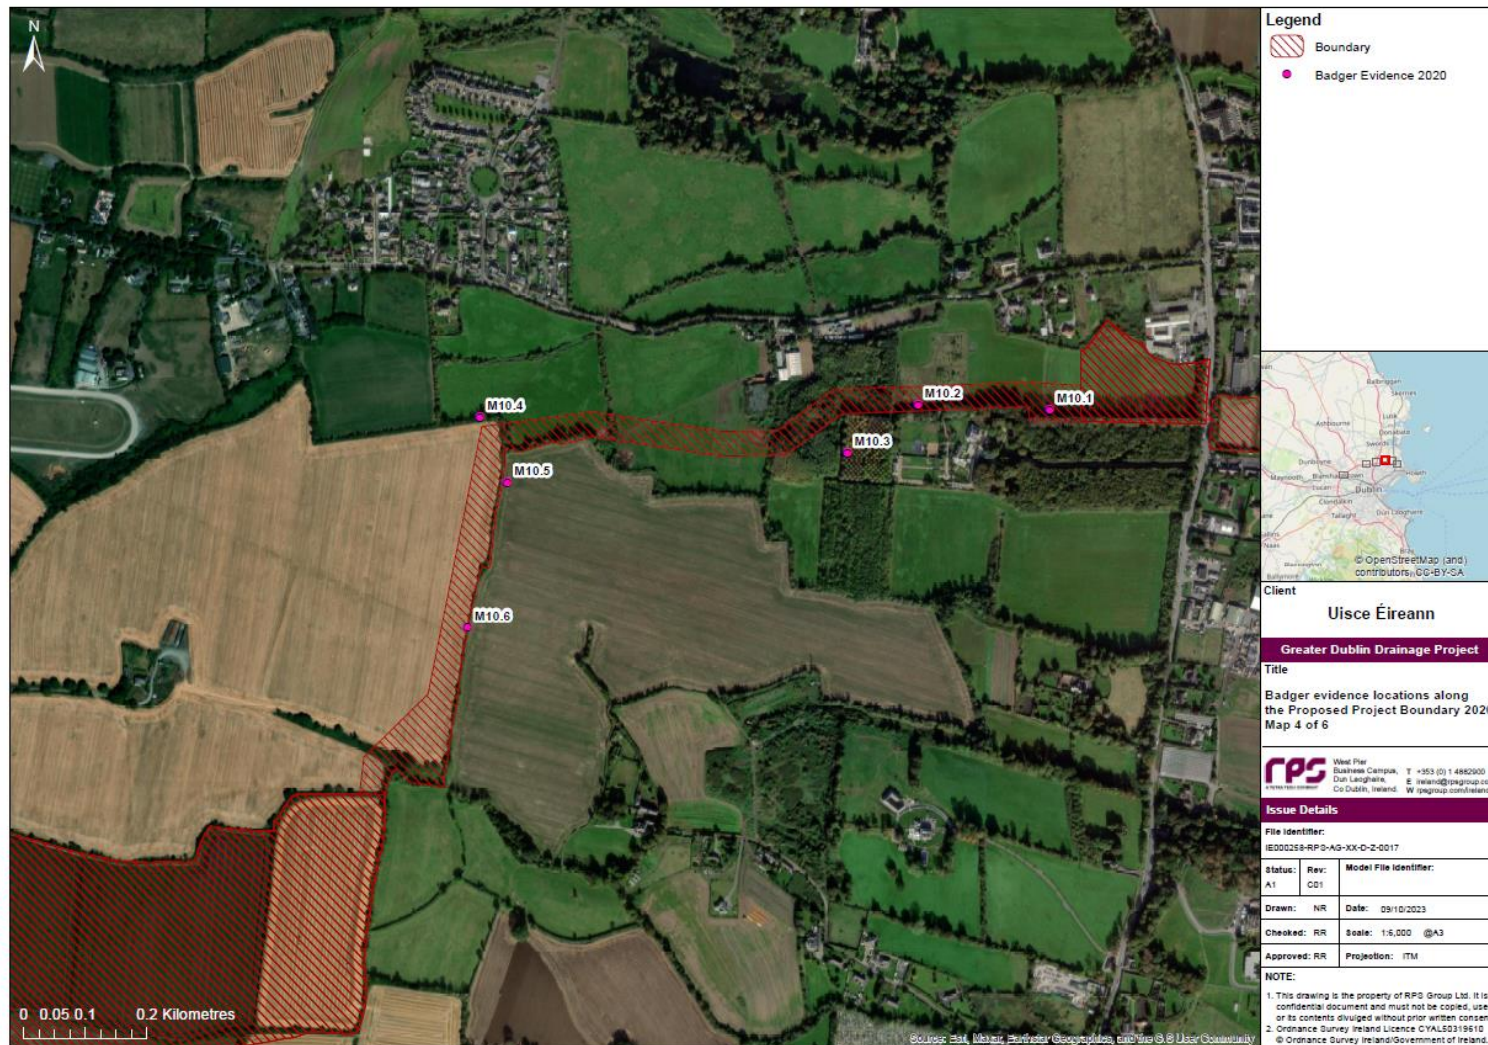
Figure B-5 Badger evidence locations along the Proposed Project Boundary 2020 (4)

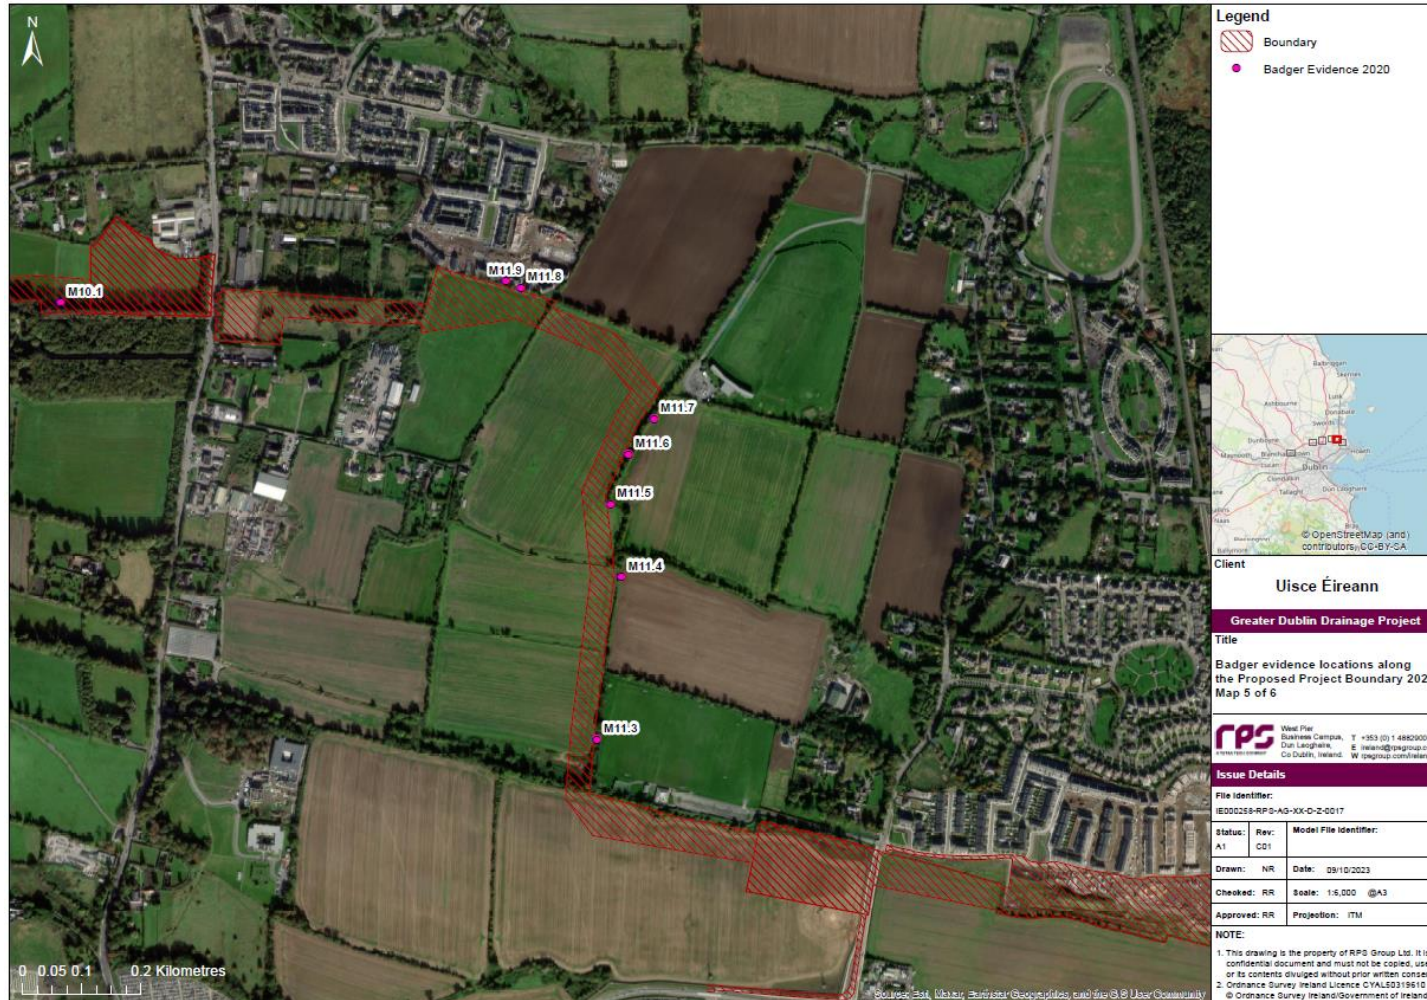
Figure B-6 Badger evidence locations along the Proposed Project Boundary 2020 (5)

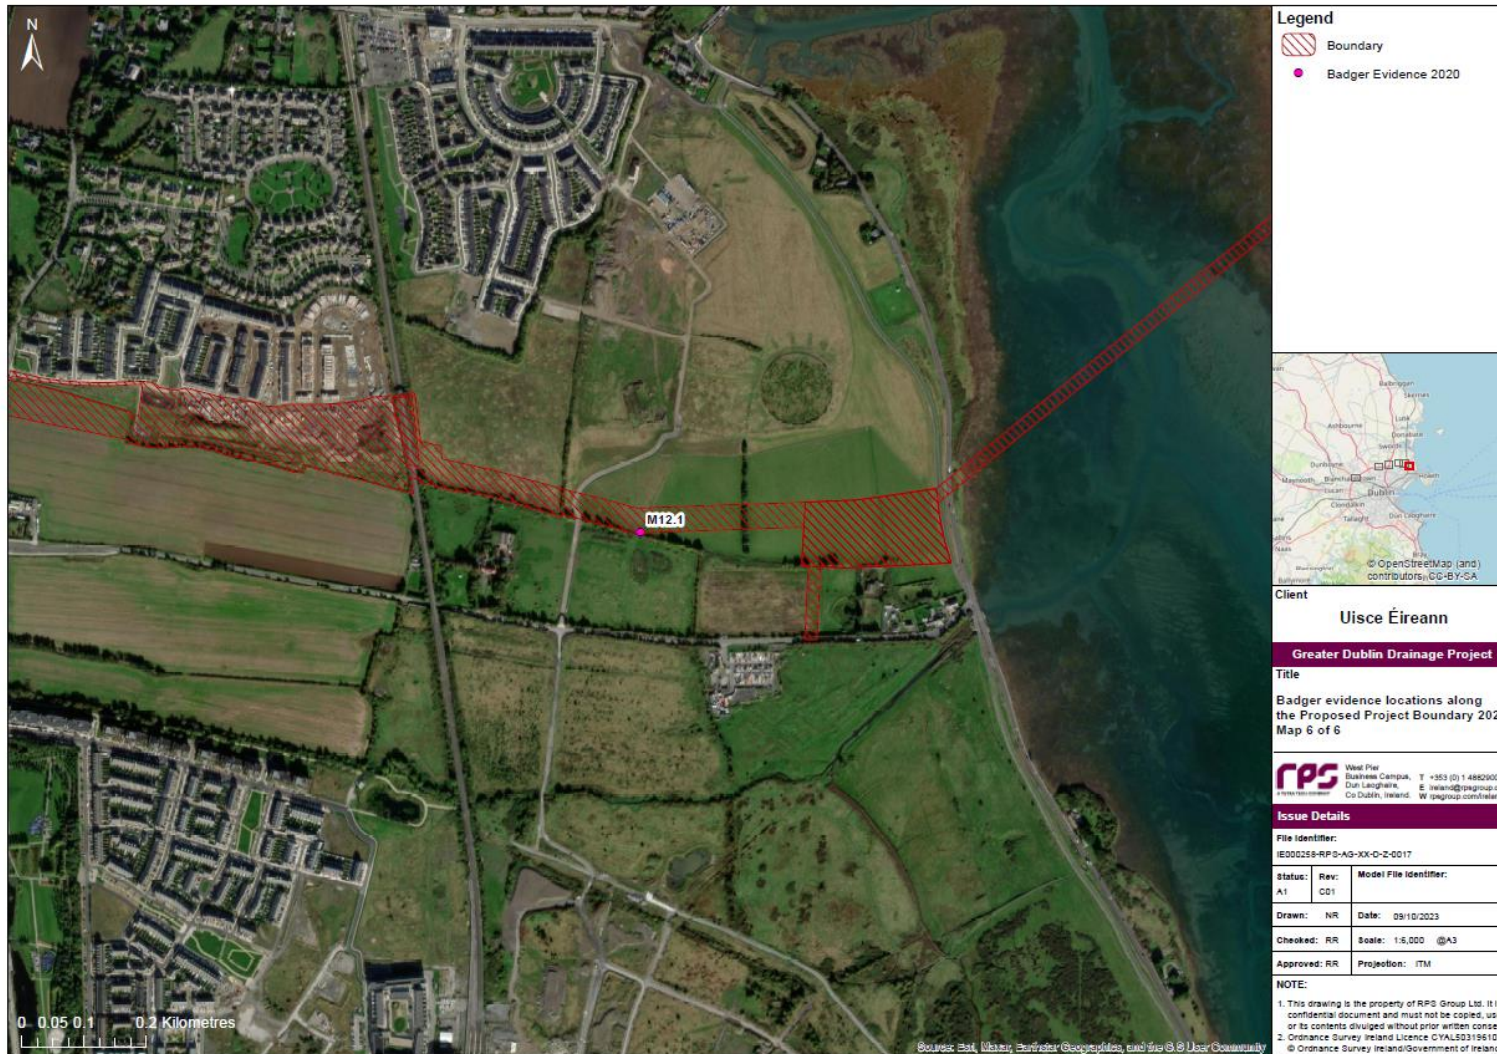
Figure B-7 Badger evidence locations along the Proposed Project Boundary 2020 (6)

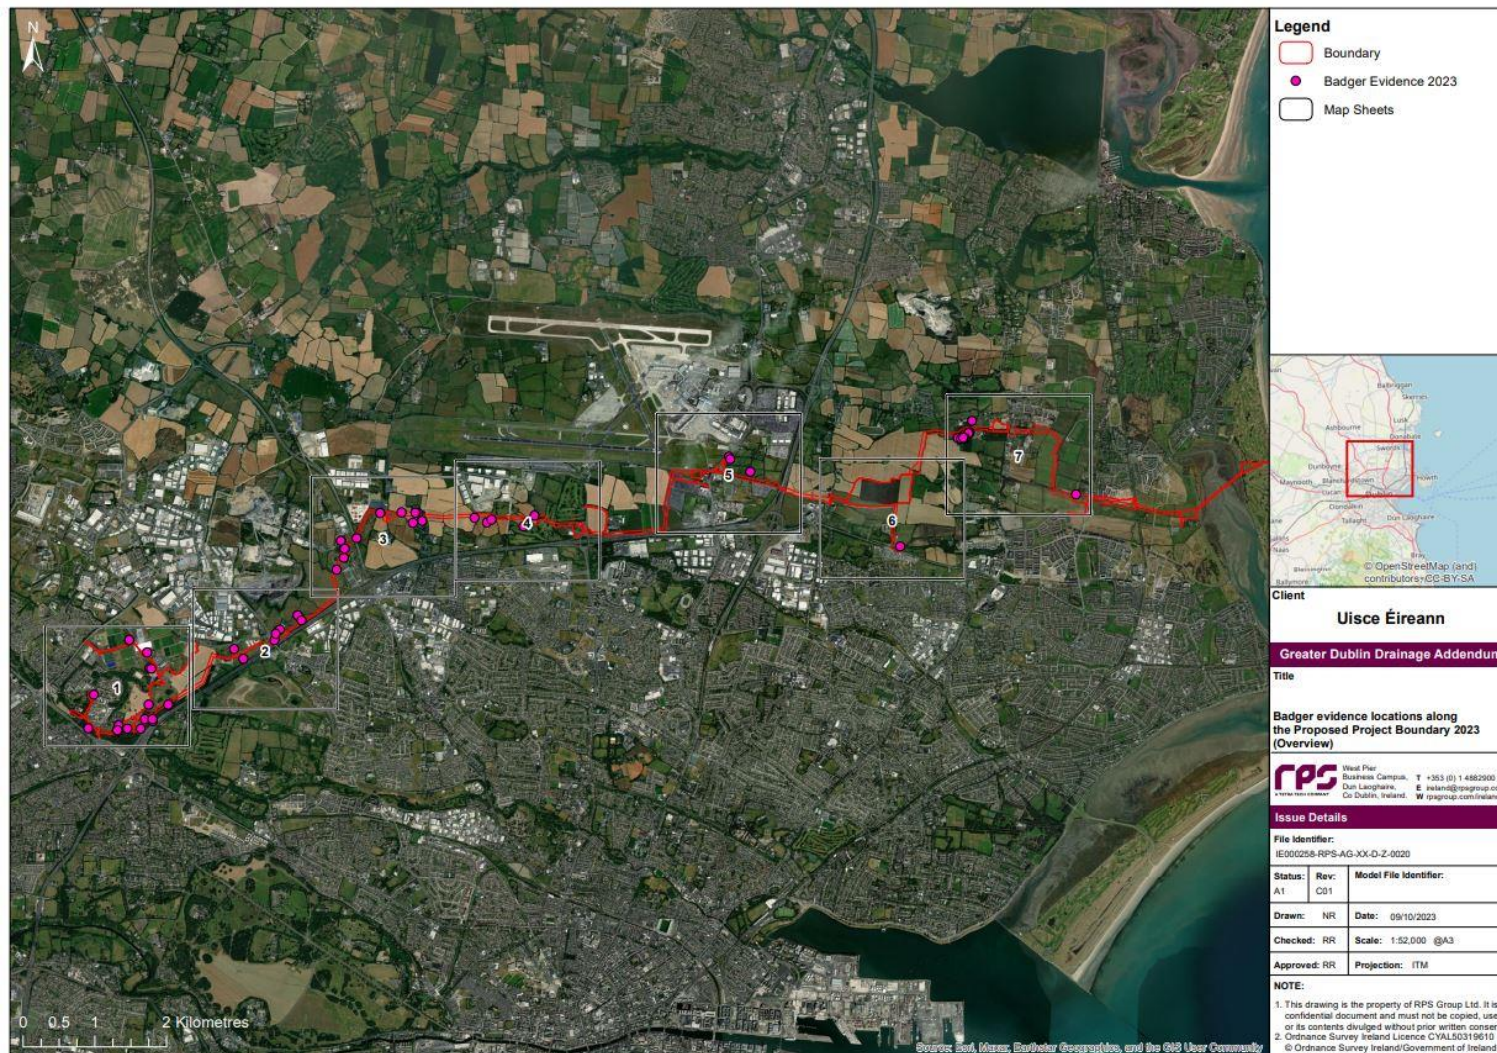
Figure C-1 Badger evidence locations along the Proposed Project Boundary 2023 (Overview)

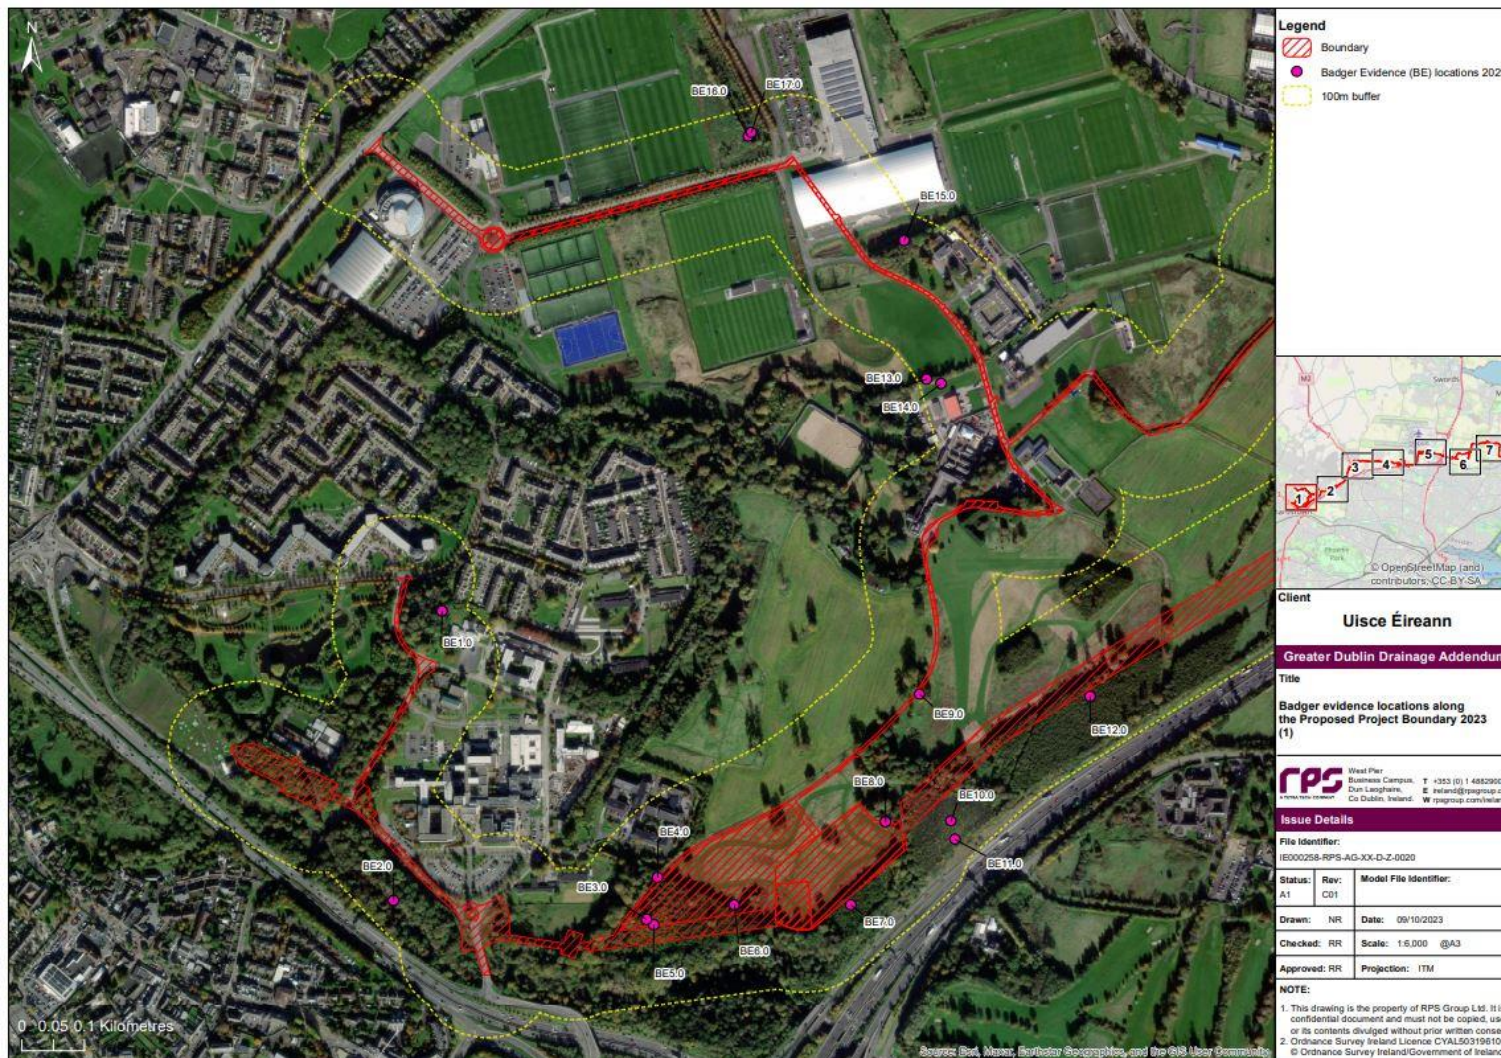
Figure C-2 Badger evidence locations along the Proposed Project Boundary 2023 (1)

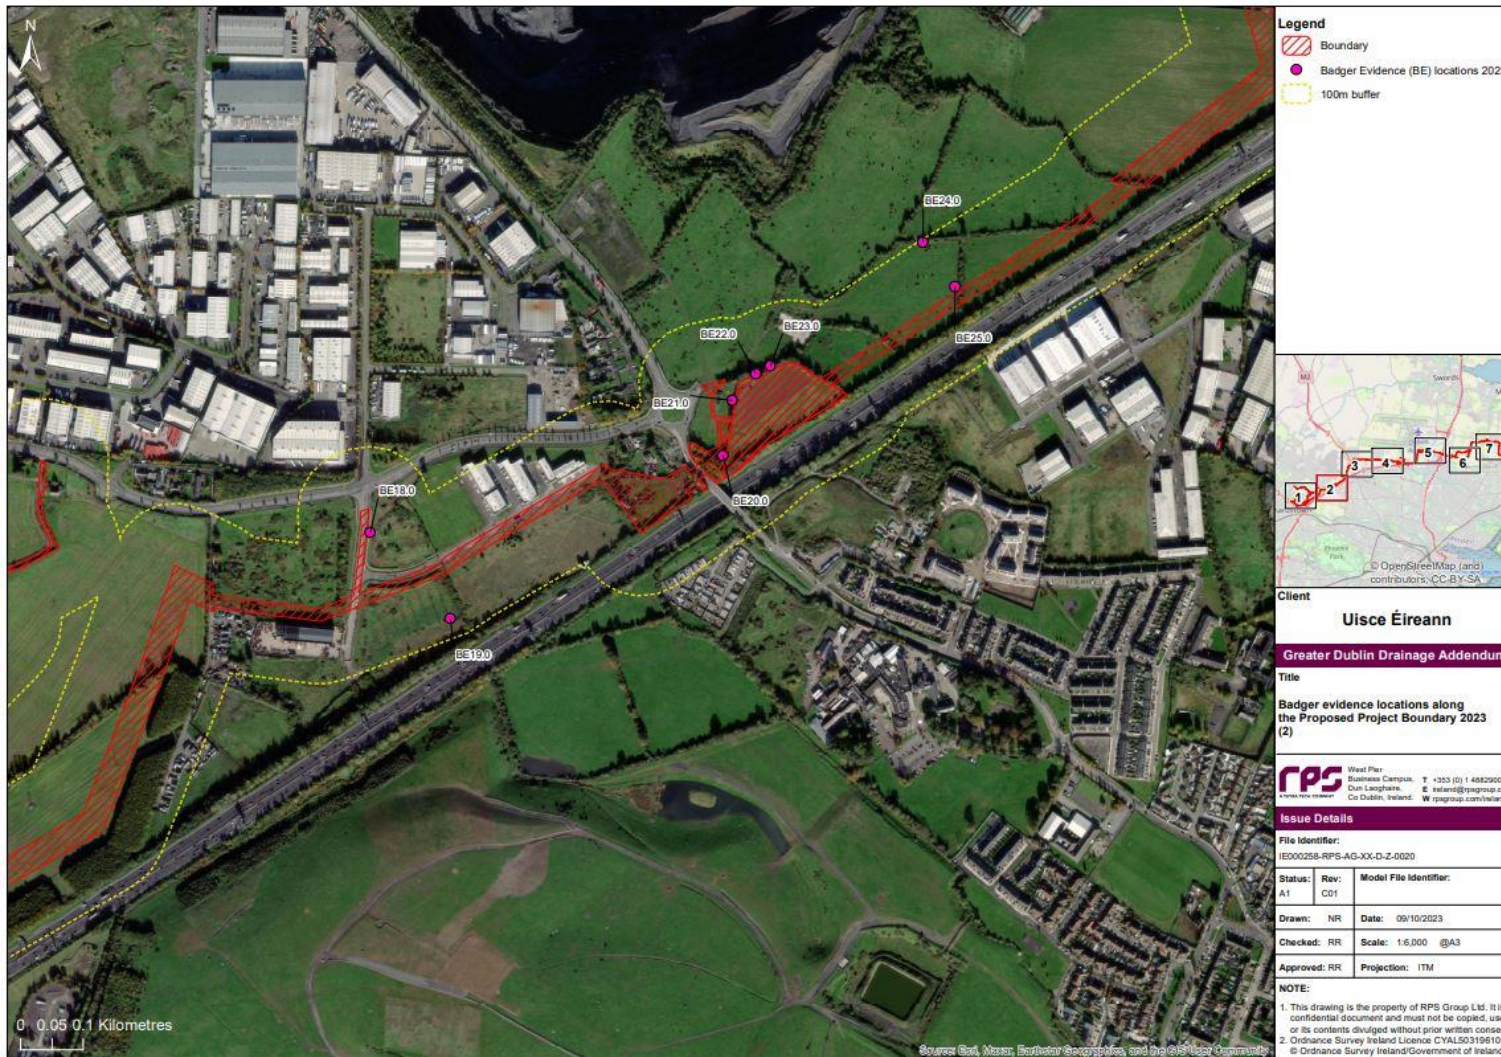
Figure C-3 Badger evidence locations along the Proposed Project Boundary 2023 (2)

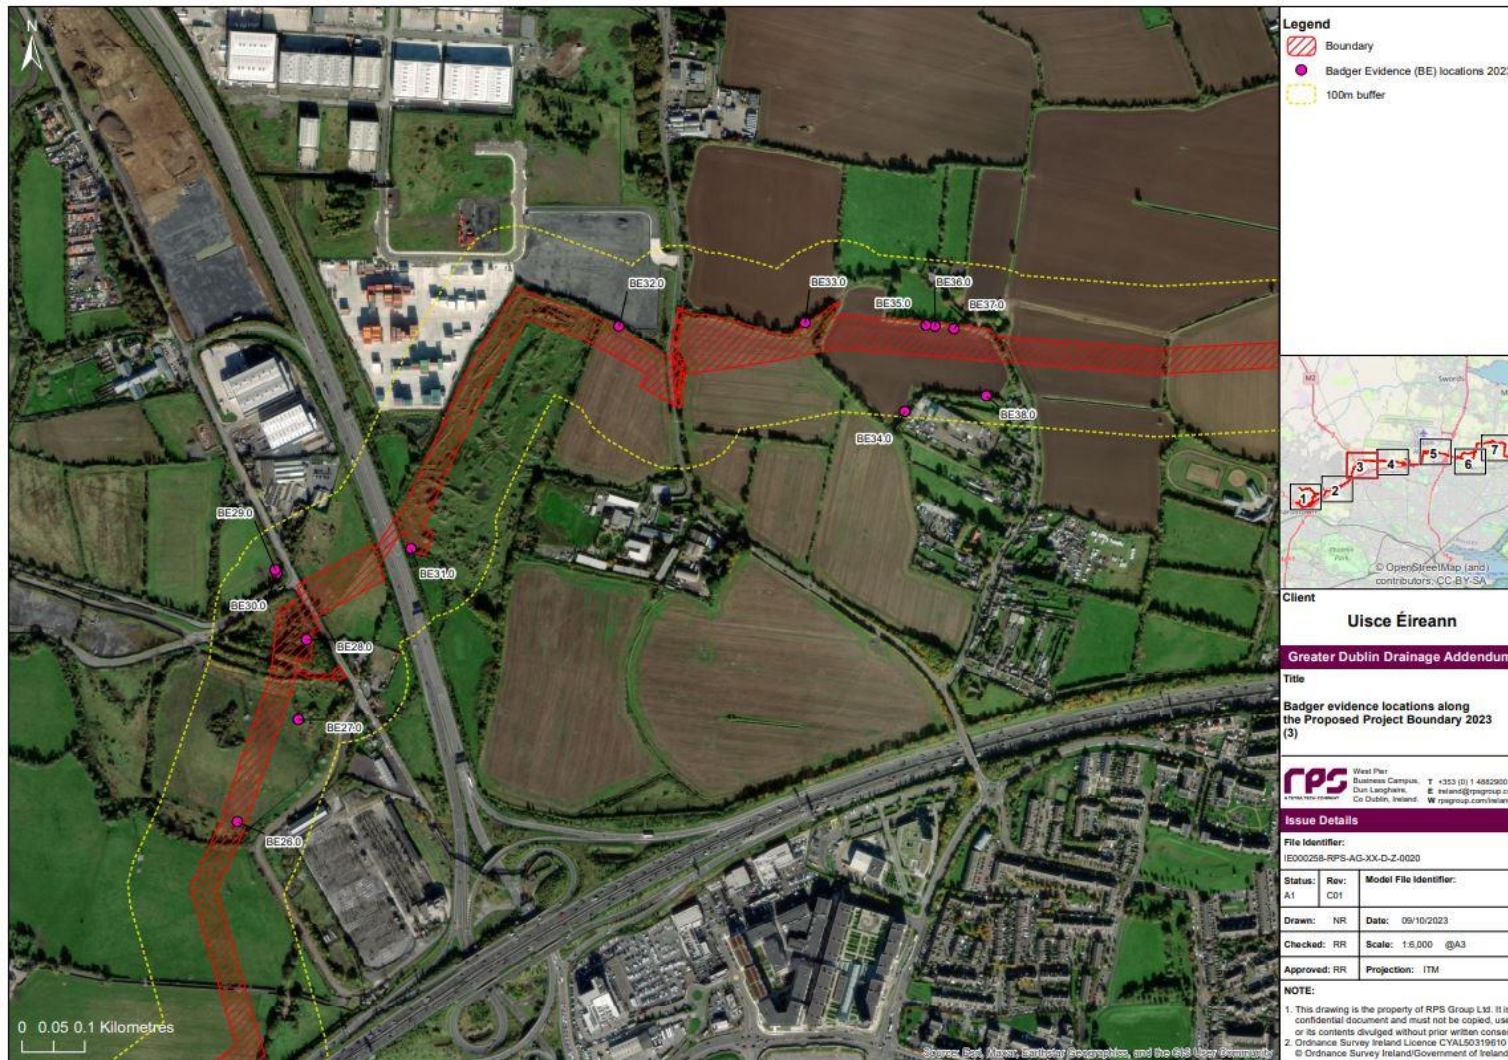
Figure C-4 Badger evidence locations along the Proposed Project Boundary 2023 (3)

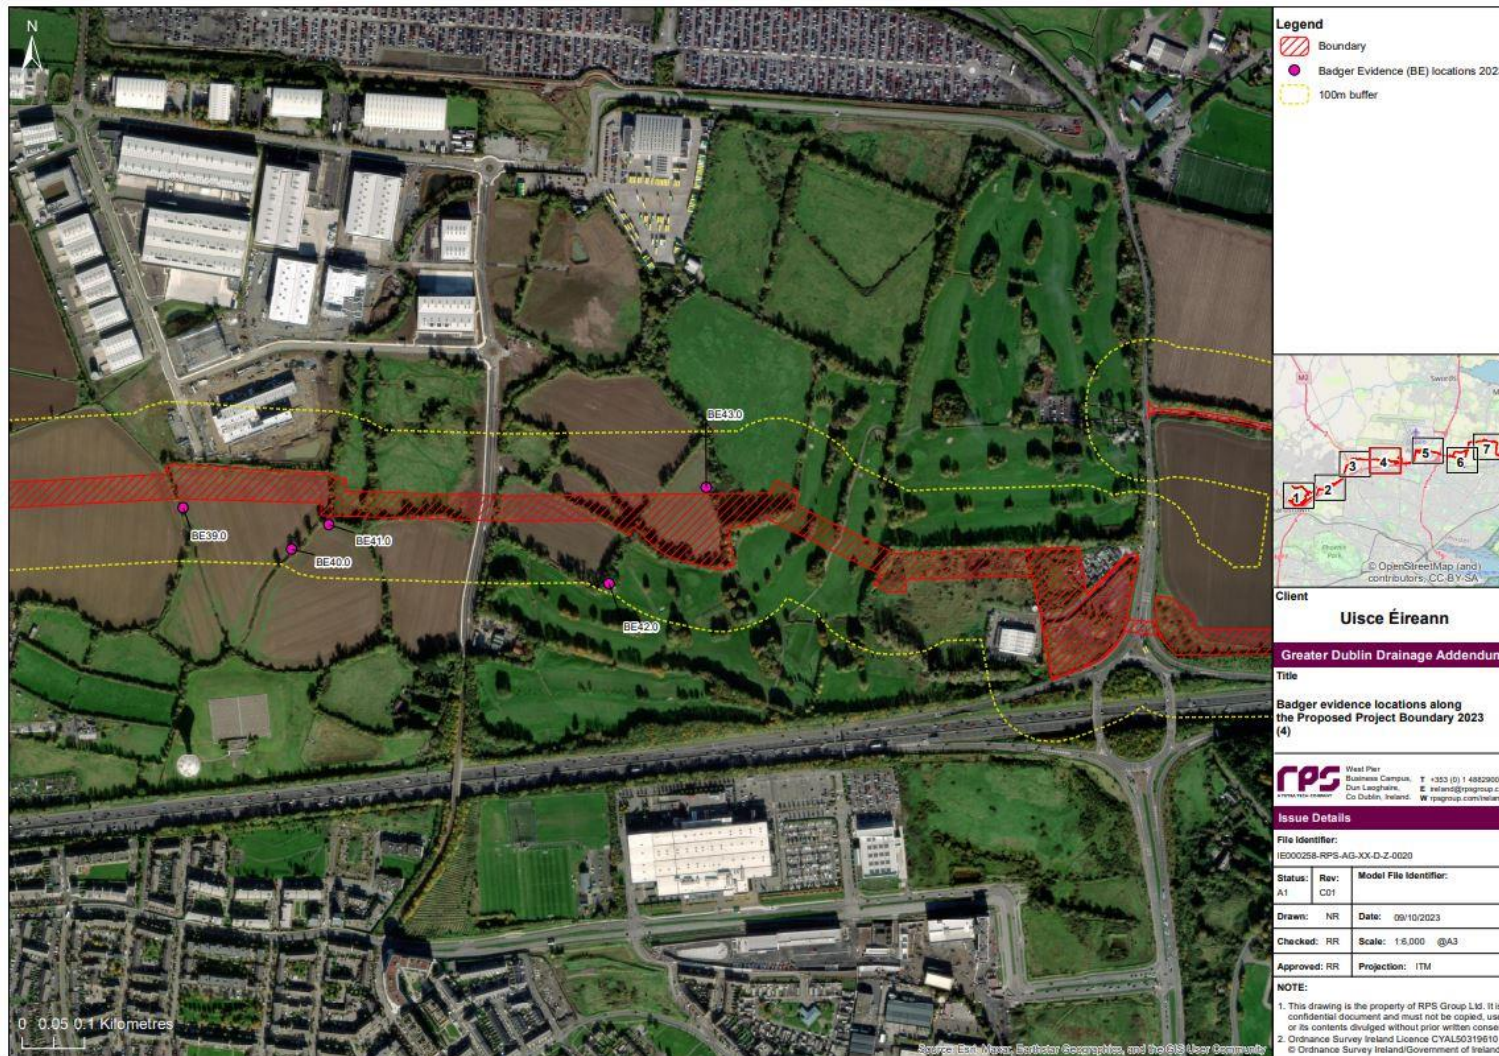
Figure C-5 Badger evidence locations along the Proposed Project Boundary 2023 (4)

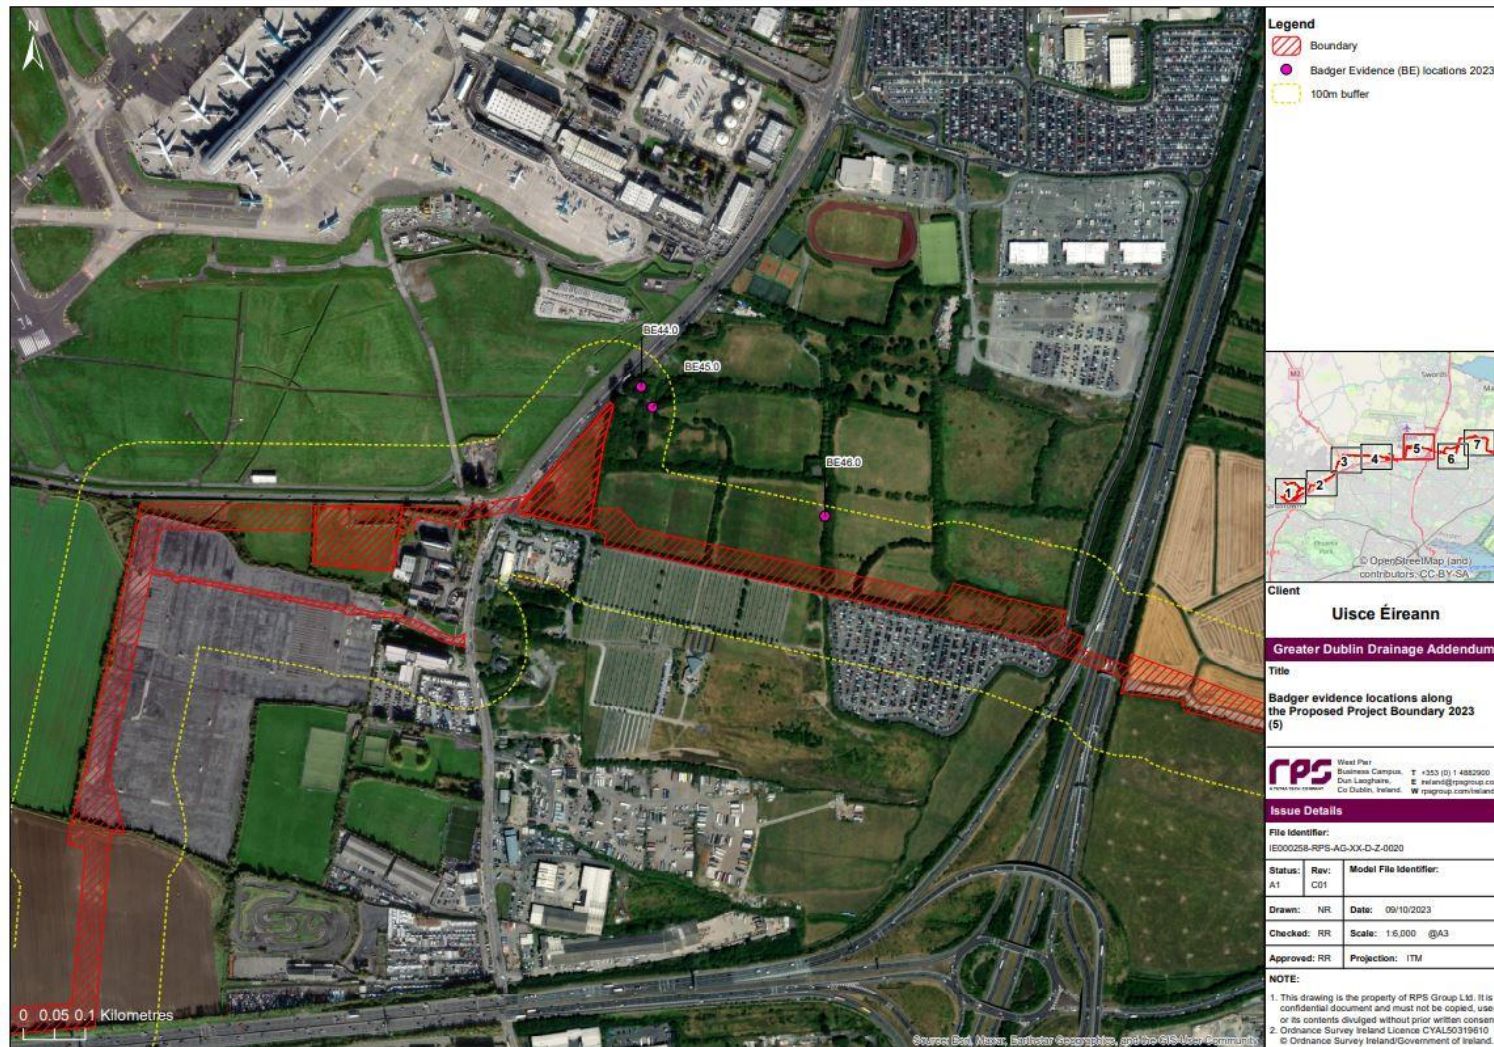
Figure C-6 Badger evidence locations along the Proposed Project Boundary 2023 (5)

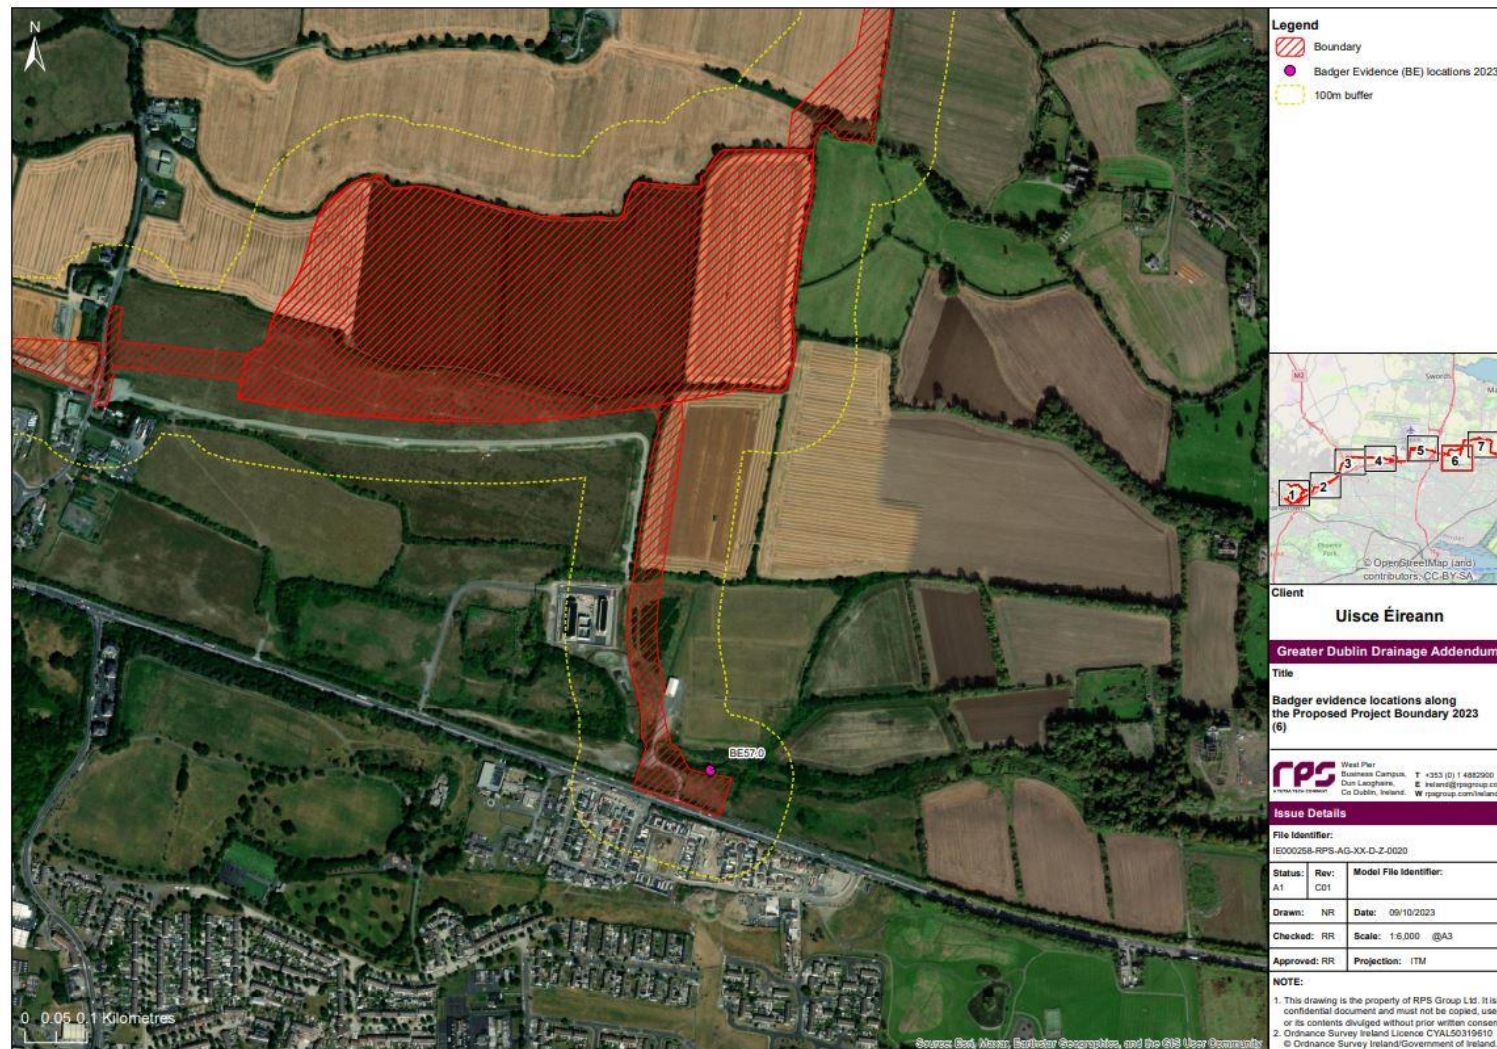
Figure C-7 Badger evidence locations along the Proposed Project Boundary 2023 (6)

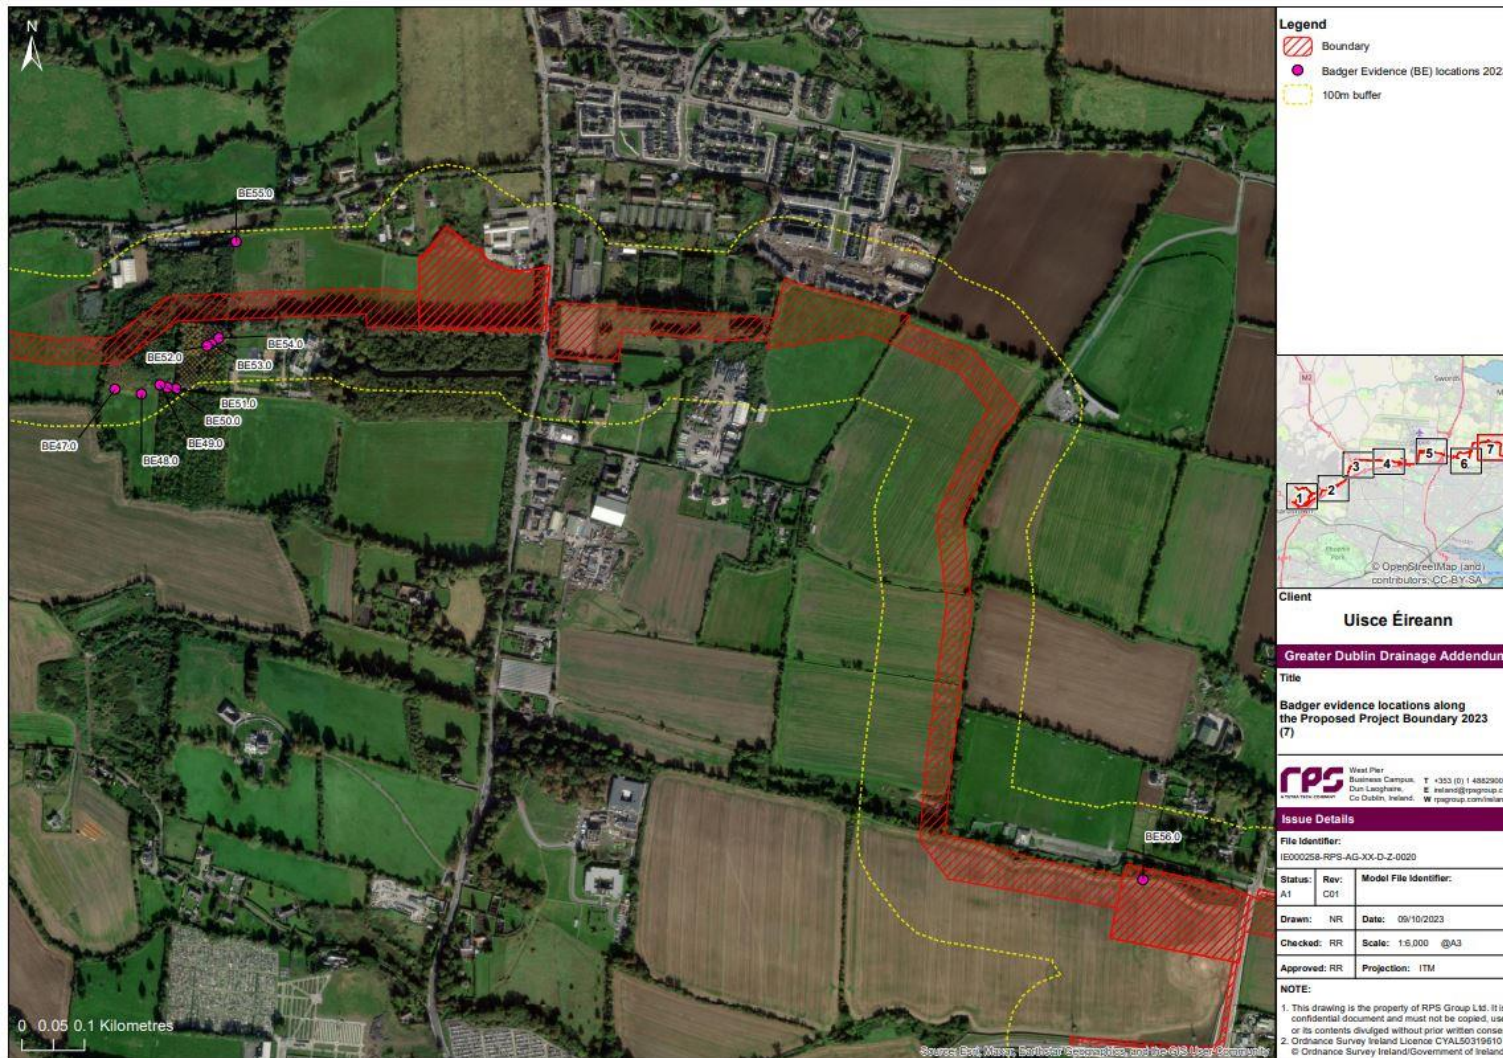
Figure C-8 Badger evidence locations along the Proposed Project Boundary 2023 (7)

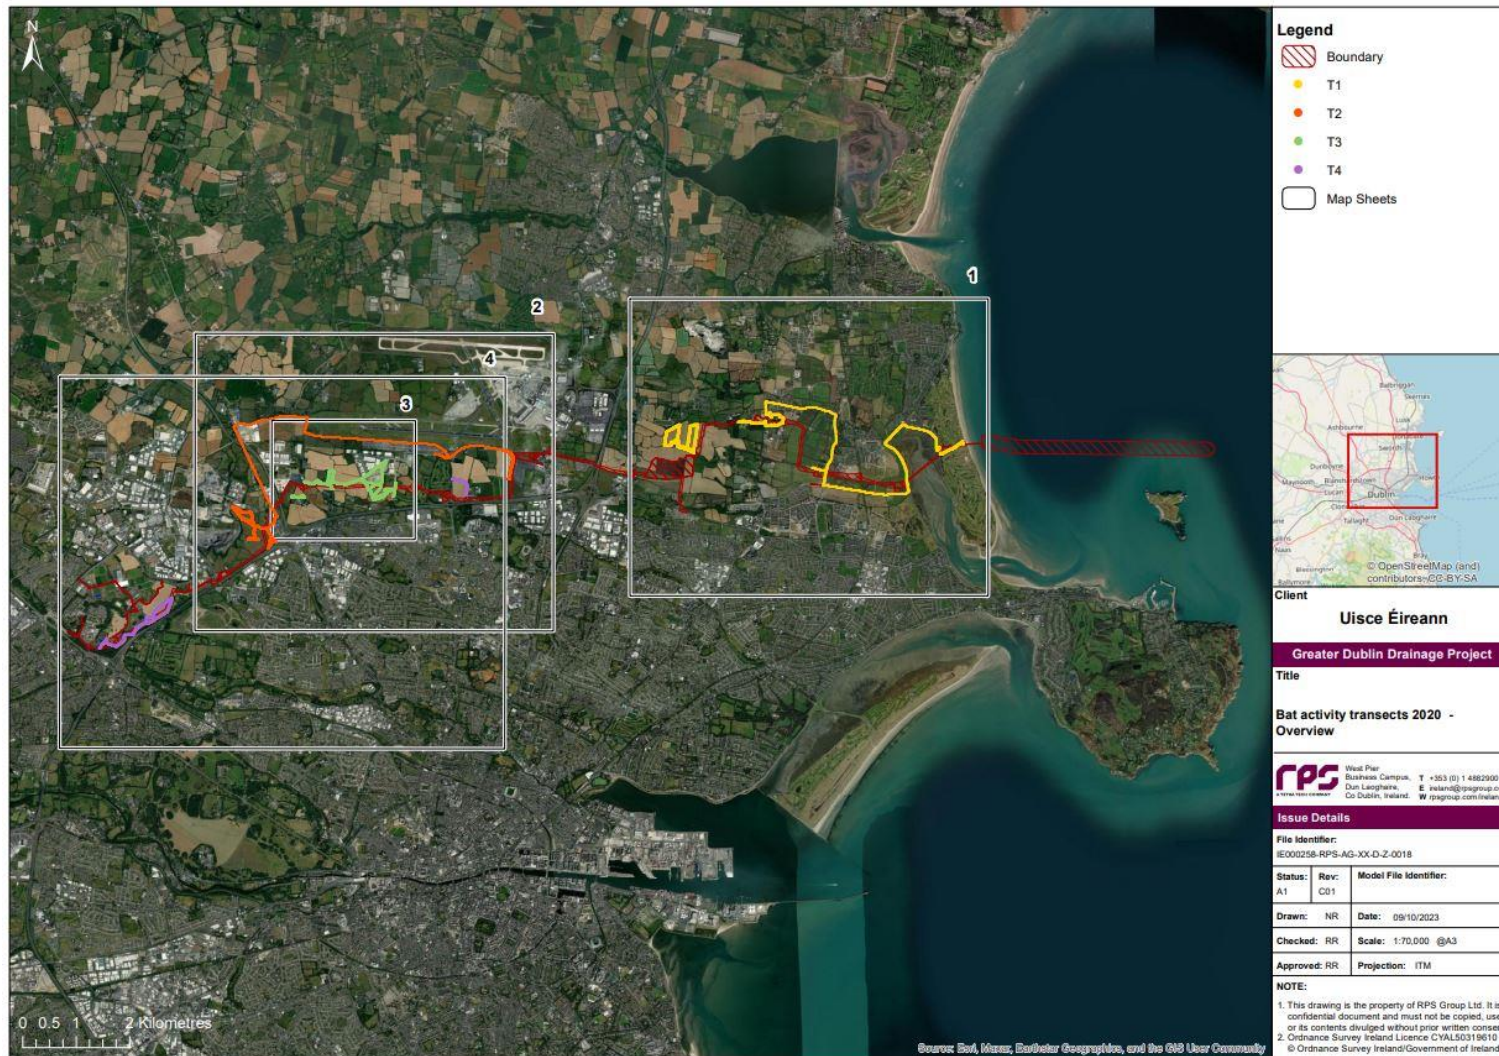
Figure E-1. Bat activity transects 2020 (overview^[JE1])

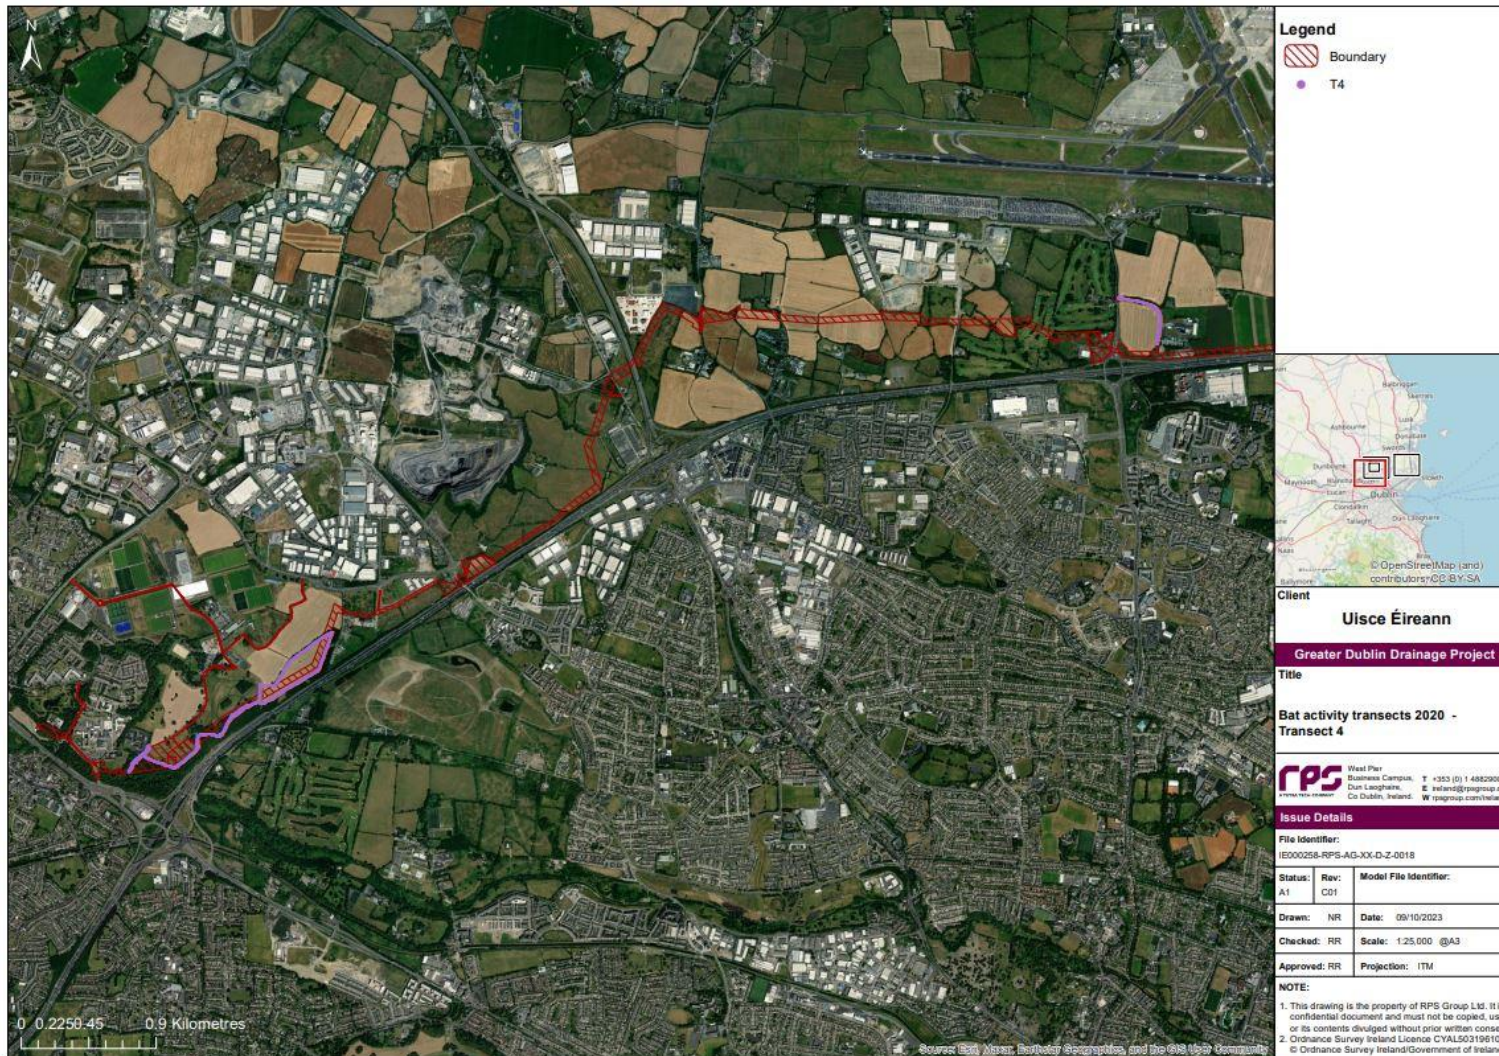
Figure E-2. Bat activity transects 2020 Transect 4
