GREATER DUBLIN DRAINAGE PROJECT

ElAR Addendum Chapter 11A (Biodiversity (Terrestrial and Freshwater Aquatic))
Appendix A11.1 Terrestrial Baseline Survey Report

IE000258
S4P01
October 2023

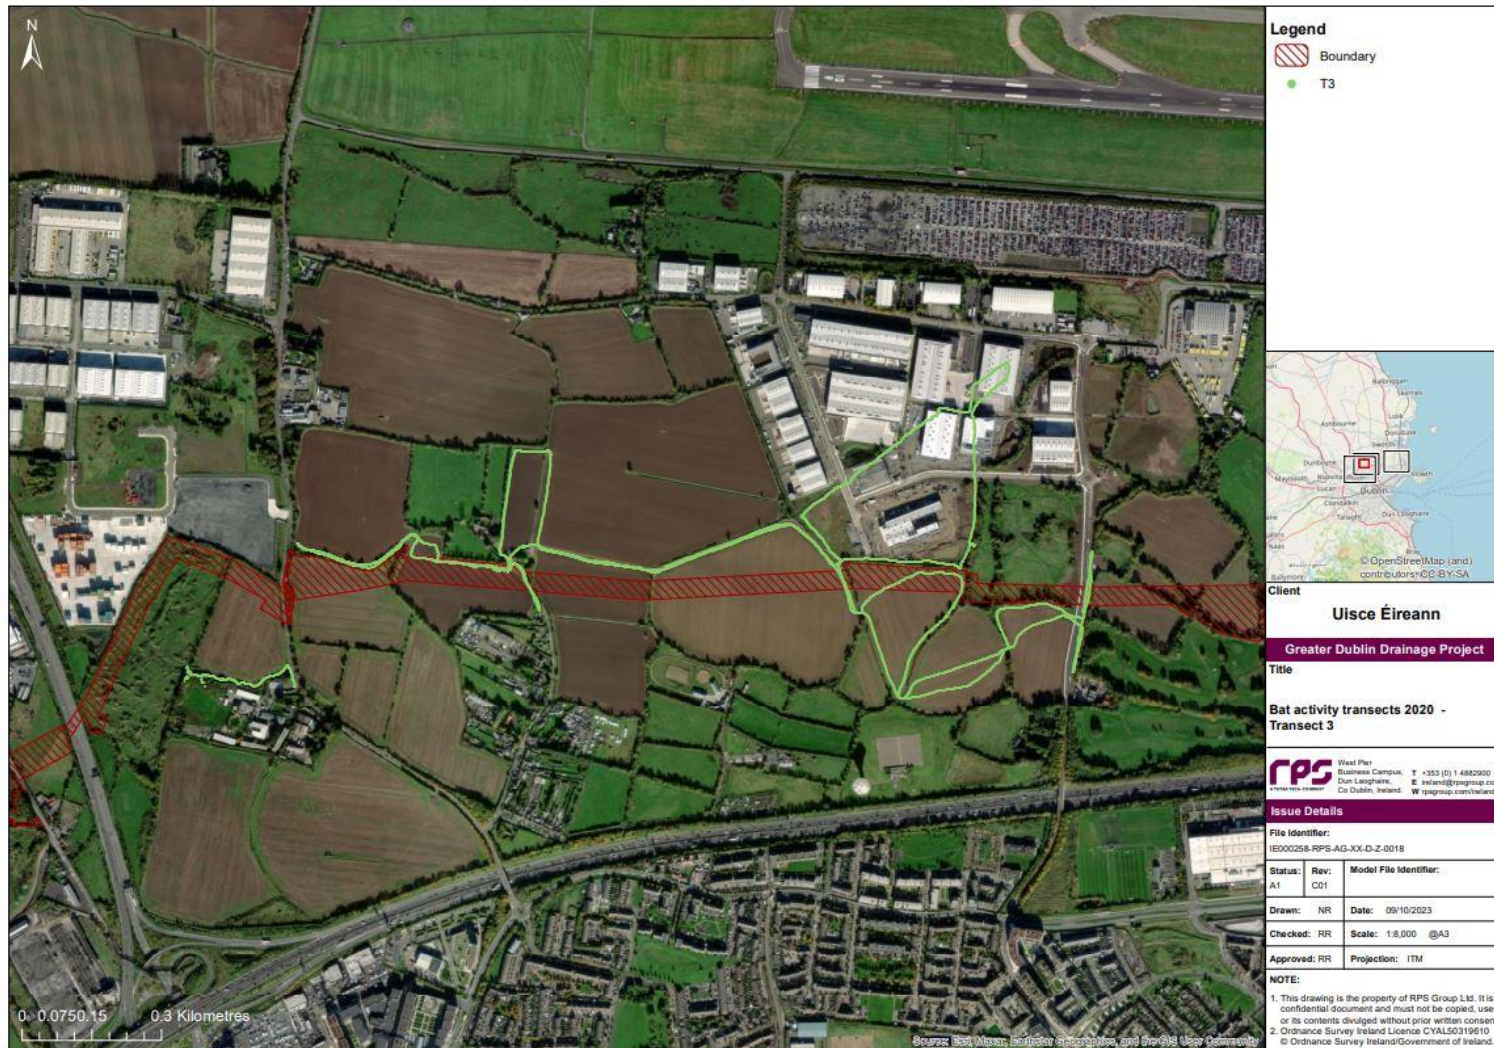
Figure E-3. Bat activity transects 2020 Transect 3

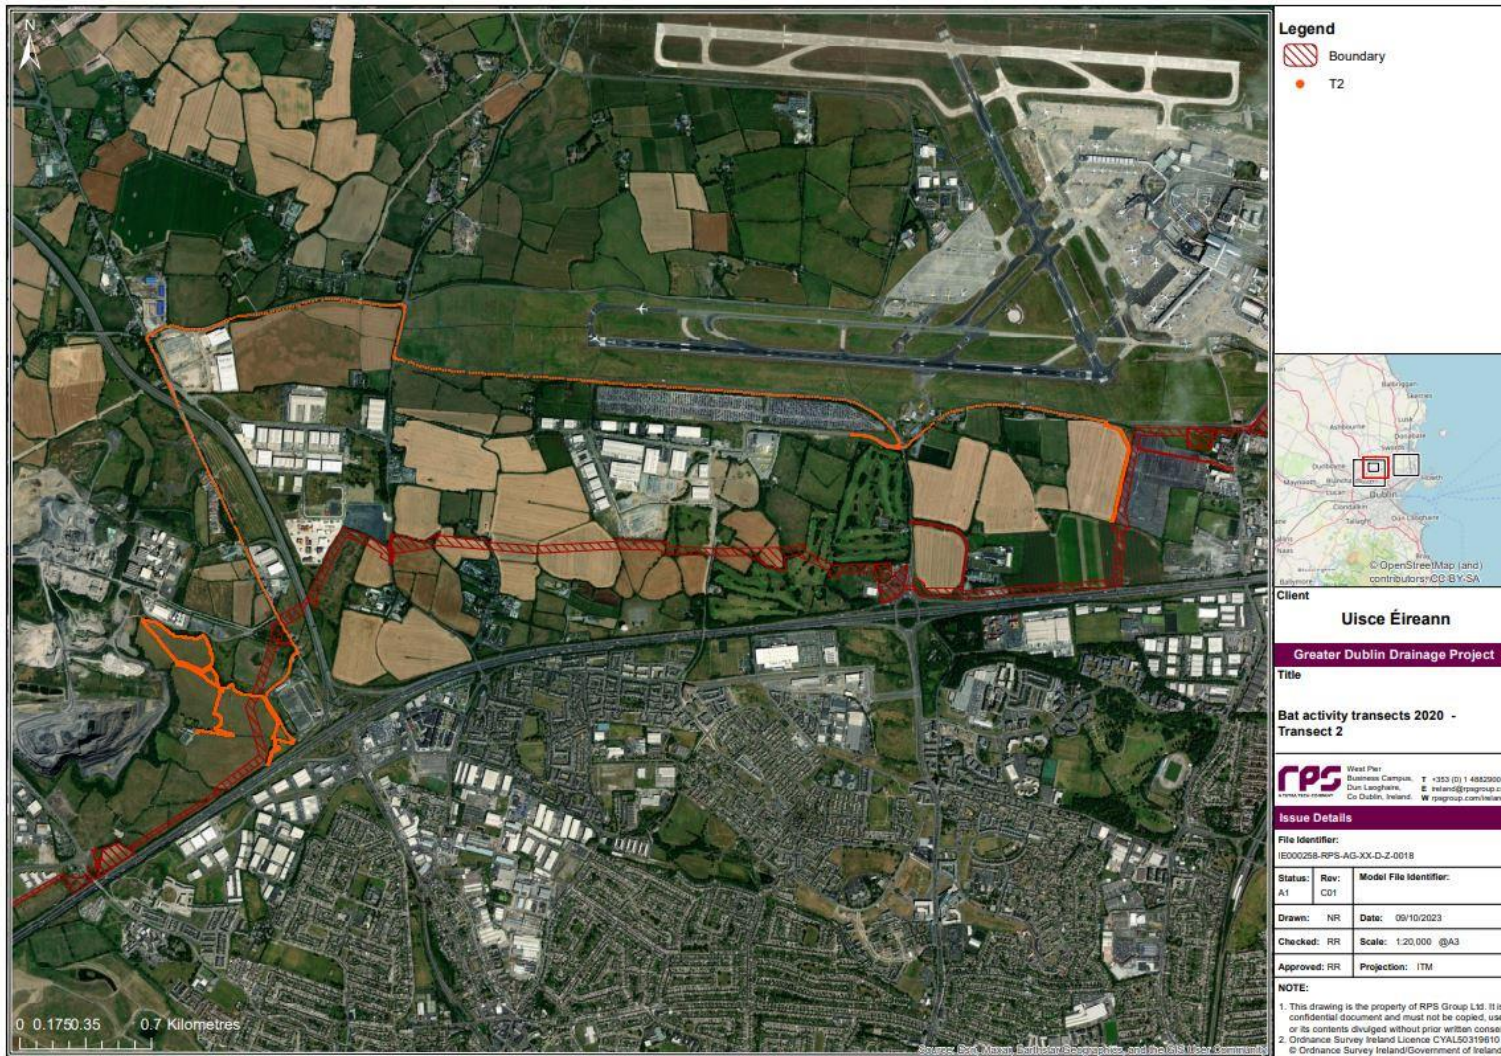
Figure E-4. Bat activity transects 2020 Transect 2

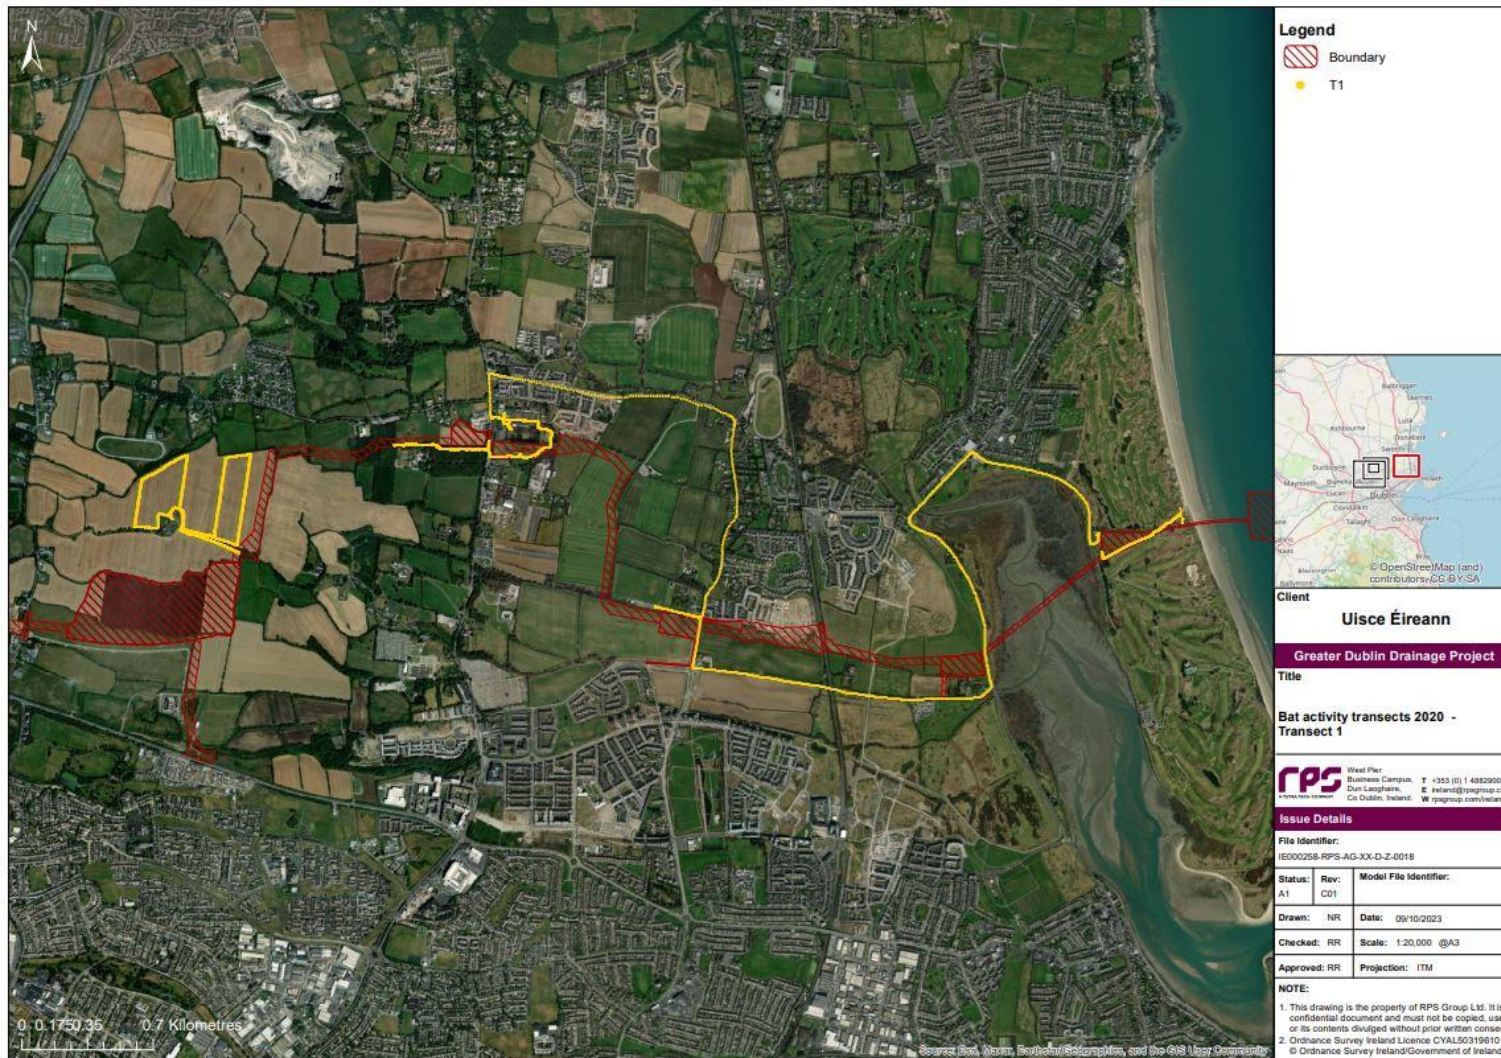
Figure E-5. Bat activity transects 2020 Transect 1

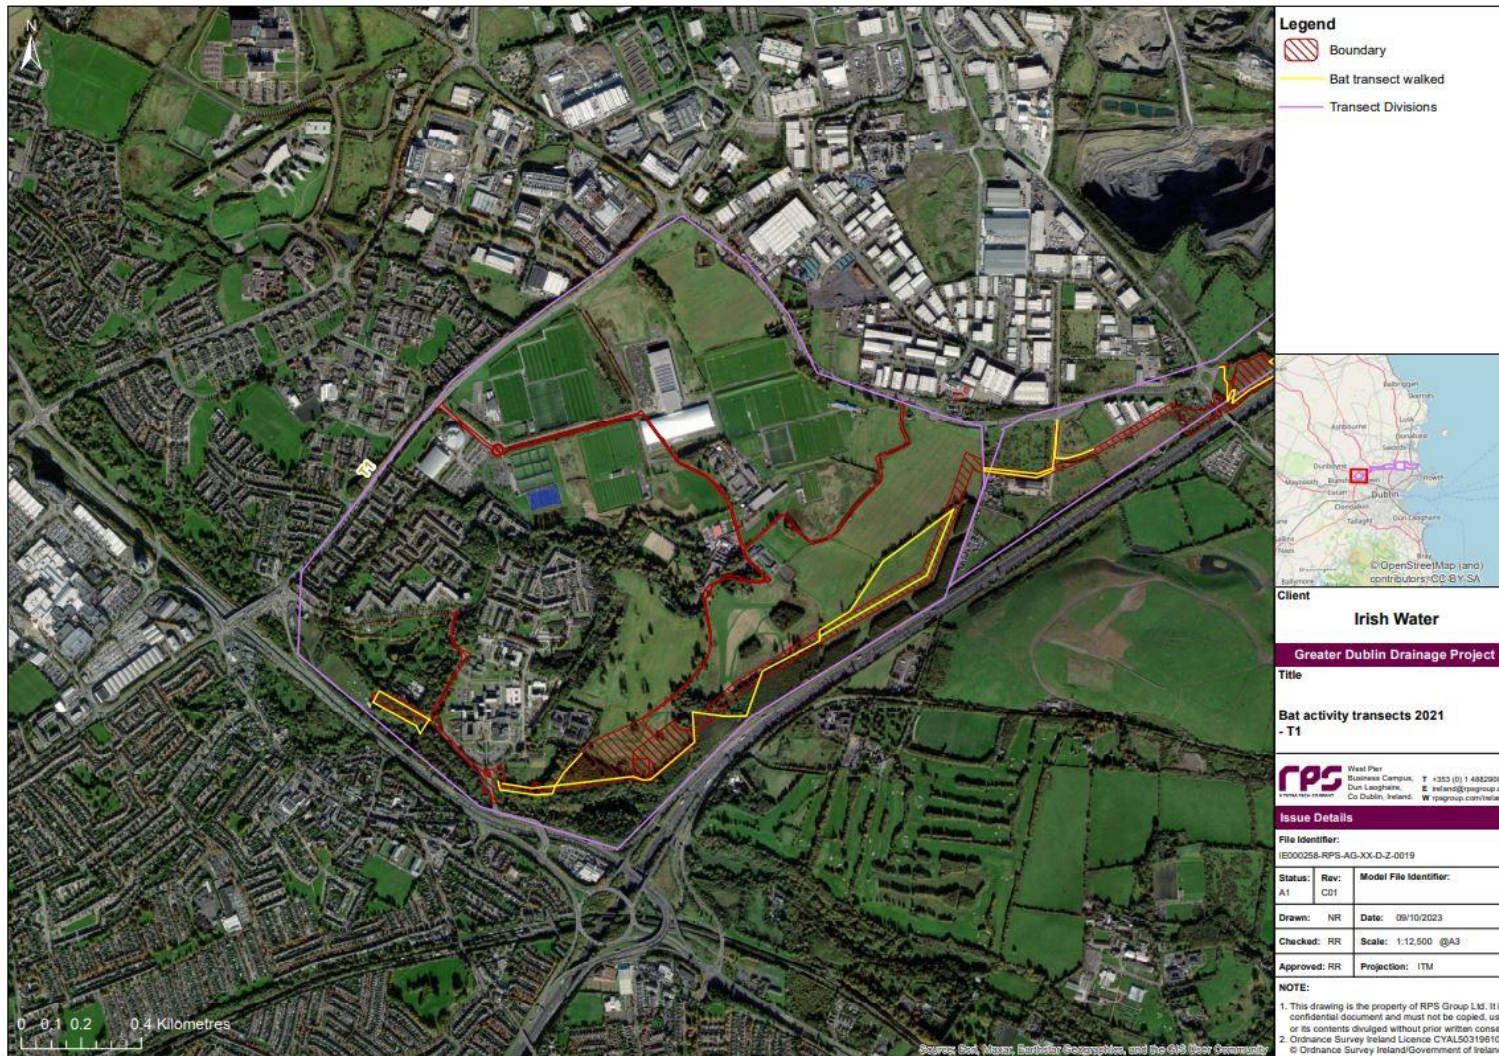
Figure F-2 Bat activity transects 2021 T1

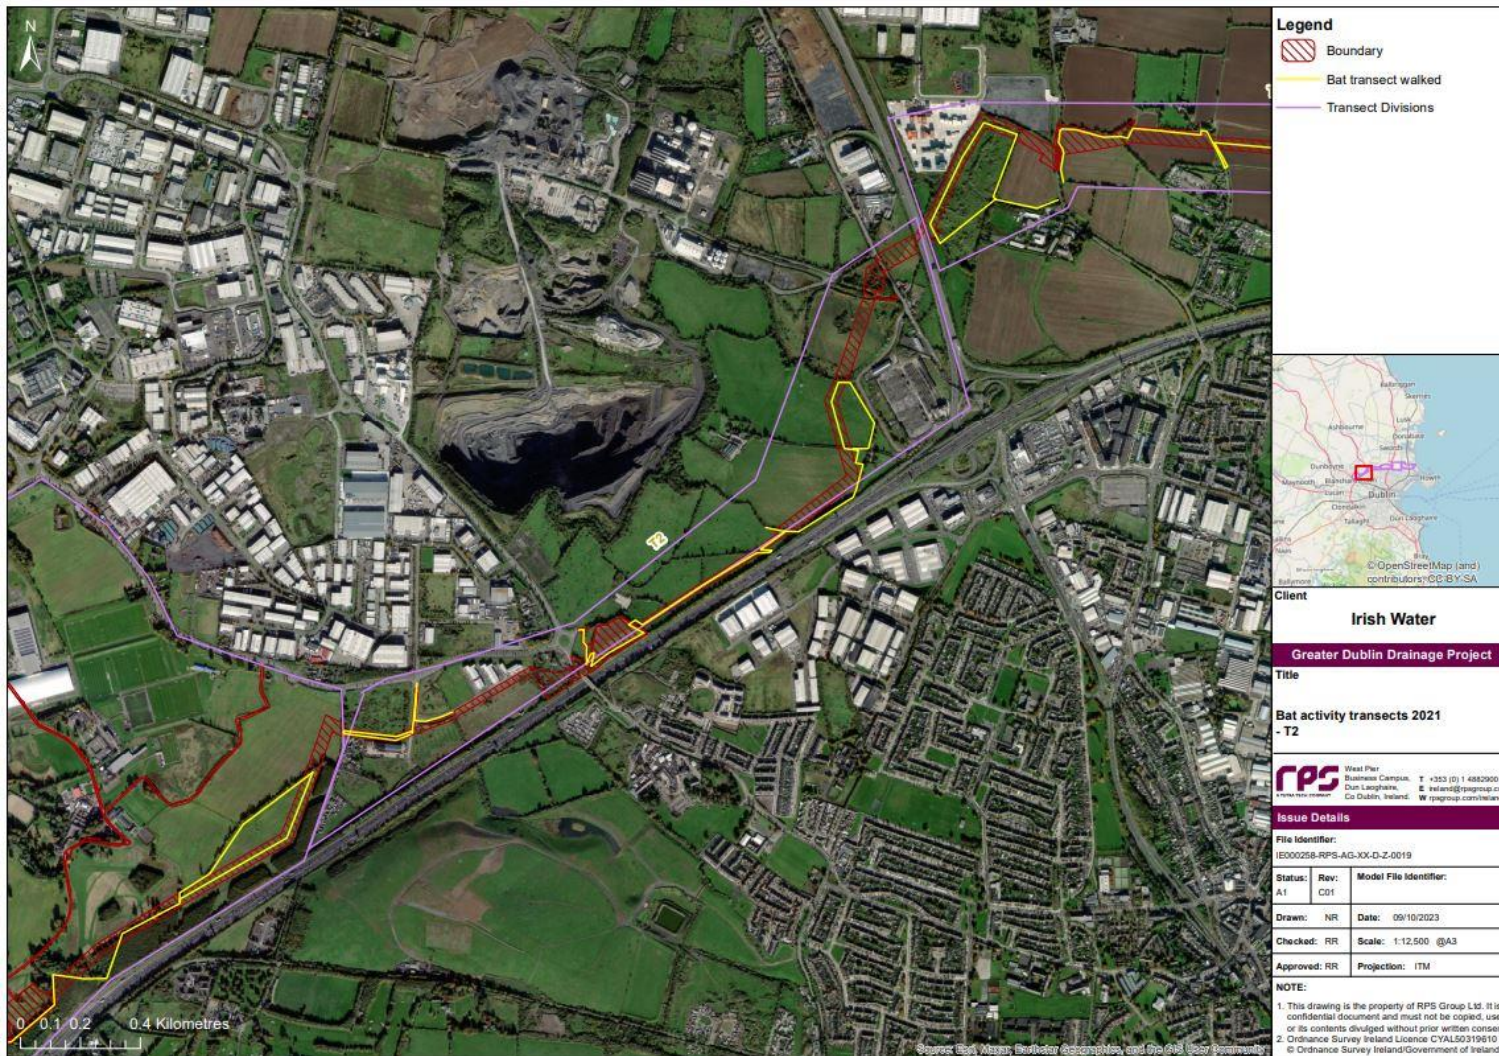
Figure F-3 Bat activity transects 2021 T2

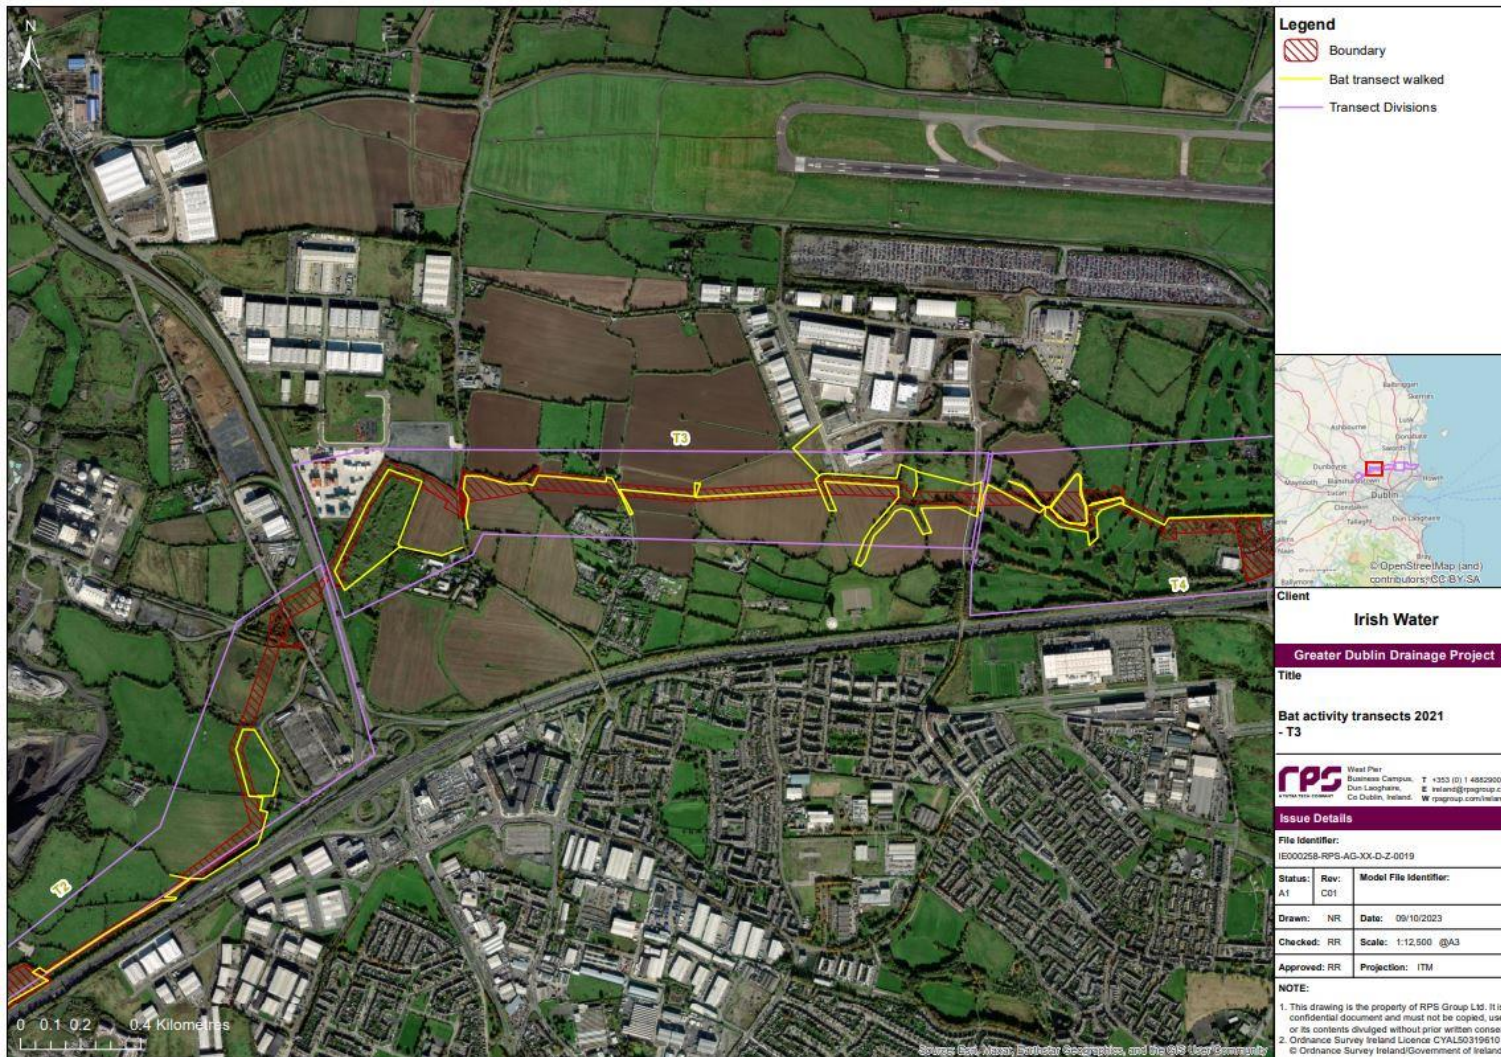
Figure F-4 Bat activity transects 2021 T3

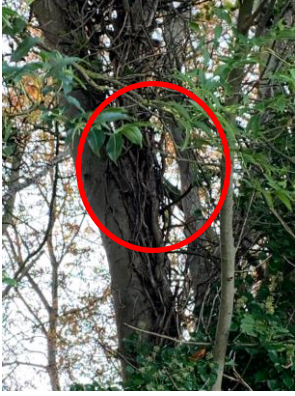
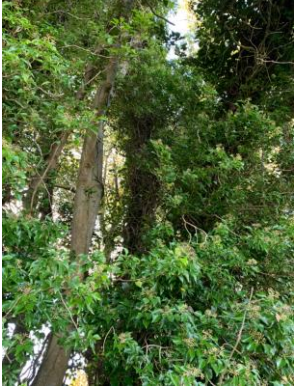
3-10	Unknown	720817.609 742841.732	<p>Unknown tree with ivy.</p>

<p>Partially detached ivy with stem diameter in excess of 50mm/Low</p>	Low

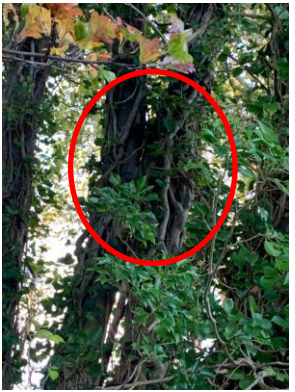
3-12	Unknown	720788.369 742839.605	Unknown tree with ivy.	Low

<p>Partially detached ivy with stem diameter in excess of 50mm/Low</p>

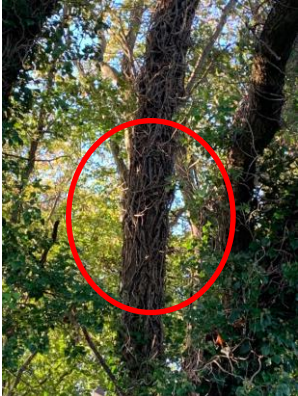
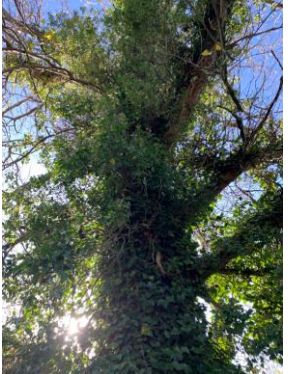
3-13	Sycamore	721544.423 742812.399	<p>Sycamore with ivy.</p>

<p>Partially detached ivy with stem diameter in excess of 50mm/Low</p>	Low

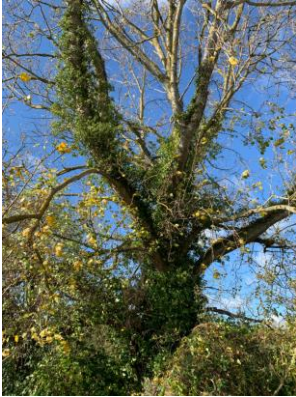
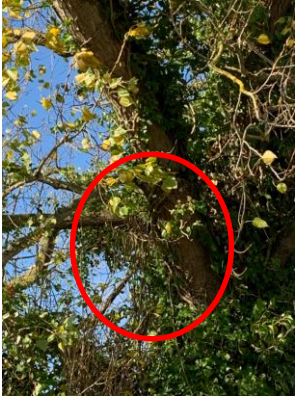
3-14	Poplar	721581.144 742887.75	<p>Poplar with ivy.</p>

<p>Partially detached ivy with stem diameter in excess of 50mm/Low</p>

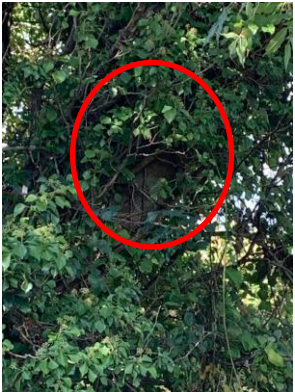
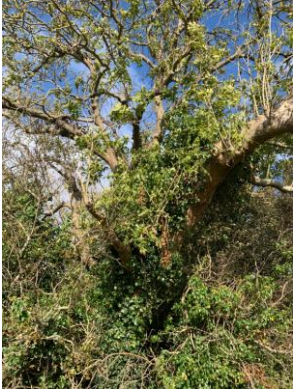
3-16	Ash	721838.954 742004.014

<p>Ash tree with cavity in branch.</p> <p>Cavity created by rot/low</p>	Low

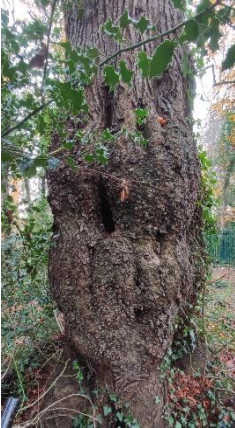
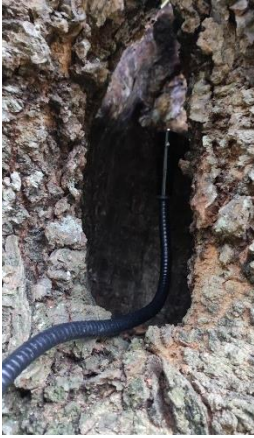
Section	Tree No.	Tree Species	Grid Ref		Tree Photo	Tree	Ground Level Roost Assessment	Roost Suitability after Tree Climbing PRF Inspection	Feature 1	Notes	Feature 2	Notes	Feature 3	Notes	Feature 4	Comments
			X	Y												
1	1-x	Lime	53.386577	-6.365871

Lime tree with burl feature at base	<u>Moderate</u>	<u>Low</u>

Small, shallow cavity approx. 1.2m high on burl feature with low dome apex. Relatively exposed to the elements.						Prior to felling, an inspection must be carried out by a licenced ecologist to ensure that there are no roosting bats present.

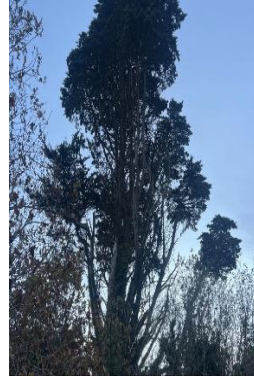
Section	Tree No.	Tree Species	Grid Ref		Tree Photo	Tree	Ground Level Roost Assessment	Roost Suitability after Tree Climbing PRF Inspection	Feature 1	Notes	Feature 2	Notes	Feature 3	Notes	Feature 4	Comments
			X	Y												
1	1-5	Cypress	53.386718	-6.362120582

Large Cypress Tree with Ivy knothole and horizontal cracks	Moderate F1 – <u>Low</u> F2 – <u>Moderate</u> F3 – <u>Moderate</u>	Low F1 – <u>Low</u> F2 – <u>Negligible</u> F3 – <u>Low</u>

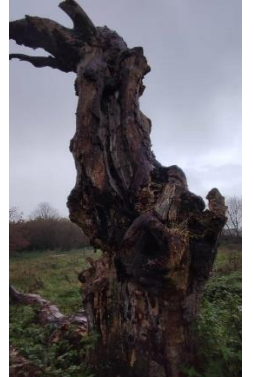
Dead beech tree with large knothole and wound feature	Moderate F1 – <u>Moderate</u> F2 – <u>Moderate</u> F3 – <u>Not Assessed</u>	Moderate F1 – <u>Moderate to Low</u> F2 – <u>Negligible</u> F3 – <u>Moderate</u>

Wound/tear out approximately 4m high on main stem. 10cm deep, upward cavity, with small ram's horn cavity on left side. Second cavity at top of feature 25cm x 5cm full of debris.		Prior to felling, an inspection must be carried out by a licenced ecologist to ensure that there are no roosting bats present.

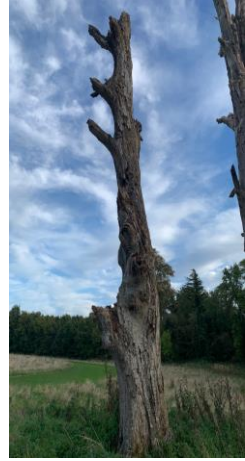
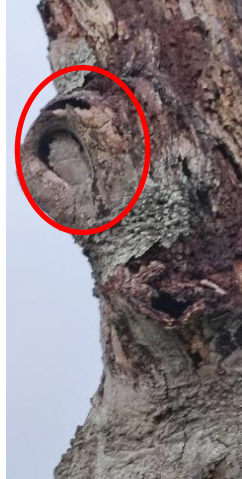
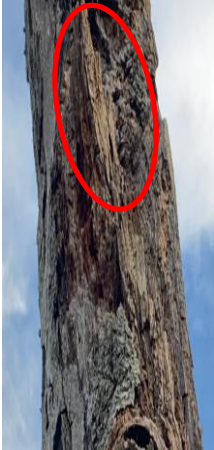
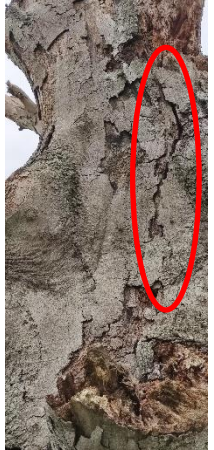
Section	Tree No.	Tree Species	Grid Ref		Tree Photo	Tree	Ground Level Roost Assessment	Roost Suitability after Tree Climbing PRF Inspection	Feature 1	Notes	Feature 2	Notes	Feature 3	Notes	Feature 4	Comments
			X	Y												
1	1-9	Beech	53.38709983	-6.361453143

Dead beech tree with pruning cur PRF, breakage and vertical crack.	Moderate F1 – <u>Moderate</u> F2 – <u>Moderate</u> F3 – <u>Not Assessed</u>	Moderate F1 – <u>Negligible</u> F2 – <u>Moderate</u> F3 – <u>Moderate</u>

Knothole Considered unsuitable upon inspection.

Knothole Rotten branch approx. 7m up travels around in 25cm, 13cm internal diameter, rough texture inside with lots of debris and webs, some smaller narrow cavities, slightly exposed.

Vertical crack on bark. Approximately 2-3m wide at widest part and 12cm deep. Sufficient room inside the cavity for a small number of bats.	Prior to felling, an inspection must be carried out by a licenced ecologist to ensure that there are no roosting bats present.

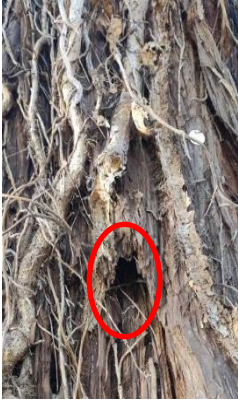
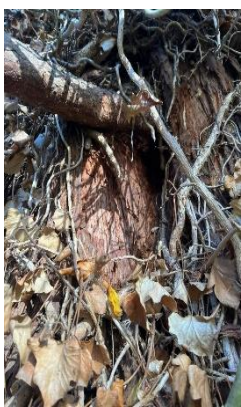
Californian Redwood. Raised/lifting bark cavities, and compression type groove in bark under overhanging limb.	Moderate F1 – <u>Low</u> F2 – <u>Moderate</u>	Moderate F1 – <u>Moderate</u> F2 – <u>Negligible</u>

Vertical crack/low All under 2m bark plate cavities from 10 – 25cm – moderate. There are other smaller cavities on all aspects of tree, considered to have Low Bat Roosting Suitability.

unsuitable upon close inspection.				Prior to felling, an inspection must be carried out by a licenced ecologist to ensure that there are no roosting bats present.

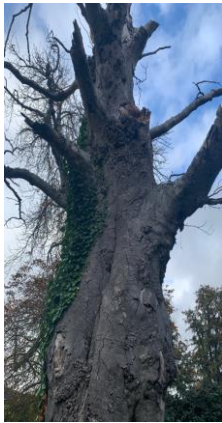
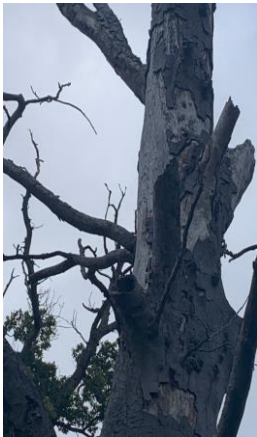
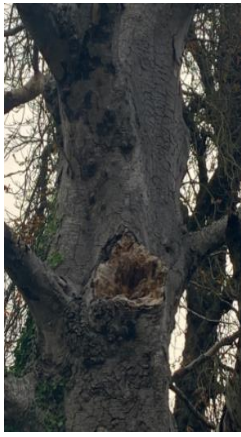
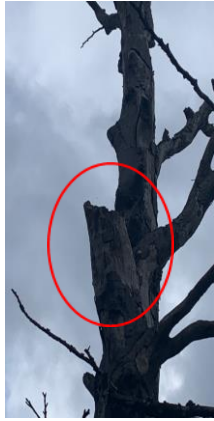
Section	Tree No.	Tree Species	Grid Ref		Tree Photo	Tree	Ground Level Roost Assessment	Roost Suitability after Tree Climbing PRF Inspection	Feature 1	Notes	Feature 2	Notes	Feature 3	Notes	Feature 4	Comments
			X	Y												
1	1-34	Beech	53.39024099	-6.353970711

Large Dead beech tree with knotholes	Moderate F1 – <u>Moderate</u> F2 – <u>Moderate</u> F3 – <u>Moderate</u>	Negligible F1 – <u>Negilible</u> F2 – <u>Negilible</u> F3 – <u>Negilible</u>

Knothole – not suitable upon inspection

No cavity present – not suitable

Knothole-downward facing cavity – not suitable upon inspection		No actions required.

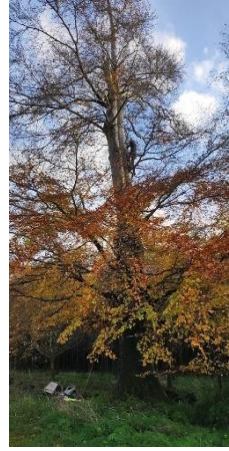
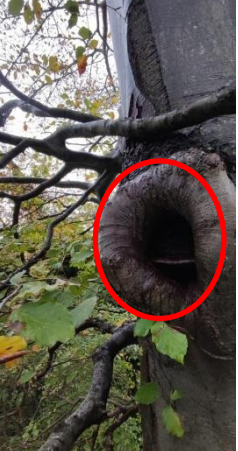
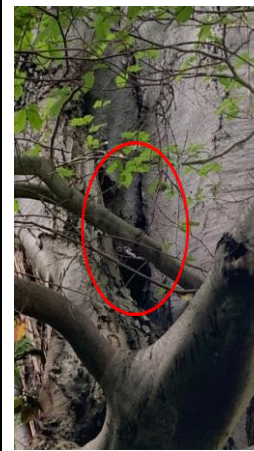
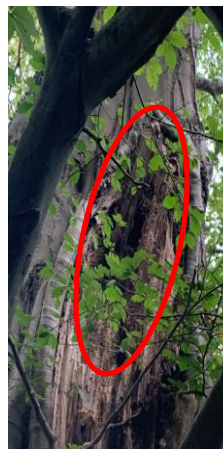
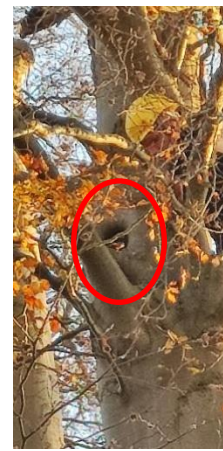
Section	Tree No.	Tree Species	Grid Ref		Tree Photo	Tree	Ground Level Roost Assessment	Roost Suitability after Tree Climbing PRF Inspection	Feature 1	Notes	Feature 2	Notes	Feature 3	Notes	Feature 4	Comments
			X	Y												
1	1-35	Beech	53.39025321	-6.353435219

Large twin stemmed beech with knotholes, rot cavities and crack.	Moderate F1 – <u>Low</u> F2- <u>Moderate</u> F3 – <u>Moderate</u> F4 – <u>Not Assessed</u> F5 – <u>Not Assessed</u> F6 – <u>Not Assessed</u>	High F1 – <u>Low</u> F2- <u>Moderate/High</u> F3 – <u>Moderate/High</u> F4 – <u>High</u> F5- <u>Moderate</u> F6- <u>High</u>

Knothole 9m high on main lower single stem. 12cm tall x 10cm wide, bracket fungus inside, wet, internal depth 13cm, exposed to weather.

5m high, east facing, bracket fungus, partially damp, 12cm wide x 15cm tall depth 15cm internal upwards cavity travels approximately 40cm – debris inside.

Large cavity, south facing cavity, rotting leading into a canker feature lower down, >1m– non uniform in shape, partially damp inside, rough texture, cavity travels into heartwood of tree.

Prior to felling, an inspection must be carried out by a licenced ecologist to ensure that there are no roosting bats present. Other PRFs- Feature 5 – Vertical crack Approx. 8m high on one of two stems, 90cm long, 2-3cm wide which leads into a narrow cavity. Active honeybee nest present at time of survey. Feature 6- wound cavity above Feature 5. Entrance height 25cm, entrance width 7cm, internal height 80cm, depth 25cm. Three knotholes located at 13m, 11m, and 10m were inspected and found to be unsuitable.

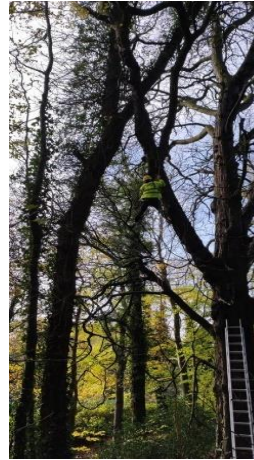
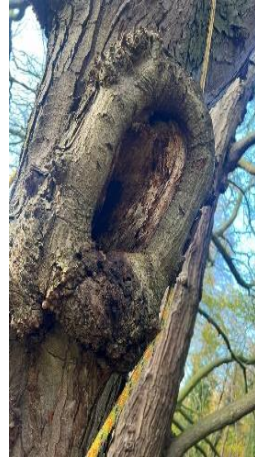
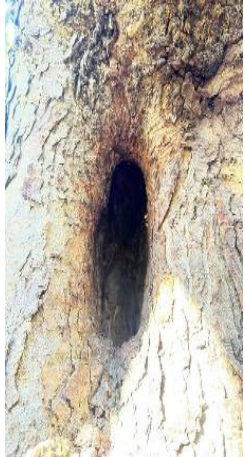
Section	Tree No.	Tree Species	Grid Ref		Tree Photo	Tree	Ground Level Roost Assessment	Roost Suitability after Tree Climbing PRF Inspection	Feature 1	Notes	Feature 2	Notes	Feature 3	Notes	Feature 4	Comments
			X	Y												
	1-51	Horse Chestnut	53.388887	-6.373321507

Horse chestnut tree with knot hole and wound.	High F1 – <u>High</u> F2 – <u>Not Assessed</u>	Negligible F1 – <u>Negligible</u> F2 – <u>Negligible</u>

Large Knot hole 5m high. Upon close inspection it is considered unsuitable.

Wound 10 m high. Upon close inspection it is considered unsuitable due to insufficient cavity size and exposure to the elements.				No actions required.

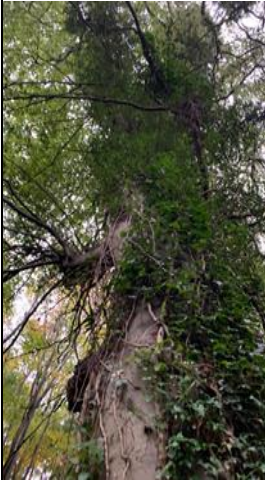
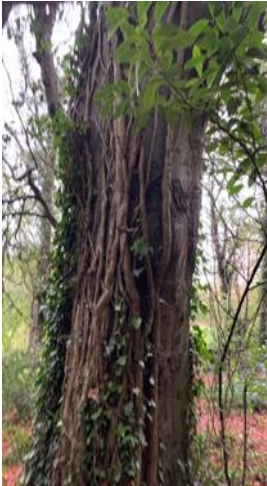
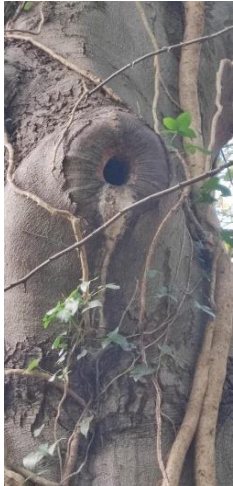
Section	Tree No.	Tree Species	Grid Ref		Tree Photo	Tree	Ground Level Roost Assessment	Roost Suitability after Tree Climbing PRF Inspection	Feature 1	Notes	Feature 2	Notes	Feature 3	Notes	Feature 4	Comments
			X	Y												
1	1-52	Beech	53.38892073	-6.373207361

Beech tree with ivy and knothole	Moderate F1 – <u>Low</u> F2 – <u>Moderate</u>	High F1 – <u>Low</u> F2 – <u>High</u>

Ivy – limited Roosting Suitability.

Knothole 6m high, external diameter 10cm, depth approx. 75cm, width 35cm, 80cm high, damp ground, dry inside, various sections, dome apex.				Prior to felling, an inspection must be carried out by a licenced ecologist to ensure that there are no roosting bats present.

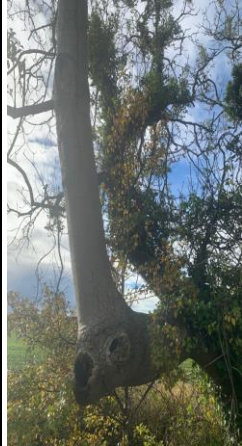
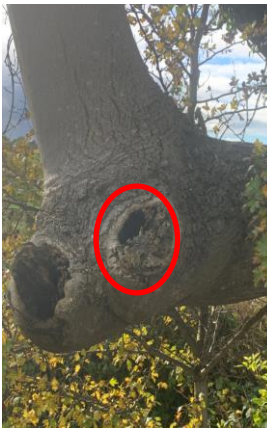
Section	Tree No.	Tree Species	Grid Ref		Tree Photo	Tree	Ground Level Roost Assessment	Roost Suitability after Tree Climbing PRF Inspection	Feature 1	Notes	Feature 2	Notes	Feature 3	Notes	Feature 4	Comments
			X	Y												
2	2-3	Ash	53.41295368	-6.289062384

Ash tree with knothole	<u>Moderate</u>	<u>Moderate</u>

<p>Knothole approximately 1.3m high.</p> <p>Cavity depth 40cm x 5cm x 5cm, travels horizontally into the stem, dirty and damp inside.</p>						Prior to felling, an inspection must be carried out by a licenced ecologist to ensure that there are no roosting bats present.

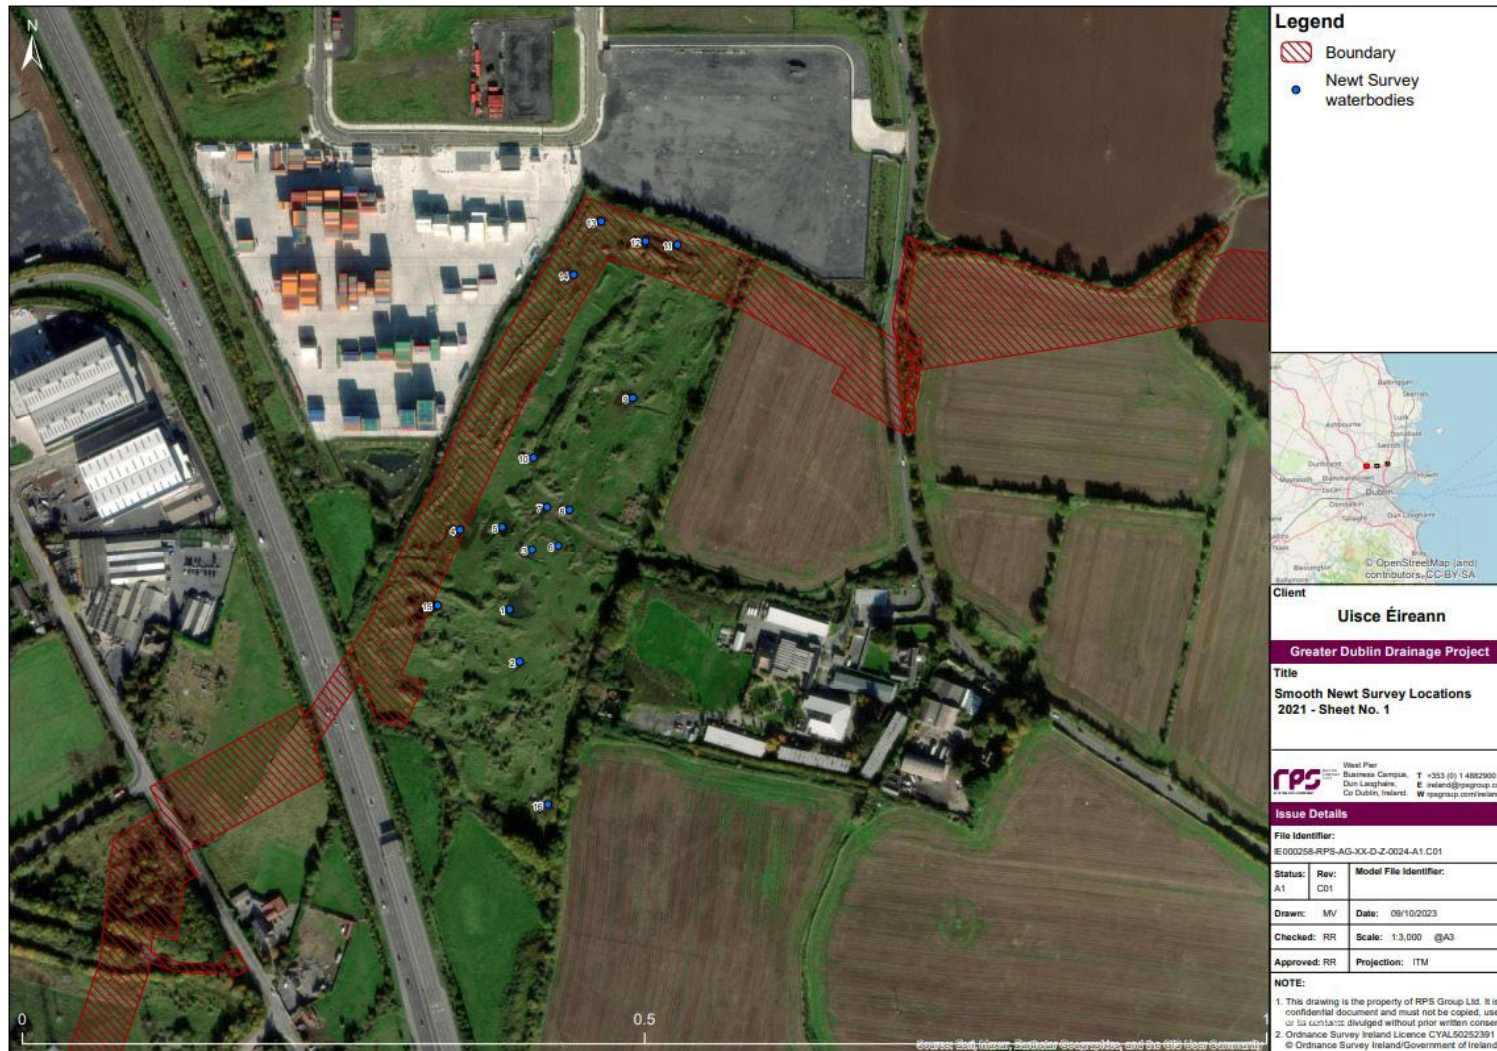
Figure M-2 Smooth Newt survey locations 2021 (1)

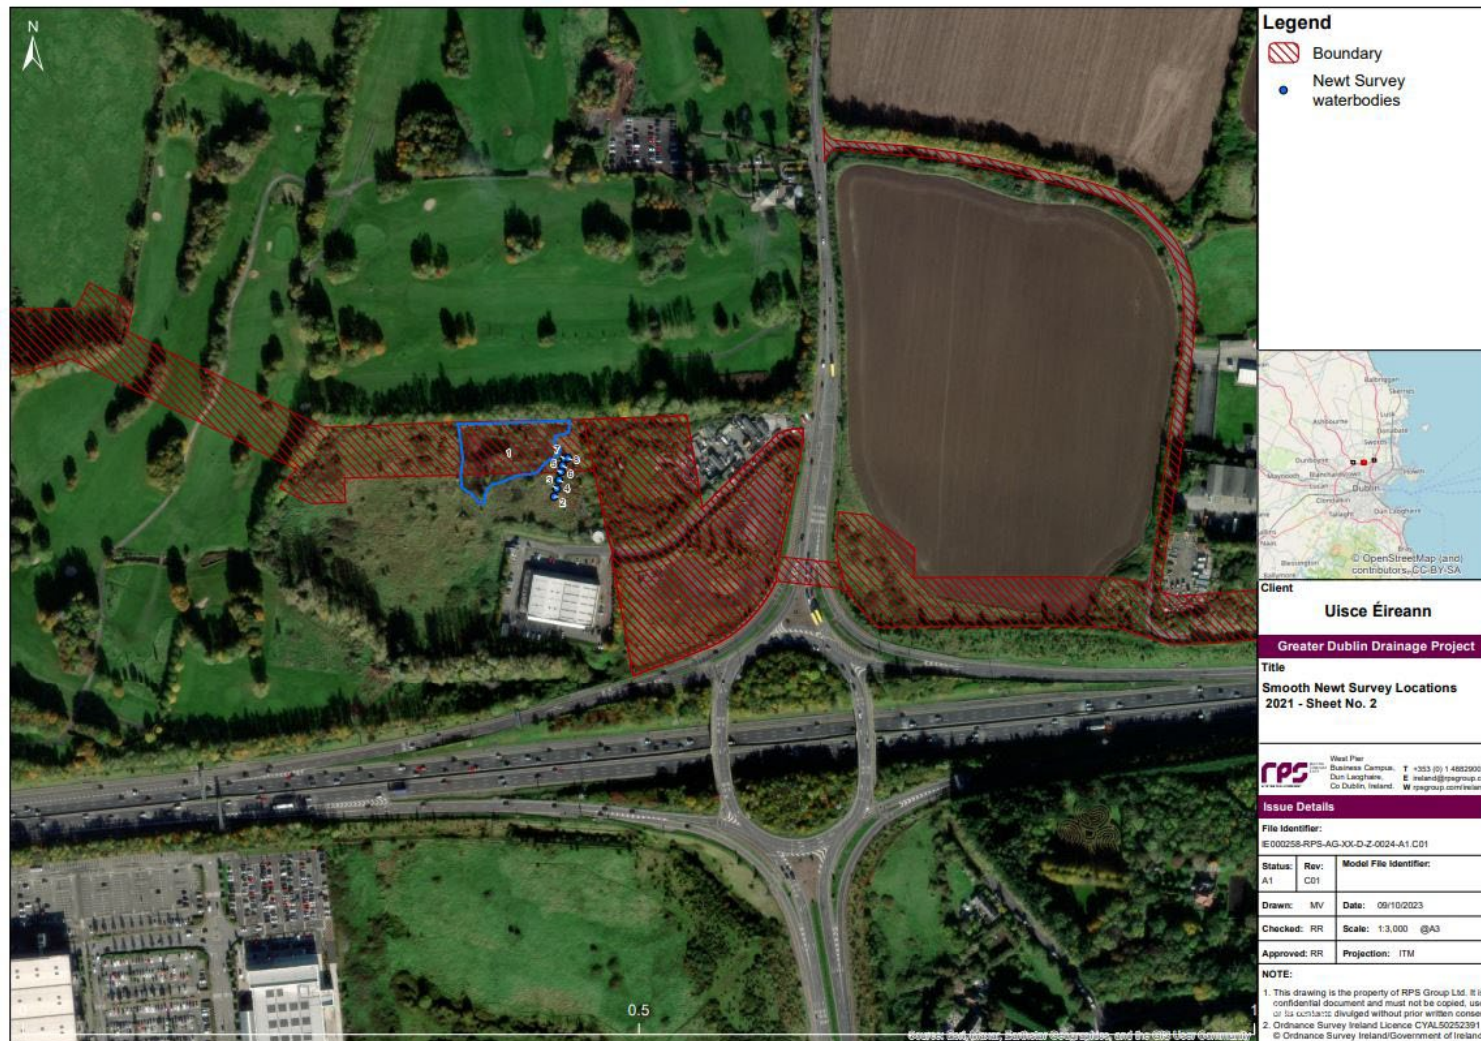
Figure M-3 Smooth Newt survey locations 2021 (2)

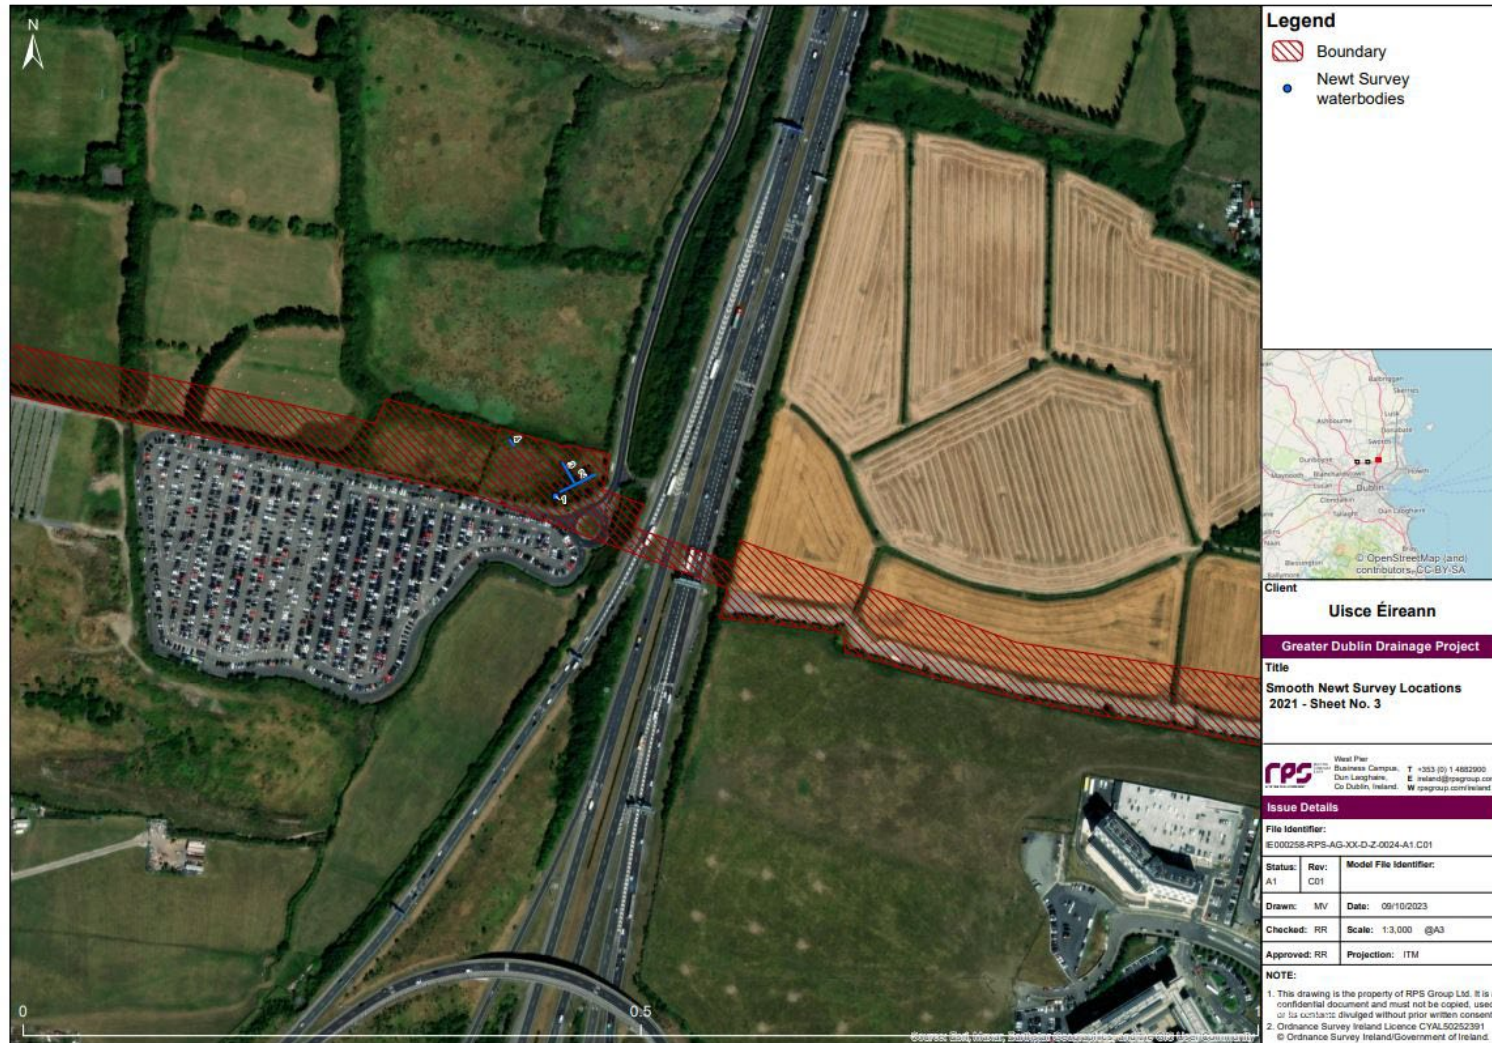
Figure M-4 Smooth Newt survey locations 2021 (3)

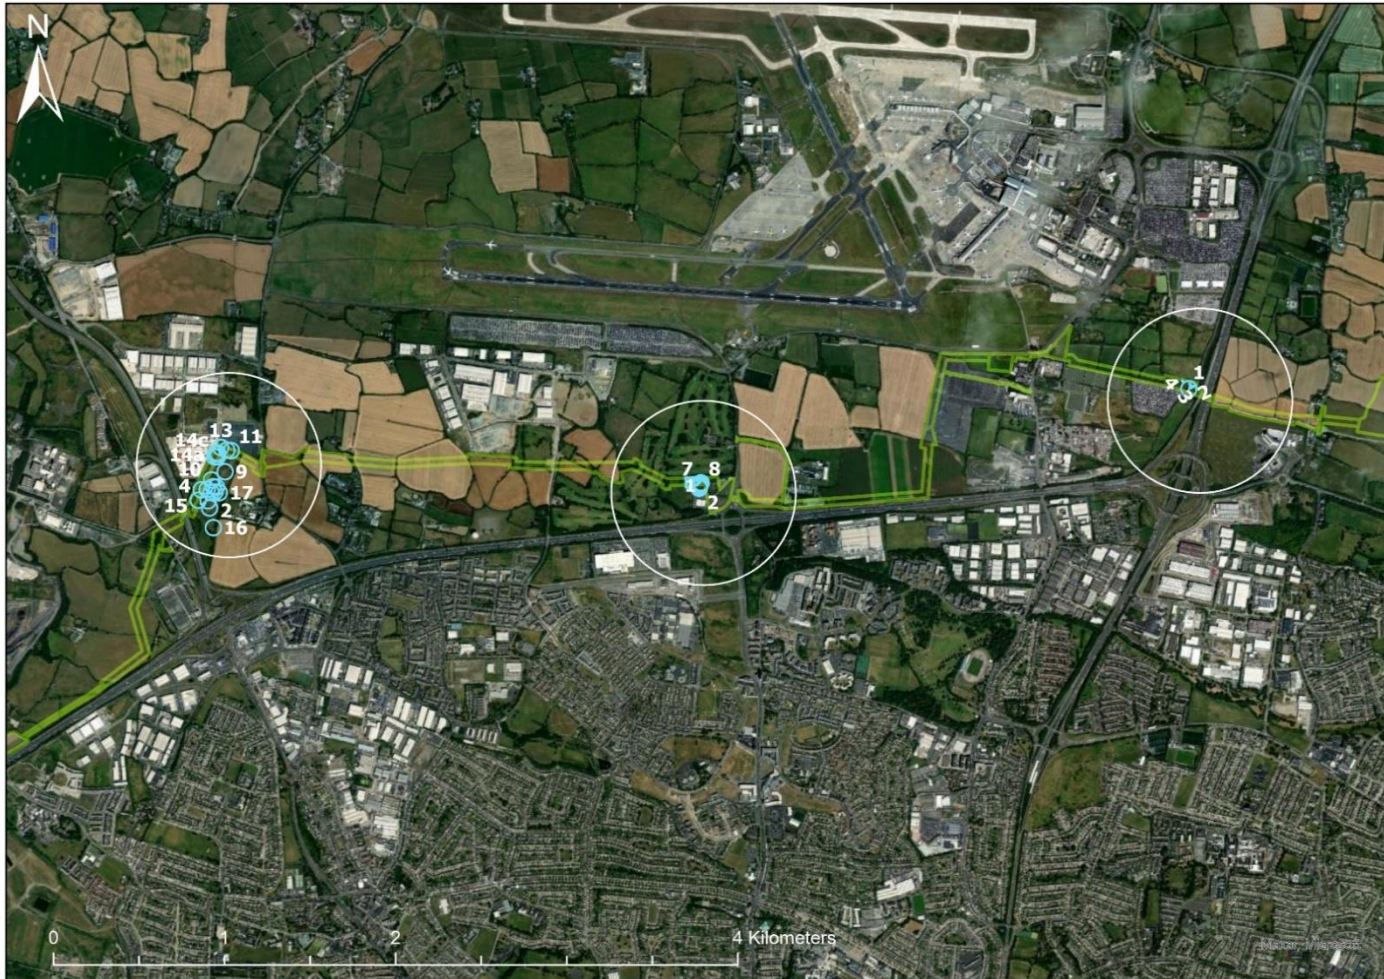
Figure 3.1: Site 1, Site 2 and Site 3 Locations – Overview Map

The site locations are presented in **Figure 3.1** (overview map), **Figure 3.2** (Site 1), **Figure 3.3** (Site 2) and **Figure 3.4** (Site 3).

Site no.	Location	No of waterbodies	Description
1	Coldwinters	20	A mixture shallow depressions with deeper pools or ponds
2	Ballymun	8	One large, interconnected waterbody (variable depths) with seven aligned smaller pools (old foundation works) adjacent
3	Toberbunny	4	One shallow depression and 3 drainage ditches
